**"THE NON-TIDAL, NAVIGABLE THAMES:
A BANK EROSION MANAGEMENT STRATEGY"**

by Sue Reed BSc, MSc, MCIWEM

**Thesis submitted to the University of Nottingham
for the degree of Doctor of Philosophy, October 1998**

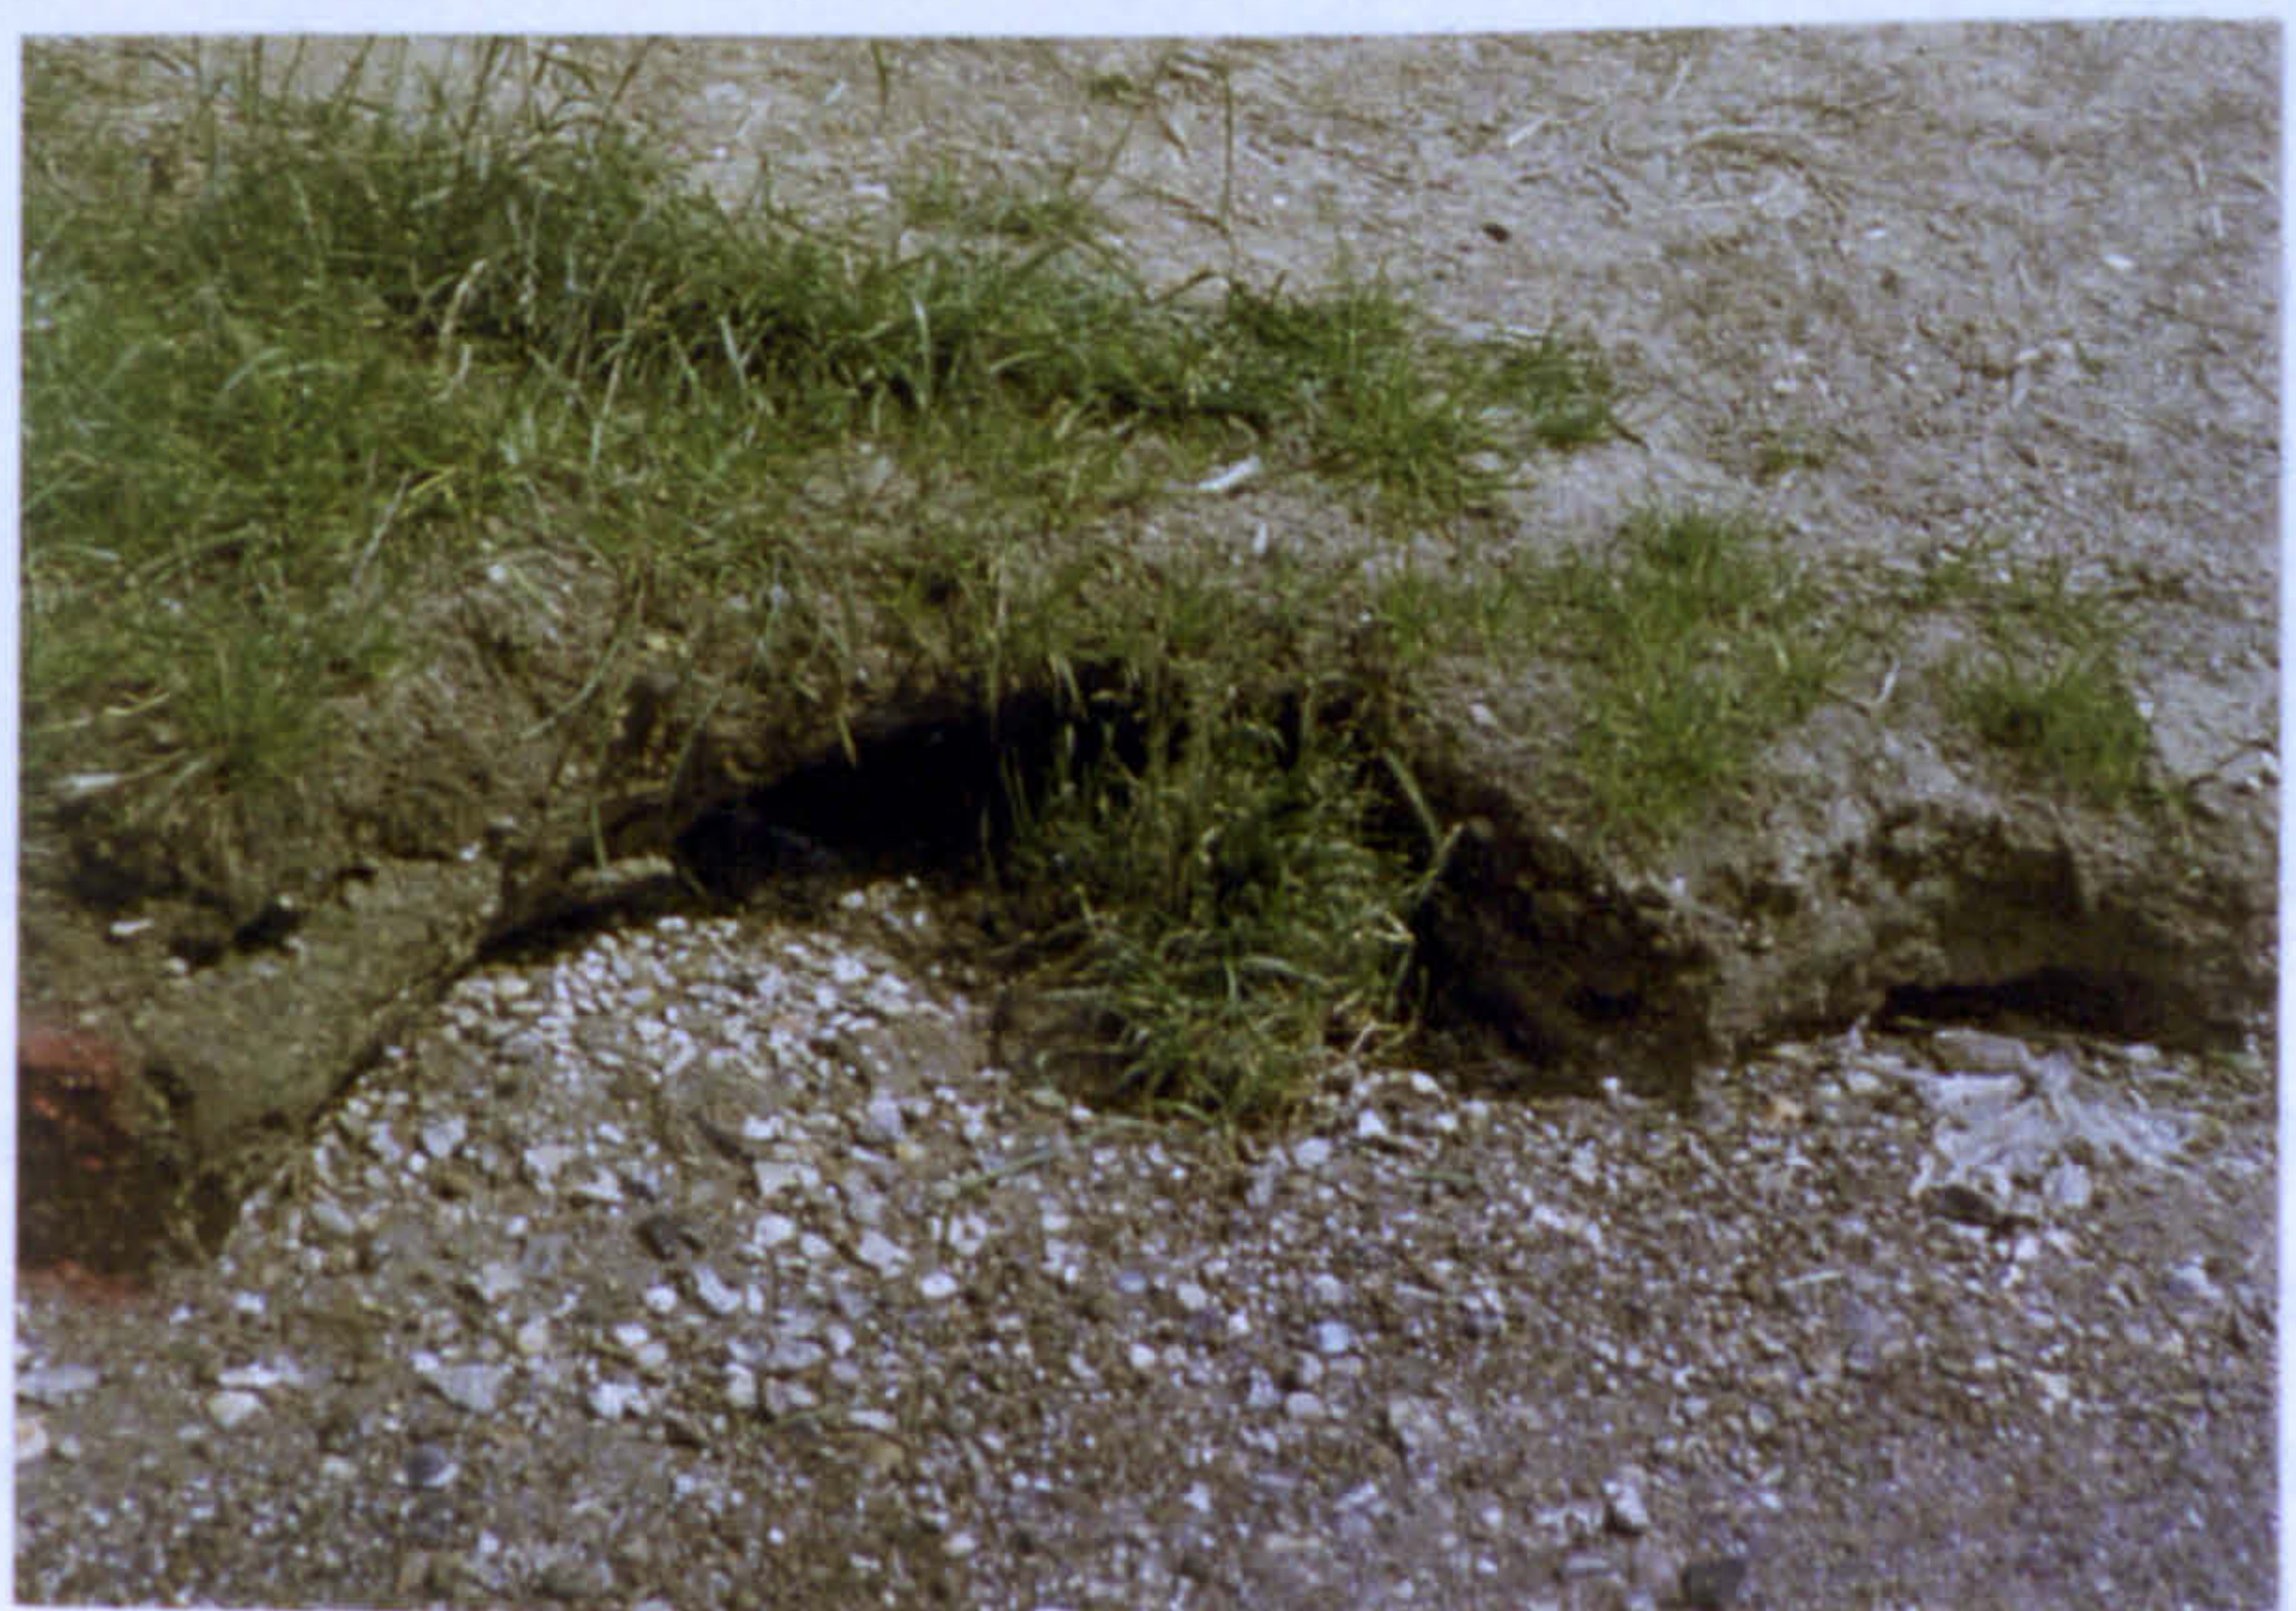
At profile three the most upper bank erosion measured was 51mm between 3 January and 5 February 1992 however, the cumulative contribution to upper bank erosion from the autumn and winter discharges amounted to 80mm. The lower bank erosion measured between 9 March and 13 April 1992 amounted to 45mm and was the most recorded at the lower bank in any one visit. However, after the autumn flows an additional 40mm of erosion was recorded here, and the pins could not be relocated again during the monitoring period. Bank failure had not occurred to any great extent at profile three prior to the February 1993 survey as the bank survey shown in Appendix 4.4 would have collaborated with this. In addition, the upper erosion pin was located on the February visit but the high flow prohibited measurement of erosion at the lower pin. The appearance of the bank would suggest that there had not been any significant retreat of the bank since the visit to the site in February 1993. However, the toe of the bank had obviously been undercut in the vicinity of the lower pin and the upper pin had been deliberately dug out of the bank (see Plate 4.11).

Plate 4.11
Undercutting at the
toe of the bank at
profile three.

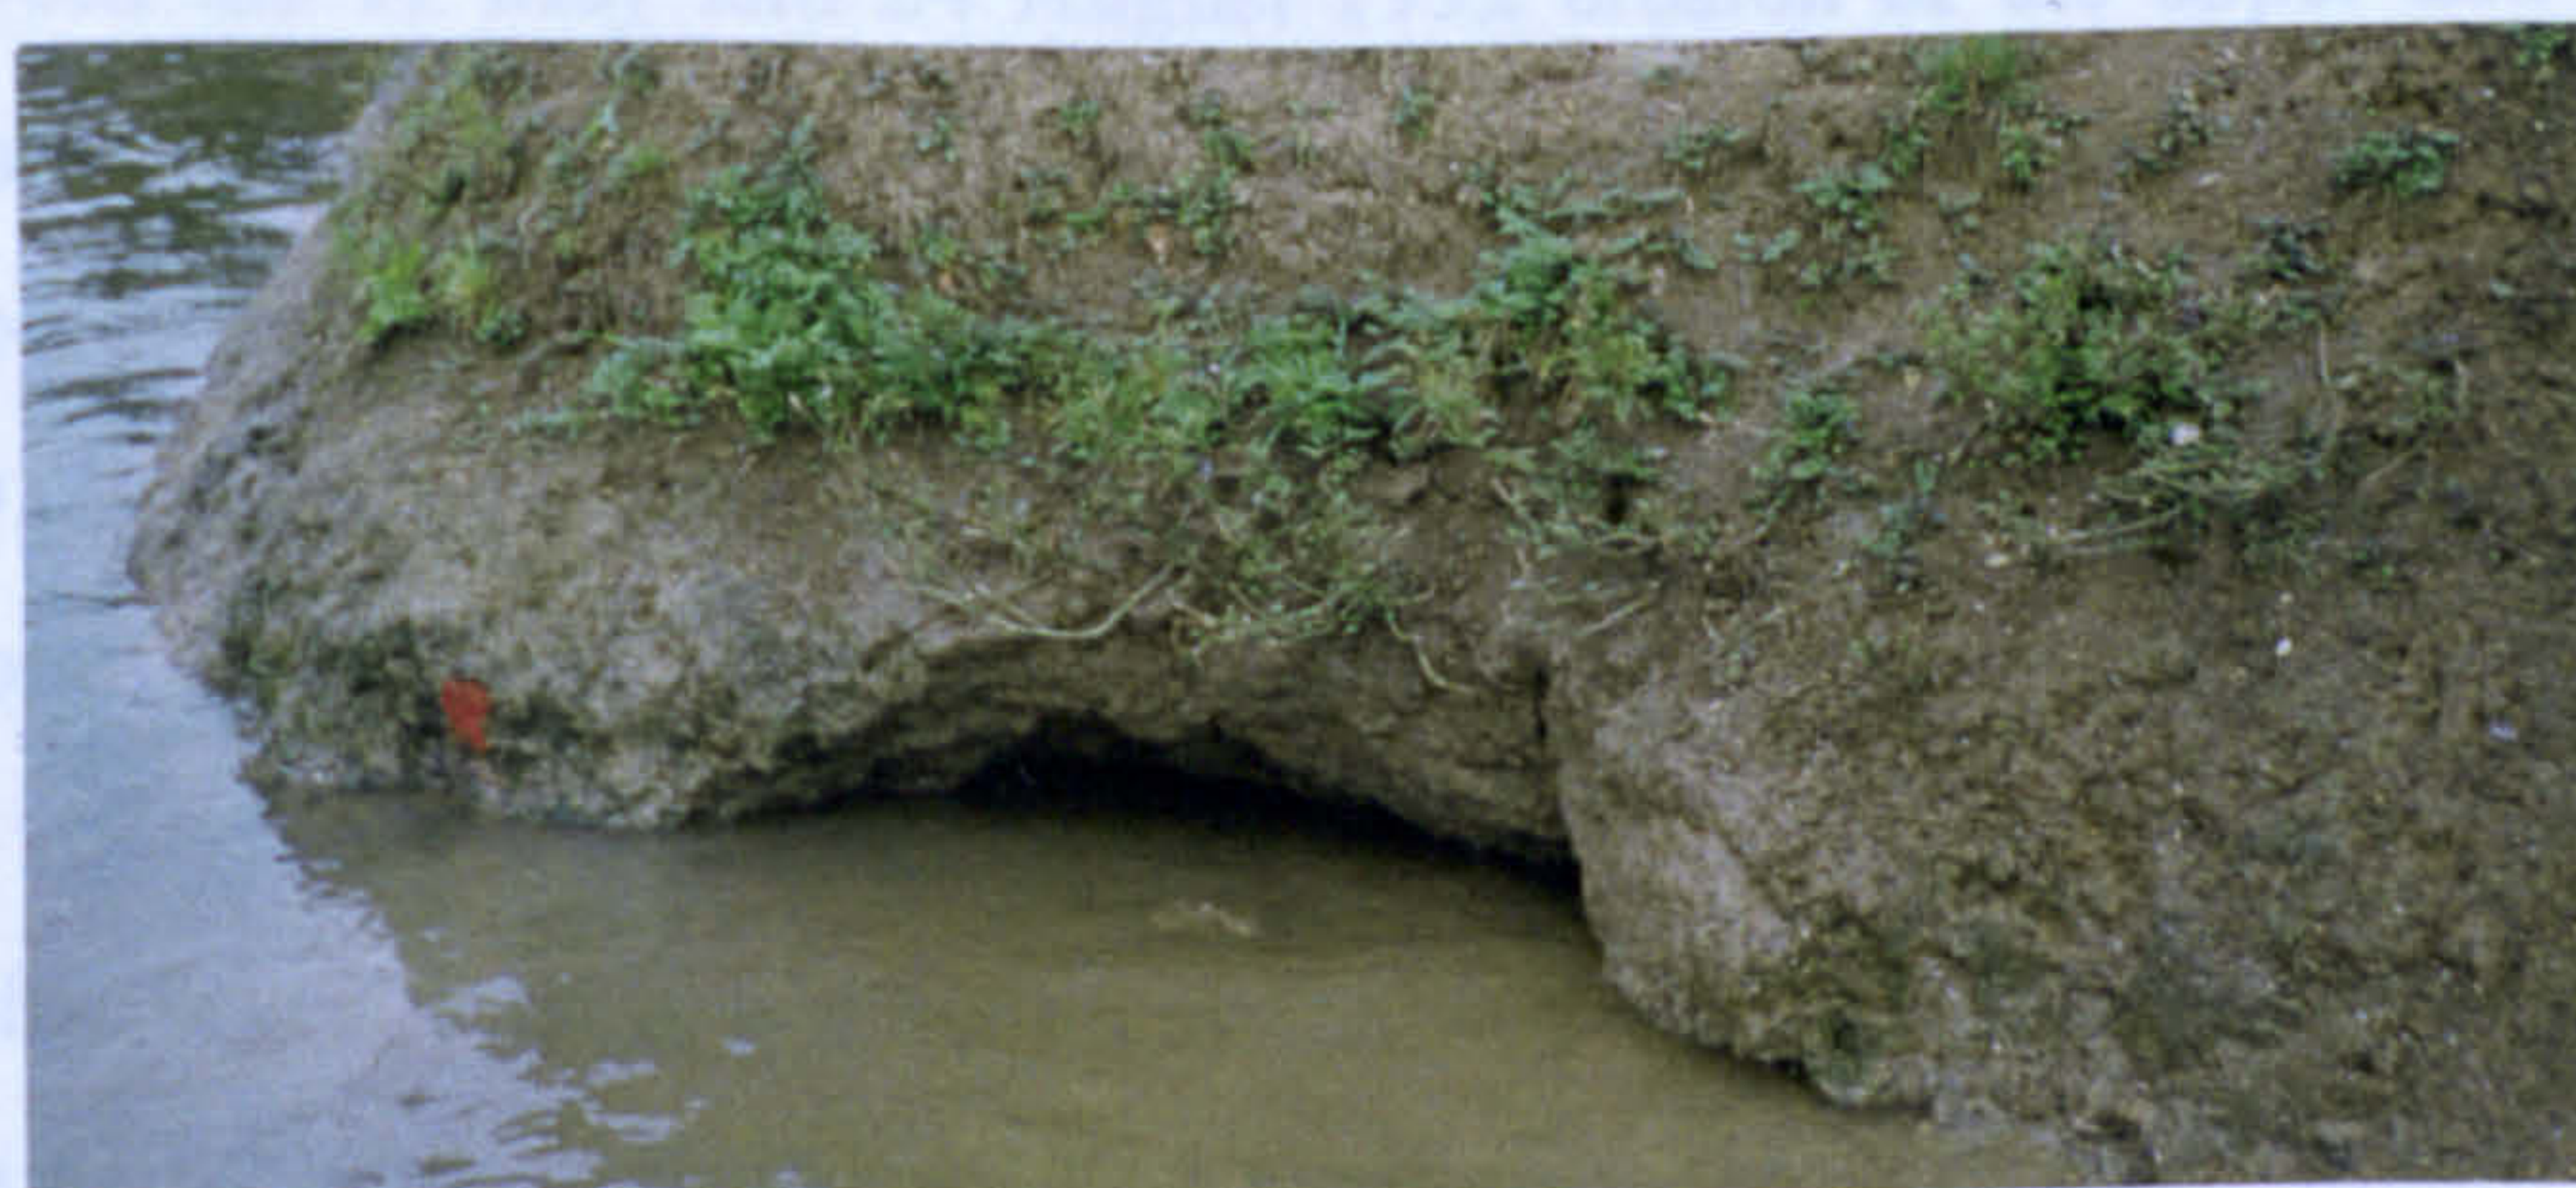
*Plate 4.12
Undercutting
at the toe of
the bank at
profile four.*

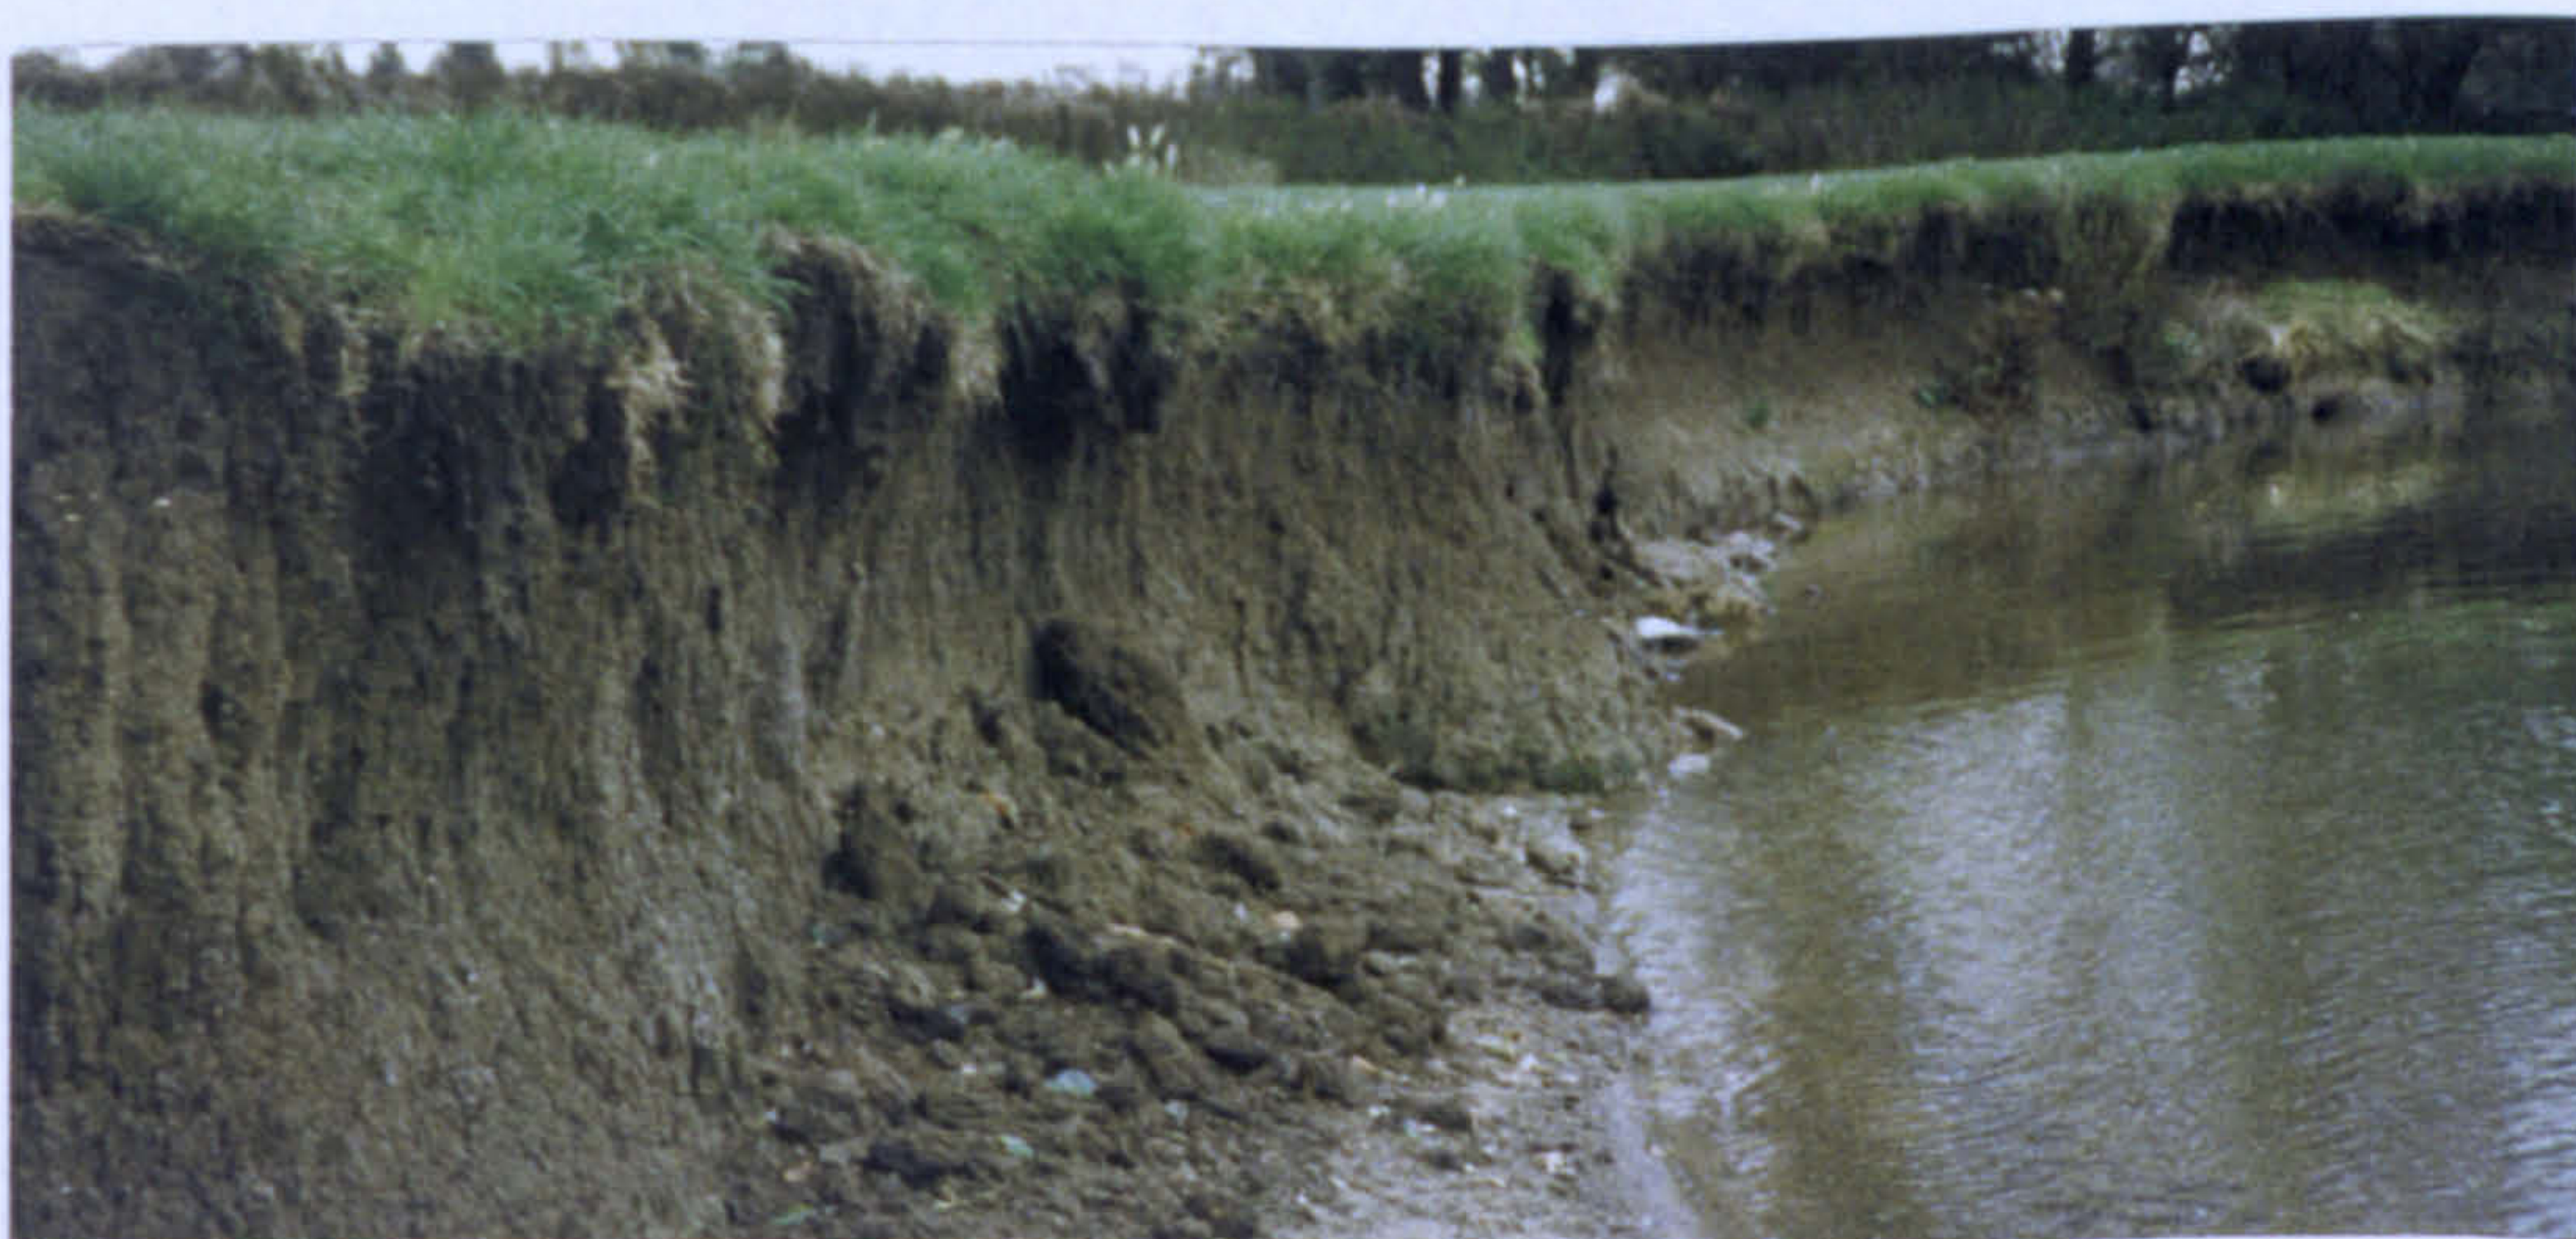
Plate 4.16 Bank failure following subsidence of high flows in autumn 1992.

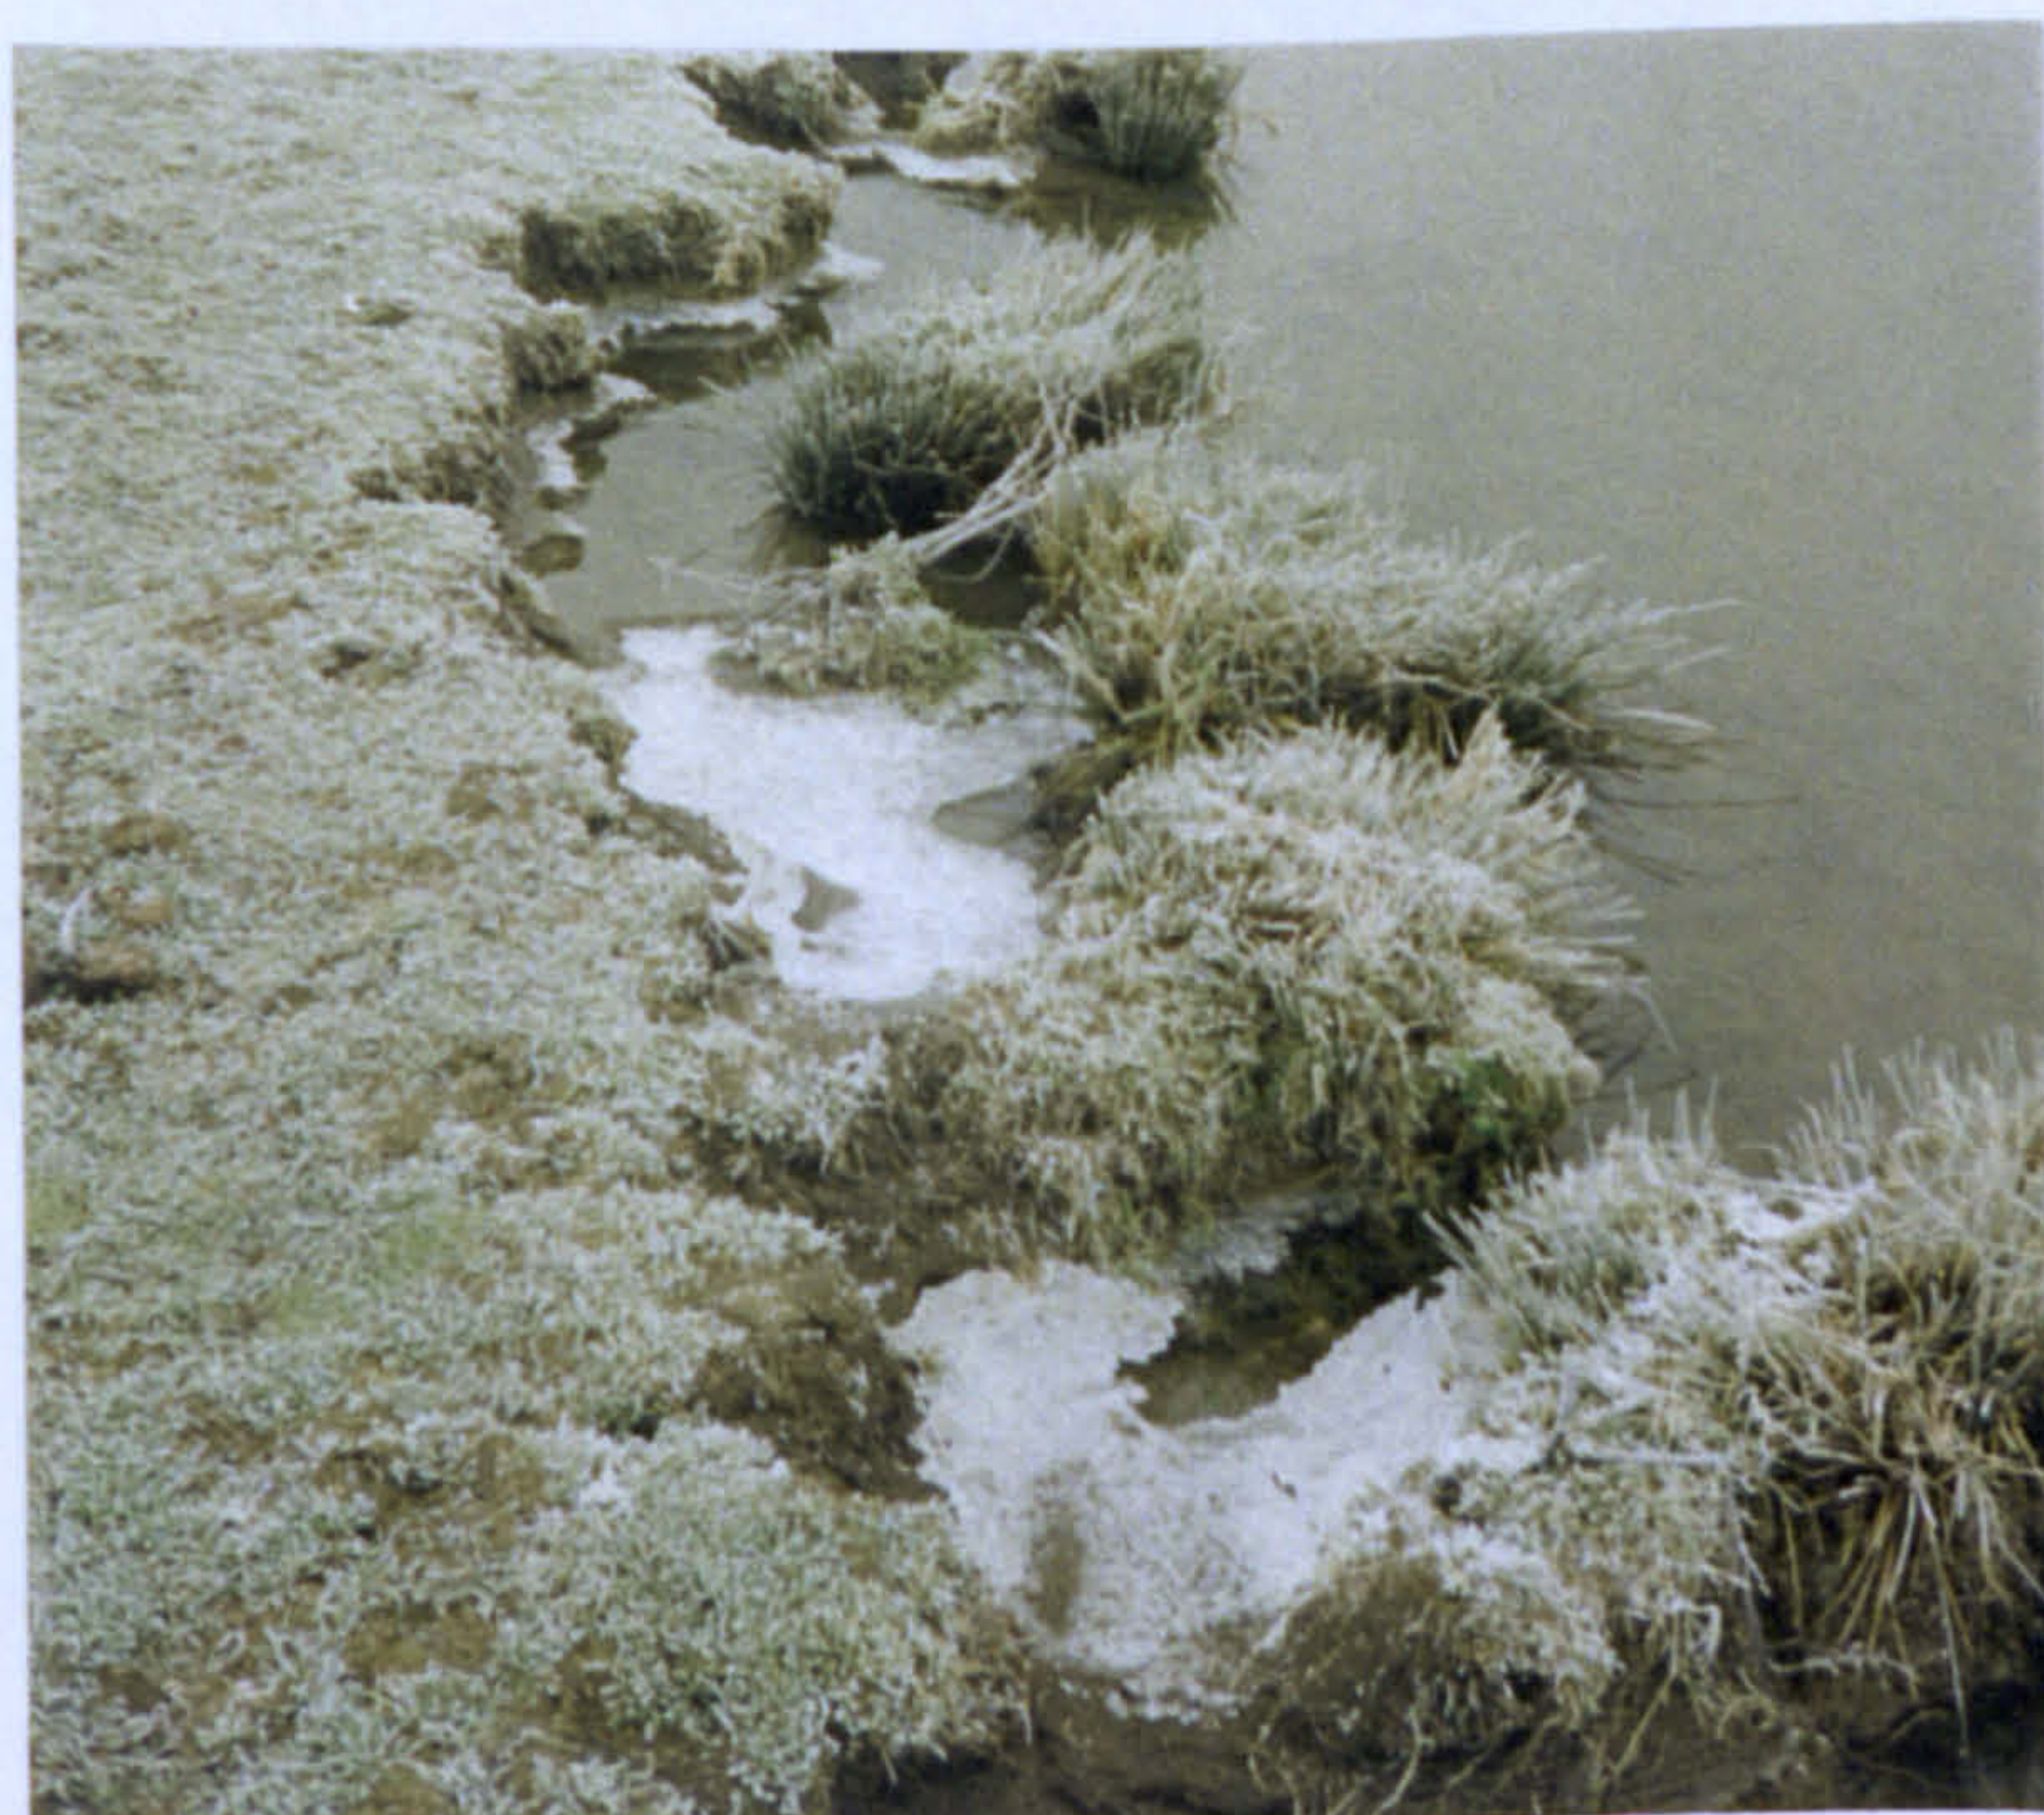
The bank here is low ($<0.5\text{m}$), and remained saturated most of the year, with frost action during the early part of the monitoring season probably responsible for the majority of the spring time erosion. Frost action was particularly significant at the lower erosion pin, which was placed at the level of the water surface (Plate 4.20).

Plate 4.20
Frost action
at Goring.

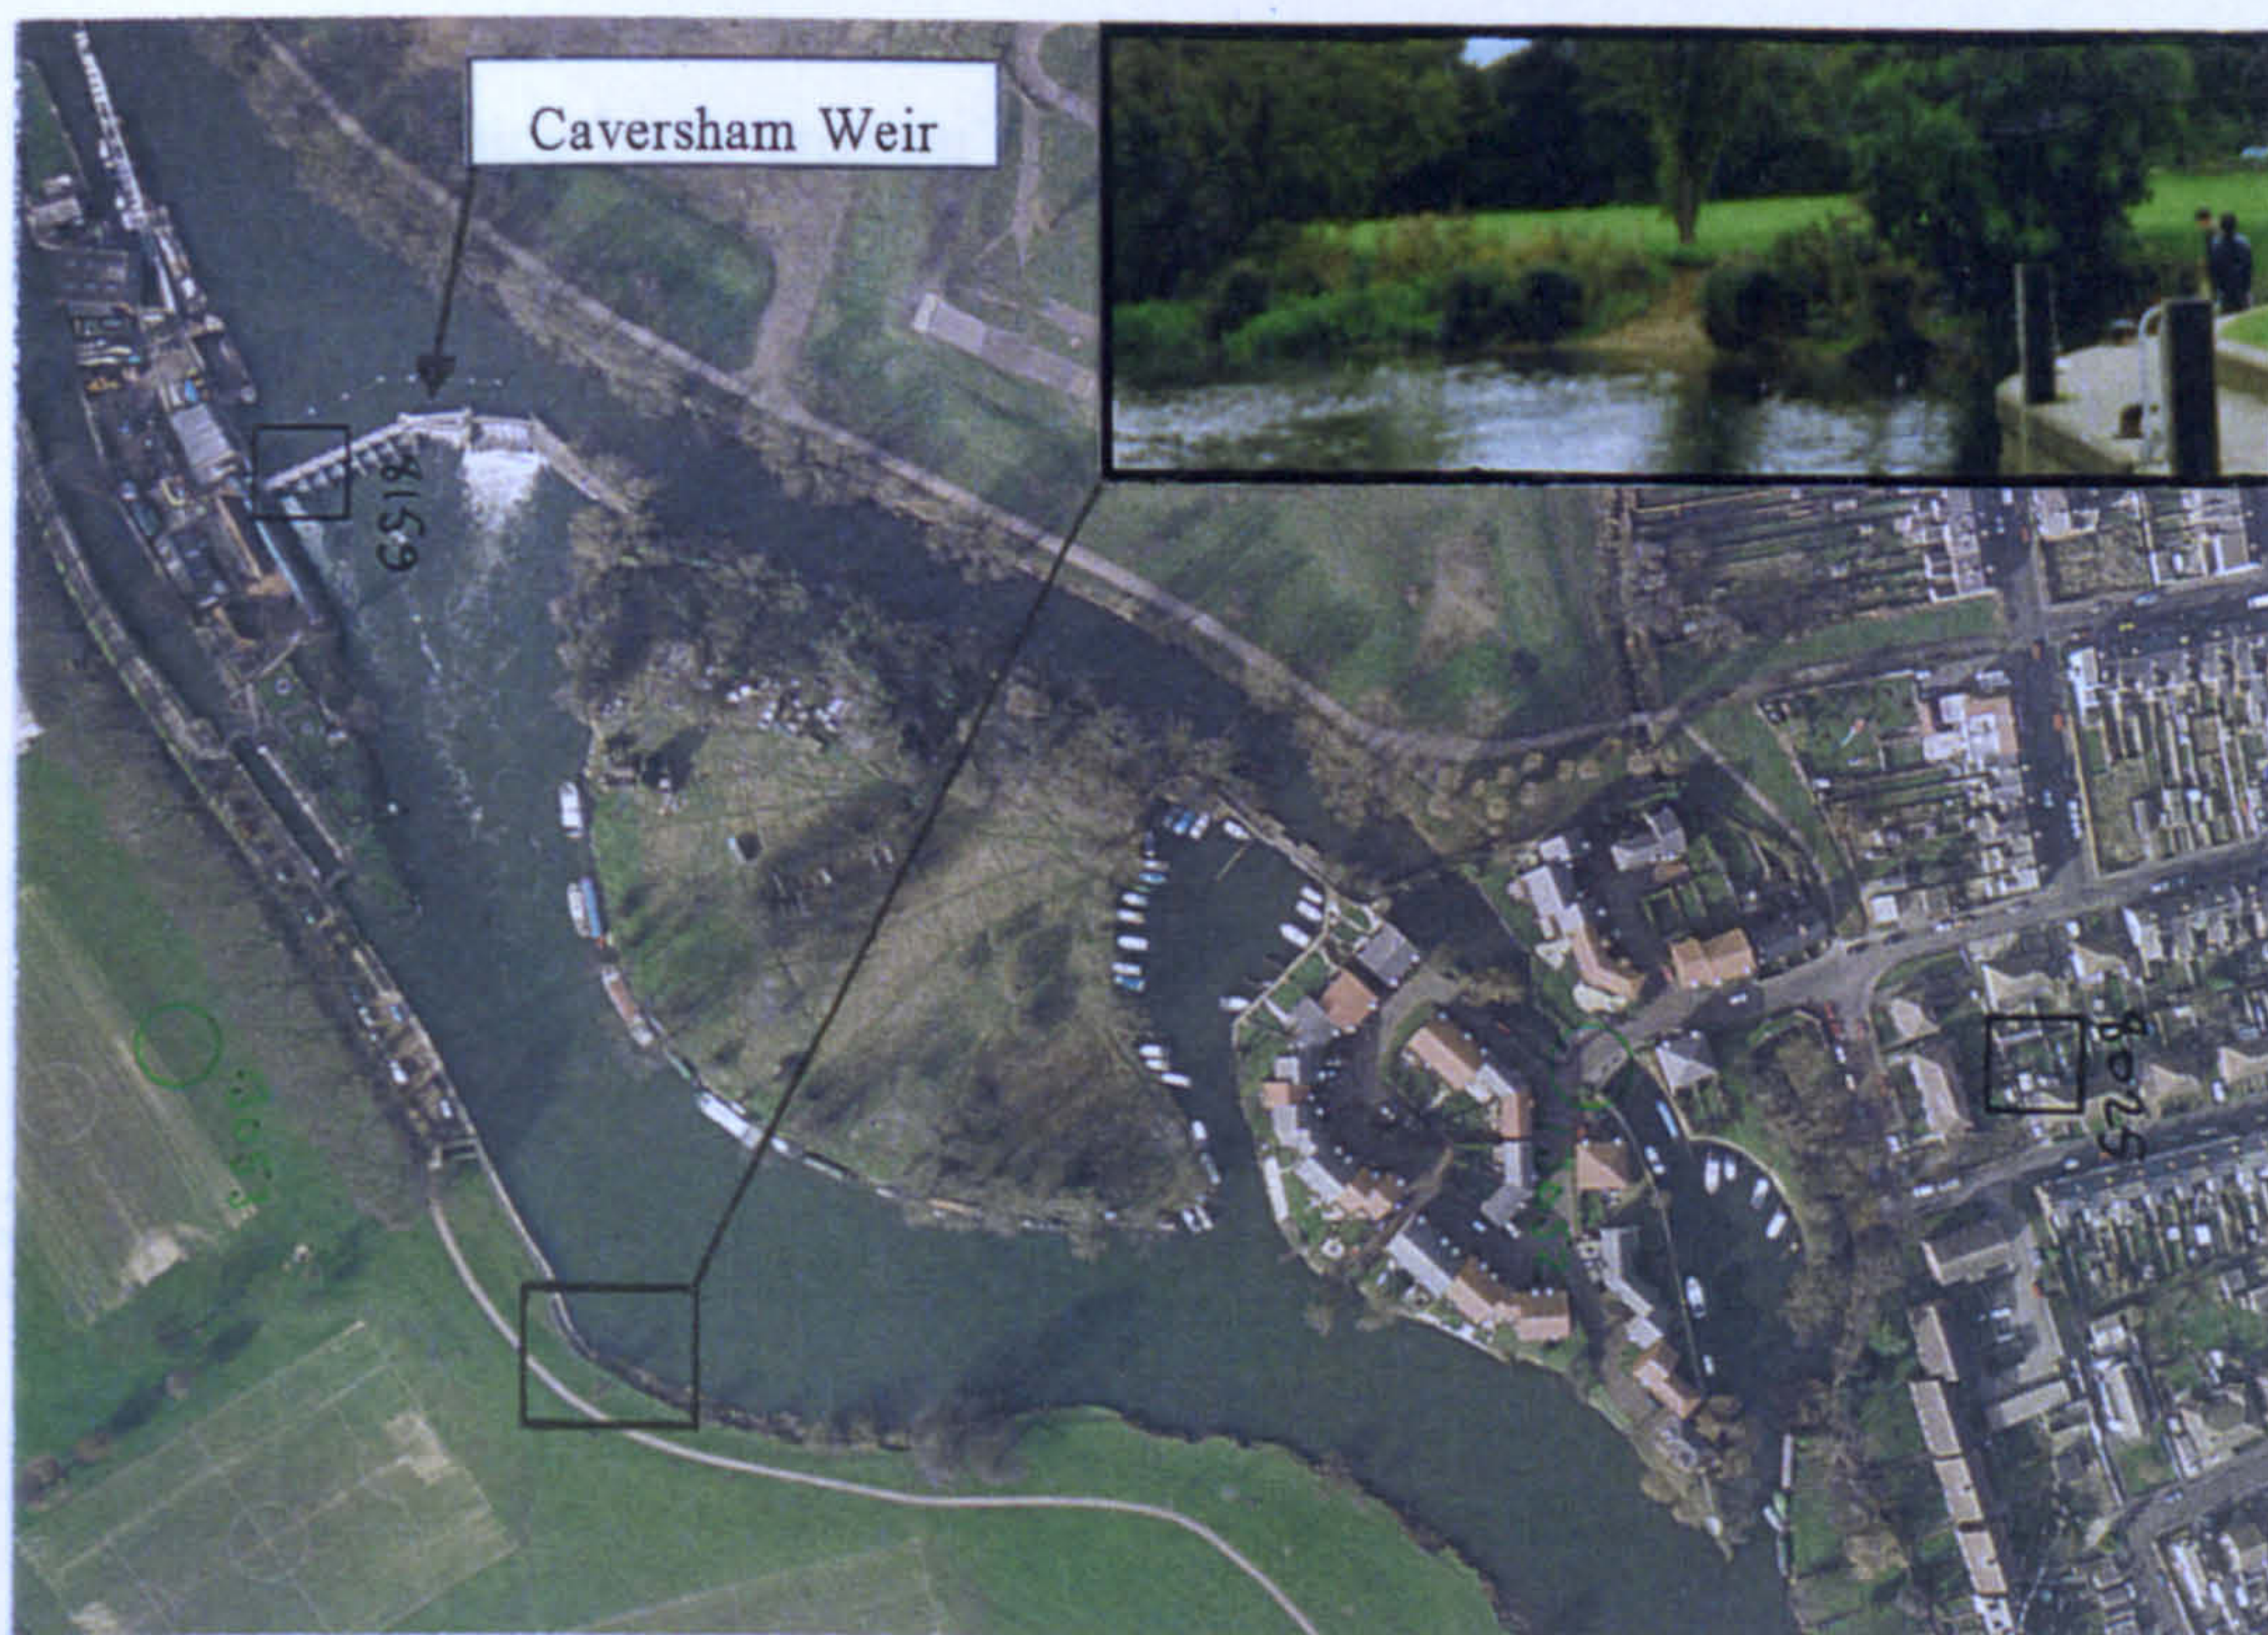
Plate 5.4 Erosion opposite Caversham Weir (see Bank erosion site no. 83, Map 24, Volume III). Aerial photograph courtesy of Environment Agency.

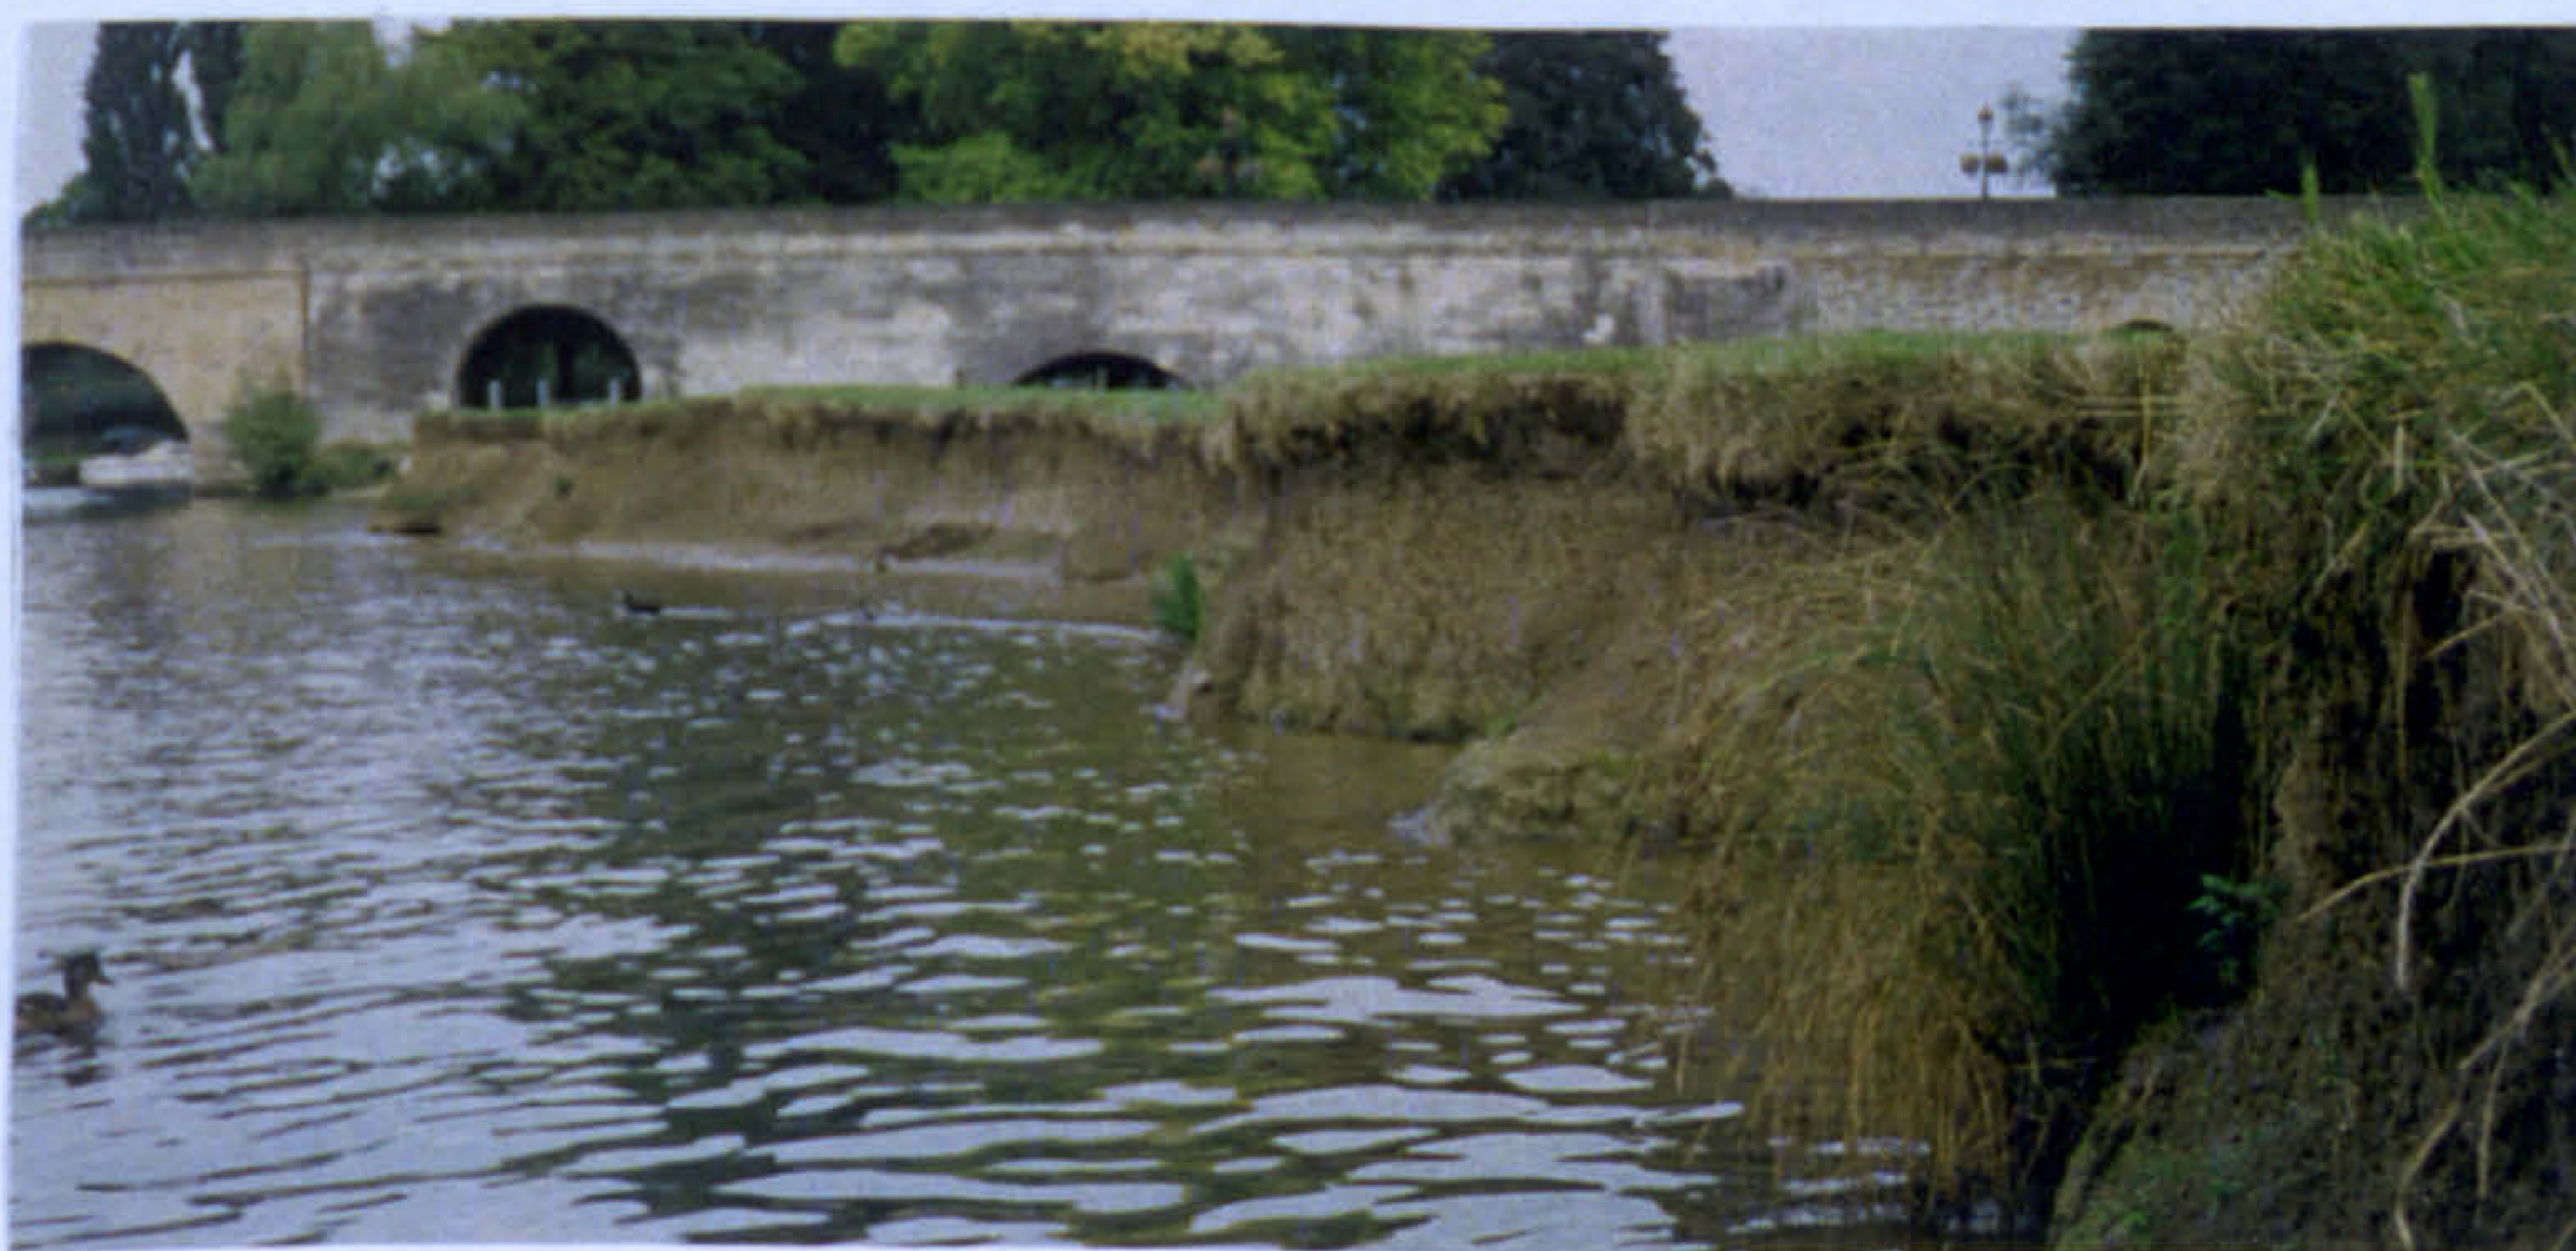
Plate 5.5 Bank erosion downstream of Wallingford Bridge.
