**"THE NON-TIDAL, NAVIGABLE THAMES:
A BANK EROSION MANAGEMENT STRATEGY"**

by Sue Reed BSc, MSc, MCIWEM

**Thesis submitted to the University of Nottingham
for the degree of Doctor of Philosophy, October 1998**

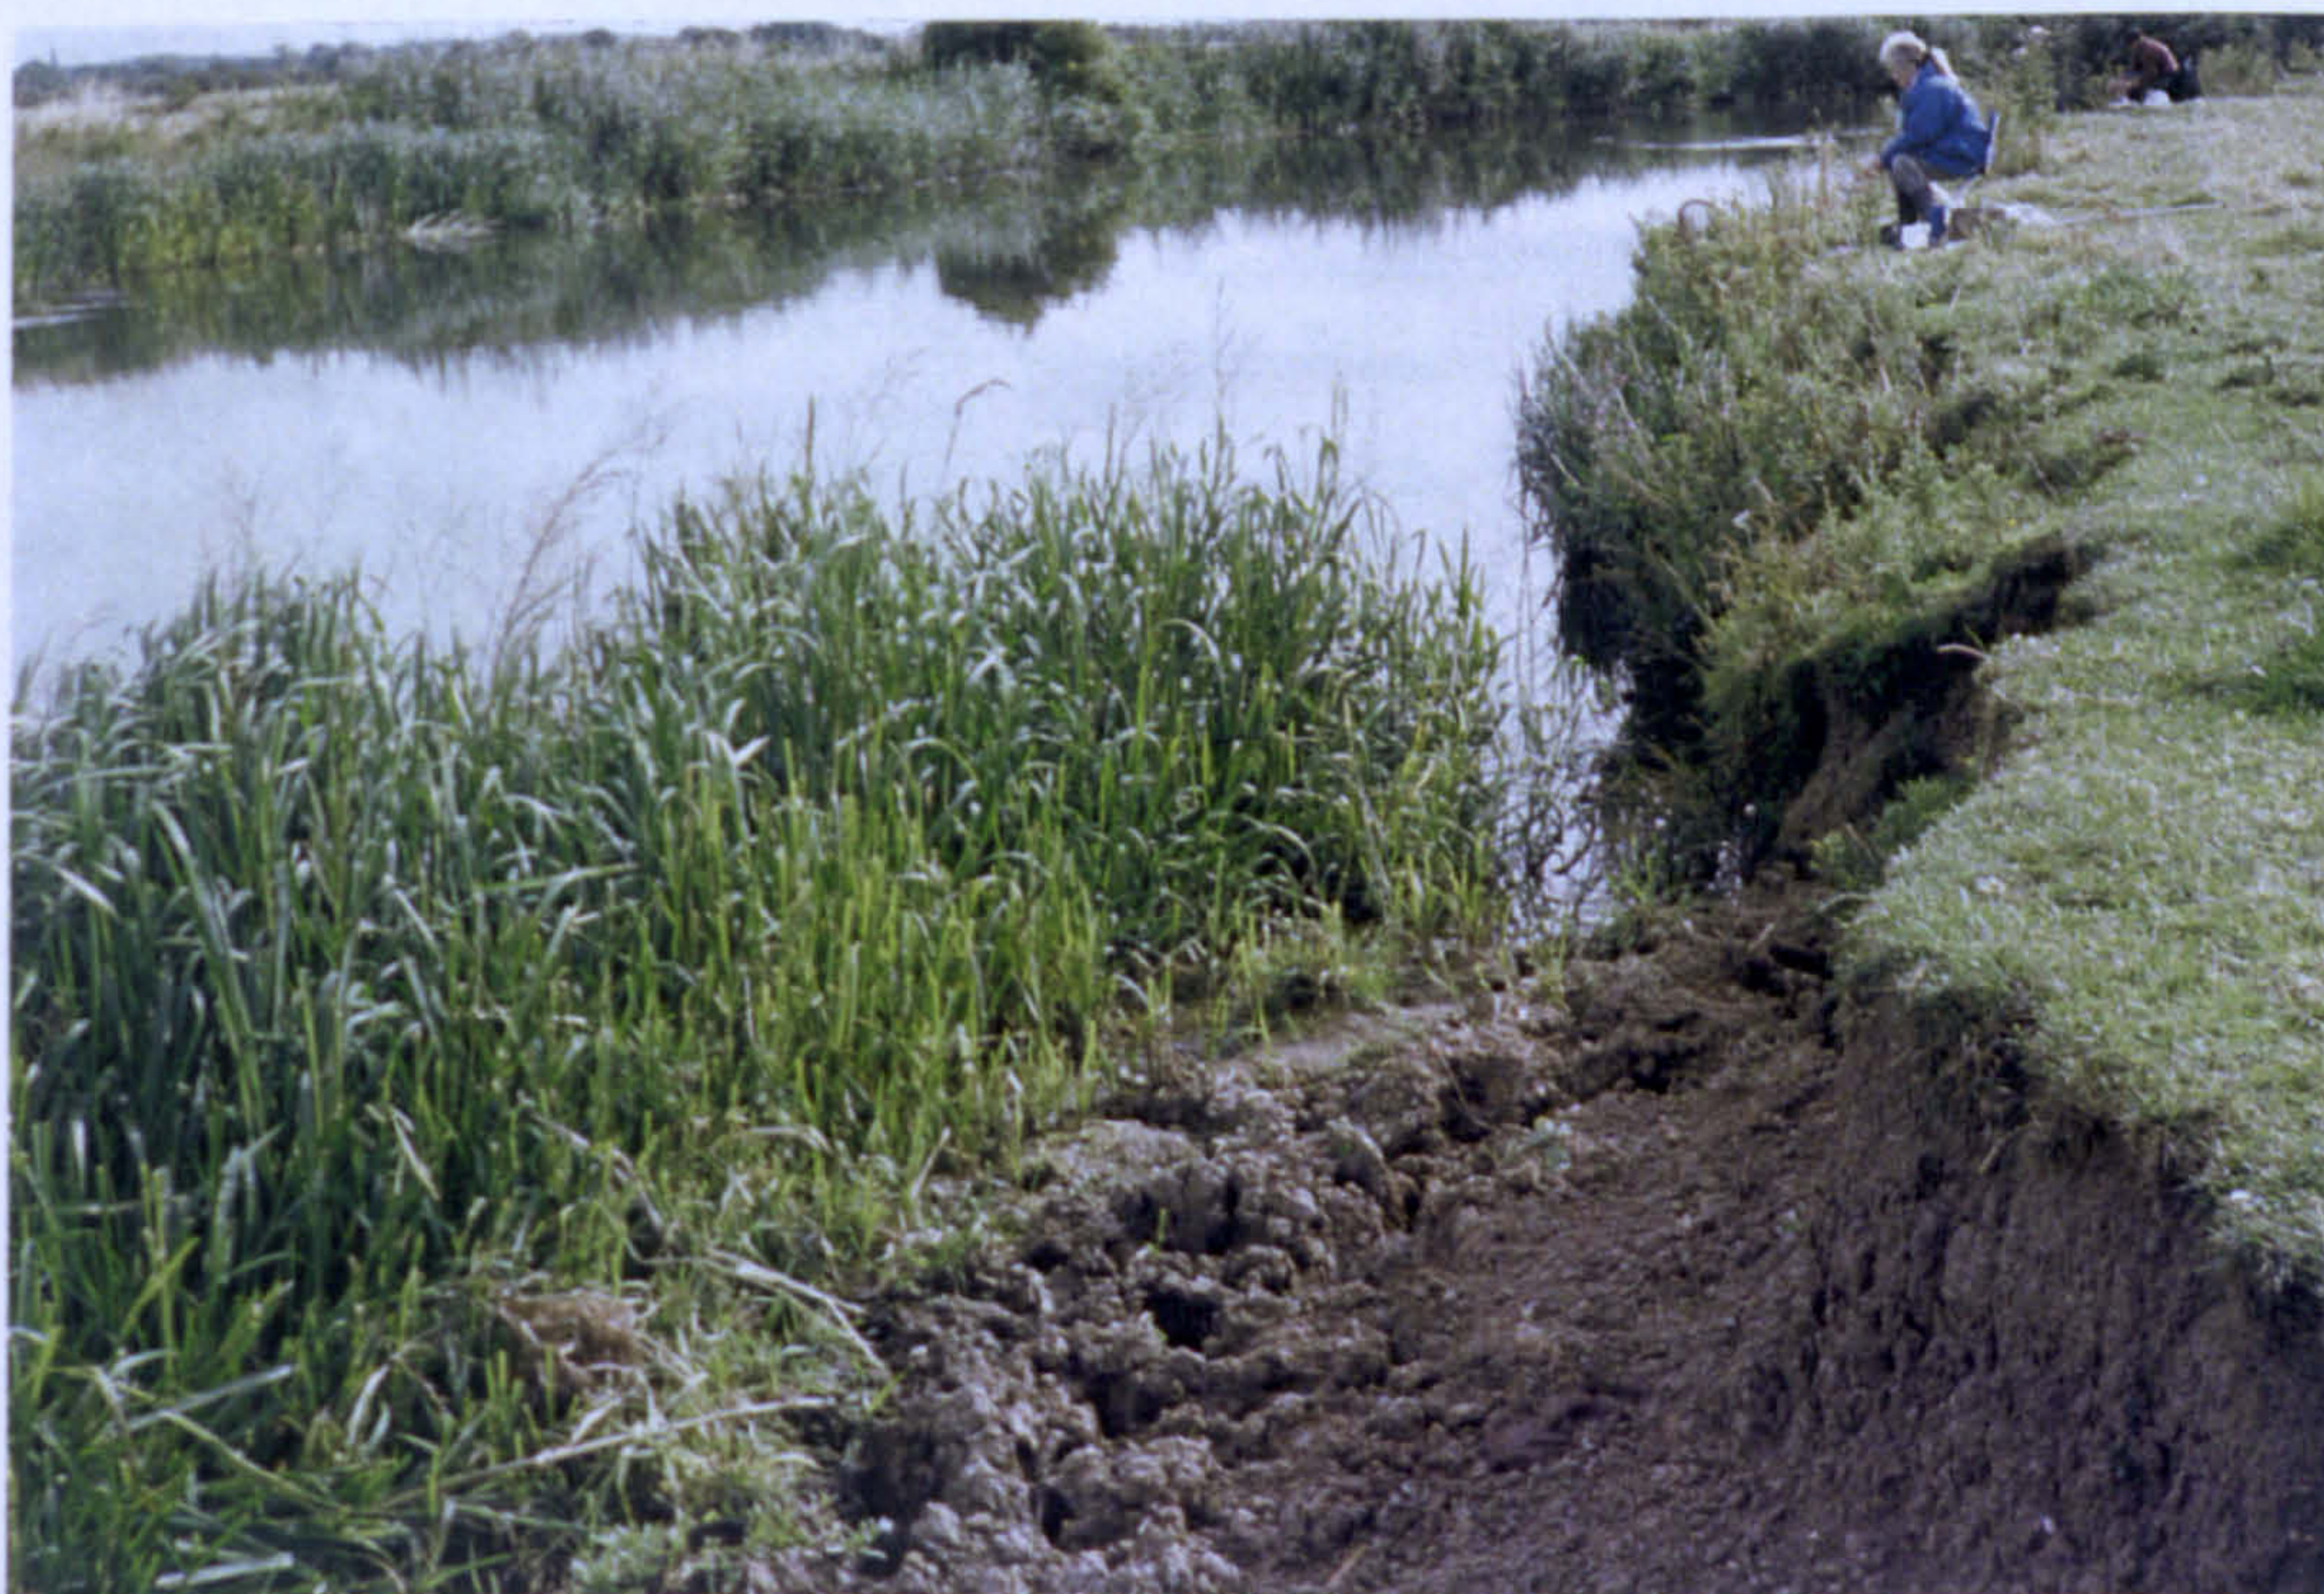
*Plate 5.6 Poaching of the river bank downstream of Eynsham Lock
(see Bank erosion site no. 36, Map 9, Volume III) .*

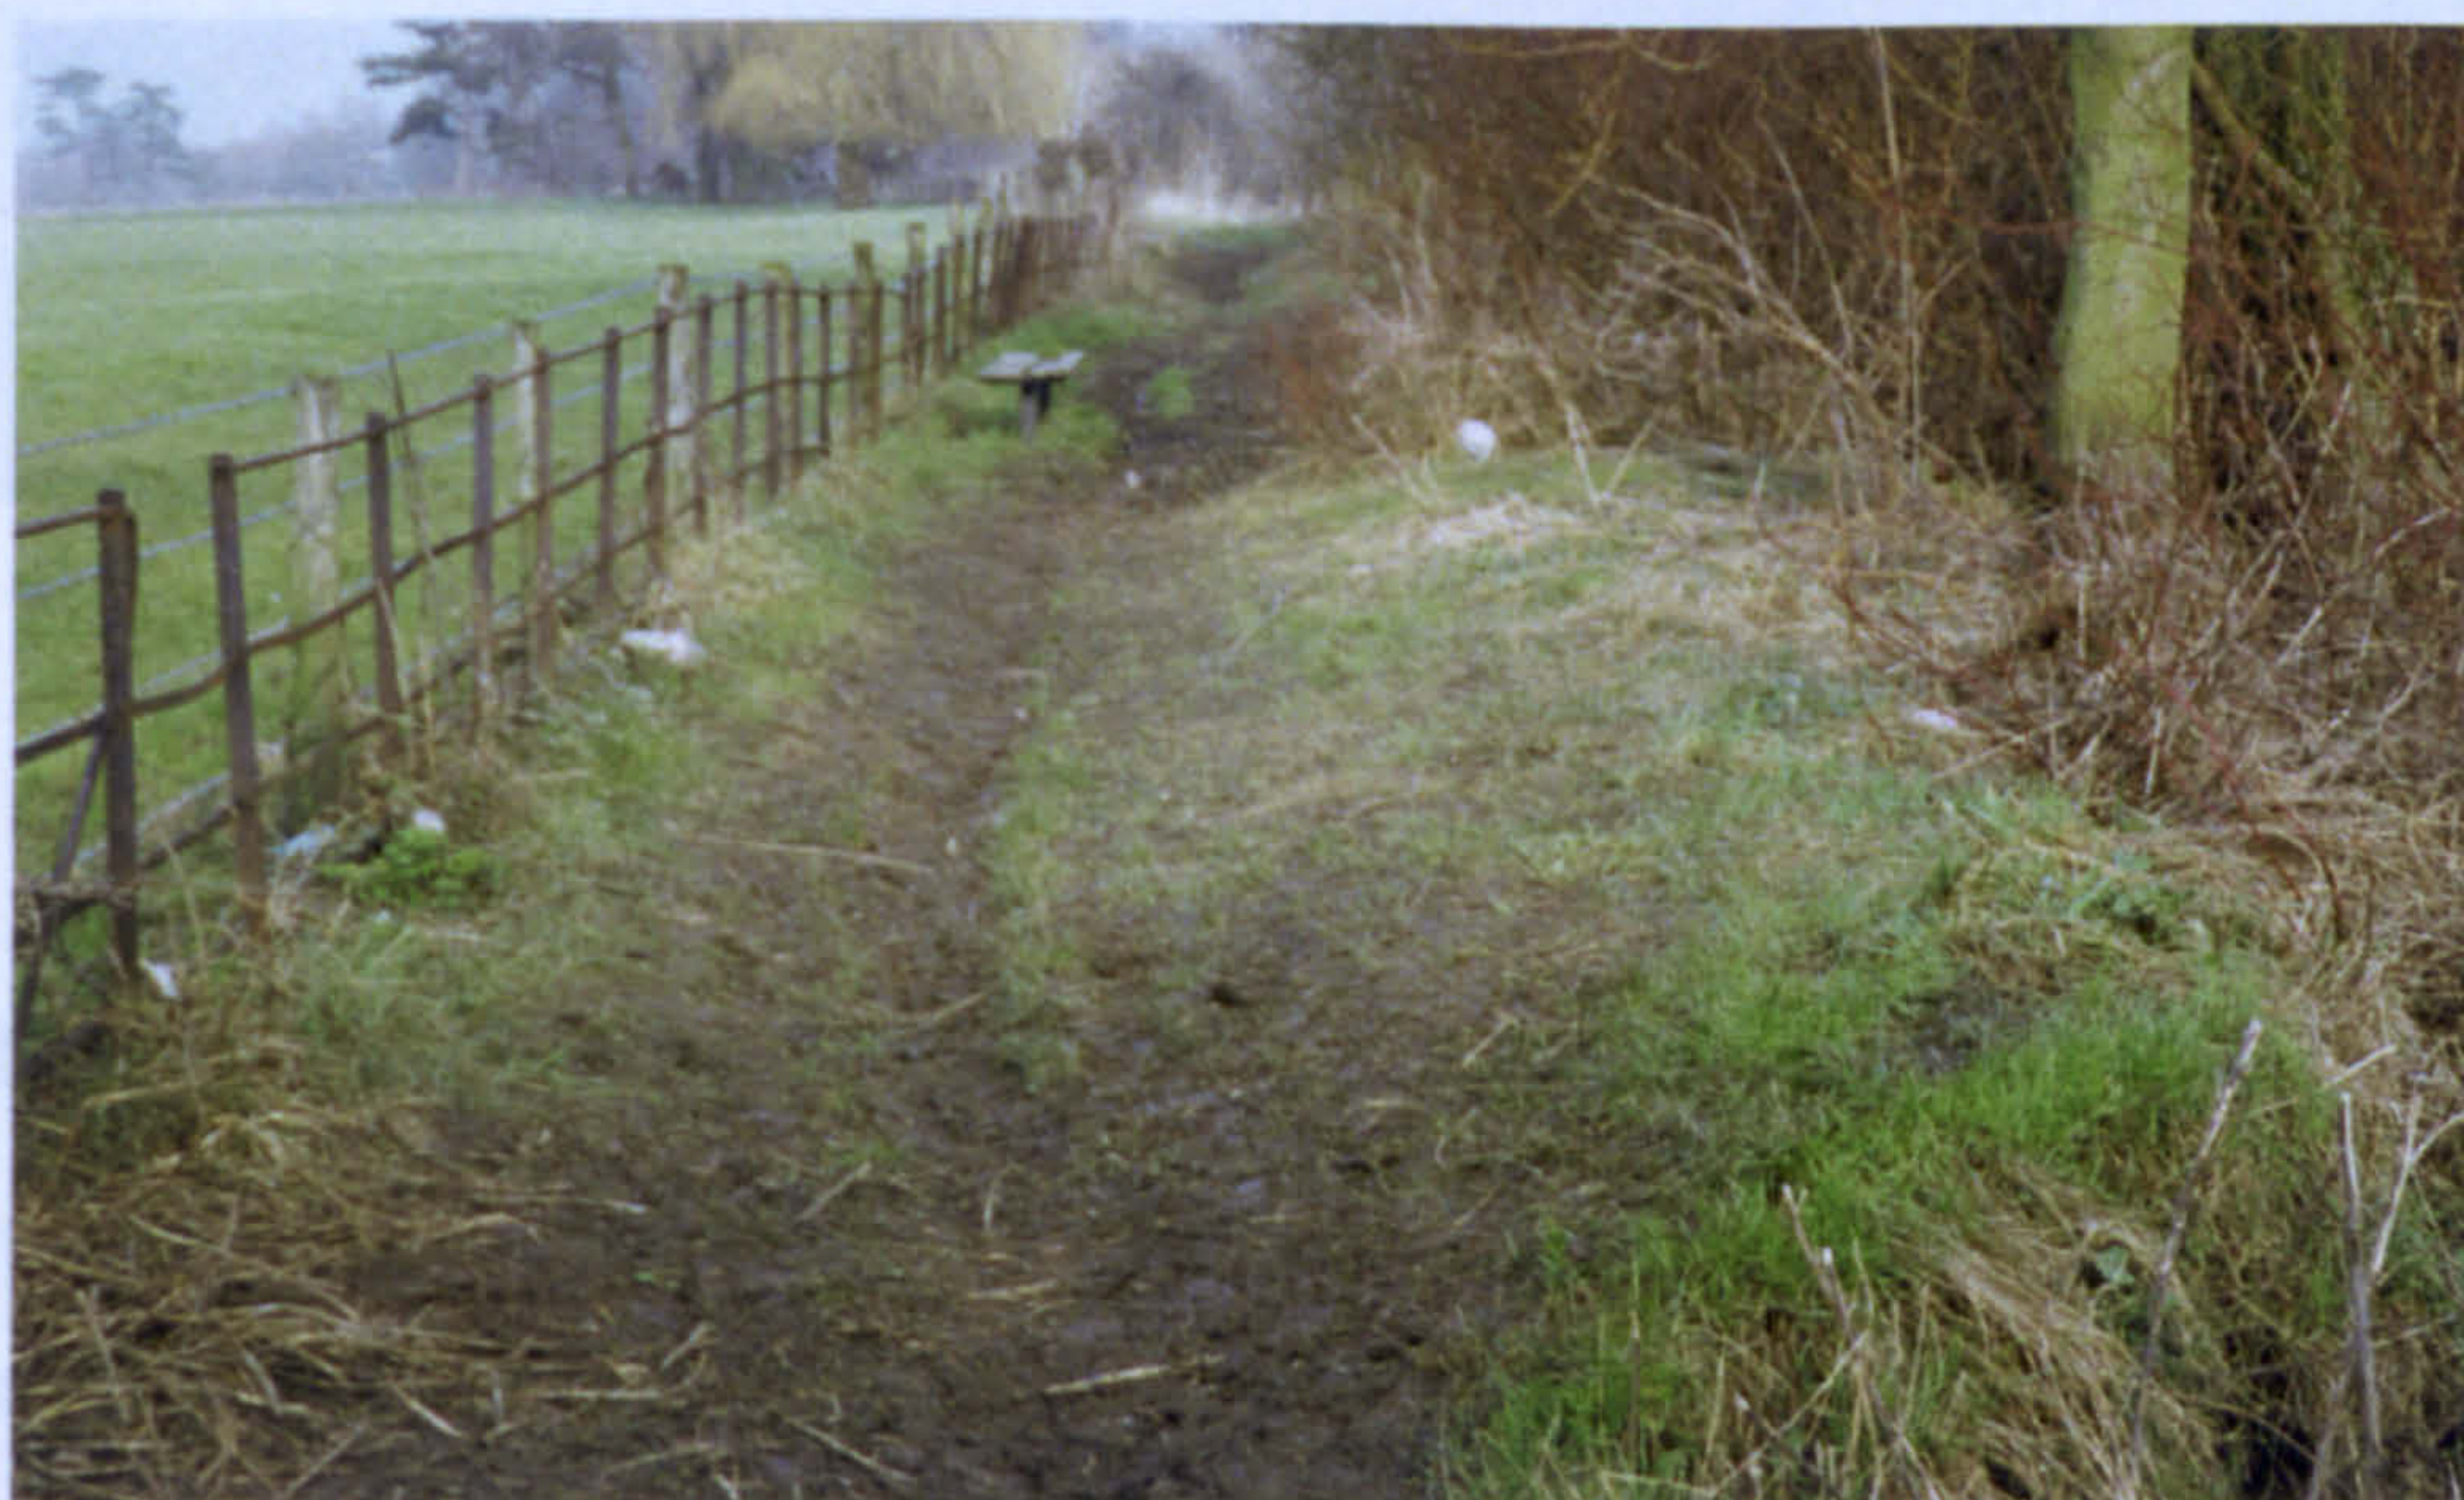
Plate 5.8 Erosion of the surface of the tow path due to pedestrian access, upstream of Wallingford Bridge.

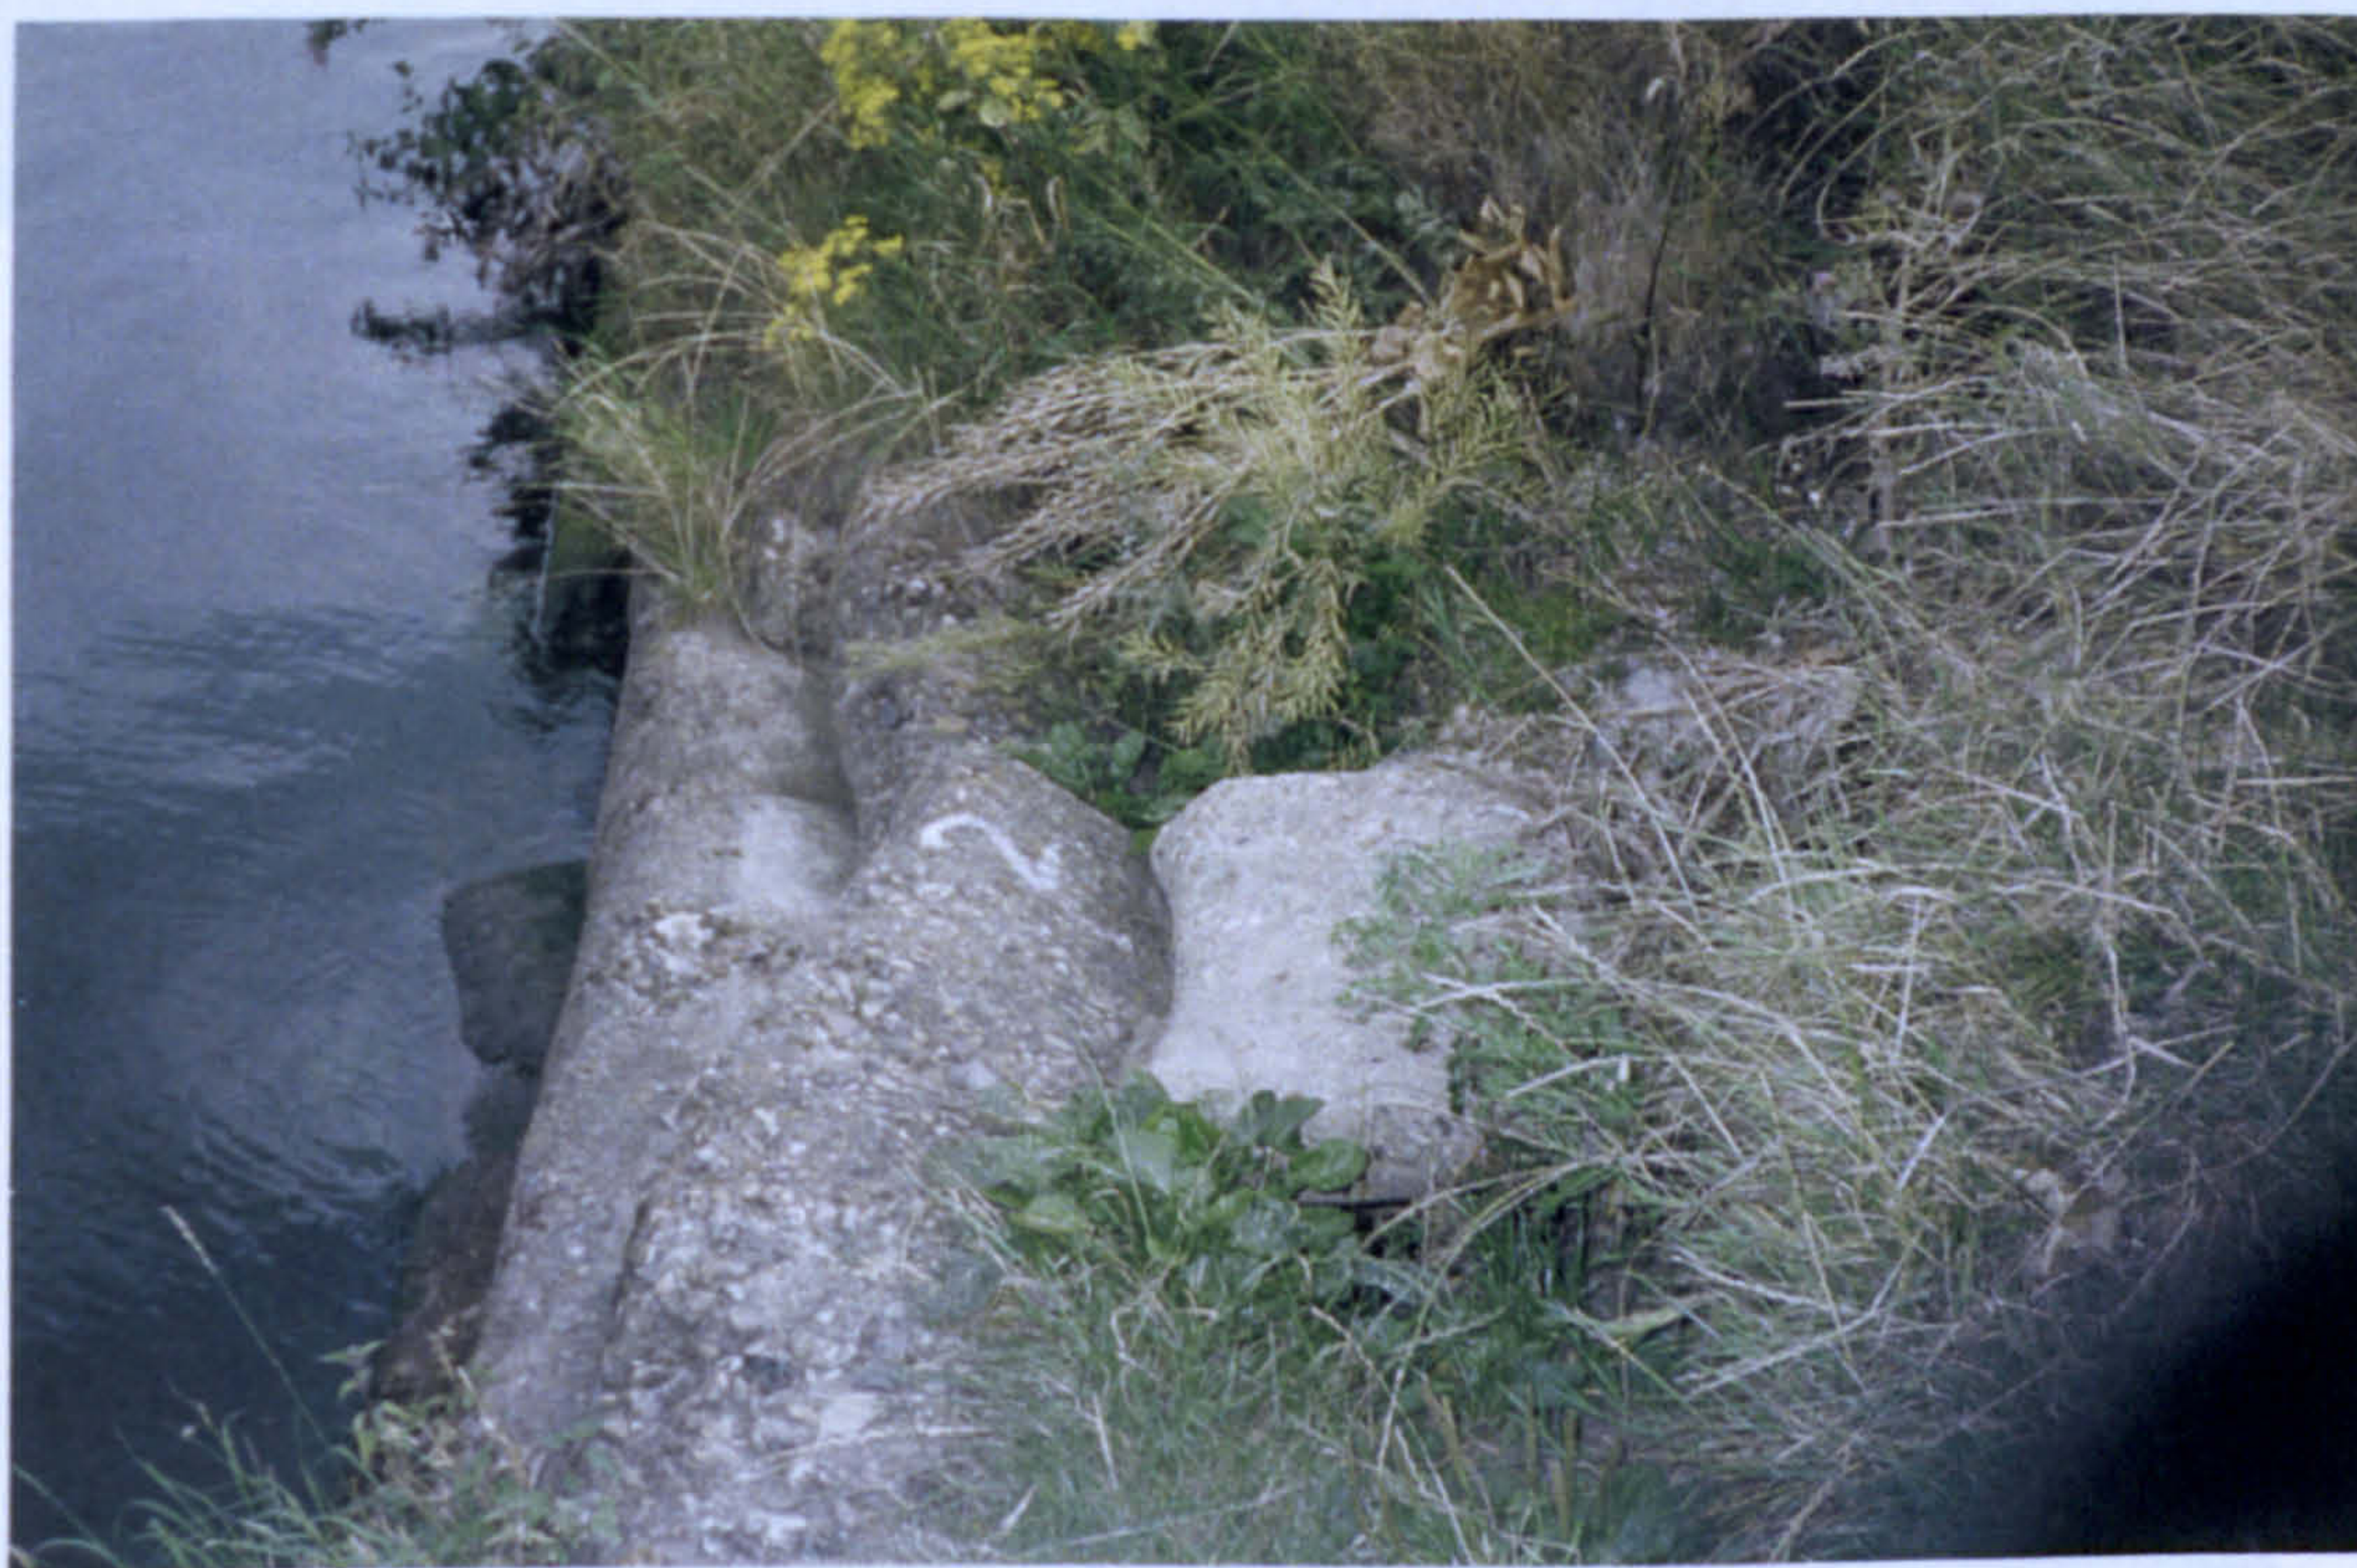
Plate 5.9 Displacement of concrete bagwork at angling swim along Old Windsor Reach (see Bank erosion site no. 127, Map 36, Volume III).

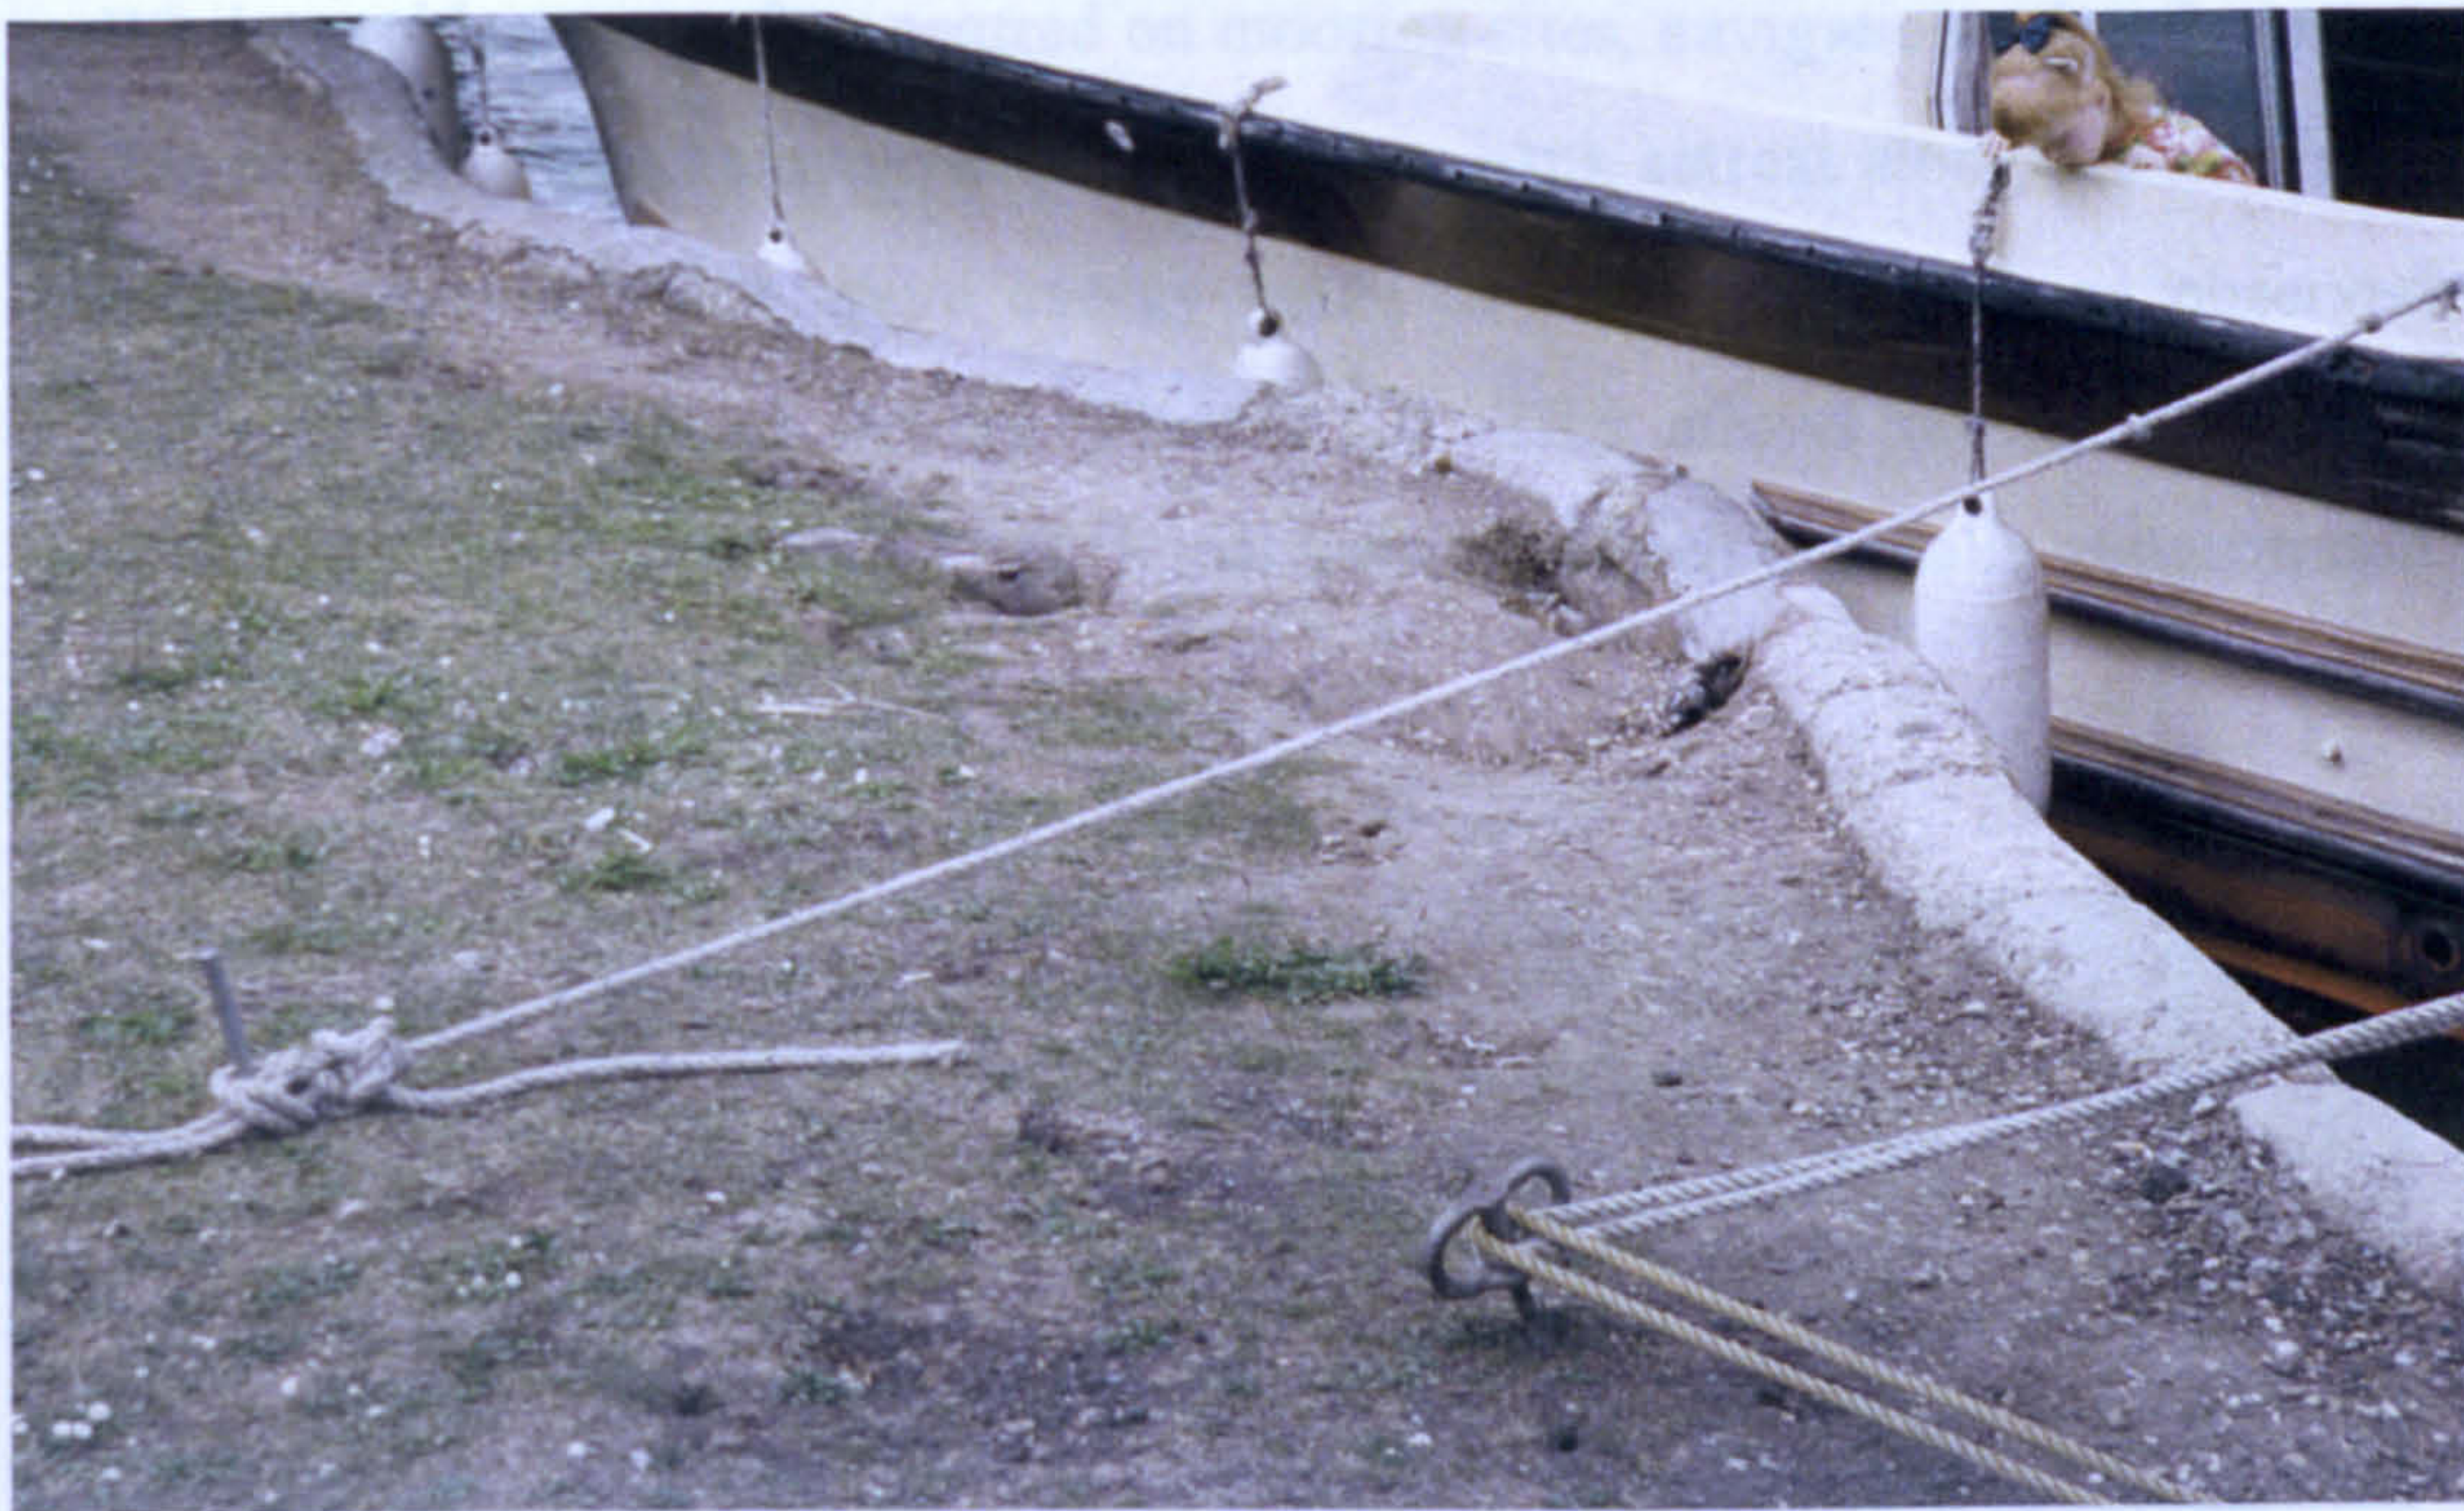
Plate 5.10 Damage of the river bank resulting from the use of mooring pegs at Deadwater Ait, Romney Reach (see Bank erosion site no. 124, Map 35, Volume III)

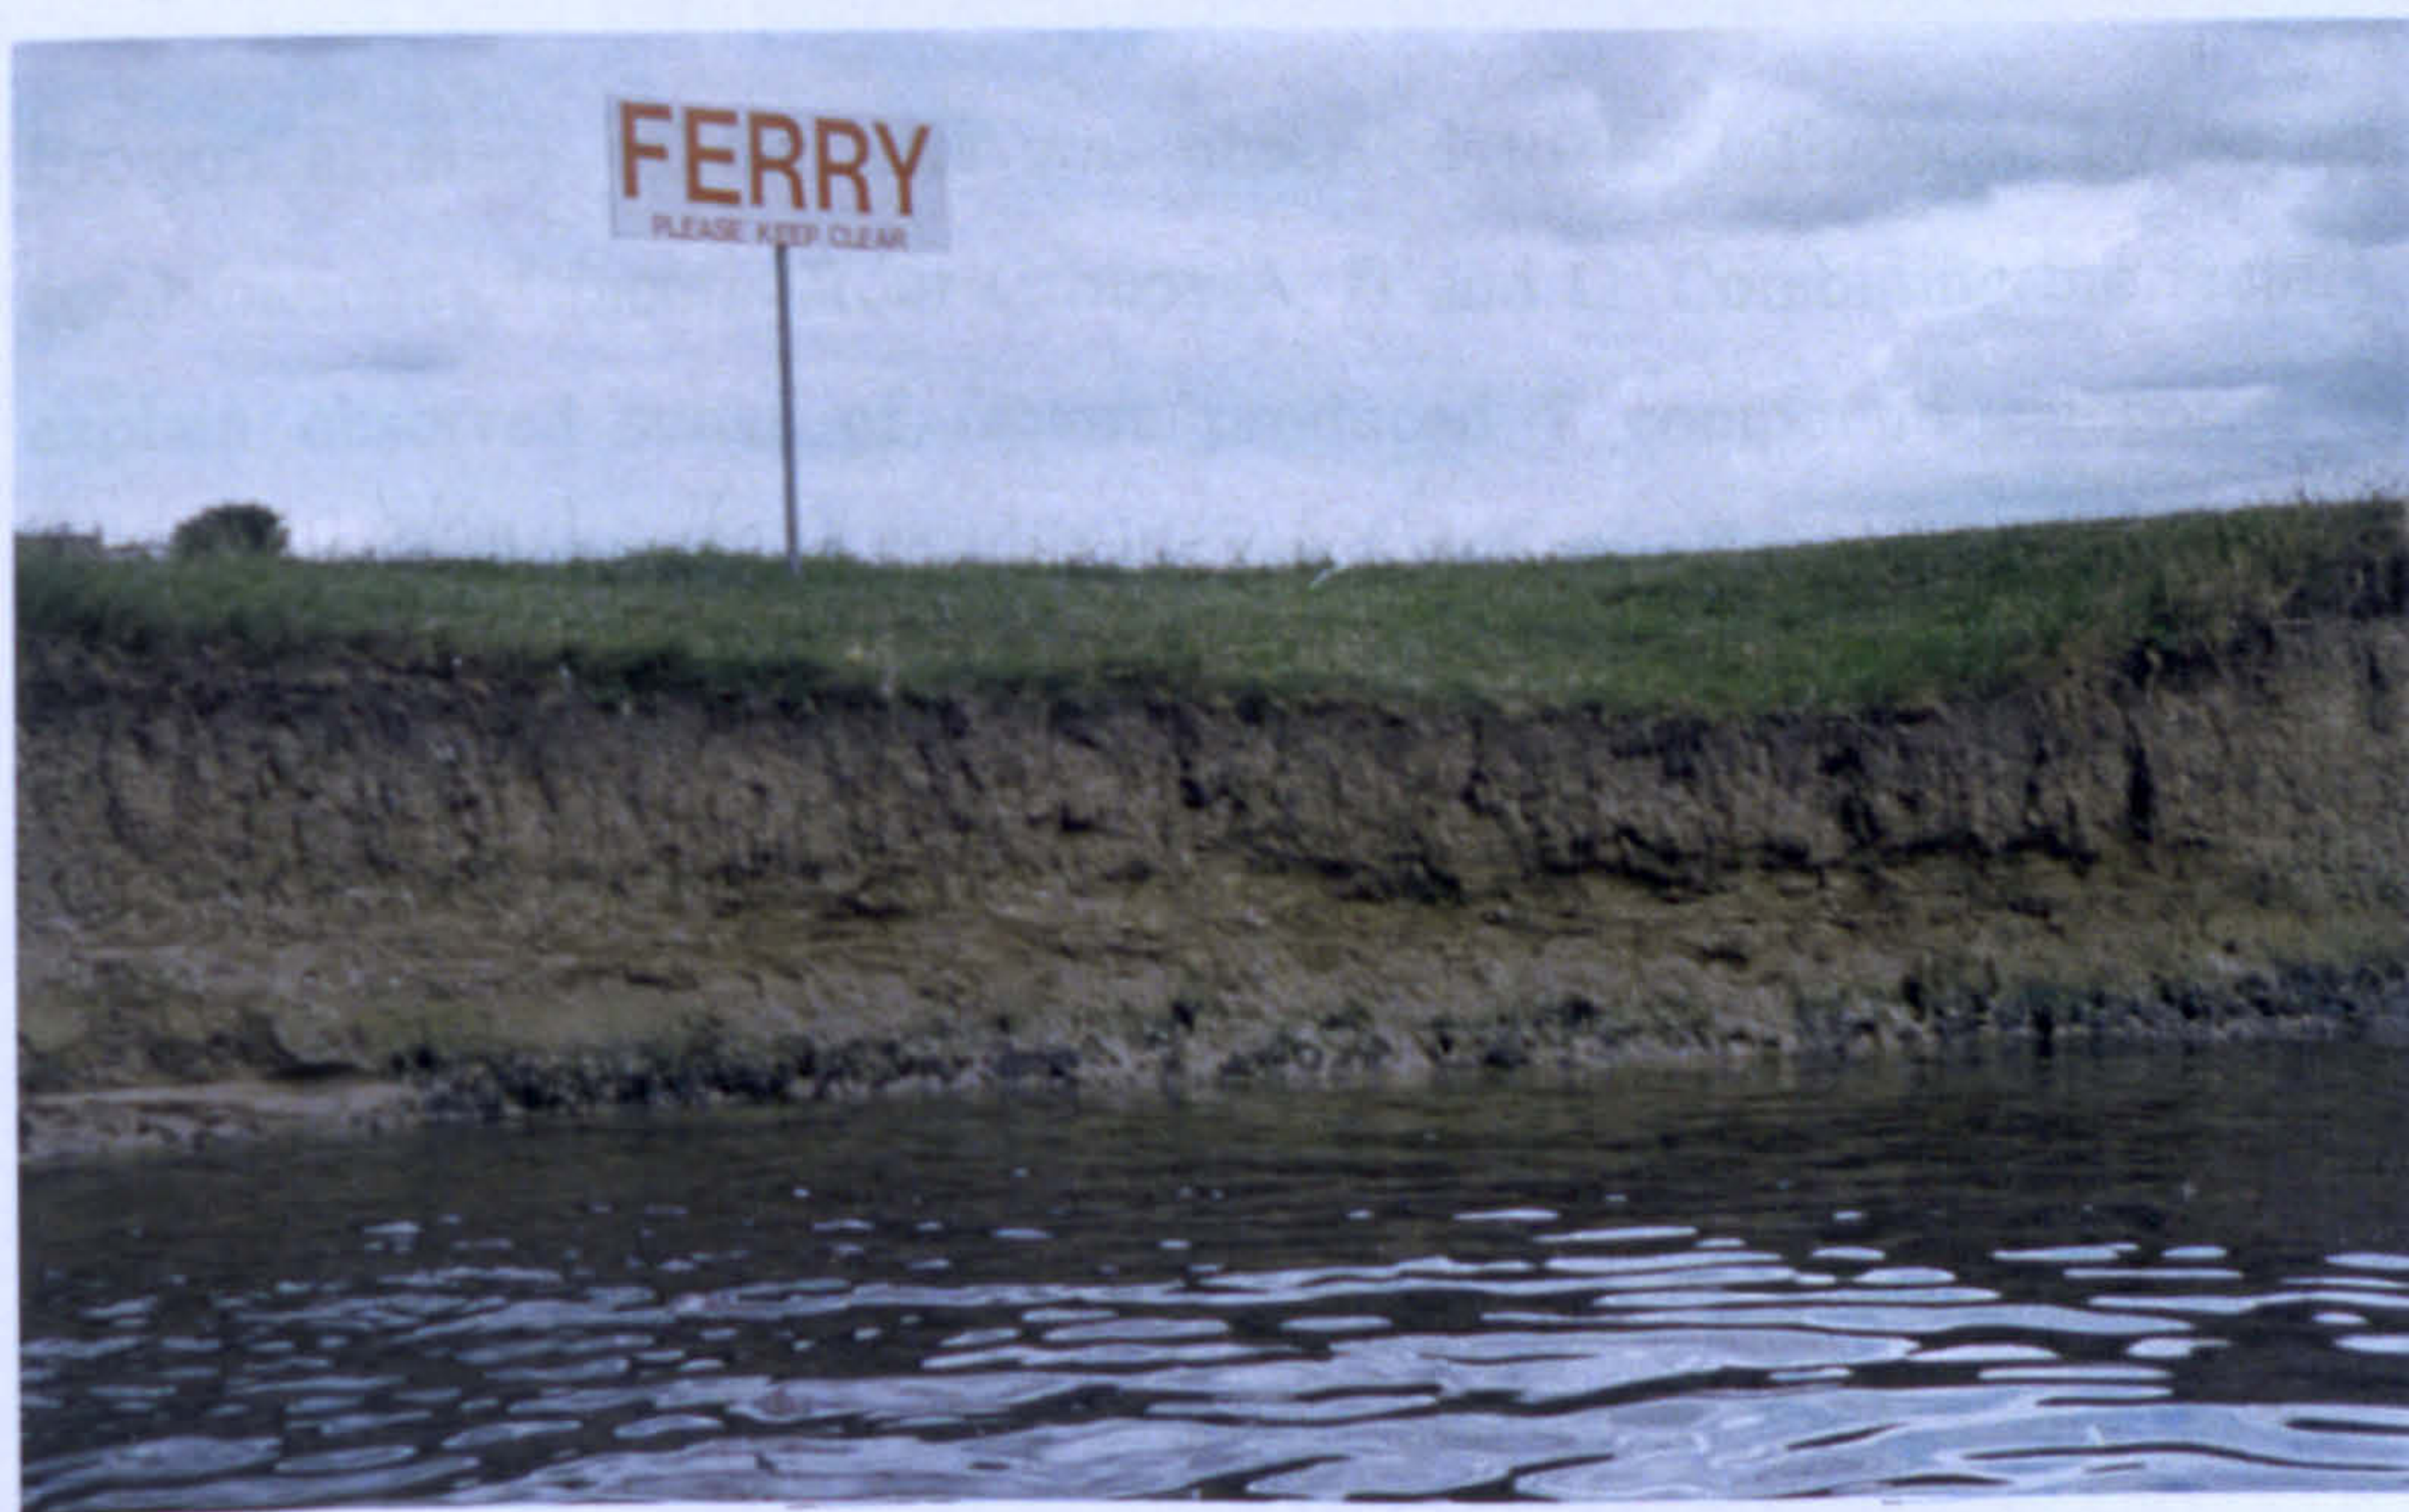
Plate 5.11 Shearing of the vertical cliff face at the Brocas along Romney Reach (see Bank erosion site no. 125, Map 35, Volume III)

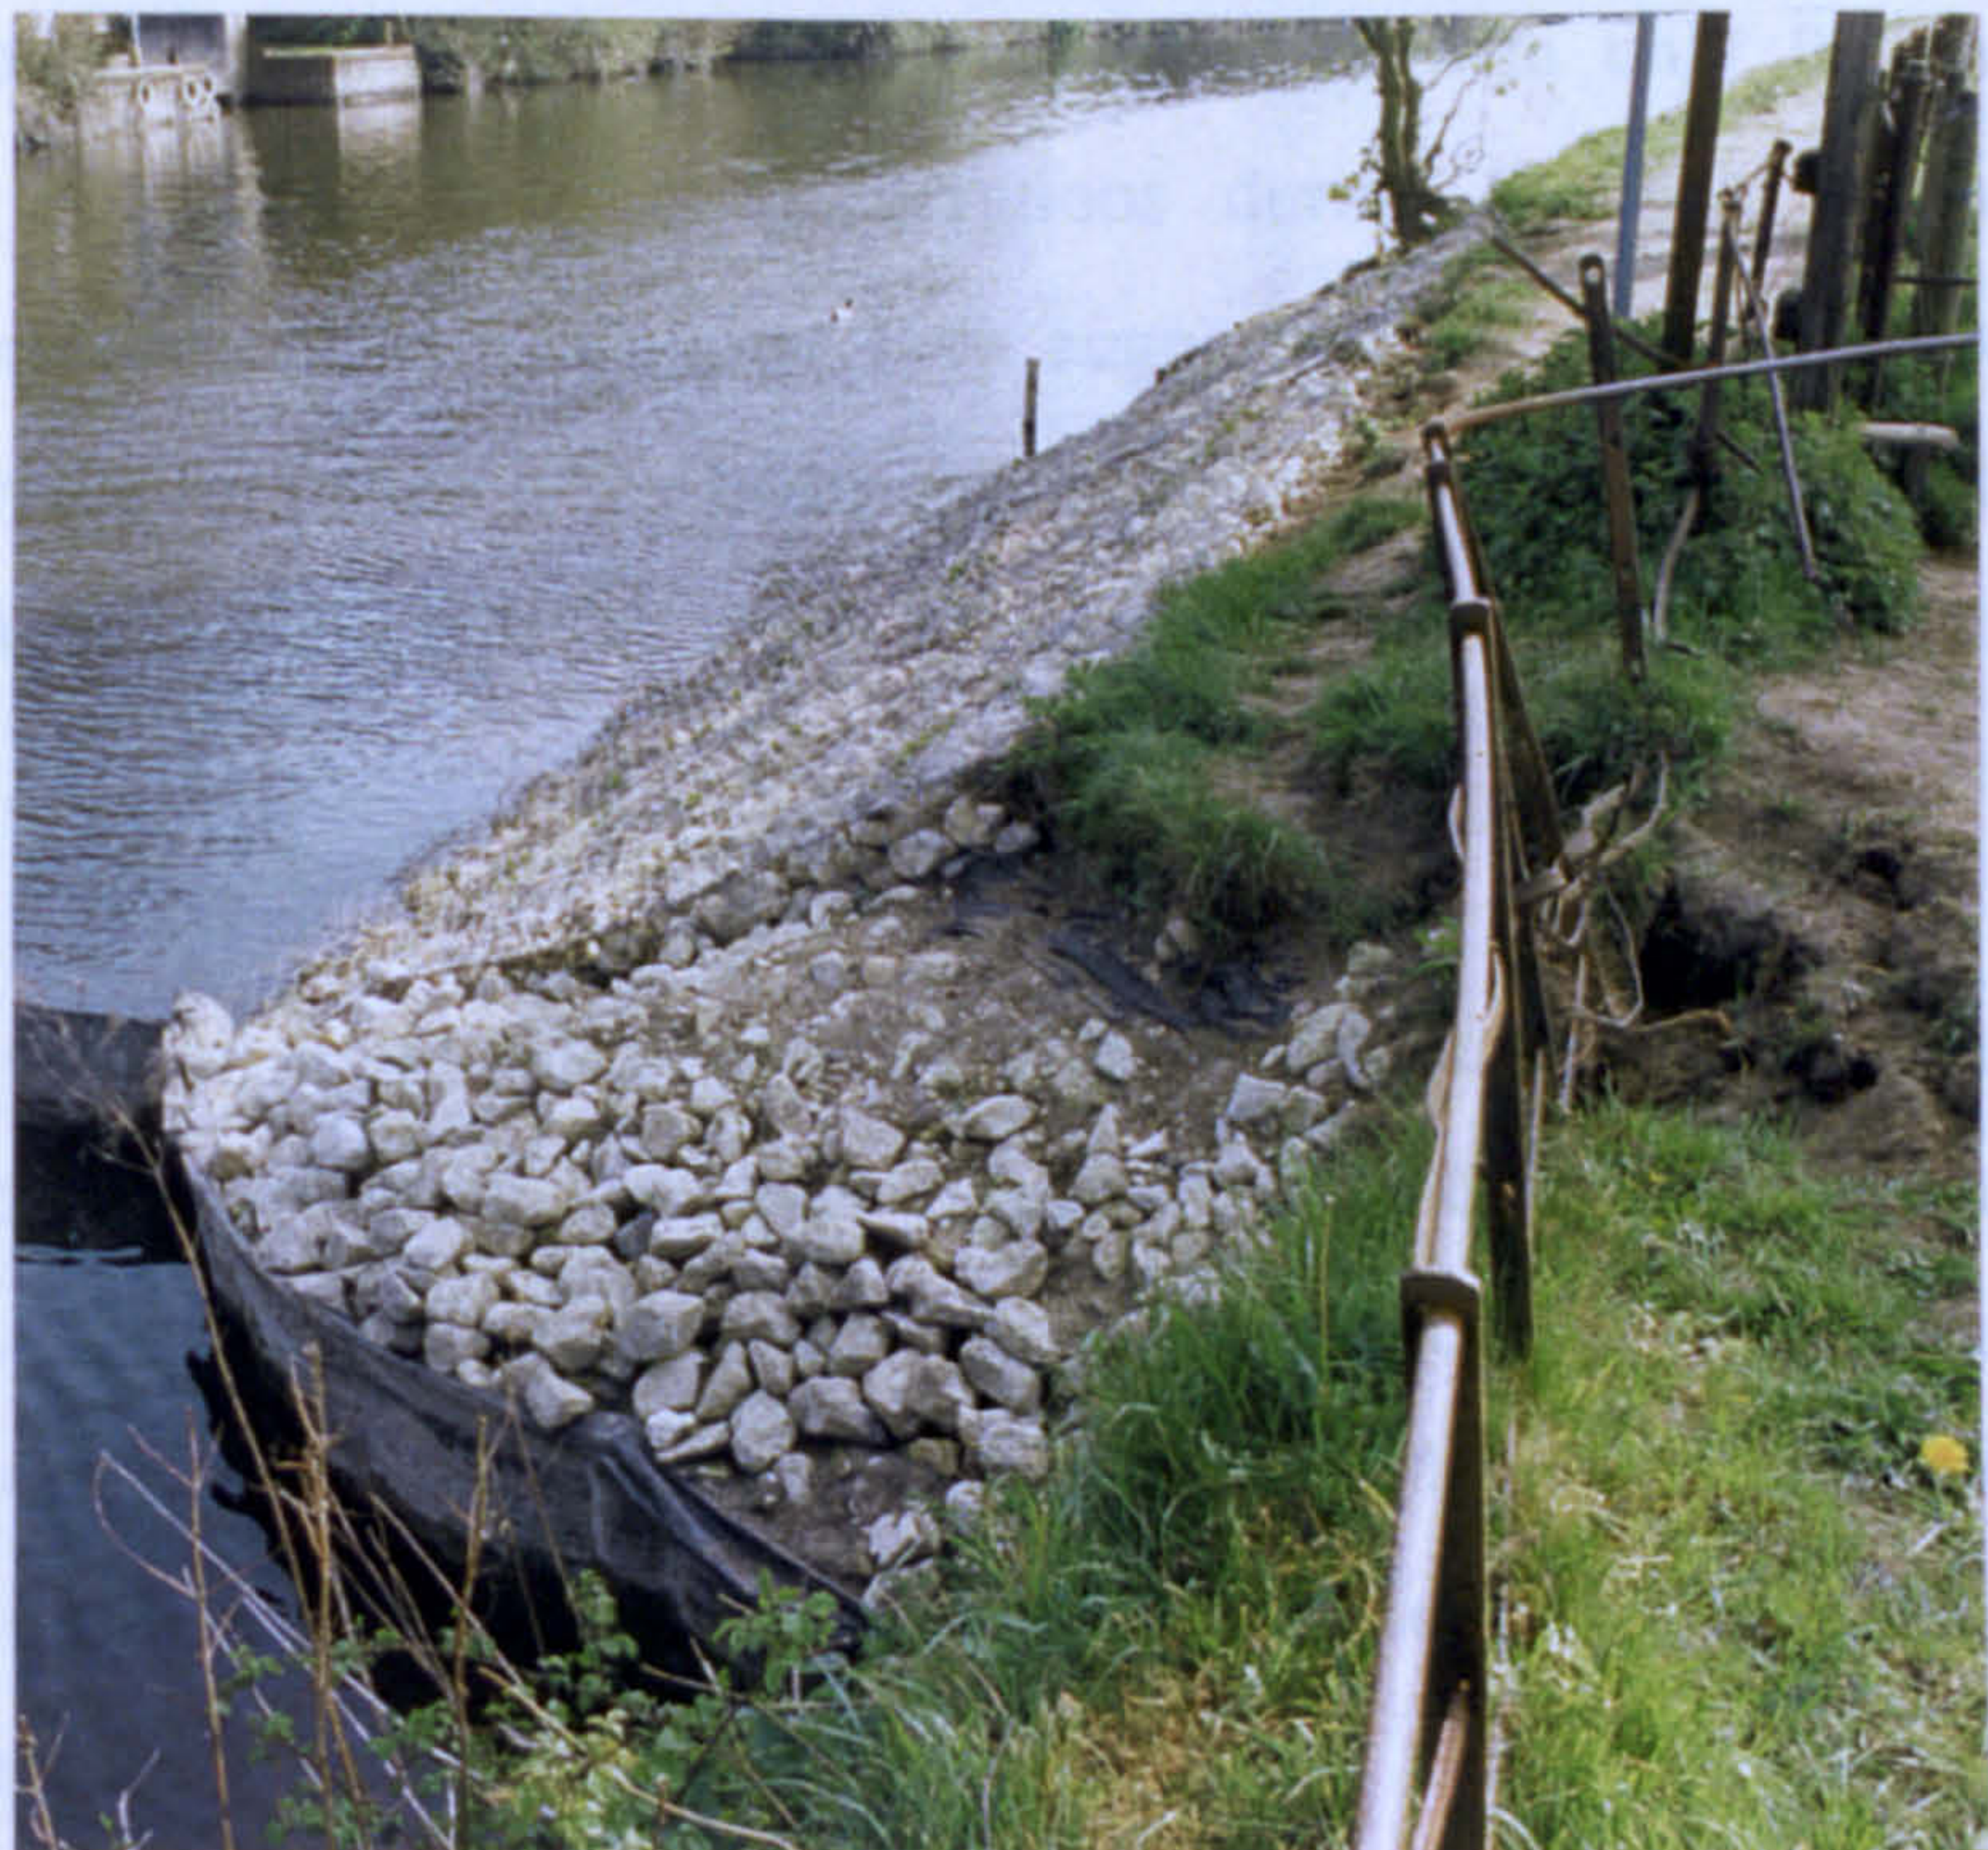
Plate 6.14
Case study no. 9:
exposed geotextile
underlay where
riprap had been
placed (June 1997)
