**"THE NON-TIDAL, NAVIGABLE THAMES:
A BANK EROSION MANAGEMENT STRATEGY"**

by Sue Reed BSc, MSc, MCIWEM

**Thesis submitted to the University of Nottingham
for the degree of Doctor of Philosophy, October 1998**

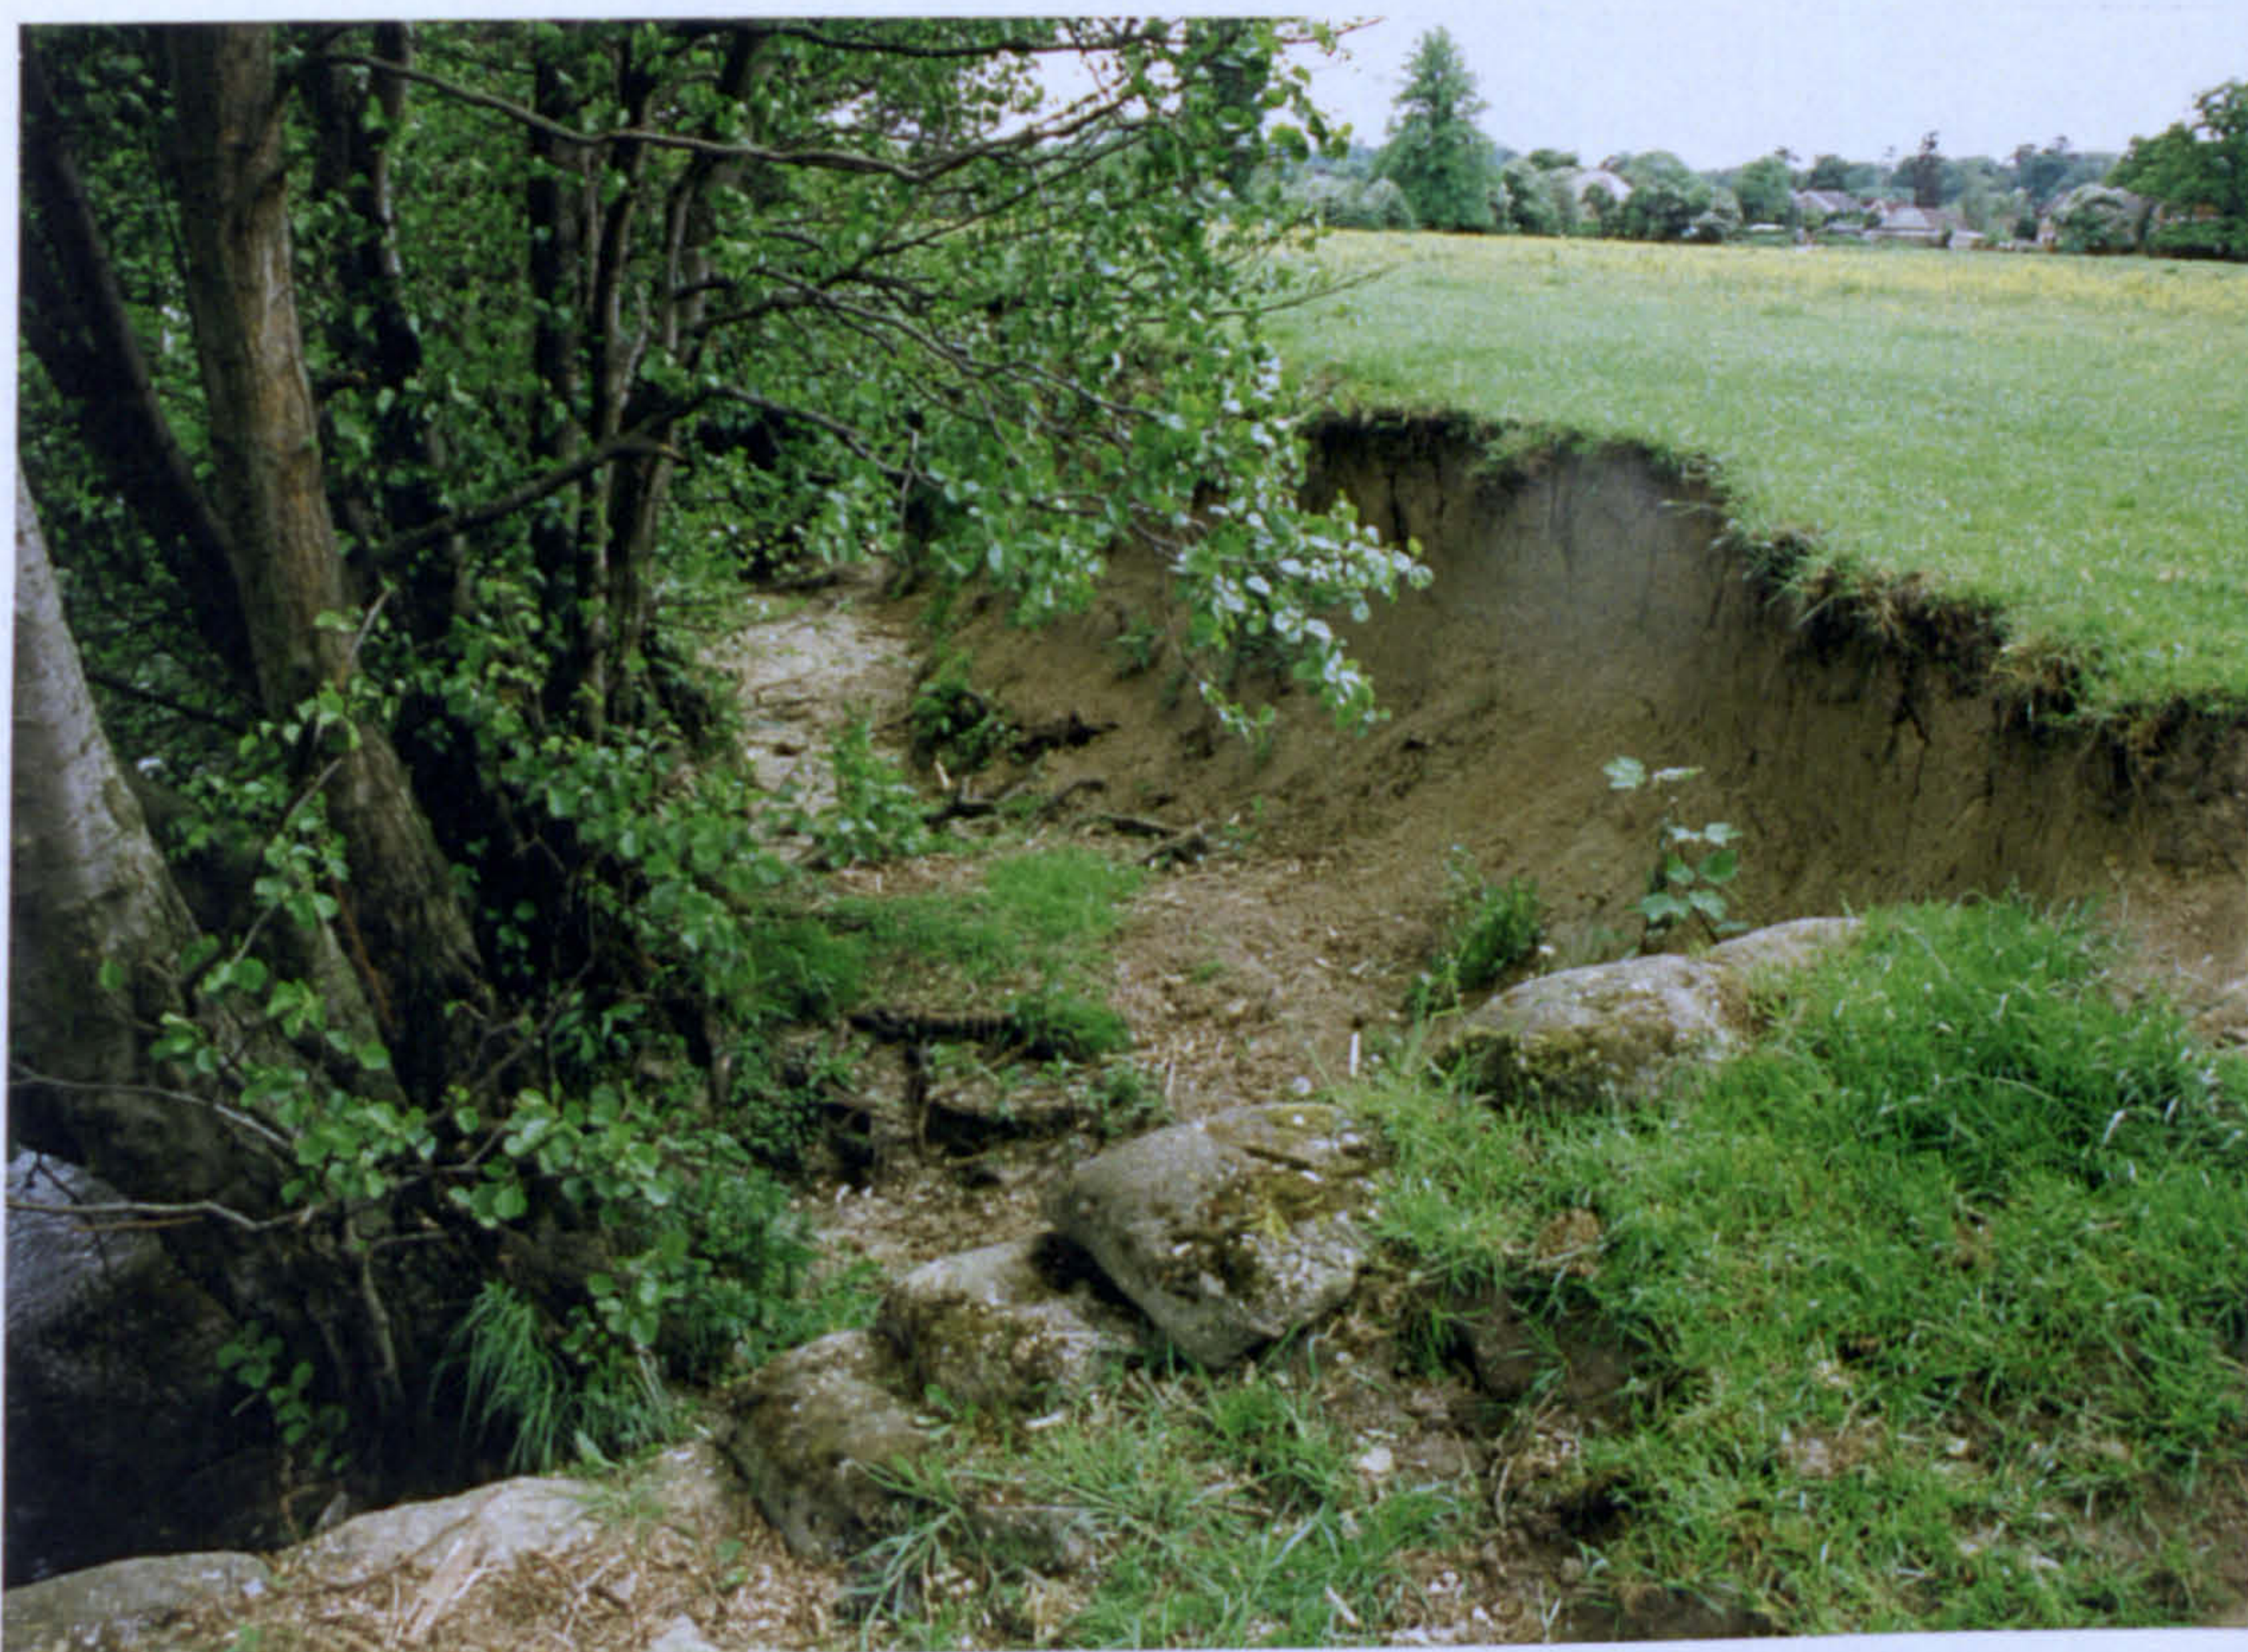
*Plate 6.20 Case study no. 12: erosion downstream of Mapledurham Lock
prior to bank protection*

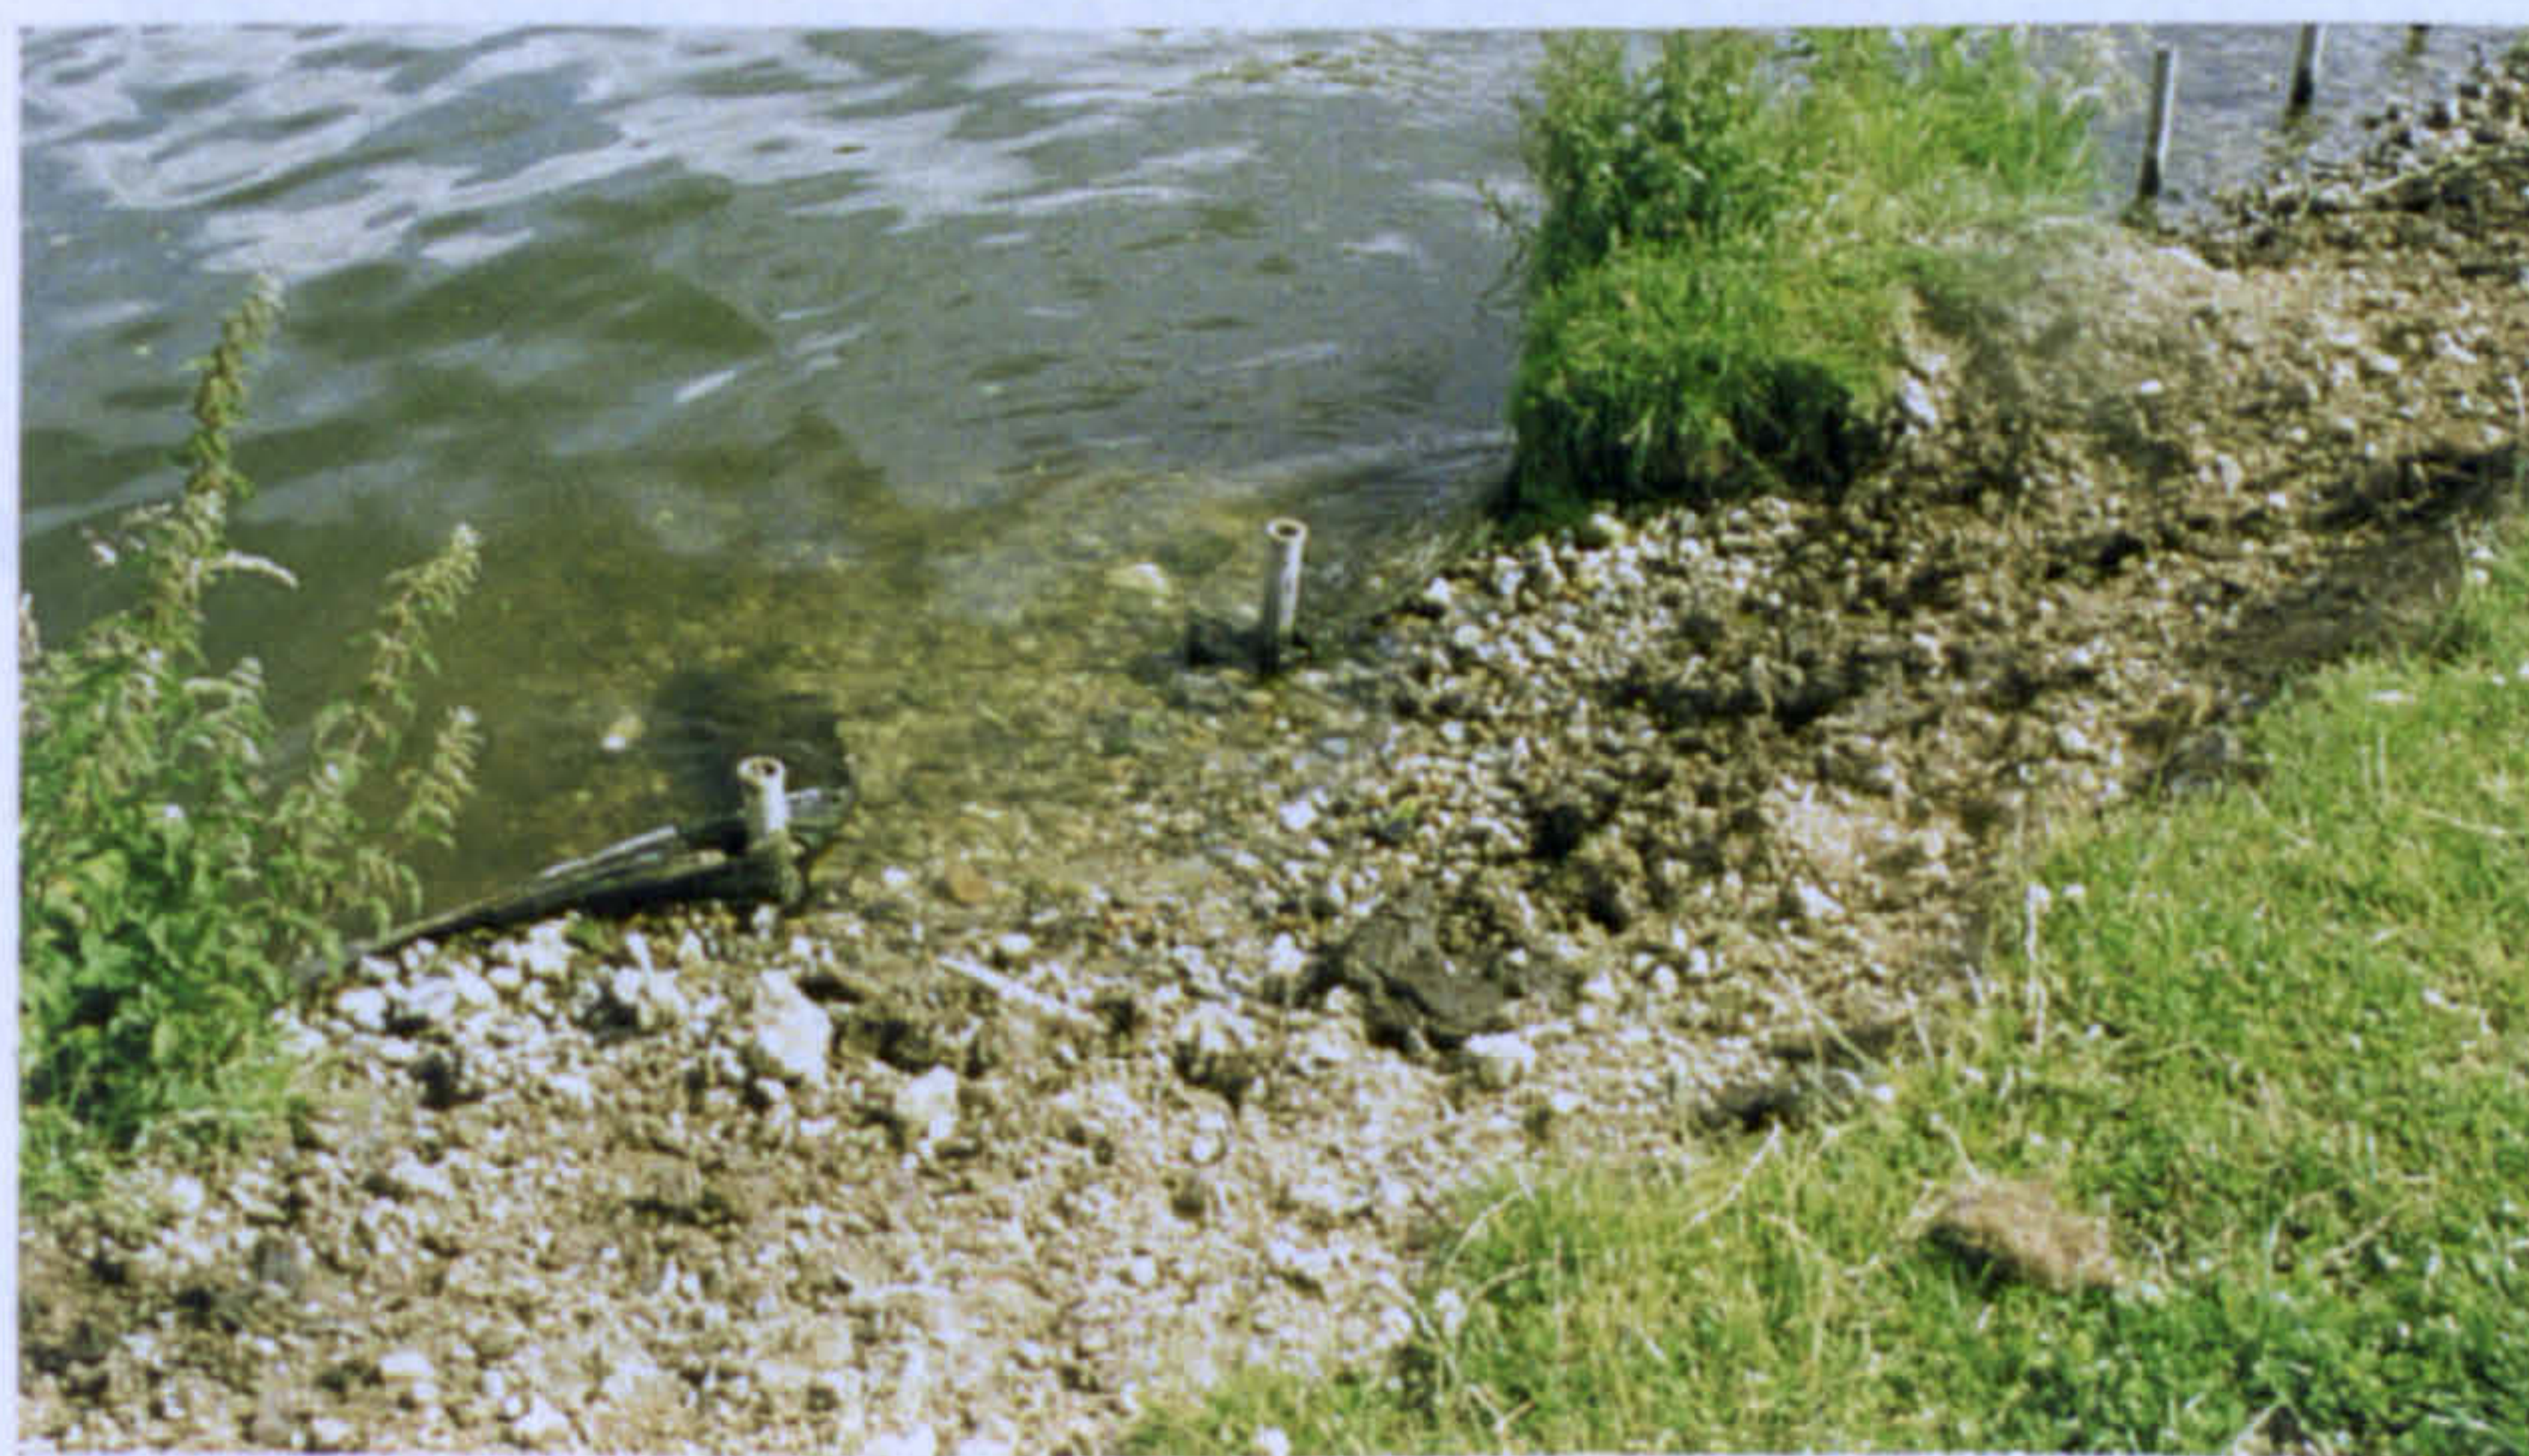
*Plate 6.22
Case study no. 13:
failed Nicospan
geotextile along
Marlow Reach*

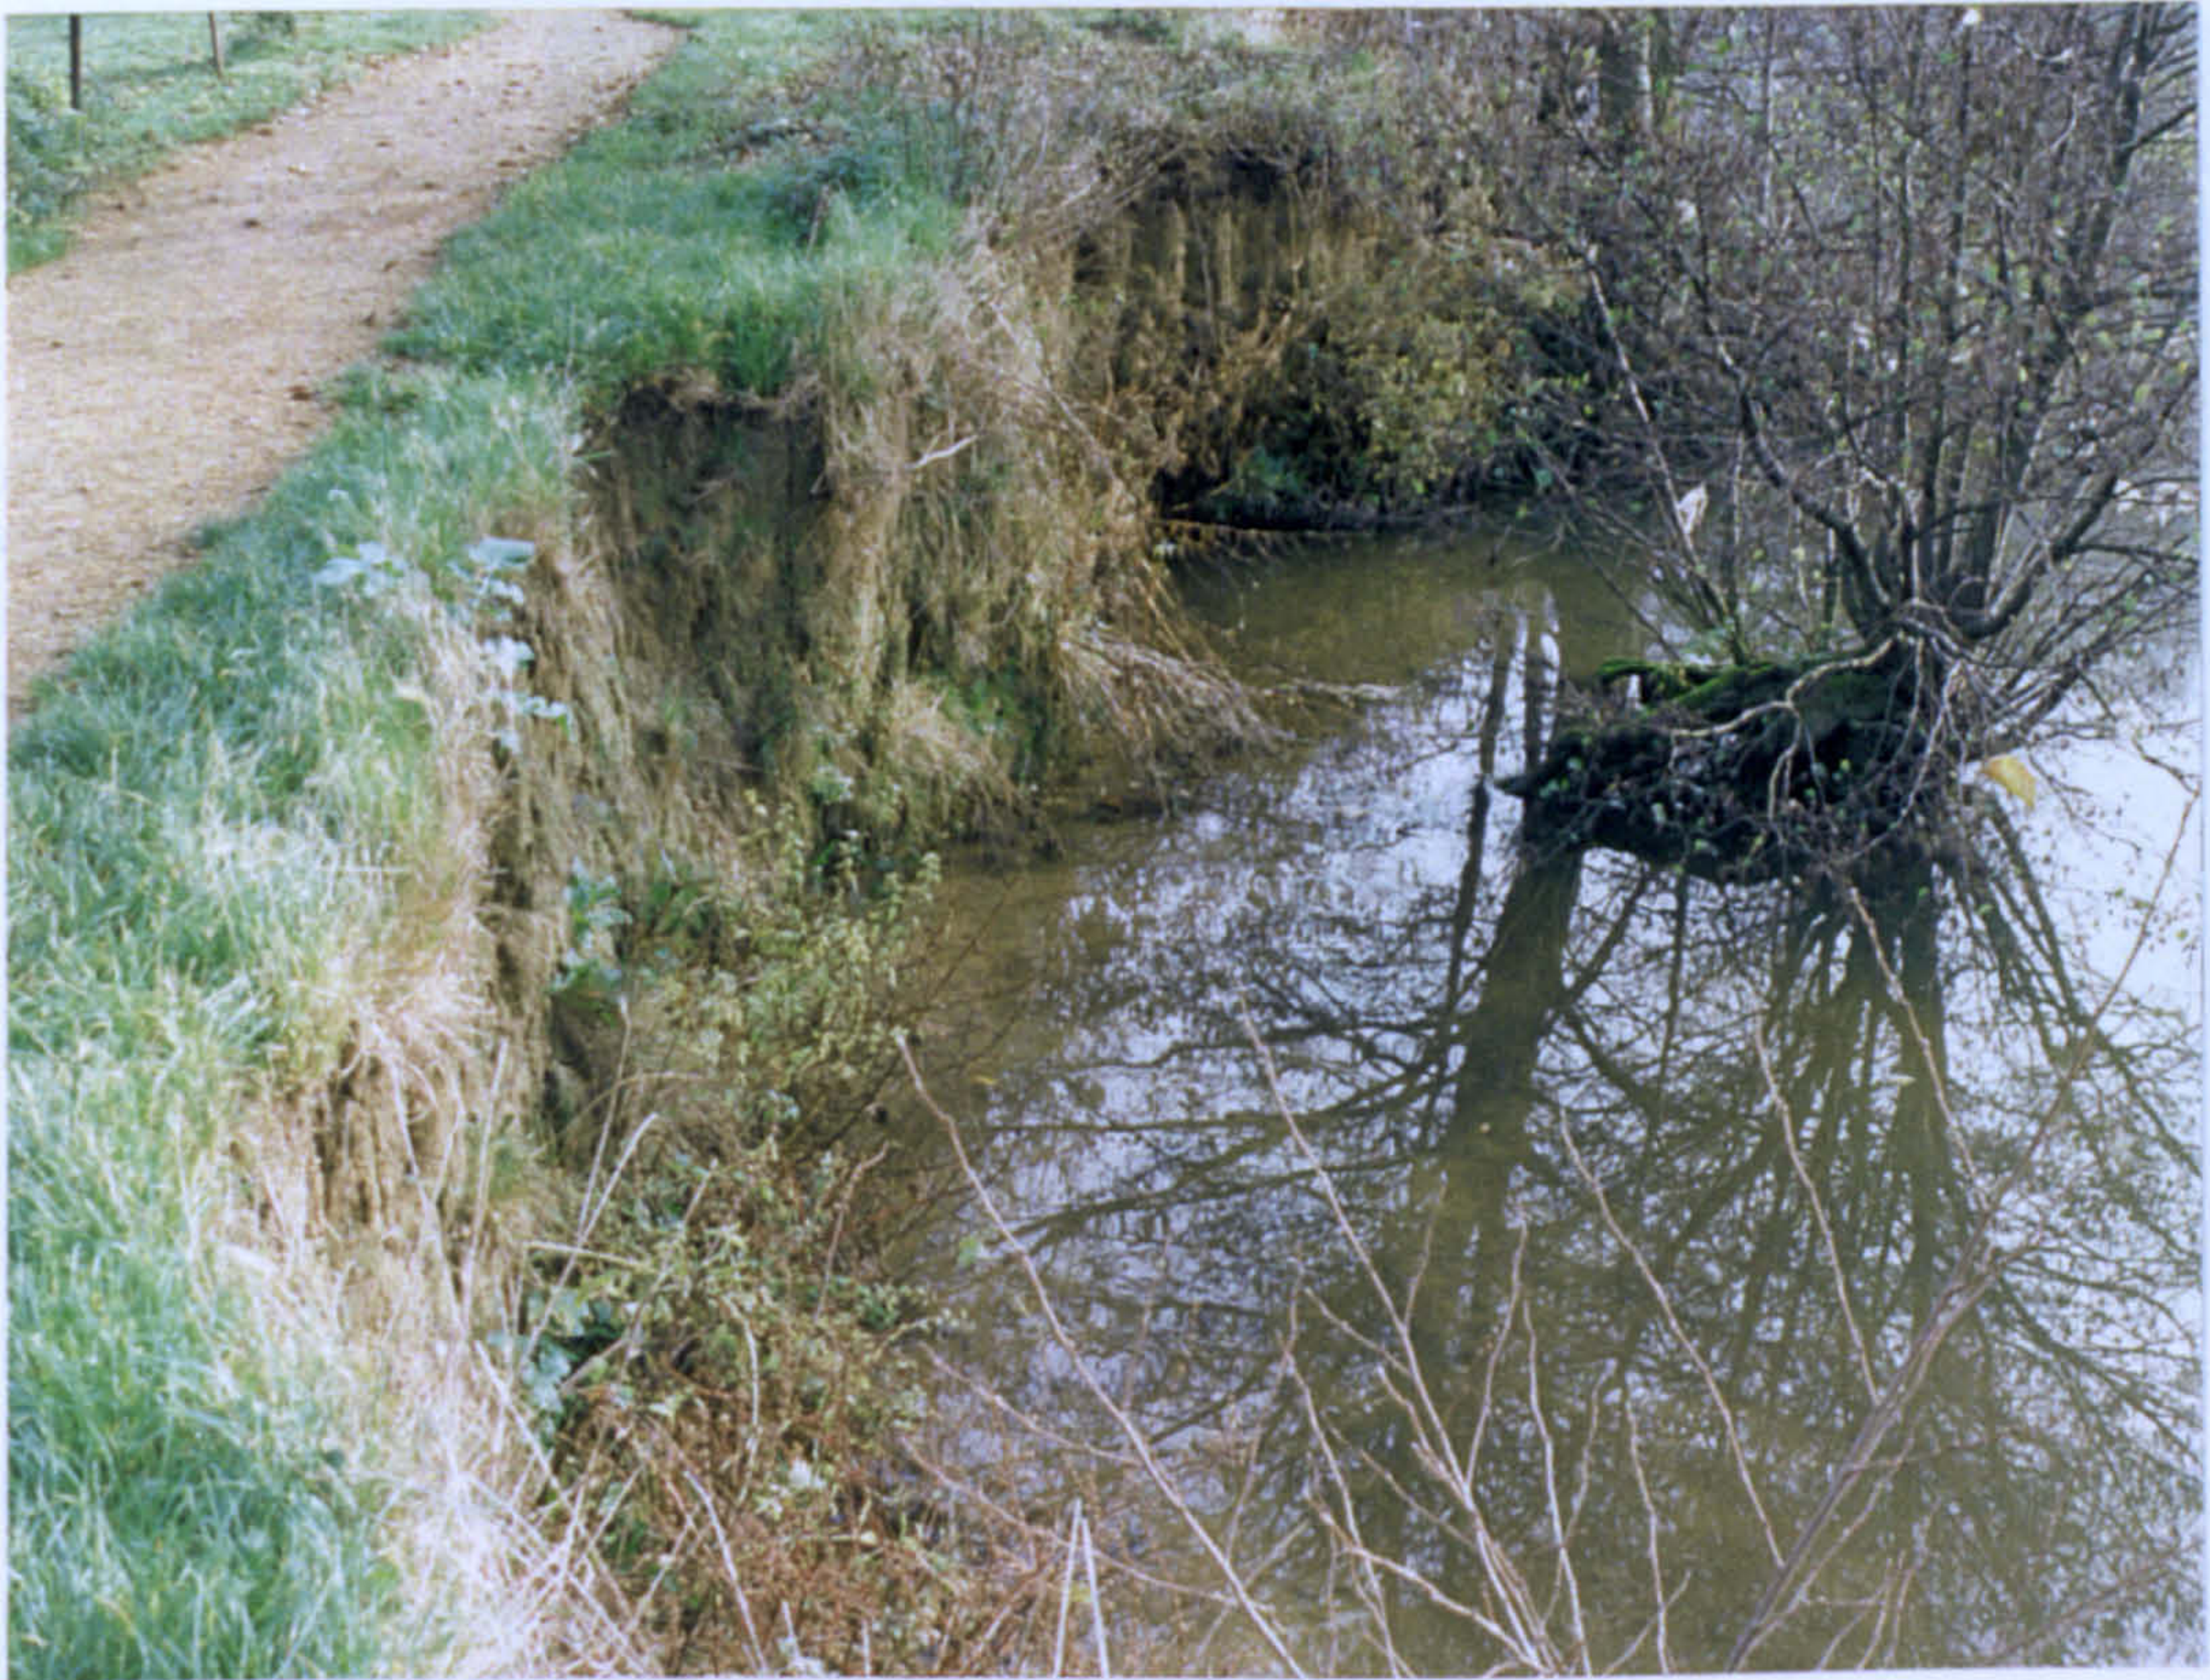
Plate 6.25 Case study no. 15: steep eroding cliff face along Cookham Reach

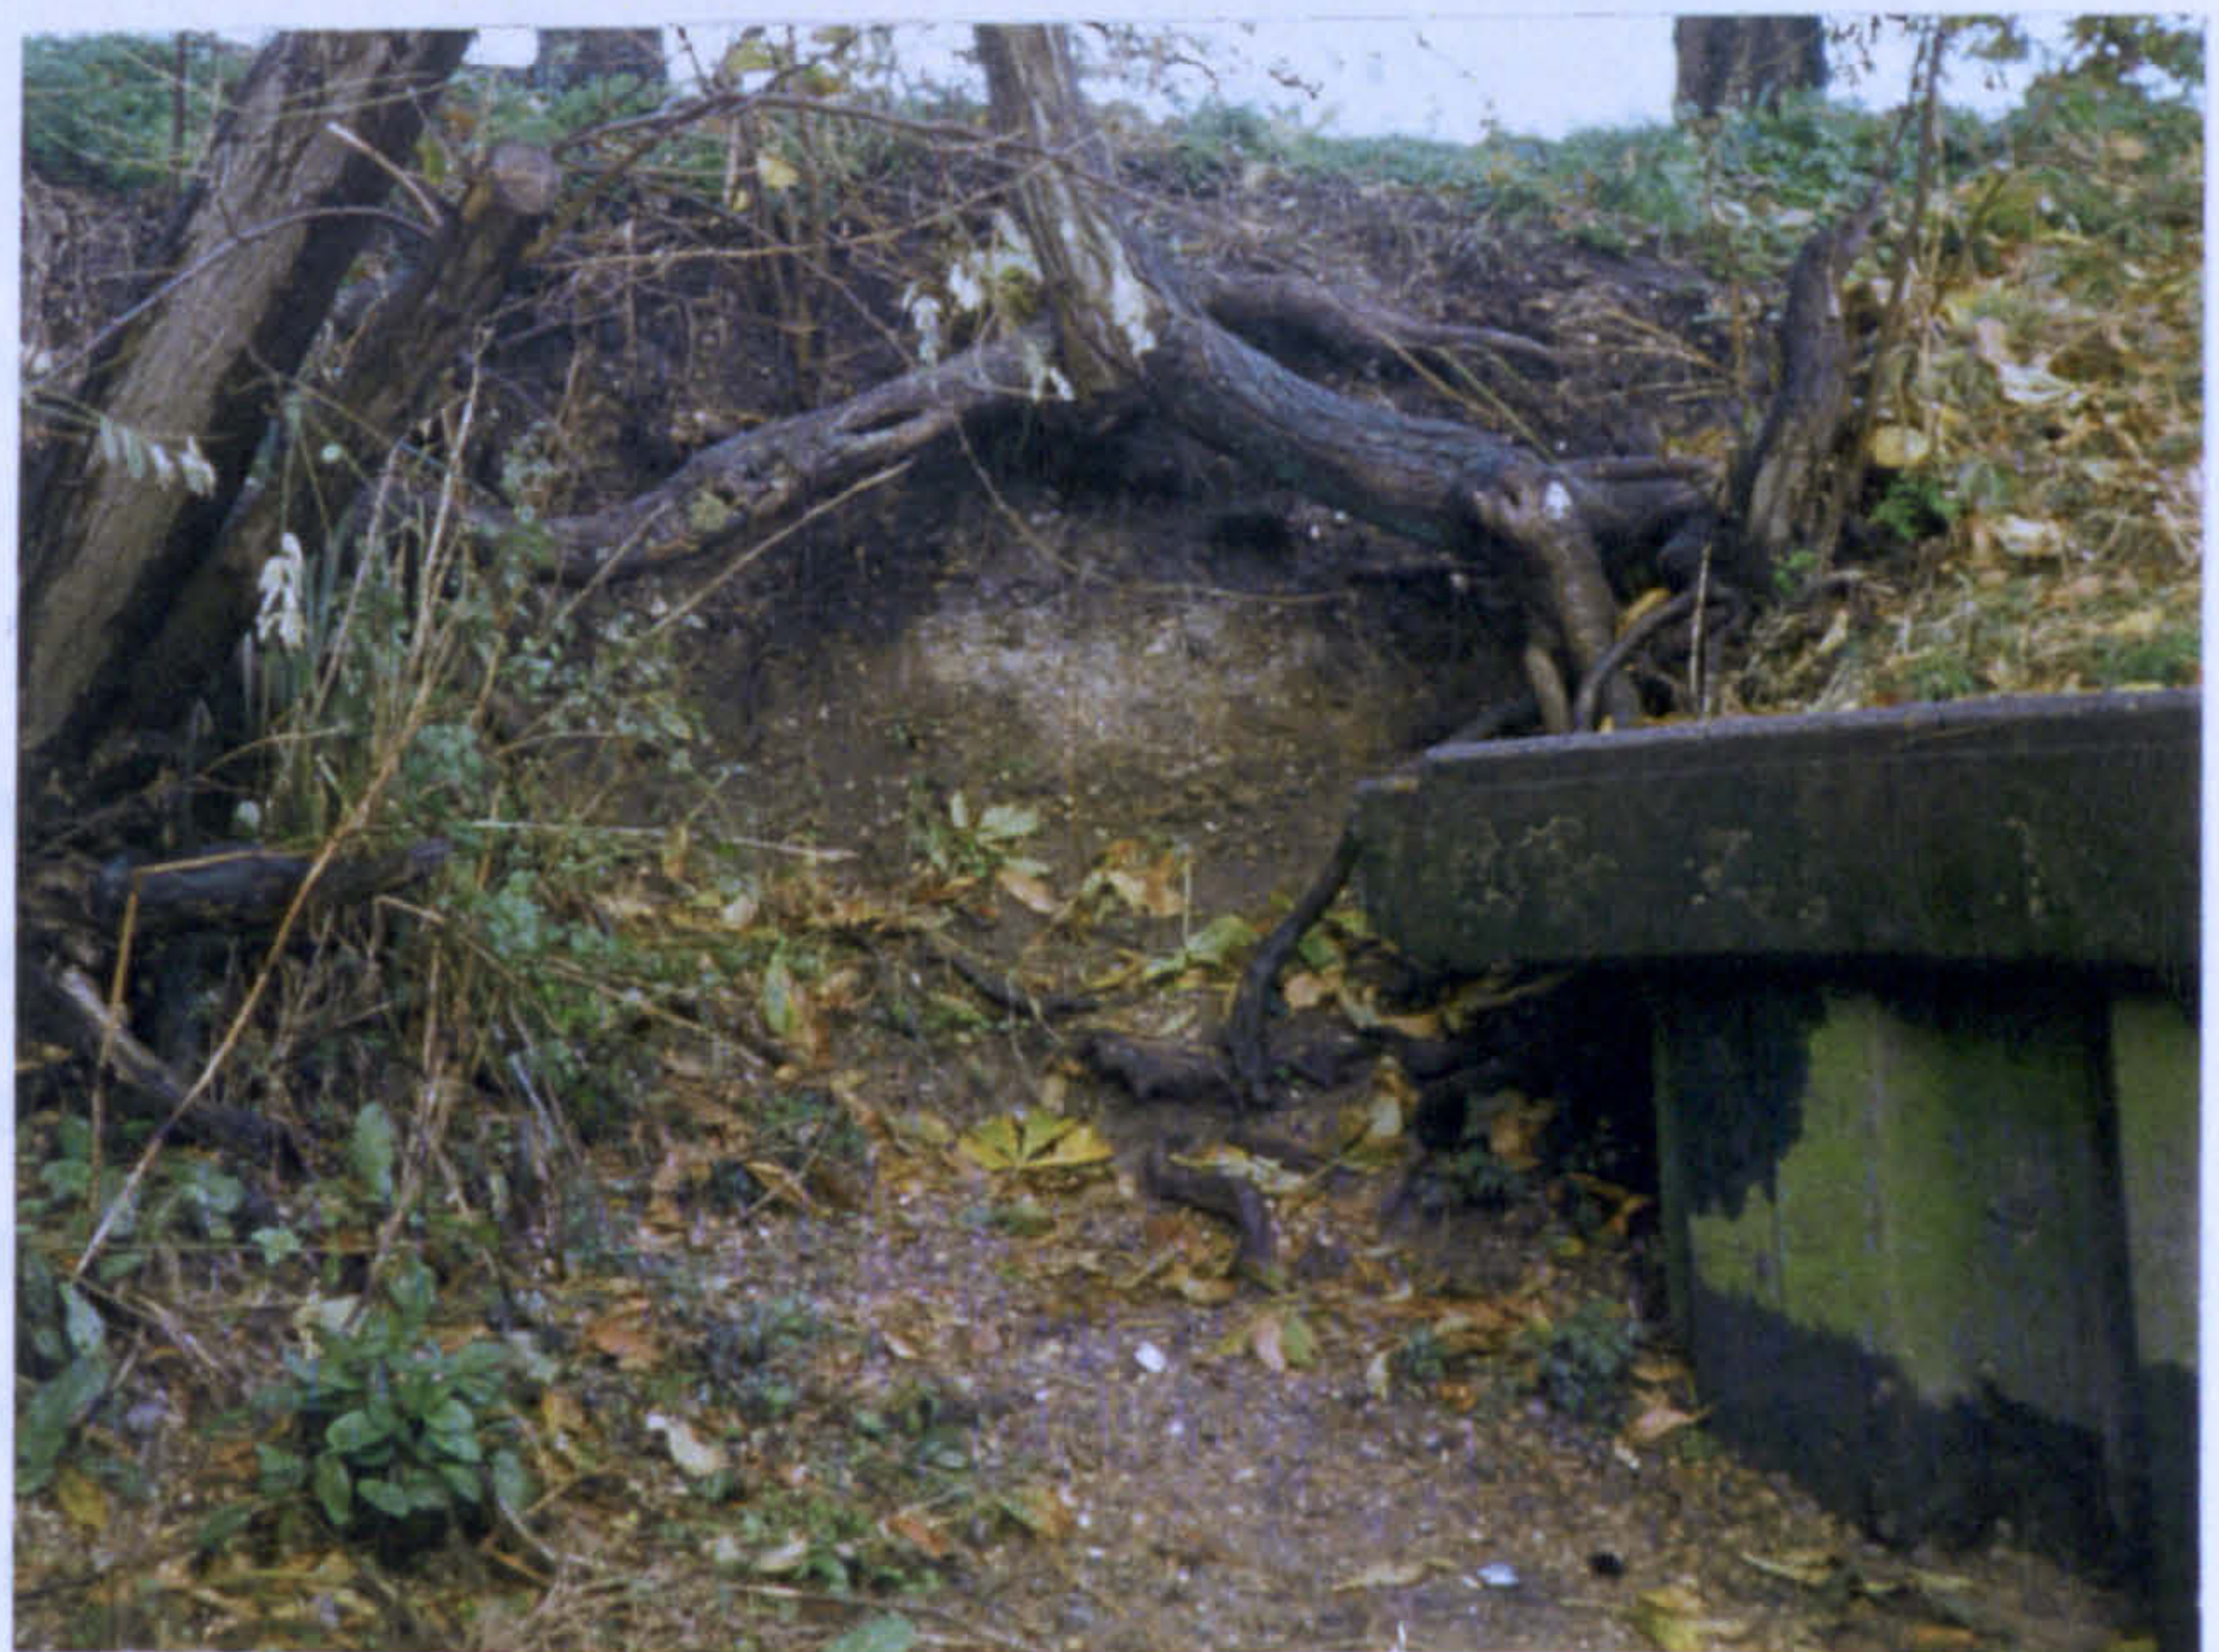
*Plate 6.39
Case study no. 21:
scour behind sheet
piling downstream
of Teddington Weir*
