Energy Absorption Capability of Damage Affected Composite Structures

by Michael Ribeaux, MEng (Hons)

Thesis submitted to The University of Nottingham for the degree of Doctor of Philosophy, October 2003

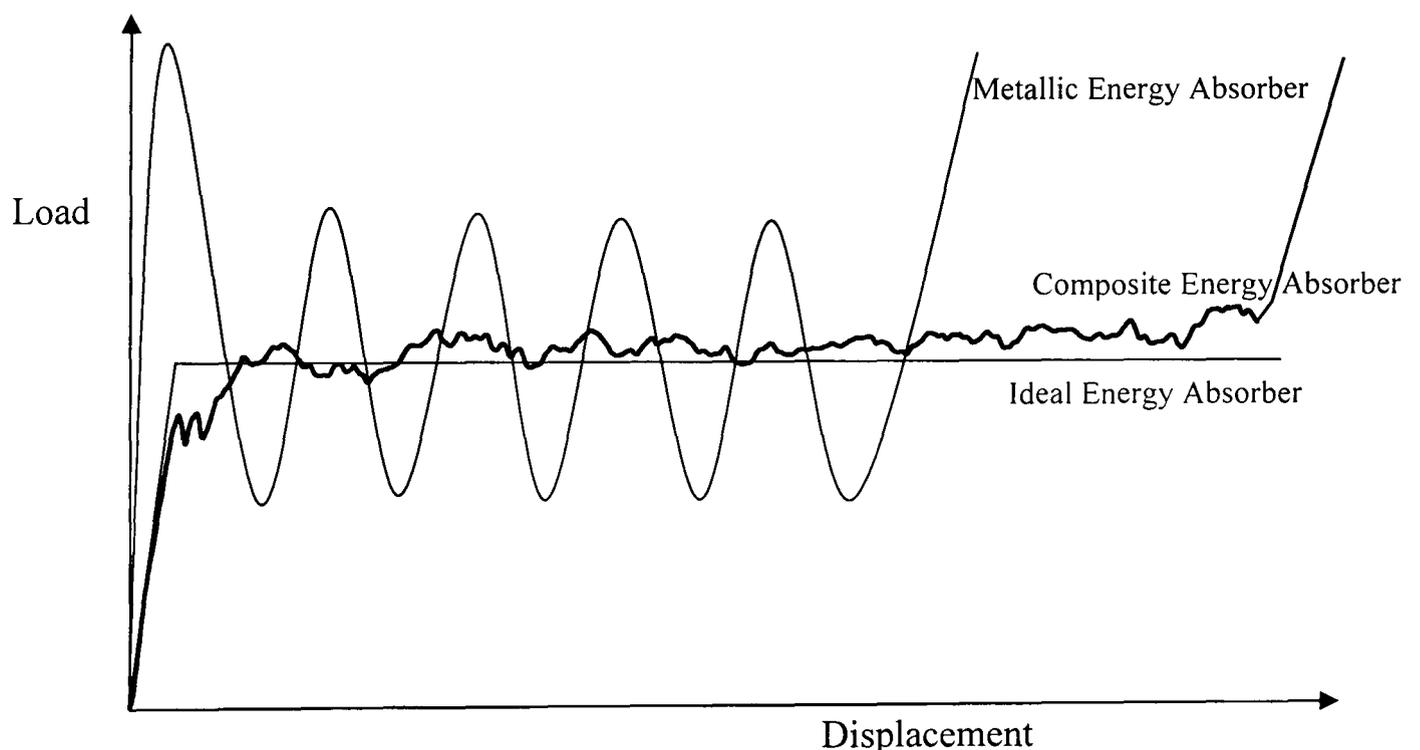
Figure 1: Idealised Load-Displacement Graph of Different Energy Absorbers

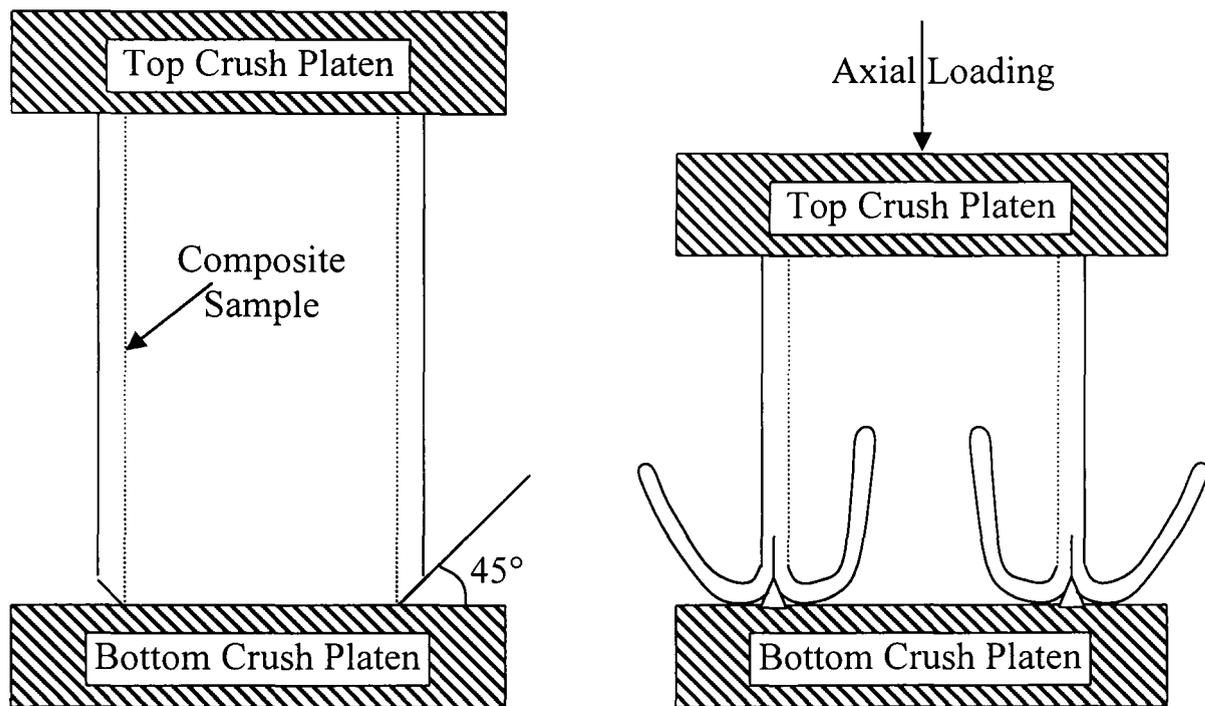
Figure 2: Schematic of Progressive Splaying Development

The CoFRM E-glass/polyester tubes tested in this project are positioned between two parallel crush platens. The top crush platen then places the sample under axial compression. Without a trigger the samples would fail by compressive shear (see Figure 10). The 45° bevel provides a stress concentration by reducing the cross sectional area of the tube at the crush platen. As the sample crushes the length of the chamfer, the load steadily increases until a steady state load is achieved and a progressive splaying mode is observed (see Figure 2 and section 2.2.1).

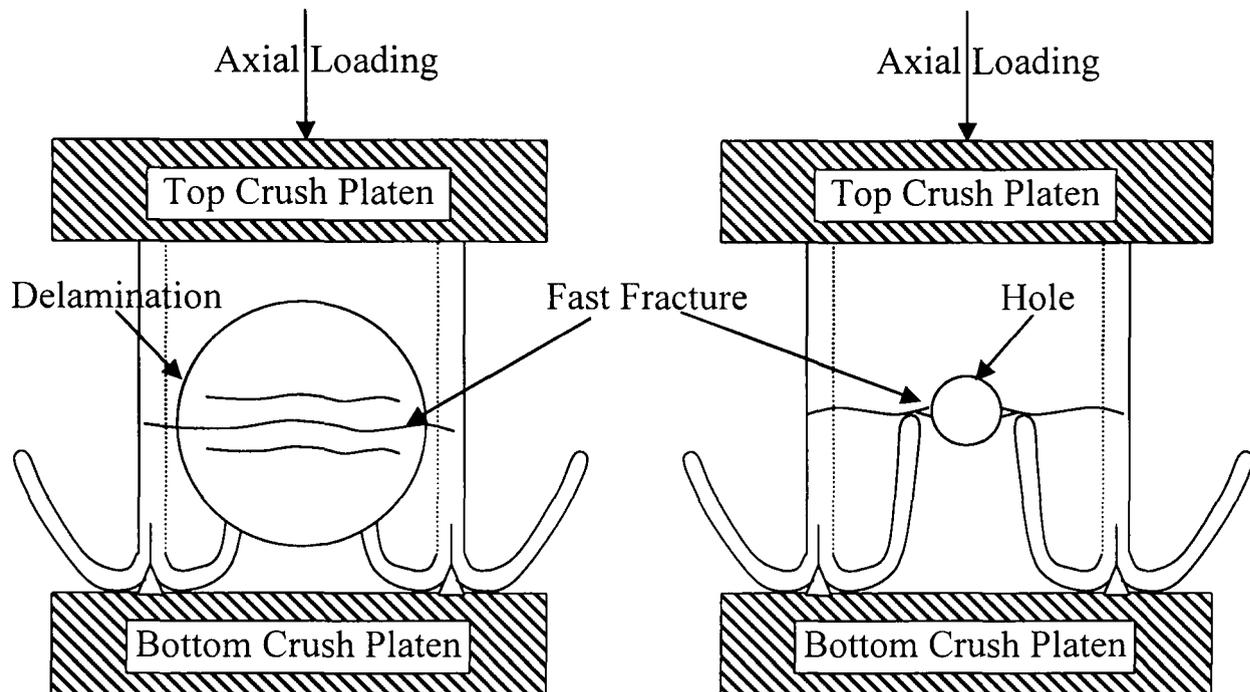
Figure 3: Schematic of Fast Fracture Development

At the steady state crushing stress the sample will either continue to crush progressively, or fail by fast fracture. The crushing stresses for the tubes studied here are such that fast fracture will only occur in the presence of a stress raiser. A zone of delamination, which will divide the tube wall into 2 or 3 thinner sections (depending on the number of delaminations), can cause local buckling. Holes or areas of impact damage will cause a stress concentration, which can also lead to fast fracture (see Figure 3).

Fast fracture occurs if the stress in the sample exceeds the ultimate compressive stress or the local buckling stress. A threshold damage level or hole size exists where the stress in the material is just below that required for fast fracture. As the crush front progresses, the centre wall crack splits the wall of the tube and acts as a stress raiser, which cause fast fracture to occur in the vicinity of the crush zone.

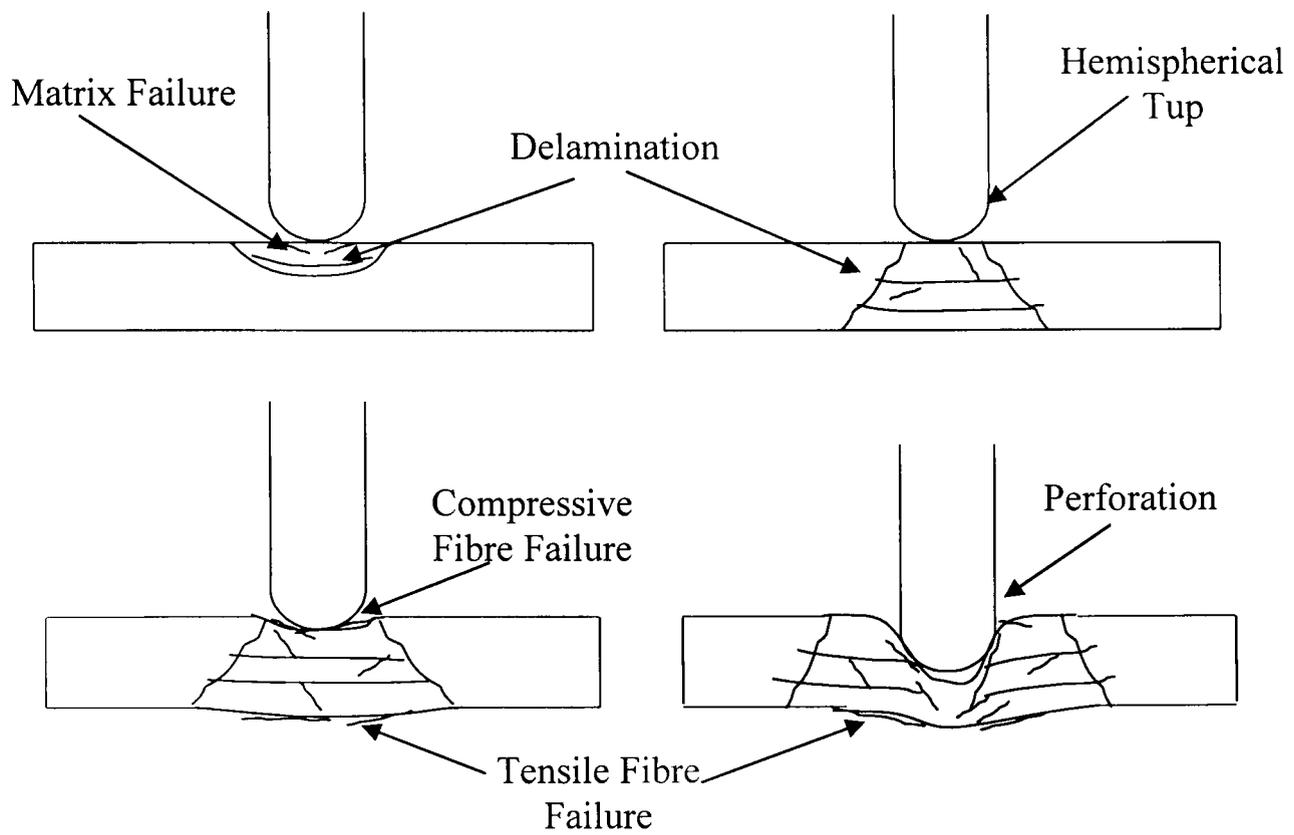
Figure 4: Modes of Failure in Low Velocity Impact

Cantwell and Morton [6] reviewed research papers and found that, of these four failure modes, those that involve fracture of the matrix or interphase region result in low fracture energies whereas failures involving fibre fracture result in significantly greater energy dissipation.

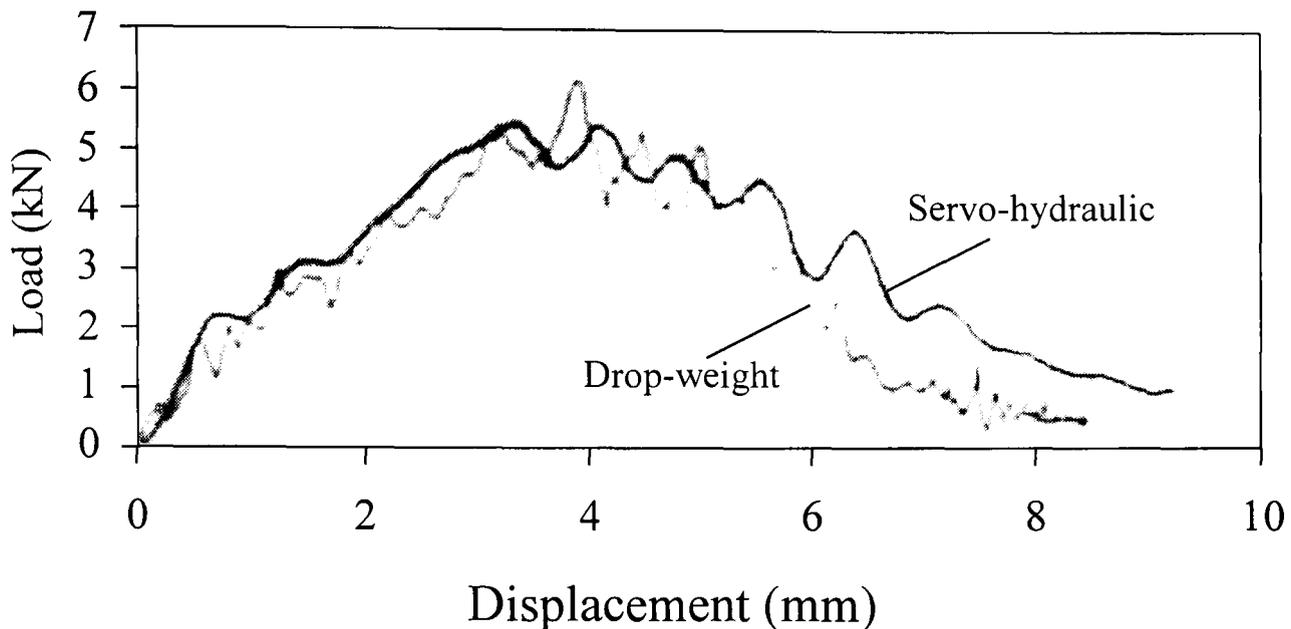
Figure 5: Load displacement graph for a drop-weight impact at 4.4m/s compared with servo-hydraulic impact at 1m/s

It has been shown that an impact that may not produce any visible damage can create a damage area in the order of 50% of the damage area for a fully penetrated specimen. Dear and Brown [7] showed this through C-scan imaging of the damage zone after damaging sheet moulding compound (SMC) laminates. The onset of visible surface damage does not appear until the load displacement trace reaches its peak (see Figure 5), at which point through thickness damage starts to occur.

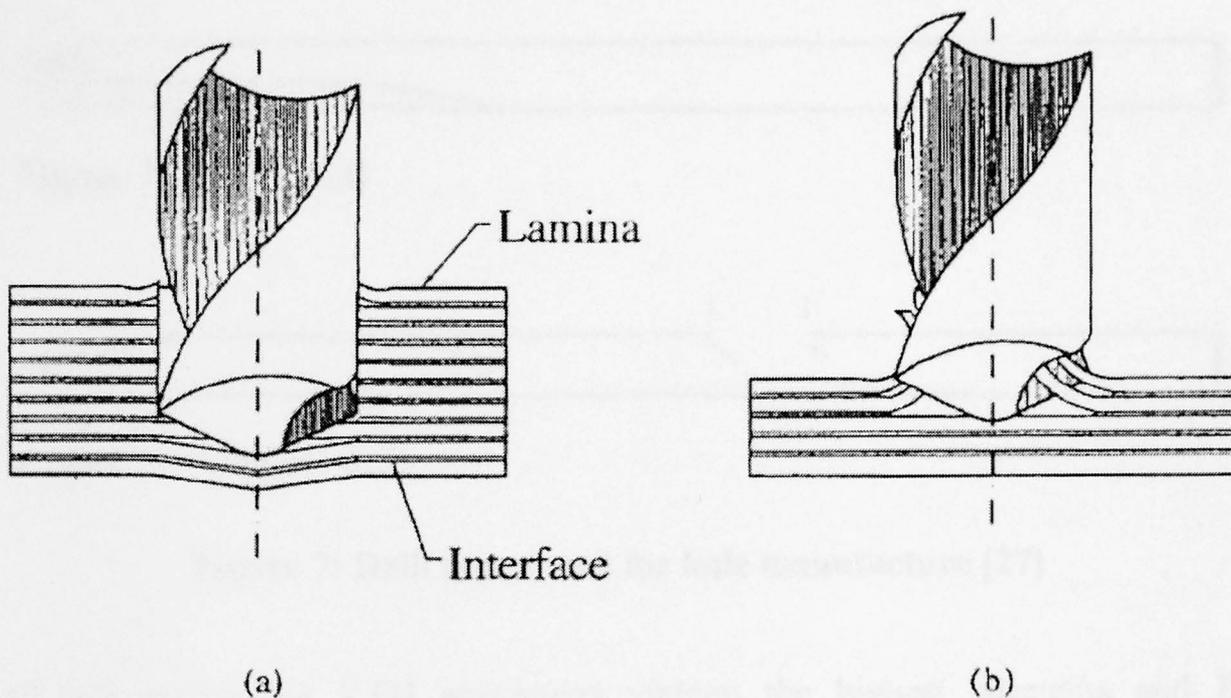
Figure 6: Delamination at exit (a) and at the entrance (b) side of the drilled hole [27]

For many structures it is necessary to drill holes for various purposes. One important requirement is bolt holes. Bolted joints are used to transfer loads within a structure. The strength of a bolted joint may be, to a considerable extent, influenced by the quality and accuracy of the machined holes. If it were possible to machine holes without defects, weight reduction and increased fatigue life would be possible. However, machining defects, such as delamination, chip-out of fibres / matrix, and degradation of the matrix due to overheating can reduce the strength of the composite (see Figure 6).

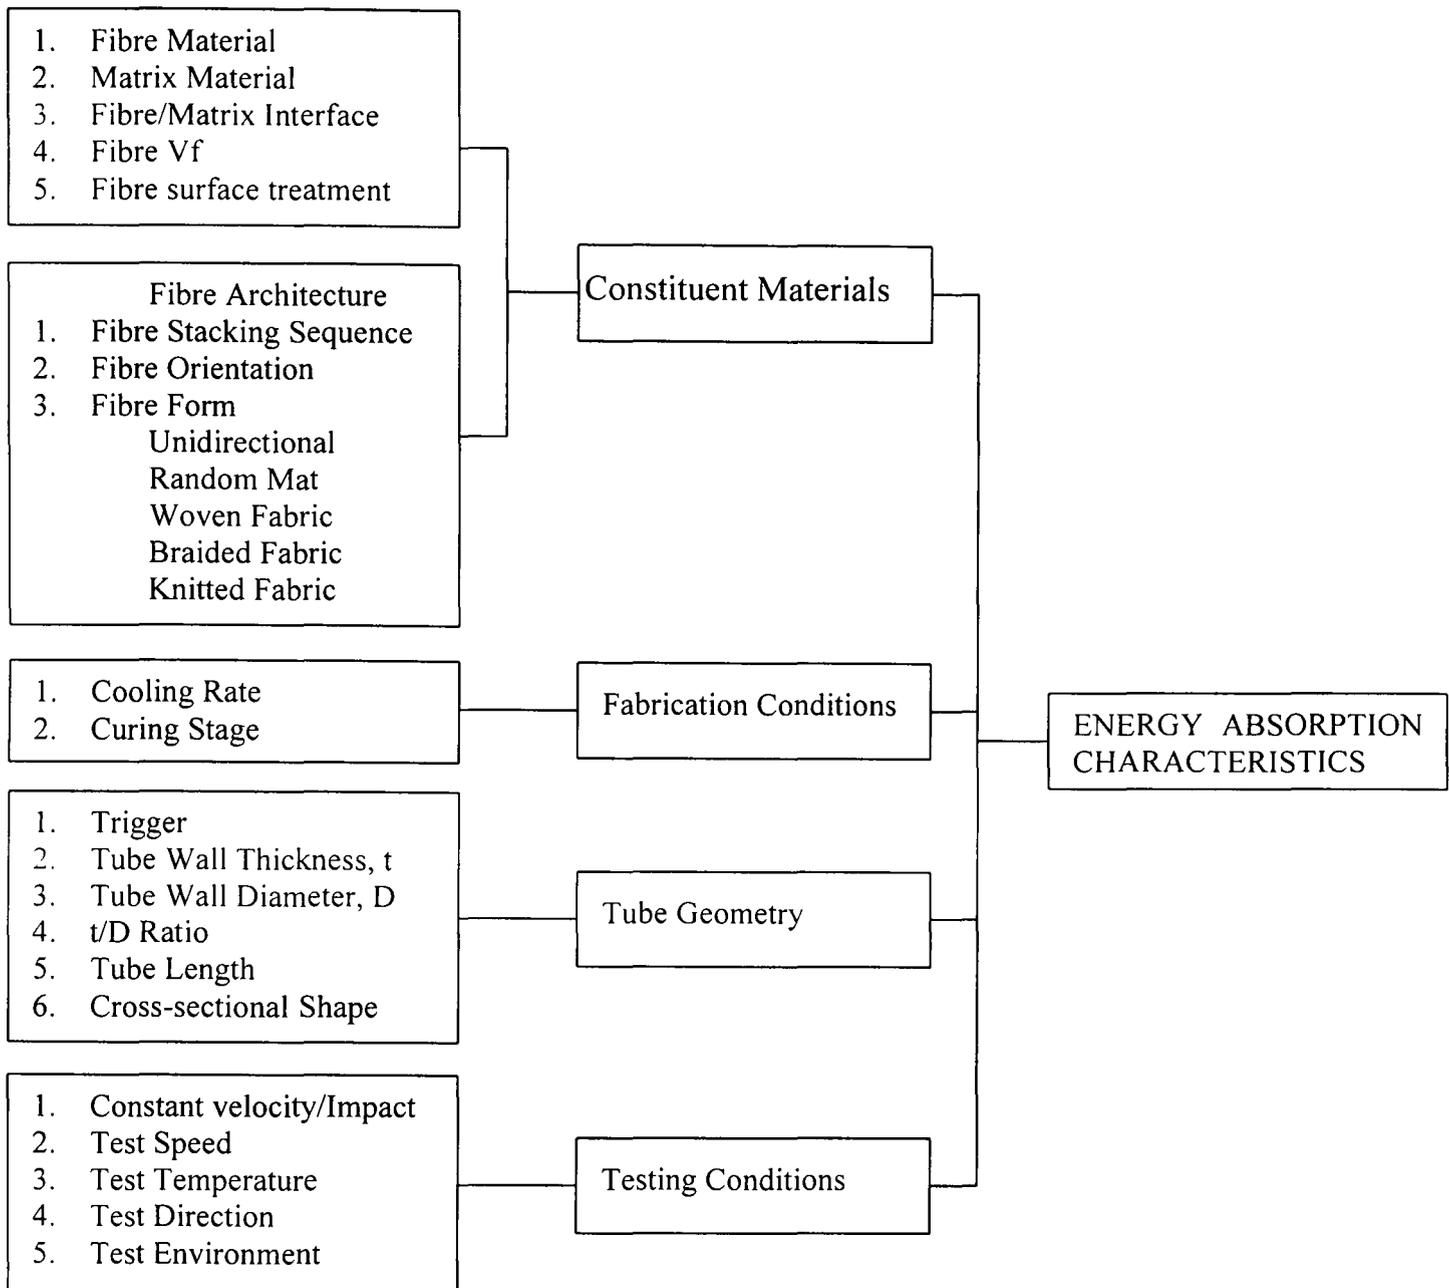
Figure 9: Parameters Affecting Specific Energy Absorption [49, 50]

Many parameters affect the specific energy absorption of composite materials. This is highlighted in Figure 9.

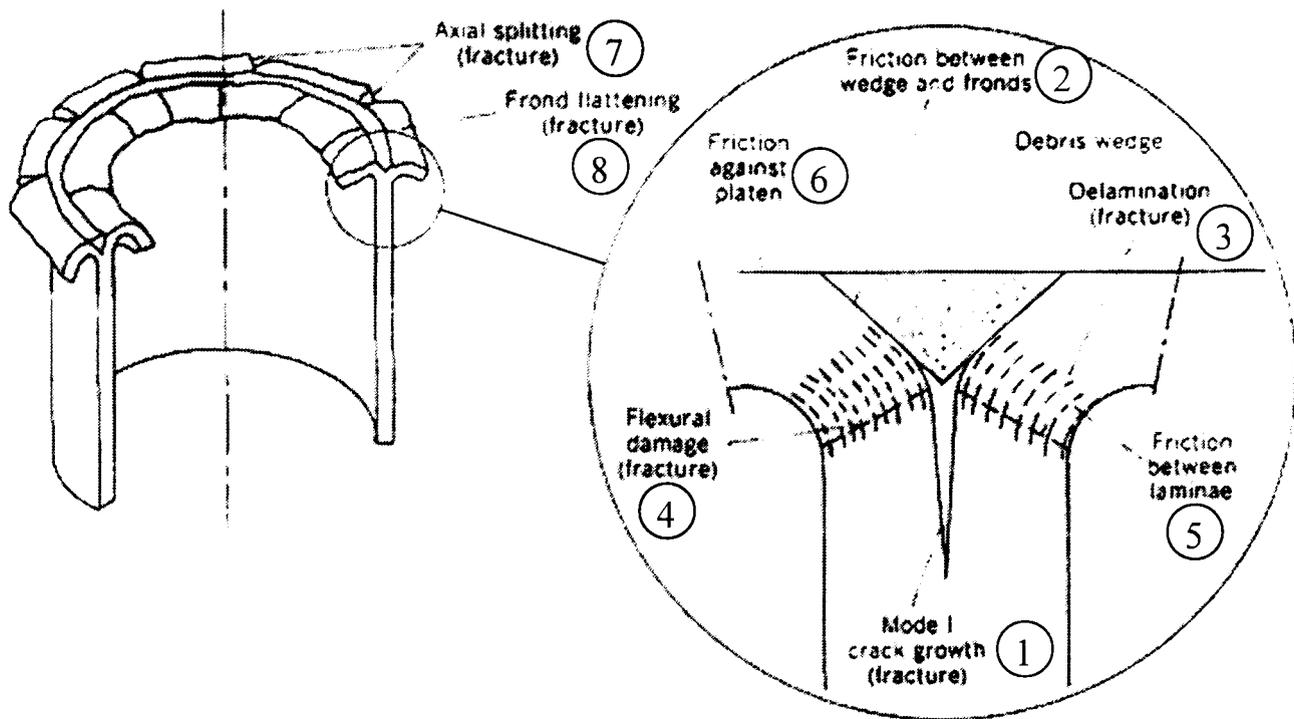
Figure 12: Schematic of the Splaying Crush Mode [59]

The main feature of the splaying crush mode is the annular wedge of tightly compacted and highly fragmented debris that is forced axially through the tube wall. The wedge is formed during crushing of the trigger and subsequently deflects delaminated strips from the wall radially inward and outward in the form of a continuous frond (see Figure 12 from Fairfull and Hull [59]). The splaying mode is usually observed in structures containing a relatively high percentage of axial fibres [60].

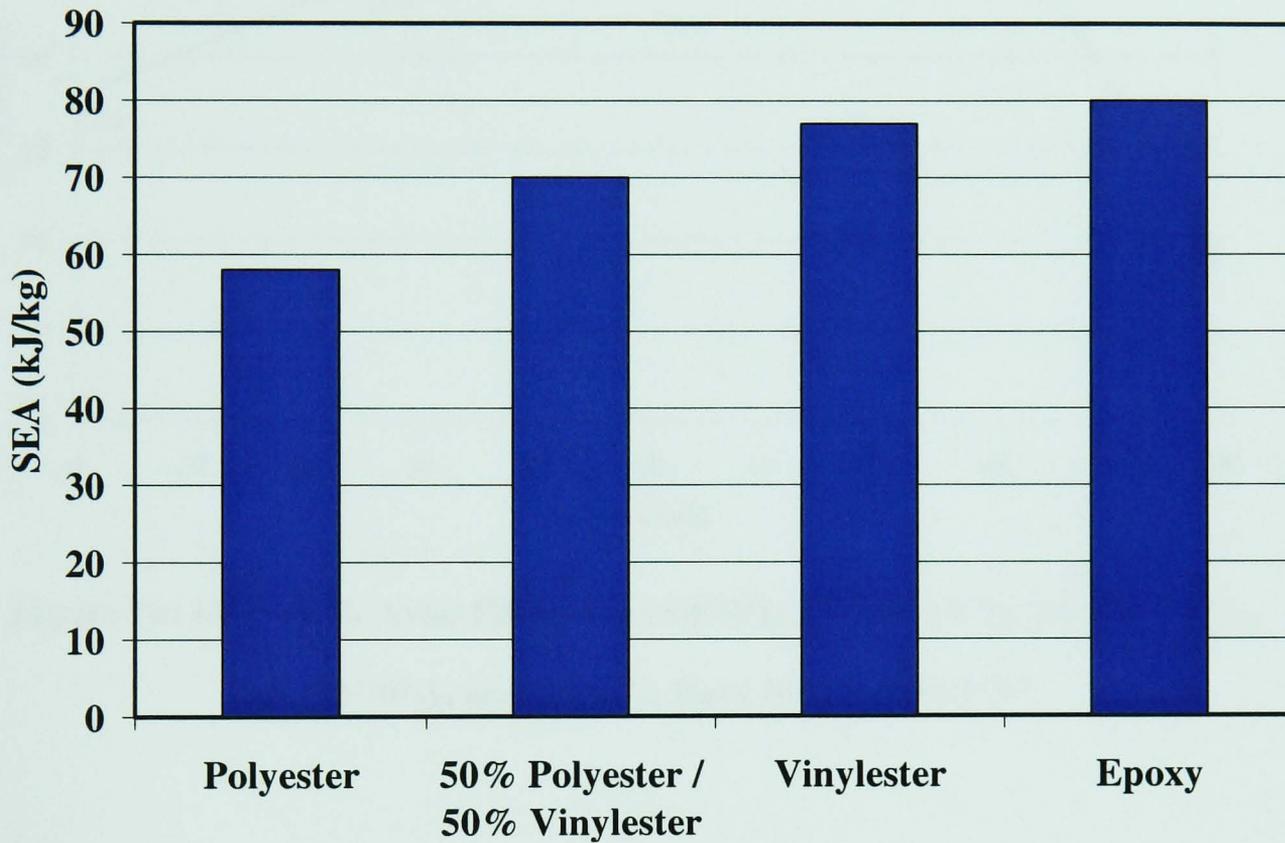
Figure 15: Effect of Resin Type on SEA of CoFRM E-Glass Composite Tubes [68]

Turner [68] at the University of Nottingham fabricated tubes from CoFRM E-glass and found that epoxy resin provided the greatest SEA, then vinylester and finally unsaturated polyester (see Figure 15). By blending vinylester and polyester it was possible to change the SEA in proportion to the mix ratio. The cylindrical tubes tested in the work by Turner had outer diameter of 88.9mm, wall thickness of 4mm and fibre volume fraction of 23%.

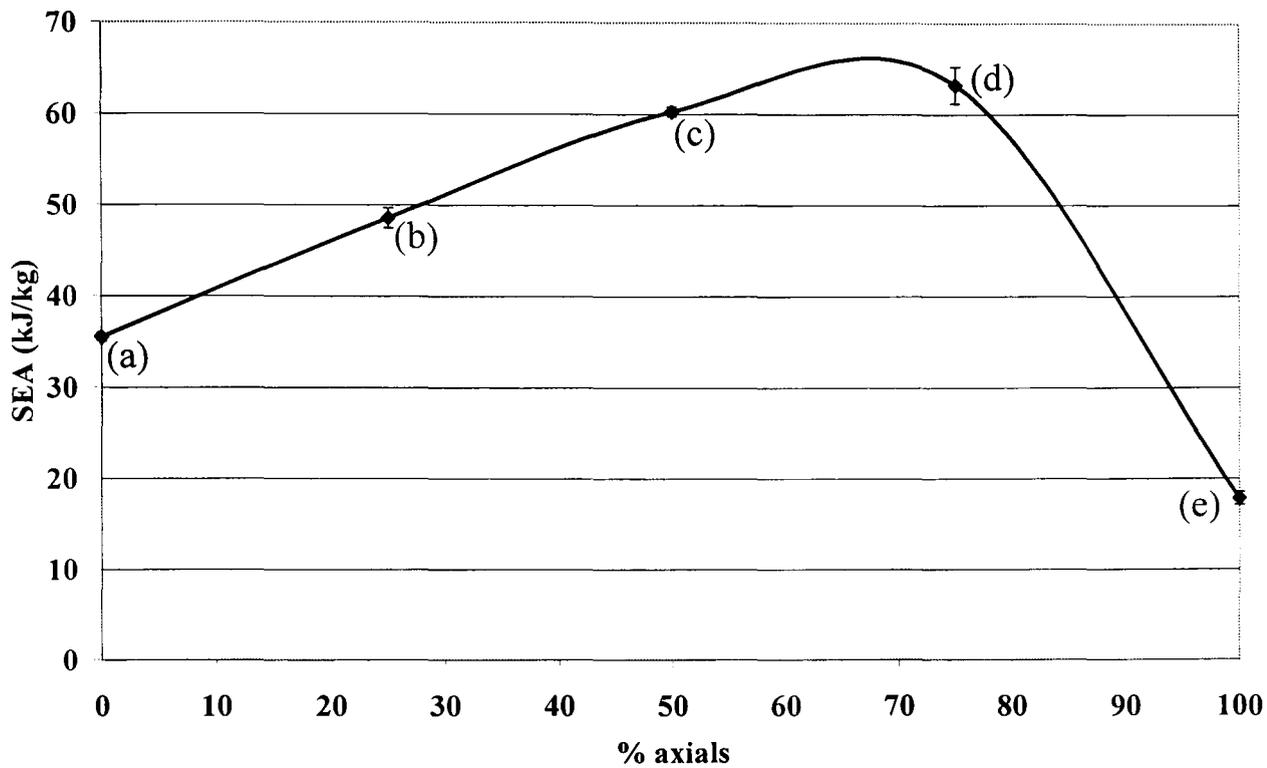
Figure 16: SEA vs % Axial Fibres for (a) $[90^\circ]_8$, (b) $[90^\circ_3/0^\circ]_S$, (c) $[90^\circ_2/0^\circ_2]_S$, (d) $[90^\circ/0^\circ_3]_S$ and (e) $[0^\circ]_8$ Data from Curtis [70]

may require the removal of some axial fibres to enable their inclusion and therefore reduce the load bearing capacity of the composite. By optimising the percentage of axial fibres it is possible to ensure stable crush and maximise SEA (see Figure 16).

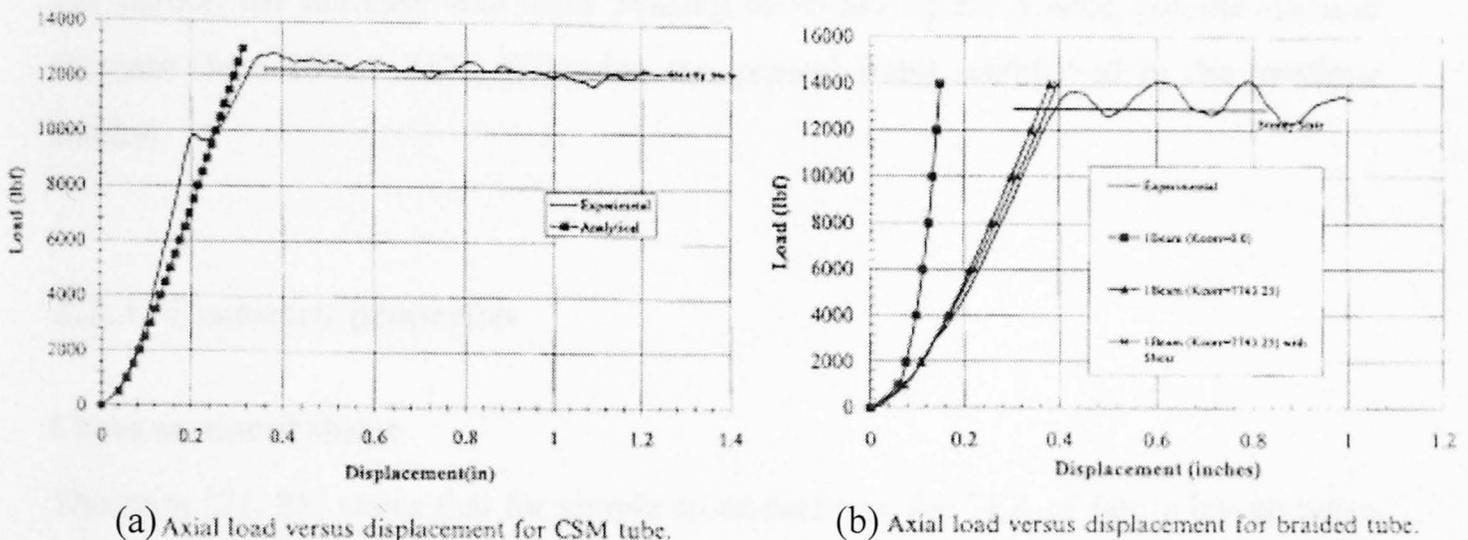
Figure 17: Graphs Showing Crush Response of (a) Axially Loaded CSM Tube, and (b) Axially Loaded Braided Tube

Quek *et al.* [82] found that under quasi-static crush conditions the crush load for CSM glass fibre tubes oscillated less about the steady state crush load than braided tubes, which exhibited a more distinct periodicity (see Figure 17).

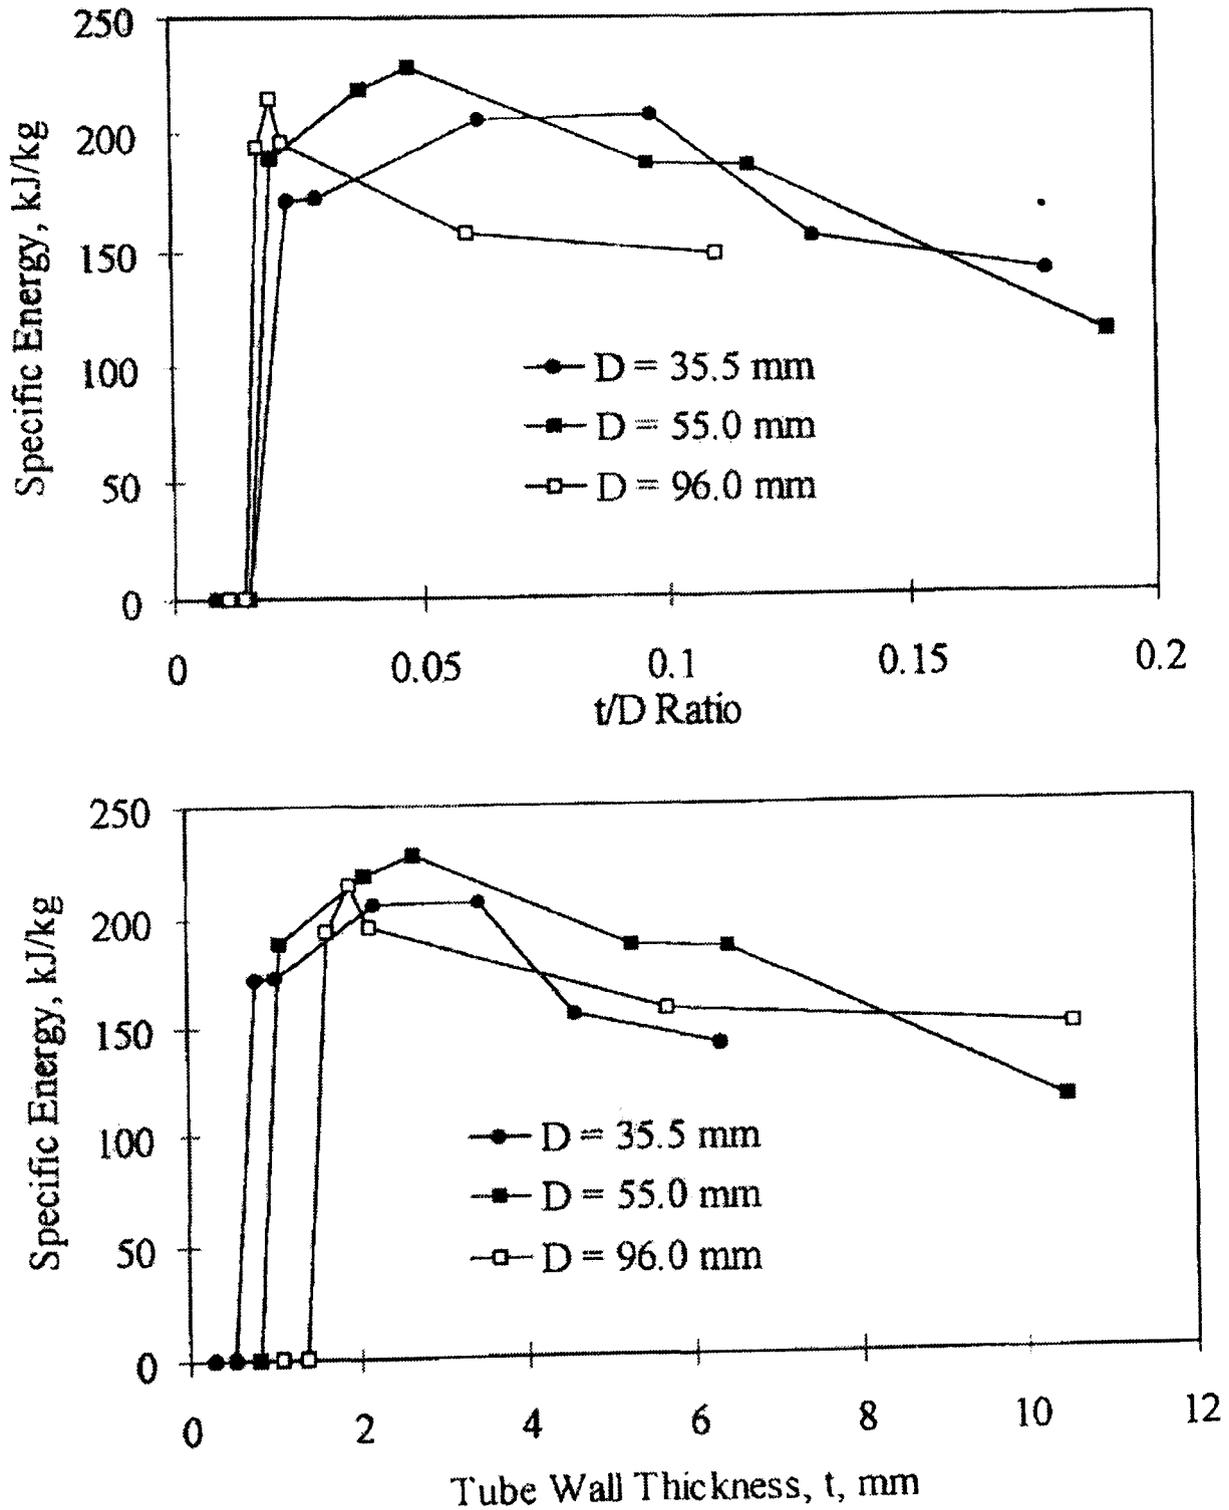
Figure 18: Variation of SEA with Tube t/D Ratio and Wall Thickness (t) [50]

With carbon fibre / PEEK tubes Hamada *et al.* [100] found that SEA was dependent on the absolute value of t rather than the t/D ratio. However, the absolute value of t affects the t/D ratio and it can be seen in Figure 18 that graphs of both SEA vs t and SEA vs t/D show similar trends for carbon/PEEK tubes. t/D results for this material showed unstable failure for ratios of less than 0.015, and highest SEA values for wall thicknesses in the range of $t=2-3\text{mm}$.

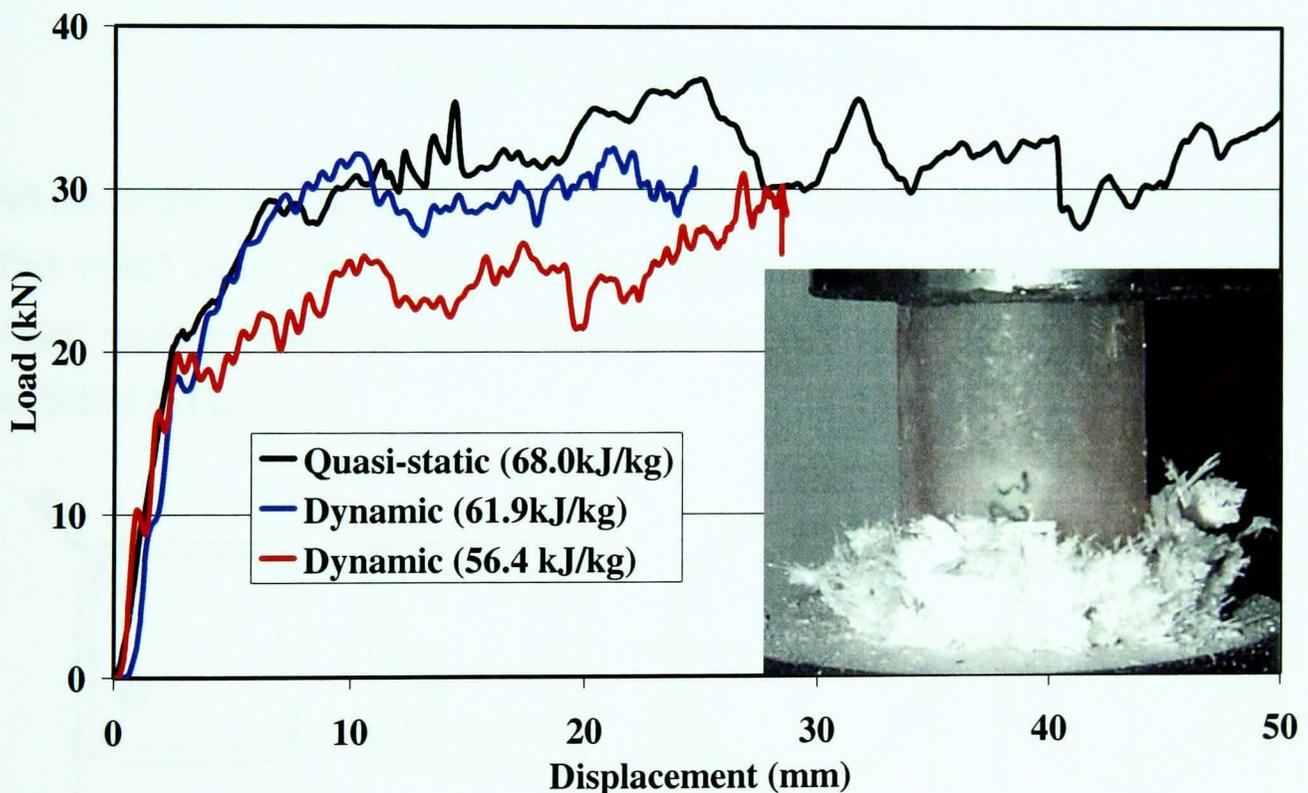
Figure 23: Test Results for Dynamic Tests with Prototype Shrink Wrapped Cylindrical Tube

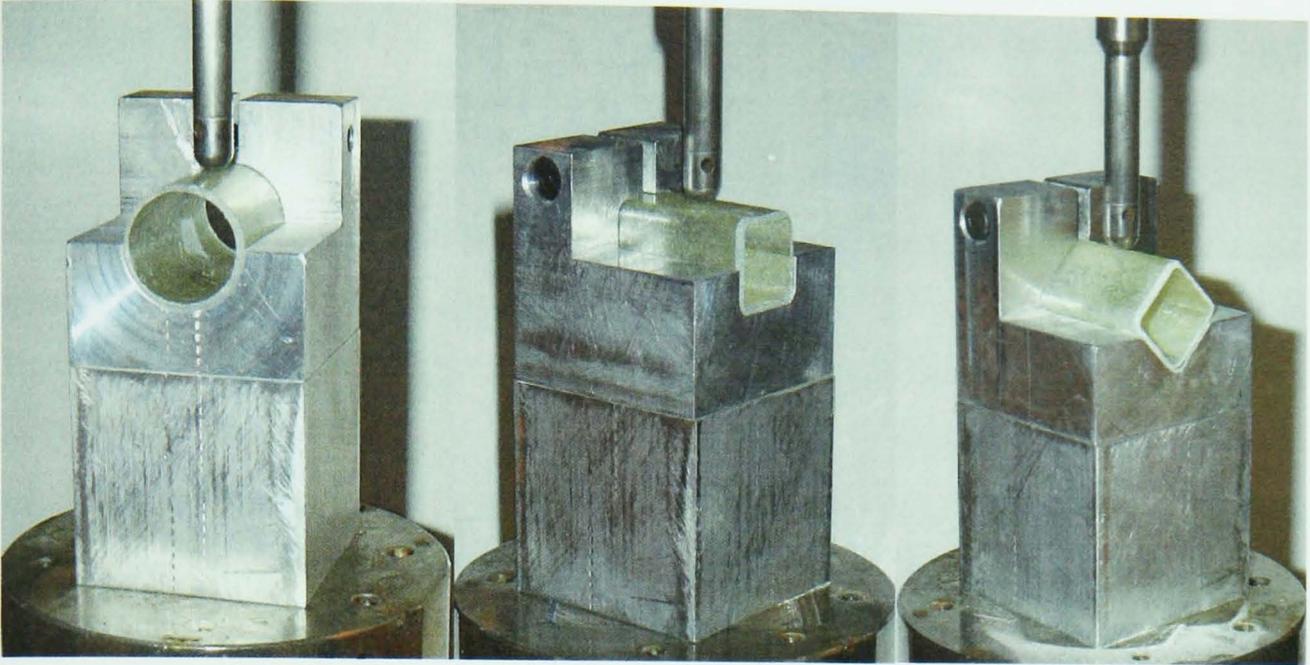
Figure 31: Test Rigs for causing controlled impact damage to composite tubes

The tubes were damaged by dropping a fixed weight from a controlled height using the Rosand instrumented falling weight drop tower. A tup with hemispherical end of diameter 12.7mm was used as the impactor (see Figure 31). The fixtures holding the specimens during impact were designed to constrain the sample and ensure that all the energy from the impact was absorbed by the sample.

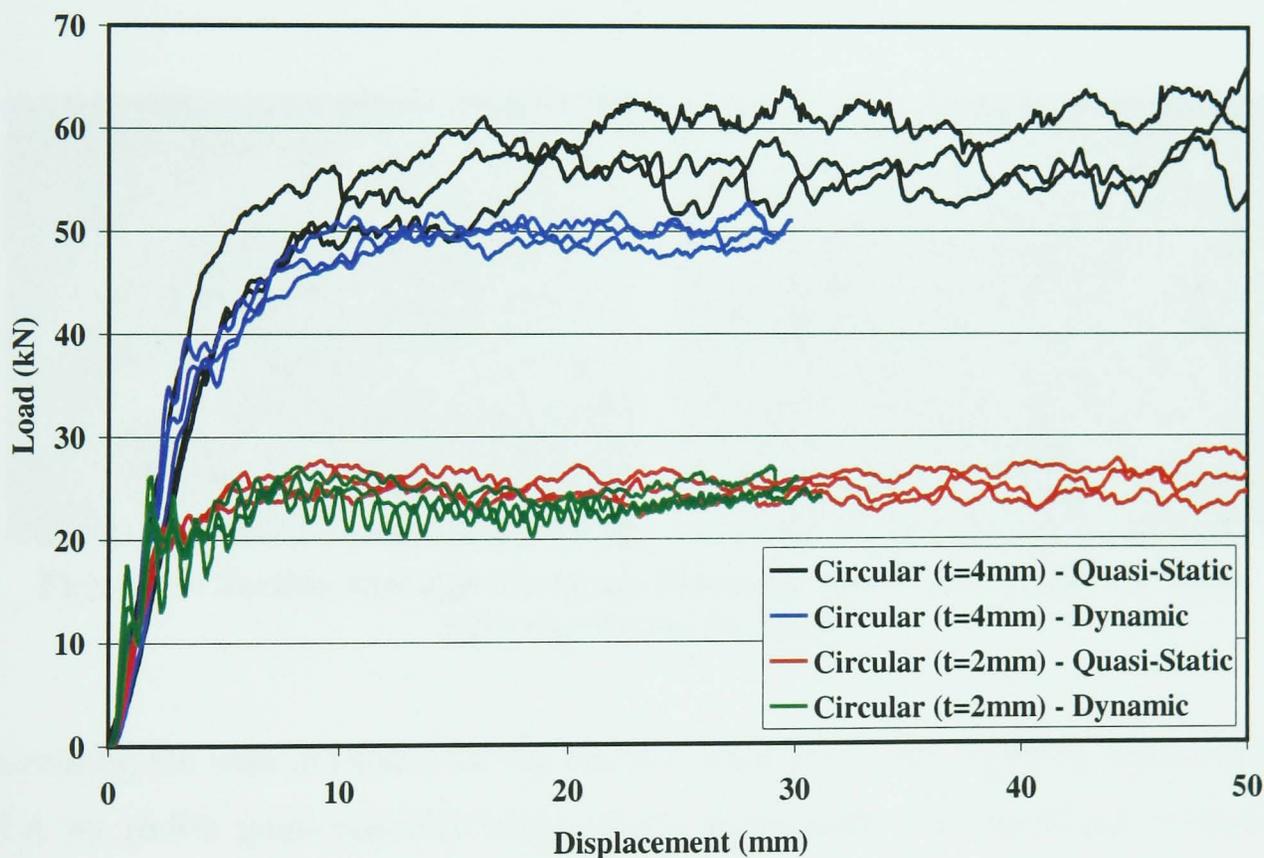
Figure 37: Load vs Displacement for all Circular Tubes

Both quasi-statically and dynamically tested samples crush progressively with a steady increase in load as the tube starts to crush at the chamfered trigger, before reaching a steady state crushing load (see Figure 37).

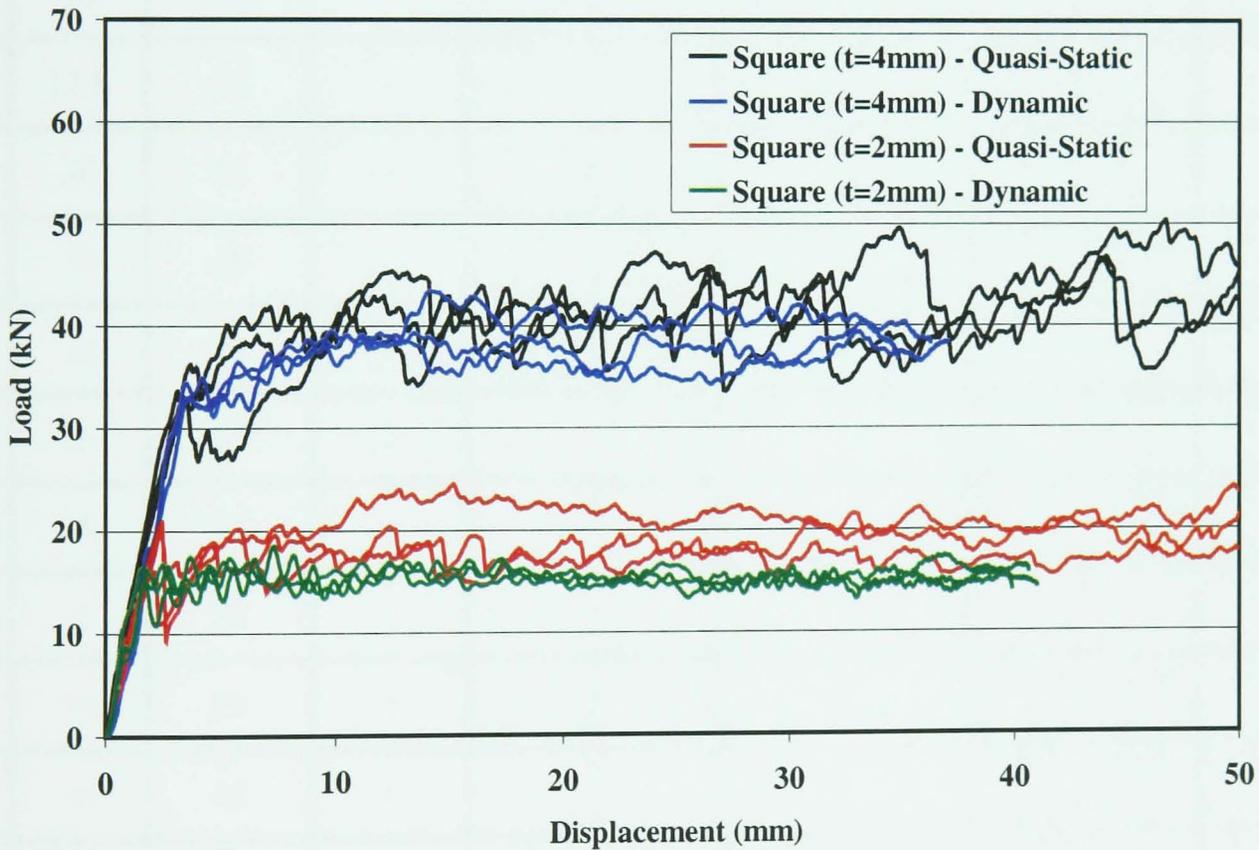
Figure 41: Load vs Displacement for all Square Tubes with No Damage

The load displacement trace for the square samples exhibits a greater degree of serration than that of the circular samples (see Figure 41). This is due to the start – stop tearing Mode II fracture at the corners.

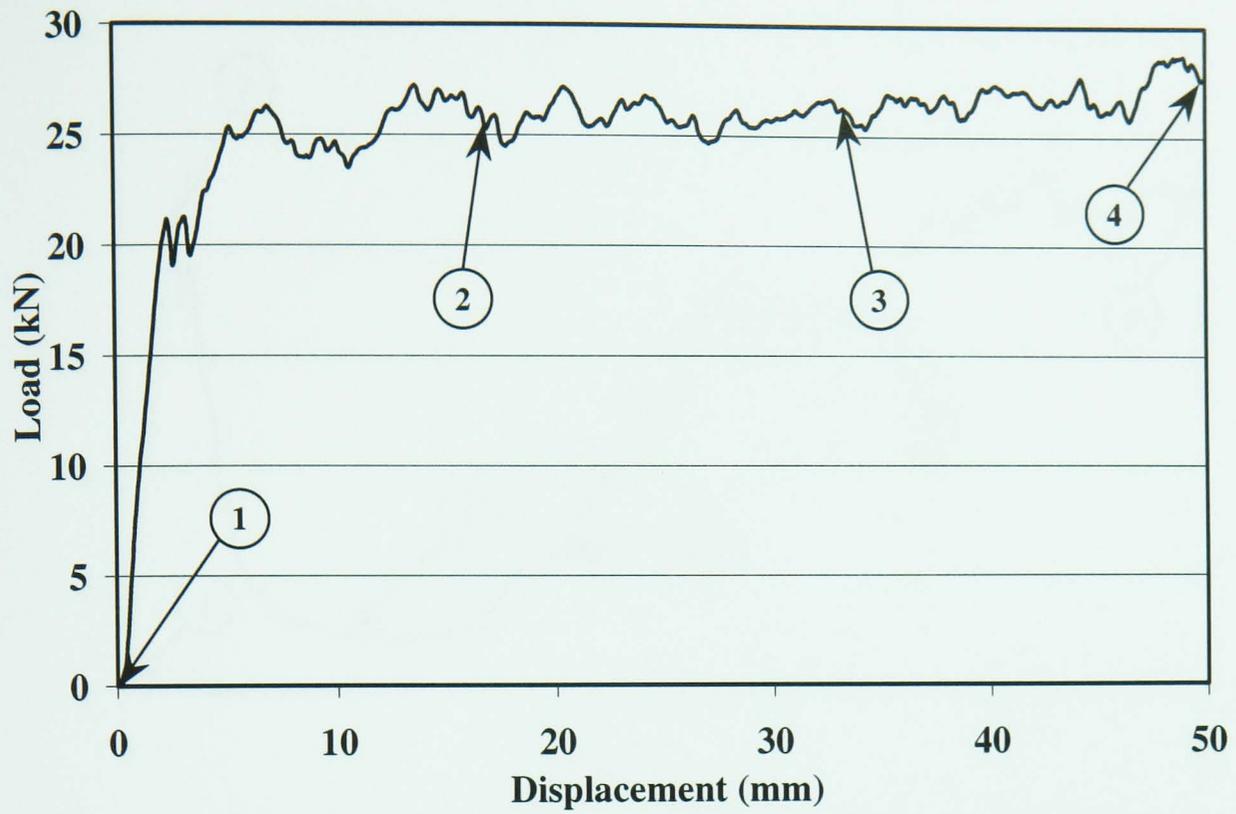
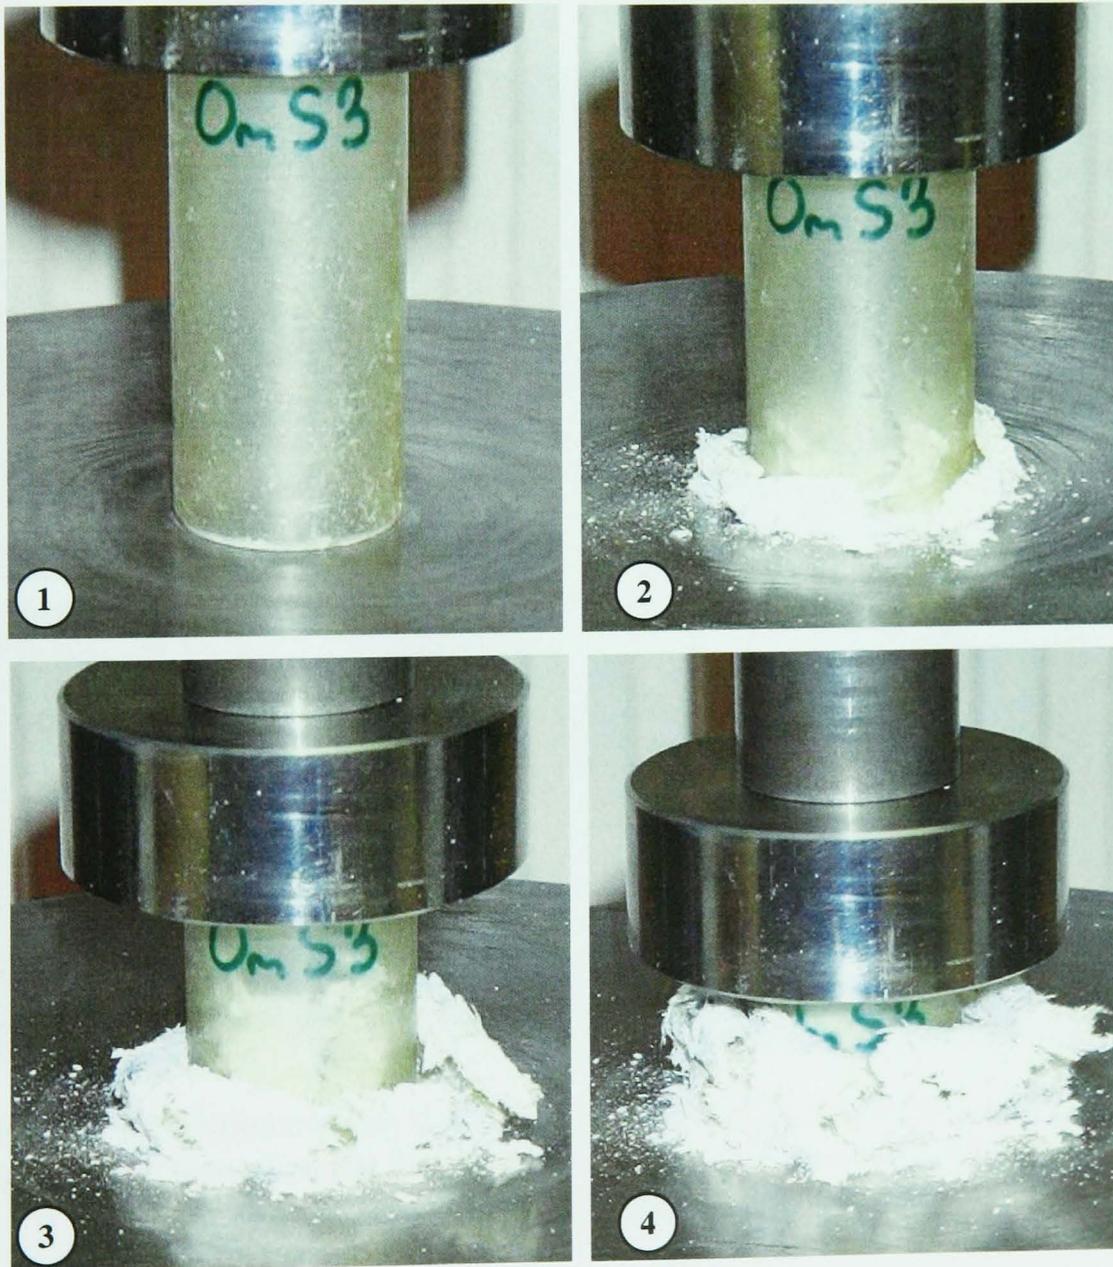
Figure 42: Failure Mode A – Progressive Crush of Cylindrical Sample ($t=2\text{mm}$) Tested Quasi-Statically (C_0mS3)
