Energy Absorption Capability of Damage Affected Composite Structures

by Michael Ribeaux, MEng (Hons)

Thesis submitted to The University of Nottingham for the degree of Doctor of Philosophy, October 2003

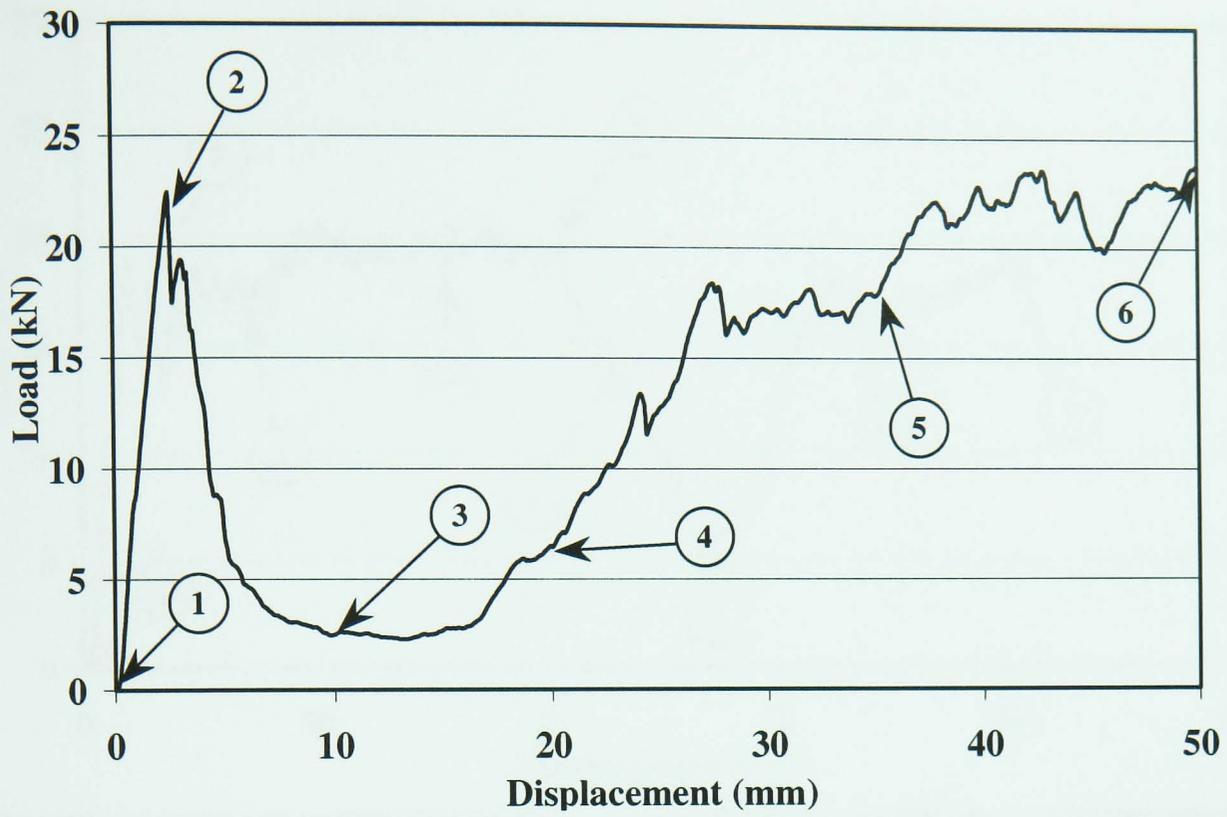
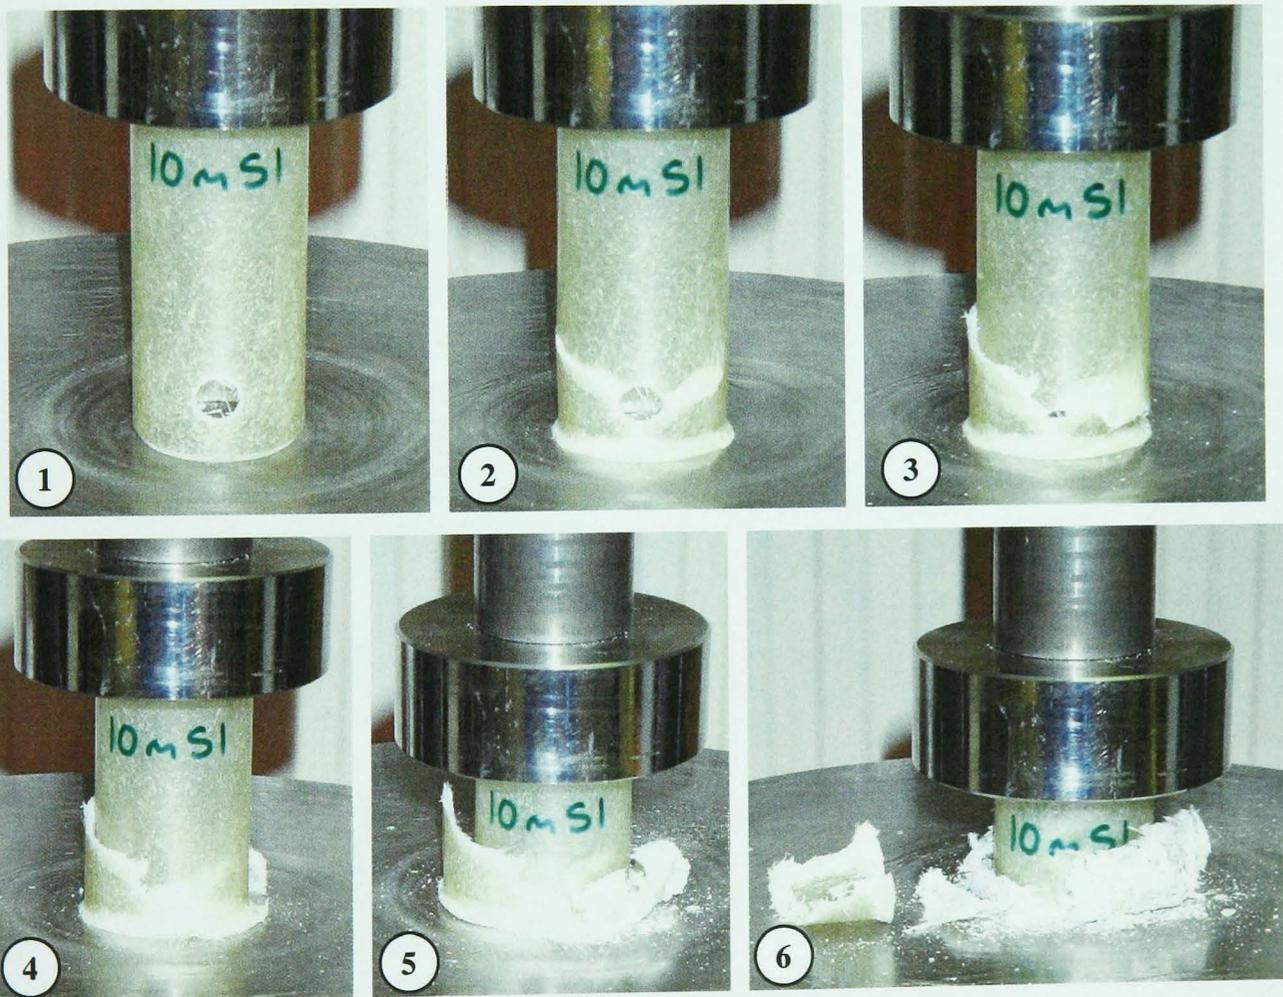
Figure 43: Failure Mode B – Global Failure at Stress Concentration of Cylindrical Sample with 10mm Hole 15mm from Chamfer Tested Quasi-Statically (C_10m15S1)

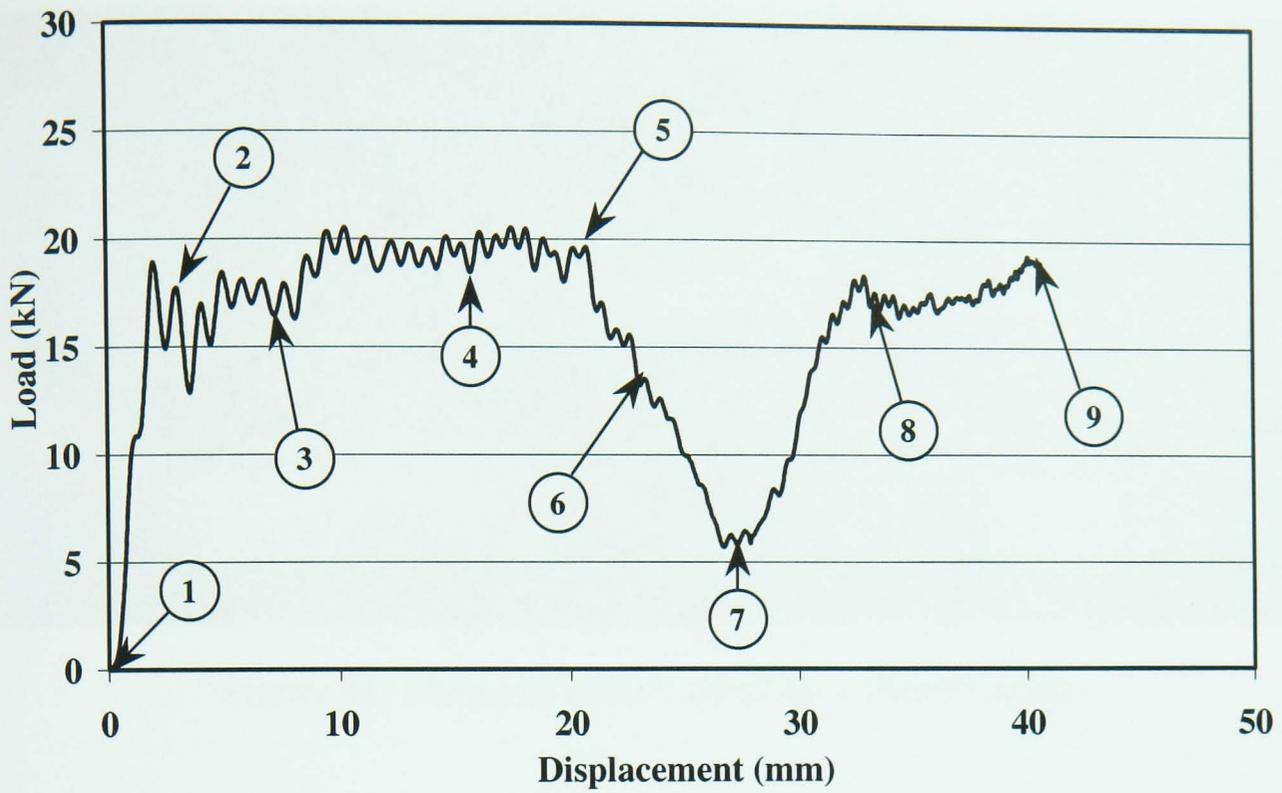
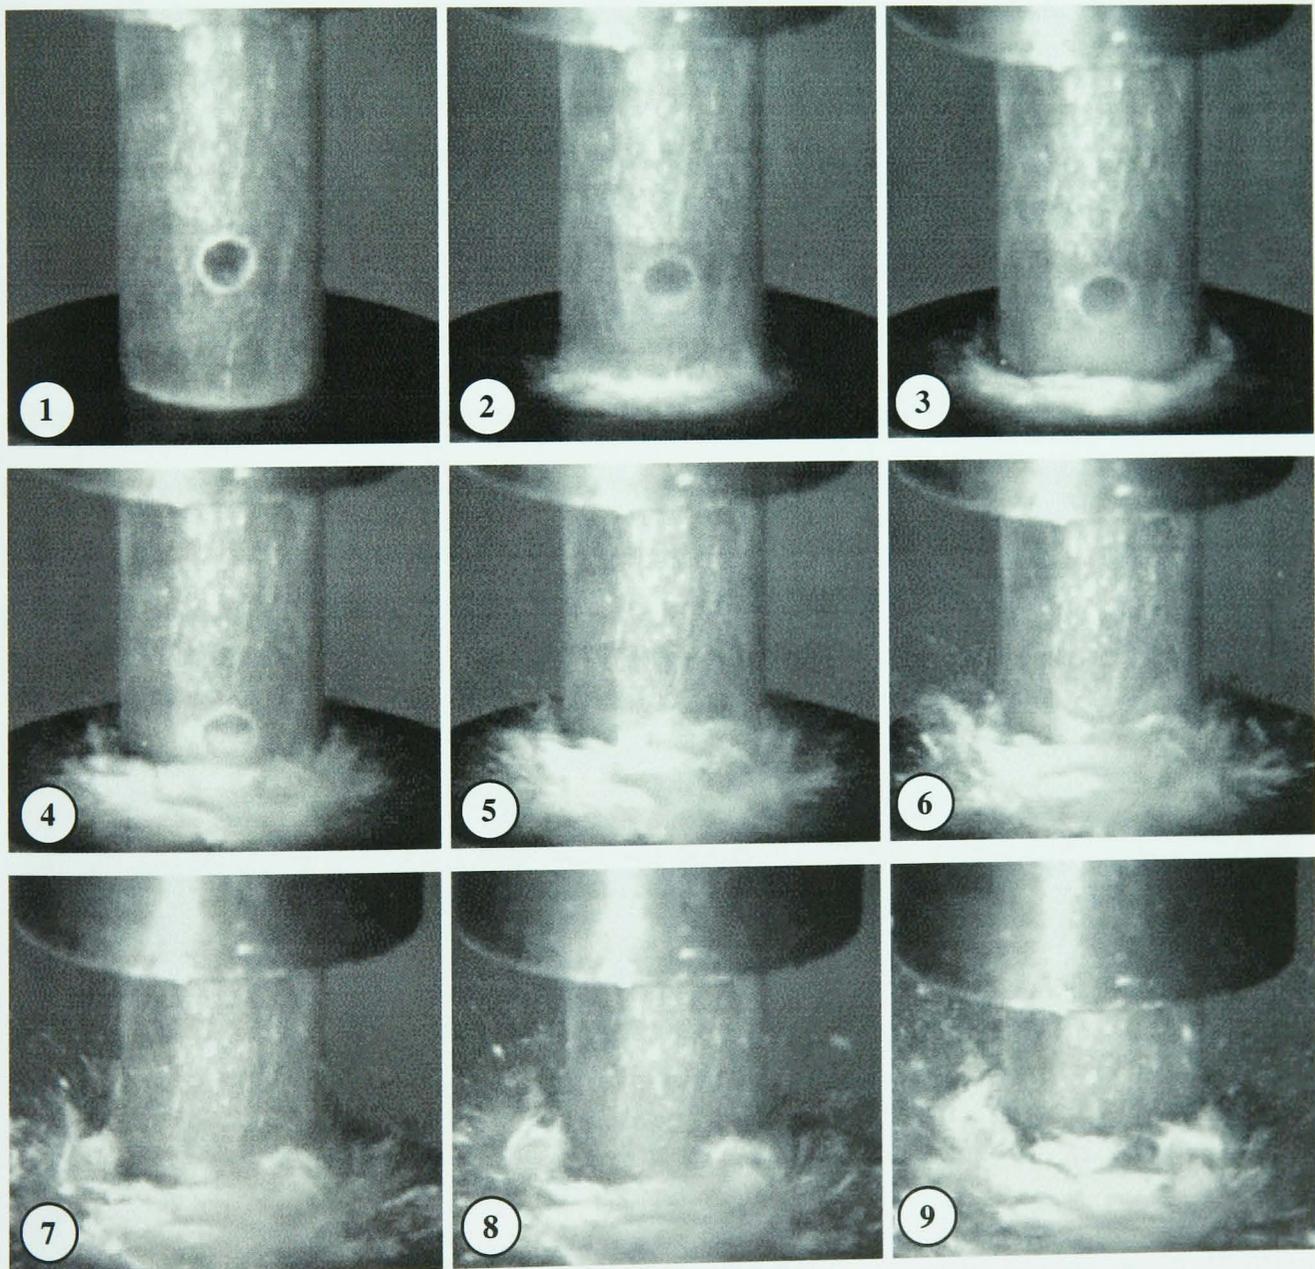
Figure 44: Failure Mode C – Local Failure at Stress Concentration of Cylindrical Tube ($t=2\text{mm}$) with 10mm Hole 30mm from Chamfer Tested Dynamically (C_10m30D1)

Failure mode C exhibits an initial progressive crushing mode (as in Failure Mode A) followed by a drop-off in load being observed in the immediate vicinity of the damaged region. The drop-off in load is larger than could be accounted for by reduction in area, but is smaller than in mode B. In most cases a similar unstable crack forms to mode B, but the crack may progress into the crush zone, or it may be engulfed by the crush zone before it is able to affect the tube significantly and therefore causes only a slight drop in load. The load recovers to the steady-state level after the crush zone passes through the damage area (see Figure 44). The initiation of the crack in this case is usually due to the crush front interacting with the damage zone causing further weakening. With the square samples the crack's progression is temporarily arrested at the corners of the tube, so if the crack initiates with the crush front in the vicinity of the damage zone the unstable failure may be obvious visually, but may cause little or no reduction in load as the remainder of the tube will be unaffected.

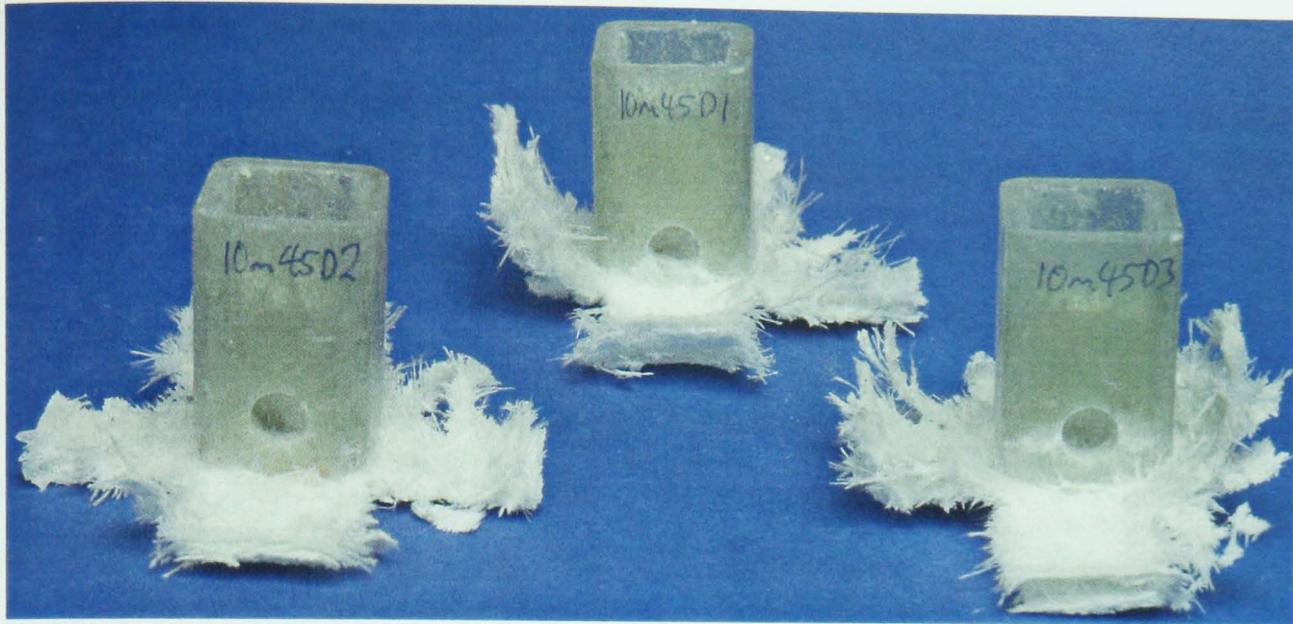
Figure 45: Modes of Failure at Stress Concentration

Figure 45 shows the way the samples fail as the stress concentration size reaches the threshold level. The sample on the left shows no effect due to the hole. The middle sample shows a crack forming at the hole propagating at 45° down to the crush zone where it would be quickly engulfed with very little drop in load. The third sample shows a circumferential crack forming. This crack has been arrested at the corners of the tube so only a small amount of the tube will break off and not absorb energy. Above the threshold size, failure similar to the third sample occurs away from the crush zone and continues to propagate around the circumference of the tube bisecting it (see Figure 46). This causes a large drop in load and large sections of the tube are removed uncrushed.

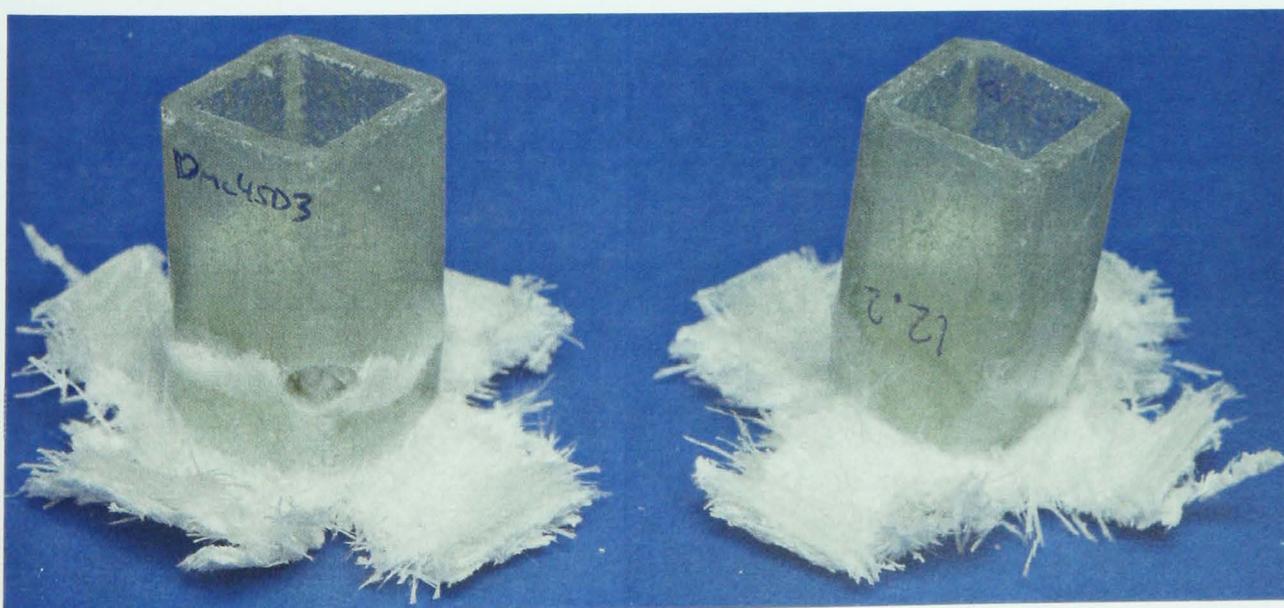
Figure 46: Circumferential Crack Propagated around 3 Sides of Sample

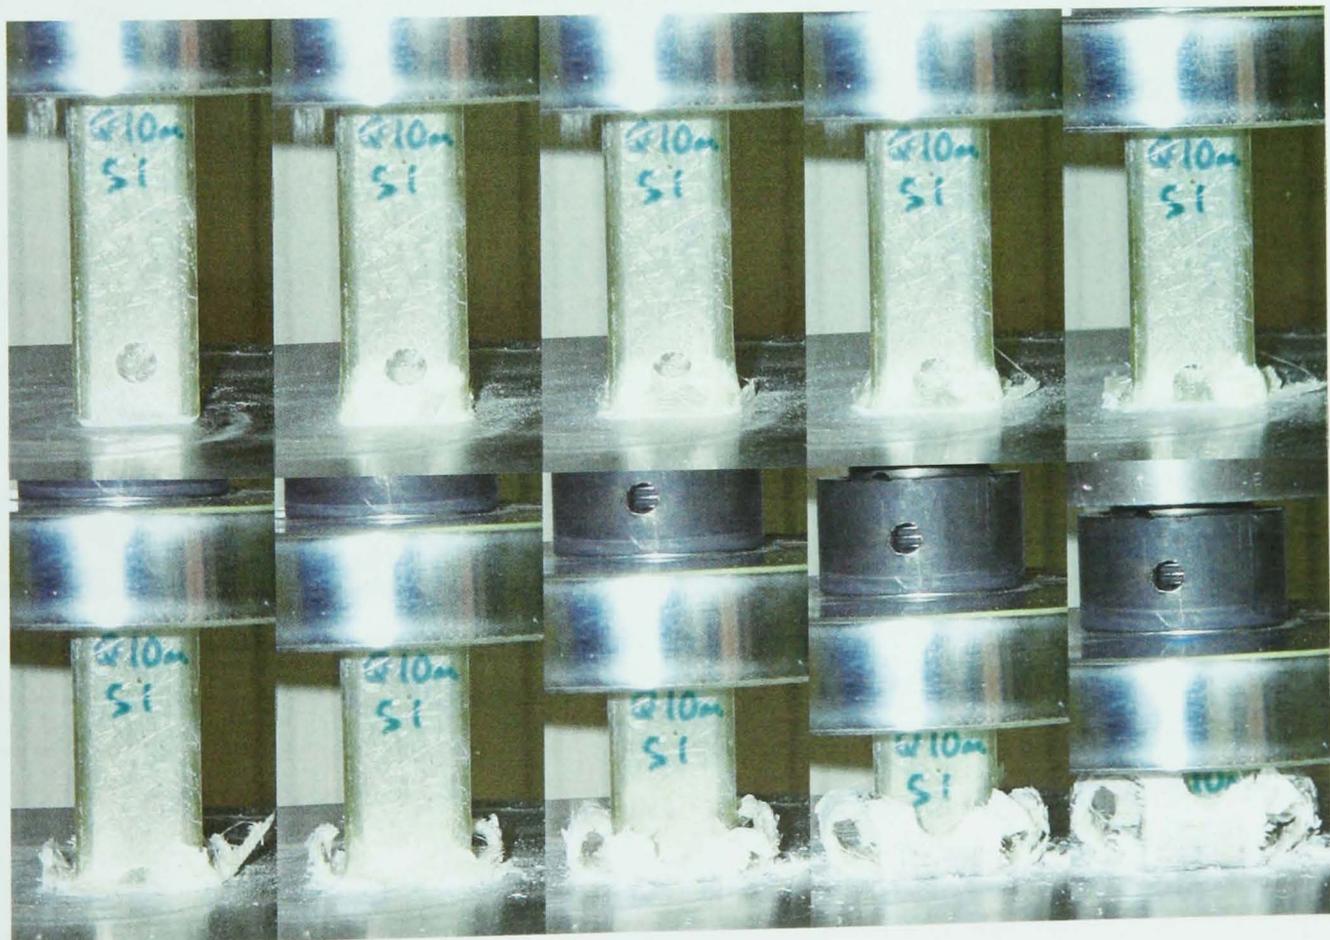
Figure 48: Progressive crush of square tube with 10mm hole (photos at 0, 2.5, 5, 7.5, 10, 15, 20, 30, 40 and 50mm of crush)

During the quasi-static crush of the square tubes with a 5mm hole two of the samples tested showed no sign of damage crushing progressively through where the hole had been manufactured. On one of the specimens a crack propagated from the hole, but its progression was arrested at the two adjacent corners and only a small piece of the sample broke off without being crushed. This caused a slight reduction in load around the position of the hole, which was quickly recovered, which can account for the very similar SEA values between the specimens with the 5mm hole and those with no damage.

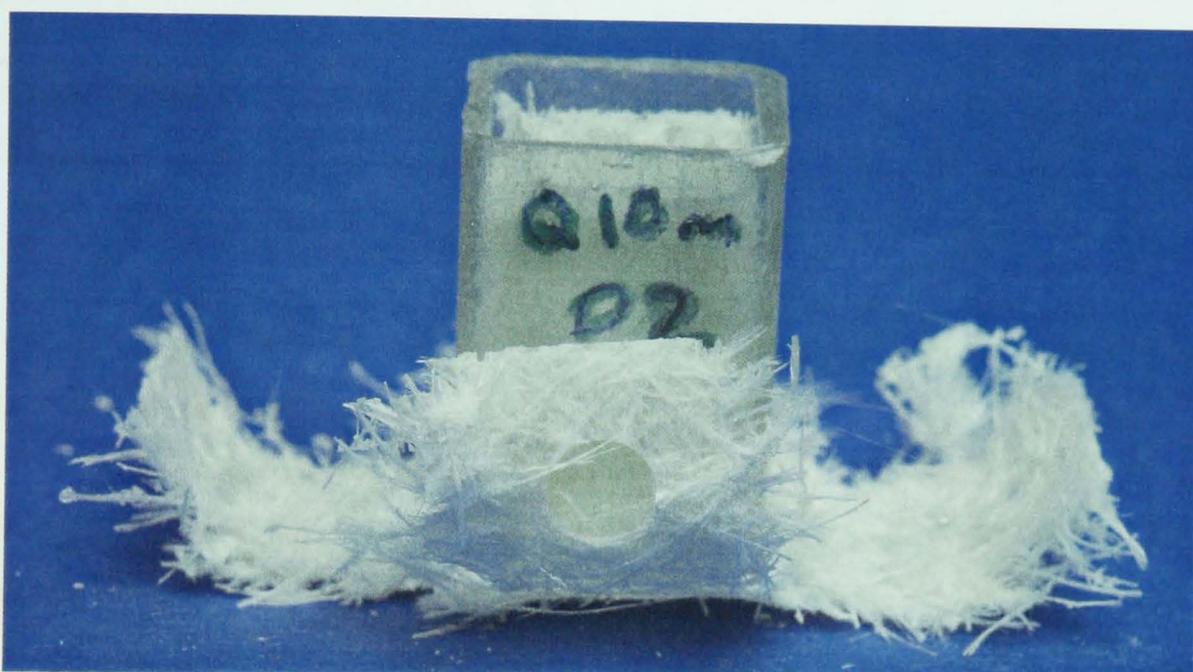
Figure 49: Hole in Frond of Square Tube Post Crush

When tested dynamically the hole appeared to have no effect, being clearly visible in one of the fronds of the post-crushed samples (see Figure 49).

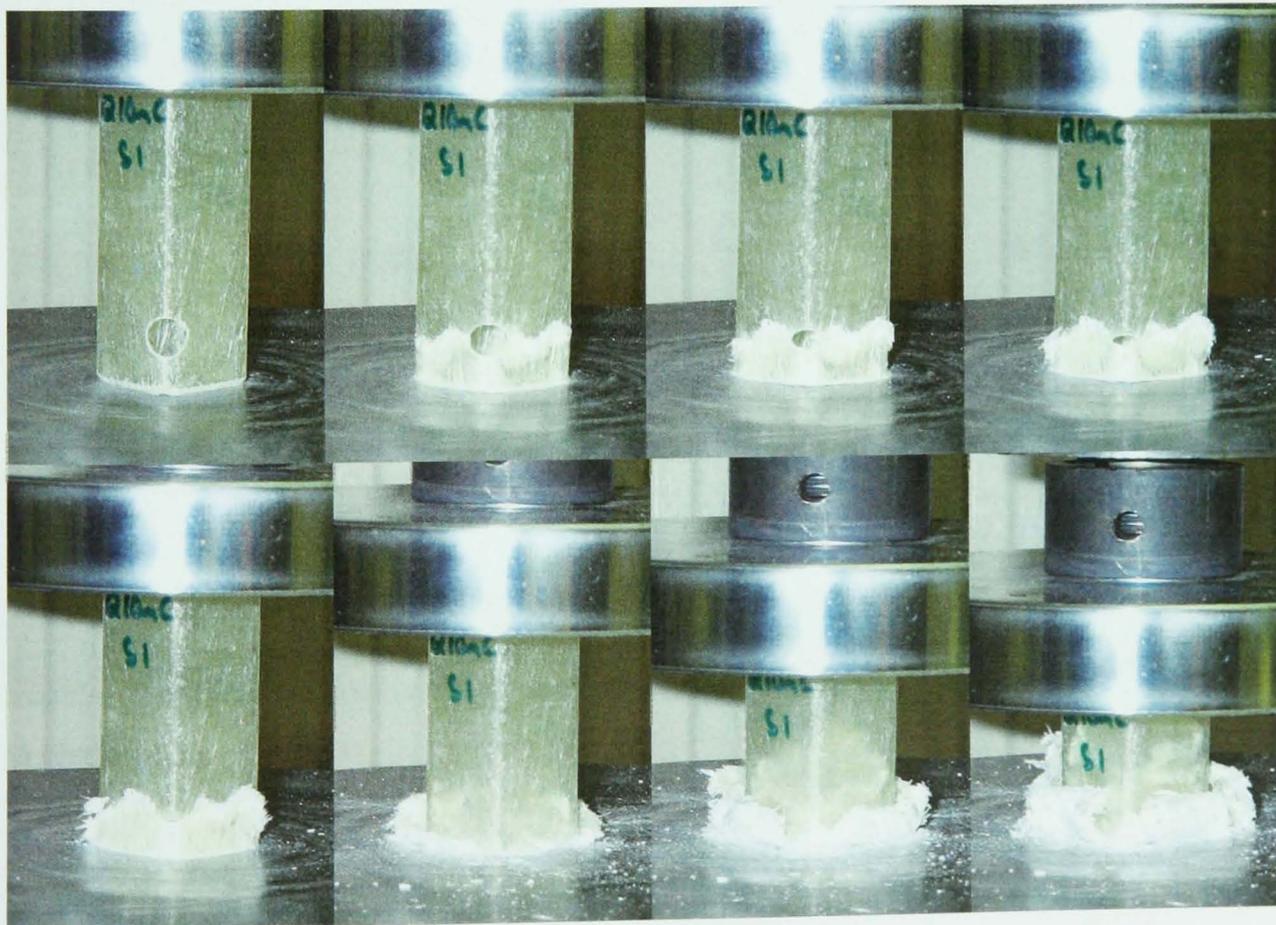
Figure 50: Crush of square tube with 10mm hole at corner (photos at 0, 2.5, 5, 7.5, 10, 20, 30 and 40mm of crush)

The quasi-static crush of the square tubes with a 5mm hole at the corner is the same as for samples where the hole is on the face of the tube.

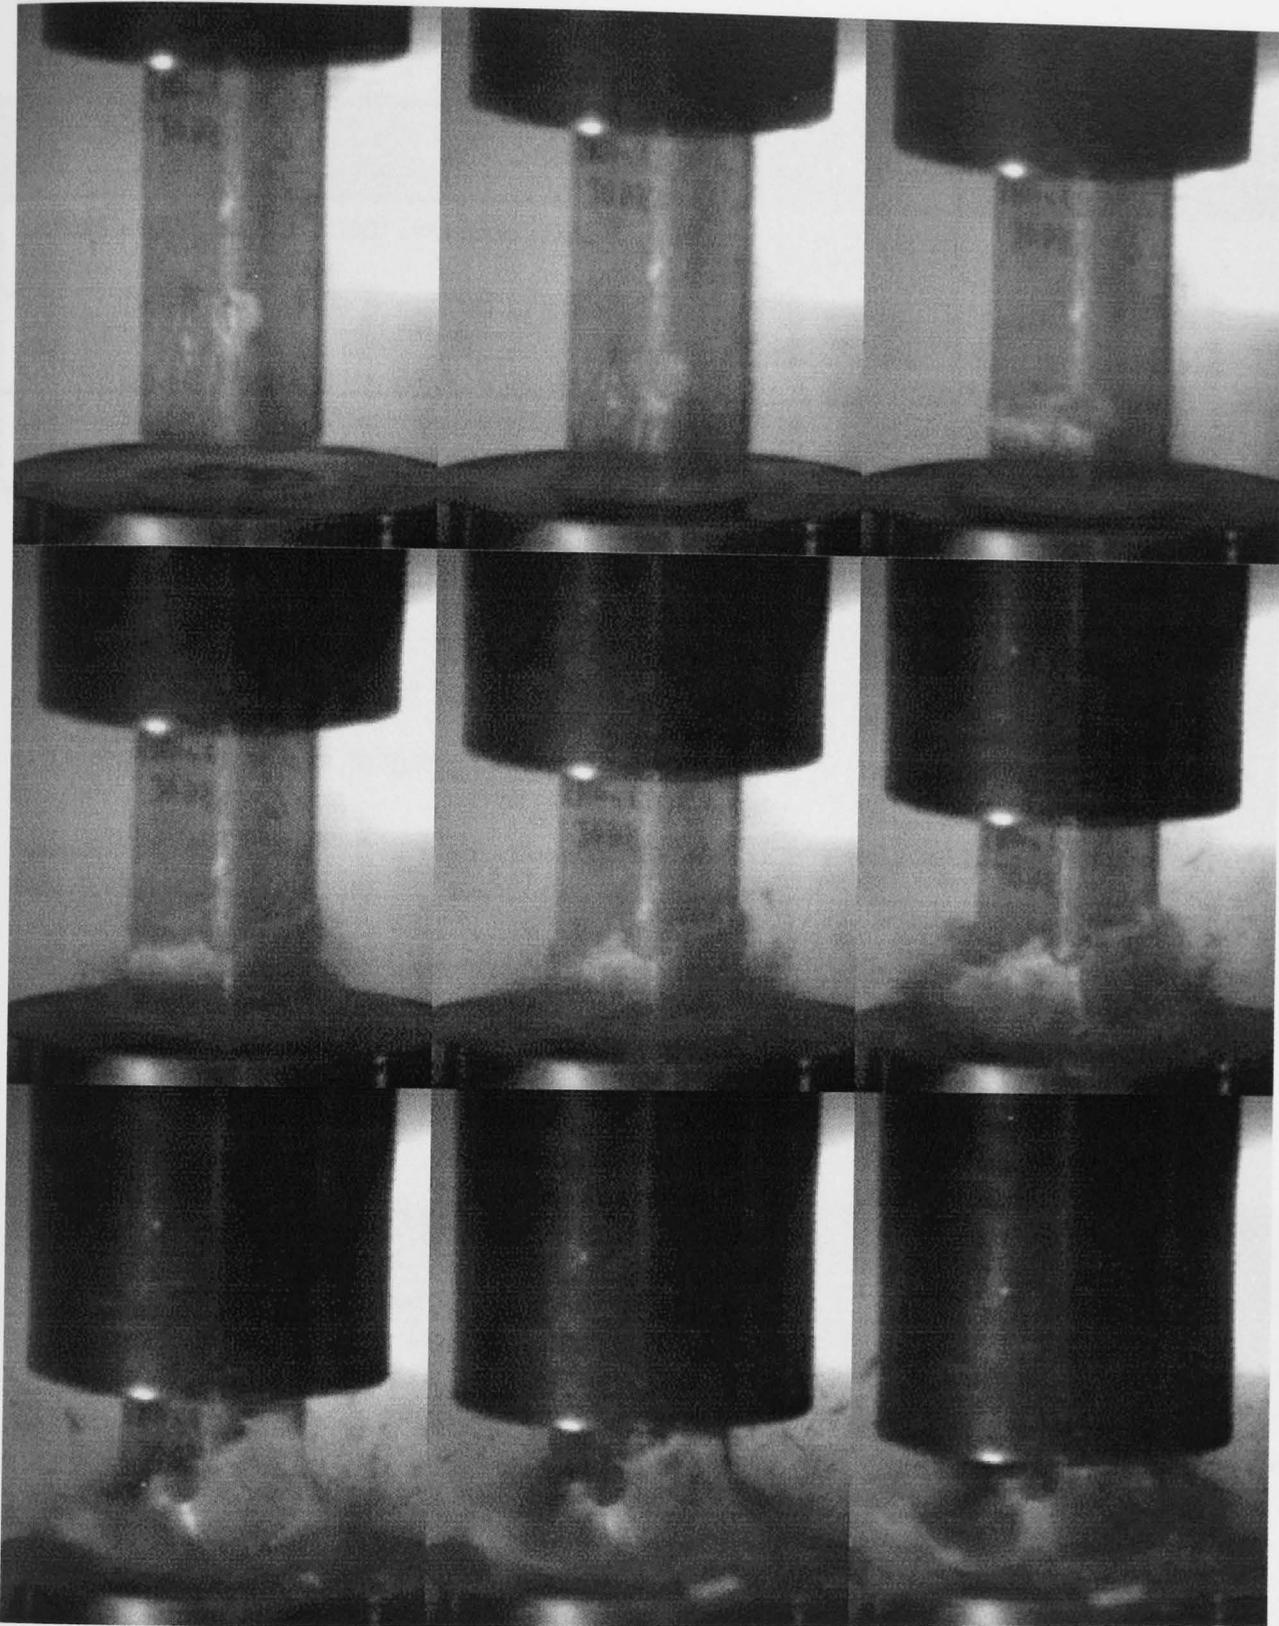
Figure 52: Unstable Failure of Square Tube ($t=2\text{mm}$) with 10mm Hole at the Corner of the Tube 30mm from the Chamfer tested Dynamically (Q_10mc30D2) Captured Using a High Speed Camera

When tested dynamically the hole causes a piece of the tube to be removed, uncrushed, by the formation of cracks similar to the quasi-static samples. Use of a high-speed camera confirms the unstable failure mode (see Figure 52).

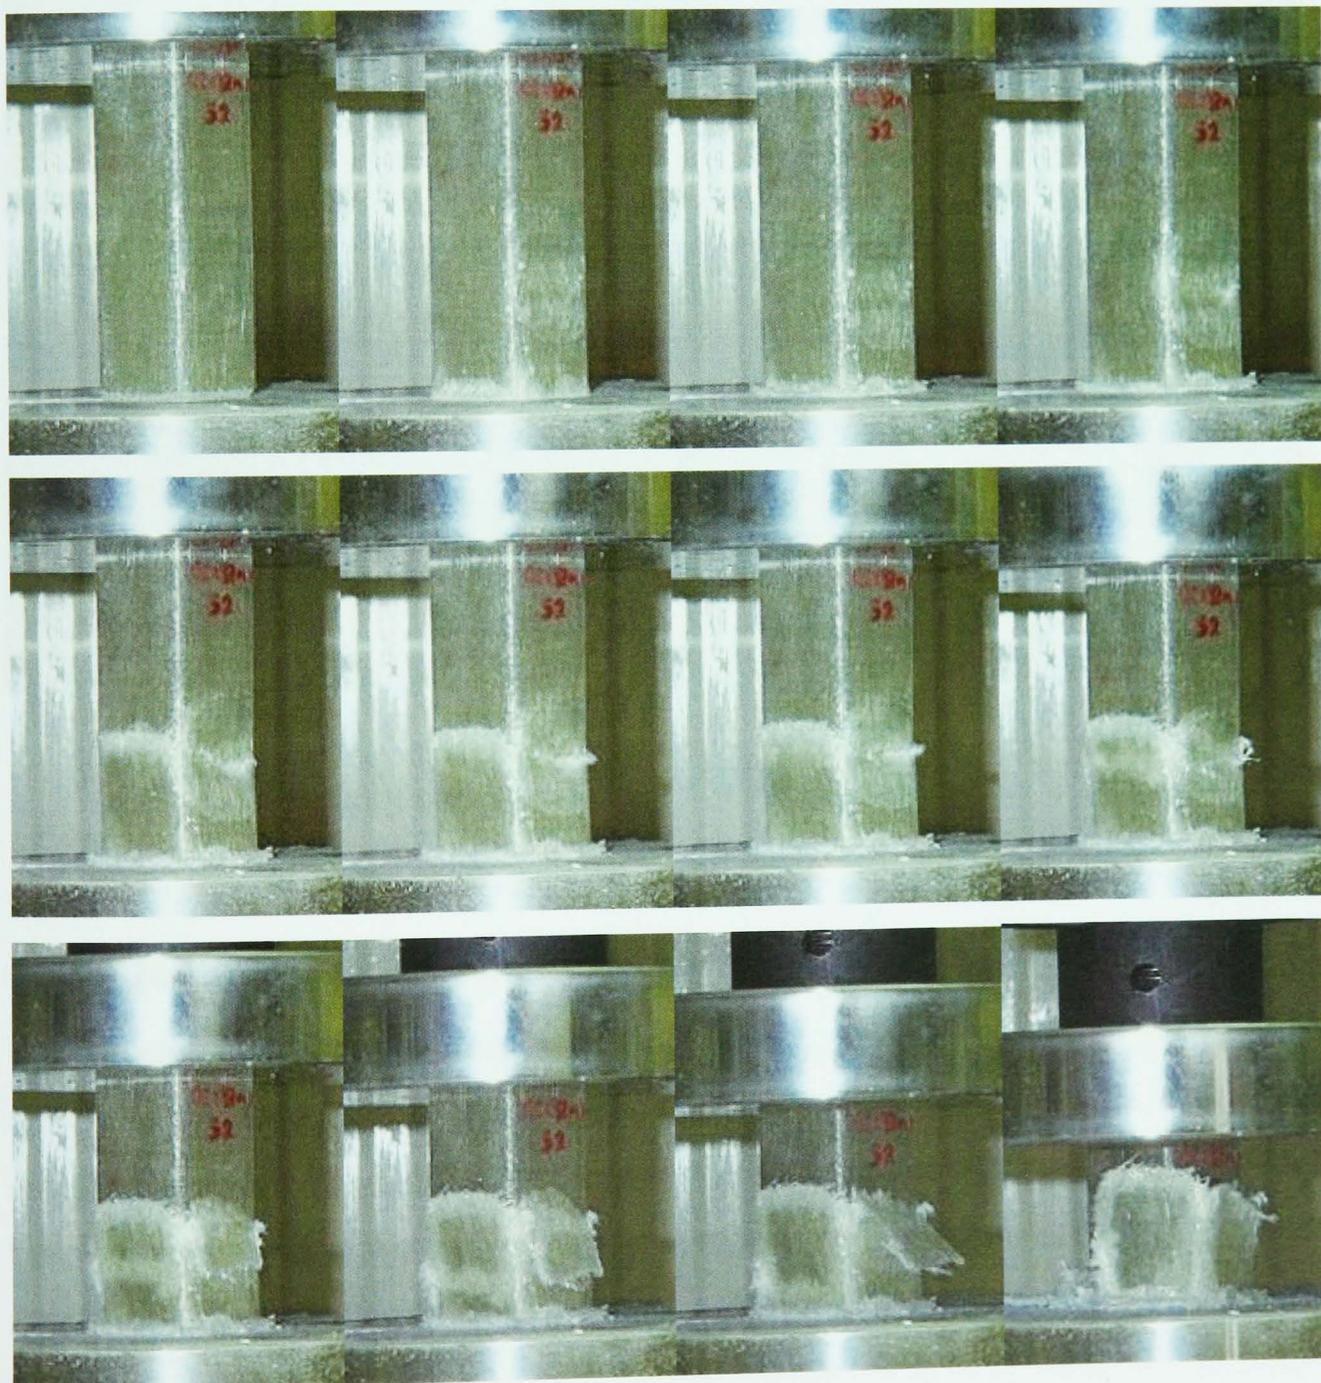
Figure 54: Unstable Failure of Quasi-Statically Tested Sample with Two 32mm Melinex® Inserts

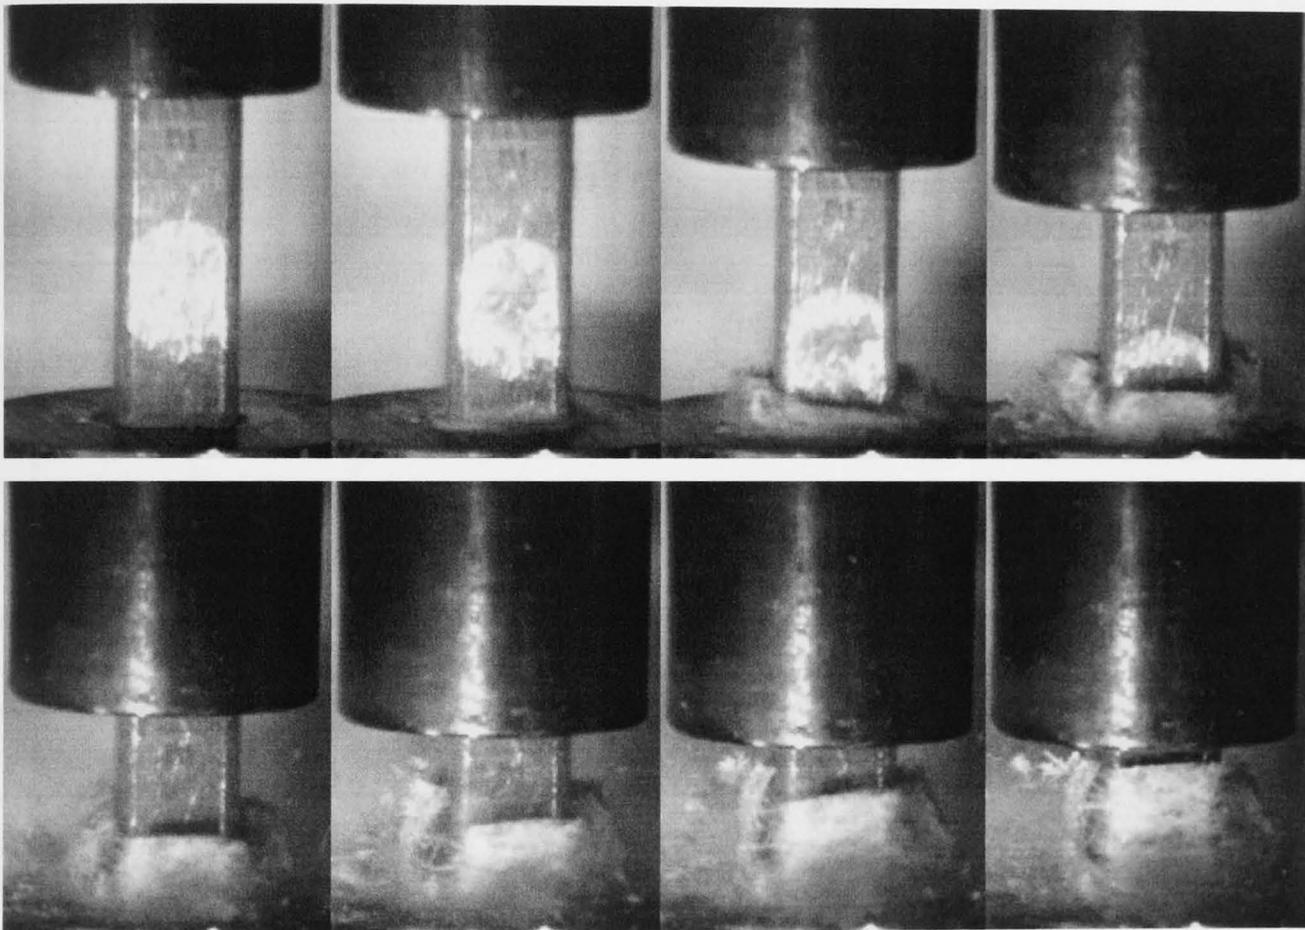
Figure 55: Rippling of Tube Surface during Stable Failure of Dynamically Tested Sample with Two 32mm Melinex® Inserts

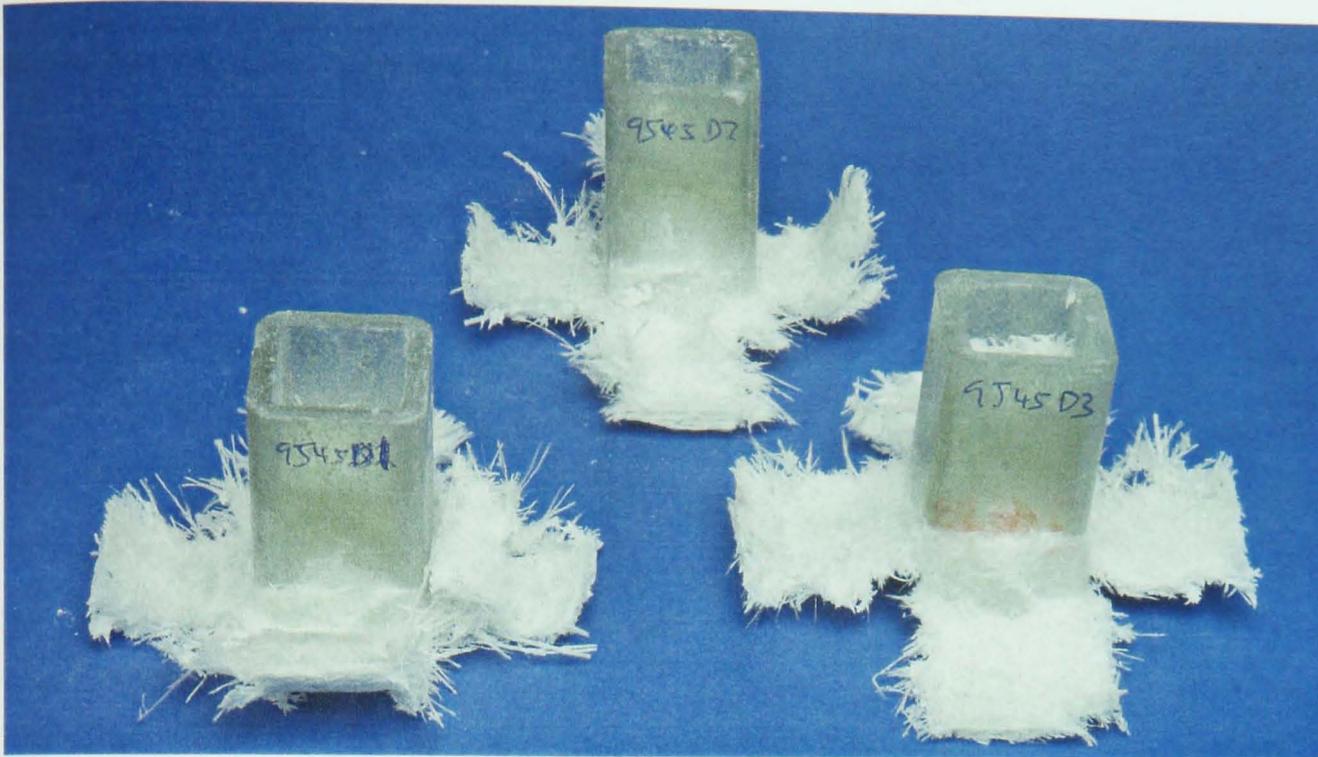
Figure 58: Square Samples (t=4mm) with 9J impact at 45mm Post Test

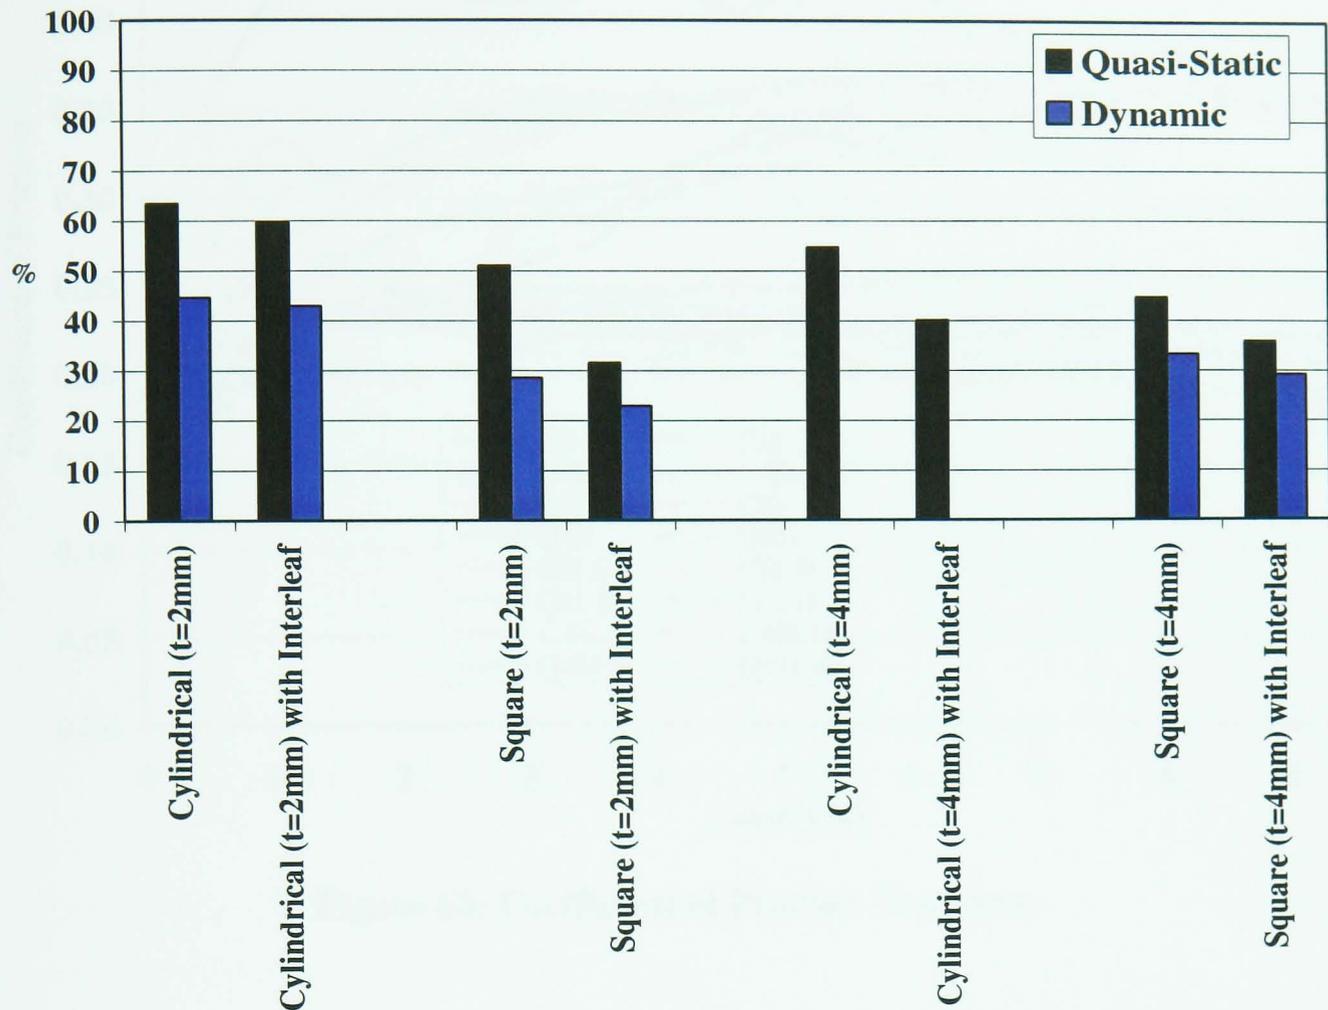
Figure 62: Crush Load as Percentage of Ultimate Compressive Load

failure to occur. This is also shown to be the case for interleaved samples when compared to samples without interleaf.

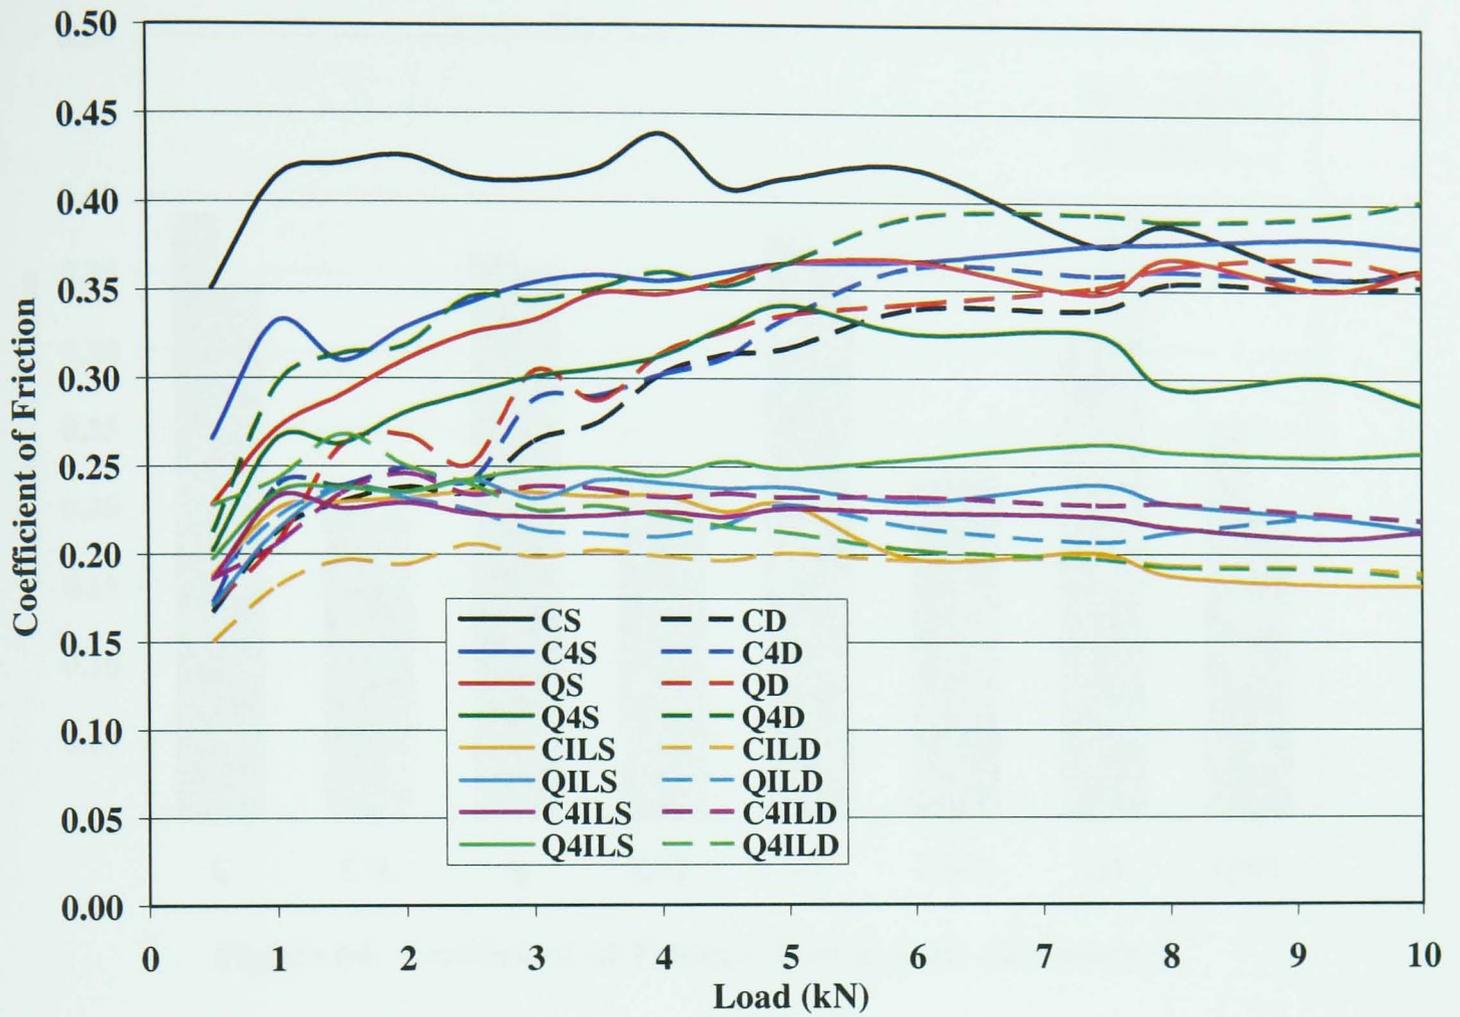
Figure 63: Coefficient of Friction Test Data

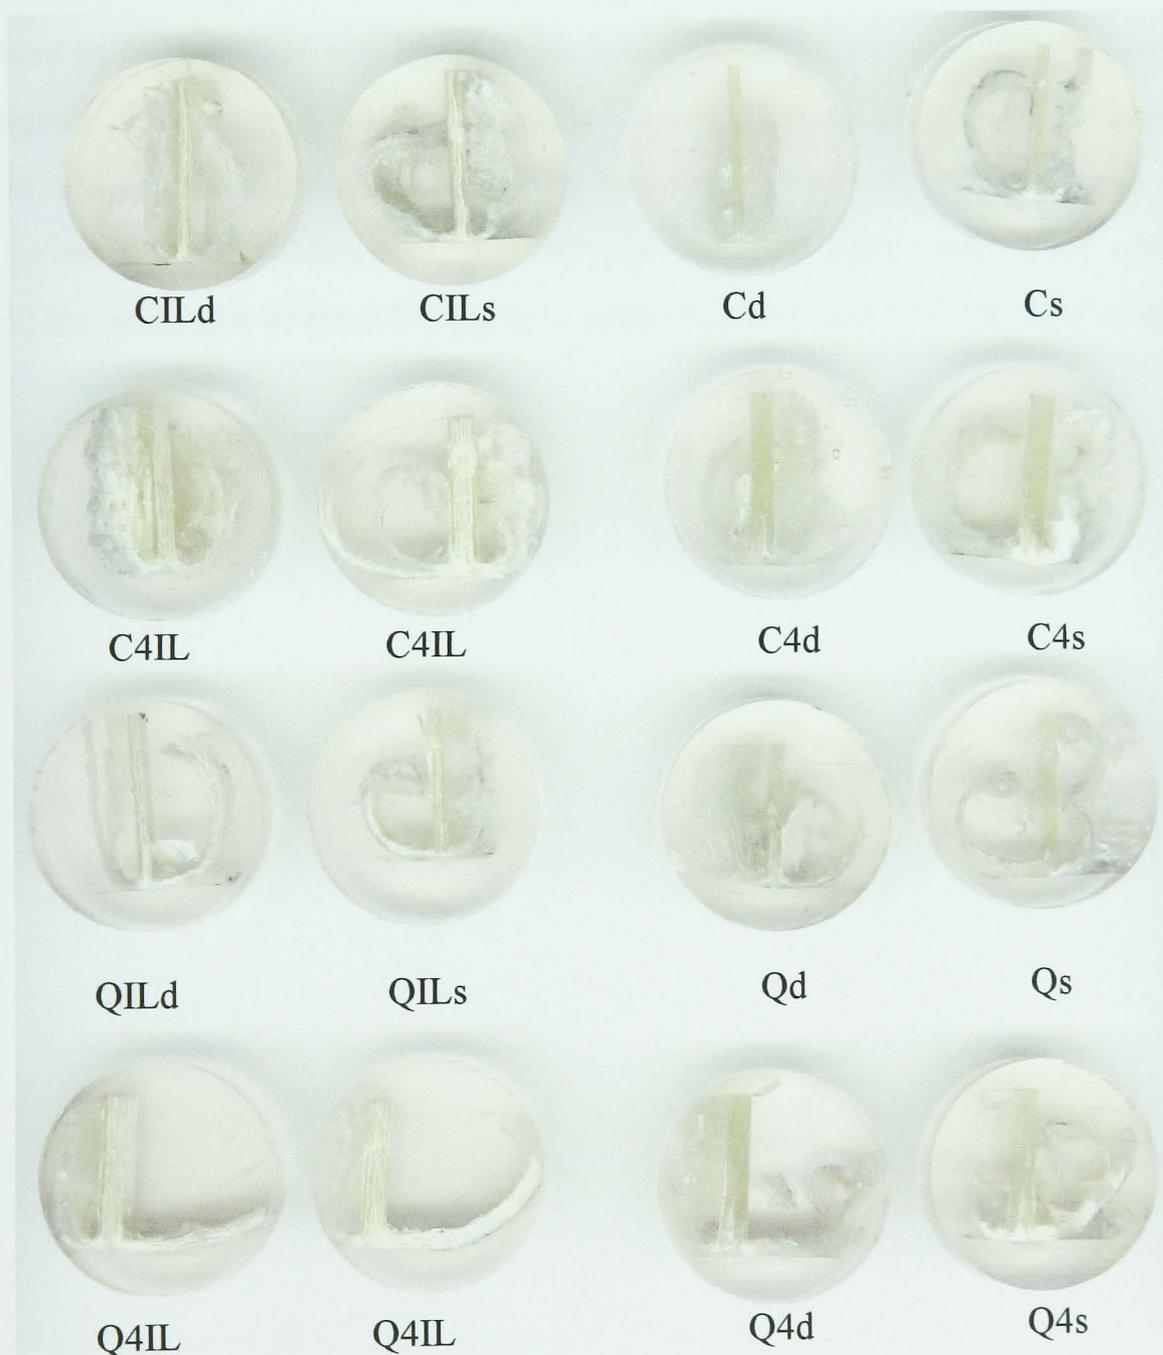
Figure 65: Scan of Samples with Crush Zone Encapsulated in Resin
