Energy Absorption Capability of Damage Affected Composite Structures

by Michael Ribeaux, MEng (Hons)

Thesis submitted to The University of Nottingham for the degree of Doctor of Philosophy, October 2003

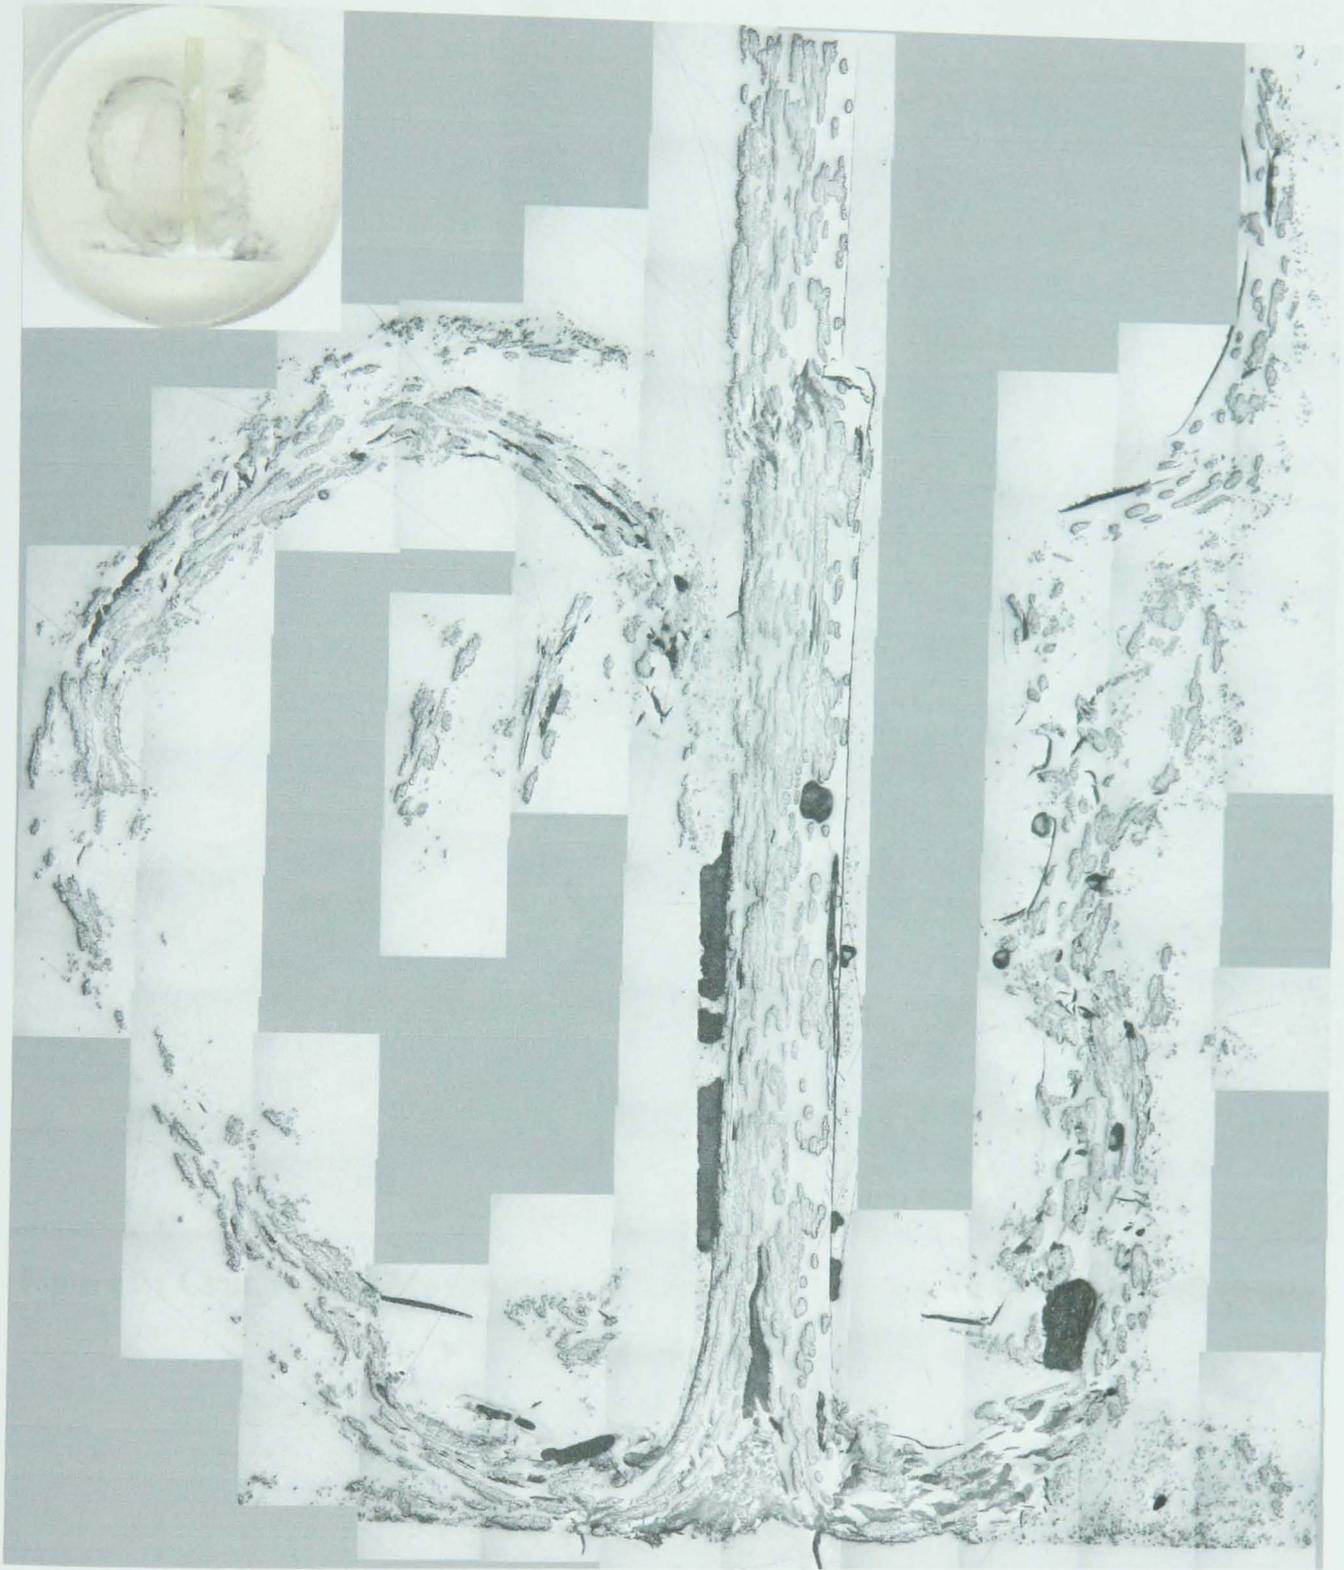
Figure 1: Micrograph of Circular Sample (t=2mm) Crushed Quasi-Statically
