The Morphological Representation of Channel-Forming Flow in Arroyos

Lucy A. Ellis

Thesis submitted to the University of Nottingham
for the degree of Doctor of Philosophy, May 2004

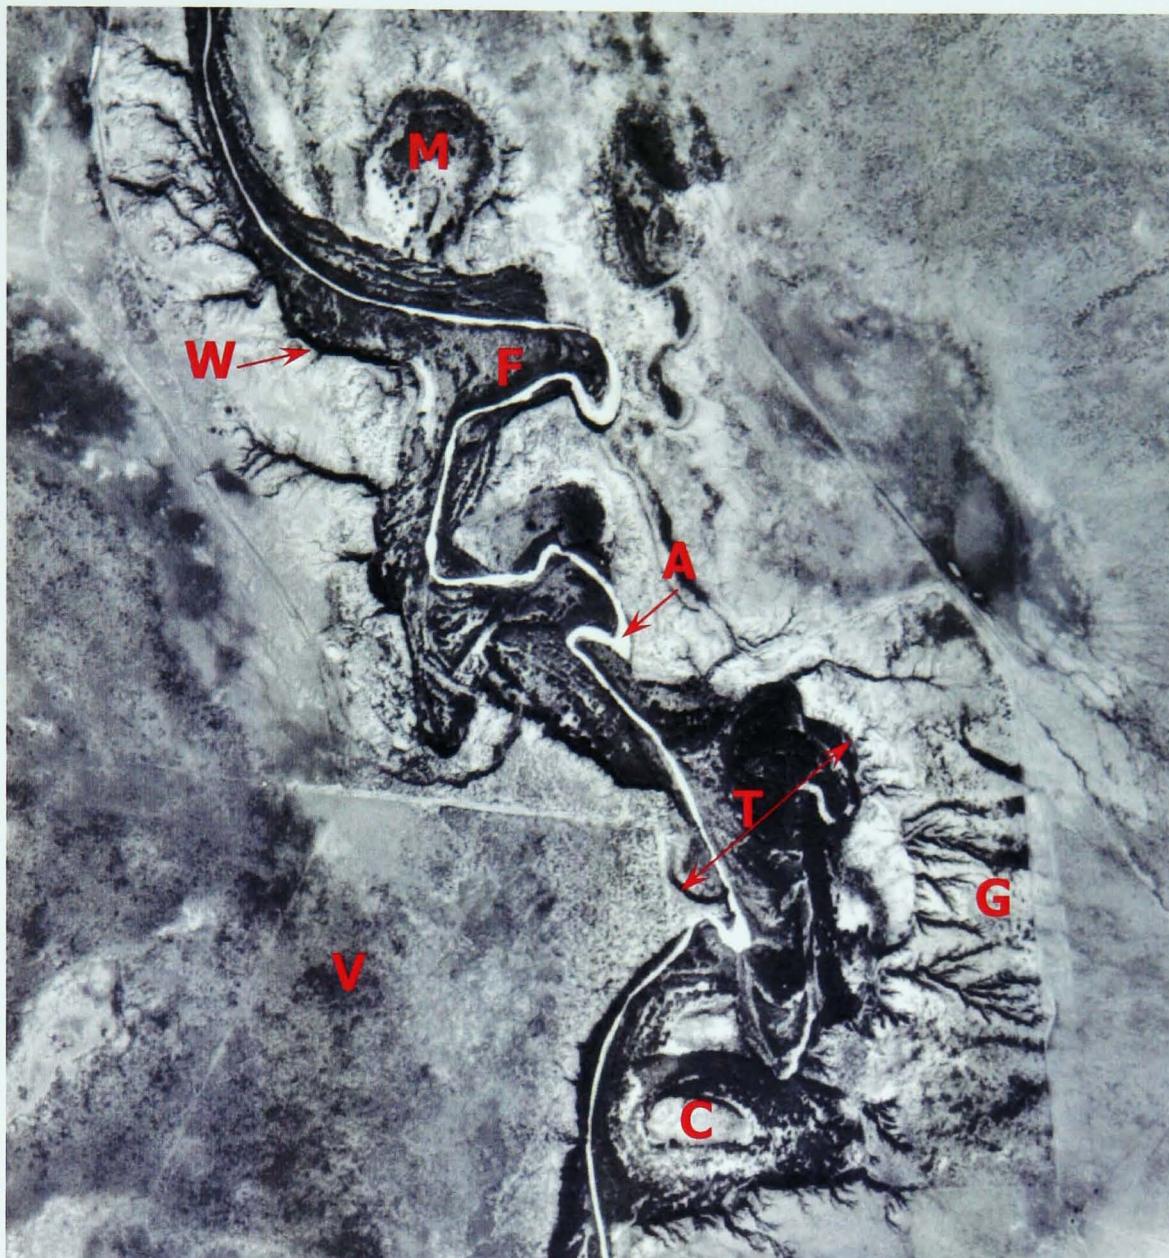
Figure 1.1 Geomorphological features of arroyo systems.

Figure 1.1 shows the major geomorphological features of contemporary arroyo systems. The arroyo trench is incised into the alluvial valley floor, which represents the pre-incision floodplain and which is, therefore, no longer active within the contemporary regime. The trench can, in places, reach dimensions in excess of 15 metres deep and 600 metres wide. Runoff entering the trench over the arroyo walls causes them to become dissected by gully networks, which may be extensive.

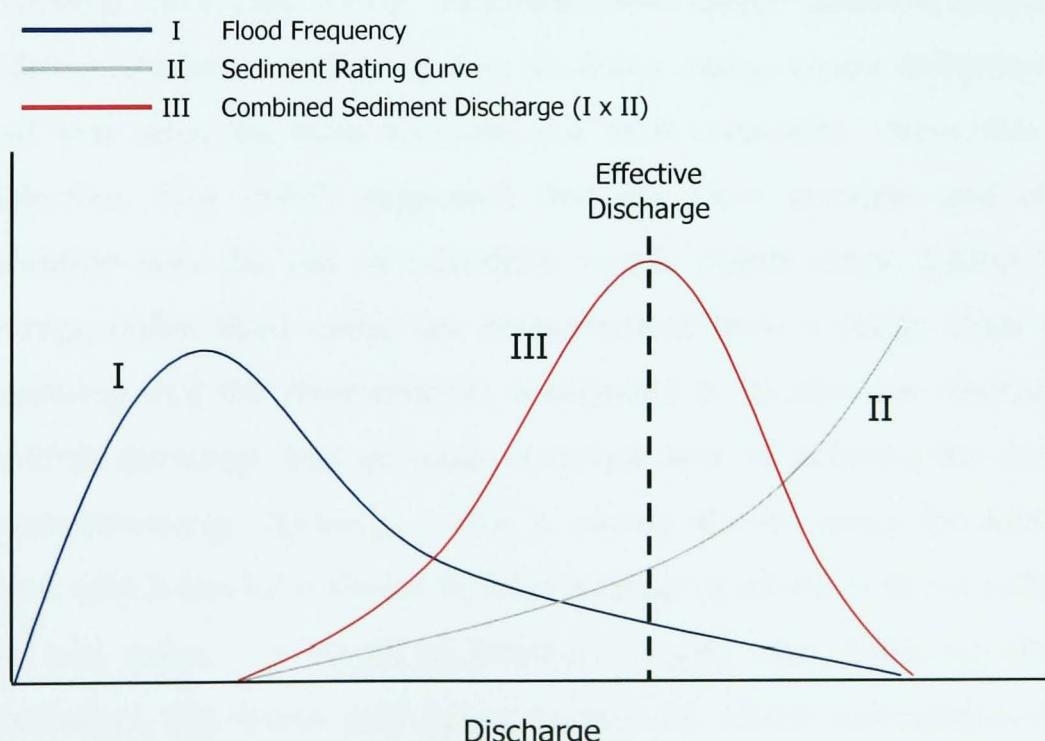
Figure 2.1 Schematic representation of effective discharge (after Thorne *et al.*, 1998).

discovering that, although catastrophic floods carry huge amounts of sediment, they occur so infrequently that their overall effectiveness is relatively low. It was observed that over 50% of the total suspended sediment load was transported by flows which occurred, on average, on one day or more per year. The majority of the remaining 50% was transported by floods which occurred at least once every five years, not by extremely large events.

Given that the effective discharge accomplishes most work in forming the channel, where work is defined by the amount of sediment transported, regime channels may be expected to adjust their channels to this flow. Thus, channel dimensions and form reflect the effective discharge of the system, assuming a stable flow regime. The channel capacity and bank-top elevation have been found to be strong morphological expressions of this effective flow, leading to the conclusion that the effective discharge equates to the dominant, channel-forming discharge. A regime channel, therefore, contains all flows up to and including the effective discharge (Biedenharn and Thorne, 1994).

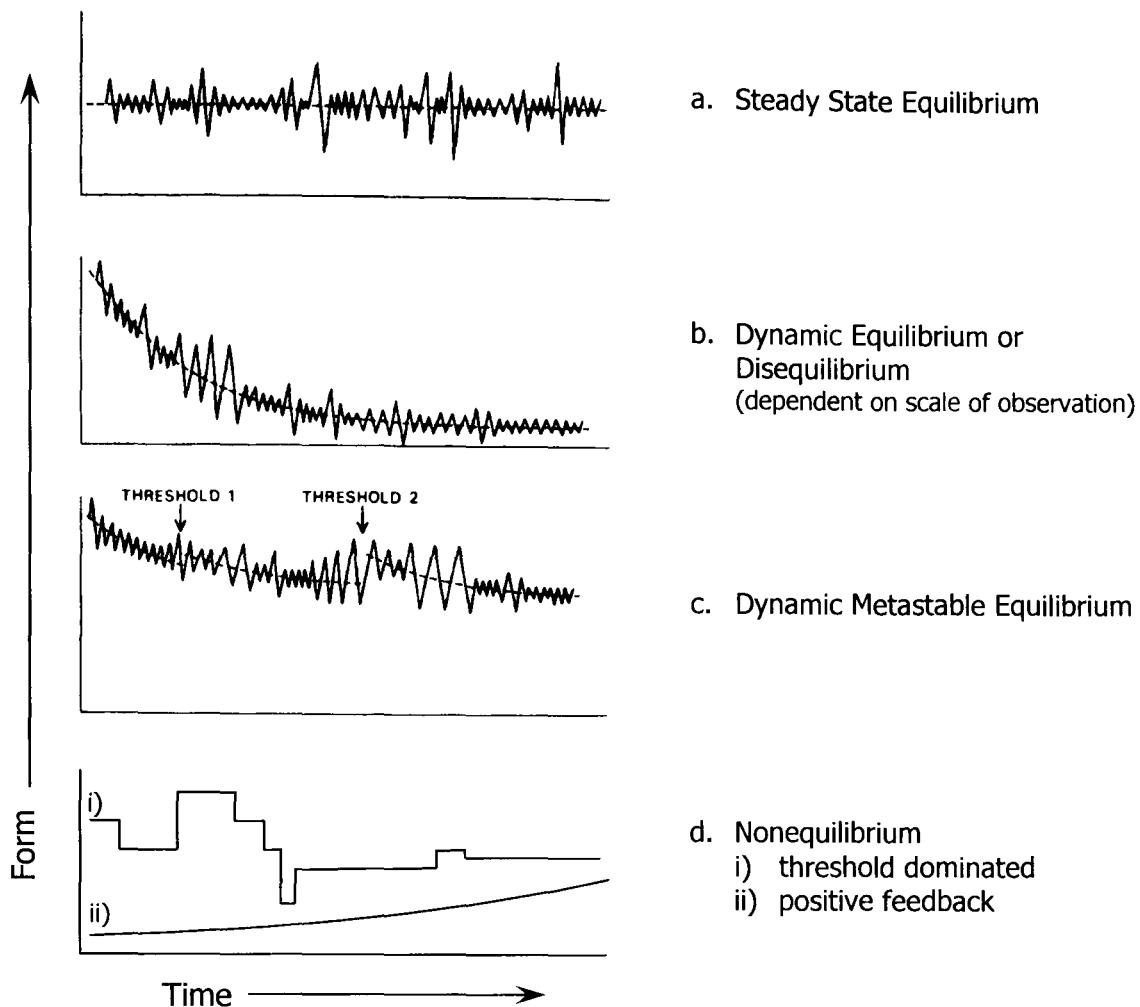
Figure 2.2 Types of equilibrium (after Chorley *et al.*, 1984; Renwick, 1992).

Systems which are in a state of equilibrium show a constant relationship between inputs to the system, outputs from the system and form. In a geomorphological context, this does not mean that the system is stable, but if observed over a long enough timescale, maintains the same relatively stable characteristics (Graf, 1979a; Chorley *et al.*, 1984; Renwick, 1992; Knighton, 1998). Adjustments to the channel occur as the river's ability to transport sediment balances the available sediment load (Chang, 1979; Baker and Costa, 1987). Thus, for given system inputs of water and sediment discharges, a particular channel geometry exists (Chang, 1979; Simon, 1992). If one link within a system in stable-equilibrium is altered through internal or external stimuli, all other links within the system respond through negative feedback mechanisms to re-establish the original balance (Graf, 1988a; Renwick, 1992). If the long-term form oscillates around an unchanging mean value, the system is said to be in steady-state equilibrium (Figure 2.2a) (Chorley *et al.*, 1984). However, if this mean itself shows a trend, the system is instead said to be in a state of dynamic equilibrium (Figure 2.2b) (Chorley *et al.*, 1984; Renwick, 1992).

External influences causing abrupt changes within a system have been termed “extrinsic thresholds”. The threshold exists within the system but is not crossed without the influence of an extrinsic variable (Schumm, 1973). A second type of threshold was also recognised, whereby the external variables acting on a system remain relatively constant yet failure or dramatic change still occurs within the system. Schumm suggested that these intrinsic geomorphic thresholds develop due to changes within the system itself. Thus, a system may be observed to evolve slowly until a critical situation is reached, triggering sudden adjustment or failure (Schumm and Khan, 1972; Schumm, 1973). It may not always be clear whether a system is responding to an external influence or to an internal geomorphological threshold. However, if a change in slope is involved, the control is geomorphic and intrinsic to the system (Schumm, 1973). Since the periods of little change approximate steady equilibrium conditions, systems showing sudden short periods of change separated by longer periods of apparent equilibrium are said to be in dynamic metastable equilibrium (Figure 2.2c) (Schumm, 1975; Chorley *et al.*, 1984; Renwick, 1992).

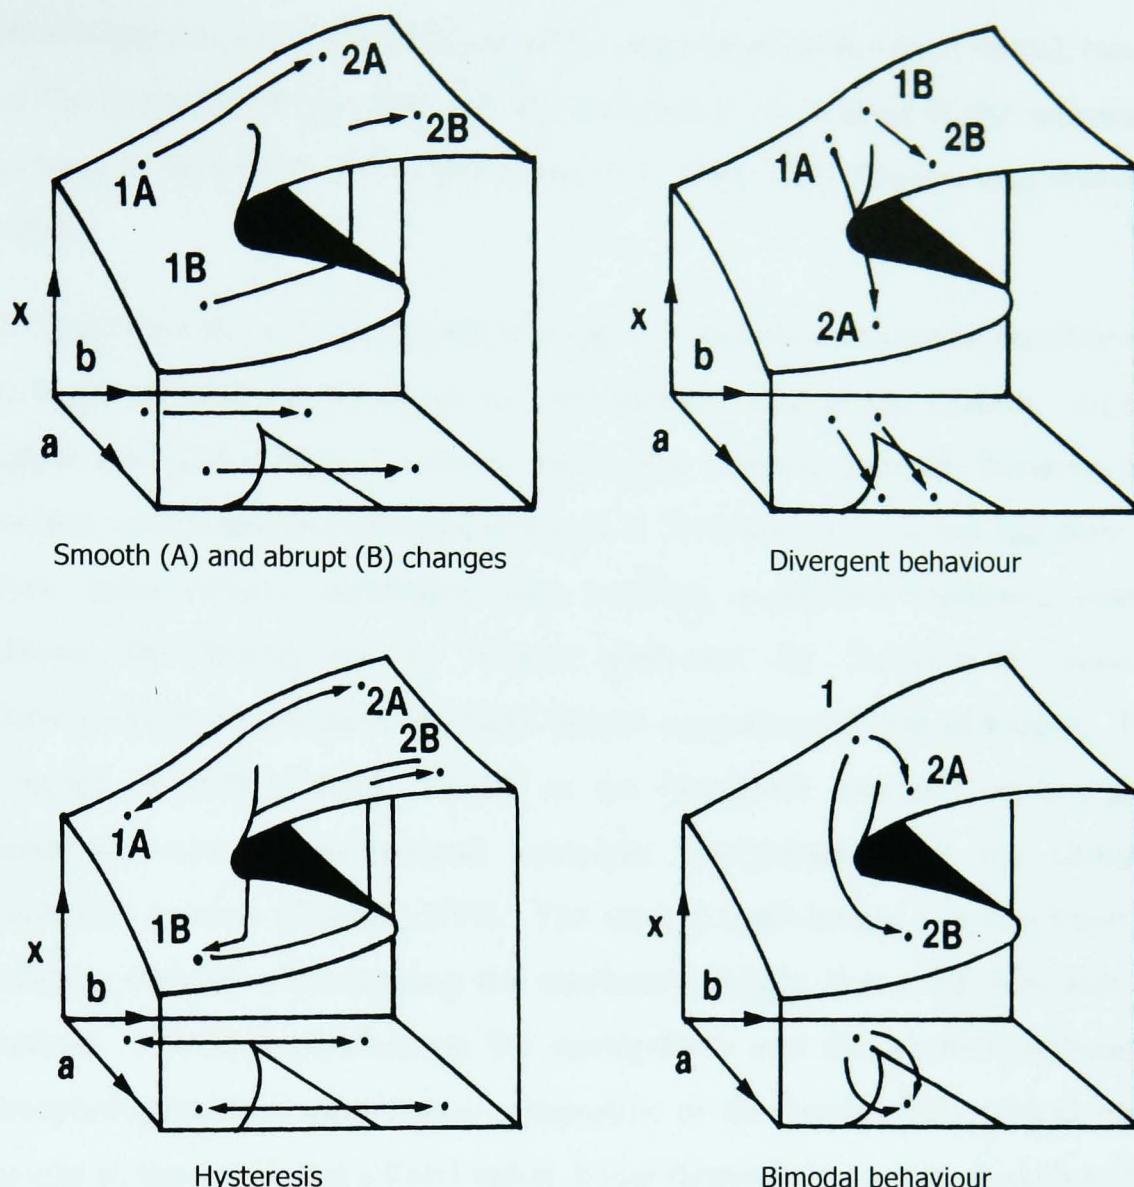
Figure 2.3 Diagrammatic representation of cusp catastrophe and different system behaviour according to initial proximity to cusp (after Graf, 1979a).

If force and resistance are used as basic control variables in fluvial systems, a behavioural variable, such as channel area, may be used to plot a three-dimensional smooth surface, or catastrophe, interrupted by a tuck, or cusp (Figure 2.3). For a given system, the cusp catastrophe describing that system remains stable and unchanging. Graf (1979a) discovered that this surface may be used to represent many of the most important behavioural change characteristics in ephemeral streams. First, the system behaves differently depending on the proximity of the system state to the cusp. A perturbation may cause very different outcomes, even though the starting points are very similar. Change may either be abrupt, if the system is close to the cusp, or gradual, if the system is far from the cusp or is at a point on the cusp where it can be bypassed rather than jumped across (Graf, 1979a; Thornes, 1980). Systems which have very similar starting points may exhibit divergence, where two stable, but very different, final conditions of the behavioural variable are possible. The cusp catastrophe concept also allows the possibility of hysteresis, a characteristic commonly observed in geomorphological systems, especially those experiencing regular increases and decreases in one (or more) controlling variable, leading to cyclic change. A fourth characteristic of cusp systems is bimodal behaviour. For any given values of the two controlling variables, two stable values of the behavioural variable are possible. All four characteristics of a cusp system are strongly

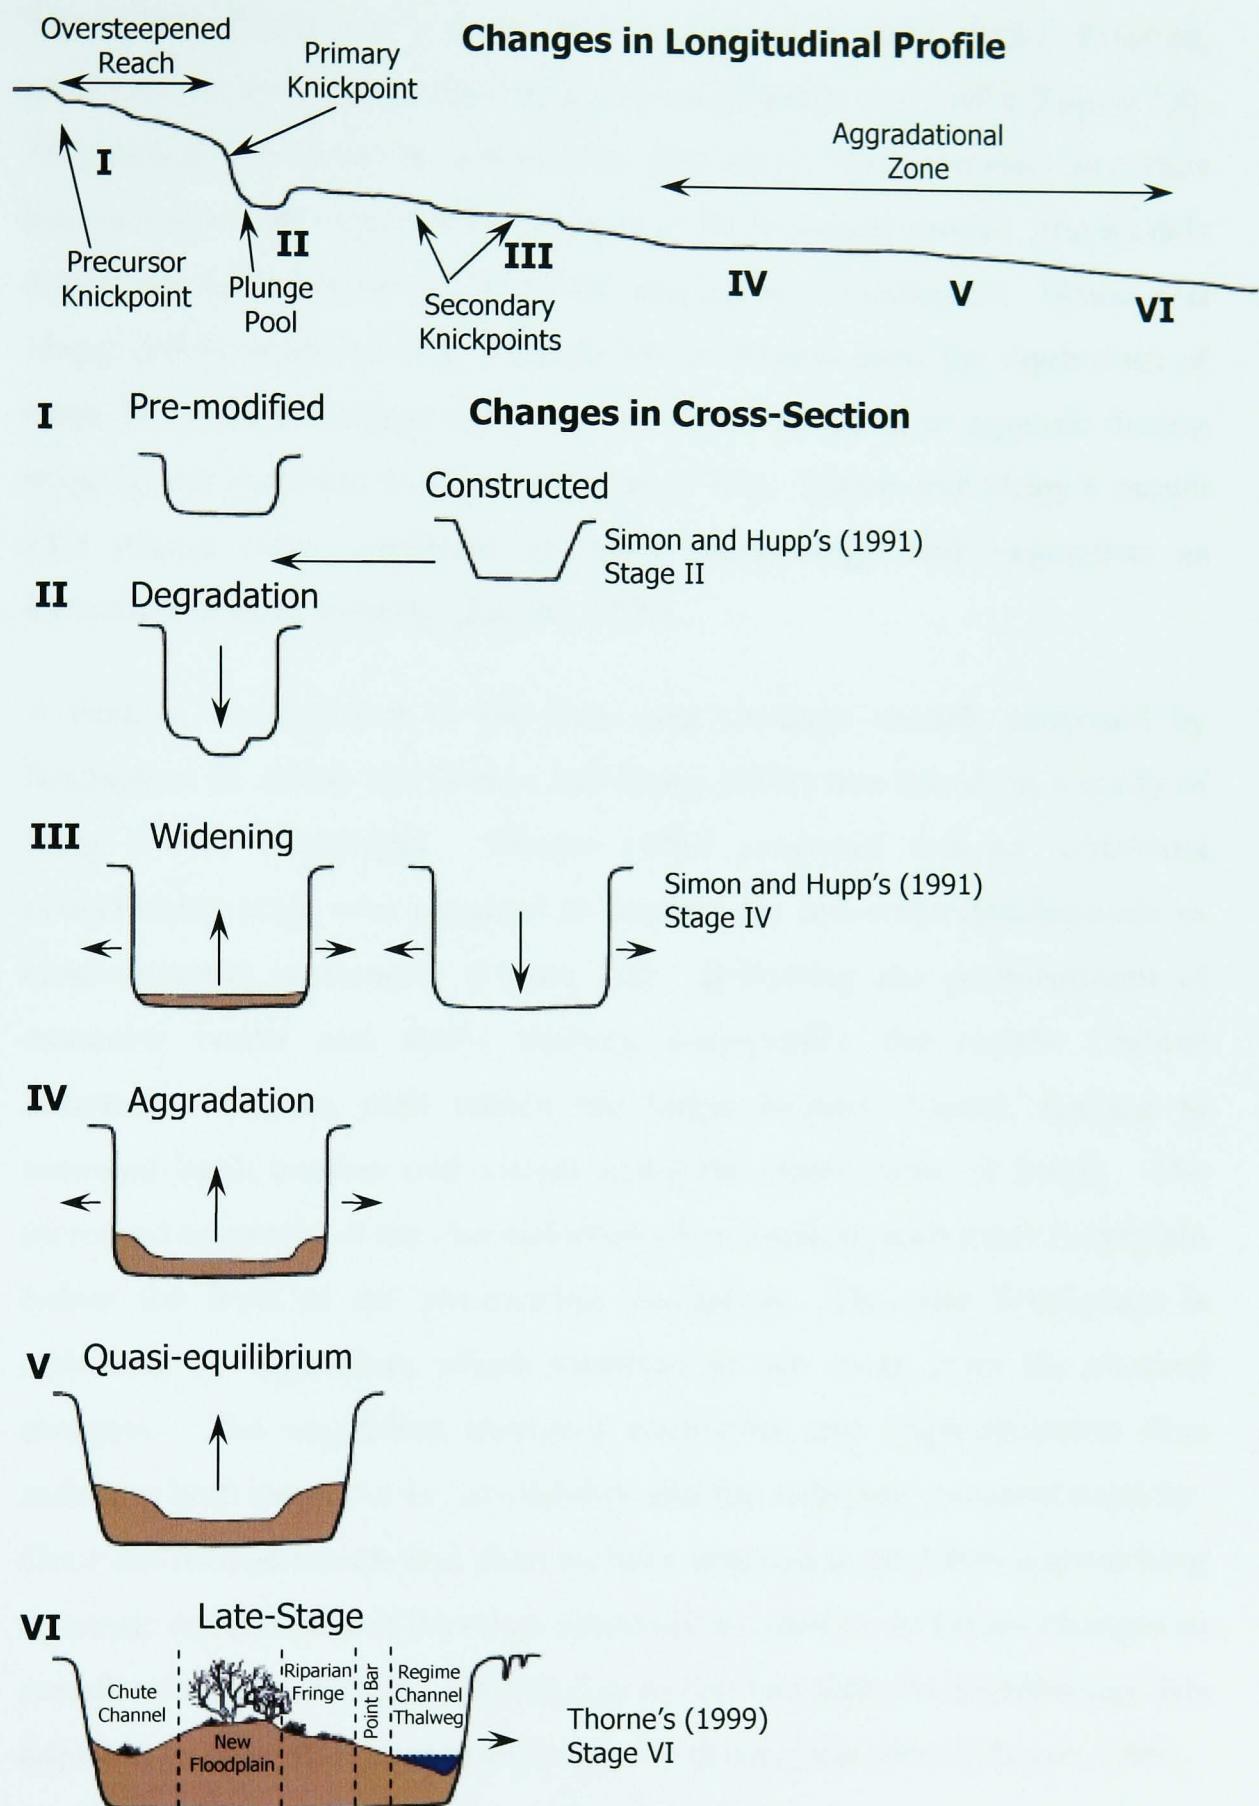
Figure 2.4 Composite incised channel evolution model (after Schumm *et al.*, 1984; Harvey and Watson, 1986; Simon and Hupp, 1991; Thorne, 1999).

Once the critical bank height is reached, mass bank failure causes the channel to begin widening. As widening continues, the banks pass from a state of impeded removal, where the sediment transport capacity of the flow is more than sufficient to remove all failure material, to a state of excess basal capacity, where the channel has become so wide that the stream is no longer able to remove the failed sediment (Thorne, 1982). The build-up of sediment at the base of the banks may allow the channel to achieve a state of quasi-equilibrium, especially if vegetation is able to become established. Secondary knickpoints may cause a complex response to occur as the sediment supply to the system decreases. This allows terraces to form, which are subsequently abandoned as progressive knickpoints pass through the system (Womack and Schumm, 1977).

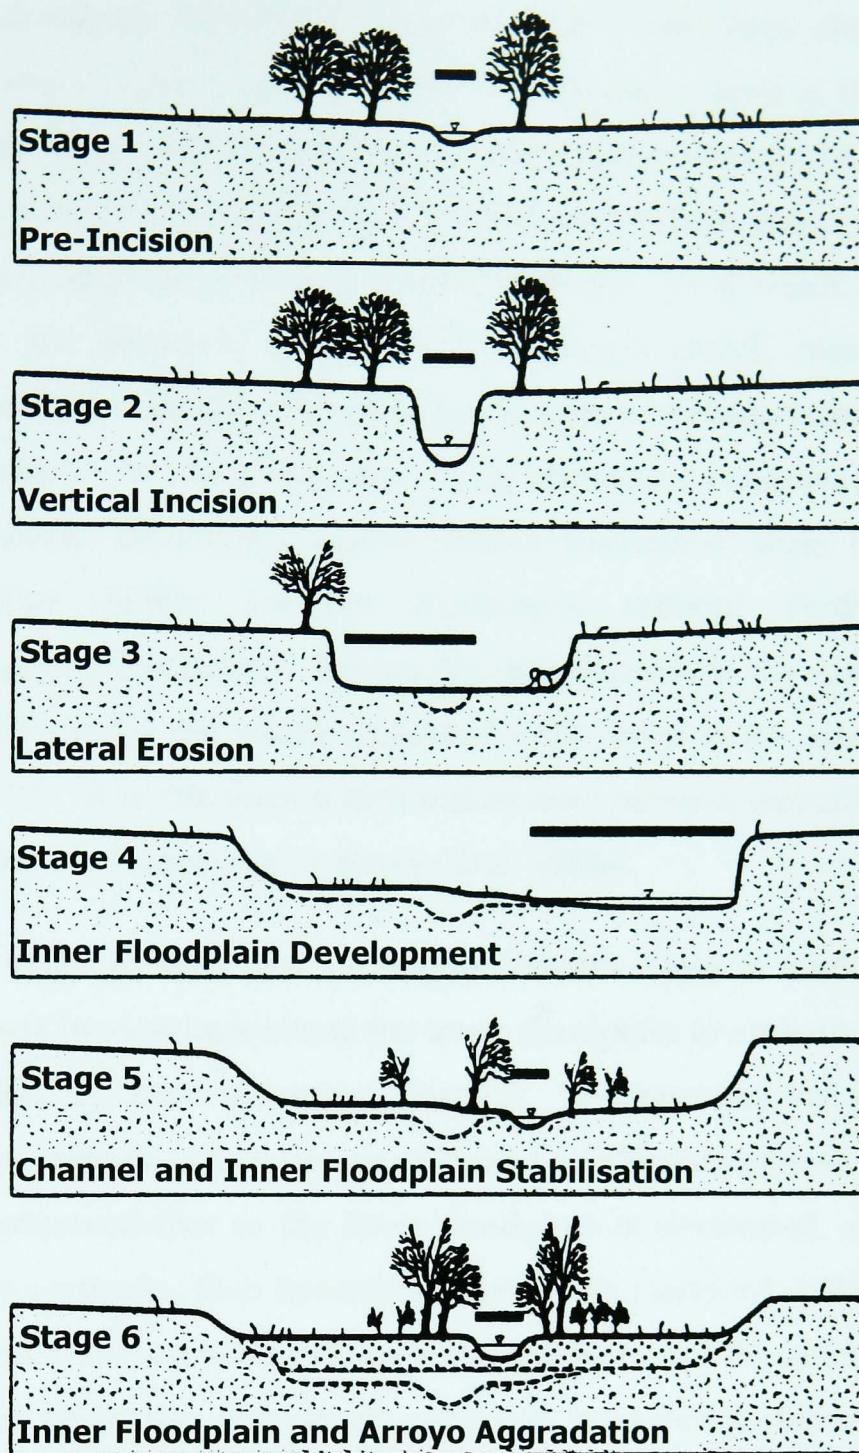
Figure 2.5 Hypothetical sequence of geomorphological evolution of large-scale arroyos (after Elliott, 1979; Elliott *et al.*, 1999).

Downcutting (Stage 2) continues until the arroyo walls reach a critical bank height, at which point widening follows (Stage 3). As first vertical and then lateral erosion progresses headwards, a large amount of sediment is released as tributaries are degraded and subsequent widening occurs (Elliott, 1979). The volume of sediment released is sufficient to overload flows, causing a braided planform to develop. This braided channel is defined as a Type 1 reach by Elliott and represents an intermediate stage in arroyo evolution (Elliott, 1979). Type 1 reaches are sustained by variable discharges and high sediment loads and are subject to lateral shifting causing continued widening of the arroyo trench. The rate of sediment production was found to attain a maximum during widening (Schumm, 1973; Gellis *et al.*, 1991), with up to five times as much sediment produced during widening compared with the initial downcutting (Meyer, 1989).

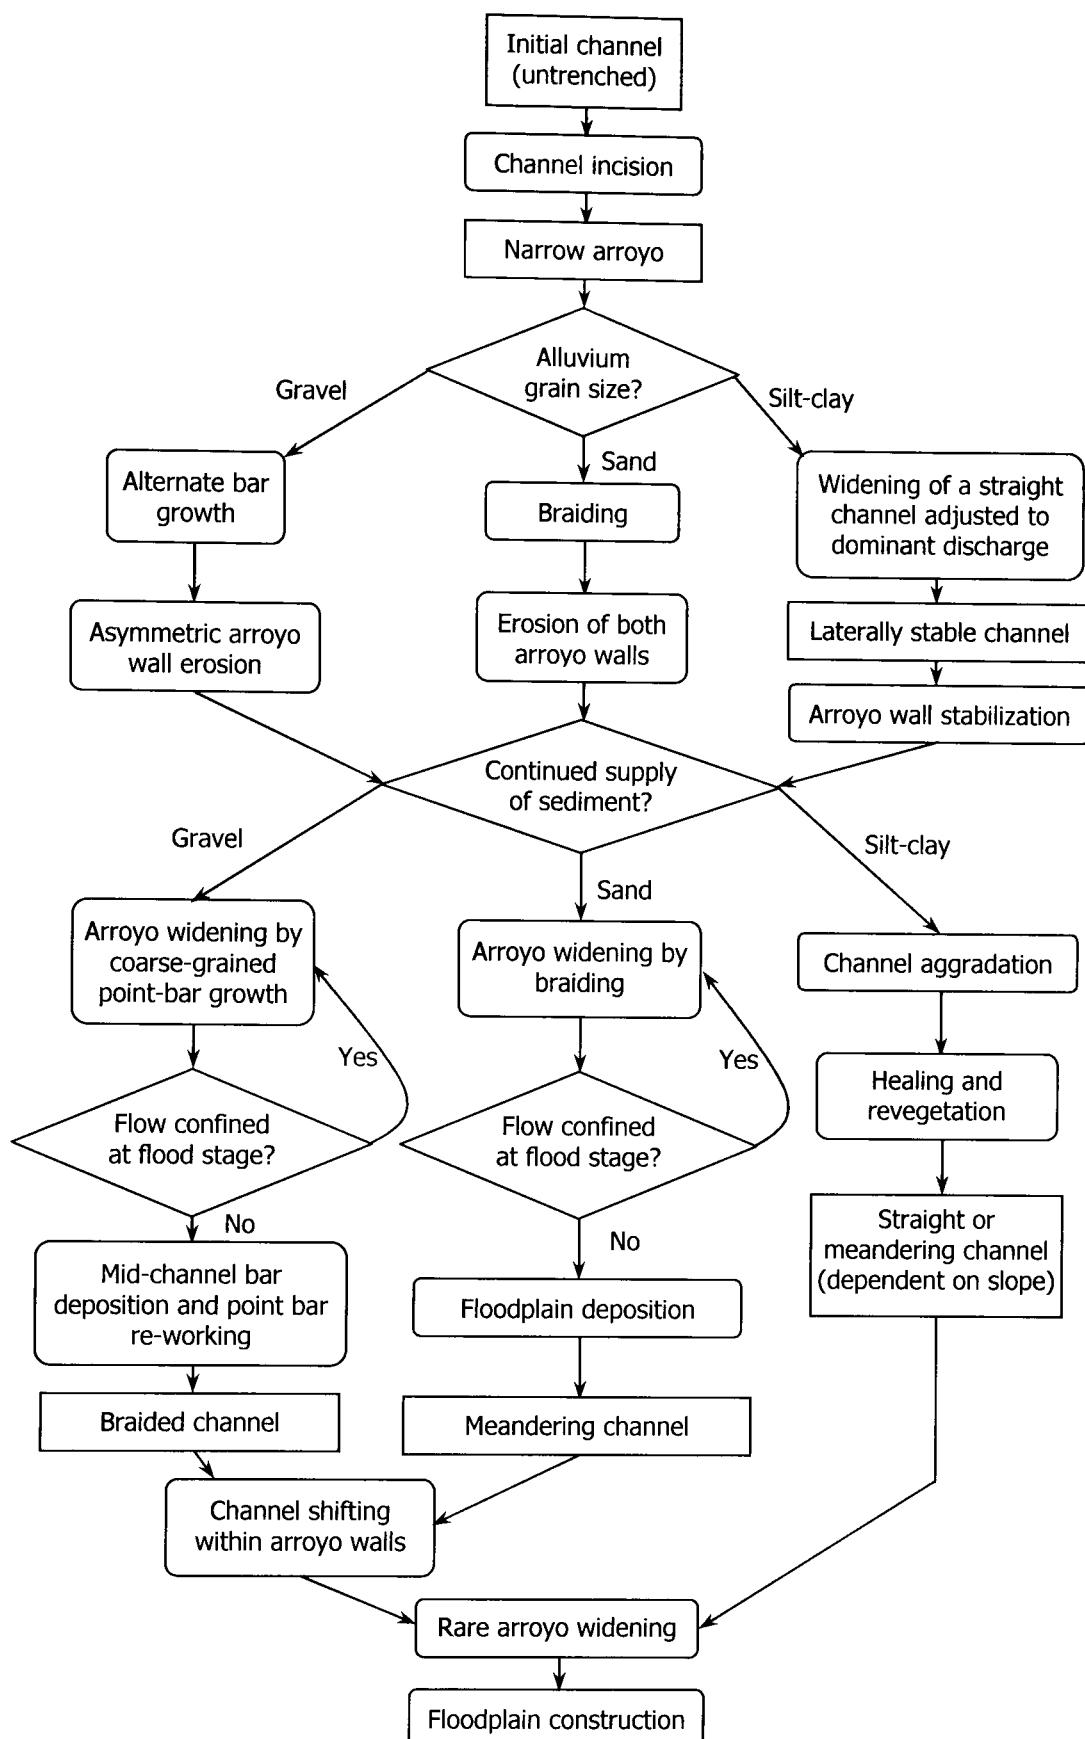
Figure 2.6 Model of arroyo development showing influence of sediment load and grain size on stability (after Meyer, 1989).

The role of intrinsic thresholds are highlighted by other models of evolution. Meyer (1989) proposed a model of development, again noting the importance of the volumes of sediment being produced and transported, but also observing the effect of different alluvial grain sizes on the arroyo pattern (Figure 2.6). Meyer argued that the models of arroyo evolution

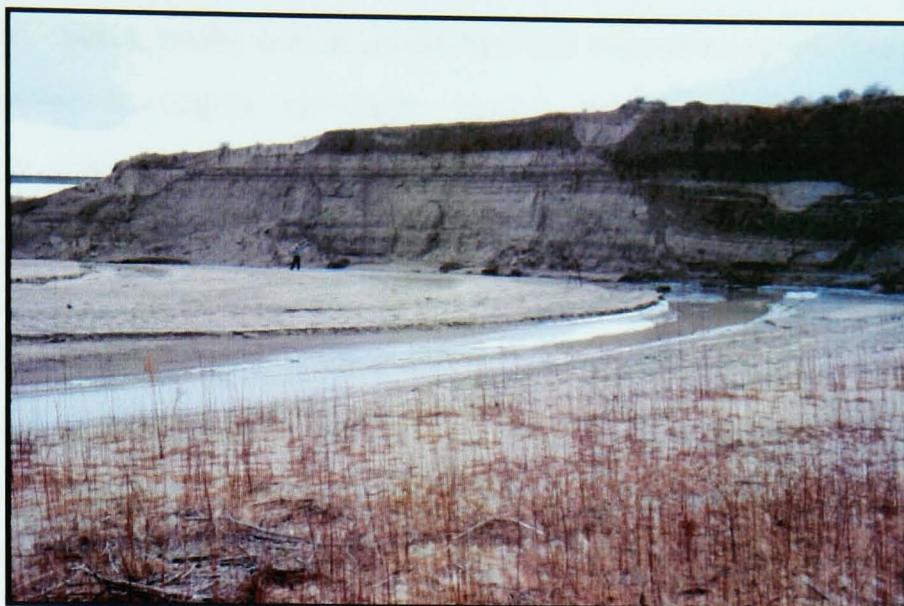
Figure 3.2 Palaeoarroyos exposed in the outer bank of XS-17, Rio Puerco (courtesy John Elliott).

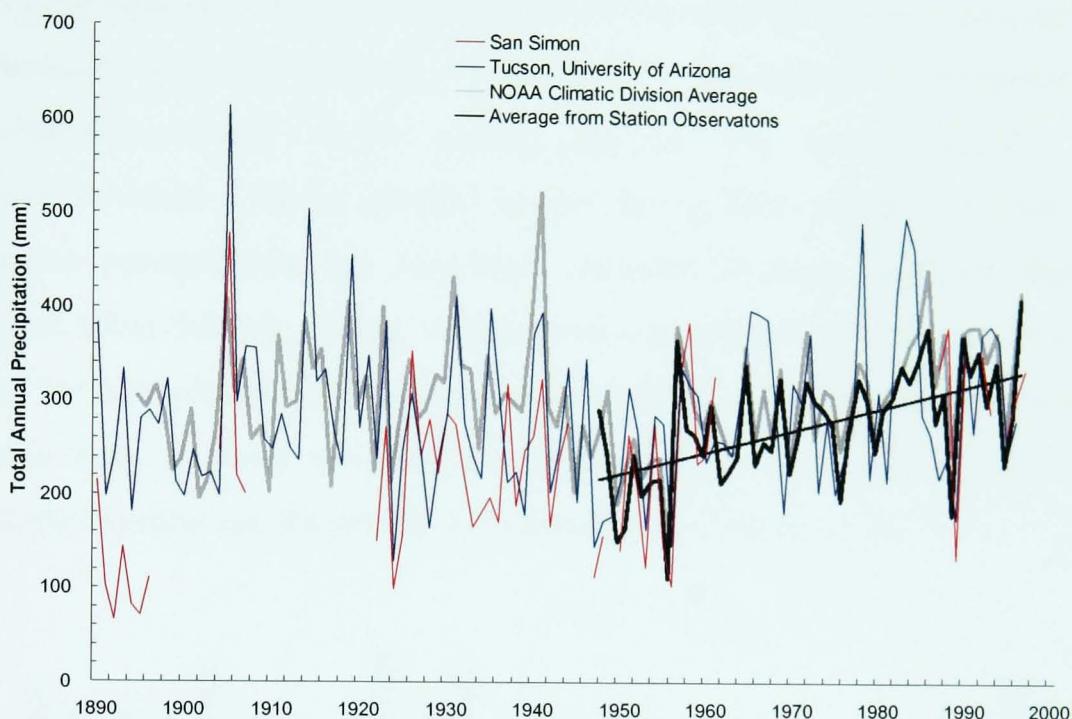
Figure 4.2 Time series of total annual precipitation (Rio Puerco data and NOAA climatic division data after Molnar (2001)). Linear trendline is for Rio Puerco data.

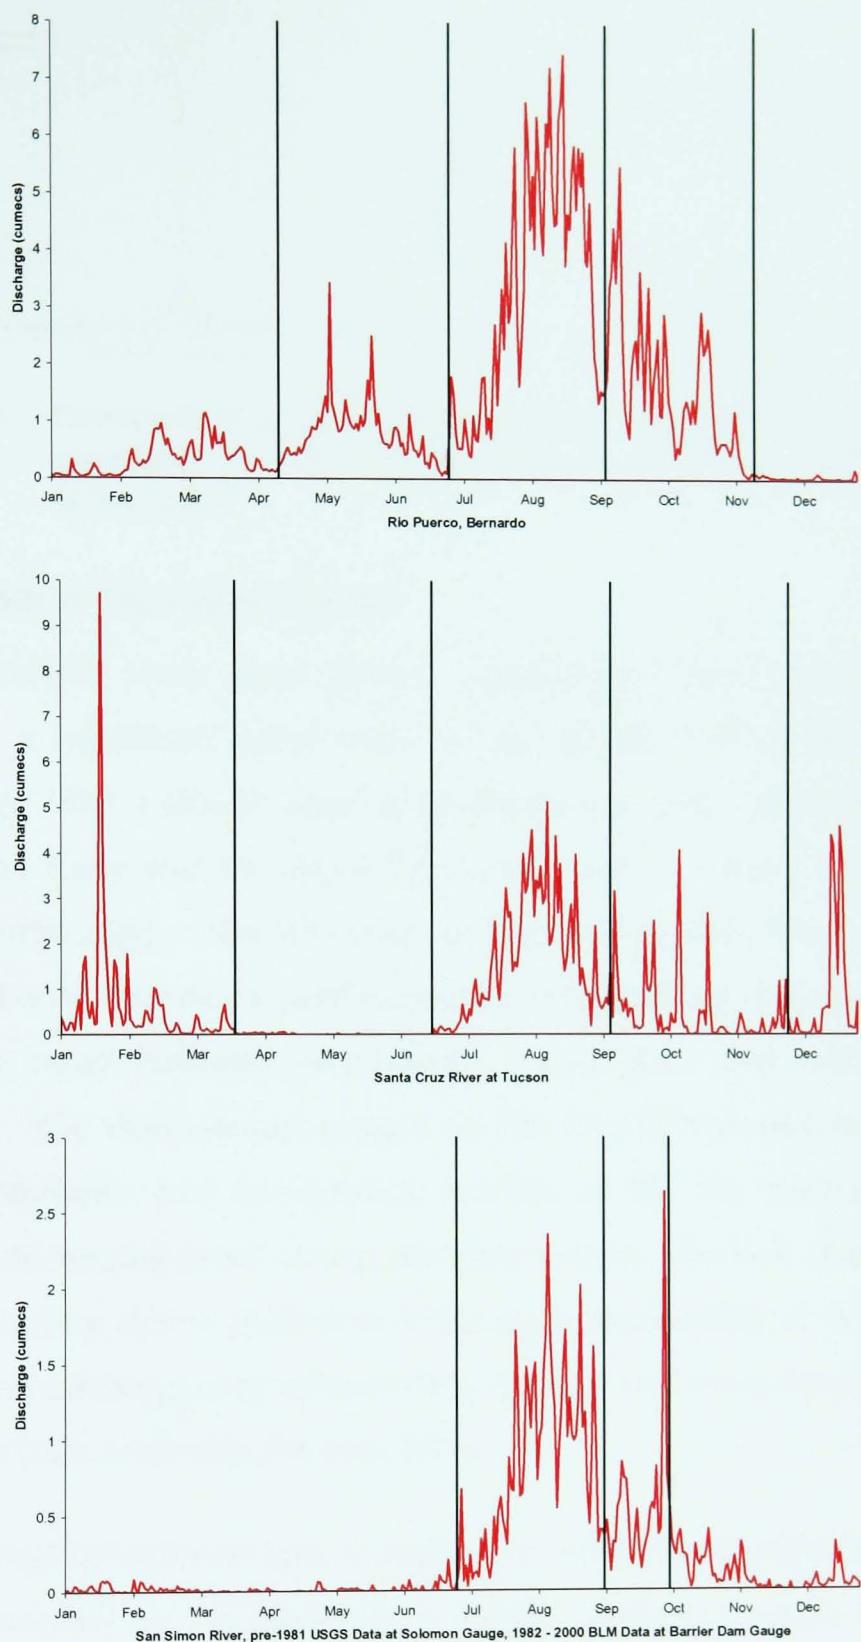
Figure 4.5 Average daily flow over entire period of record.

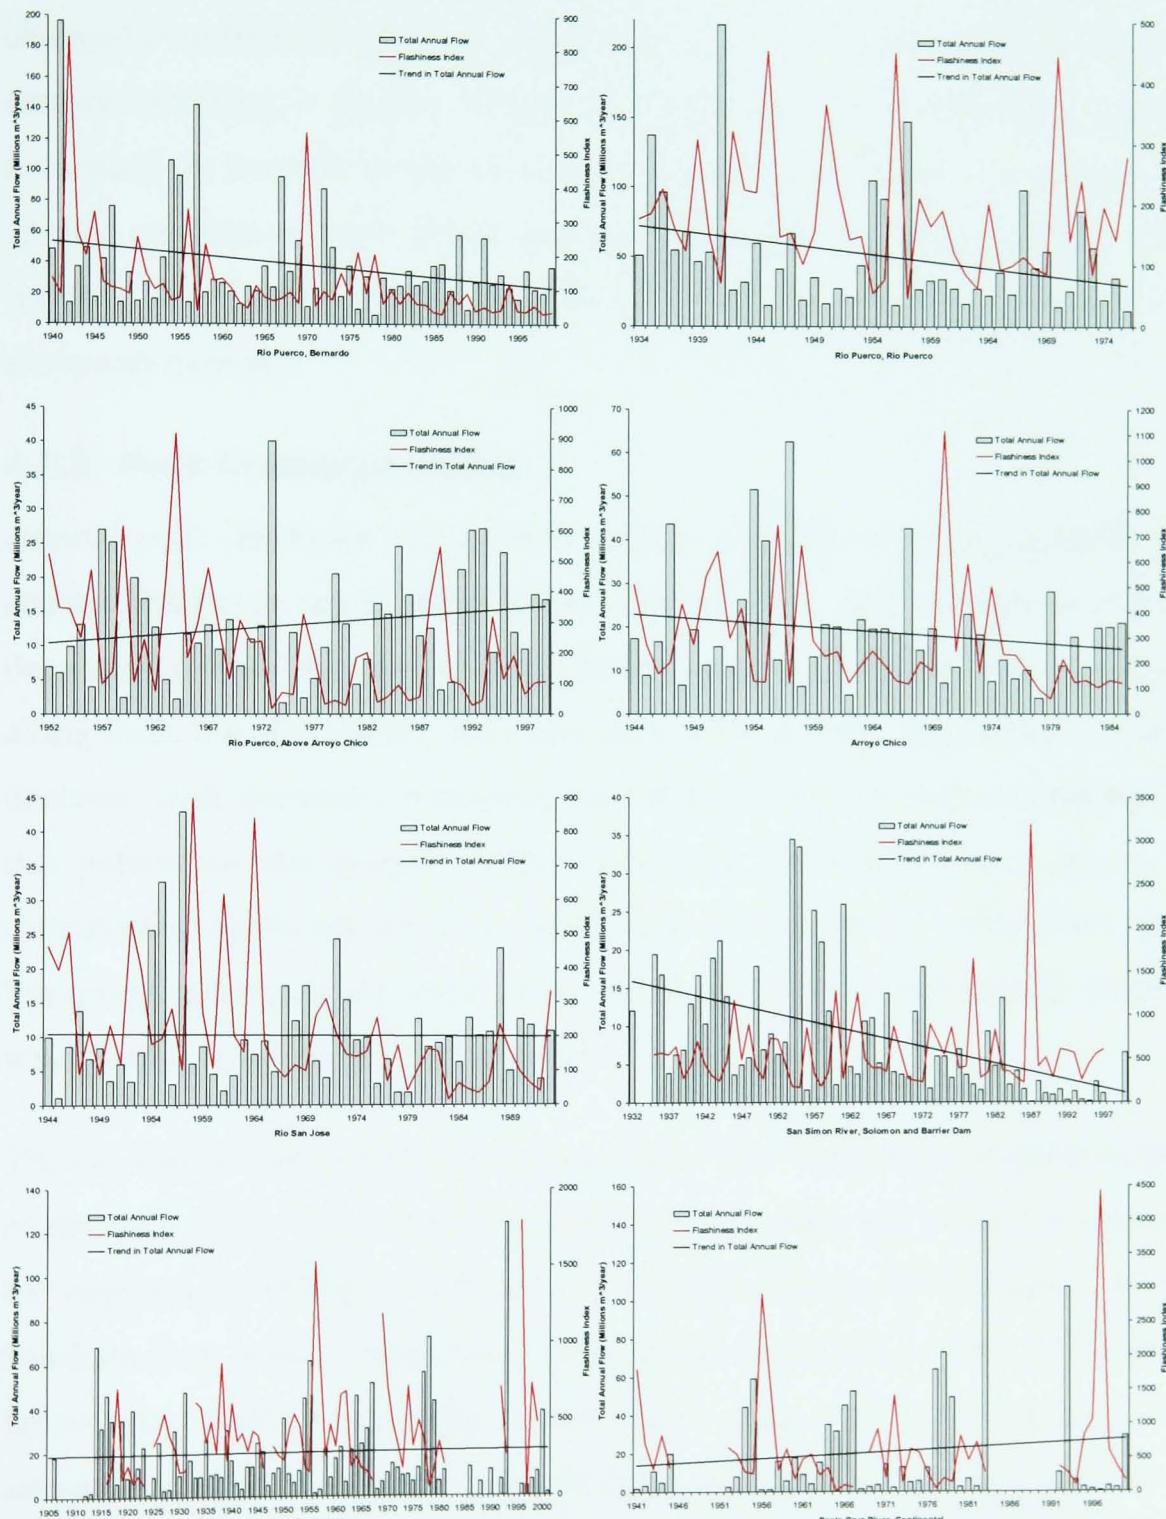
Figure 4.7 Total annual flow and annual flashiness index at all gauges along the Rio Puerco, Santa Cruz and San Simon Rivers for available period of record. Calculated from daily average discharge records. Note that scales and time periods are not the same at all gauges.

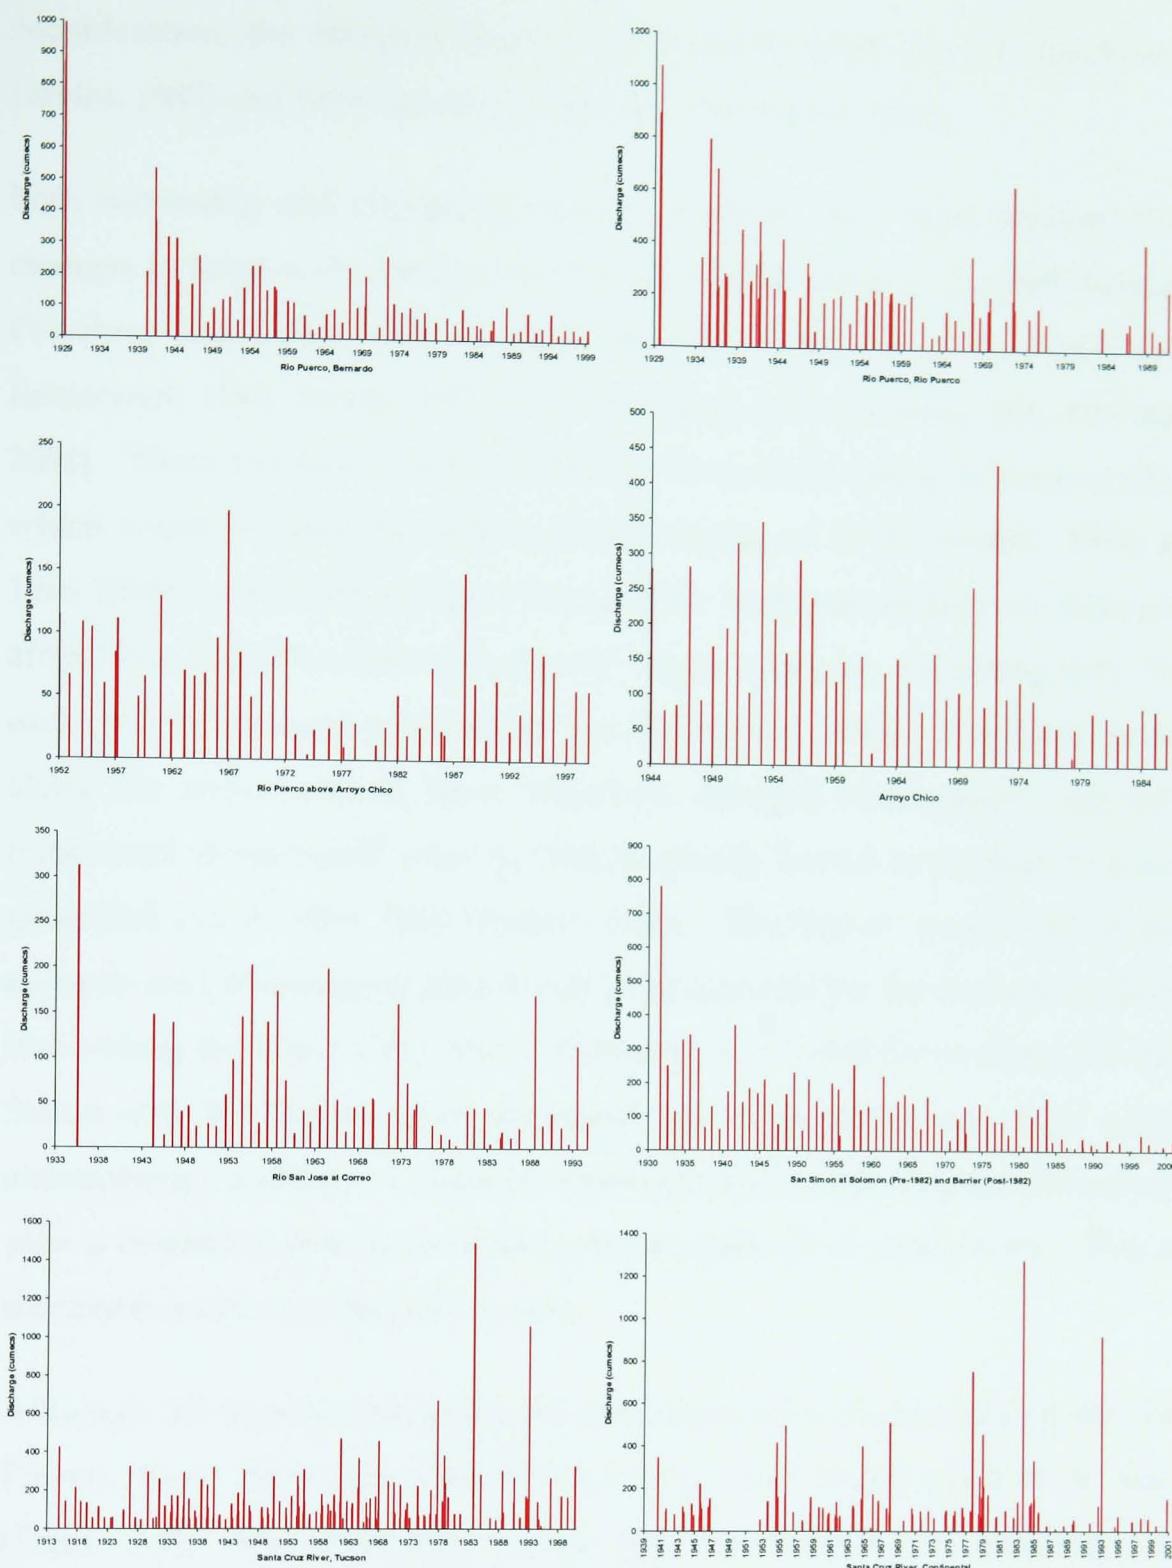
Figure 4.8 Peak annual flows at all gauges along Rio Puerco, Santa Cruz River and San Simon River for available period of record. Note that scales and time periods are not the same at all gauges.

Annual peak discharge values have shown a similar declining pattern to annual discharge totals (Figure 4.8). Since 1960, peak discharges have decreased by over 60 percent at the Bernardo gauge, although other gauges along both the Rio Puerco and San Simon River have experienced lesser declines, with decreases averaging over 40 percent. The only exceptions to this pattern are the gauges on the Santa Cruz River which have shown a statistically significant increase (Reich and Davis, 1987). After 1960, the Tucson gauge registered seven of the ten largest floods since records began, with peaks increasing over 30 percent.

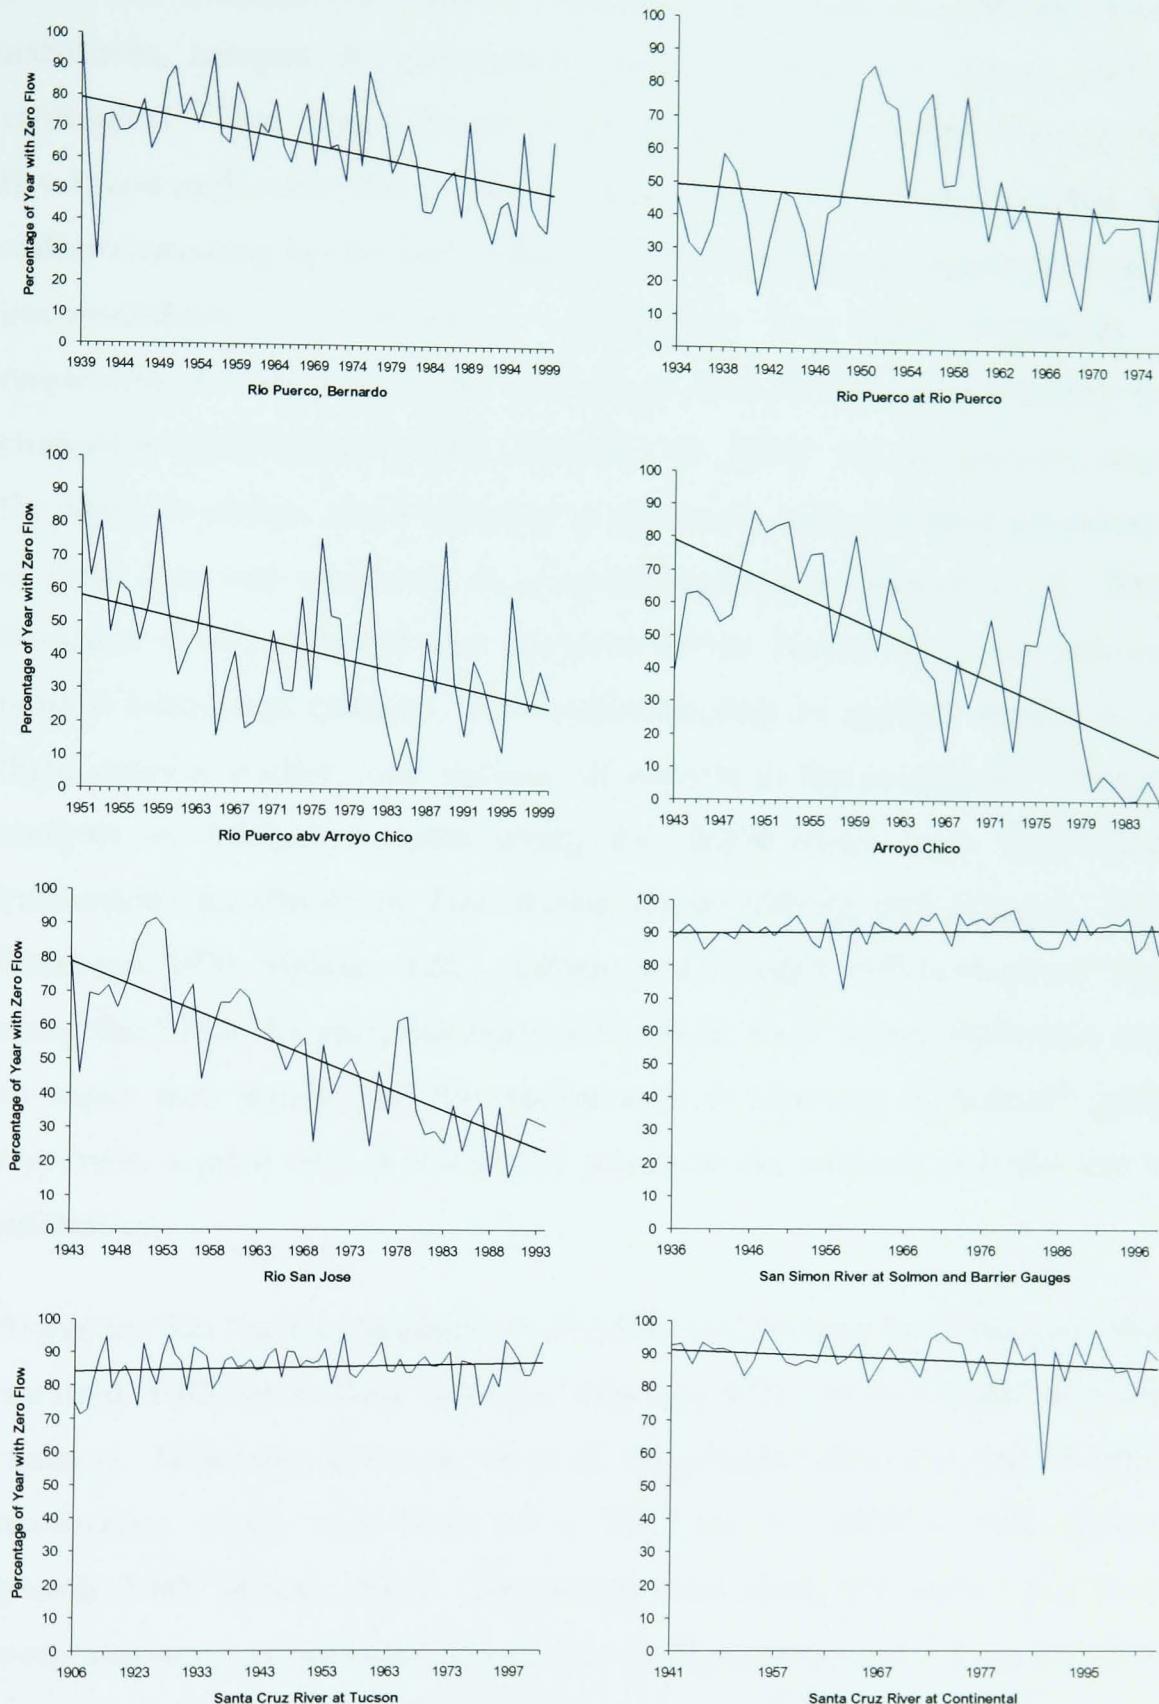
Figure 4.9 Time series showing percentage of year with zero flows for available gauges on Rio Puerco, San Simon River and Santa Cruz River Rivers. Calculated from daily average discharge records. Note that scales and time periods are not the same at all gauges.

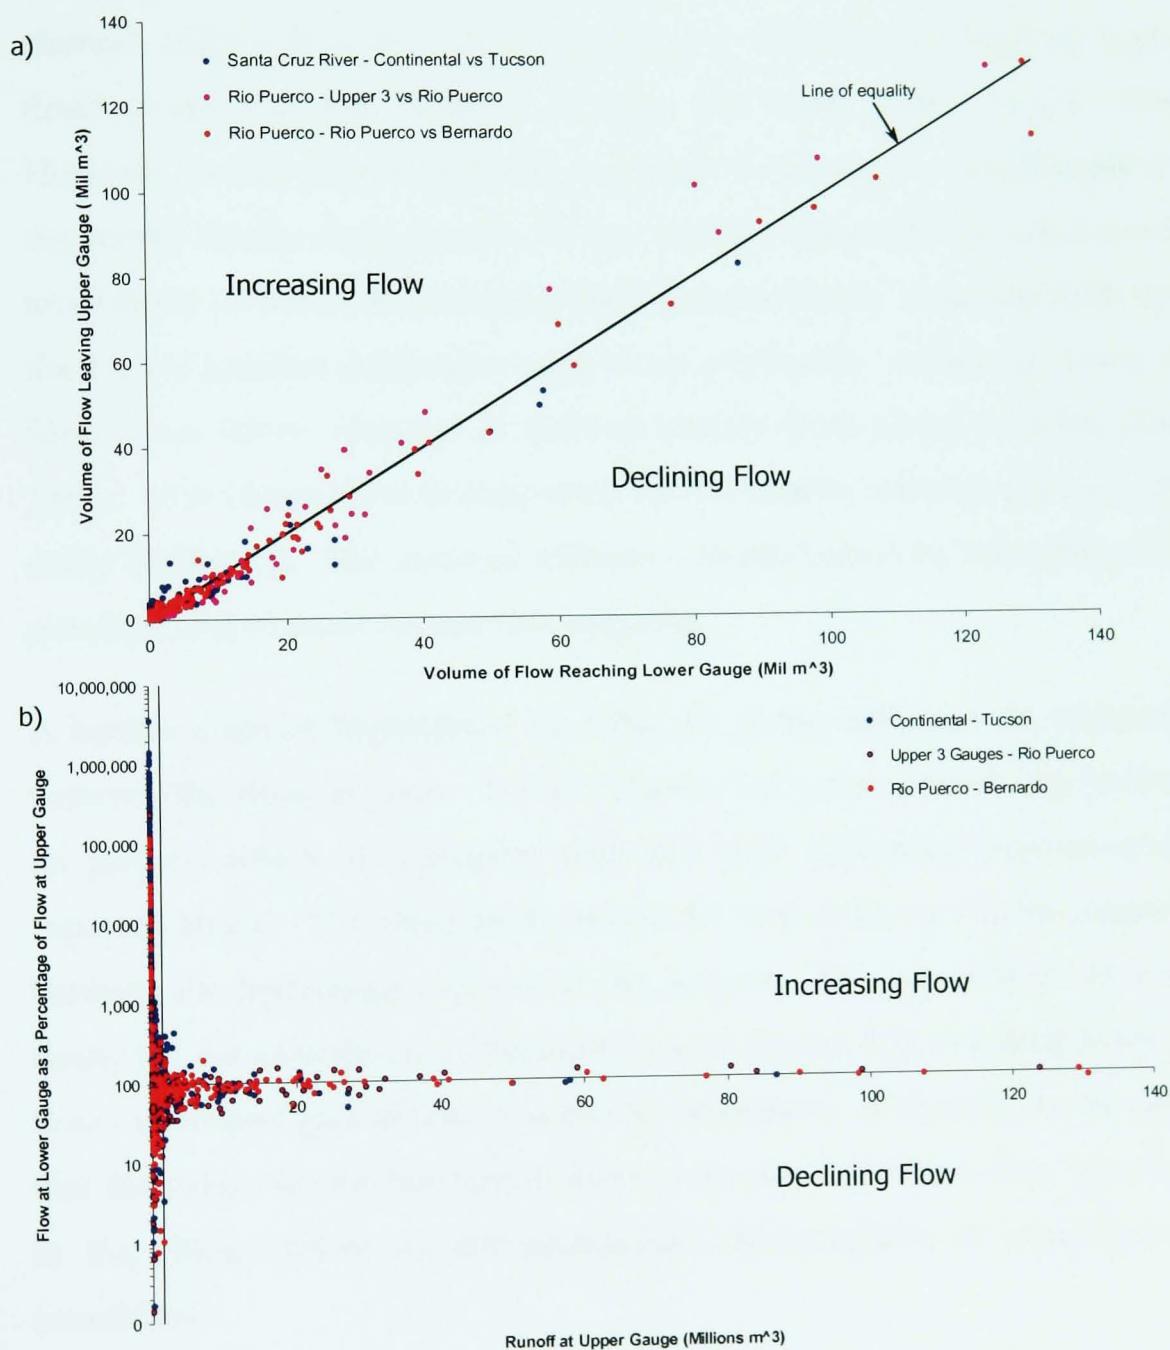
Figure 4.10 a) Difference in flow volumes between gauges along the Rio Puerco and Santa Cruz River. b) Volume of flow at lower gauge expressed as a percentage of volume of flow at upper gauge. Where flow has commenced below upper gauge, actual volume has been used.
