The Morphological Representation of Channel-Forming Flow in Arroyos

Lucy A. Ellis

Thesis submitted to the University of Nottingham
for the degree of Doctor of Philosophy, May 2004

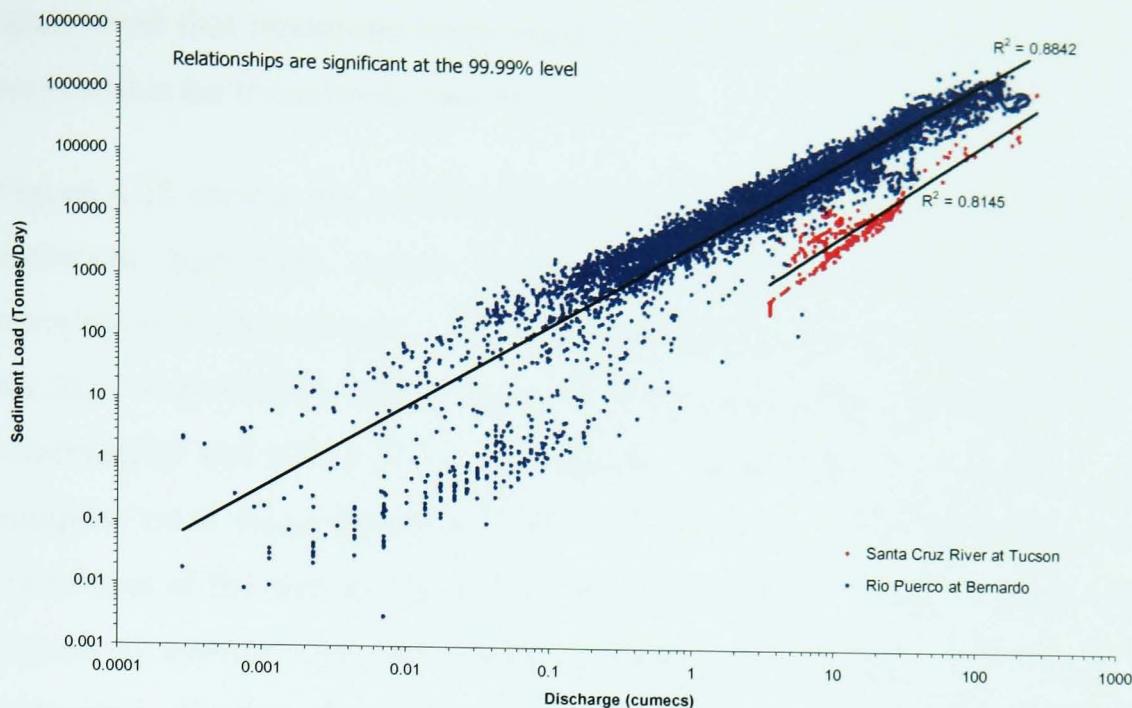
Figure 4.12 Relationship between instantaneous discharge and sediment loads, Rio Puerco at Bernardo Gauge and Santa Cruz River at Tucson Gauge.

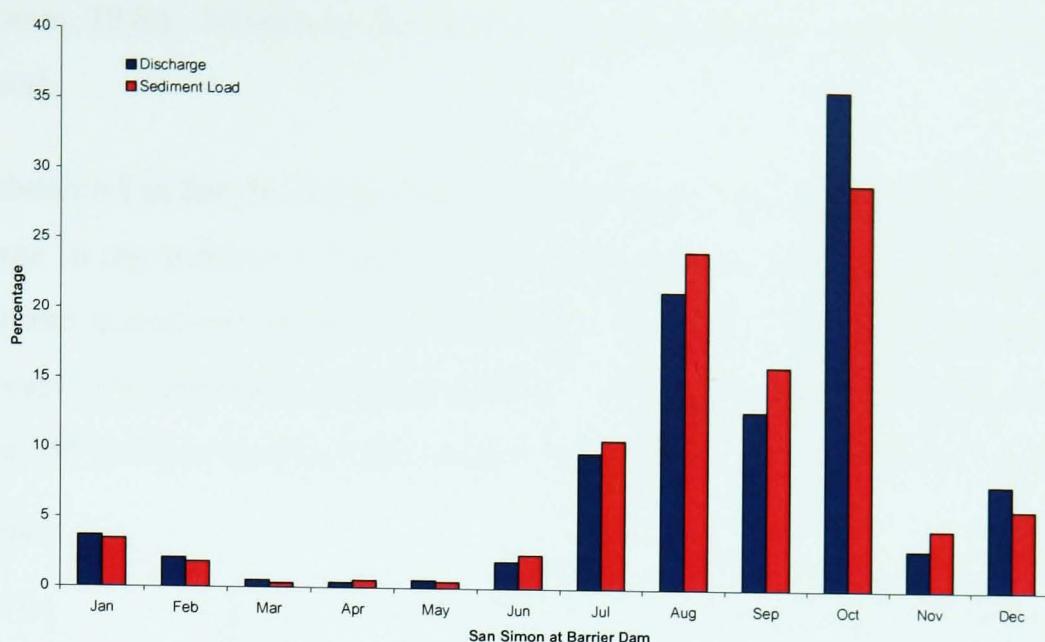
Figure 4.17 Average monthly discharge and sediment load between 1982 and 1995, San Simon River at BLM Gauge at Barrier Dam.

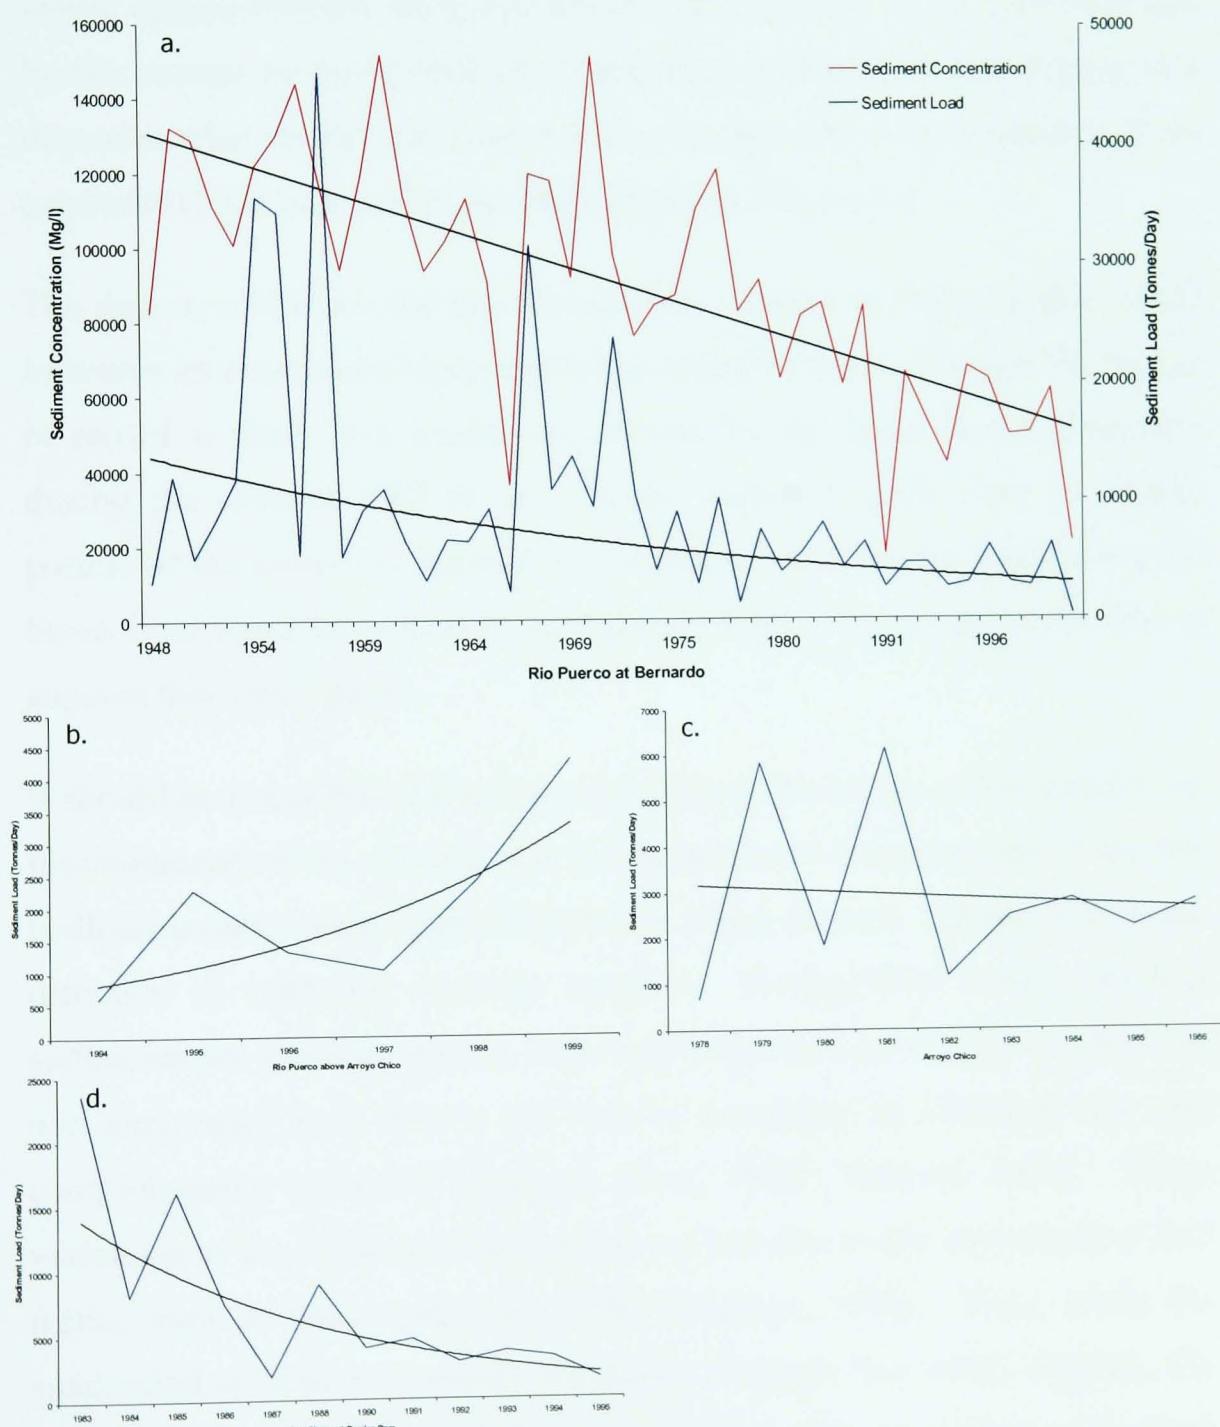
Figure 4.18 Trend in average annual sediment discharge (tonnes/day),
Rio Puerco at a. Bernardo, b. above Arroyo Chico, c.
Arroyo Chico and d. San Simon River at Barrier Dam.

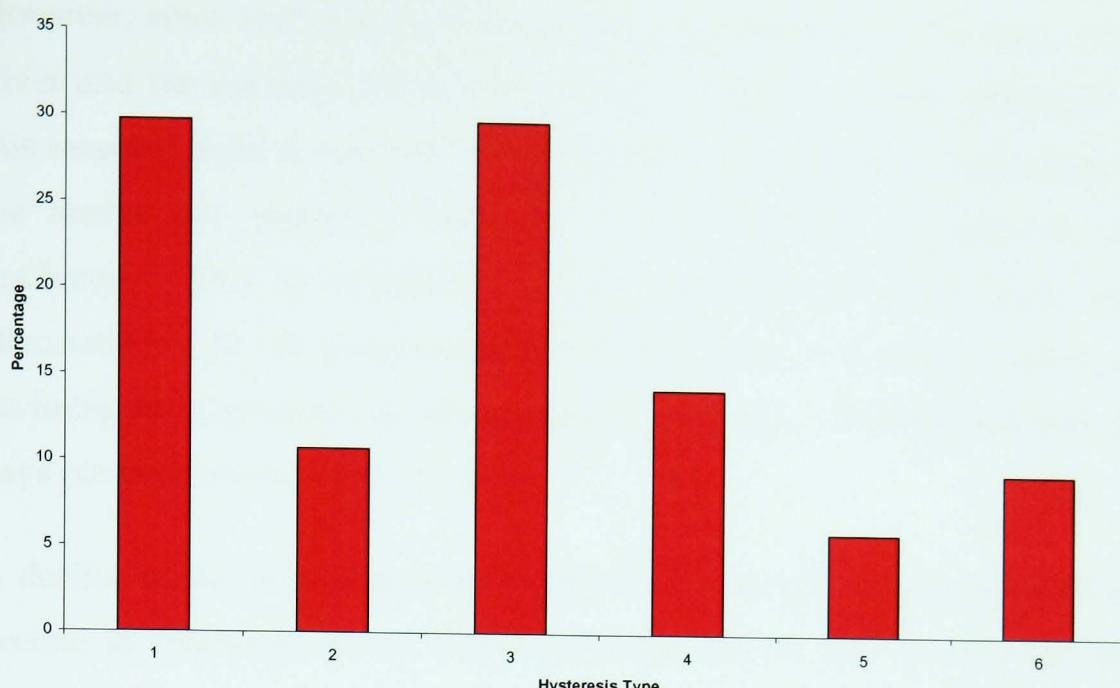
Figure 4.20 Hysteresis types, Rio Puerco at Bernardo.

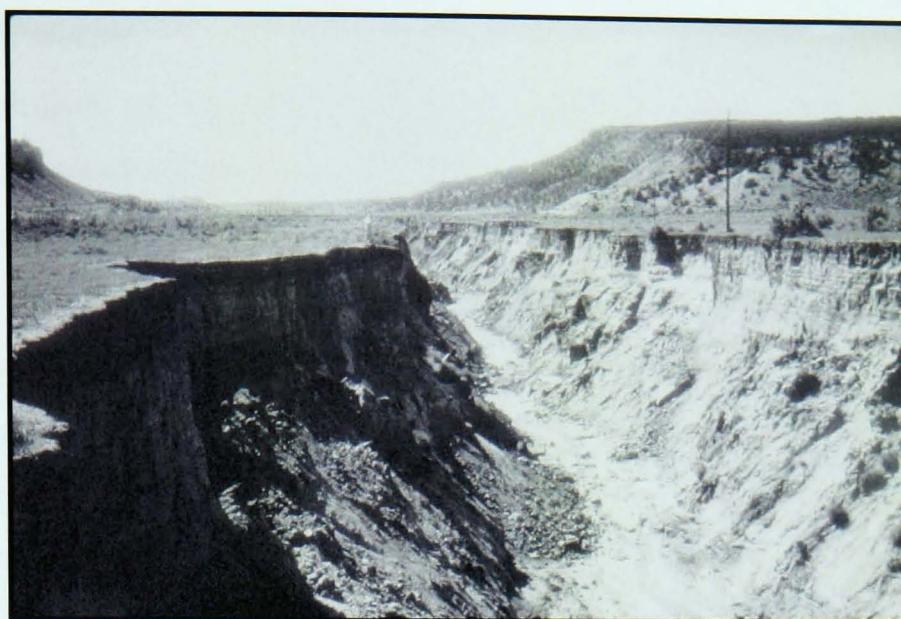
Figure 5.4 Artificial cut-off at Ventana, 1968 (photographer unknown).

The largest artificial change to the Rio Puerco since the collapse of the Old English dam was the straightening of a reach at Ventana during 1965 and 1966 (Figure 5.4) (Gorbach *et al.*, 1996; Coleman *et al.*, 2003). This rerouting was carried out in order to avoid having to build two or more bridges over the arroyo channel during the construction of a new route for Highway 44 (Coleman *et al.*, 2003). The 1.8 kilometre (1.1 mile) long channelised reach was far smaller, when constructed, than shown in the original engineering plans. This is thought to be due to the resistant bedrock outcropping in the area (Coleman *et al.*, 2003). The former channel was isolated by bulldozed dams, diverting flow into the artificial channel, which was over seven times narrower than the natural channel.

The most significant change during the 1960s was the construction of the artificial channel at Ventana in 1965 and 1966 (Figure 5.4). This channel effectively doubled the channel gradient from 0.004 to 0.0074, thus increasing the stream power and erosive capability of flows through this reach (Coleman *et al.*, 2003). The immediate response of the arroyo was to incise, creating a series of bedrock knickpoints. The geomorphology of the

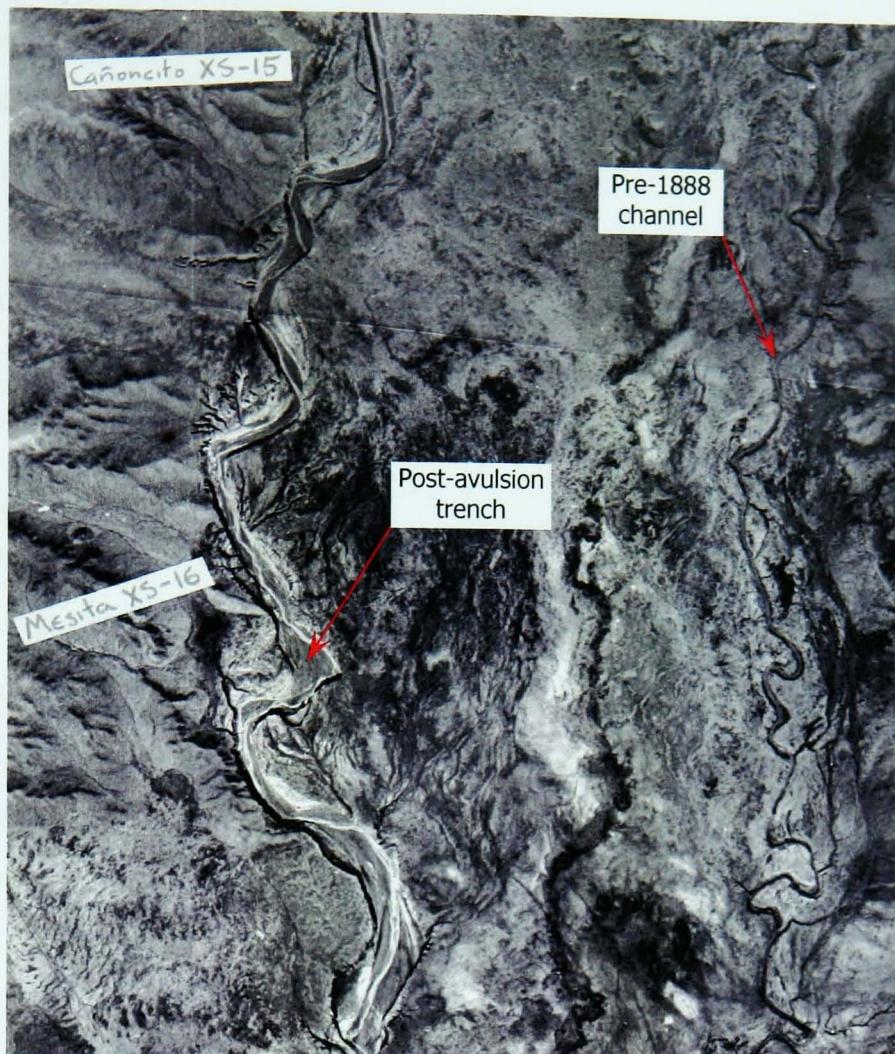
**Figure 5.5 Pre- and post-avulsion channels, 1935 aerial photograph.
Numbers refer to Elliott's cross-sections (see Appendix 2).**

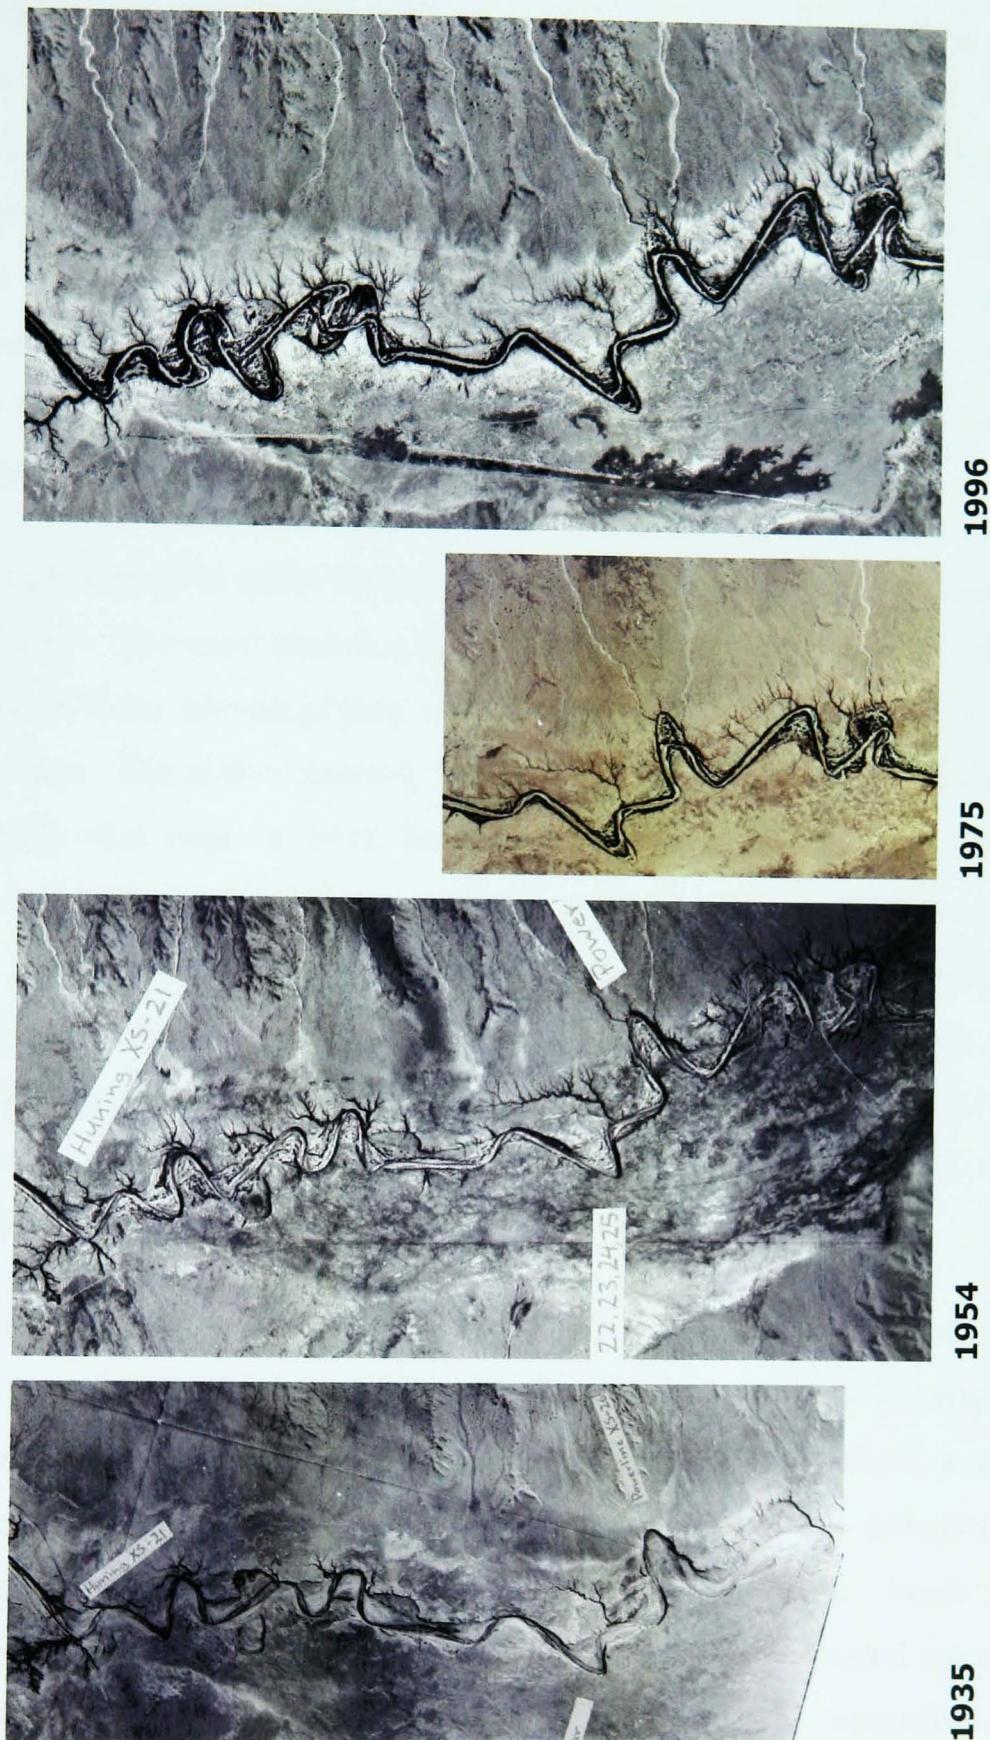
**Figure 5.8 Arroyo evolution between 1935 and 1996, Lower Reach.
Numbers refer to Elliott's cross-sections (see Appendix 2).**

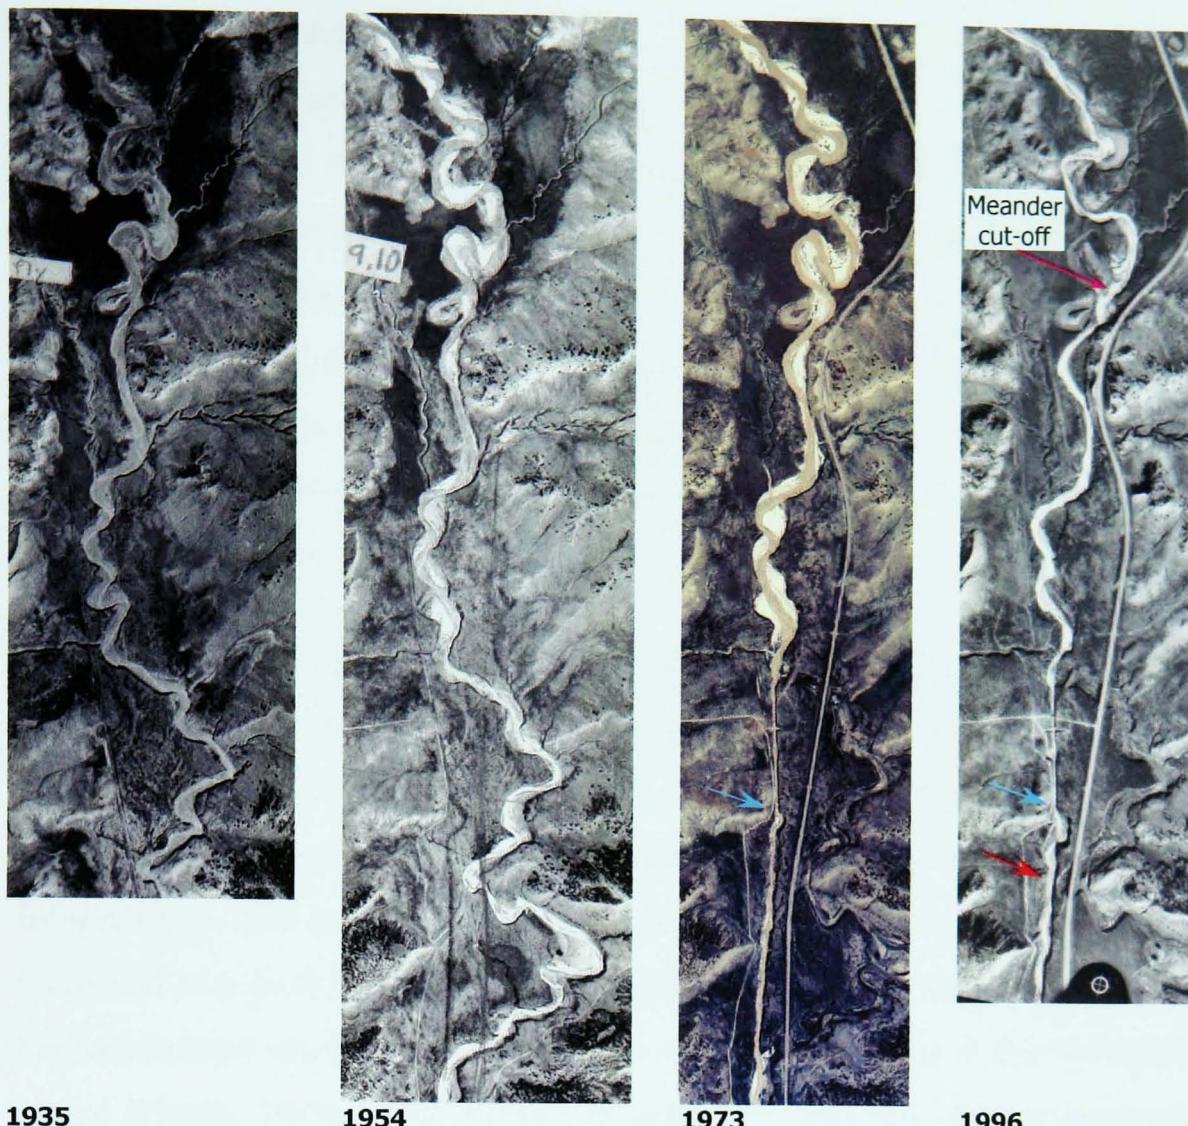
Figure 5.9 Morphological change due to the construction of artificially straightened reach at Ventana.

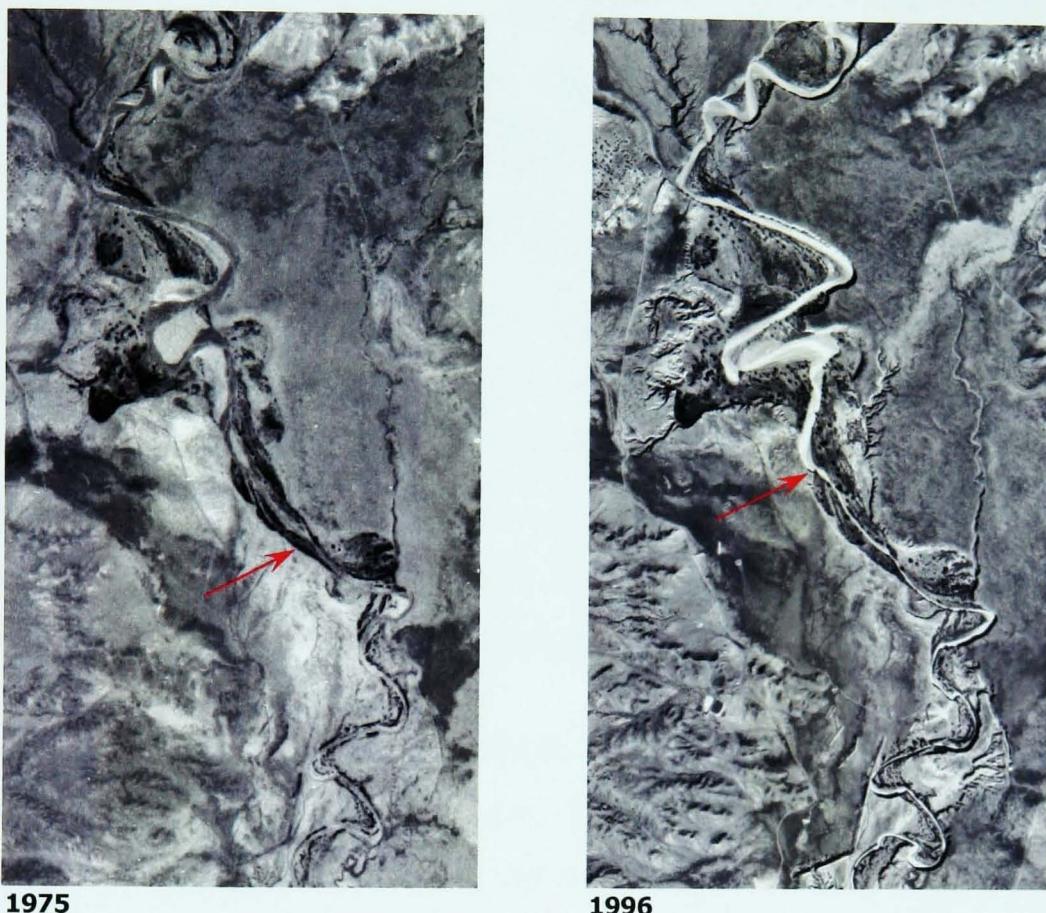
Figure 5.12 Geomorphological change at the Benavidez Ranch reach, arrow indicating point of change.

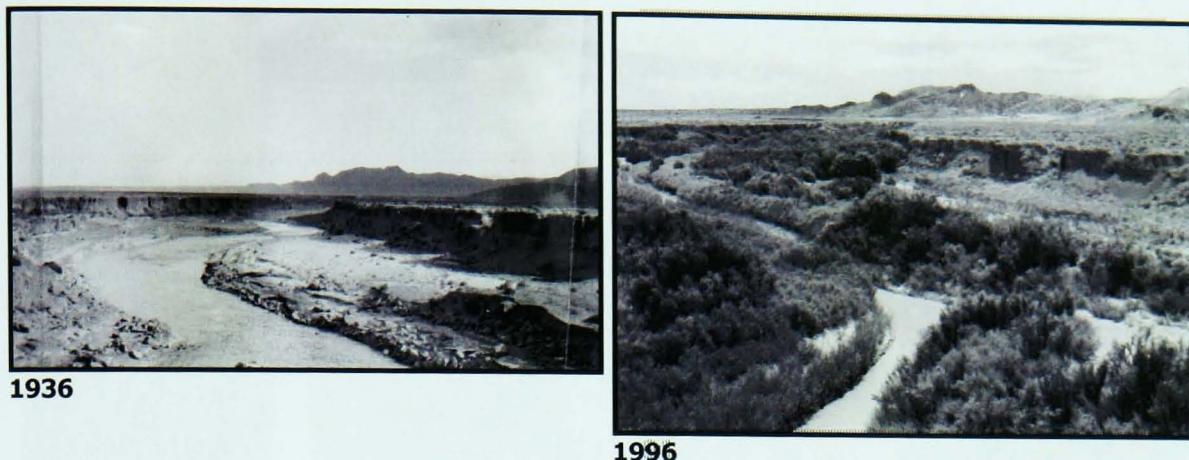
Figure 5.13 View downstream from Highway 6 bridge, Rio Puerco at Rio Puerco, showing morphological change. (1936 photograph courtesy H. Yeo, Ms 94 Box 16/76, Rio Grande Historical Collections, New Mexico State University Library; 1996 photograph courtesy J. Wall, BLM).

By the mid-1990s, the active channel along the lower reaches, downstream of the Benavidez Ranch reach, had effectively become channelised, forming a distinct trapezoidal shape (Figure 5.13). Tamarisk lining the channel are especially dense, forming an almost impenetrable barrier. This has caused

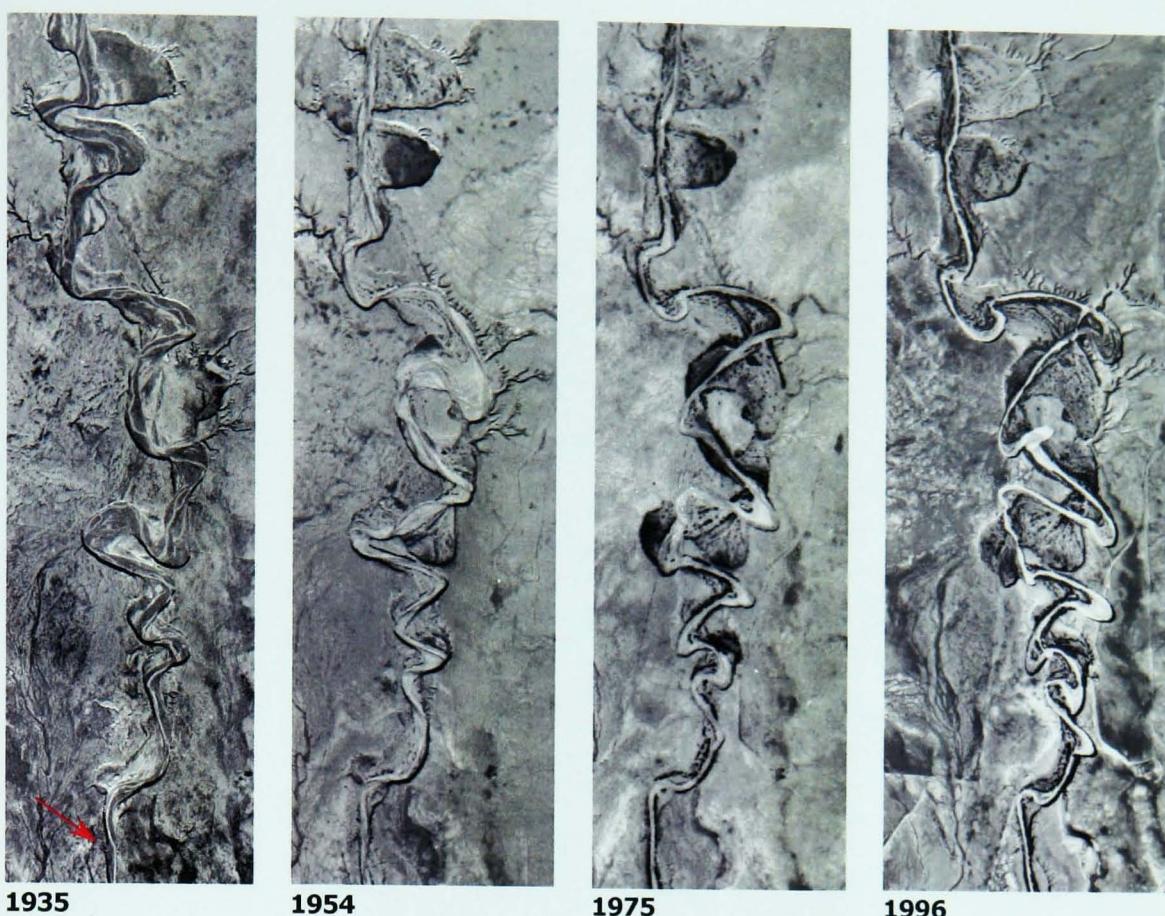
Figure 5.14 Development of hooked meanders downstream of the Benavidez Ranch reach. Arrow indicates remnants of Benavidez Ranch Dam.

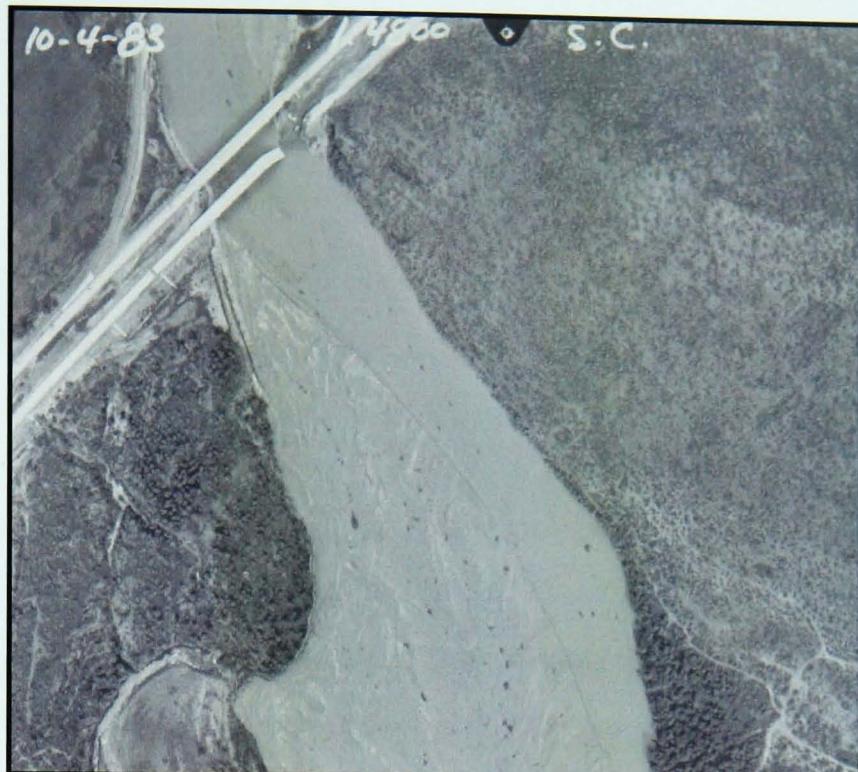
Figure 5.17 Aerial photograph showing collapse of I19 during 1983 flood.

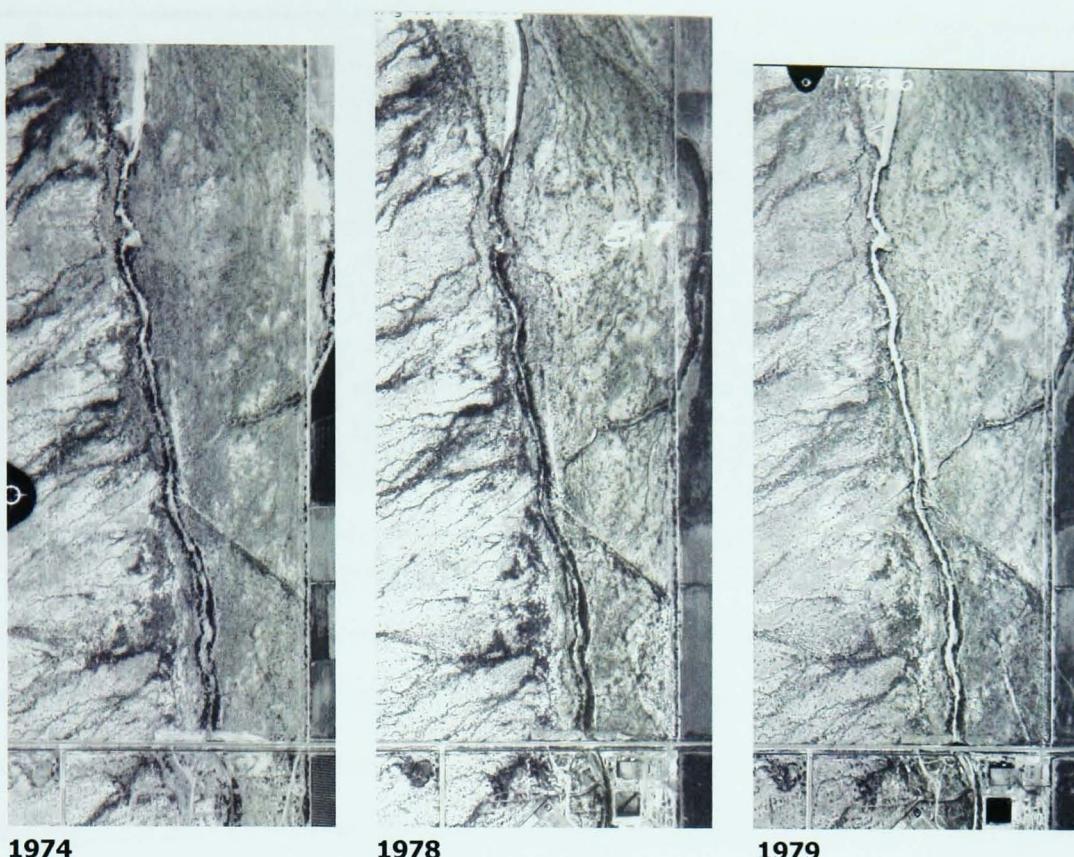
Figure 5.21 Aerial photographs showing geomorphological changes of the Santa Cruz River at Pima Mine Road due to high-magnitude flooding in October 1977 and December 1978.

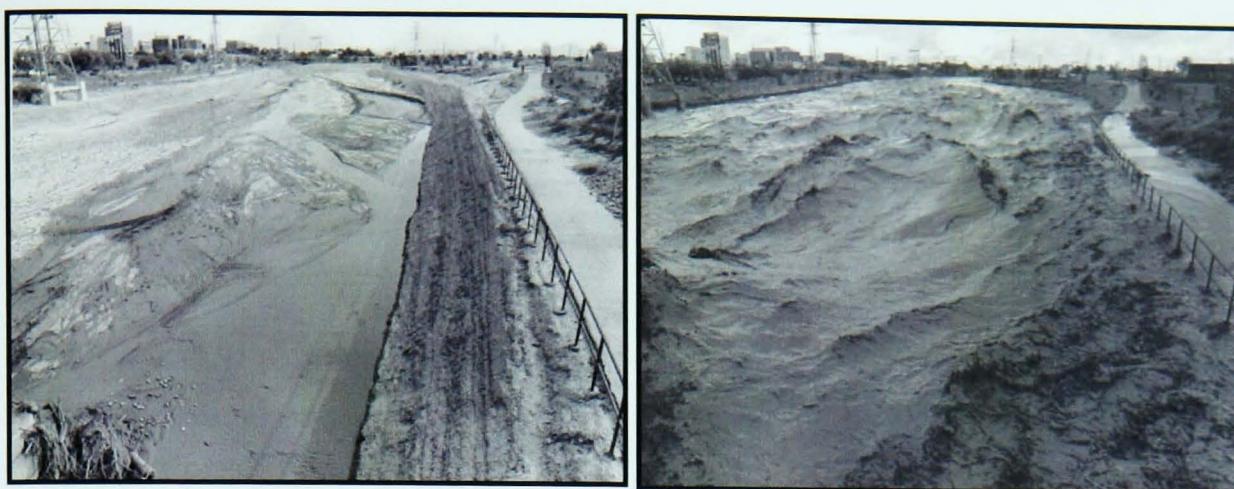
Figure 5.22 View upstream from St. Mary's Road before and during 1983 flood (courtesy P. Kresan).

The floods of the late 1970s were followed in quick succession by the flood of record in October 1983 (1,492 cumecs), and another large flood in December 1984 (282 cumecs). The 1983 flood, designated a “superflood” due to its extreme magnitude and geomorphic effect, caused the most channel change ever wrought by a single flood on the Santa Cruz River. The stream power of this flood was increased by the constrictions imposed on the arroyo due to flood protection schemes, such as soil cement, bridge revetments and grade control structures. These constrictions prevented the natural lateral adjustment of the arroyo, causing flood levels to become perilously close to trench-full, especially through the urban reaches (Figure 5.22). The relatively low channel capacity due to the outcropping of resistant Pleistocene sediments at Pima Mine Road and artificial

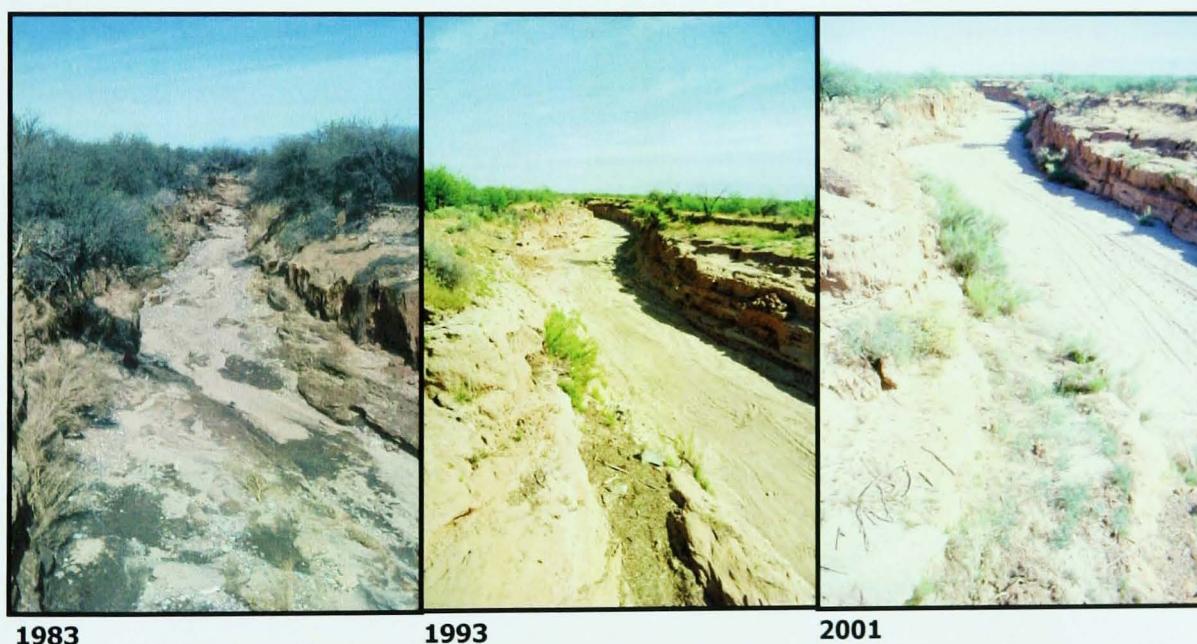
Figure 5.24 View from Pima Mine Road bridge after 1983, 1993 and 2000 floods (1983 photograph courtesy J. Parker).

The removal of the grade control structure upstream of Martinez Hill in 1977, followed by the sequence of large floods during the 1980s and 1990s caused the reach downstream of Pima Mine Road to degrade appreciably (Figure 5.24). Once this degradation had caused the arroyo walls to reach a critical height, widening commenced, replicating the pattern of development which had previously occurred in downstream reaches.

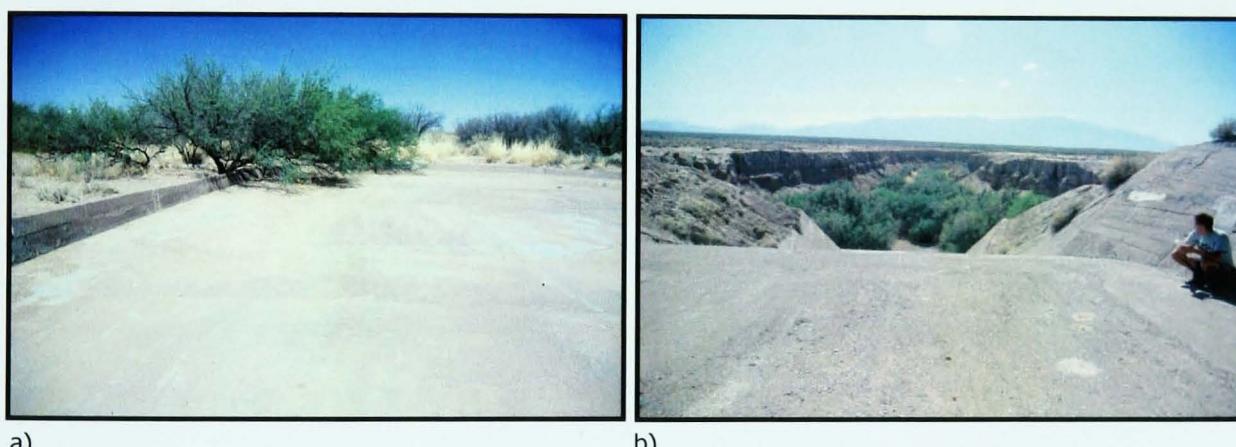
Figure 5.26 Goat Well Detention Dam a) looking upstream at aggraded channel, b) looking down drop structure into Slick Rock Wash arroyo.

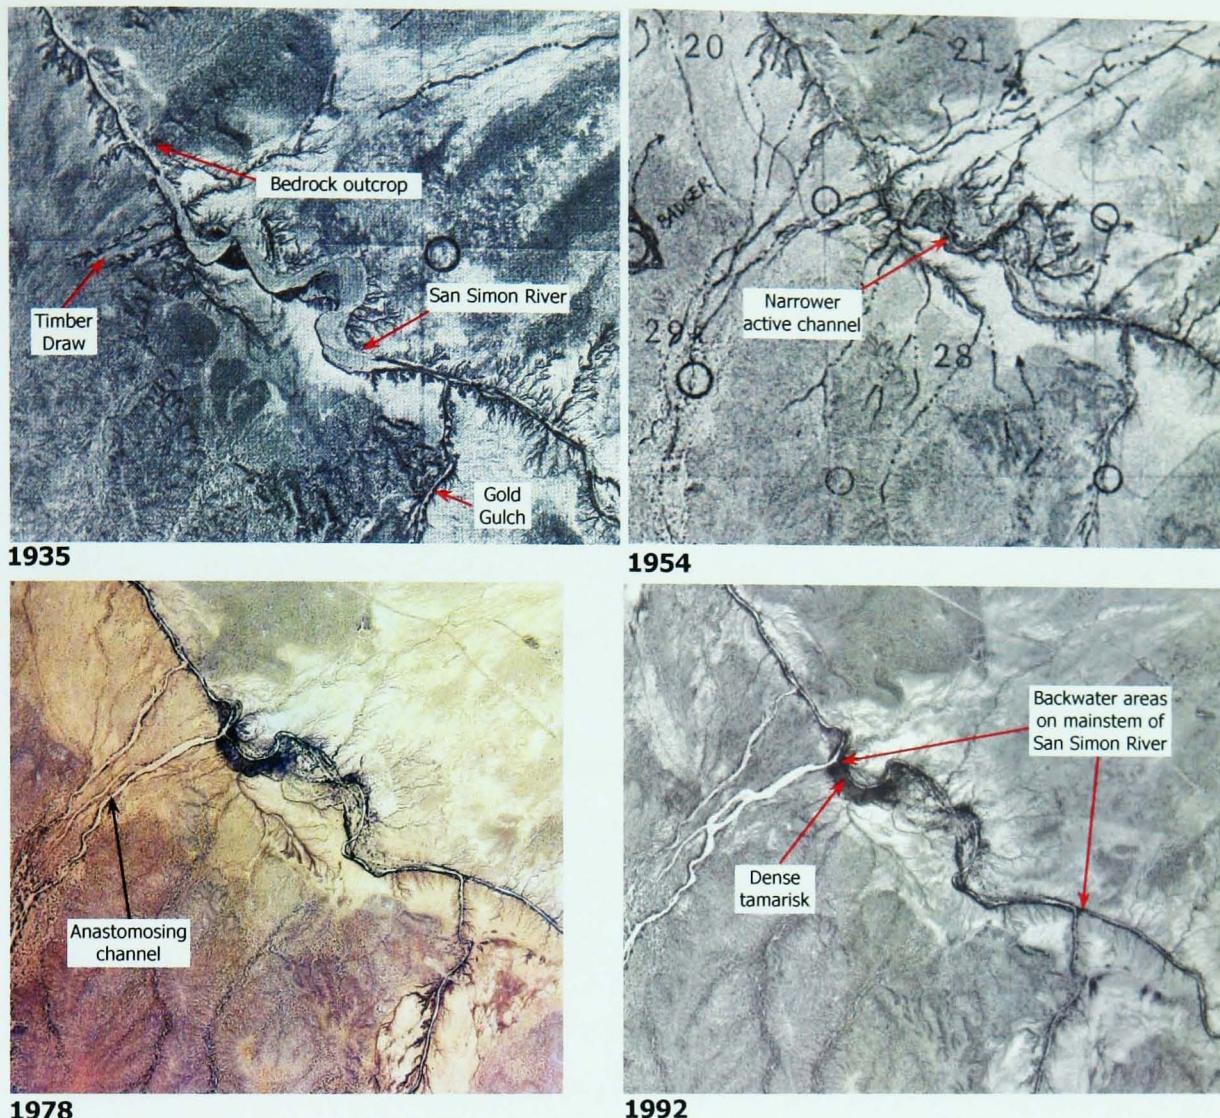
Figure 5.27 Arroyo evolution between Gold Gulch and Timber Draw, 1935 - 1992.

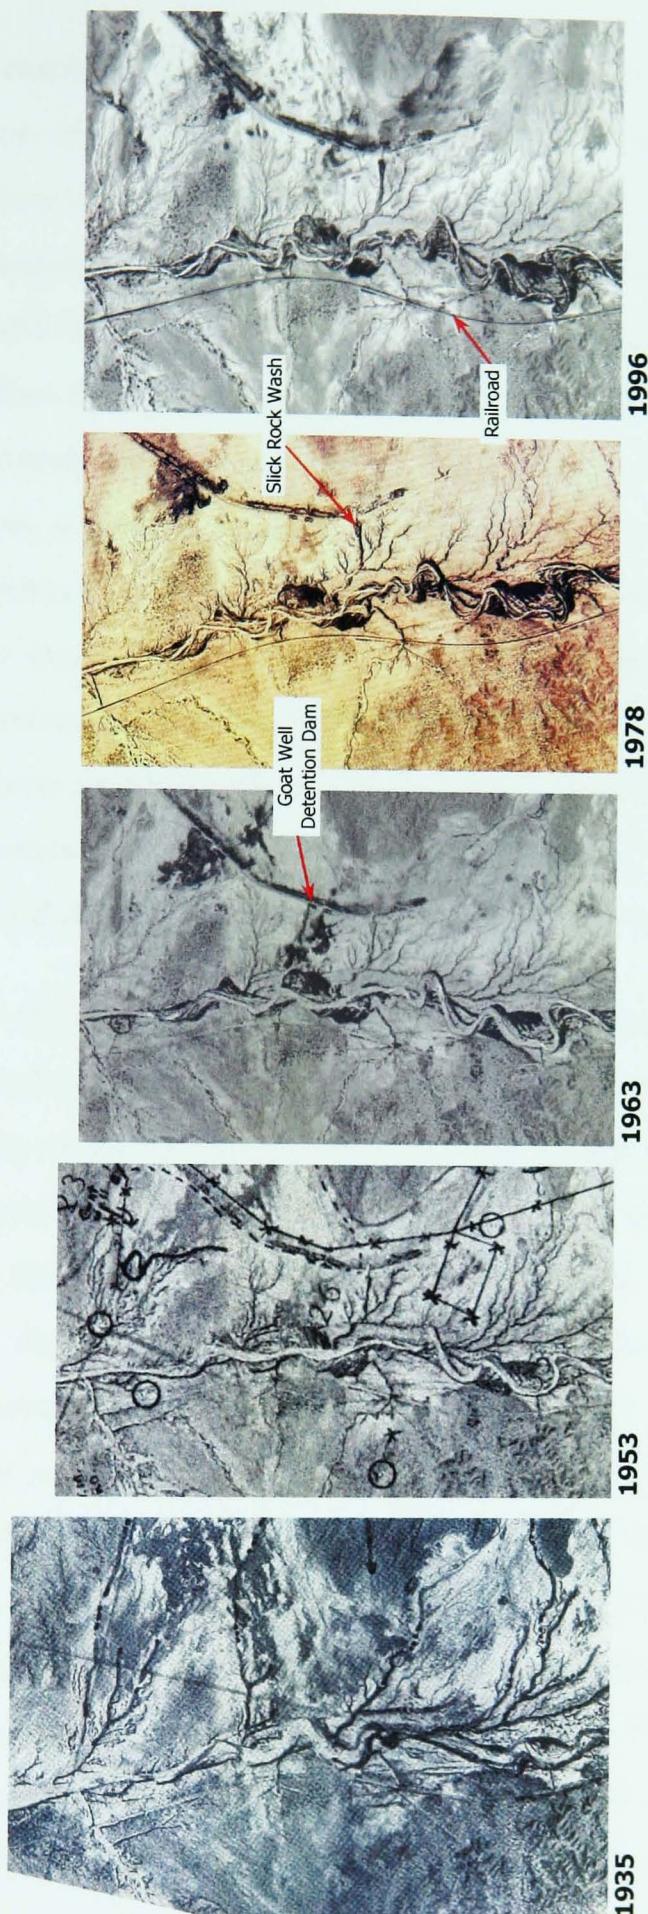
Figure 5.29 Arroyo evolution between 1935 and 1996, Goat Well Sub-Reach, Lower San Simon.

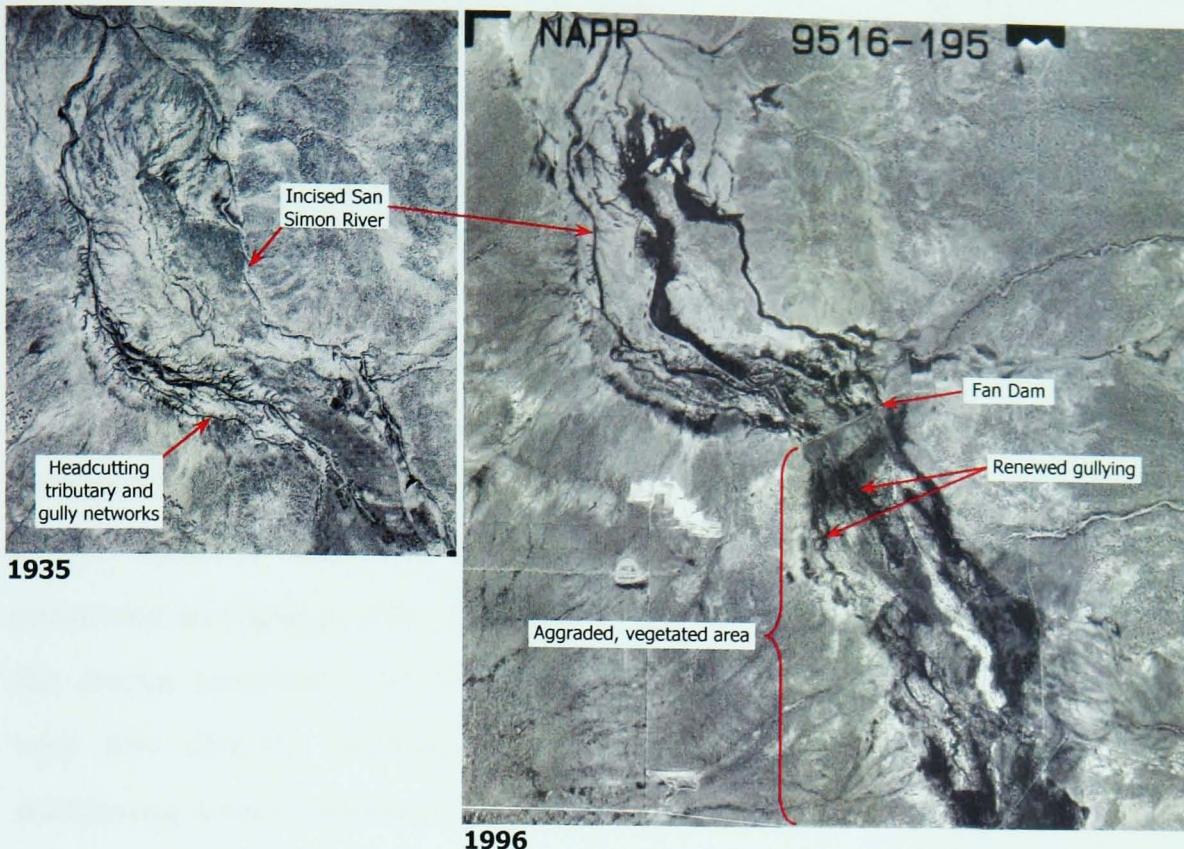
Figure 5.30 Morphological change caused by the Fan Dam.

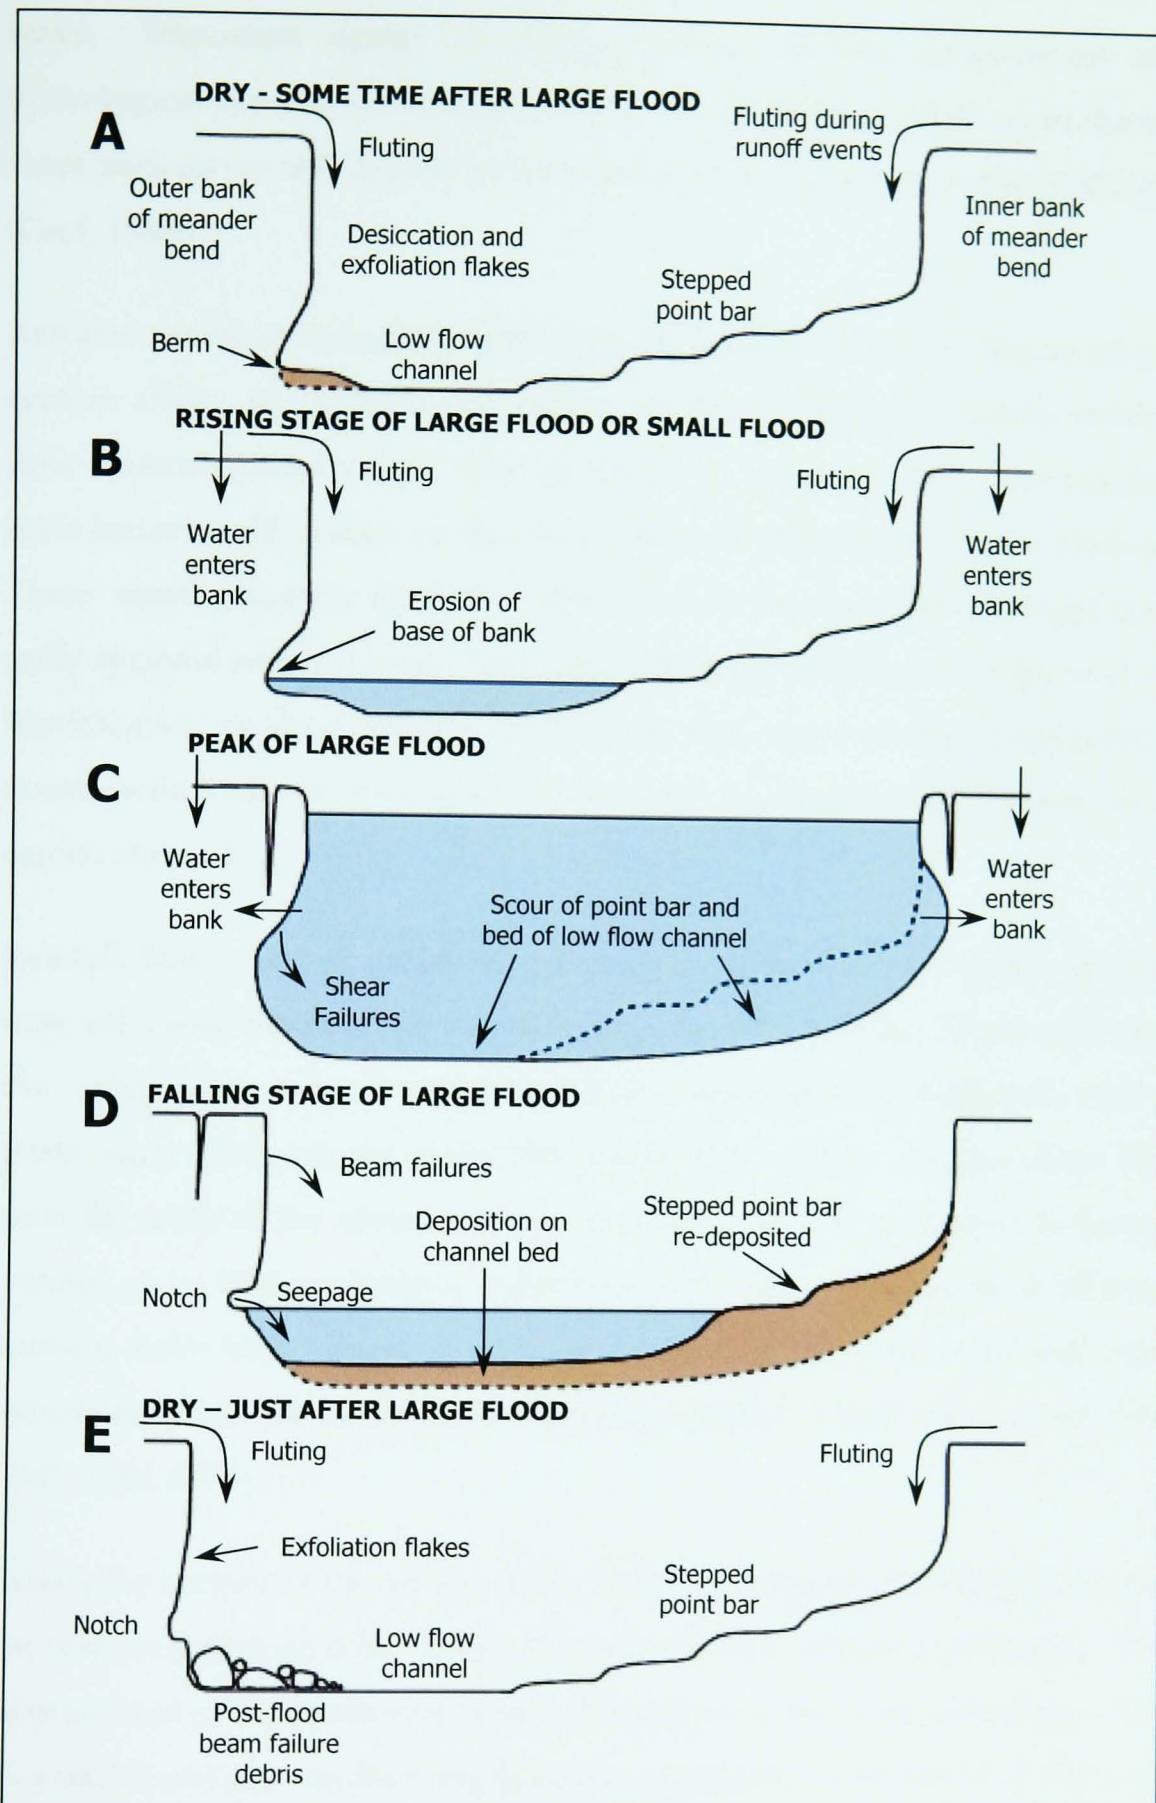
Figure 6.1 Model of arroyo behaviour during flow events, developed for the Santa Cruz River (after Ellis, 1993).

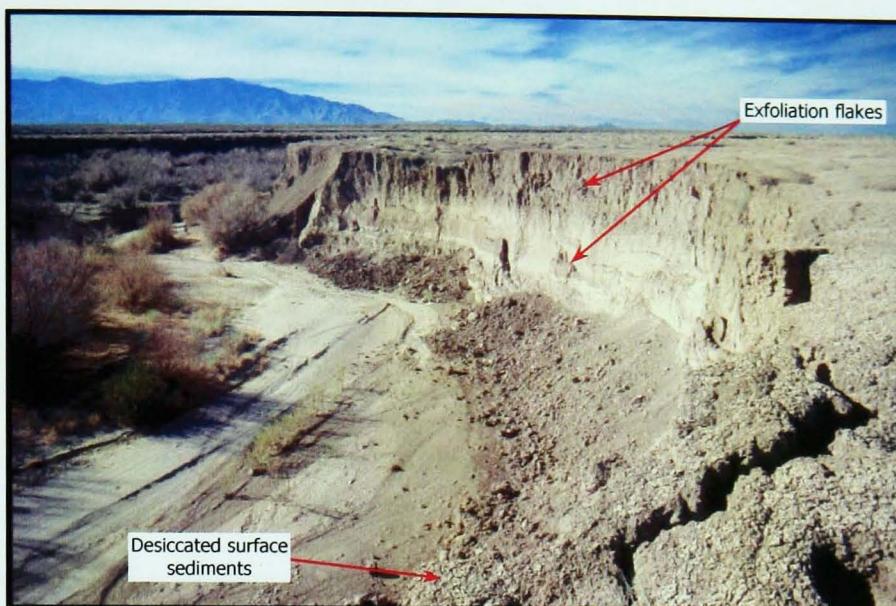
Figure 6.2 Desiccation and exfoliation flakes along the arroyo walls, Goat Well Sub-Reach, San Simon River.
