The Morphological Representation of Channel-Forming Flow in Arroyos

Lucy A. Ellis

Thesis submitted to the University of Nottingham
for the degree of Doctor of Philosophy, May 2004

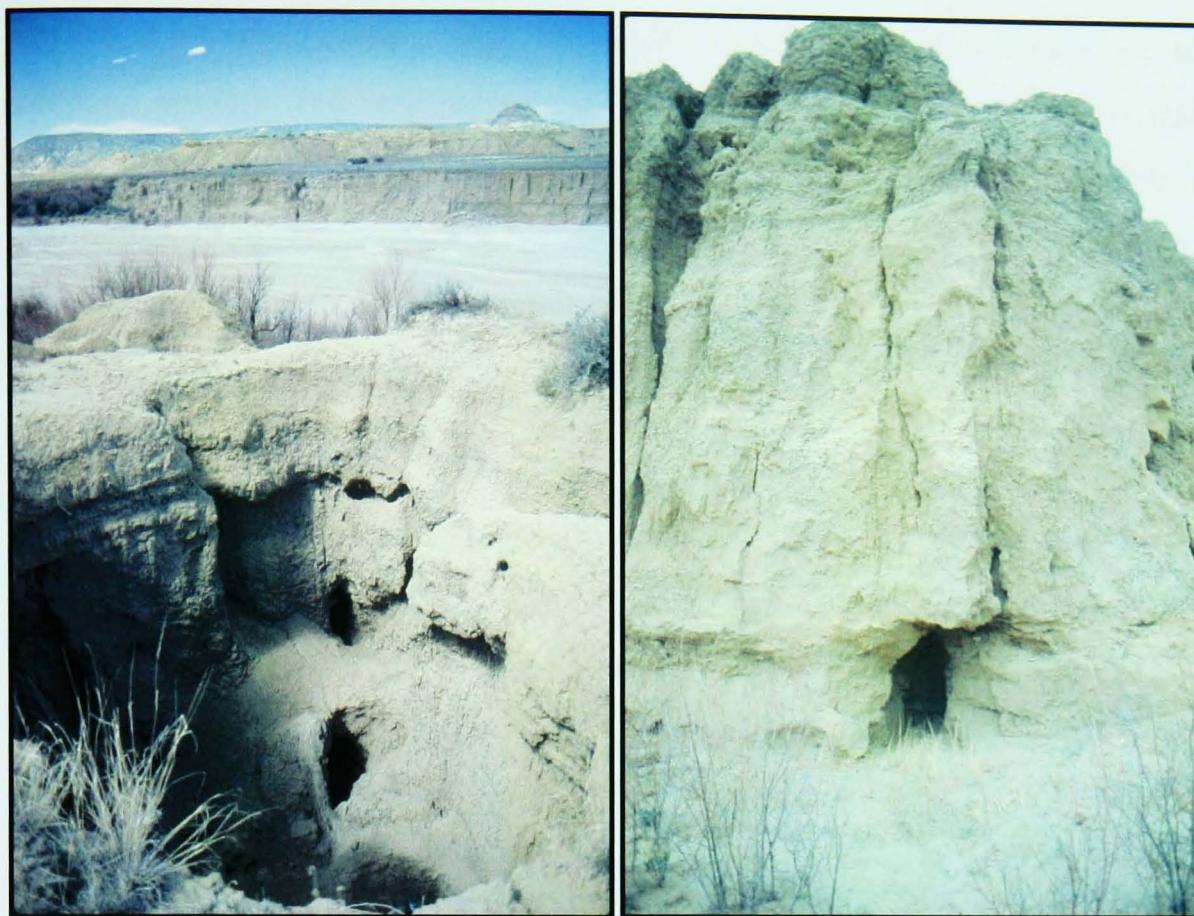
Figure 6.4 Large pipe and pipe outlet, Guadalupe Sub-Reach, Rio Puerco.

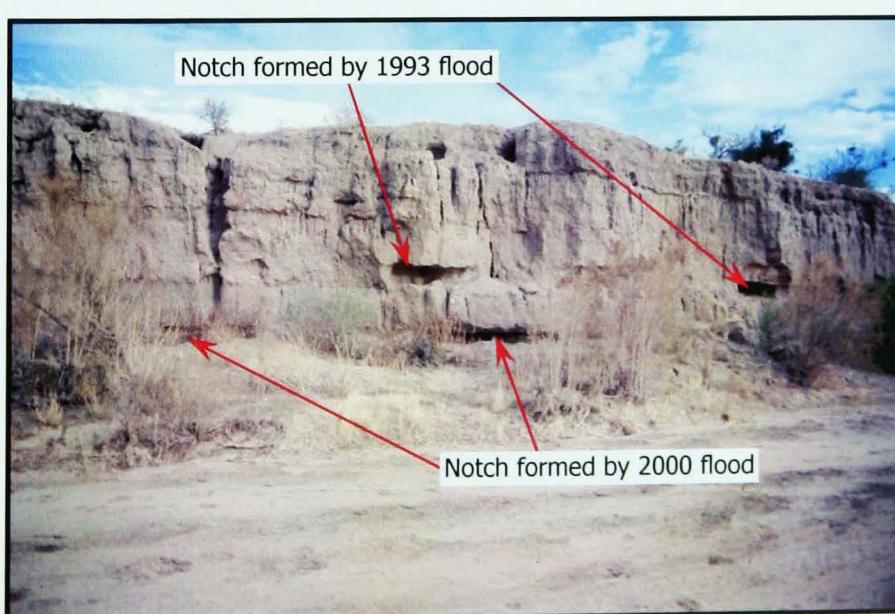
Figure 6.5 Seepage notches along the Santa Cruz River, upper level representing 1993 flood, lower level representing 2000 flood.

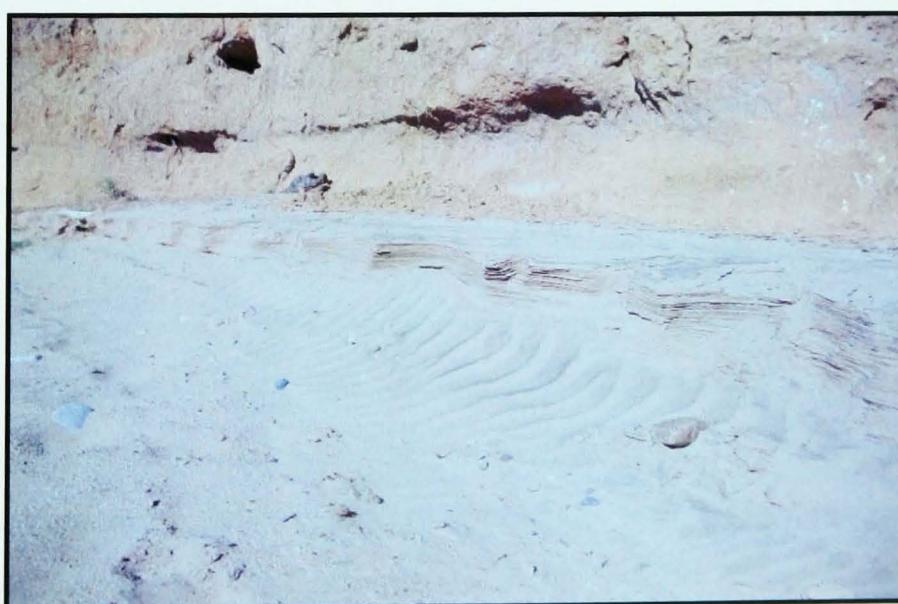
Figure 6.6 Parallel laminated sediments deposited in the San Xavier Reach of the Santa Cruz River during the October 2000 flood.

As the flood stage falls, sediment transport competence decreases, causing the re-deposition of entrained sediment (Figure 6.1.D). Point bar sediments are often deposited in discrete steps, corresponding to more stable phases of the hydrograph and indicating rapid width adjustment to the decrease in discharge. Shifts in the position of the active channel during the falling stage may also generate different bar surface levels, each level corresponding to the stage at which it was deposited. Lateral migration of the active channel also causes the recently deposited flood sediments to be exposed, revealing thick layers of parallel laminated sands (Figure 6.6).

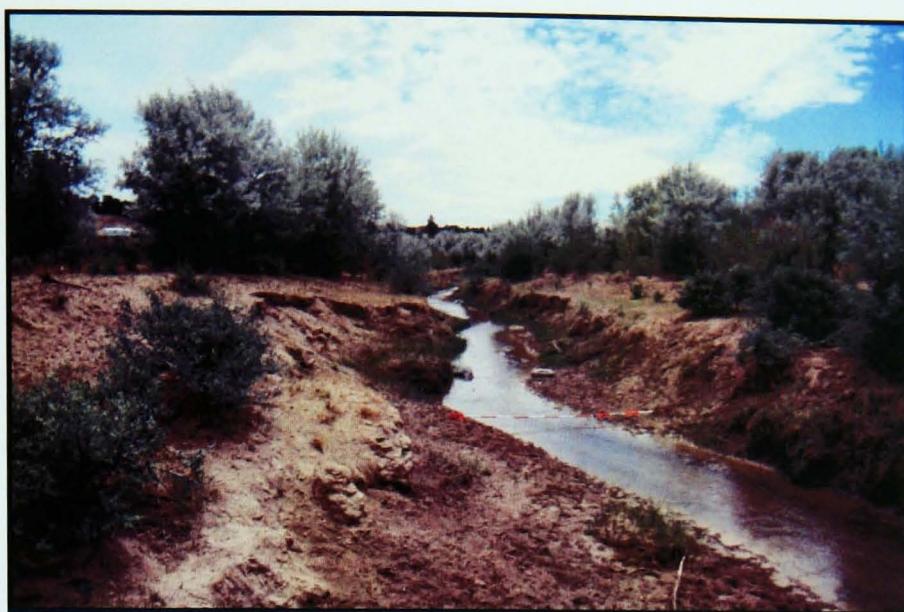
Figure 6.7 Active channel and stabilised inner floodplain at Elliott's XS-1, Upper Reach 1, 1996 (courtesy J. Elliott).

This reach, the furthest upstream, has developed a compound arroyo morphology with a mainly trapezoidal active channel, although some asymmetry occurs around the outer bank of meanders (Figure 6.7). Migration of meanders in the active channel has caused the formation of

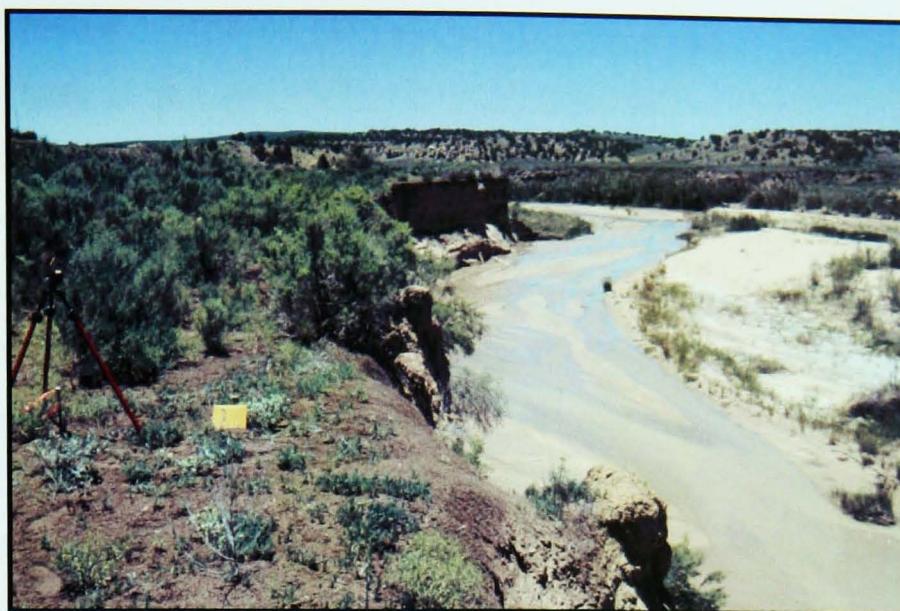
Figure 6.8 Broad, braided low-flow channel of XS-9, Upper Reach 2, 1997 (courtesy J. Elliott).

The increased inputs of flow and sediment discharge from the Arroyo Chijuilla have caused the active channel of the Rio Puerco to switch from a narrow, deep, meandering planform to a much wider, shallower planform (Figure 6.8). The arroyo has achieved sufficient width that the active channel no longer flows wall-to-wall but is instead flanked by berms and point bars, which have been stabilised by permanent vegetation. Some recently eroded failure debris was observed along the outer walls of

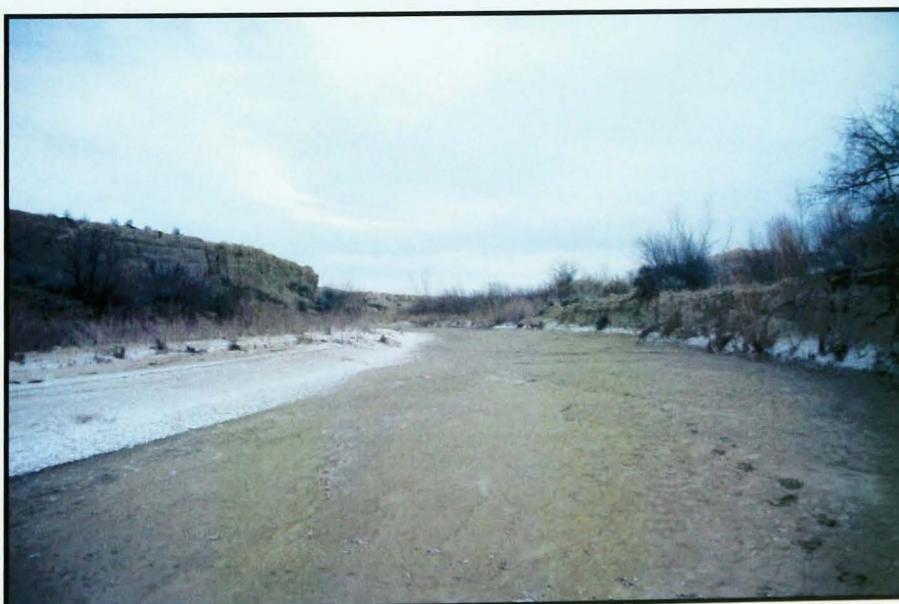
Figure 6.9 Broad, shallow active channel of Upper Reach 3, 1997
(courtesy J. Elliott).

Downstream of the artificially straightened reach at Ventana, the active channel is still distinct and braided, being flanked by vegetated berms and point bars (Figure 6.9). No cross-sections were surveyed along this reach, since Elliott's XS-11 could not be re-located during the 1990s survey, so exact dimensions are not available. However, both the arroyo and active channel are narrower than observed along the reaches immediately up- and downstream. Morphologically, this reach is similar to Upper Reach 2, above Ventana, with the exception of the high sinuosity of the active channel, which has developed meanders with a wavelength scaled to the arroyo trench. The radii of curvature of these meanders are generally large, although they become smaller towards the downstream end of reach, as the meanders are compressed due to the controlling effect of the Arroyo Chico, which prevents further downstream meander migration. Active outer bank erosion of the arroyo walls was observed, although the majority of the walls were in a state of impeded removal due to the accumulation of failure debris at their base. In places along this reach, the arroyo cuts through bedrock outcrops, for example close to San Luis, causing the trench to remain narrow.

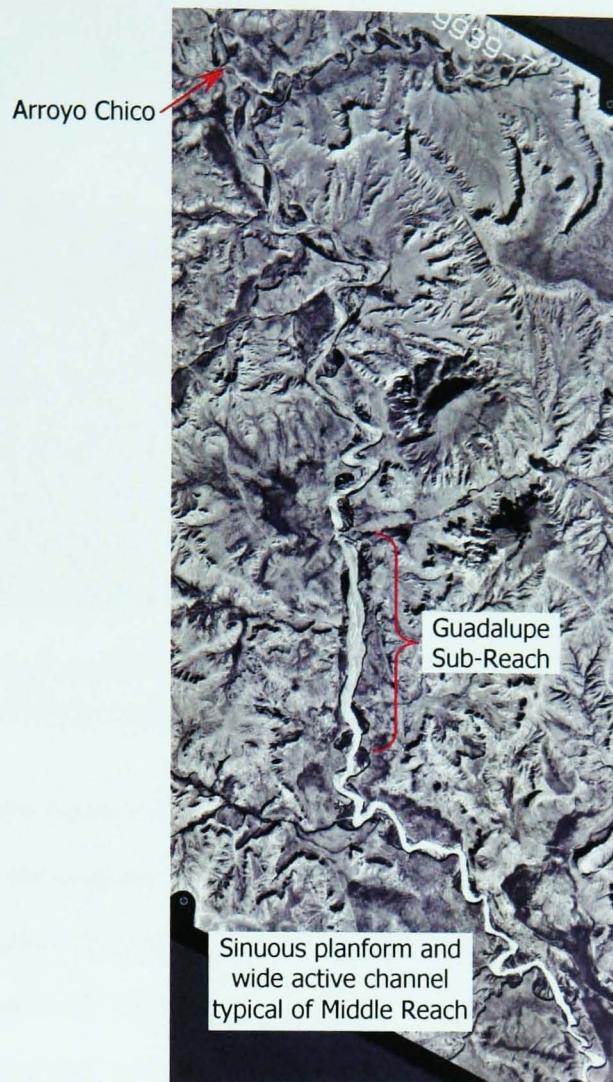
Figure 6.10 Upstream limit of Middle Reach, showing broad, straight Guadalupe Sub-Reach and more representative sinuous planform, 1997.

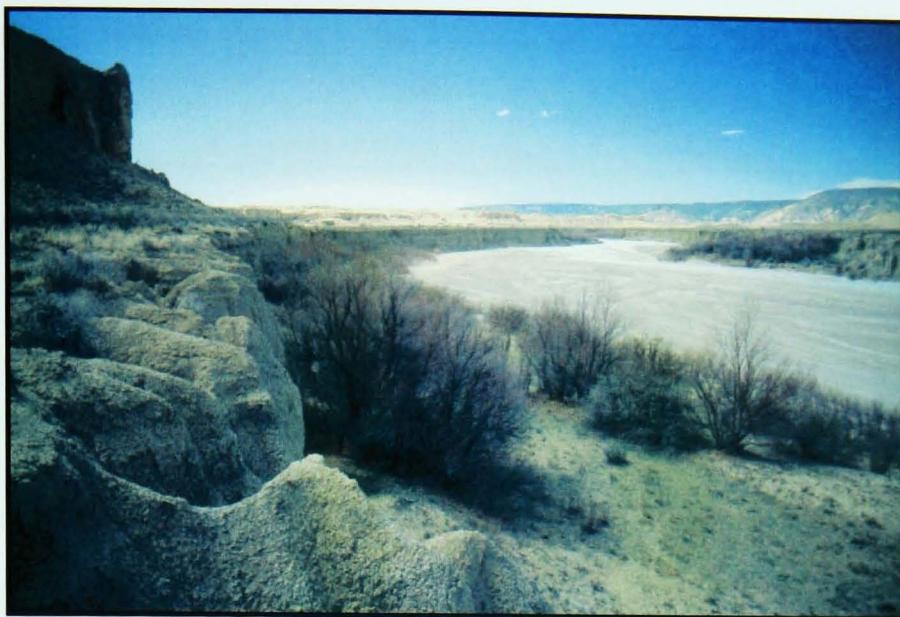
Figure 6.12 Arroyo wall dissected by piping, behind stabilised berm, Guadalupe sub-reach, 1999.

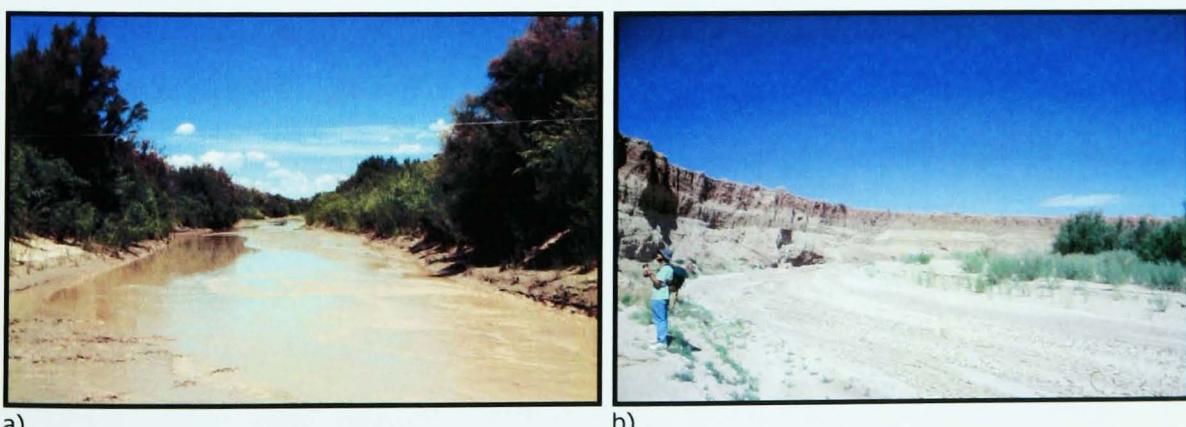
Figure 6.13 Difference in active channel morphology within Lower Reach a) Trapezoidal channel at XS-15, situated in a low-sinuosity sub-reach, 1997 (courtesy J. Elliott). b) Asymmetric channel at XS-17, located in a sinuous sub-reach, 1999.

walls at points where the active channel impinges against the arroyo wall. Elliott's cross-sections indicate that straighter sections of the arroyo had trapezoidal channels, whereas those situated in meander bends showed far more shape variability (Figure 6.13). However, rather than the channel cross-section being larger at meander bends, the opposite was found to be true. These differences in morphology are also reflected in the arroyo geometry relationships (see Appendix 3, Table A3.2). As expected, arroyo widths in the straight sections were substantially lower than those in the meandering reaches, which have been widened by lateral erosion.

The planform of the Lower Reach is characterised by hooked, recurved meanders, which have developed short radii of curvature superimposed on an arroyo-scale wavelength, indicating complex controls on planform geometry (discussed in Chapter 5, Figure 5.15). The point bars of these meanders exhibit different depositional levels, associated with accretion during the recession limbs of recent floods (Figure 6.13b). Generally point bars along this reach consist of a sparsely vegetated or unvegetated band close to the active channel, backed by parallel lines of willow and with dense lines of tamarisk higher up the bar, representing the former position channel (Figure 6.14). This pattern contrasts with the straighter reaches, where the trapezoidal active channel has little or no vegetation within its boundaries but is flanked by very dense tamarisk (Figure 6.13a).

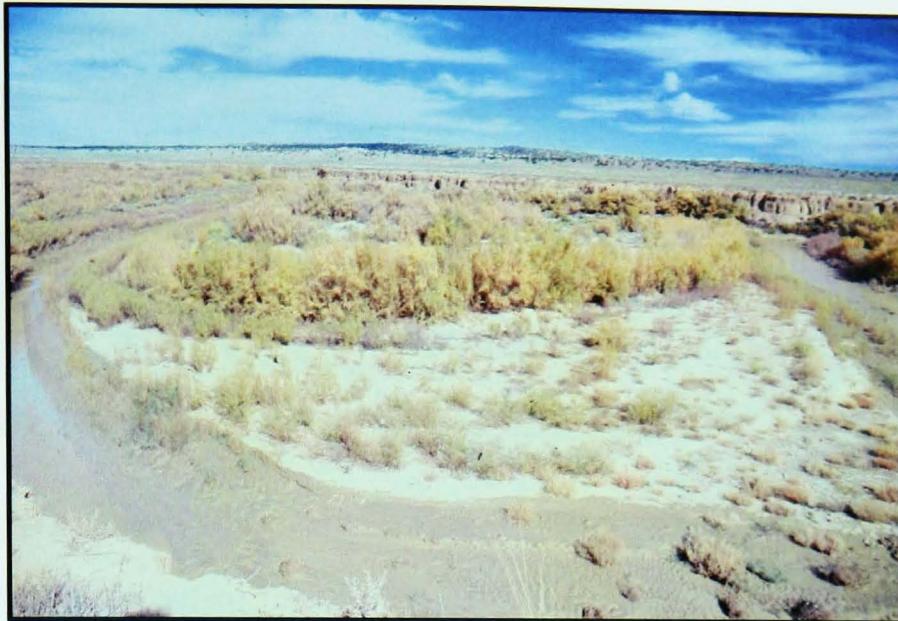
Figure 6.14 Large meander at XS-17, showing increase in age of vegetation with distance from active channel.

The dense stands of tamarisk are dying, along some reaches. This is thought by Elliott to be due to the fact that such a large amount of aggradation has occurred that groundwater can no longer be accessed by the vegetation (J. Elliott, pers. comm., 2001). At the Hidden Lady meander (XS-18), an overbank flood, most likely during August 1994, caused deposition on the abandoned meander terrace. Subsequently the tamarisk established on this terrace died, leaving a broad expanse of cracked, desiccated, unvegetated sediment. If the current aggradational trend continues to occur, the floodplain may, in the future, no longer be stabilised by this vegetation. In turn, this may reduce the attenuation of flows, causing a reversal of the historical decline in the flow regime and allowing higher-magnitude floods and renewed incision to occur. The same pattern of deposition and decline in vegetation has also been observed on other meander terraces, for example just downstream of Interstate 40. Abandoned meander terraces are periodically occupied under the current flow regime, even if only rarely, and are, therefore, still part of the active flood-plain. Hence vegetation die-back and resulting increases in peak flows have the potential to drive future changes in arroyo morphology.

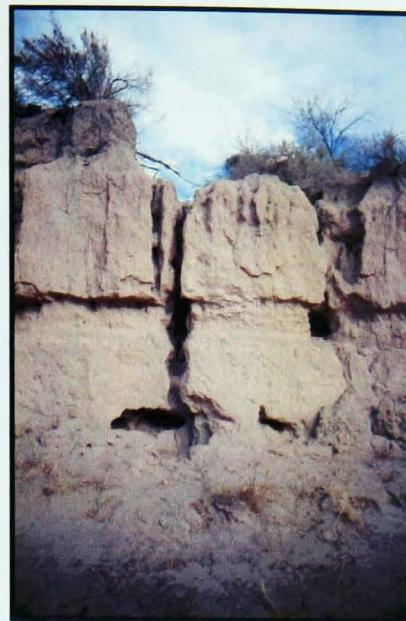
Figure 6.15 Preferential erosion of different sedimentary layers in flutes, Valencia Road Sub-Reach.

Flow concentration features, known as flutes due to their similarity with similar features found in karst regions, may also form in the arroyo walls (Ellis, 1993; Parker, 1996). Flutes are vertically elongated cavities, which may extend the entire height of the arroyo wall. These features were found mainly along the Santa Cruz River, principally where the arroyo is incised into predominantly Holocene sediments, which have a higher degree of Calcium Carbonate cementation. Although flutes are predominantly formed due to surface runoff draining into the trench over the arroyo walls, some sedimentary layers are differentially exploited by seepage erosion (Figure

6.15). As with horizontal flow concentration features, flutes may also be found at different scales, representing different stages of development. The smallest flutes are only a few millimetres in diameter, generally forming in palaeosol layers within the arroyo walls (Ellis, 1993). The extent, depth and density of these flutes depends entirely on whether the arroyo walls are being eroded by flow in the active channel, with the greatest concentrations being found along reaches where steep walls are protected by bars, terraces, berms or vegetation. However, those banks which have been inactive for some time no longer develop flutes due to their reduced bank angles. The largest flutes may erode headwards, eventually enlarging sufficiently to form gullies and tributary arroyos.

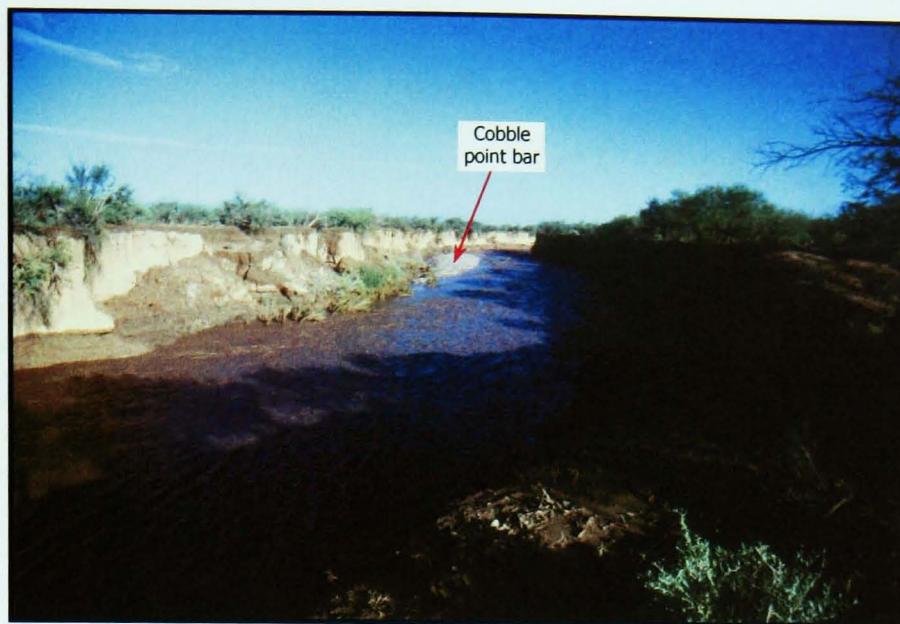
Figure 6.17 Point bar armoured with cobbles close to widening of Pima Mine Road Sub-Reach, during 2000 flood.

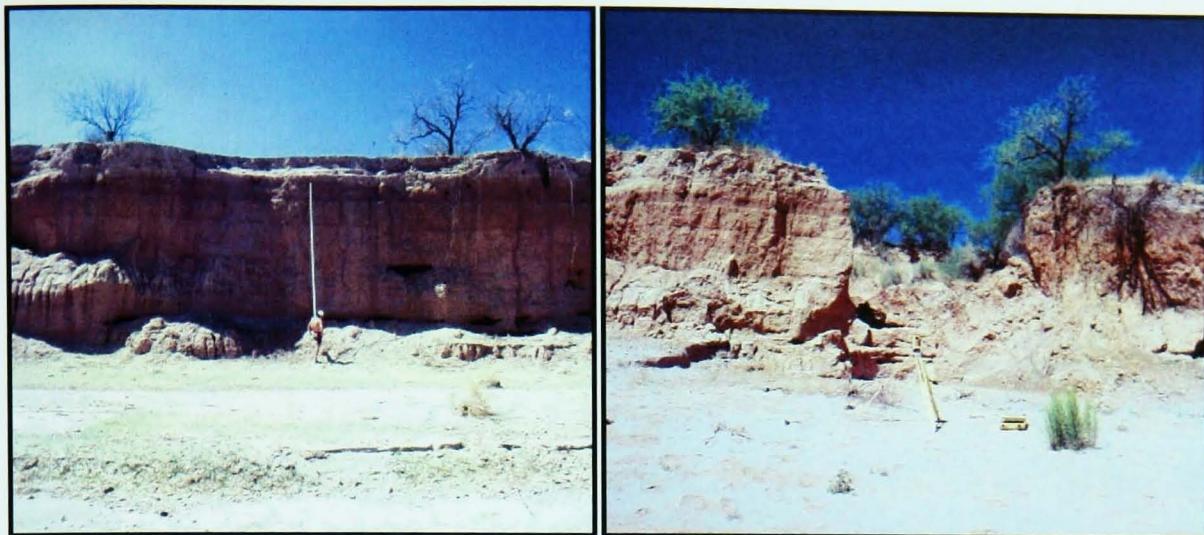
Figure 6.18 XS-1, North Pima Mine Road Sub-Reach, showing collapse of narrow wall of sediment separating tributary from main Santa Cruz River during 2000 flood.

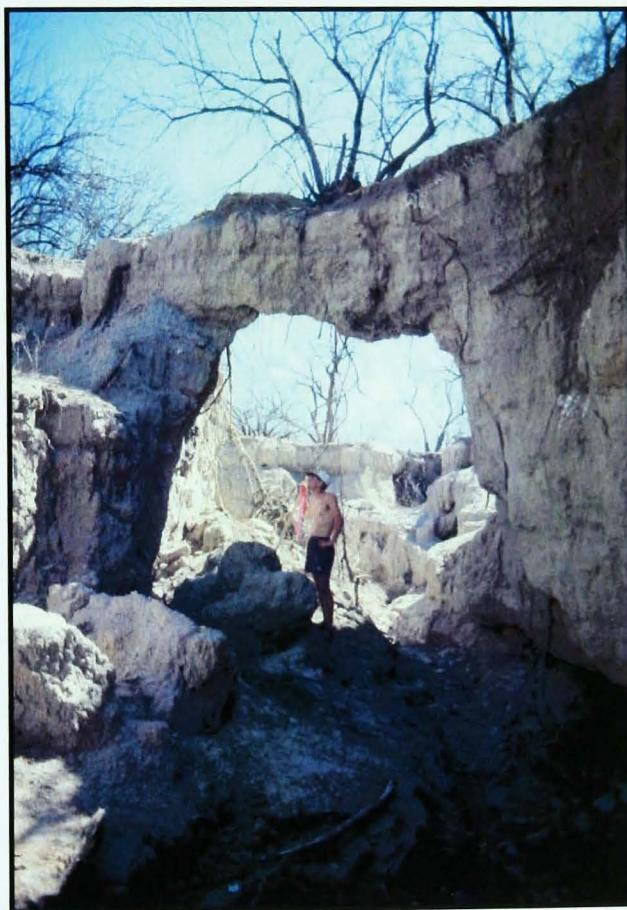
Figure 6.19 Arch formed due to tree roots binding sediments of upper layer, close to cross-section at Martinez Hill.

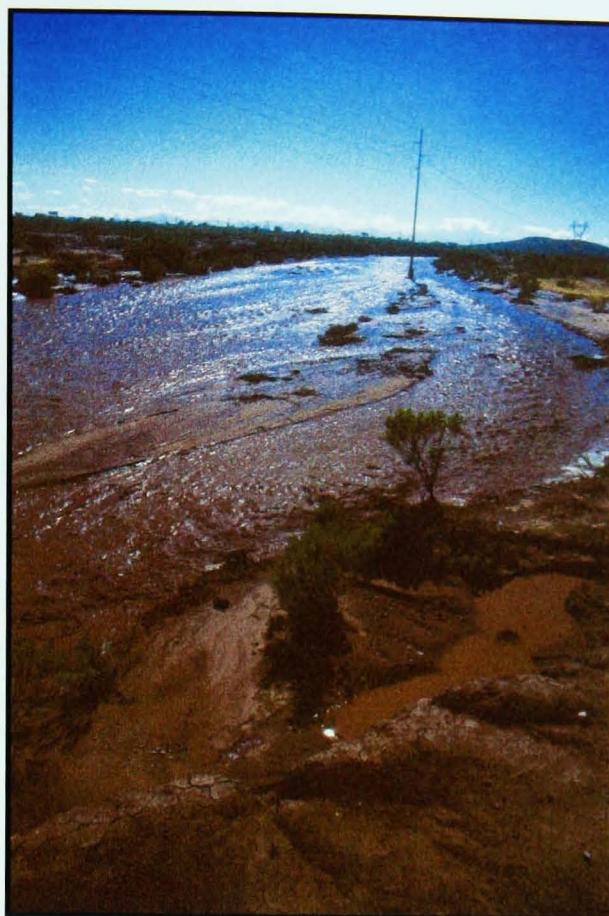
Figure 6.20 Braid bar deposited downstream of mid-stream pylon during 2000 flood, Valencia Road Sub-Reach.

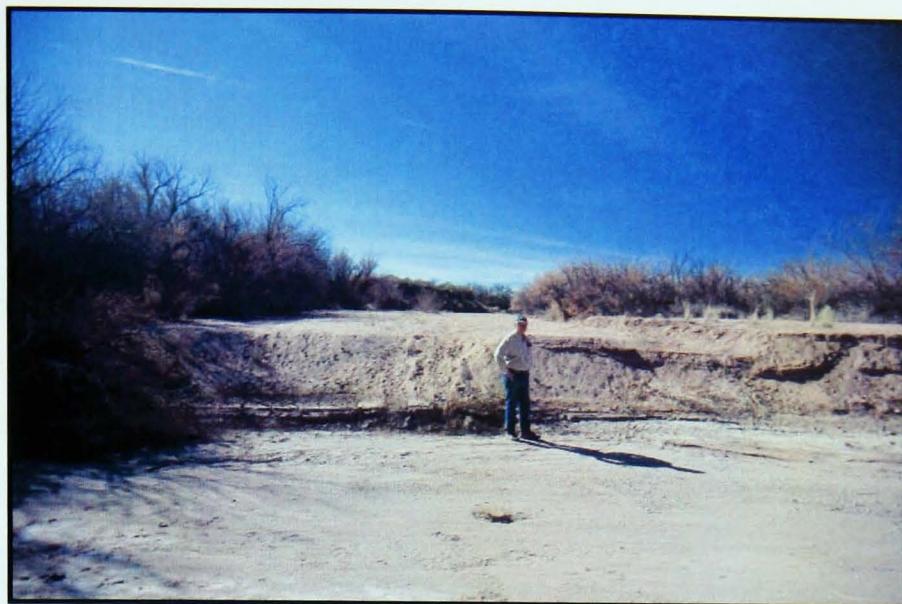
Figure 6.21 View upstream into Timber Draw emphasising the difference in bed elevation between the tributary and main channel of the San Simon River.

The morphology of these major tributaries at the confluence with the main channel raises some important questions. The bed elevation of Timber Draw is significantly higher than that of the mainstem (Figure 6.21). The reason for this difference in elevation is unclear, since it would be logical for the tributary channel to adjust its gradient to match the level of the main arroyo. However, this is clearly not the case, since the aggraded bed of the tributary arroyo is composed entirely of unconsolidated sediments. Observations of

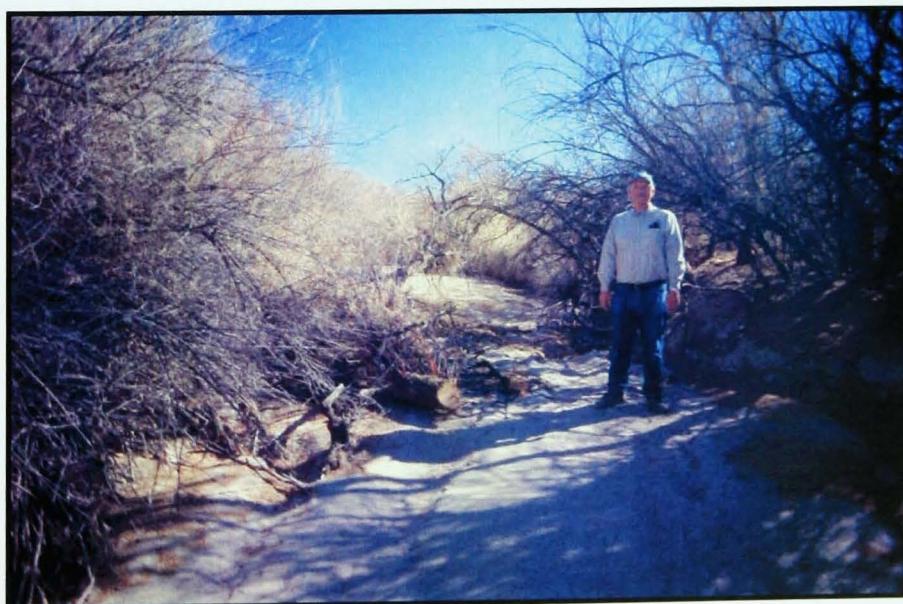
Figure 6.23 Felled Tamarisk sediment traps in the main channel of the San Simon River, downstream of Gold Gulch.

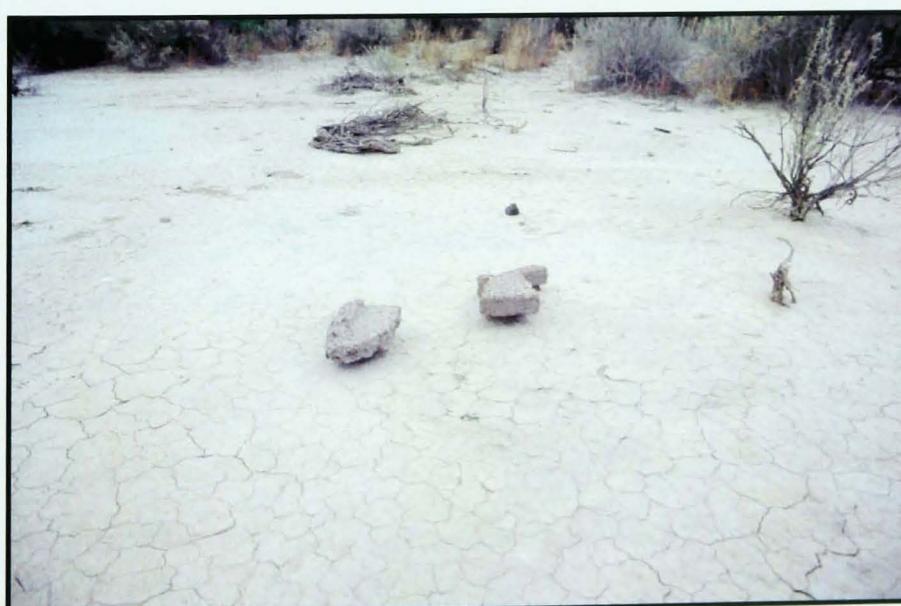
Figure 6.26 Sheetwash causing large blocks to become situated on pedestals, close to San Simon Sub-Reach.

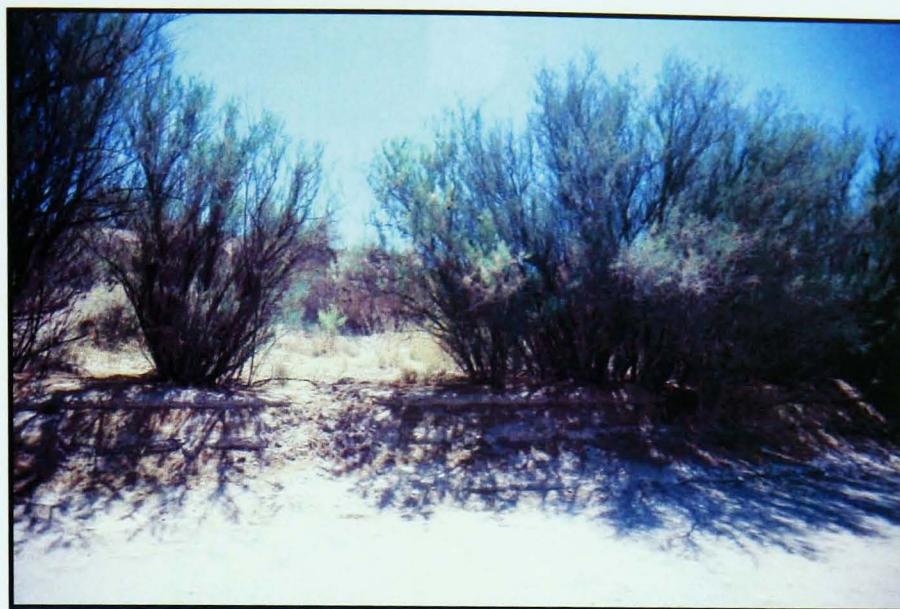
Figure 6.27 Vegetated, stepped floodplain of Yellowhammer Sub-Reach.

The Yellowhammer reach, also upstream of the Fan Dam had the sandy bed observed along the majority of the arroyo, although some gravel was still present. This reach is low sinuosity and has a far more clearly defined active channel, with a very wide, trapezoidal channel (Appendix 2, Figure A2.19). An aggraded floodplain had formed along the entire reach and it was this which had resulted in the narrowing and sharpened definition of the active channel (Figure 6.27). Small steps along the front face of the floodplain were observed, presumably corresponding to different steady stages, possibly even during a single flood. The floodplain had been stabilised by dense tamarisk and other mature vegetation. The bed of this channel was observed to be cambered: sloping downwards from its centreline towards the banks (Figure 6.28). Another feature of the bed through this reach was the presence of several alternate bars, which resulted in steep downstream bar faces oblique across the entire channel. Several deep scour holes were also noted, seemingly at random locations.

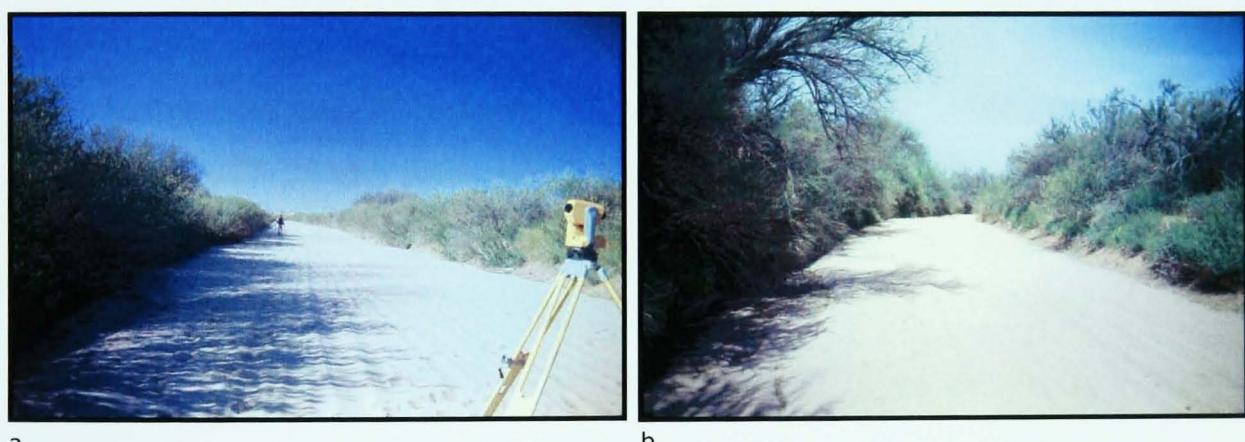
Figure 6.29 Trapezoidal active channel in a) Bailey Well Sub-Reach and b) Tanque Sub-Reach, Lower Reach.

As mentioned previously, there is a distinct downstream increase in the size of the arroyo, particularly the depth of the arroyo trench, due to increases in driving variables of flow and sediment discharge (Appendix 3, Table A3.7). However, the active channel becomes narrower and deeper with distance downstream (Figure 6.29). The sub-reach furthest upstream, Bailey Well, had the widest, shallowest active channel and smallest arroyo trench (Appendix 2, Figure A2.20). This reach was also the least sinuous. The arroyo walls along this reach were very low in both height and angle.

Further downstream, cross-sections in the Tanque and Corral Sub-Reaches represent the morphological characteristics of large meander bends (Appendix 2, Figures A2.21 and A2.22). Both bends, particularly the Tanque bend, had become compressed due to bedrock outcrops just downstream. The active channel at Tanque bend had extended laterally into the floodplain, to create a tight bend, after which the bend had retreated, turning through nearly 90 degrees to form a cut-off across the former point bar (Appendix 2, Figure A2.21). The active channel through the Corral bend had also straightened, leaving an aggraded meander terrace. The arroyo

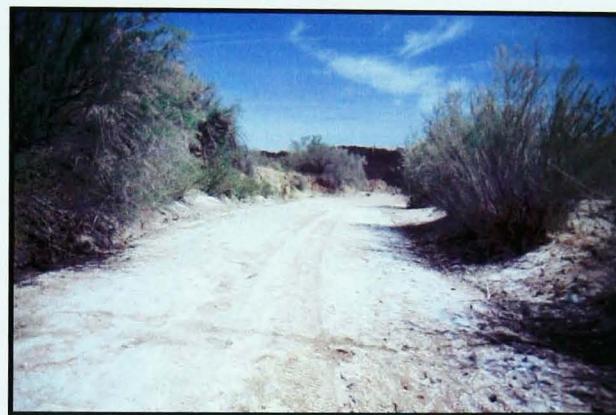
Figure 6.31 Trapezoidal active channel in Goat Well Sub-Reach, Lower Reach.

The active channel is trapezoidal along some of this section, but along other sub-reaches, especially around the outer banks of meander bends, the channel has a wider, asymmetric planform (Figures 6.30 and 6.31). This is thought to be due to the high input of sediment from both tributaries and the actively eroding arroyo walls. Many large tributary arroyo networks enter the San Simon River along the Goat Well Sub-Reach (Appendix 2, Figure A2.23). These networks are still actively eroding, except where detention dams, such as the Goat Well dam across Slick Rock Wash, have prevented further erosion.

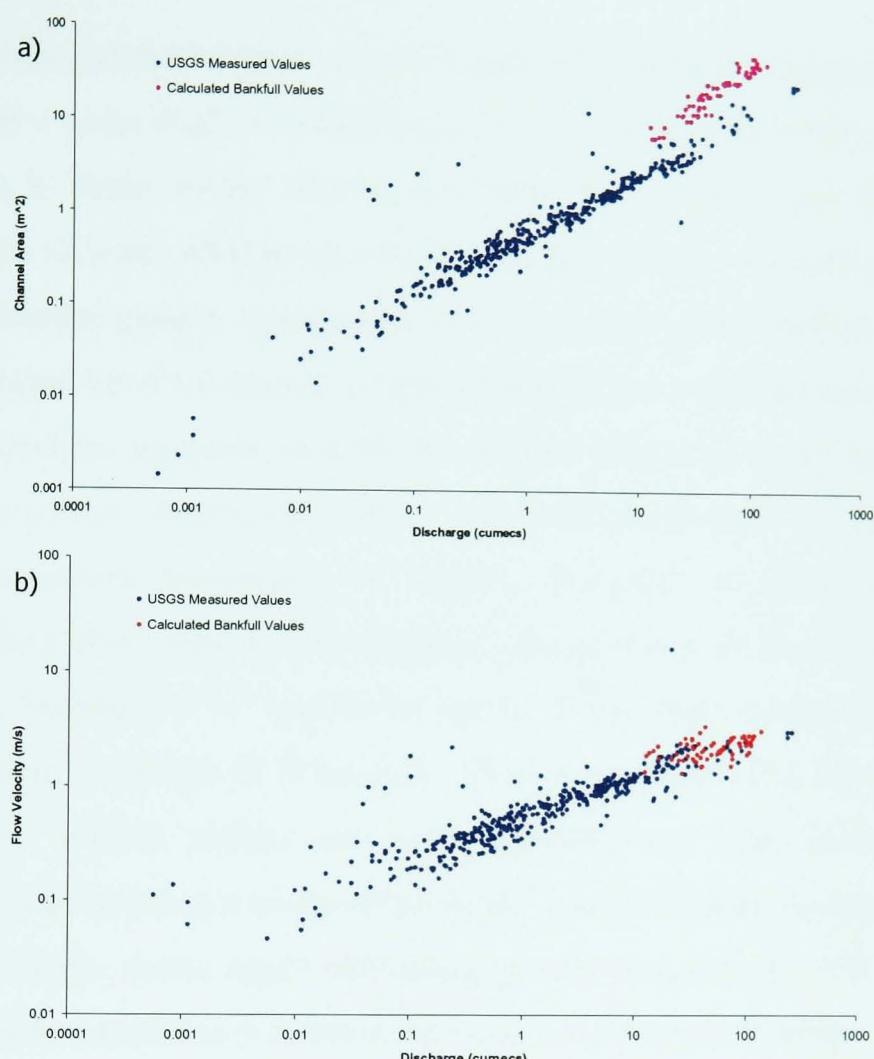
Figure 7.17 Comparison between actual values at the Bernardo Gauge and calculated bankfull values in the Lower Reach of the Rio Puerco, showing relationship between discharge and a) area and b) flow velocity.

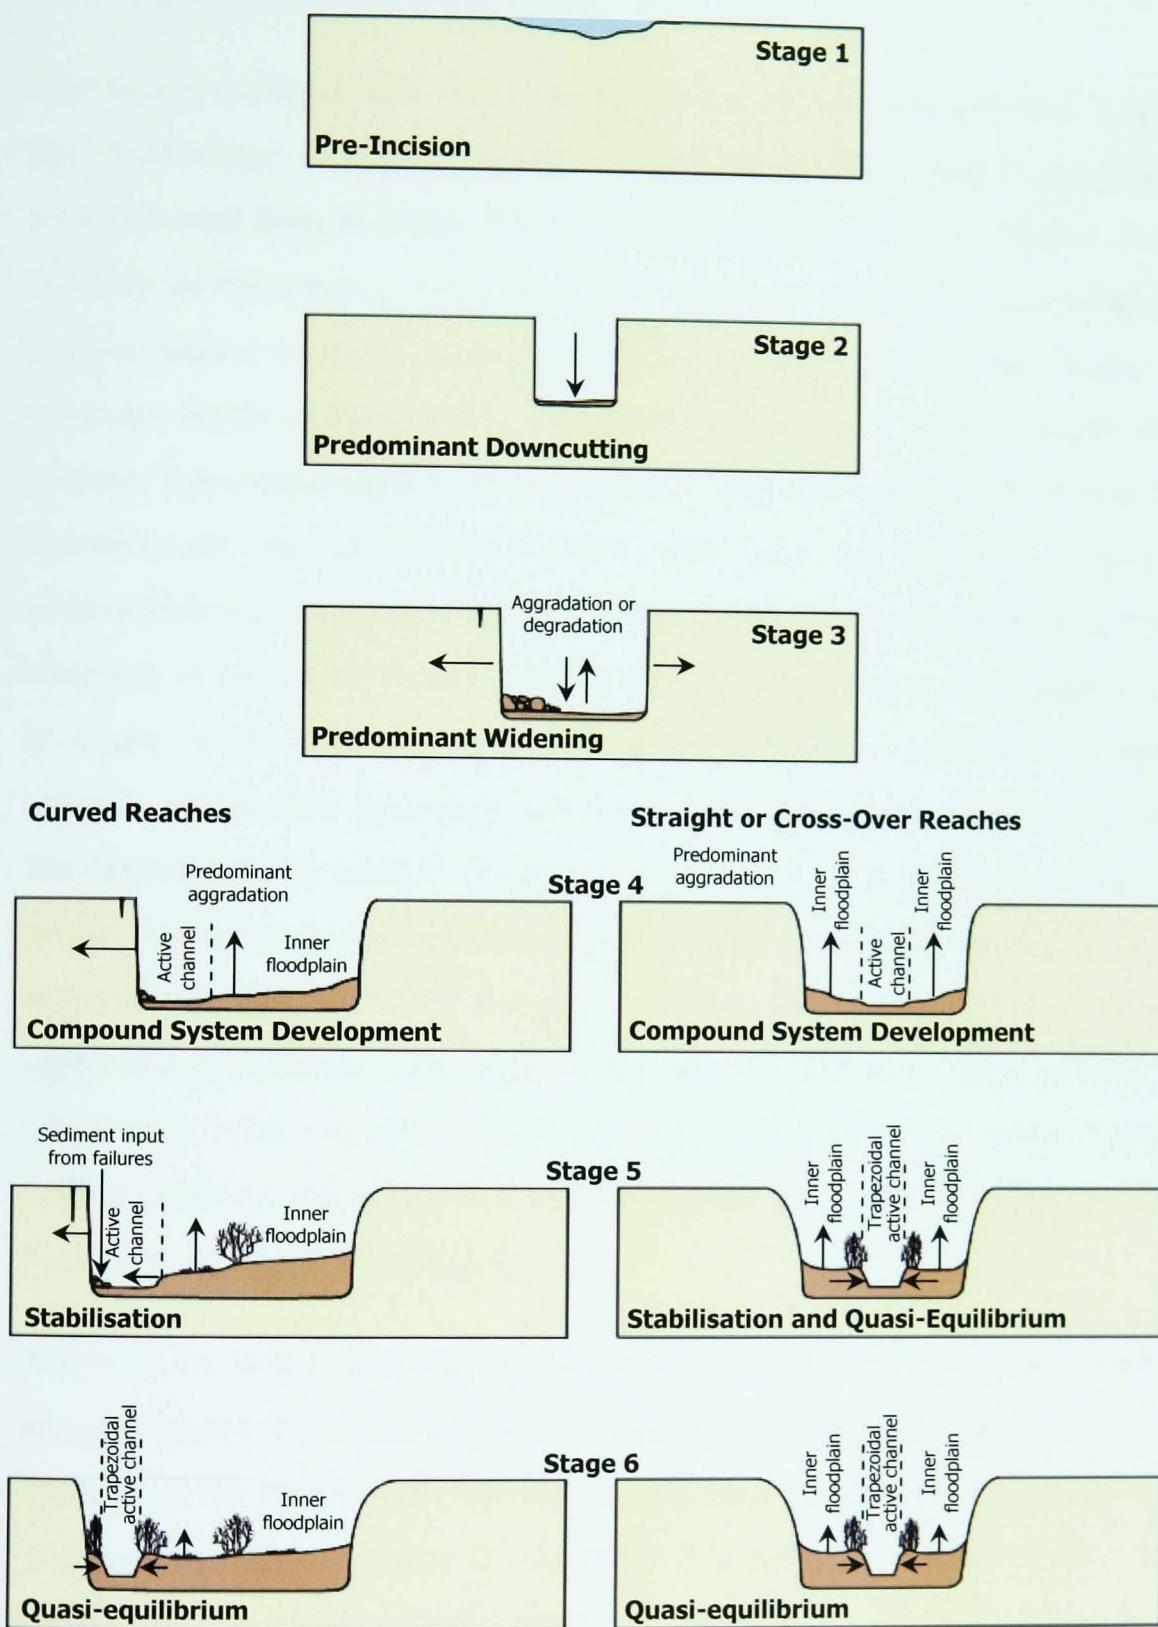
Figure 8.1 General conceptual model of arroyo evolution.

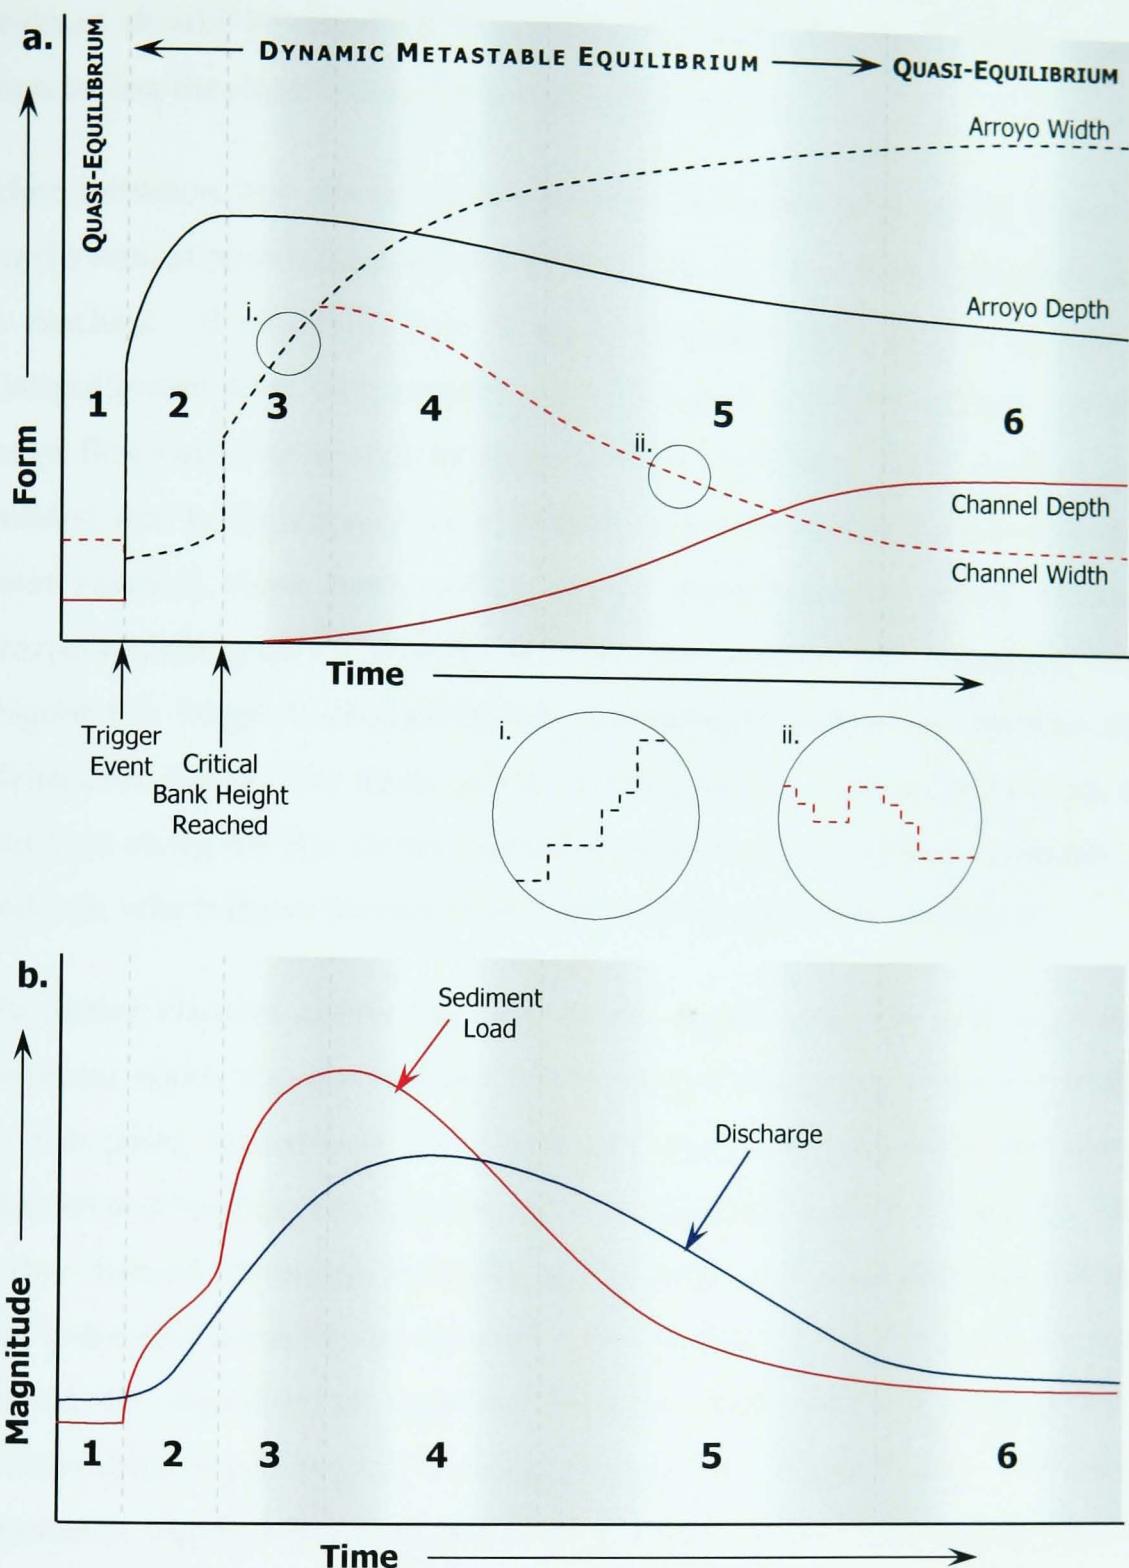
Figure 8.2 Simplified schematic representation of a) arroyo equilibrium and b) variation in flow and sediment discharge with time, in response to driving variables.
