Pneumatic membranes for biogas plants

Paolo BECCARELLI*, Roberto MAFFEI^a

^a Maco Technology srl

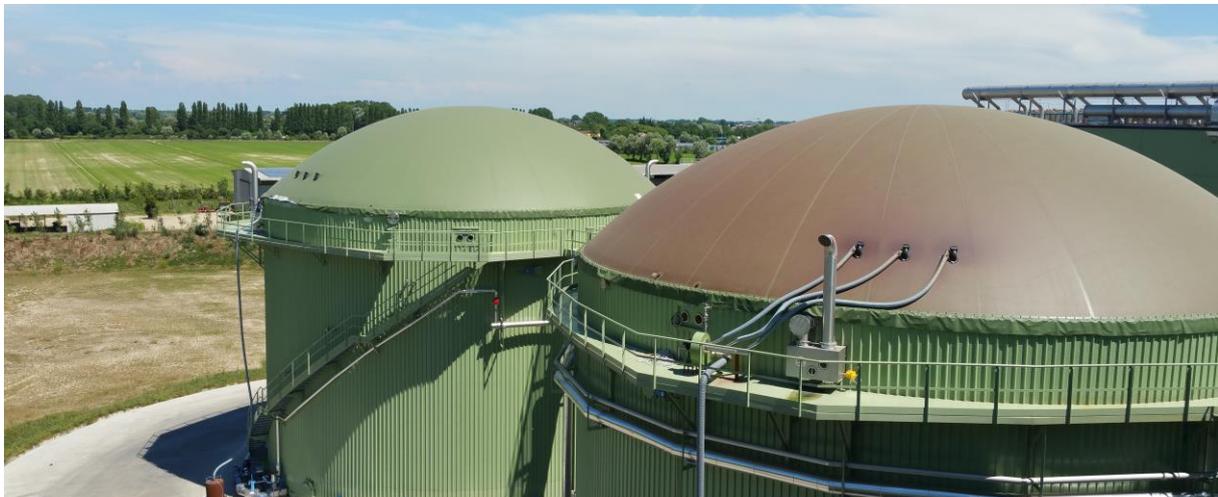
Figure 2: Typical double layer pneumatic roof for digesters. The change in the colour of the membrane roof it is clearly visible and it is related to the degradation of the membrane due to the aggressive chemical environment. (source: Maco Technology srl).

The digesters are generally based on a circular geometry realized in concrete or steel and covered with a double layer membrane roof supported by the internal pressure (pneumatic domes) or by a central pole (cones). The internal layer prevents the release of gas in the atmosphere and requires an exceptional resistance to the high concentrations of corrosive chemicals, the external layer protects the roof from the weather and the accidental loads (snow, wind, rain etc.). The solution is very effective and it is widely used in the current biogas plants.

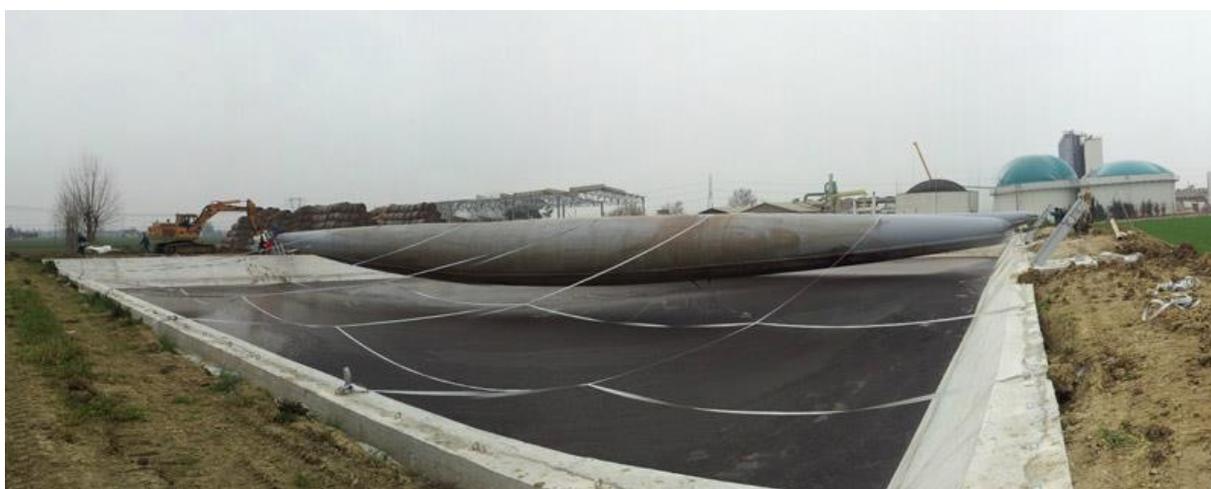
Figure 3: Rectangular lagoon covered with a pneumatic beam [5] derived from the Tensairity® concept with a total span of 45m (source: Maco Technology srl).

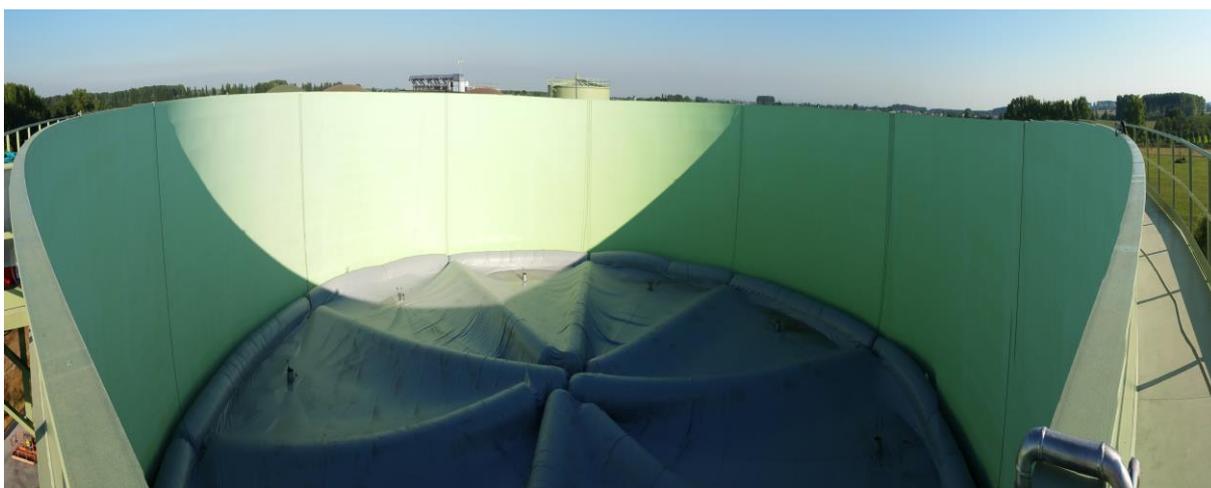
Figure 4: Circular lagoon covered with a pneumatic floating roof with a diameter of 65m (source: Maco Technology srl).

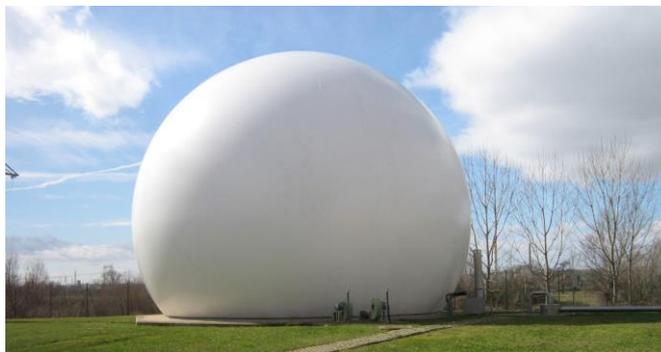
Figure 5: Example of a double-membrane gasholders [6] (source: GTI Covers)

the gas produced. The structures of a membrane tank is generally based on a double membrane system with an external membrane for weather protection, an internal airtight membrane to store the gas and a bottom membrane designed to enclose the gas space. At this stage, the gas is generally less corrosive than the mix of chemical produced in the digesters, however, for safety reason it is crucial that the gasholder is completely airtight and in good conditions during the entire service life. I small damage could cause the loss of gas with consequences in terms of safety and economic losses.

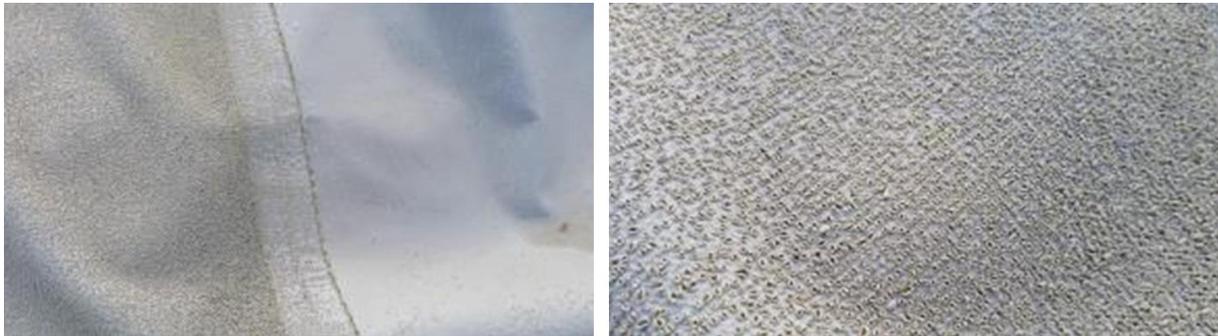
Figure 6: Degradation of a PVC coated polyester fabric due to the exposure to the chemicals of a biogas plant (source: Maco Technology srl).

An example of early degradation of a PVC coated polyester fabric due to the exposure to biogas is described in detail in Figure 6. Despite the material used was specifically designed for biogas applications, the exposure to a different gas or to a higher concentration of corrosive chemicals, combined with inaccuracies during the manufacturing, lead to the early degradation of the PCV coating. The effect, which is anticipated by a change in the color of the fabric (figure 2), is more evident on the fabric panel with the edge of the fabric exposed to the internal atmosphere. The

corrosive chemicals penetrated the fabric from the edge along the fibres and destroyed the protective coating from the inside.

The degradation of the fabric due to corrosion is confirmed by mechanical tests on a similar case study of a 5 years old digester where the breaking load of the fabric decreased by 72-80% from to the expected breaking load provided by the datasheet

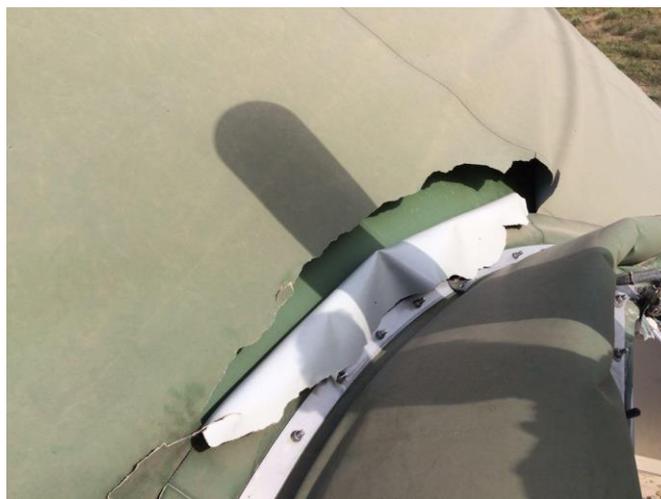
Figure 8: Damage in correspondence of a rigid boundary due to the strong wind and the progressive decrease of the mechanical performance of the coated fabric (source: Maco Technology srl).

Membranes structures are appreciated in biogas applications thanks to their light weight and high strength combined with the flexibility and elasticity of coated fabrics. However, the light weight of fabric structures makes them prone to wind load and may result in fluttering. In extreme circumstances, this fluttering may induce unexpectedly high tension forces in the fabric and in correspondence of the connection points. Figure 8 show a typical damage caused by the movement of the membrane in correspondence of the rigid boundaries. The effect of the wind, combined with the effect of the early degradation of the fabric, results in damages which are generally unusual for architectural membrane structures with the same age.

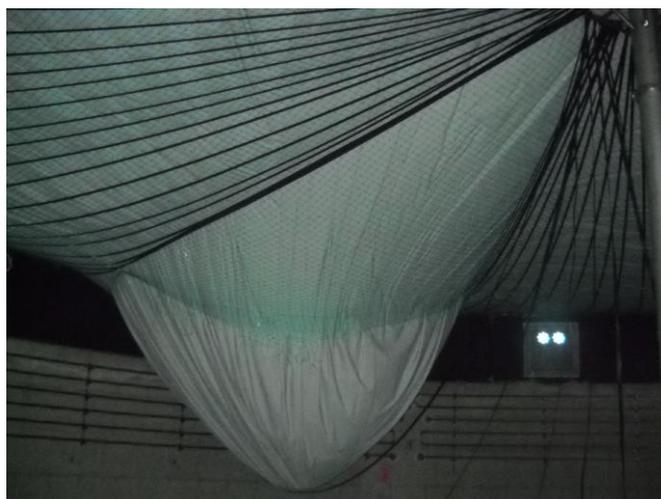
Figure 9: Failure due to snow load (source: Maco Technology srl).

All the main chemical reactions for the production of biogas develop heat that prevents the stockpile of snow. However, extreme low temperatures combined with a relatively low chemical activity can led to snow loads which exceed the accidental loads assumed during the design phase. The snow load can easily damage the membrane roof and supporting steel frame. Figures 9 describes a typical failure mode of a conic membrane roof for digesters. The deformation due to the snow load initiate a vicious cycle where the ponding of water and ice increase the deformation and the consequent increase o the accidental load up to the complete failure of the roof.
