Impact Biomechanics of the Pelvis  
and  
Lower Limbs in Occupants Involved  
in an  
Impact Aircraft Accident

Thesis submitted to the University of Nottingham  
for the degree of Doctor of Medicine

November 1992

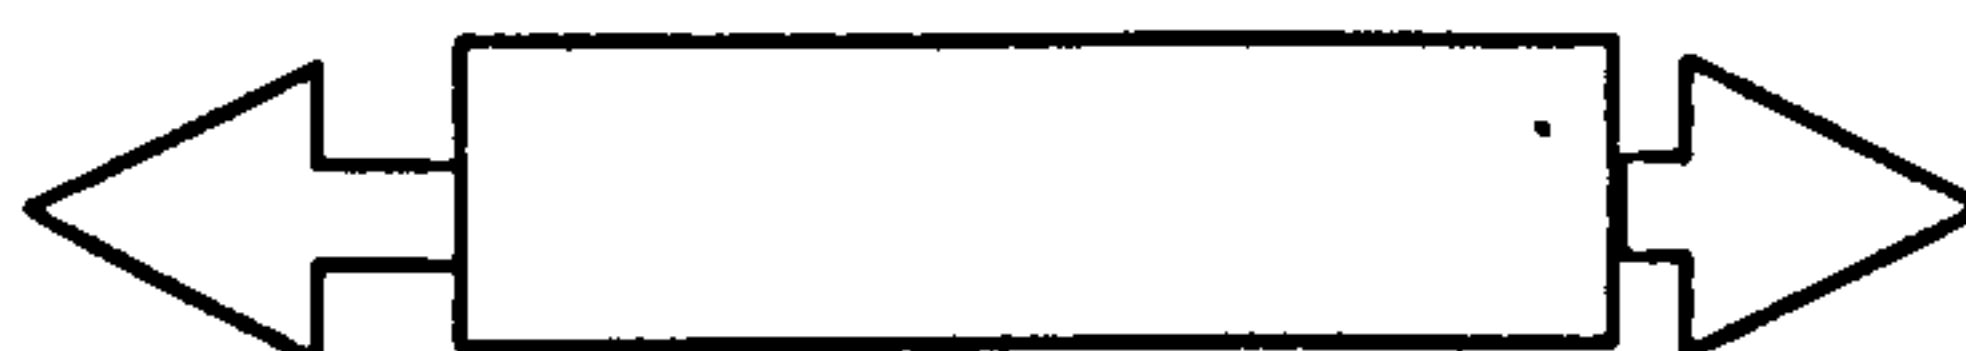
Tensile strain

An example of how these forces act is given: Impact along the axis of a femur causes an increase in its natural curvature. This results in a tensile strain on its anterior surface and a compressive strain on its posterior surface. A fracture of the femur will occur when its tensile strain limit is exceeded (Cheng et al 1984, Viano 1980, Viano and Stalnaker 1980, Nahum and Melvin 1985, Viano et al 1989).

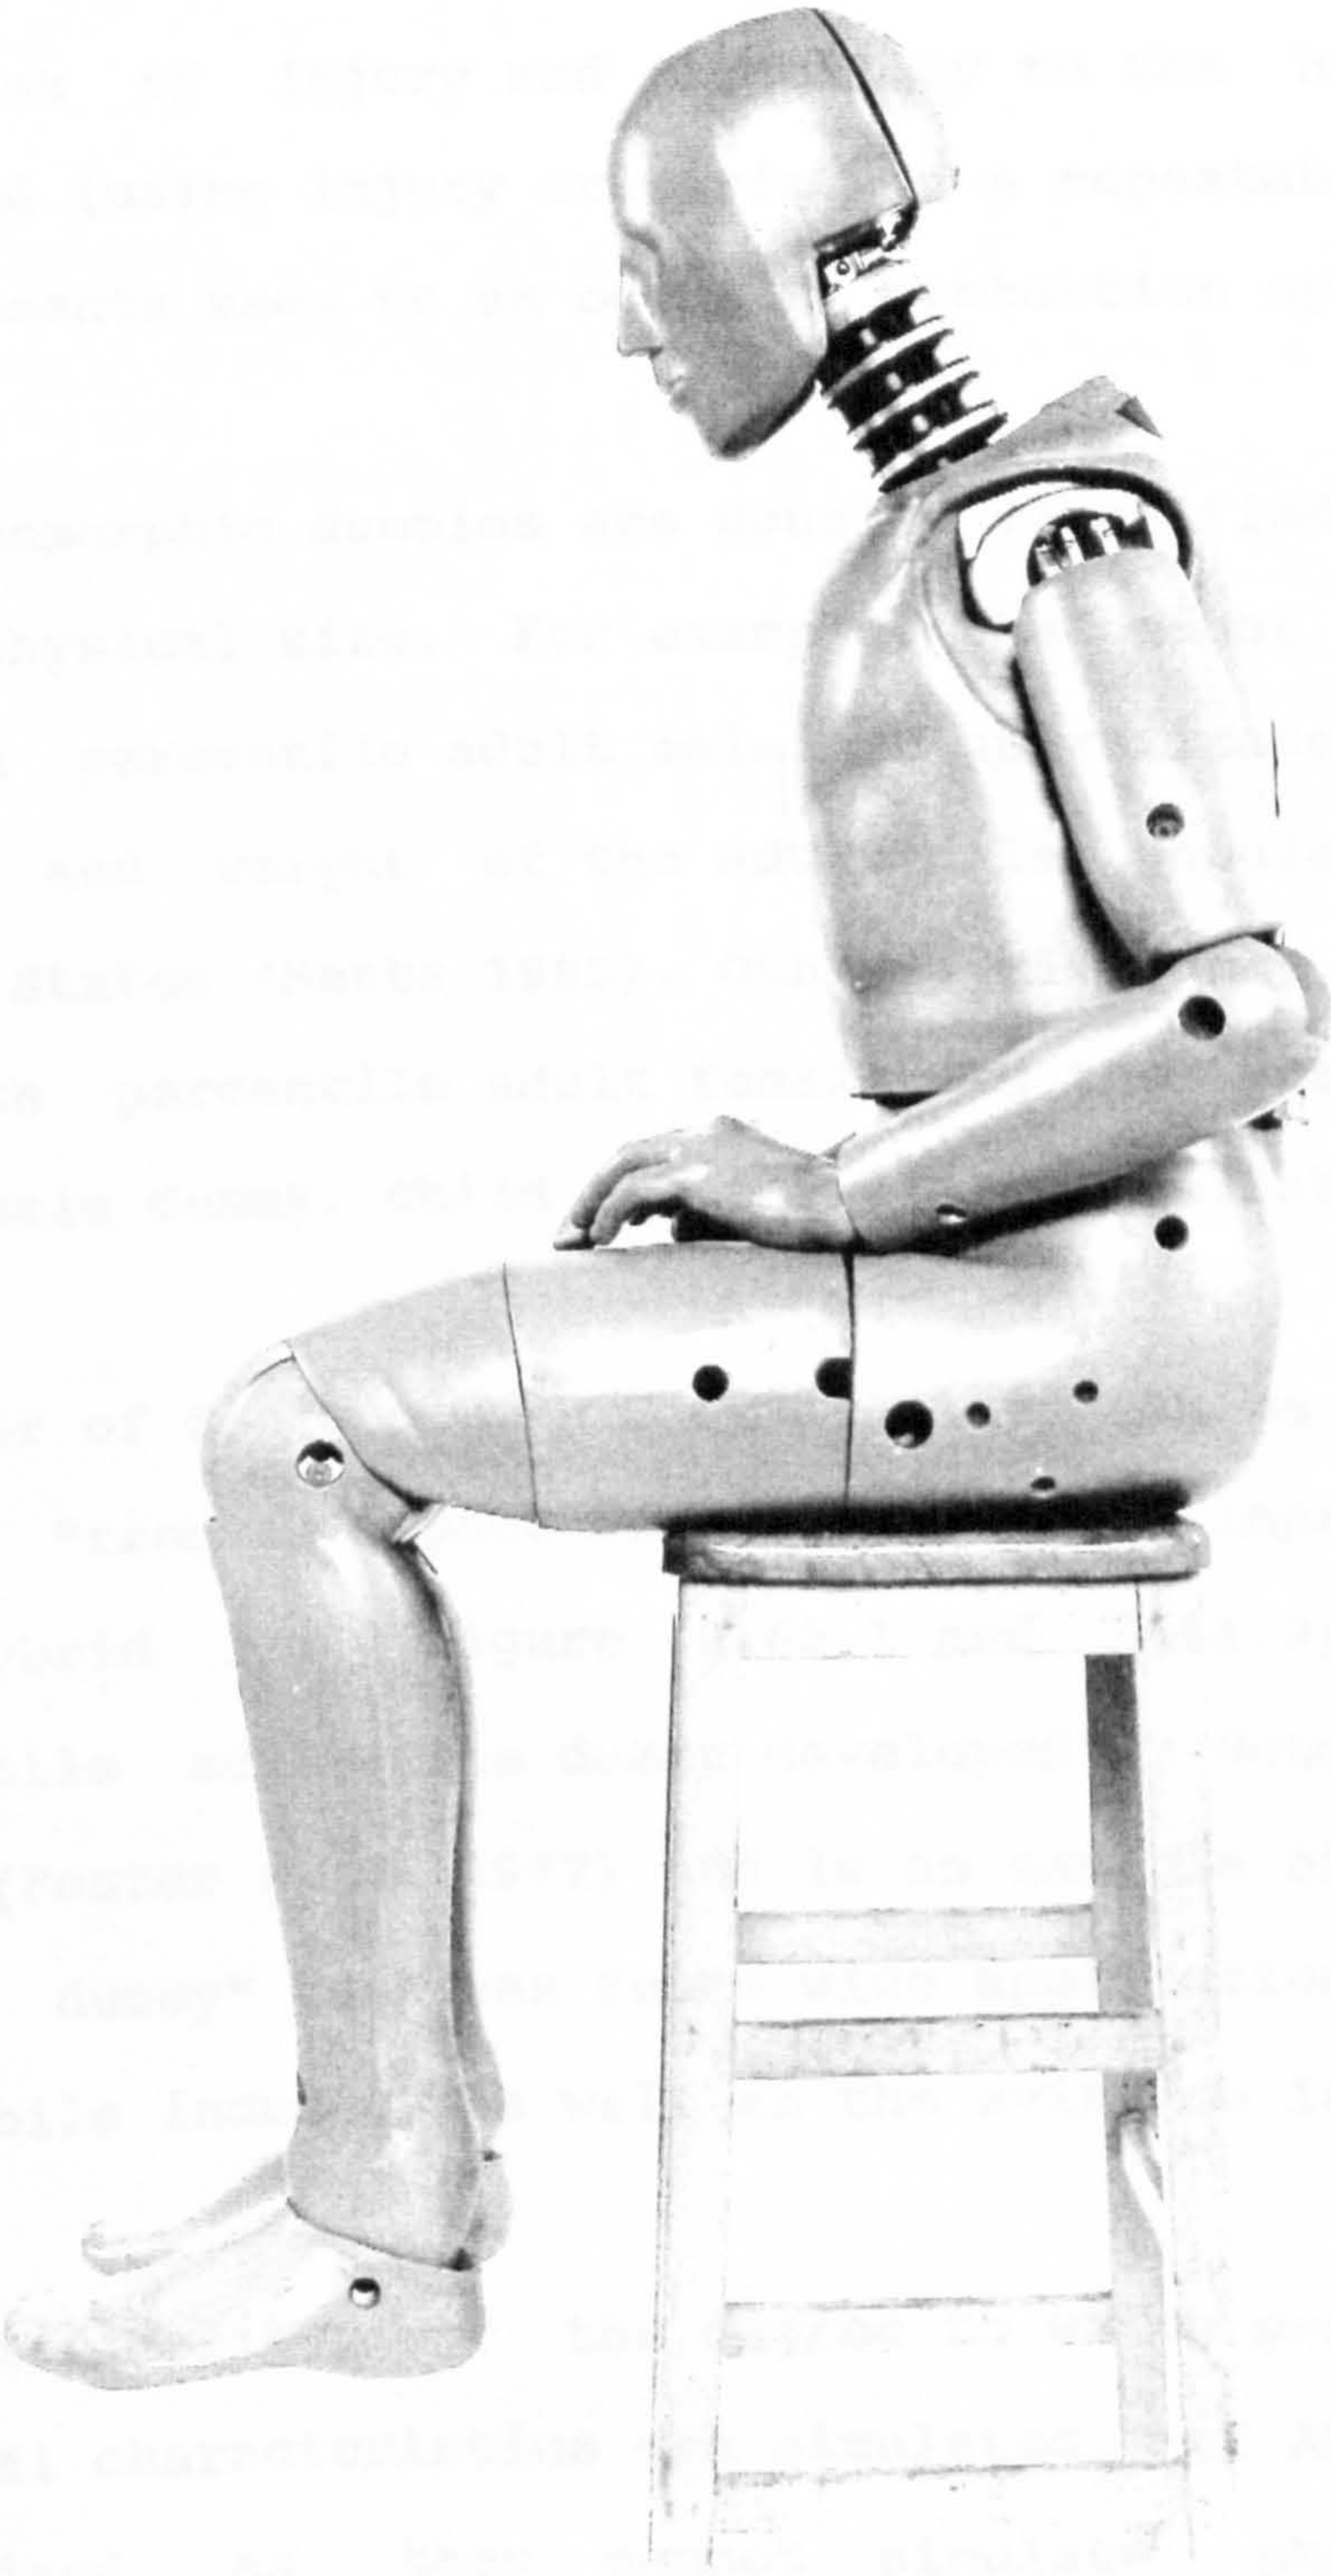
Figure 2.61.1

# Hybrid III Anthropomorphic Test Device

(Lateral view)

injury criteria determined using biological surrogates are expressed in parameters that are measurable on an ATD. Thus using instrumented ATD'S and a range of impact exposures, the risk of injury and disability to the human can be assessed (using injury criteria) in a repeatable manner and improvements made to an occupant protection system.

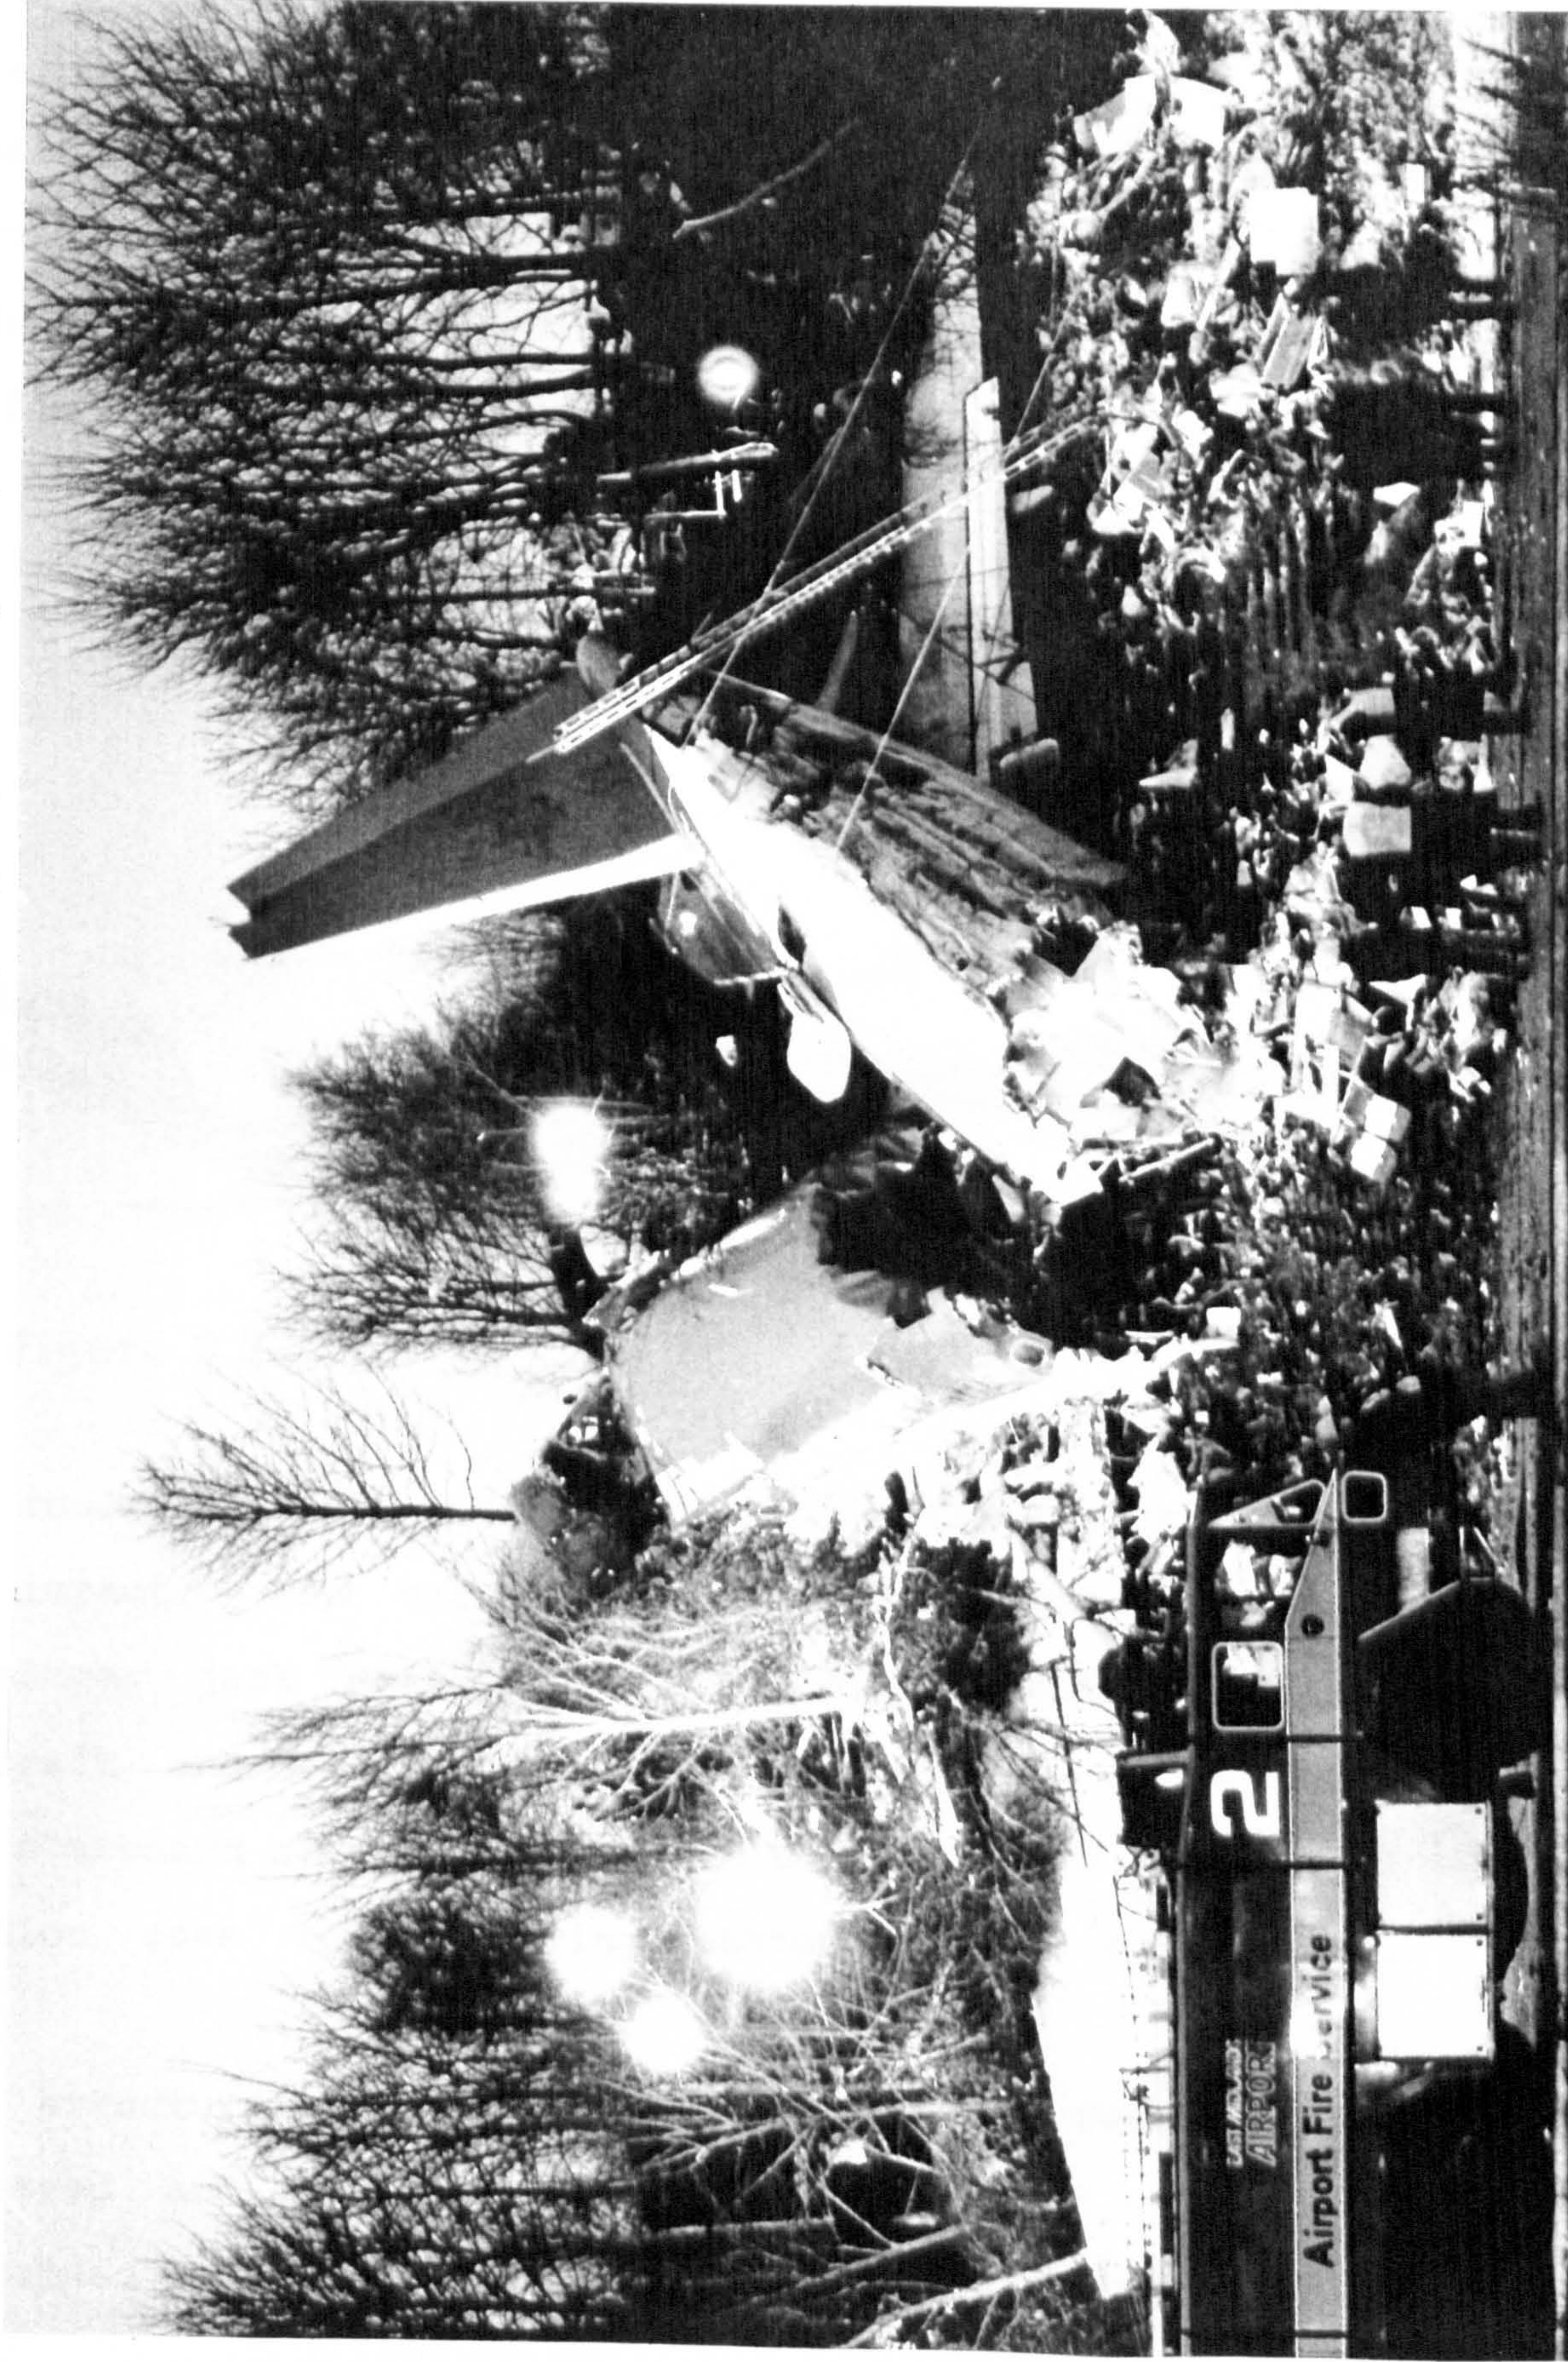
Figure 3.2.1

Crash Scene  
(Empics, Nottingham)

Examination of the airframe of G-OBME (figure 3.2.1 and 3.2.3) revealed that severe damage to the aircraft occurred in regions forward and aft of the wings. Because of the catastrophic failure in these regions a survival envelope did not exist and therefore one would expect a high mortality. Twenty nine of the fatalities were seated in the front section (rows 1-9), 4 were seated in the central section (rows 10-17) and 11 were seated in the rear section of the aircraft (rows 18-27). Thus 90% of all deaths occurred in those parts of the aircraft where there was the greatest structural damage.

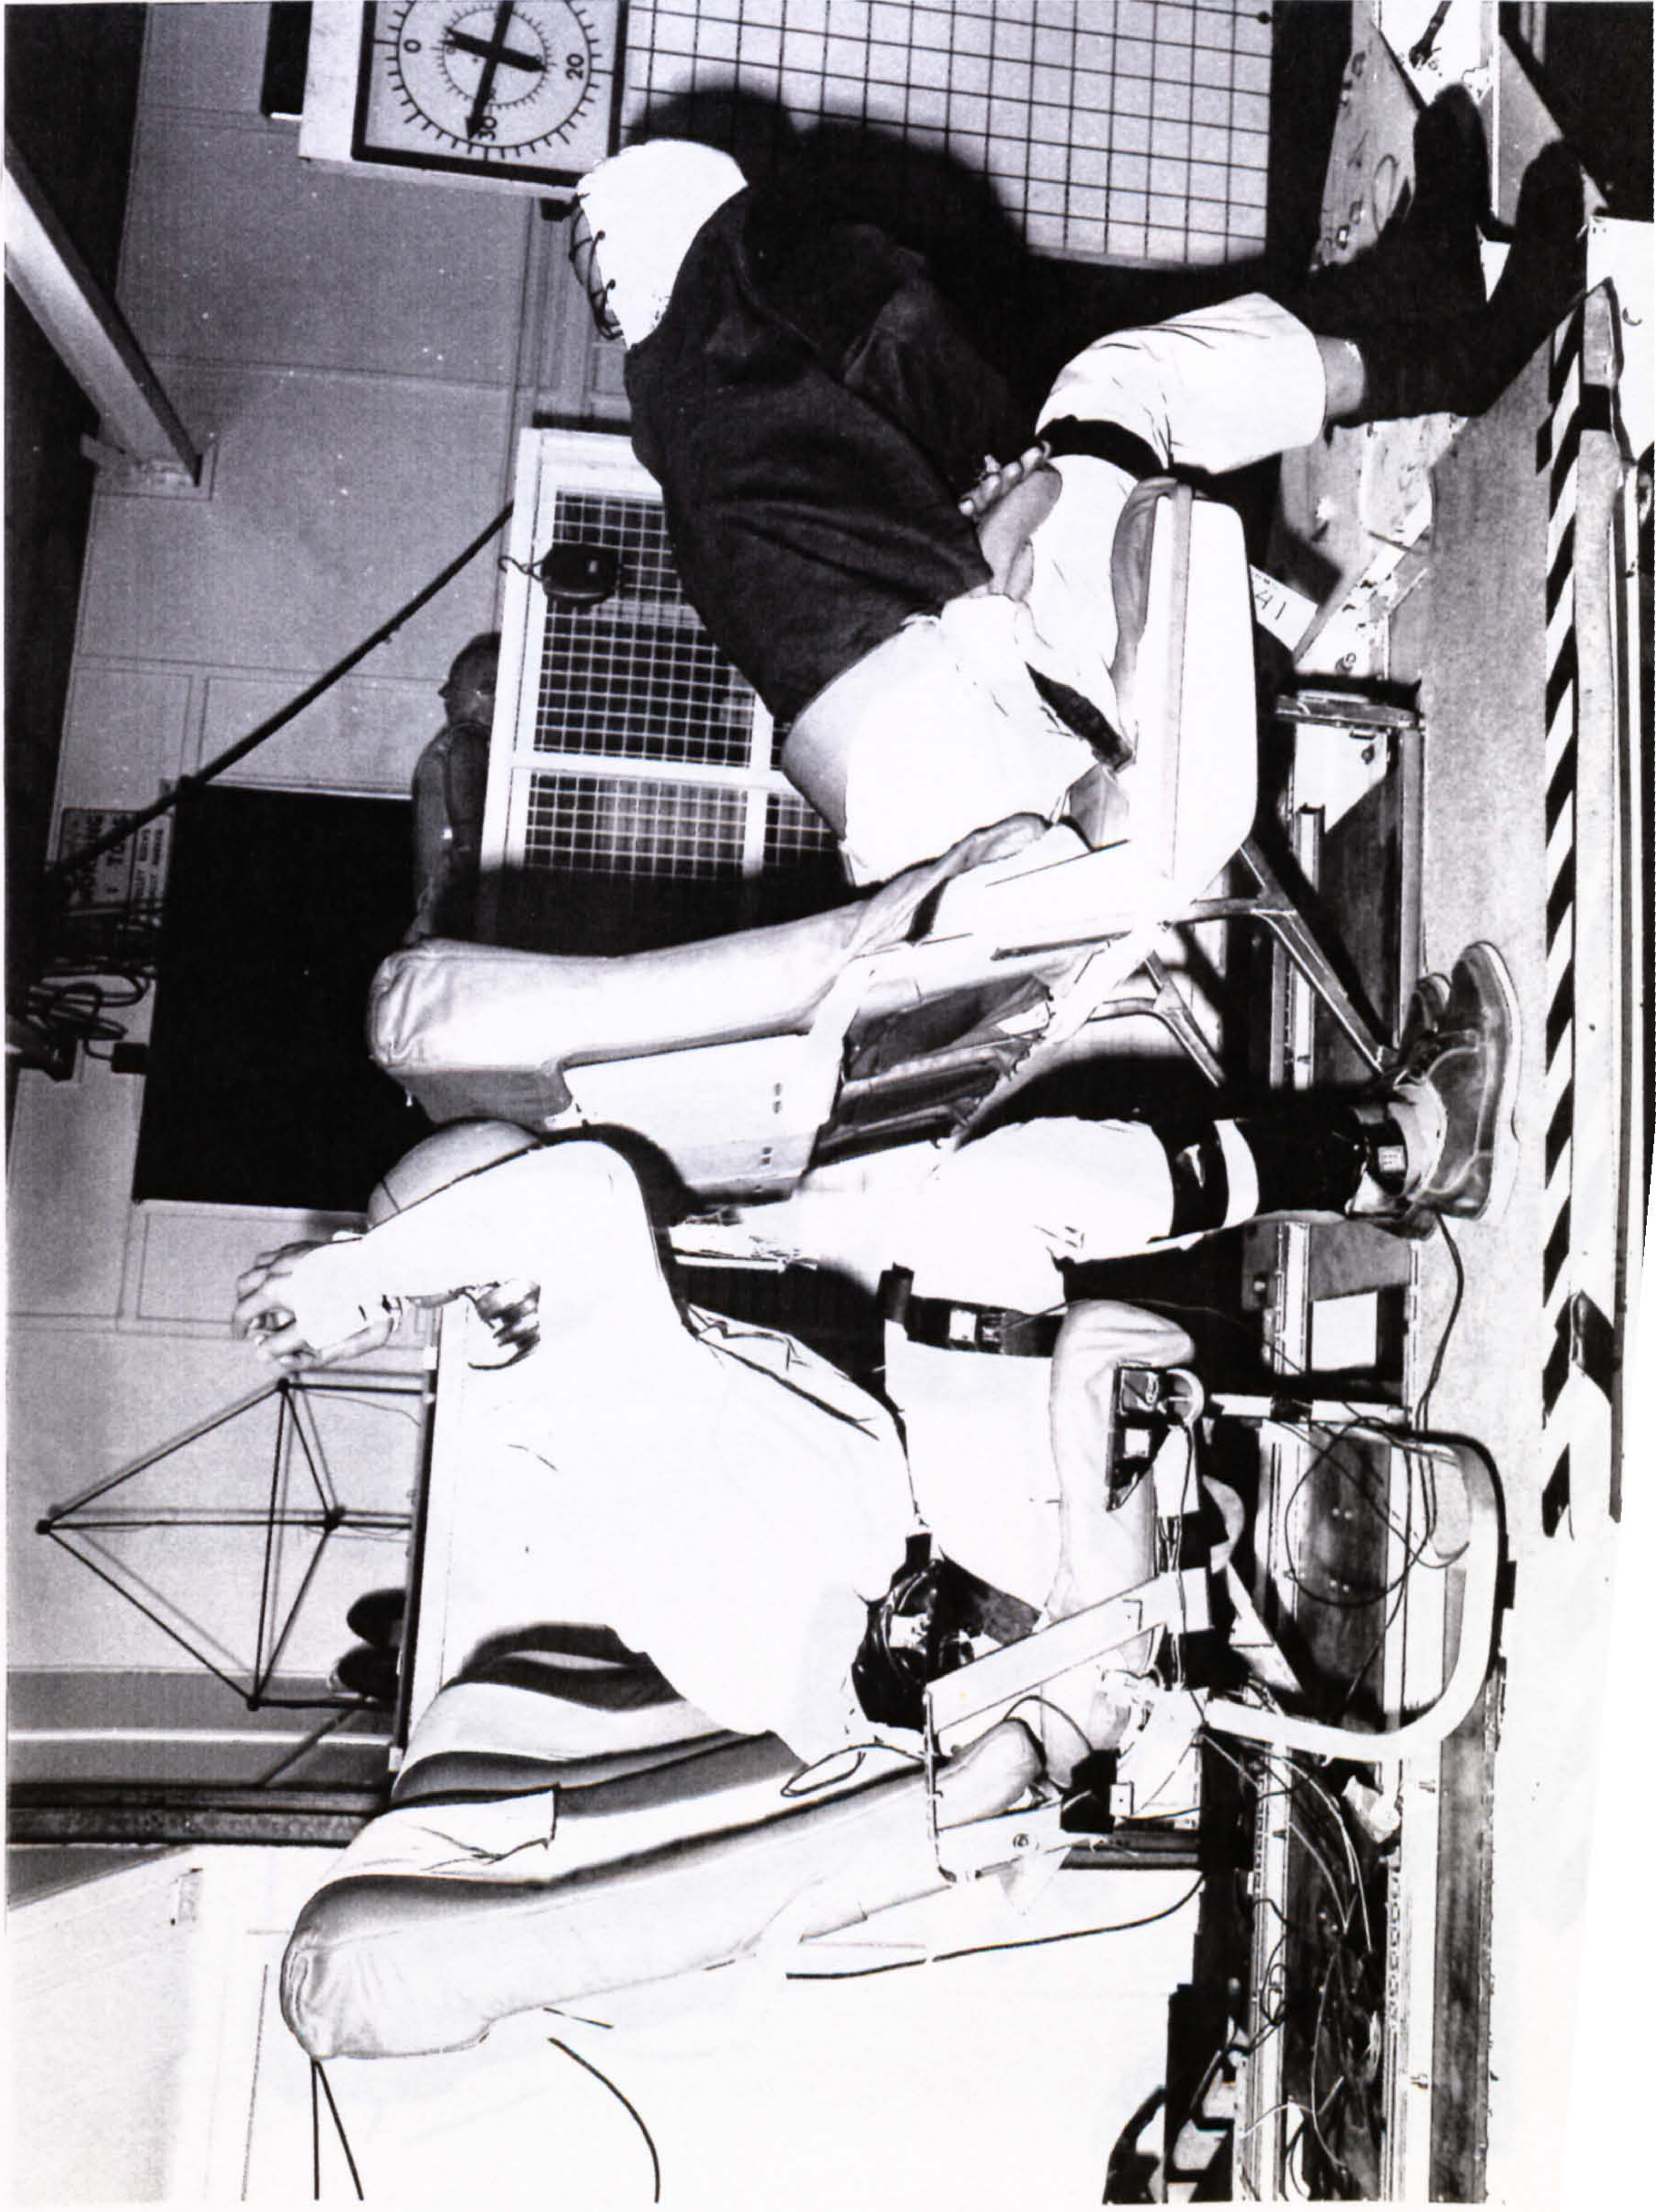
Positioning of Dummy  
Braced - feet forward

position adopted by the ATD were investigated. Figure 5.2.4 (braced -feet forward), 5.2.5 (braced -feet back), 5.2.6 (unbraced -feet forward) and 5.2.7 (unbraced -feet back) demonstrates the positions investigated. The ATD was placed in the centre of the outside seat with the back and buttocks against the seat back. In the braced position the dummy was bent forward until the head was in contact with the seat in front. The ATD was sat upright in the seat in the unbraced position. For braced positions the arms were taped behind the head, and for the unbraced positions crossed in front of the abdomen. Two lower limb positions were identified: Feet forward, ie. at an angle of 20 degrees to the vertical. This position represented a position in which the legs could be easily placed when the dummy was in an unbraced position; Feet back, ie. an angle of 12 degrees to the vertical. In this position the feet of the dummy were planted on the floor. The dummy's knees were separated by four inches (102mm) and were approximately eight inches (203mm) from the seat in front. Both positions represented a comfortable seating position.

These position were analogous with those of the impact testing experiments (see figures 5.2.4, 5.2.5 and 5.2.6). The initial lap belt tightness was fixed at 20lb. The crash pulse used was the acceleration time history obtained on the 20G runs.

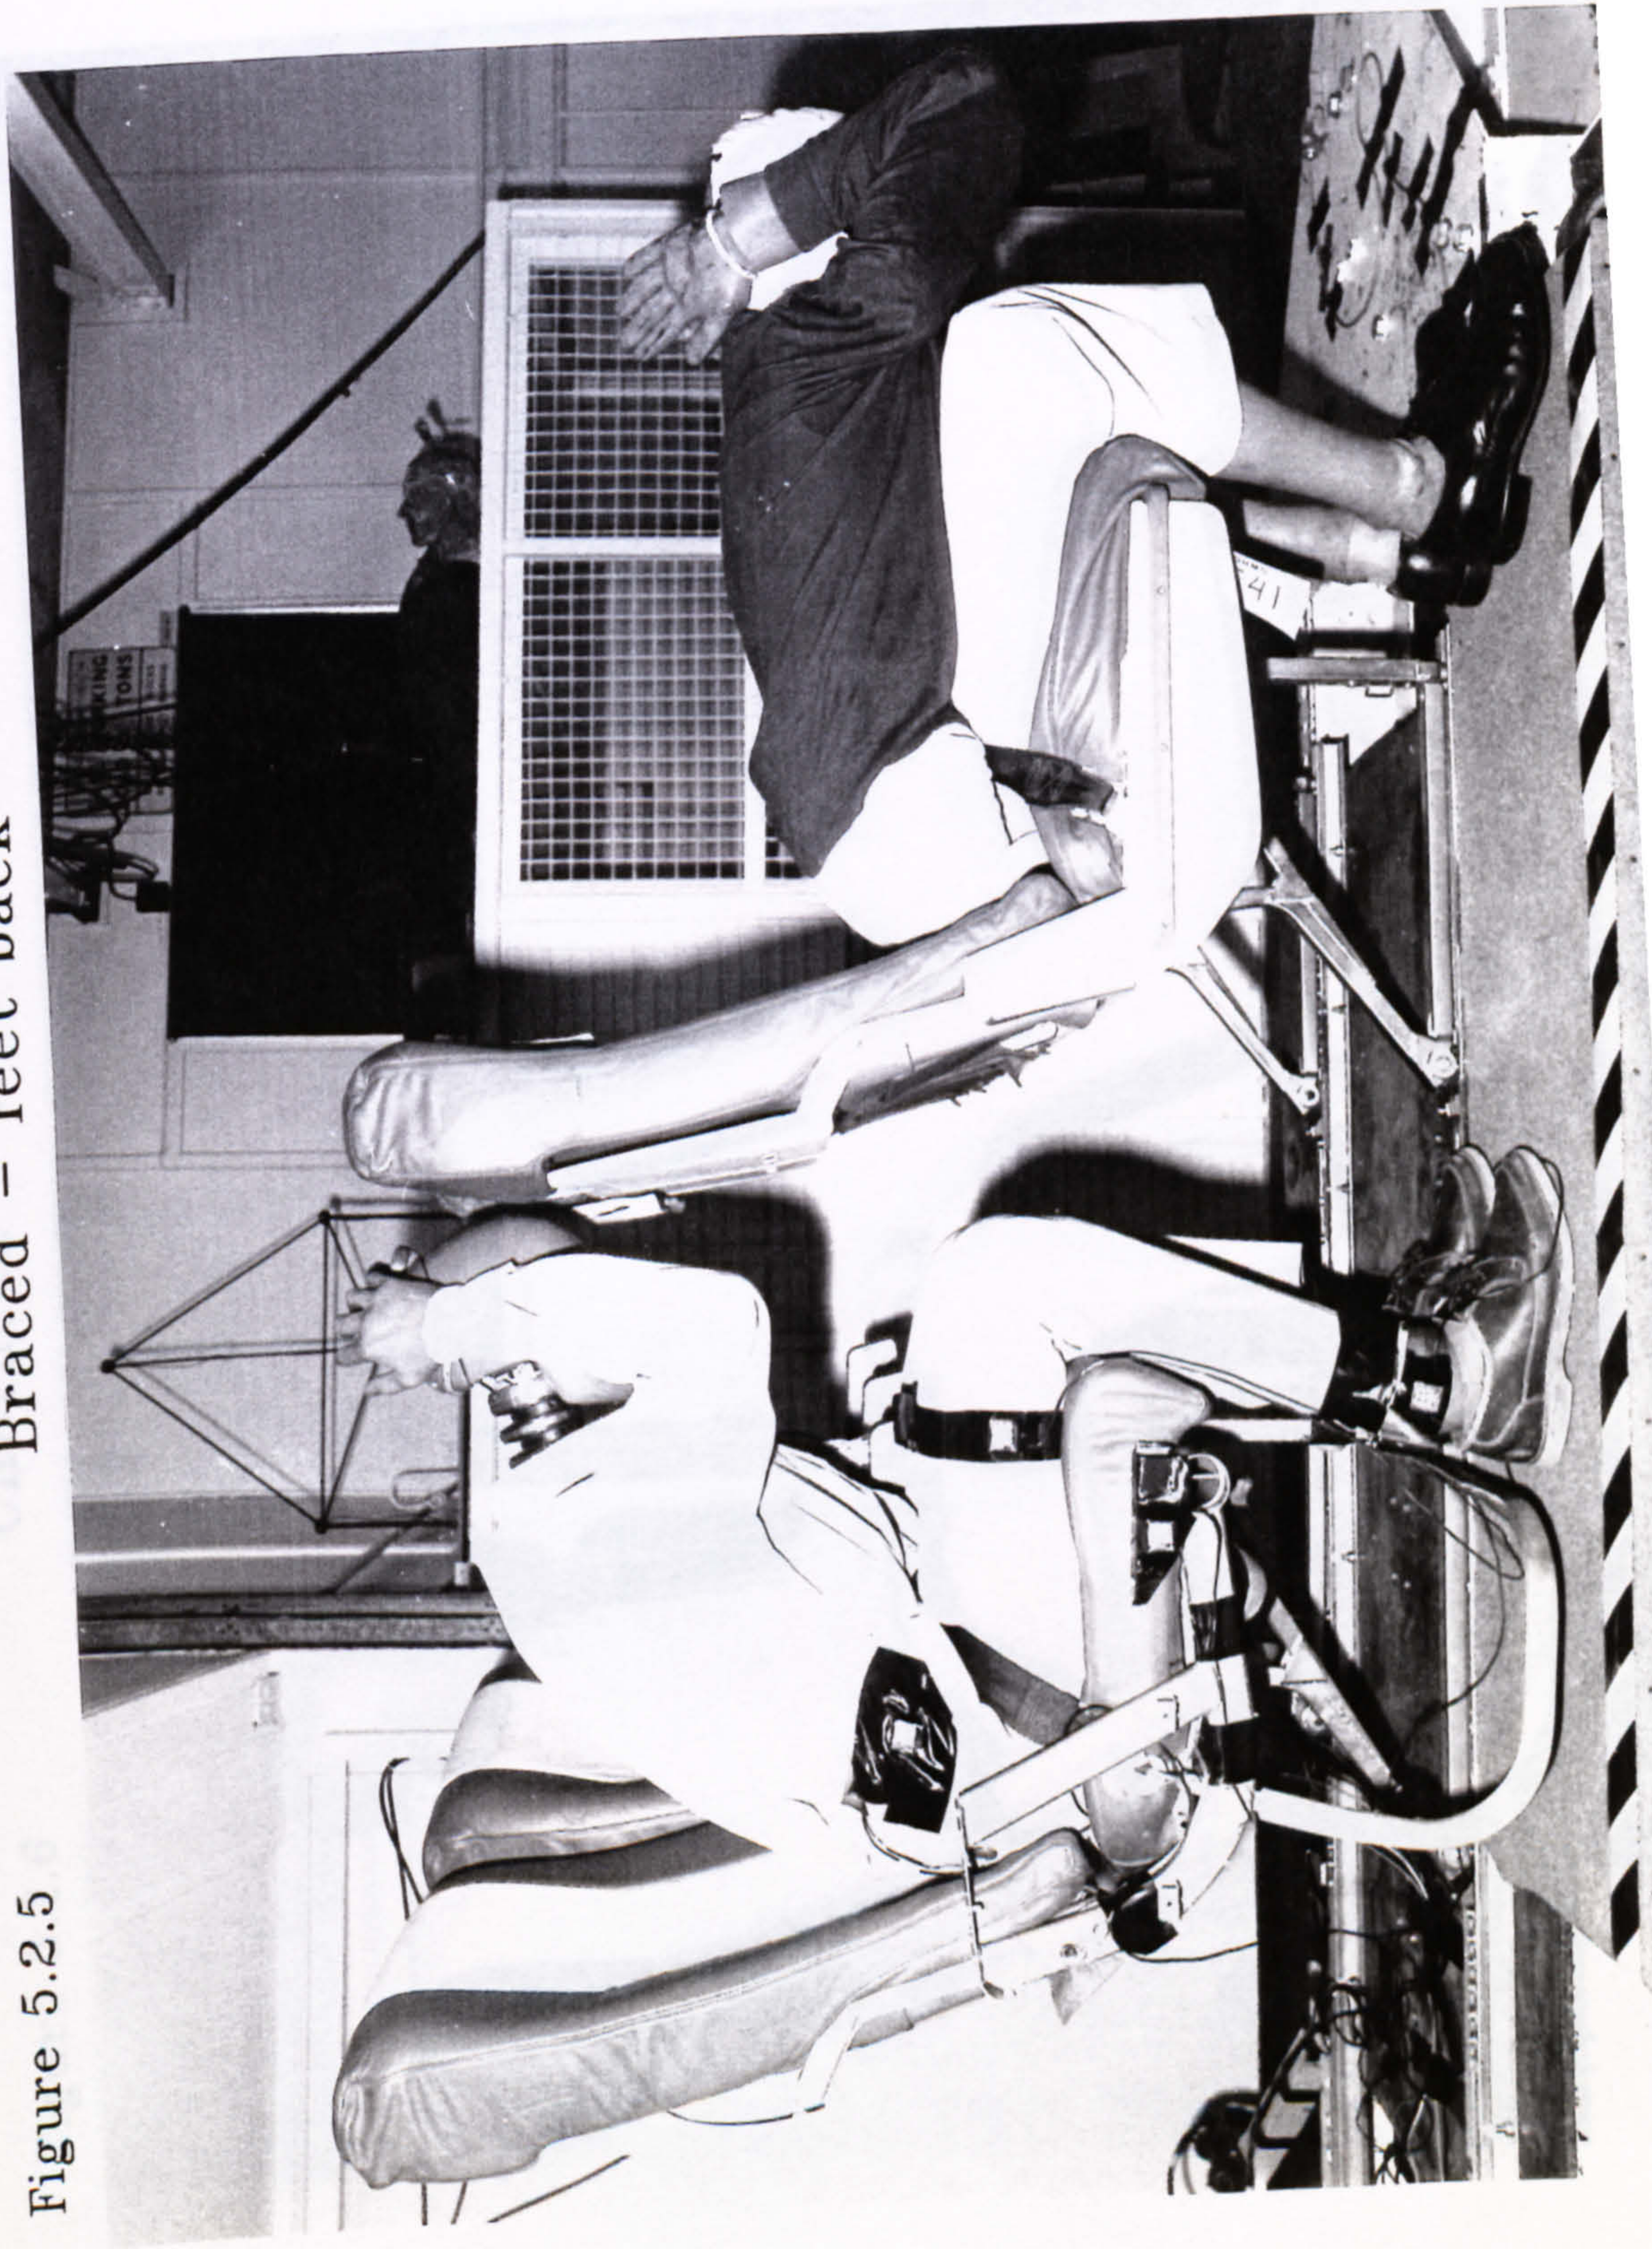
Figure 5.2.5

Positioning of Dummy  
Braced - feet back

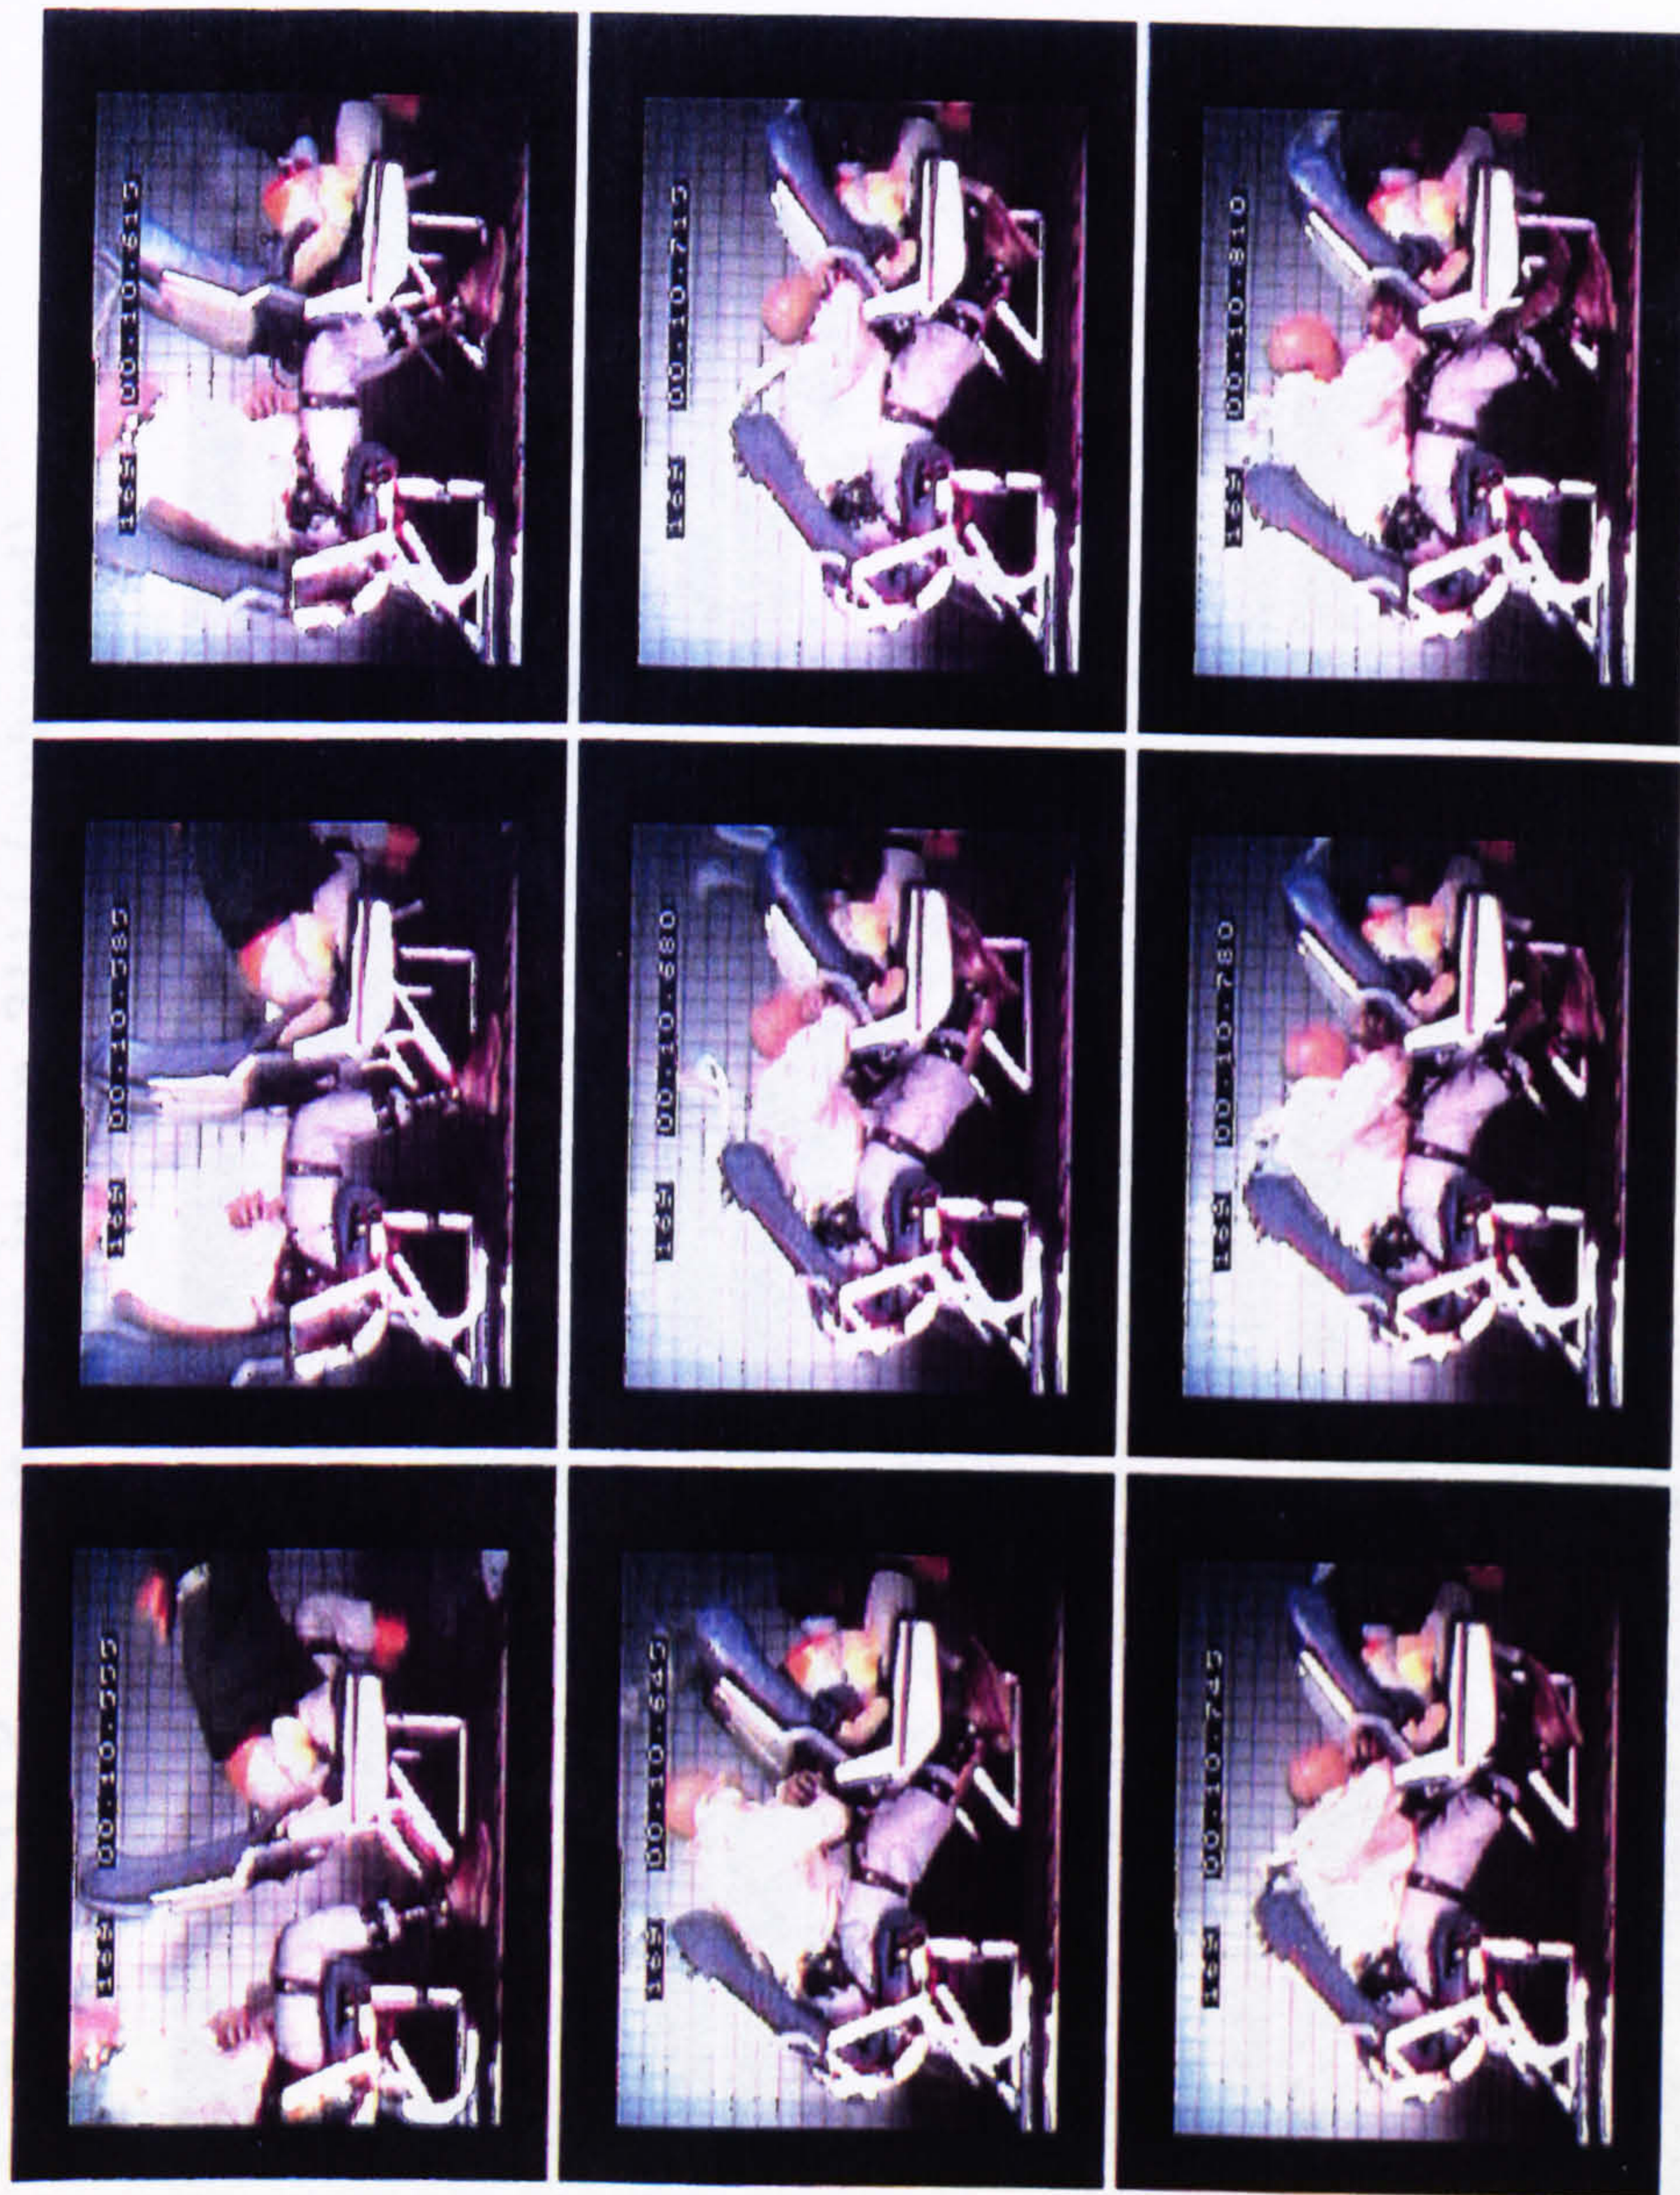
Series 5.31.1

# Flail Behaviour as seen in run 3122

The run types that demonstrated flail behaviour were:-

1121	1122
2121	2122
3121	3122 (3123)
