Impact Biomechanics of the Pelvis  
and  
Lower Limbs in Occupants Involved  
in an  
Impact Aircraft Accident

Thesis submitted to the University of Nottingham  
for the degree of Doctor of Medicine

November 1992

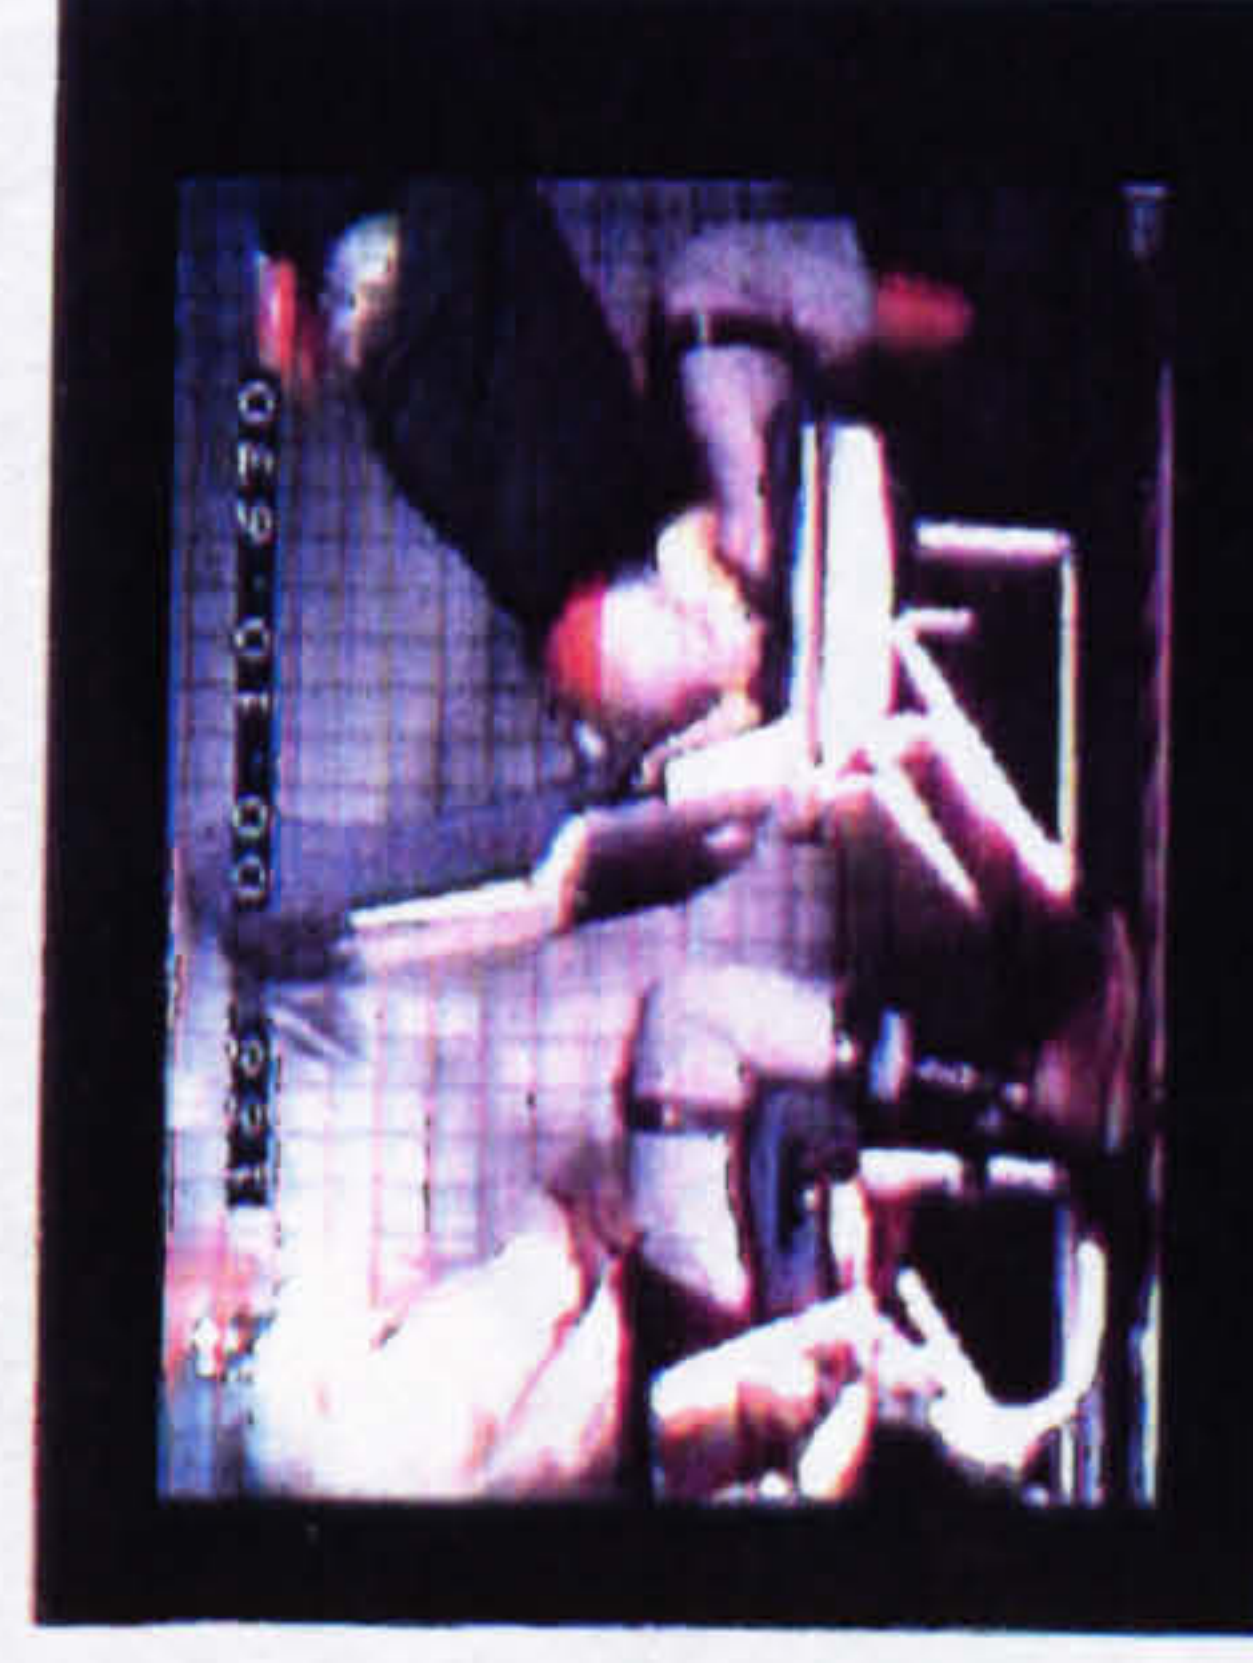
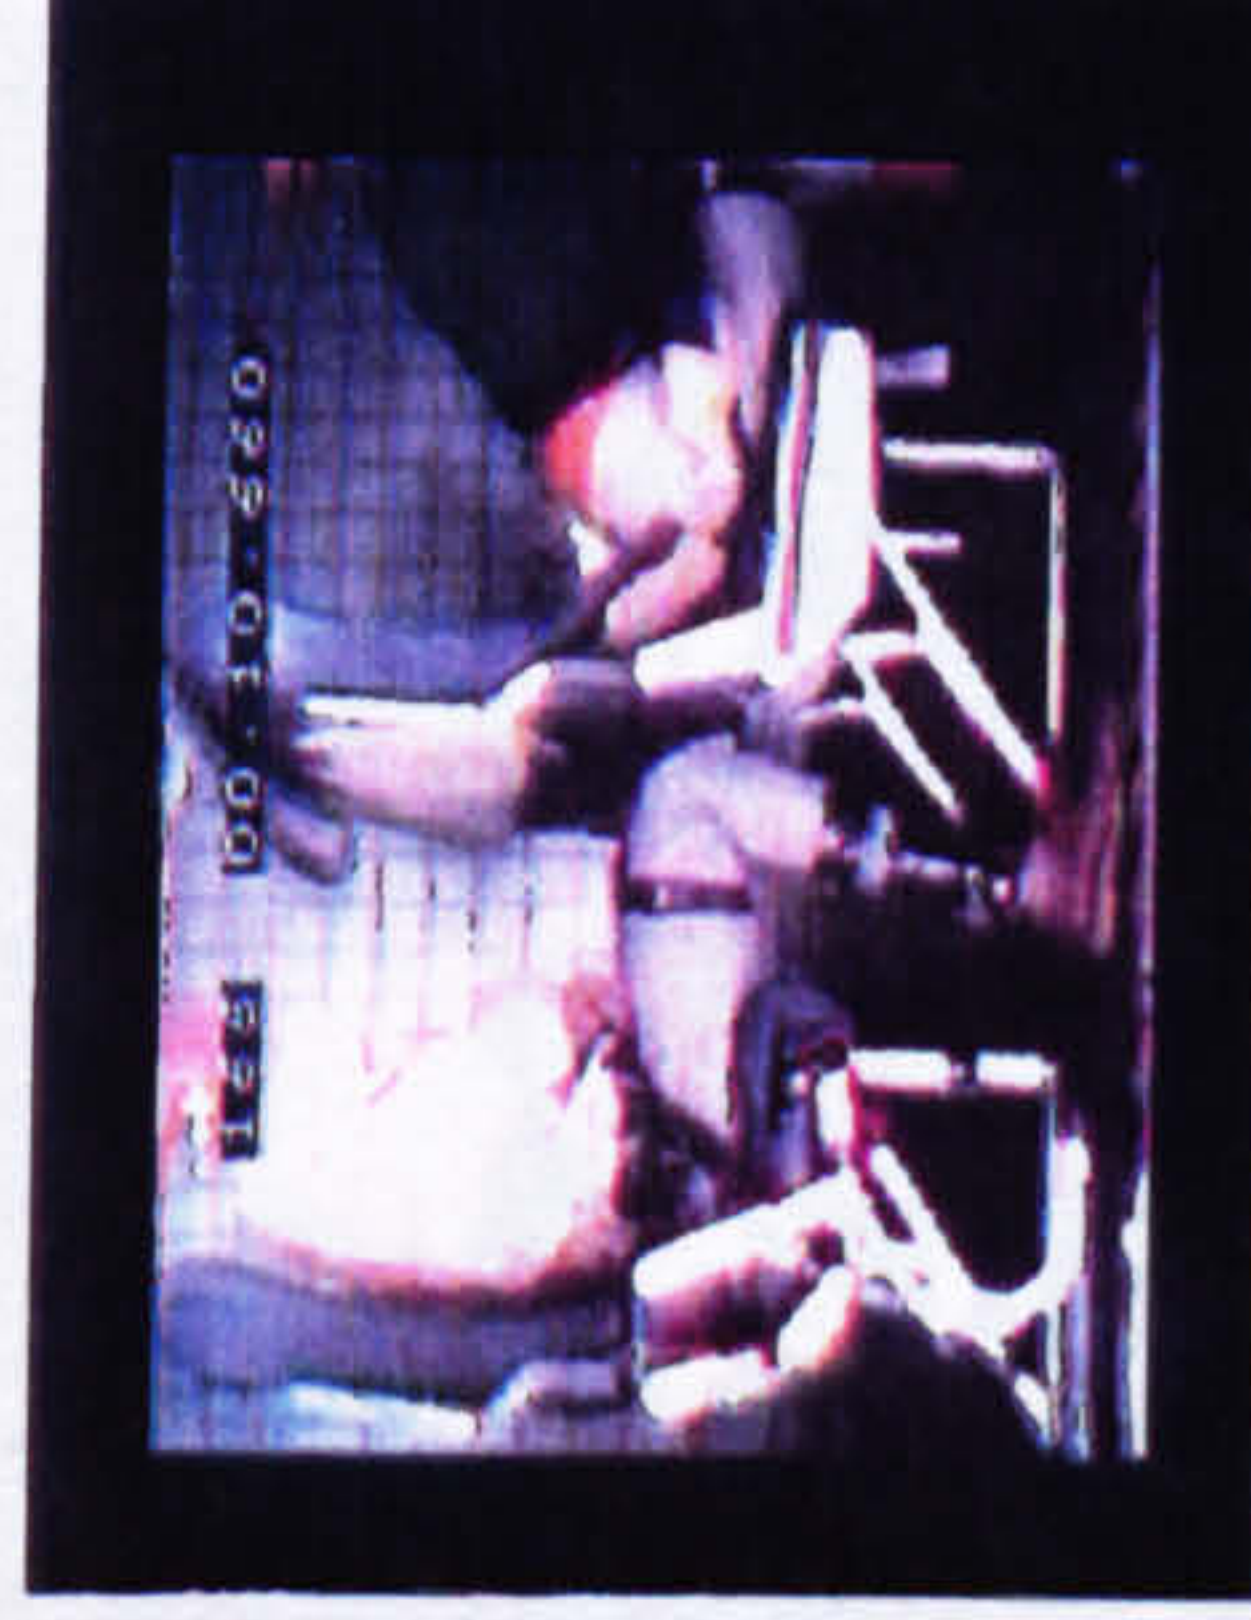
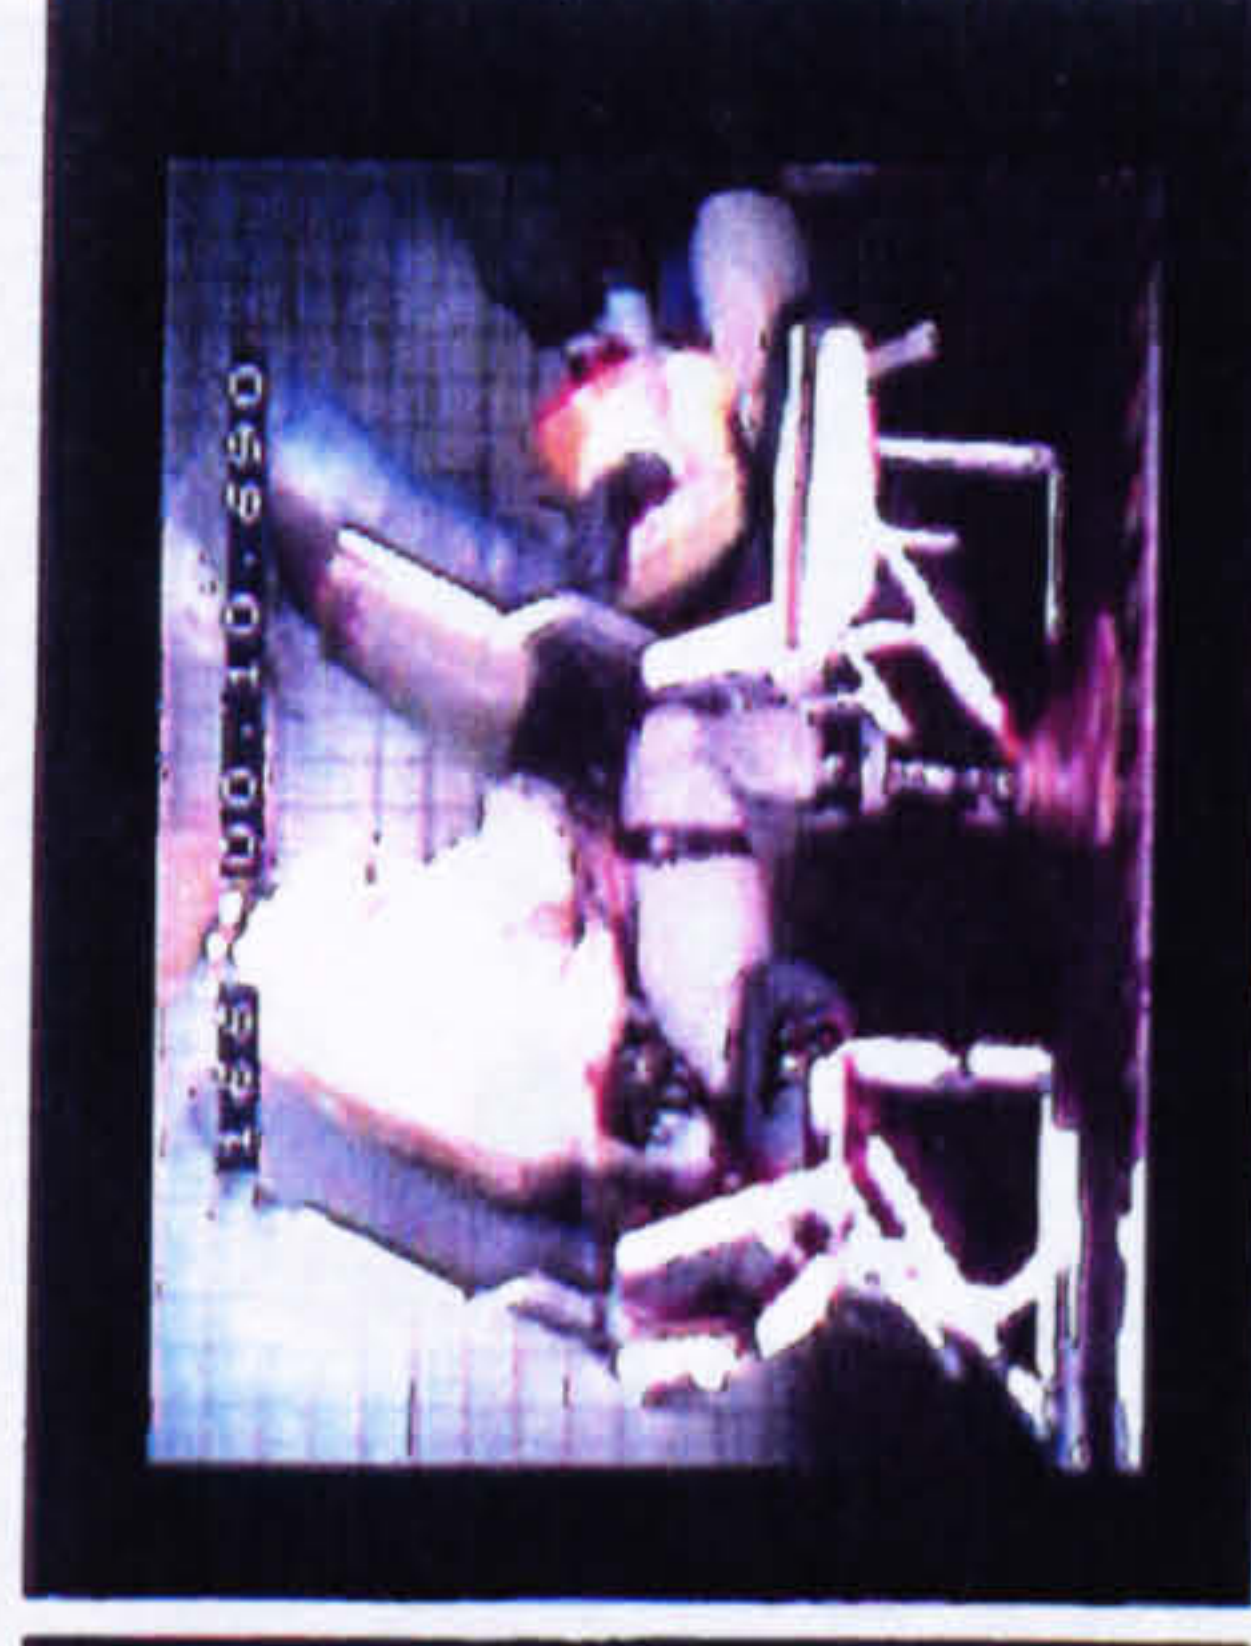
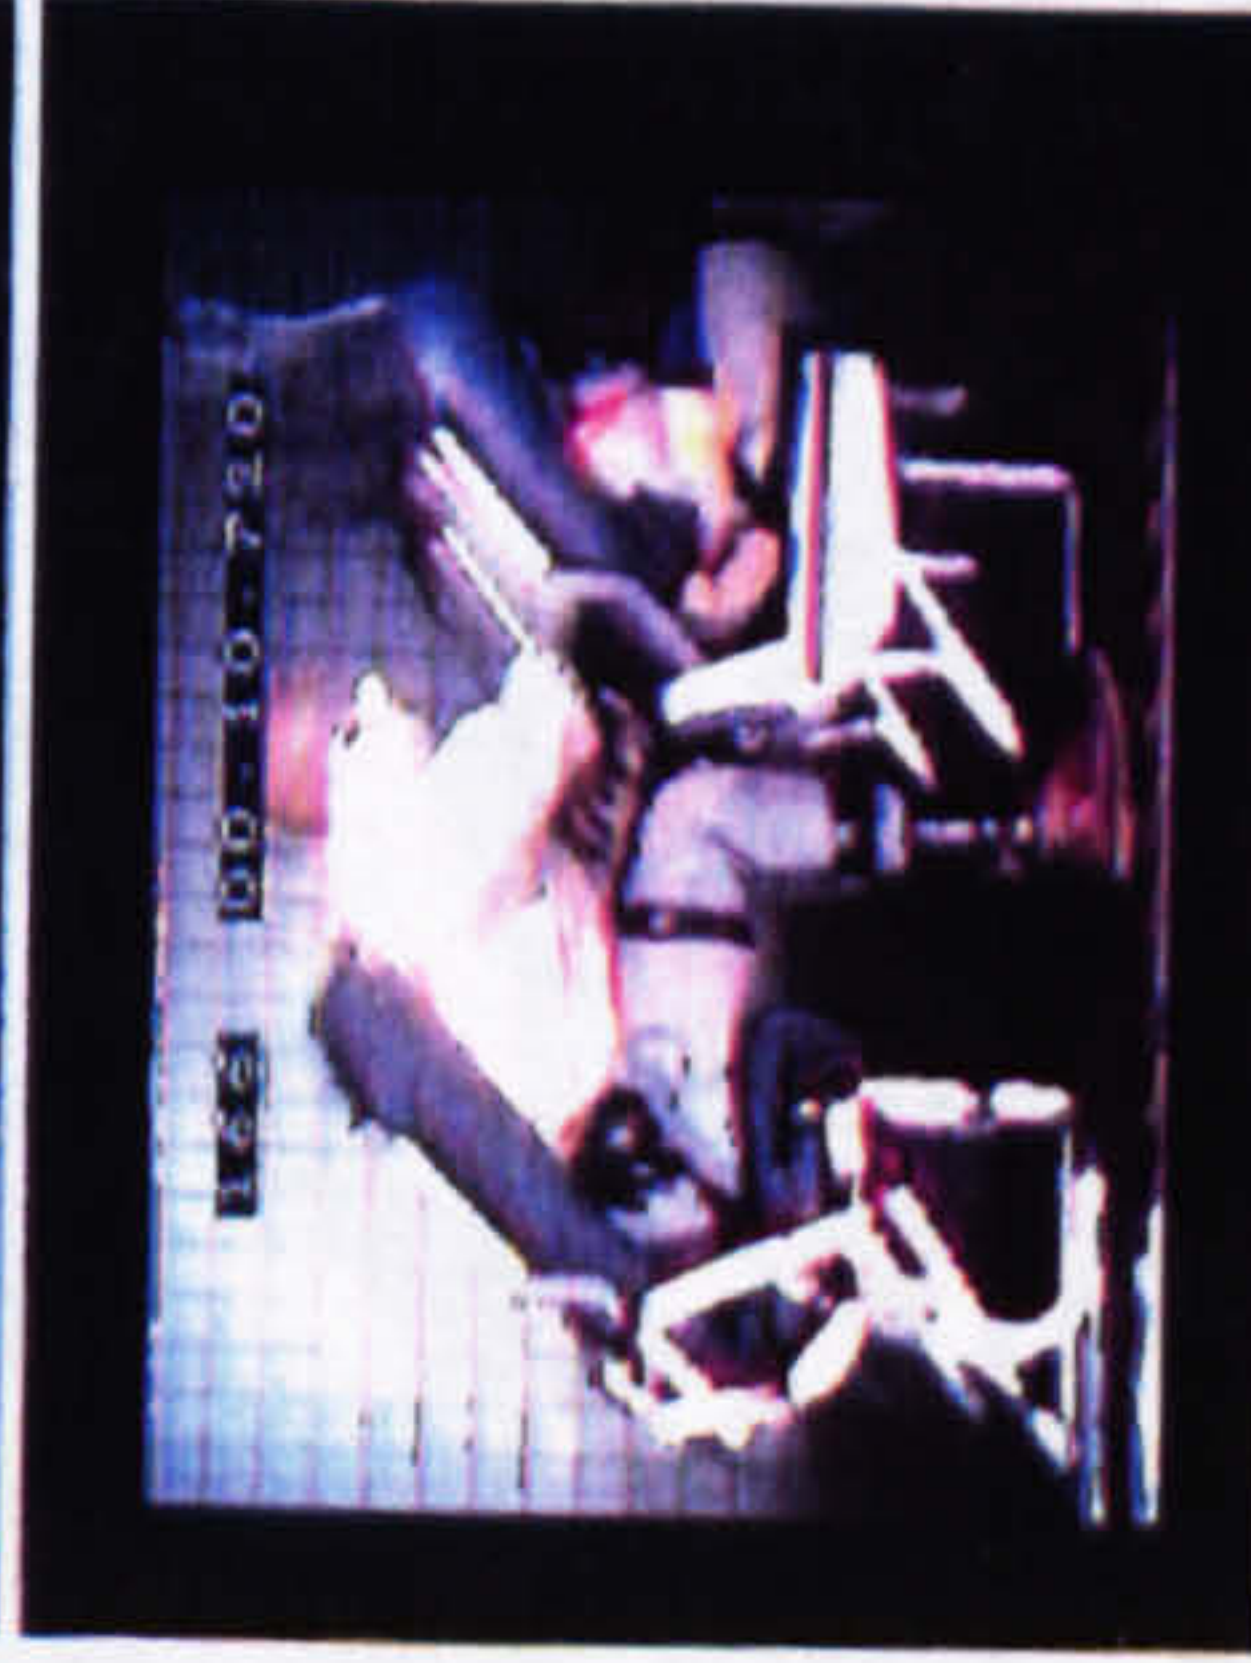
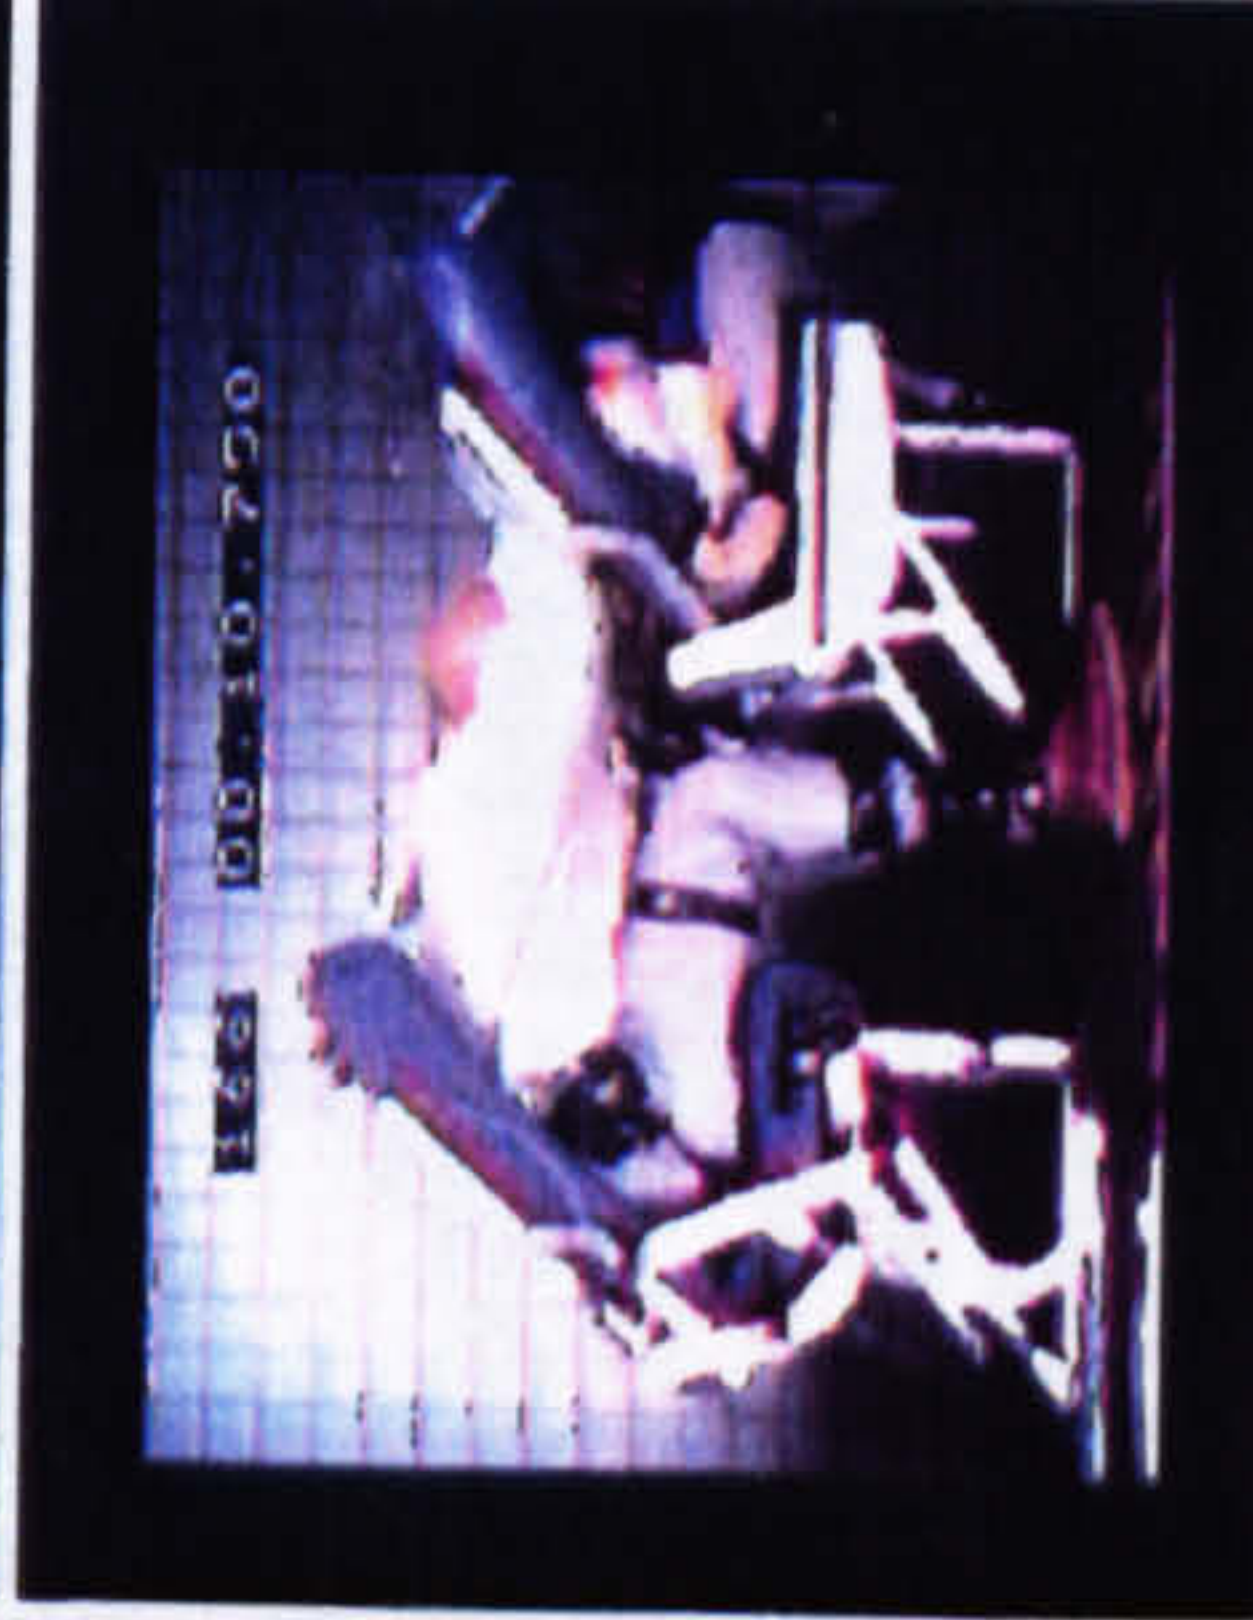
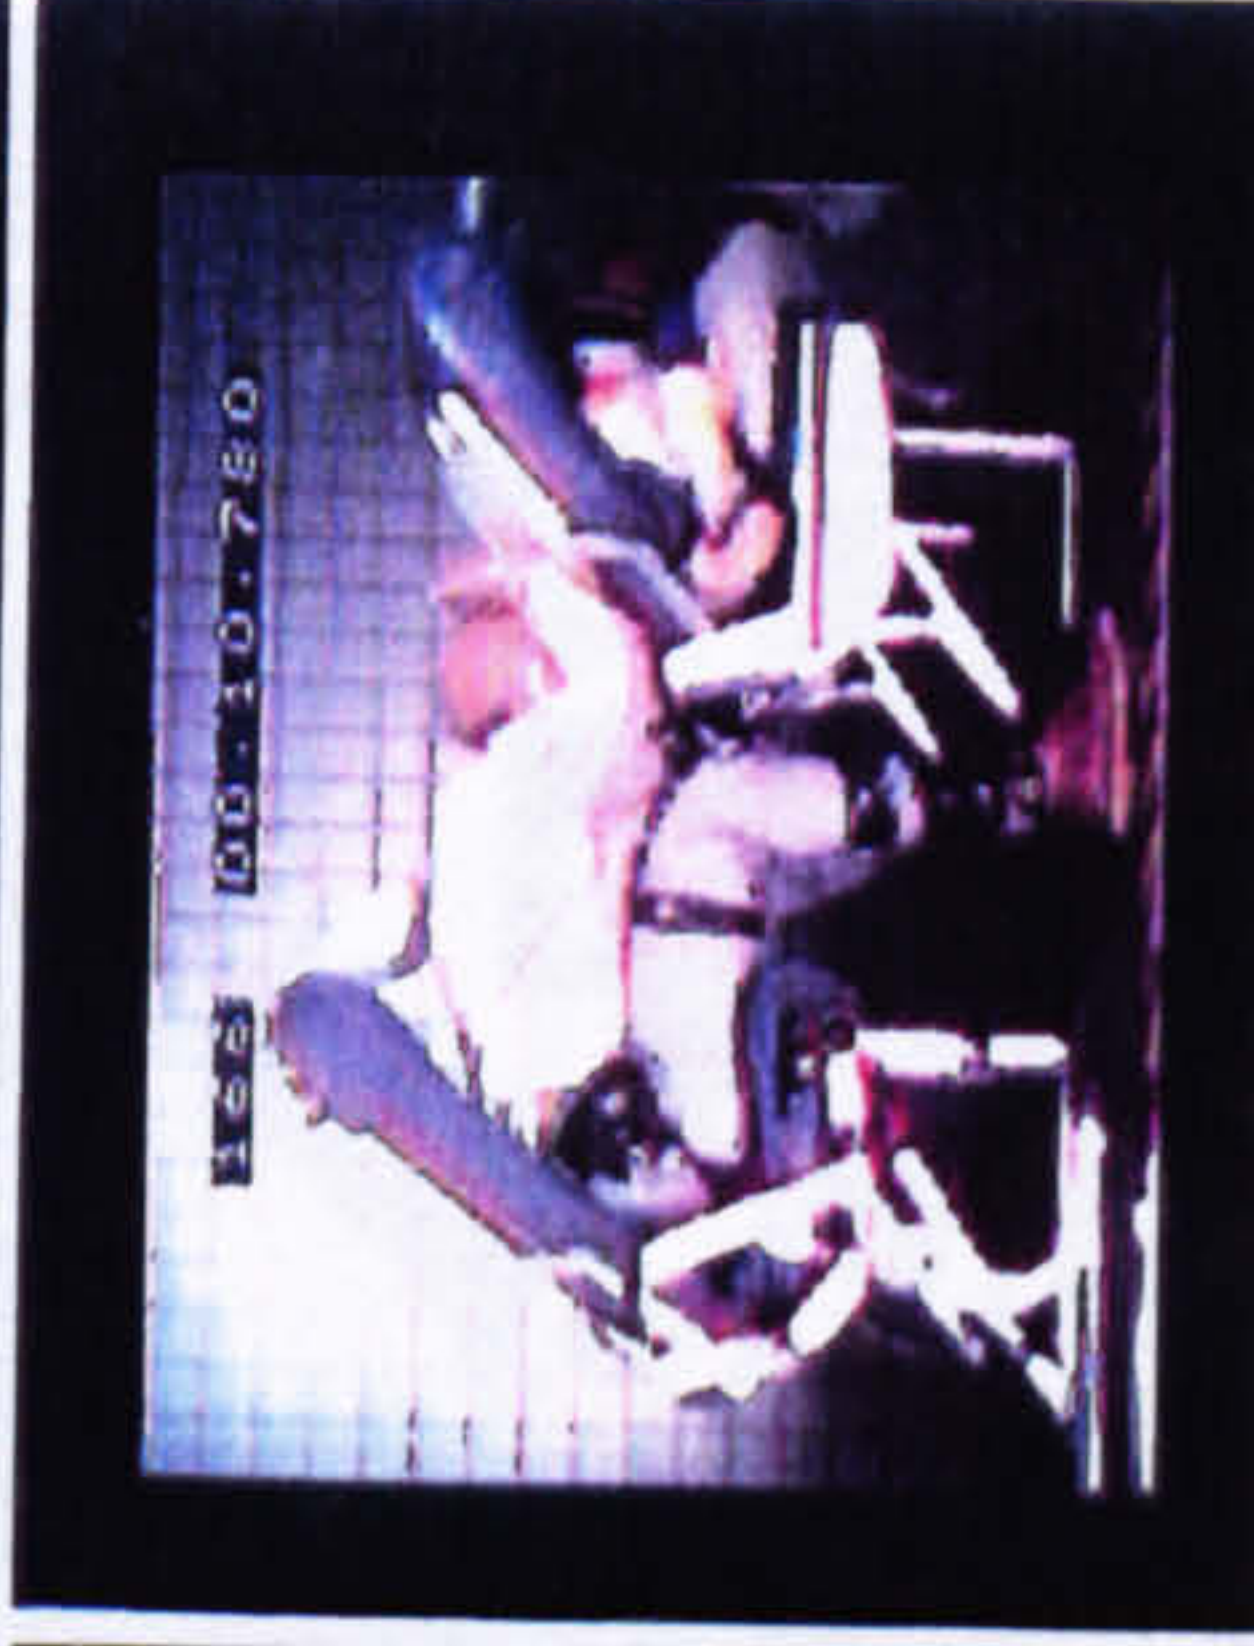
Series 5.31.2

Non Flail Behaviour

as seen in run 3111 (unbraced)

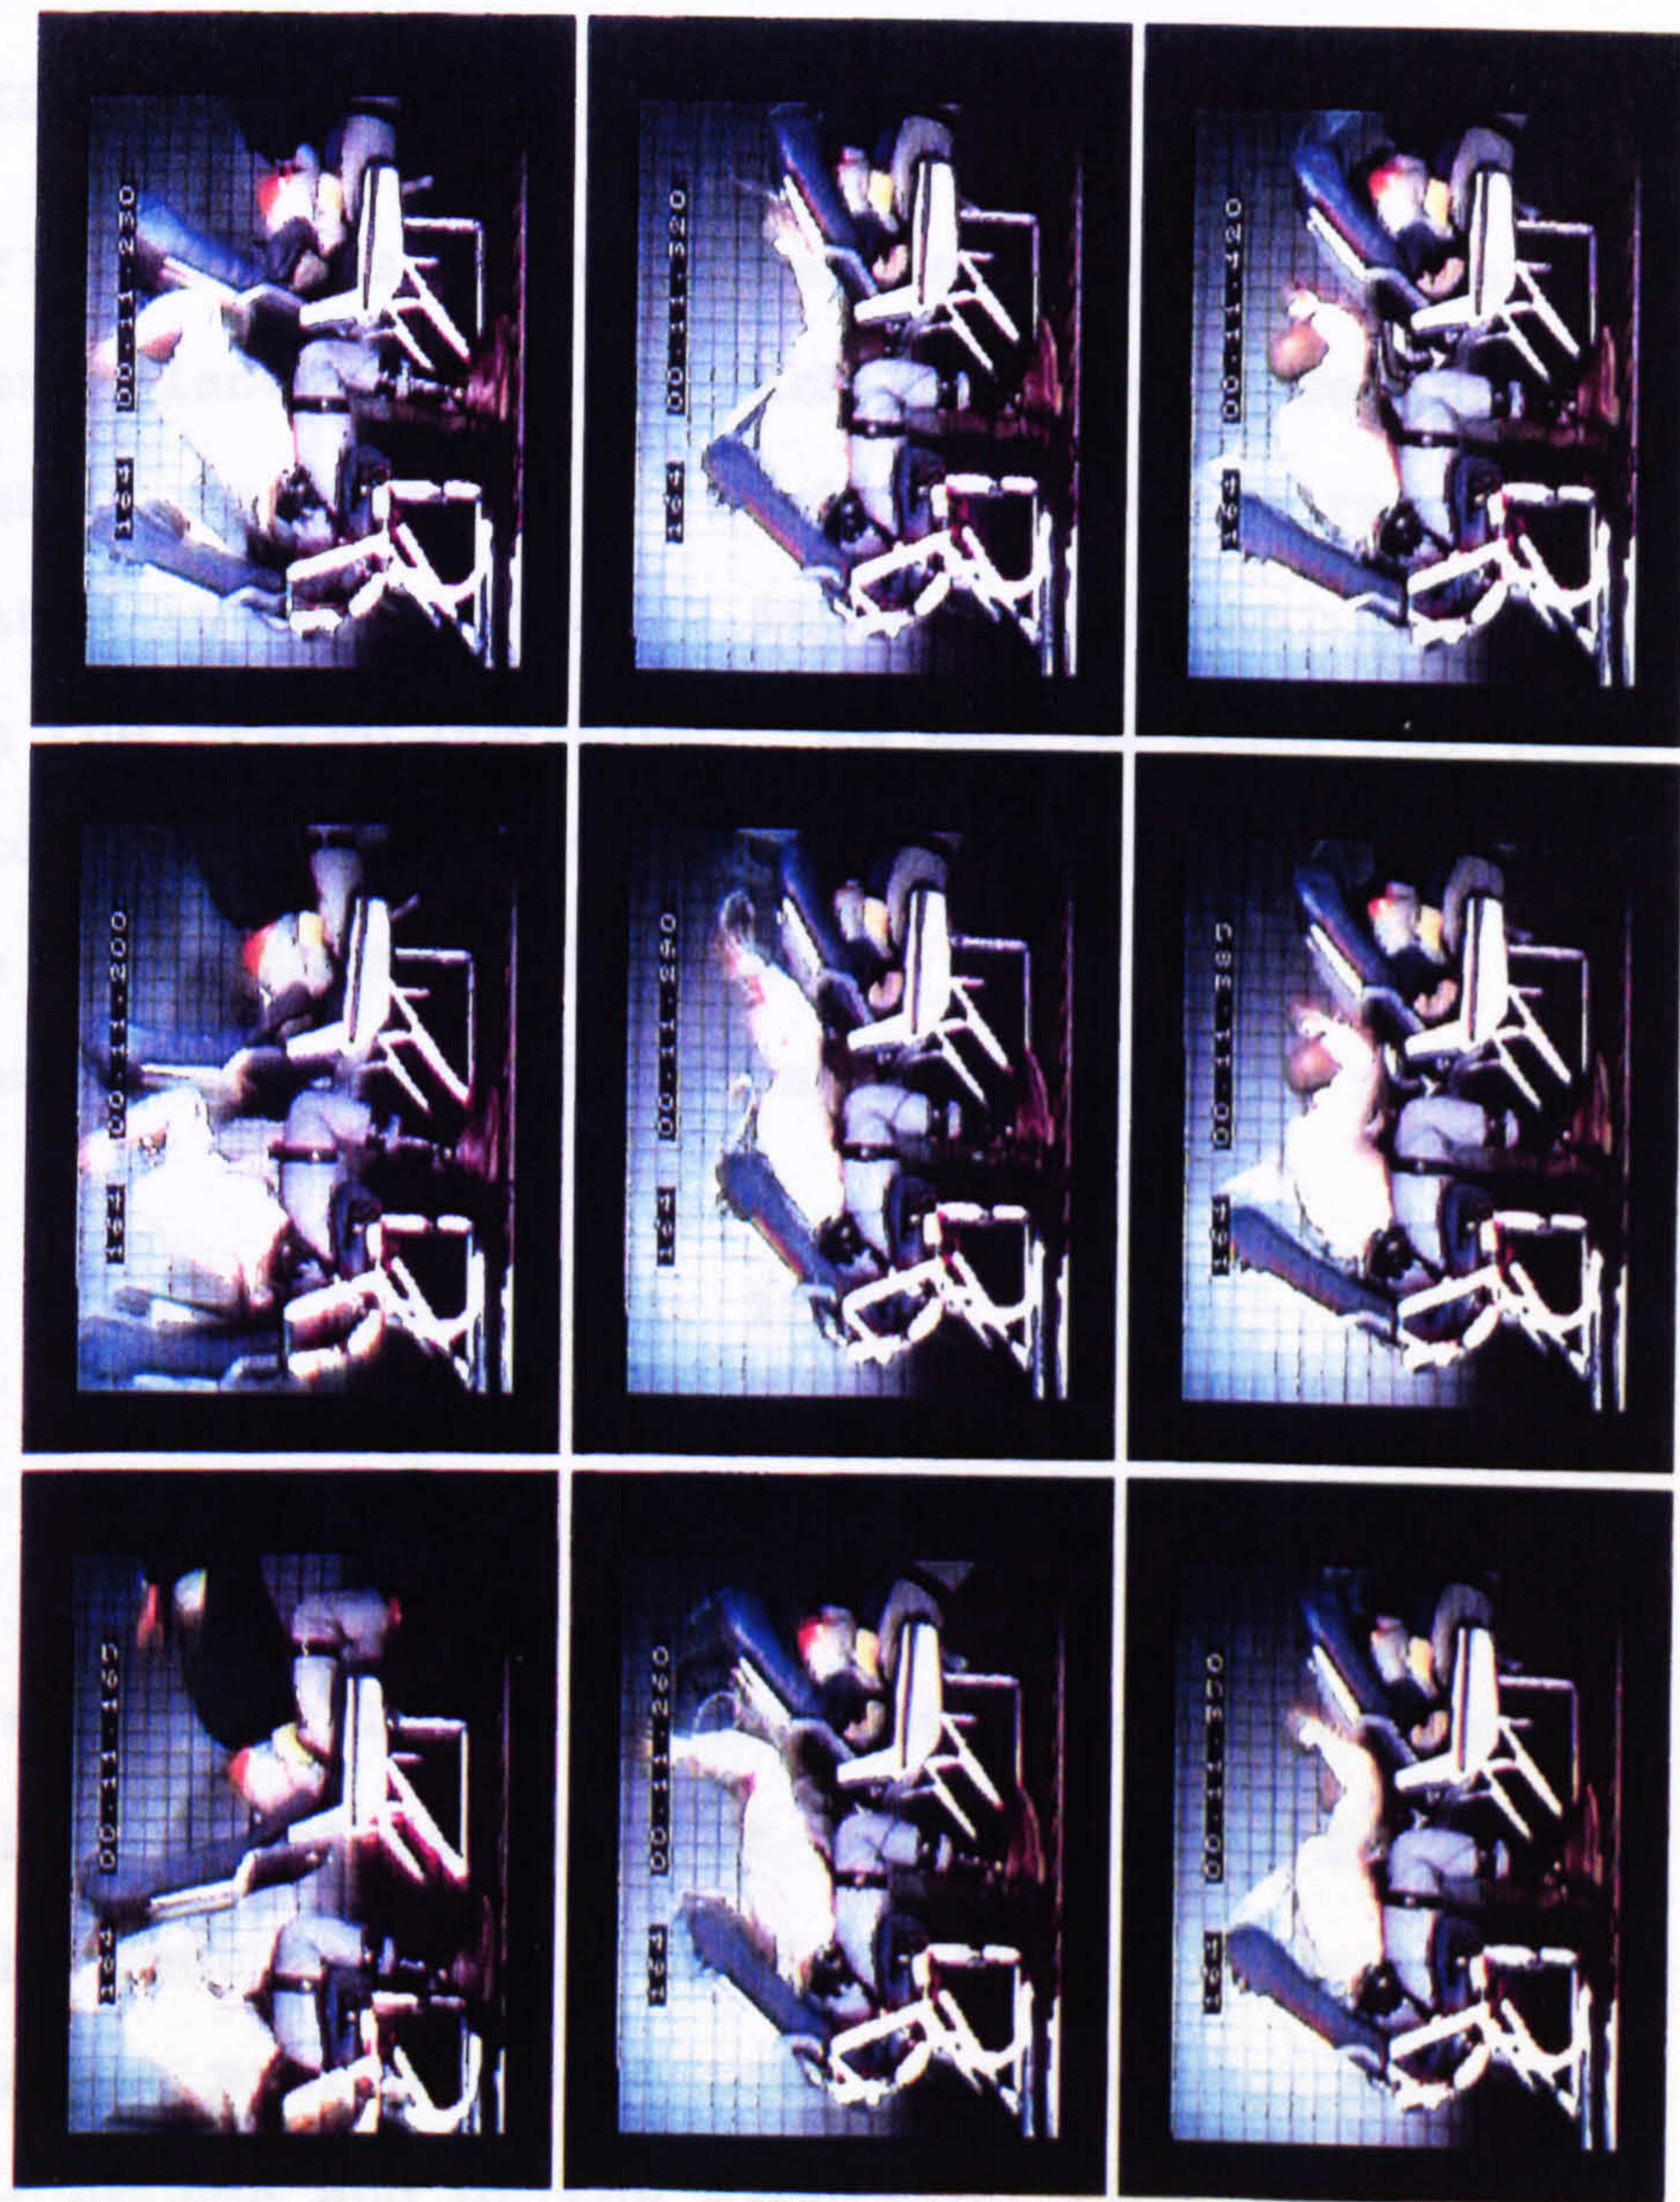
Series 5.31.3

# Non Flail Behaviour as seen in run 3212 (braced)
