1 Out-of-plane response of masonry walls strengthened using 2 textile-mortar system

3 F. A. Kariou¹, S. P. Triantafyllou², D. A. Bournas³ and L. N. Koutas⁴

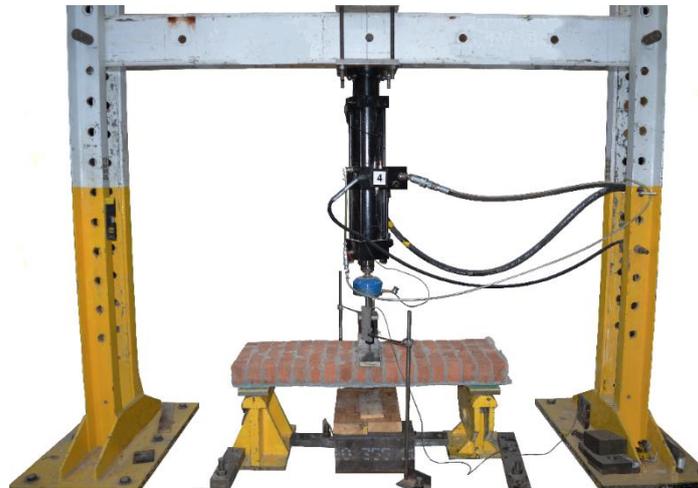
Fig. 1 Experimental setup; (a) plan view and elevation (all dimensions in mm) (b) actual setup

30 The wall specimens with their corresponding parameters are shown in Table 1. The
31 strengthening configuration is shown in Fig. 1a while the actual test setup is shown in Fig.
32 1b. The notation considered for the strengthened specimens is W_XN, where W denotes the
33 single or double-wythe walls (S for single and D for double-wythe wall), X denotes the type
34 of the textile (C for carbon, G for glass and B for coated basalt) and N denotes the number of
35 layers (1, 3 and 7). The suffix Co denotes textiles coating with epoxy resin.

4 A three-point-bending loading configuration was adopted for the out-of-plane tests of the
 5 masonry walls, resulting in an effective span of 1125 mm, as shown in Fig. 1a. The supports
 6 were spaced 107.5 mm from the ends of the masonry wall. The test setup consisted of a stiff
 7 steel reaction frame fastened with a vertically positioned actuator as shown in Fig. 1b. A 100
 8 kN capacity servo-hydraulic actuator, used for the load application at a displacement rate
 9 equal to 0.017 mm/s (i.e., 1mm/ min). Two potentiometers were used to measure the out-of-
 10 plane displacement at mid-span. The transducers were placed at a distance of 50 mm from
 11 each side of the wall, as shown in Fig. 1a. Data was collected at a frequency of 4 Hz,
 12 synchronised and recorded using a fully-computerized data acquisition system.

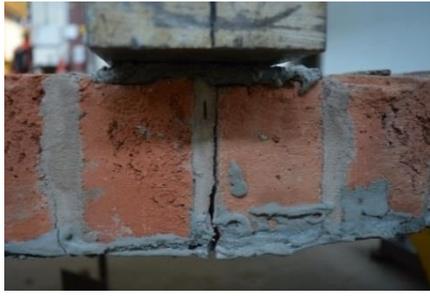
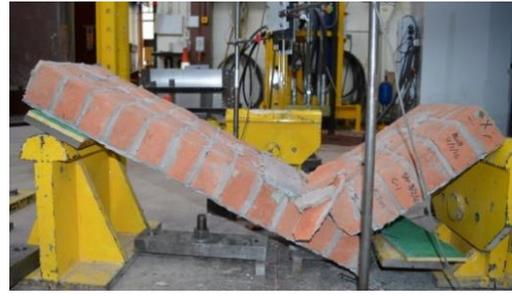
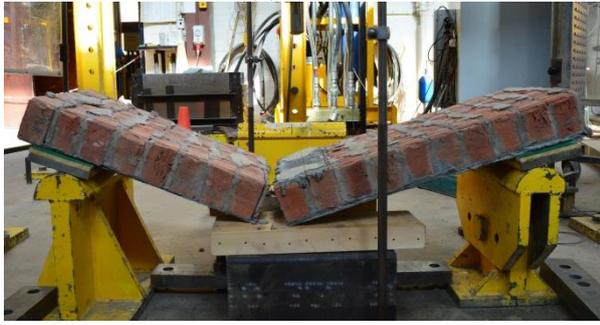
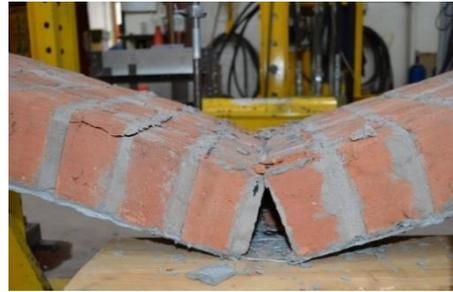
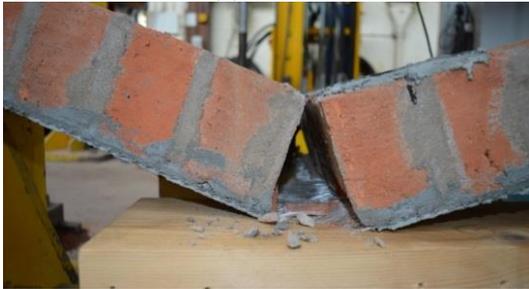
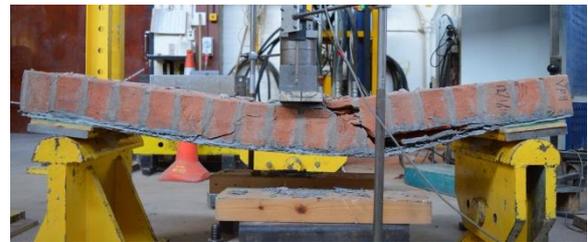
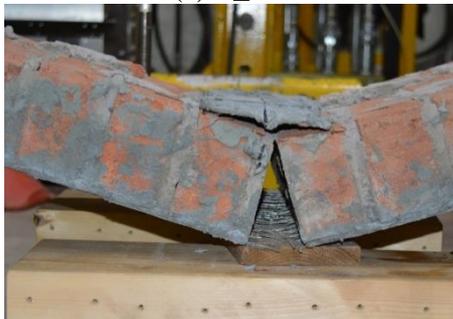
Fig. 6 Failure modes of single-wythe specimens

4 The failure mode observed in the strengthened specimens varied, depending on the textile
 5 material used, the presence of coating or not and the number of applied layers. The observed
 6 failure modes comprised textile rupture (S_C1_(Co), S_G3, S_G3_(Co), S_G7, S_B3),
 7 slippage of the textile fibres through the mortar (S_C1), and shear failure of the masonry wall
 8 (S_G7_(Co), S_B7) as shown in Table 4. Failure modes of all single-wythe specimens are
 9 shown in Fig. 6.

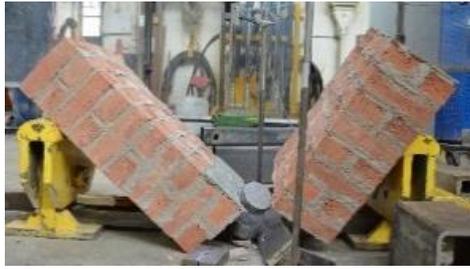
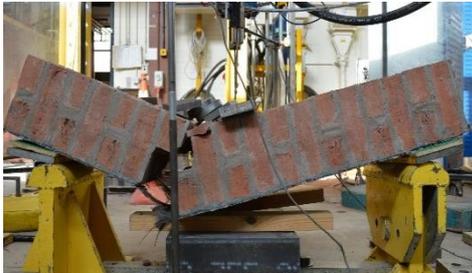
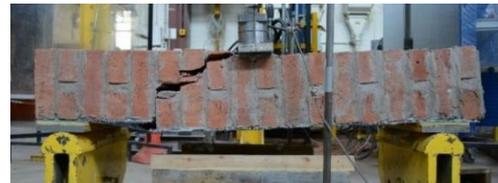
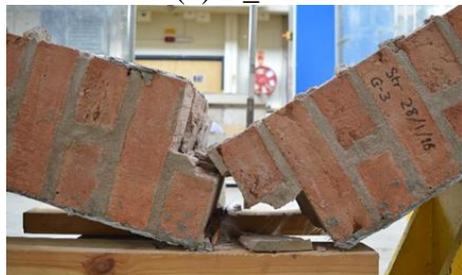
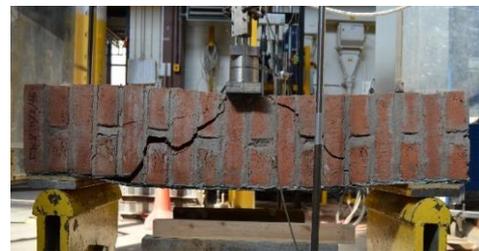
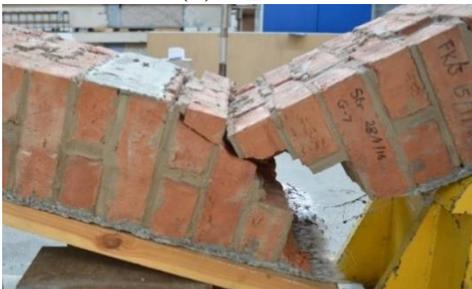
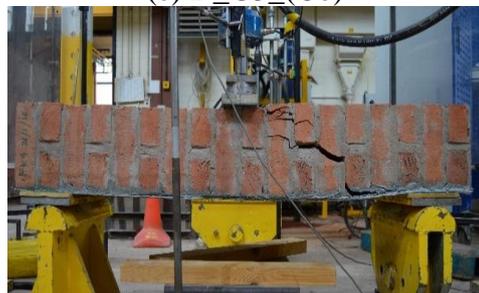
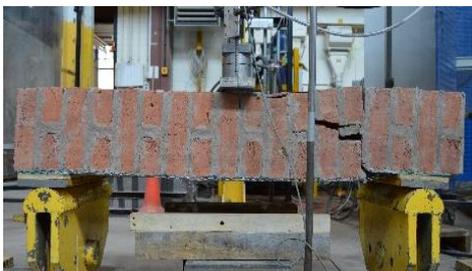
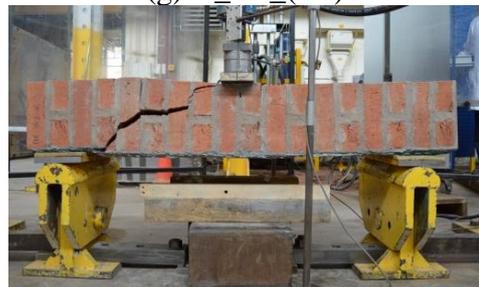
Fig. 7 Failure modes of double-wythe specimens

23 The observed failure loads were textile rupture (D_C1, D_G3), diagonal tension (D_B7),
 24 shear flexure followed by TRM debonding (D_G3_(Co), D_G7_(Co)), shear-flexure
 25 followed by textile rupture (D_G7), and shear-flexure followed by brick sliding and partial
 26 textile rupture (D_C1_(Co), D_B3). Failure modes of all single-wythe specimens are shown
 27 in Fig. 7.
