**"THE NON-TIDAL, NAVIGABLE THAMES:
A BANK EROSION MANAGEMENT STRATEGY"**

by Sue Reed BSc, MSc, MCIWEM

**Thesis submitted to the University of Nottingham
for the degree of Doctor of Philosophy, October 1998**

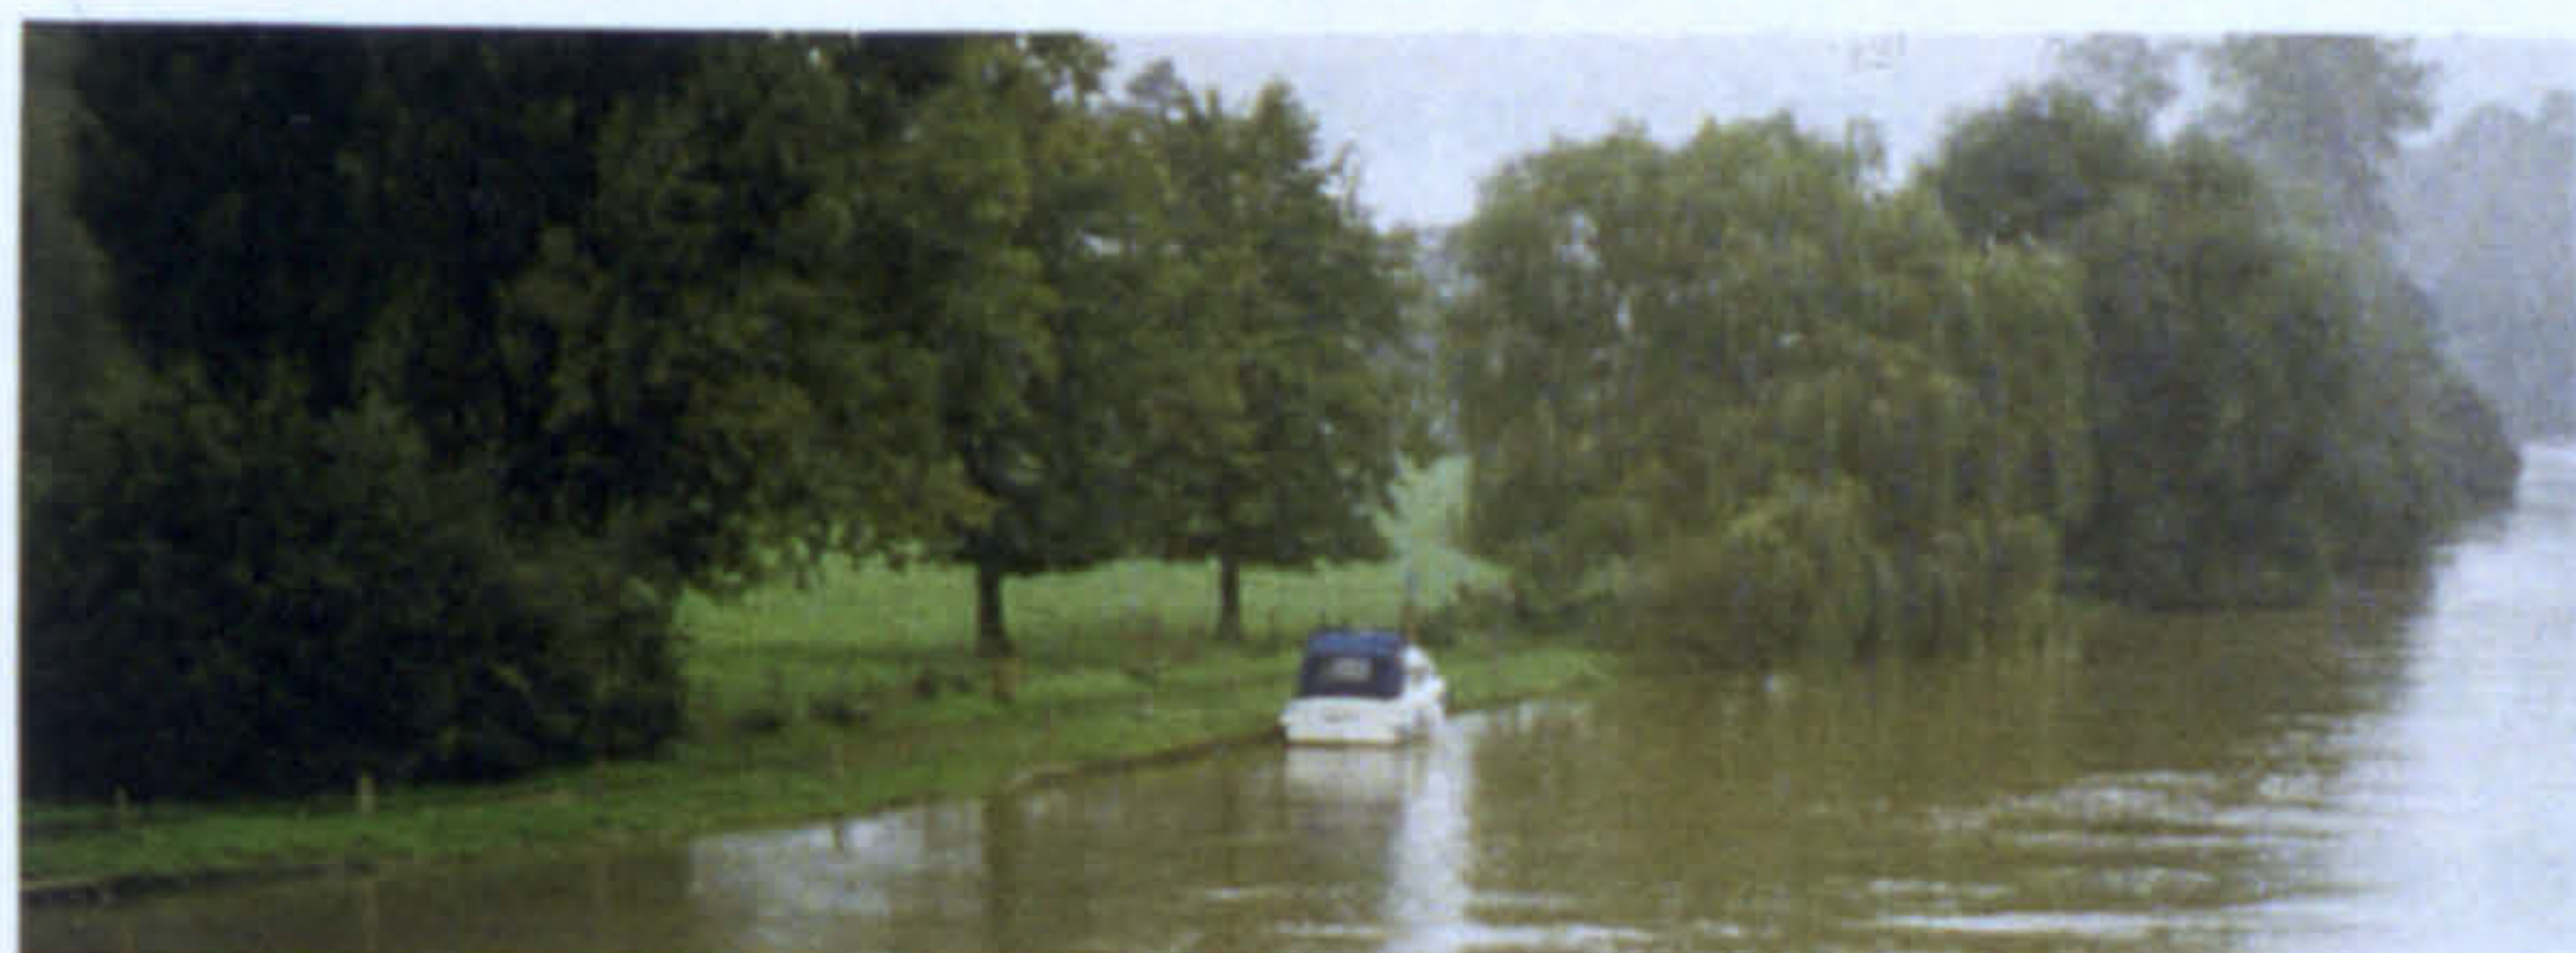
The influence of the high autumn and winter flows is particularly apparent at profile four. Plate 4.4 is an upstream view of the left bank upstream of Wallingford Bridge, taken during the high autumn flows on 28 September 1992. Plate 4.5 shows the same stretch of river taken during the winter floods on 30 November 1992 when the water level was well above bankfull discharge, inundating the flood plain. For comparison, Plate 4.6 shows the flow in May 1993 when winter discharges had subsided.

*Plate 4.4
Upper Wallingford
during the high
autumn flows in
September 1992.*

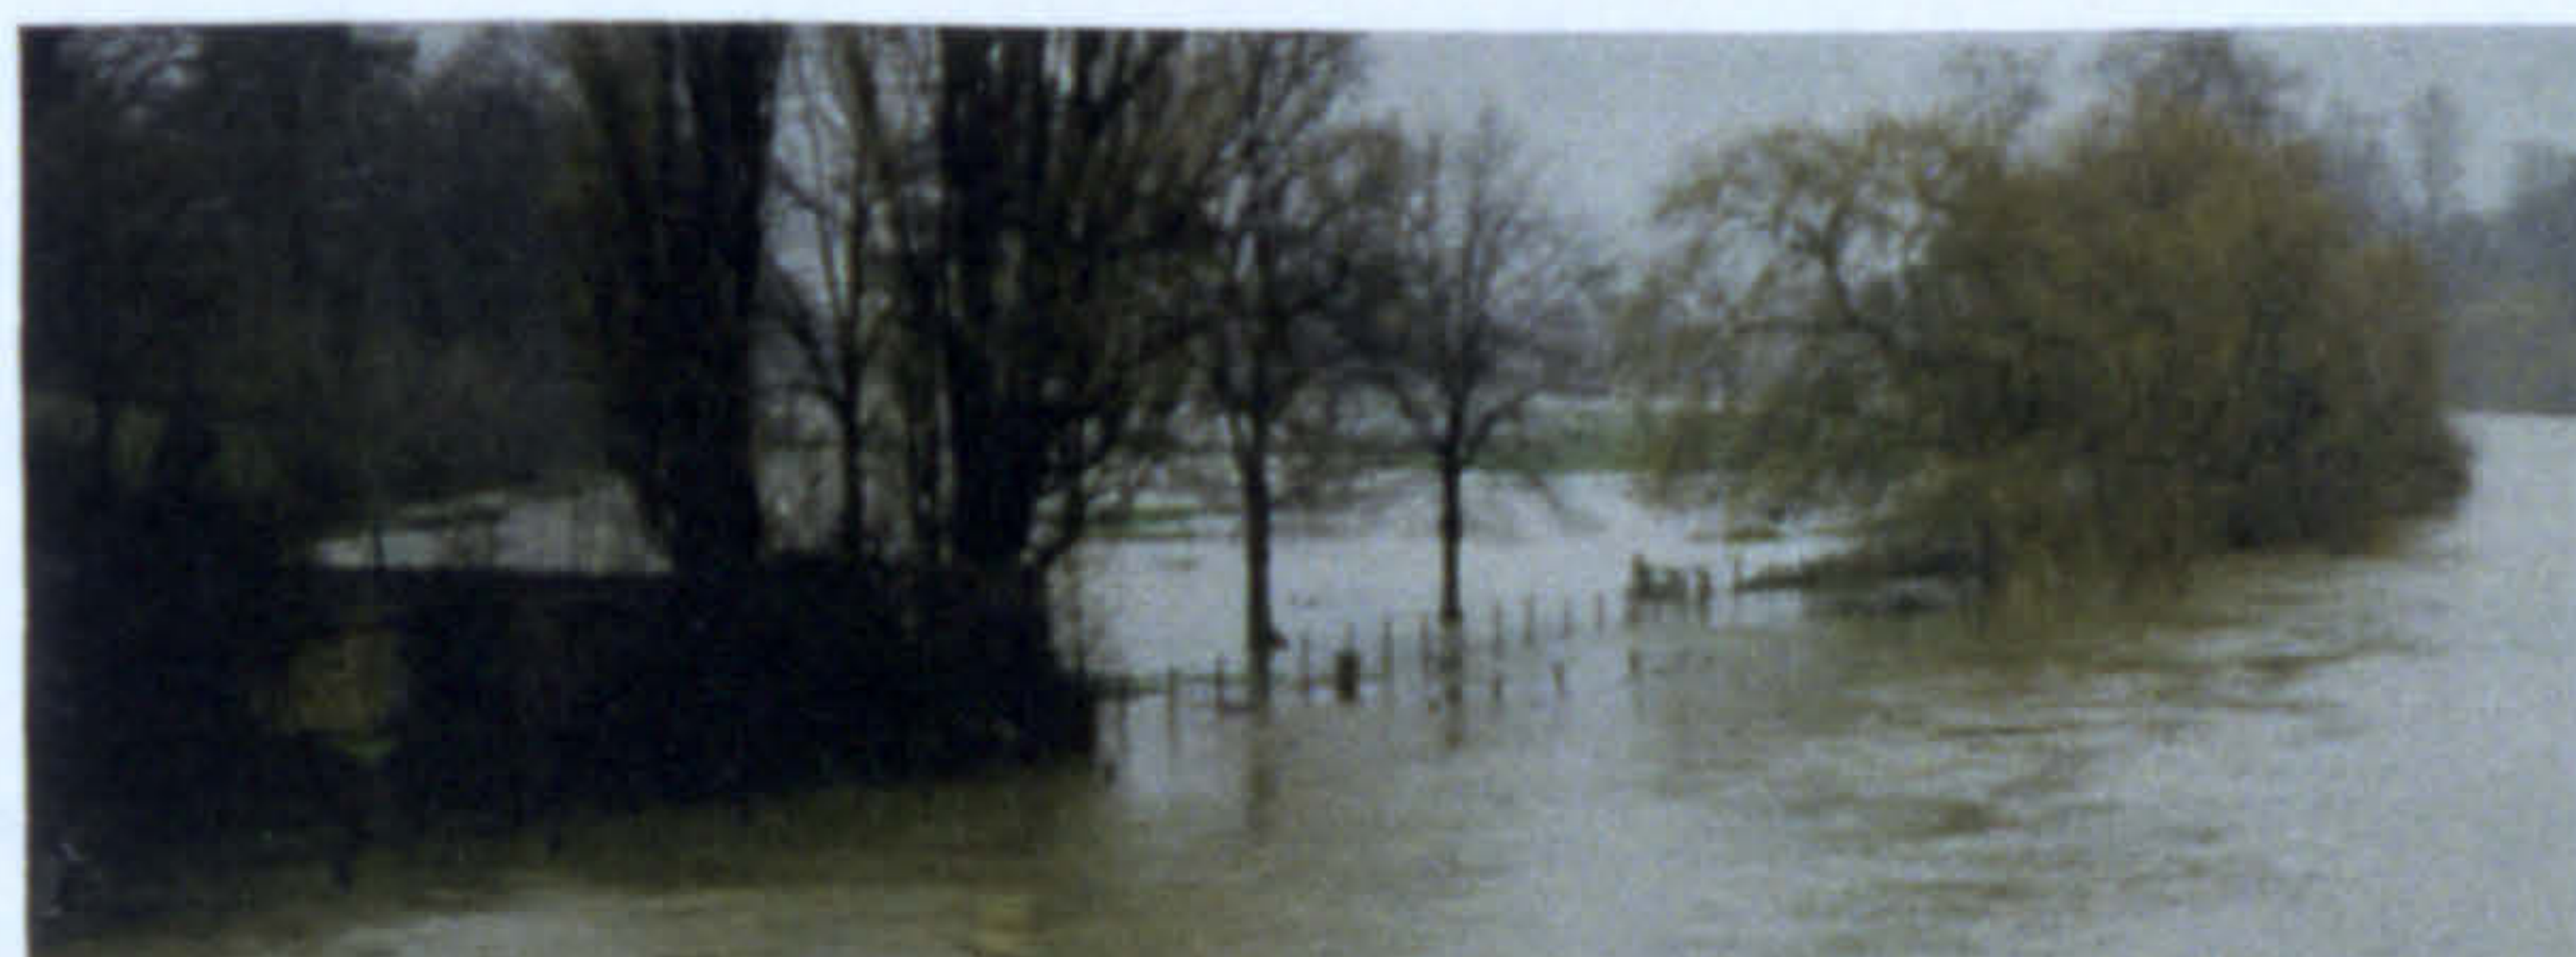
*Plate 4.5
Upper Wallingford
during the high
winter flows in
November 1992.*

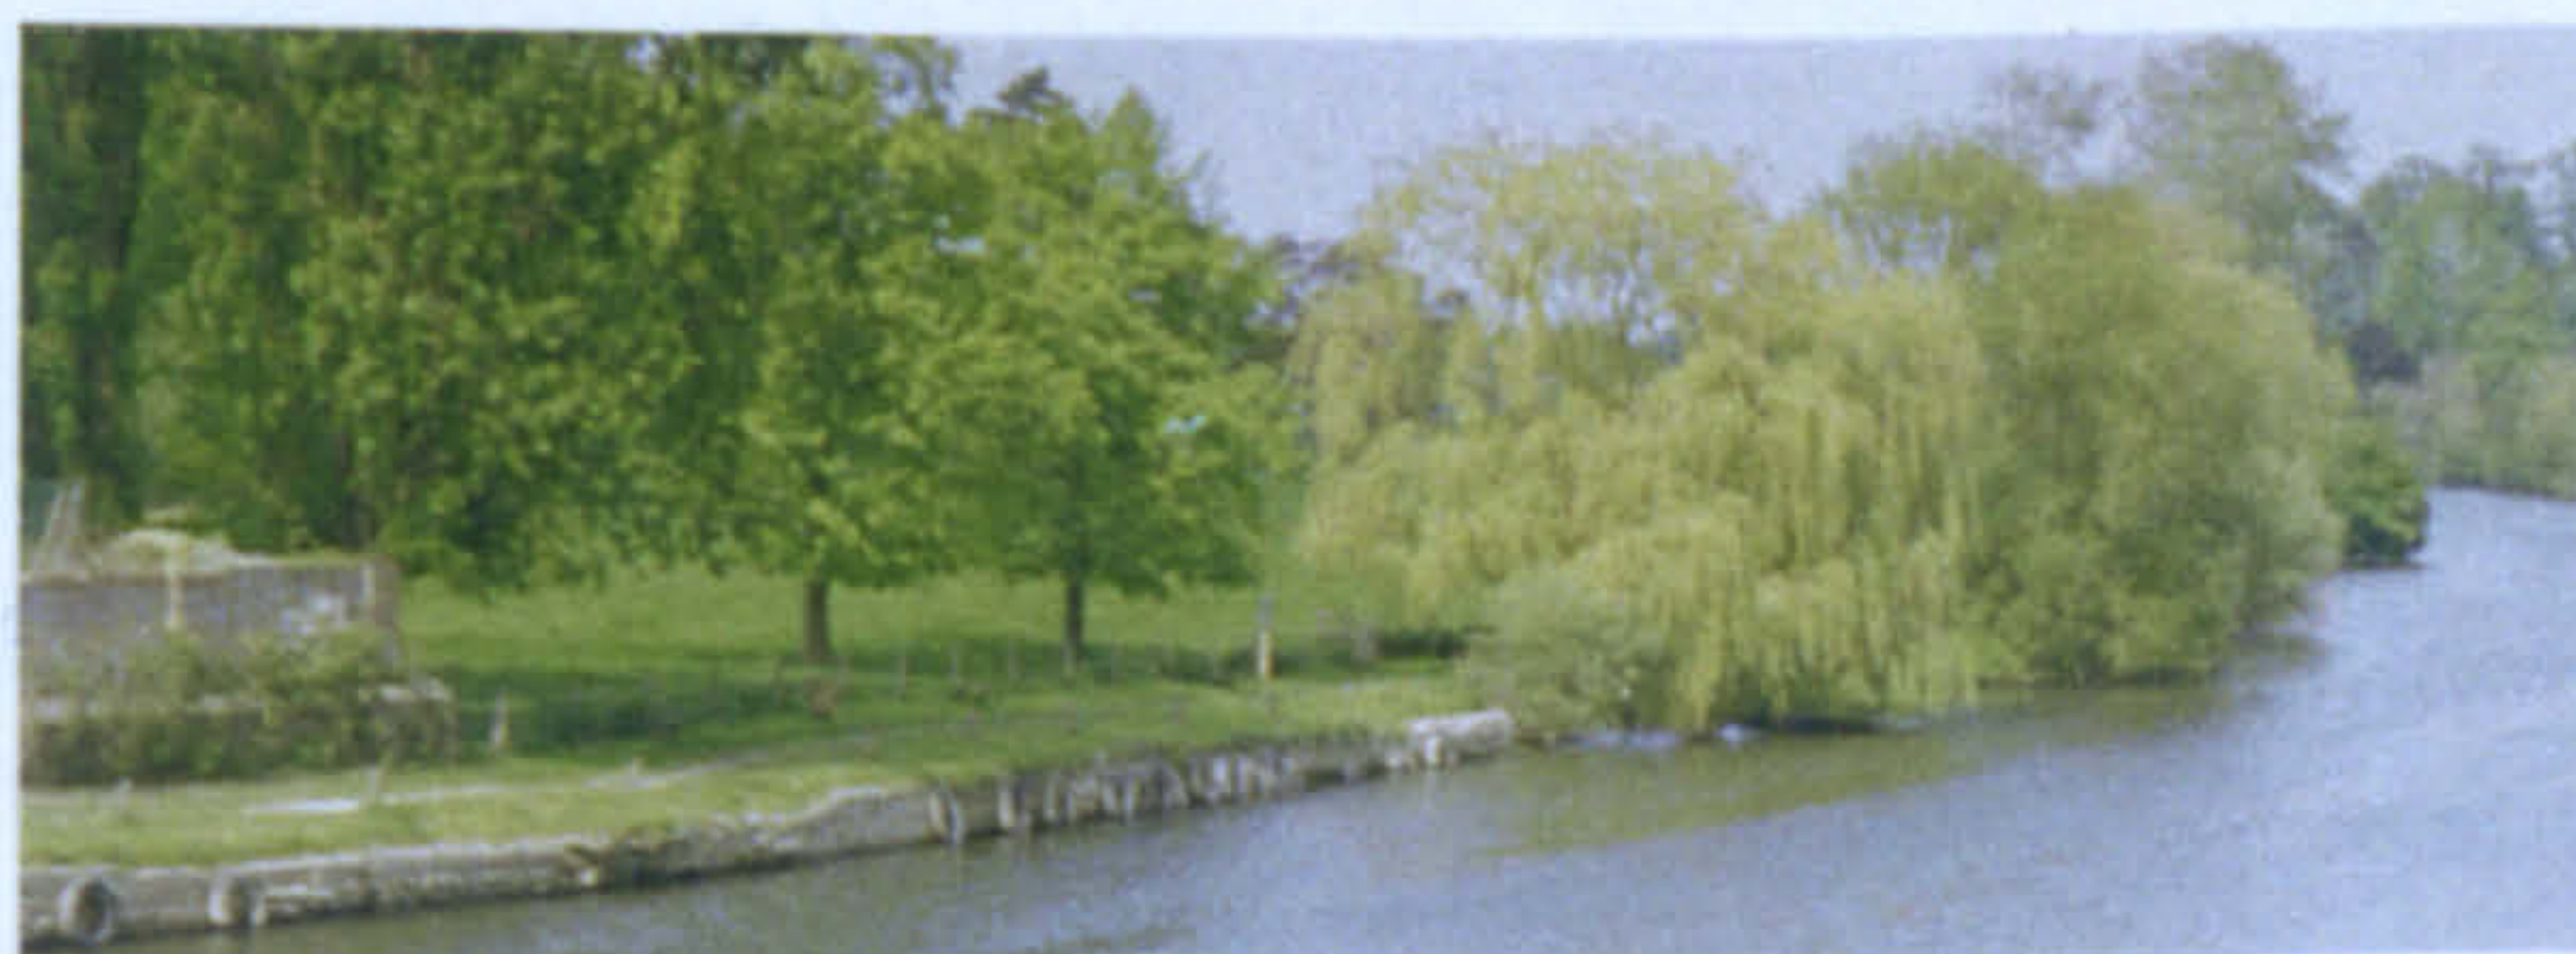
*Plate 4.6
Upper Wallingford
after subsidence
of the high flows
(May 1993).*

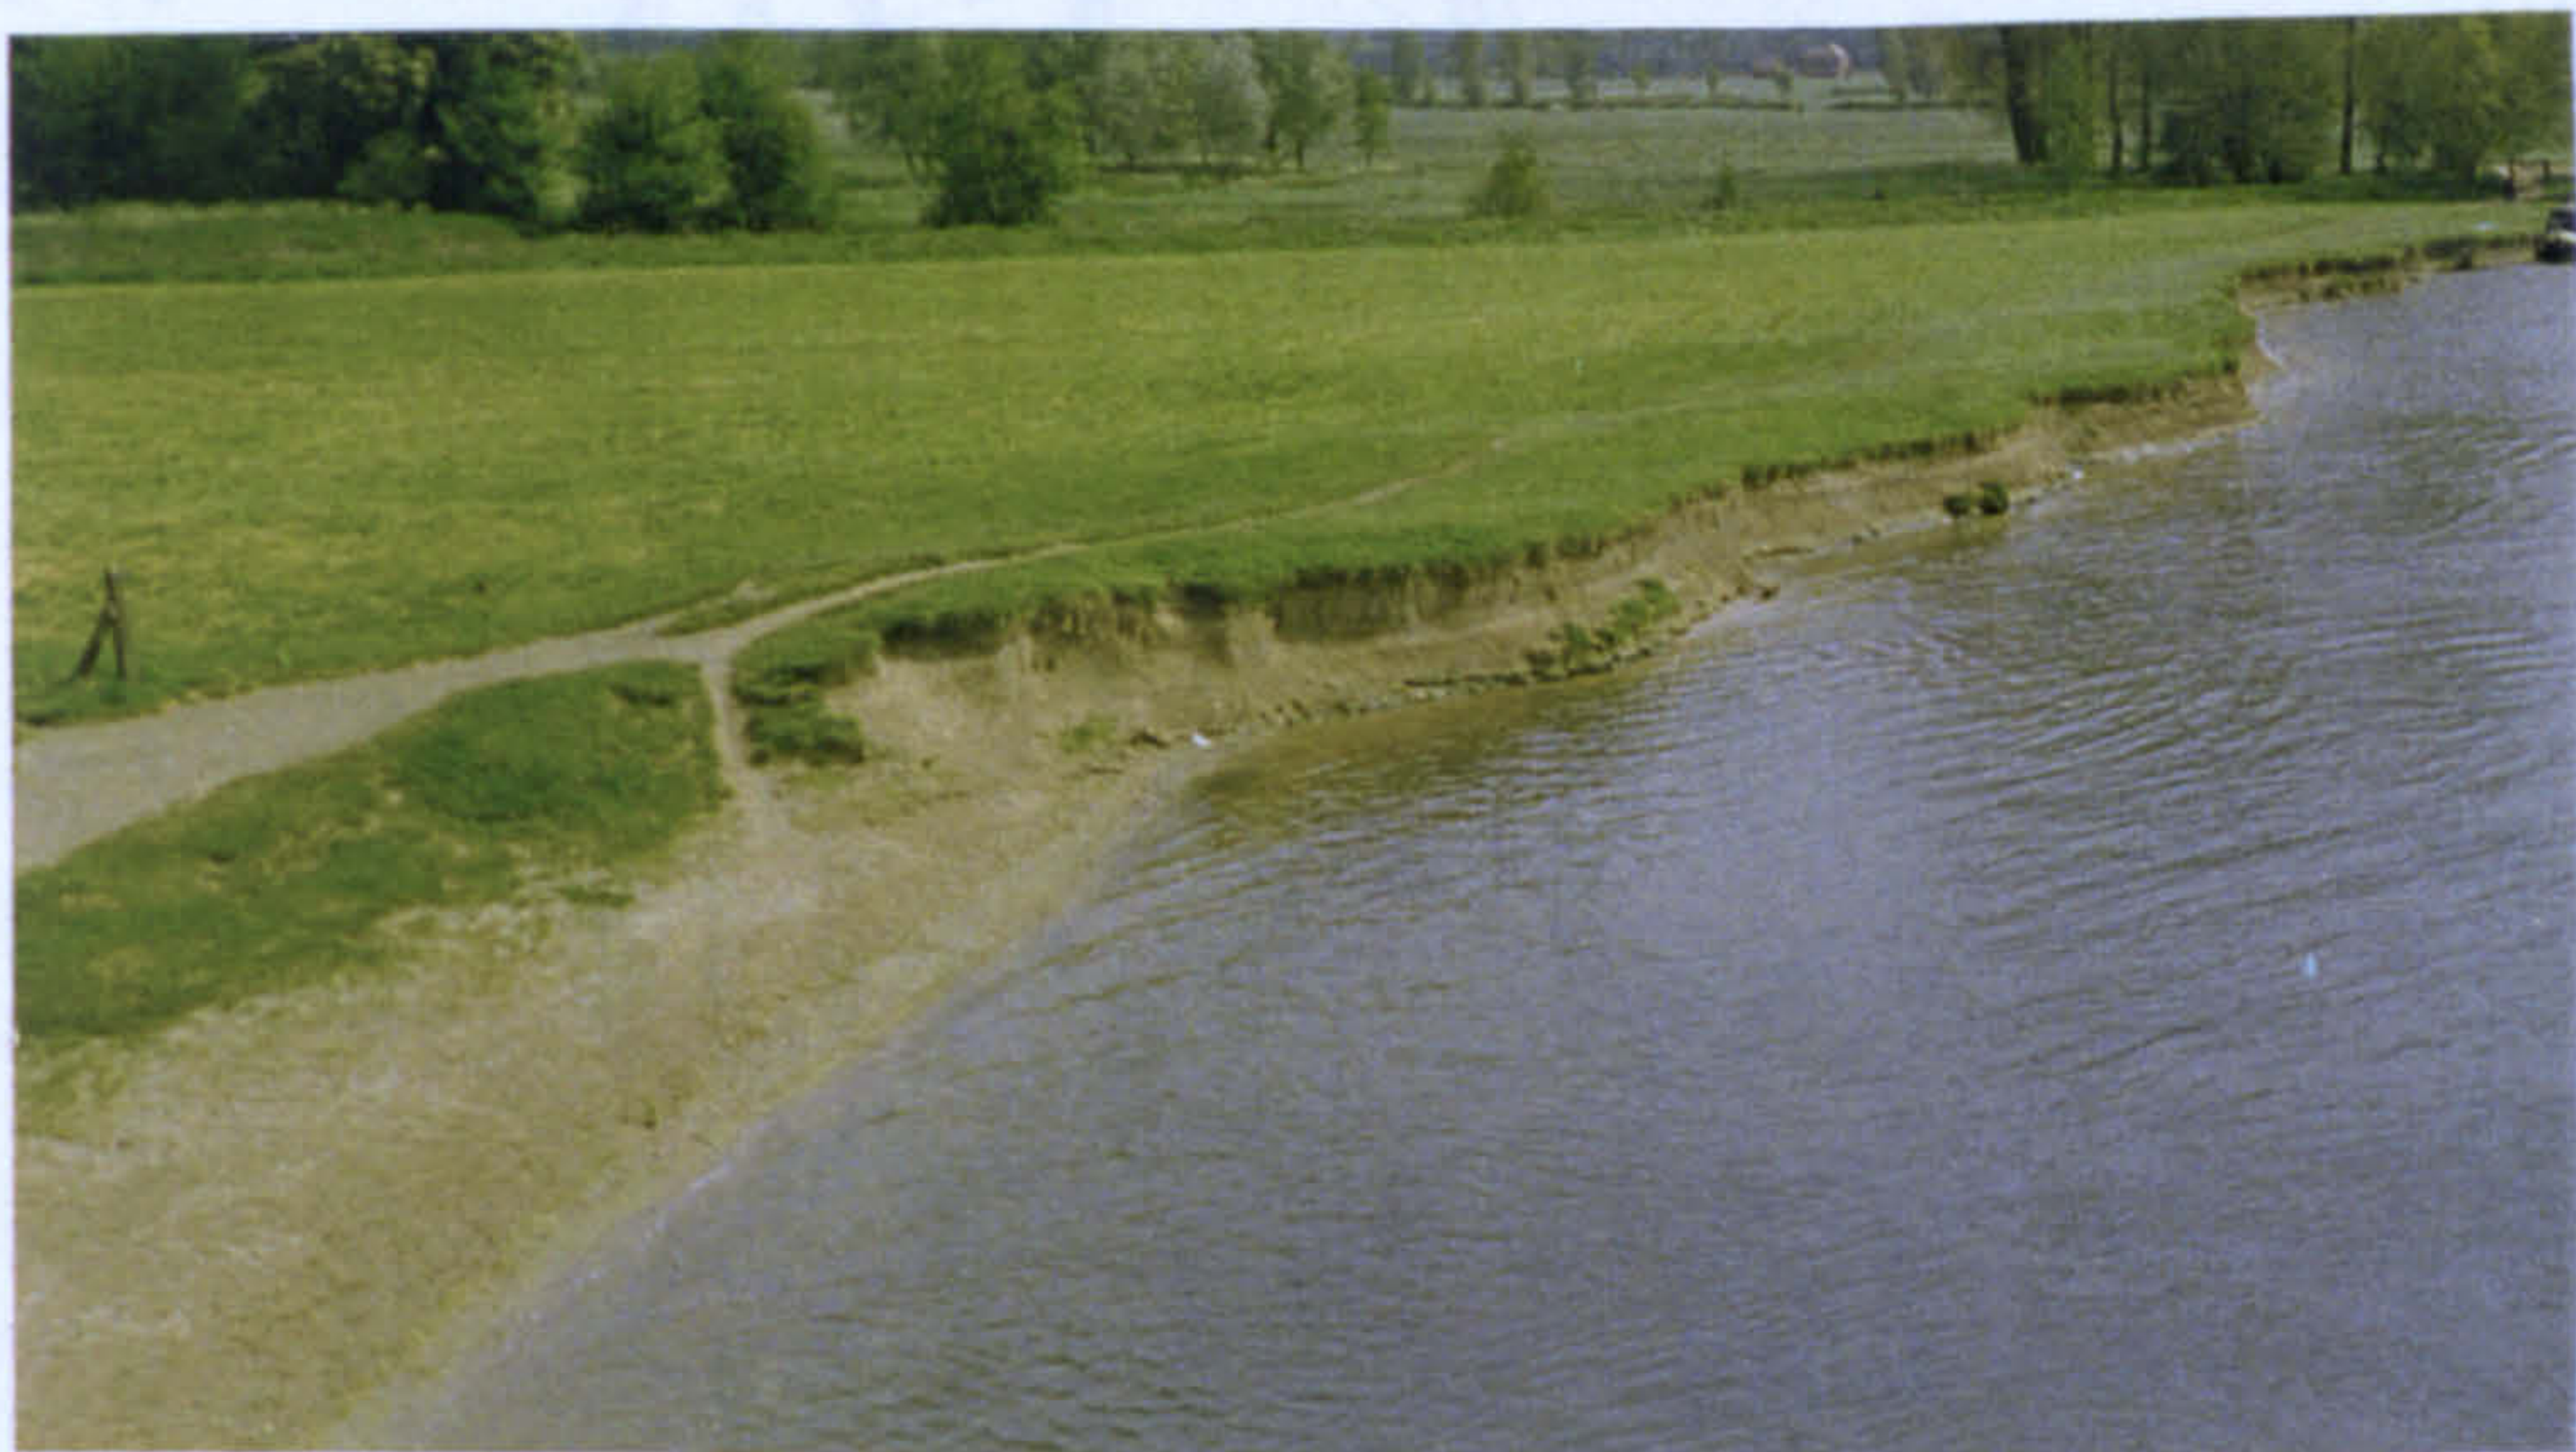
Plate 4.7 is a downstream view of the Lower Wallingford monitoring site, taken from Wallingford Bridge. The bank here is high and steep. The face of the bank remained unvegetated for most of the year, with summer vegetation being restricted only to the few parts where the bank is sufficiently shelved to facilitate colonisation.

Plate 4.7 Downstream view of the Lower Wallingford monitoring site.

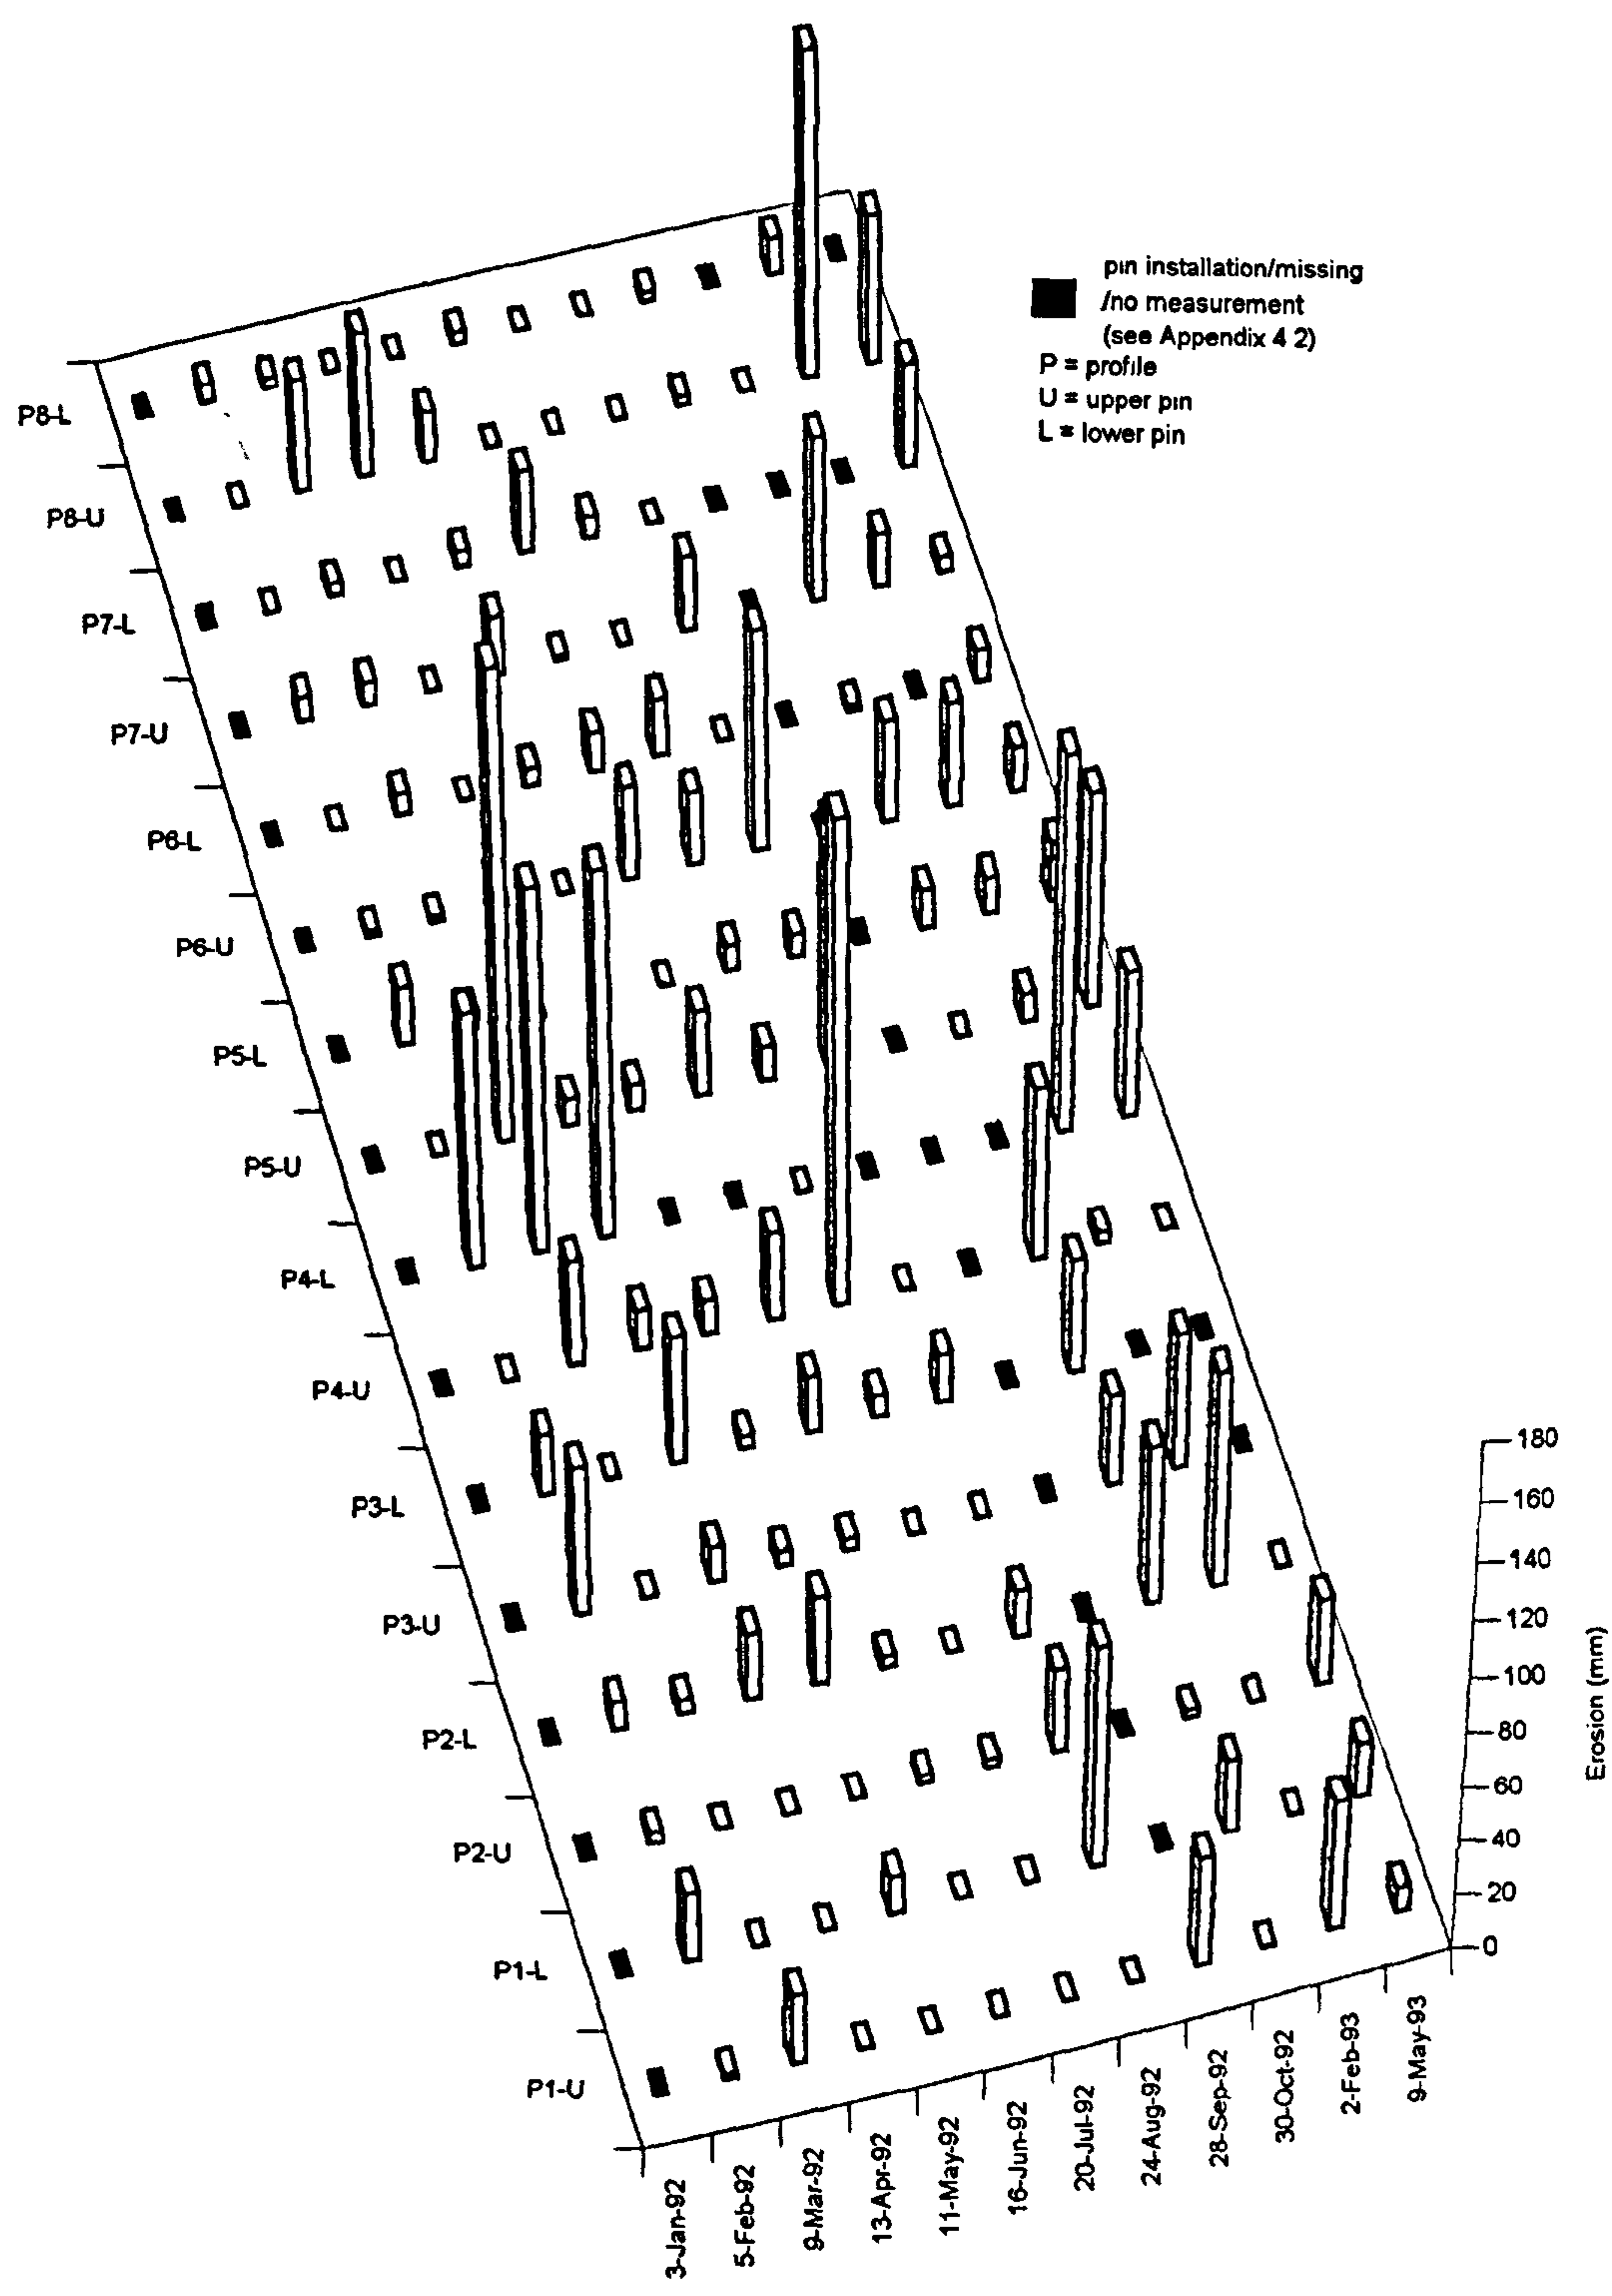
Figure 4.4, along with the bank survey, show the total erosion at the upper bank of profile one through the monitoring period to be comparable to that at the lower bank. However, the majority of the lower bank erosion was during the summer, from 20 July to 24 August 1992, when 81mm of erosion was measured, compared to the majority of the upper bank erosion being during the

high autumn and winter flows. After the autumn flows 40mm of upper bank erosion was measured, compared to 48mm on 2 February, after the winter floods.

Figure 4.4 Bank erosion measured at Lower Wallingford.

The surveys taken at profile two are also shown in Appendix 4.4. Figure 4.4 shows that the majority of lower bank erosion was measured after the high flows in autumn and winter, 55mm and 75mm, respectively, whereas the most upper bank erosion measured at one visit was 30mm for both the periods between 16 June and 24 August 1992 and 2 February to 9 May 1993.

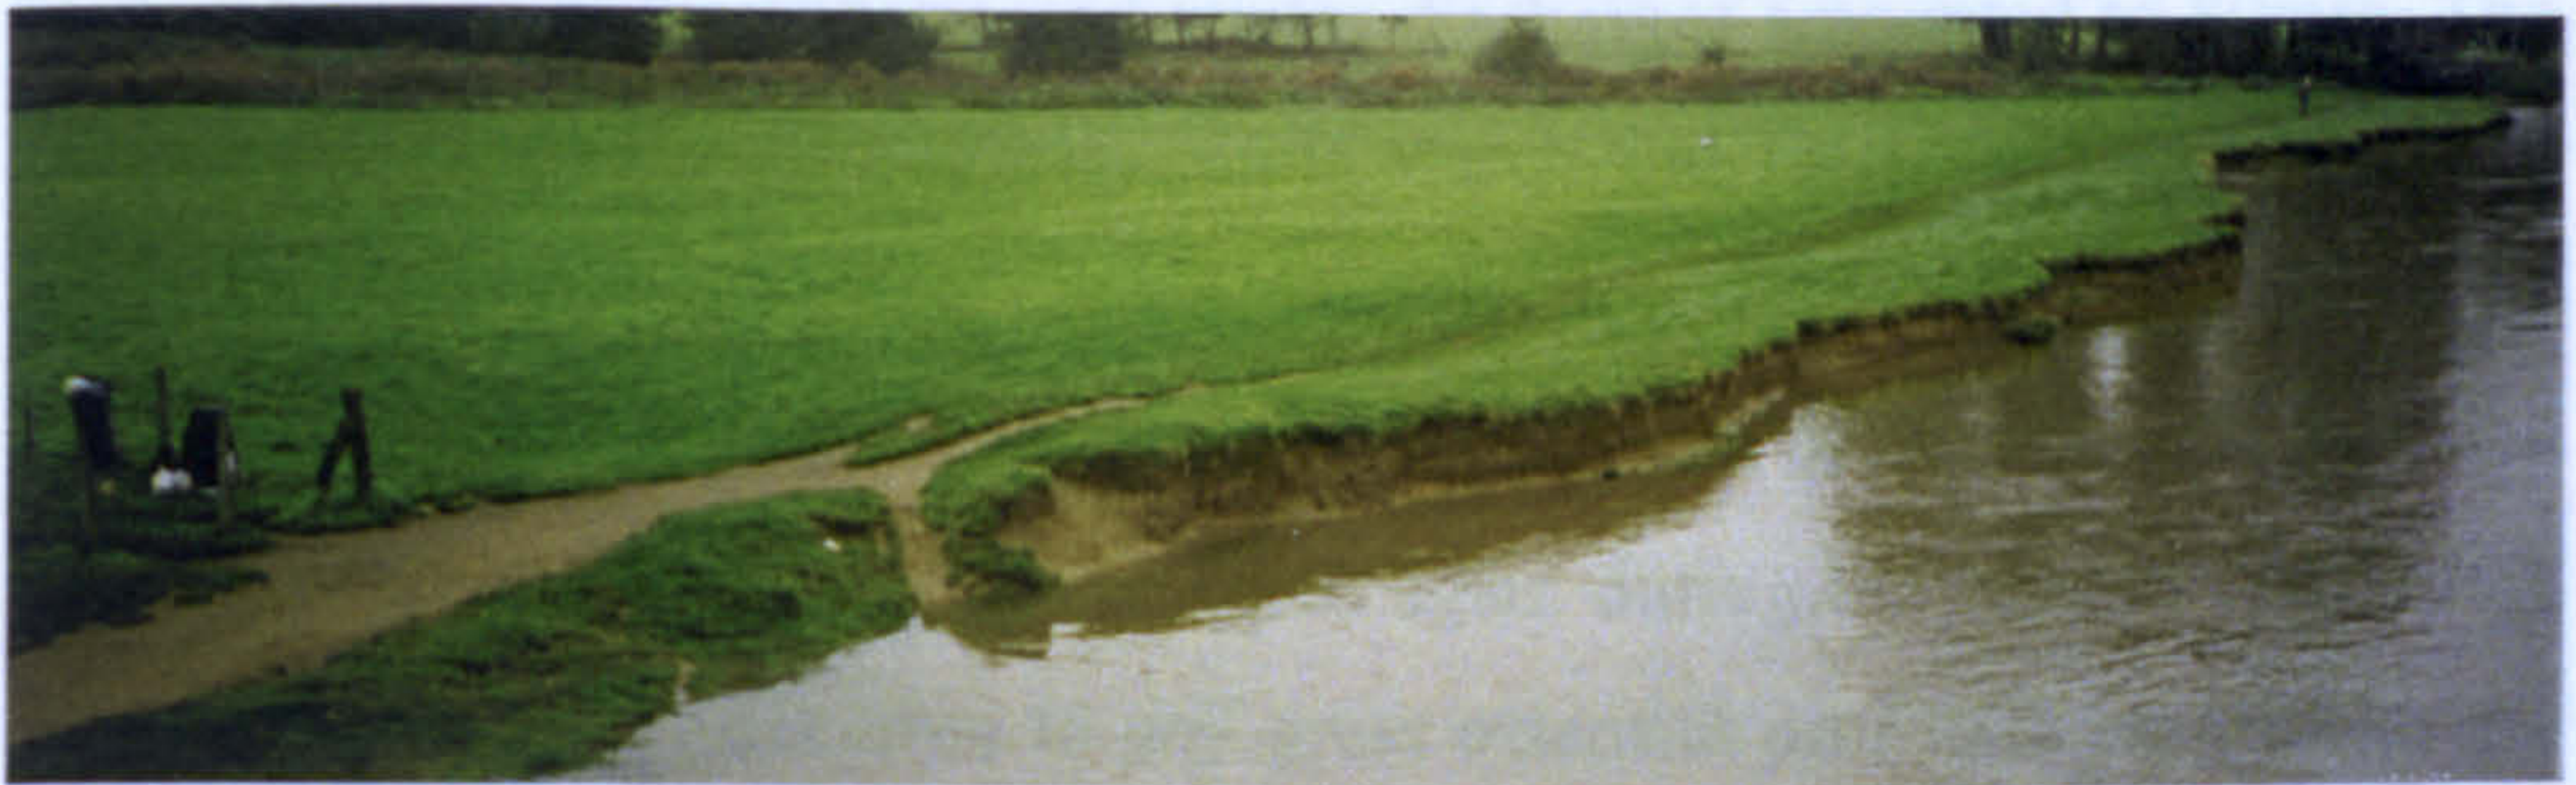
Plates 4.8 and 4.9 were taken at this site during the high autumn and winter flows, respectively. These were taken from Wallingford Bridge and show a downstream view of the monitoring site. Profile one is just downstream of the small unvegetated gully visible in Plate 4.8 but inundated in Plate 4.9. Lower bank erosion at profile one was also substantial in spring 1992 and spring 1993 which may be as a result of frost action and cycles of wetting and drying. Plate 4.10 was taken on 24 January 1992, just downstream of profile one, and shows the freezing conditions at the lower bank.

Plate 4.8 Lower Wallingford during the high autumn flows in September 1992.

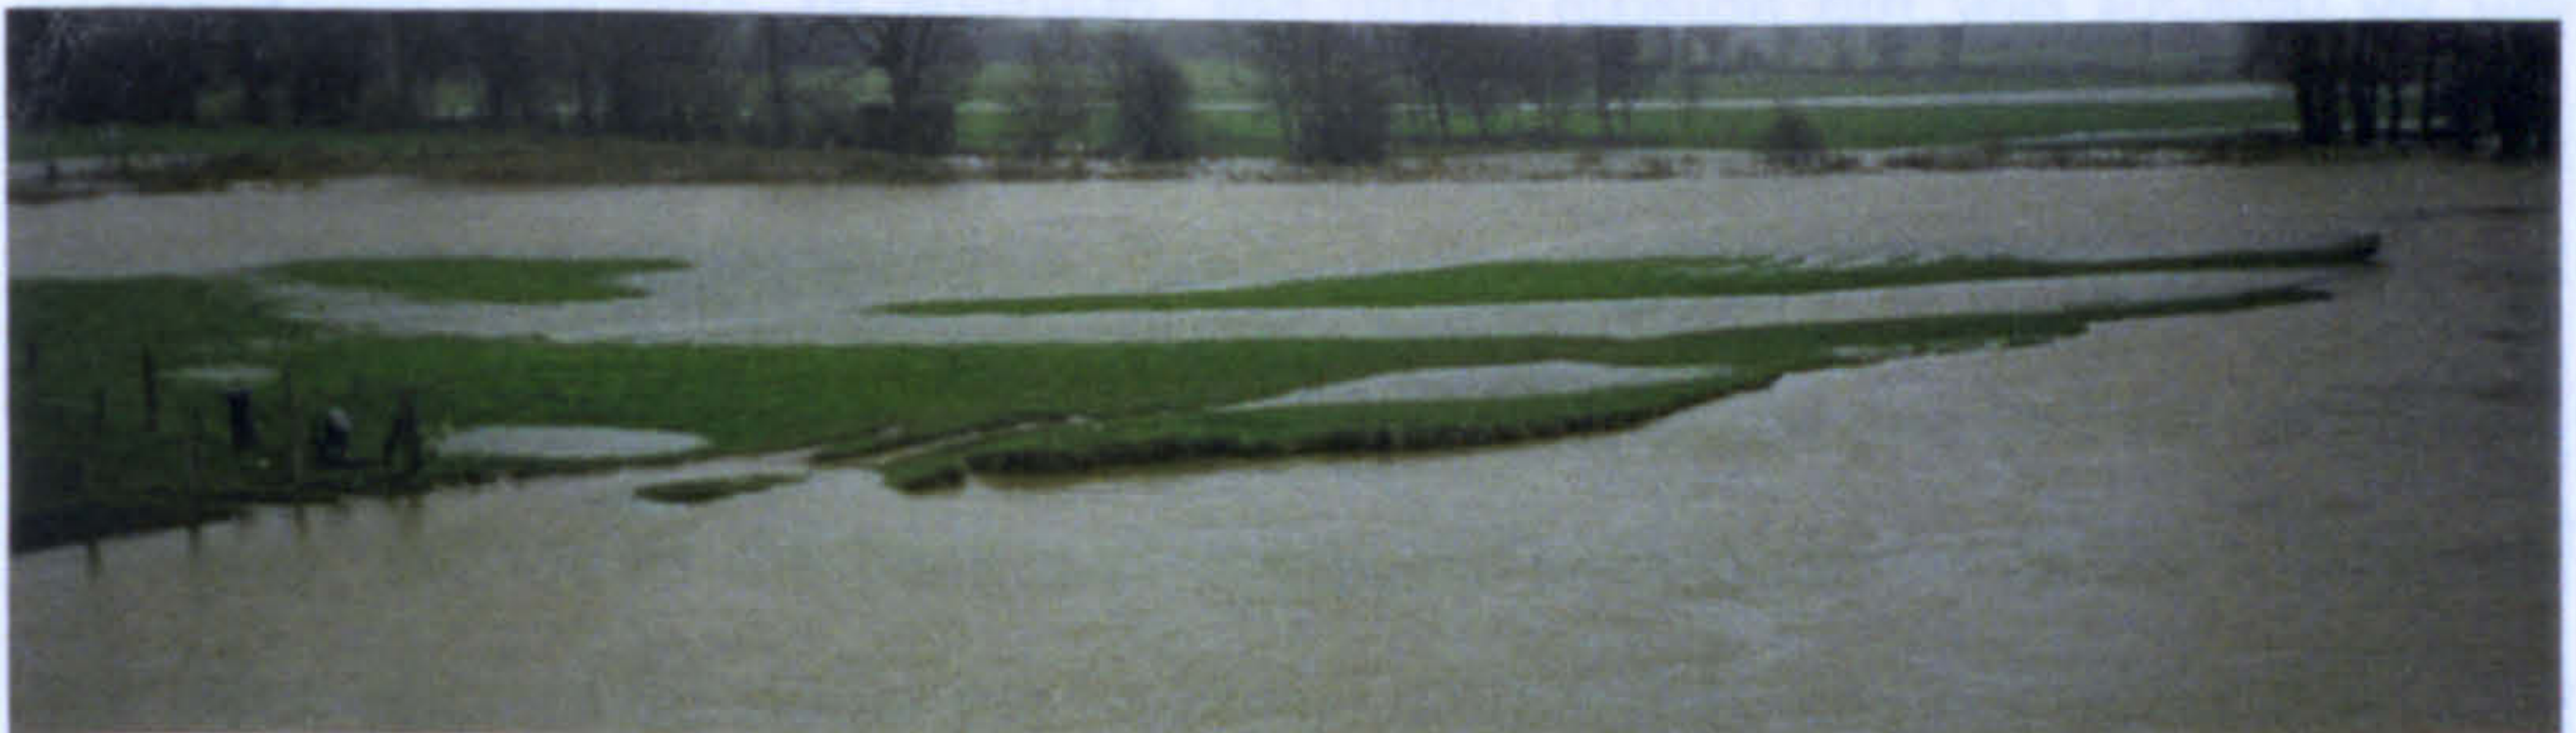
Plate 4.9 Lower Wallingford during the high winter flows in November 1992.

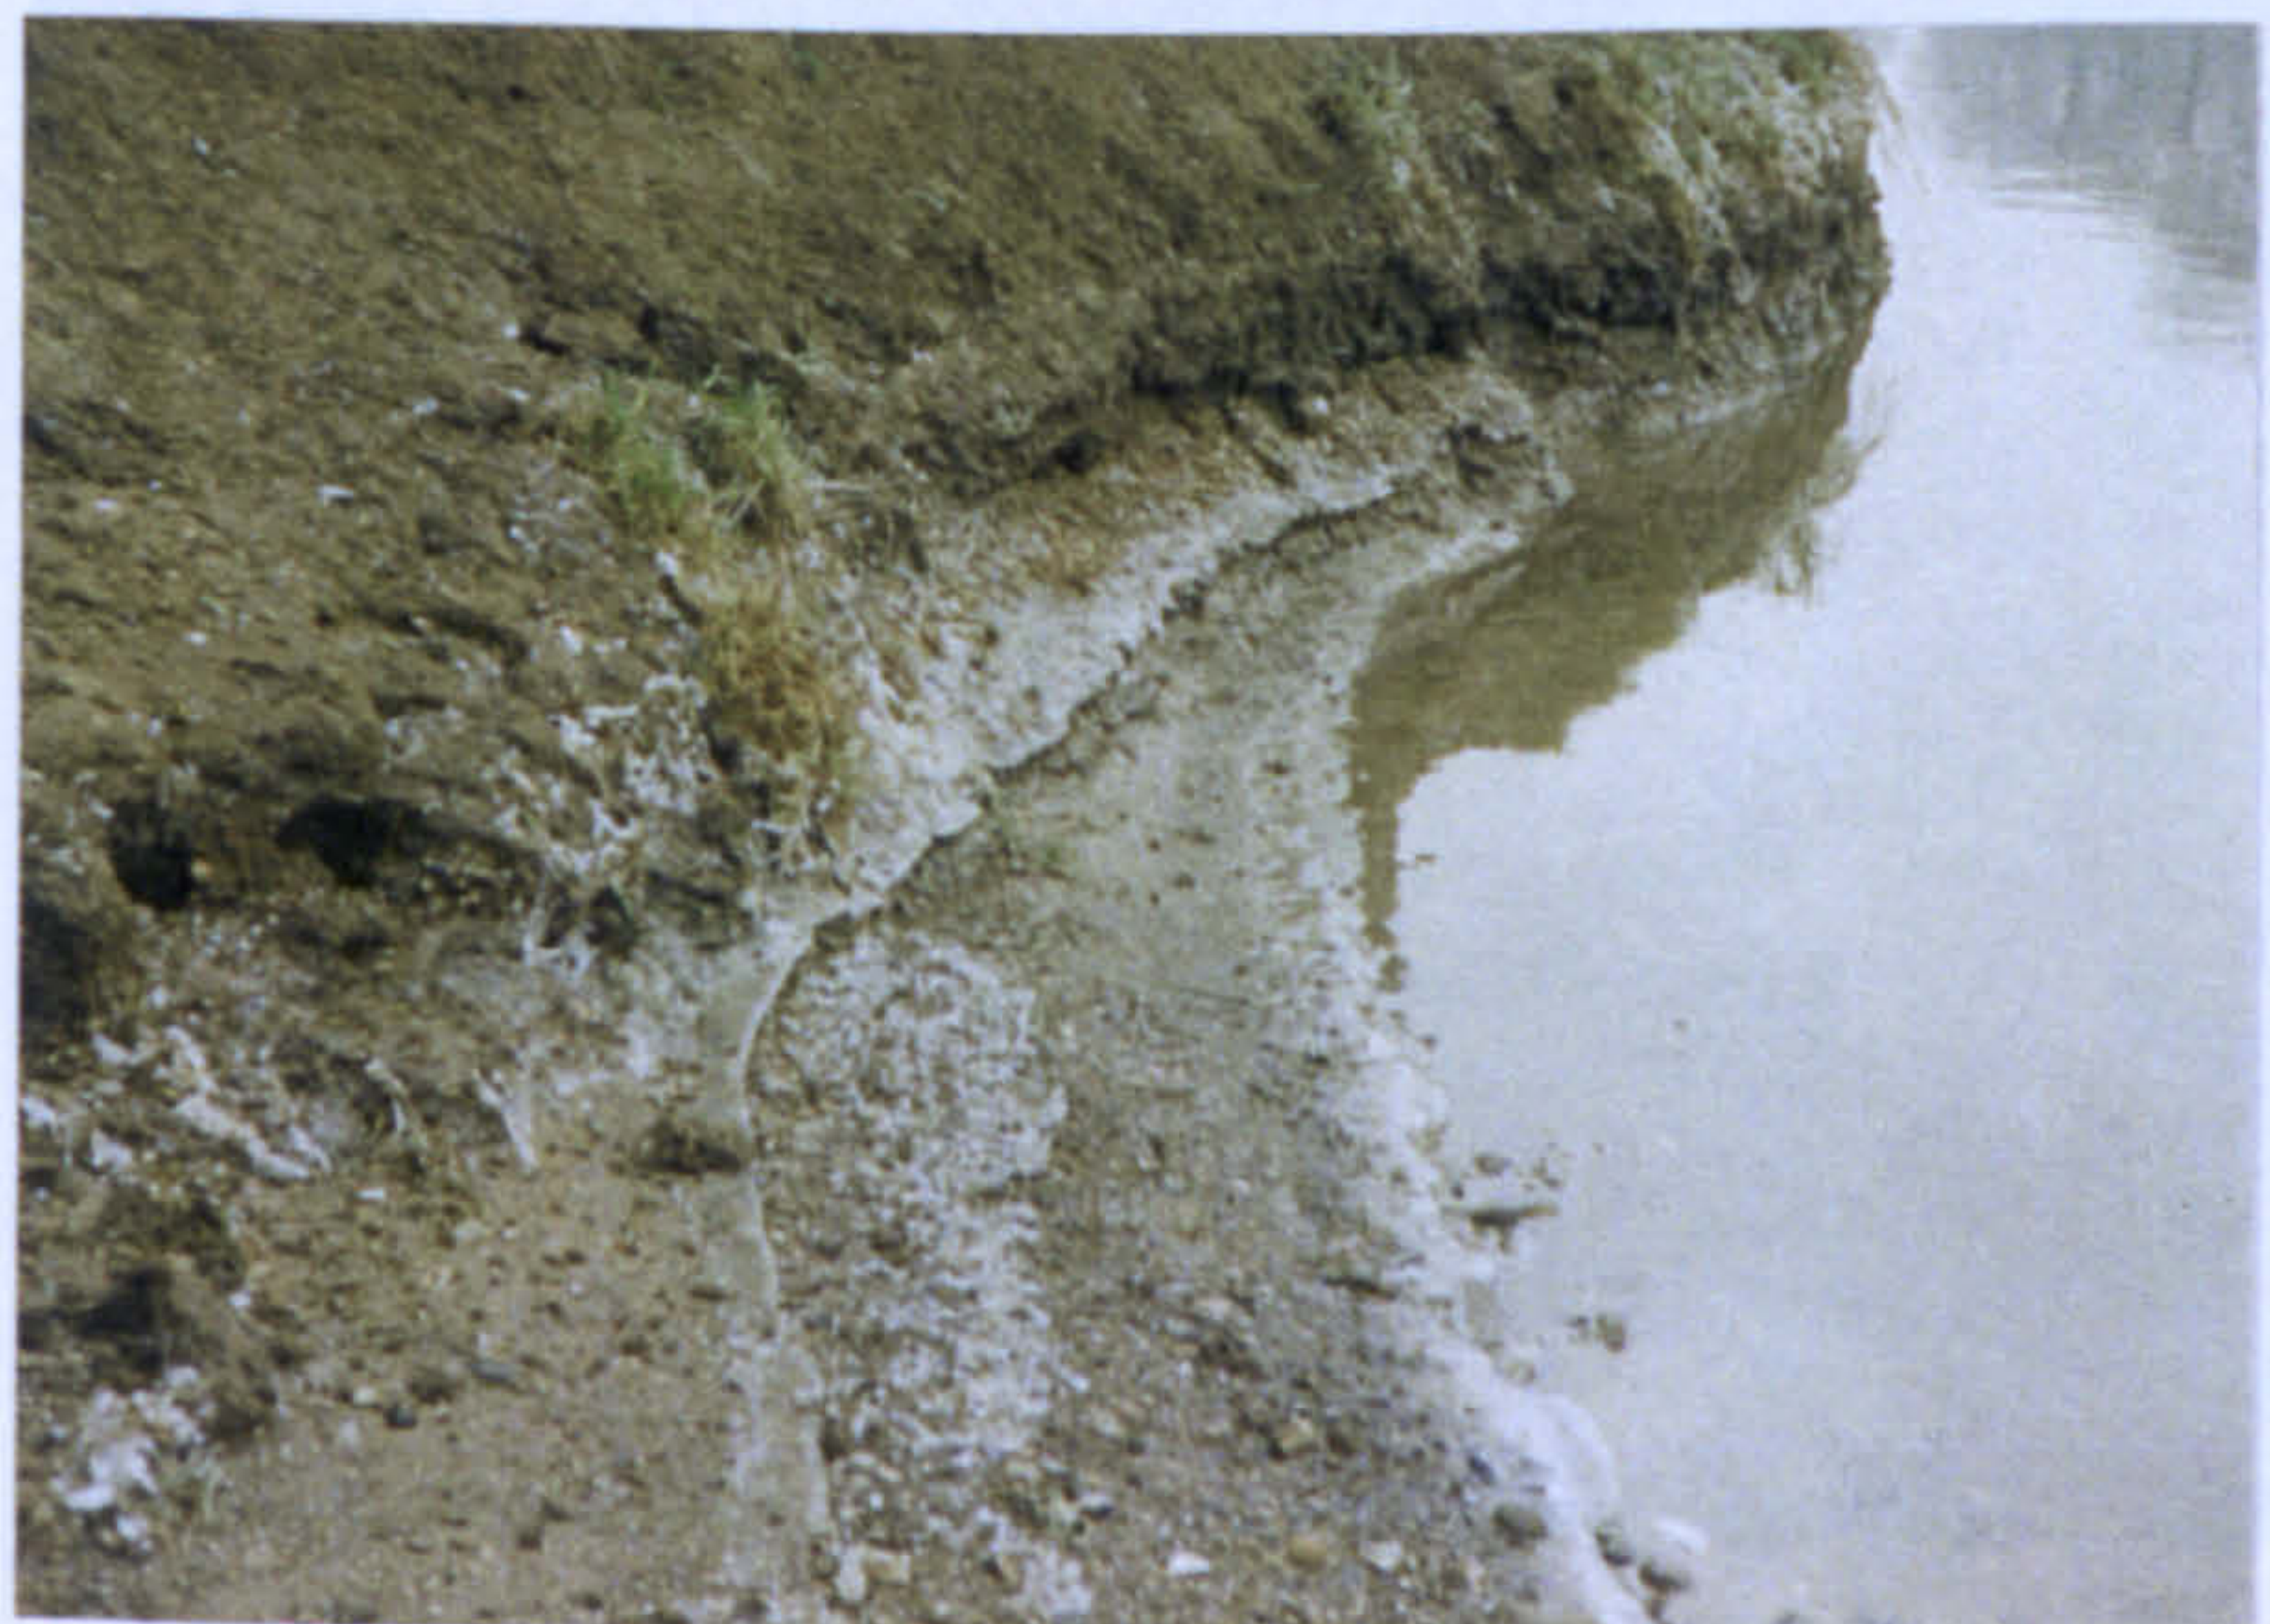
*Plate 4.10
Freezing
conditions
at the Lower
Wallingford
monitoring site.*
