**"THE NON-TIDAL, NAVIGABLE THAMES:
A BANK EROSION MANAGEMENT STRATEGY"**

by Sue Reed BSc, MSc, MCIWEM

**Thesis submitted to the University of Nottingham
for the degree of Doctor of Philosophy, October 1998**

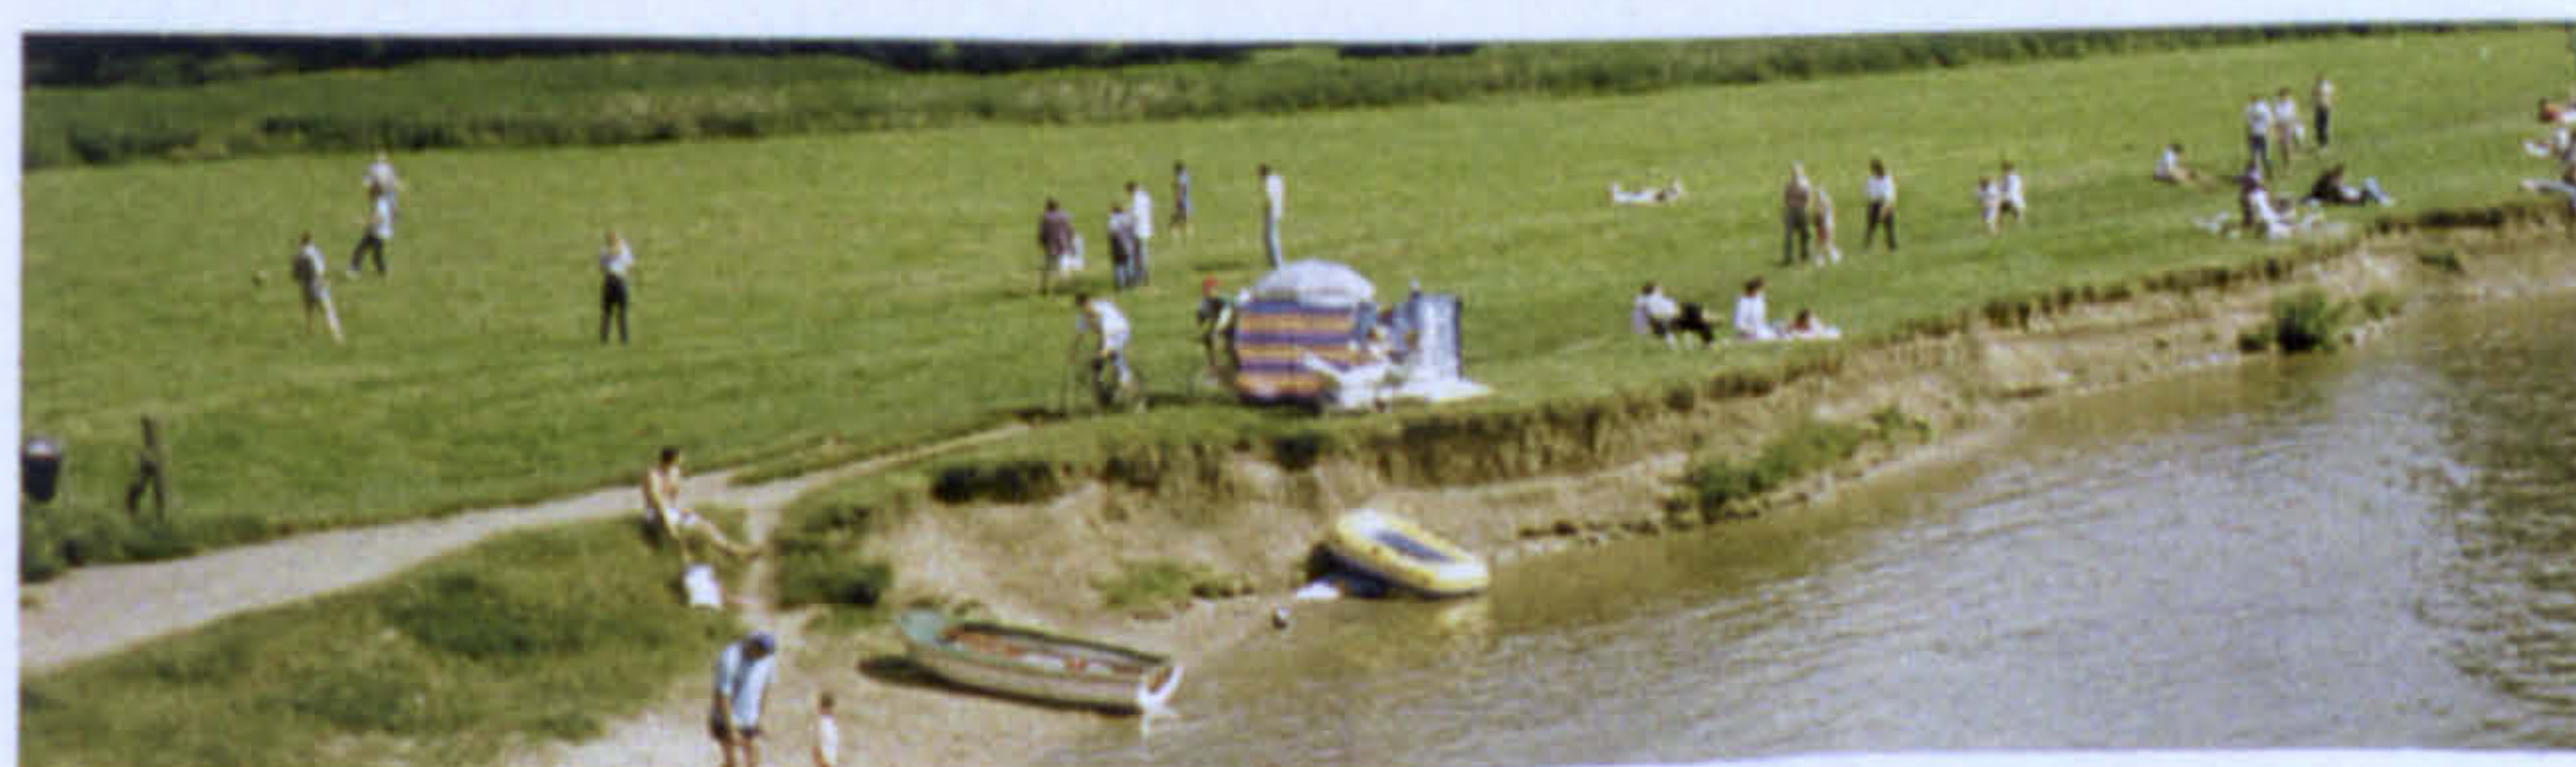
The contribution to erosion during the summer will be primarily from boat wash undercutting and eroding the lower bank, along with recreational access (see Plate 4.13) and the influence of wetting and drying cycles. Desiccation of the upper bank led to crumbling of the root zone, while drying of the lower bank led to shrinkage and cracking of clay toe (Plate 4.14).

*Plate 4.13
Recreational
access at Lower
Wallingford.*

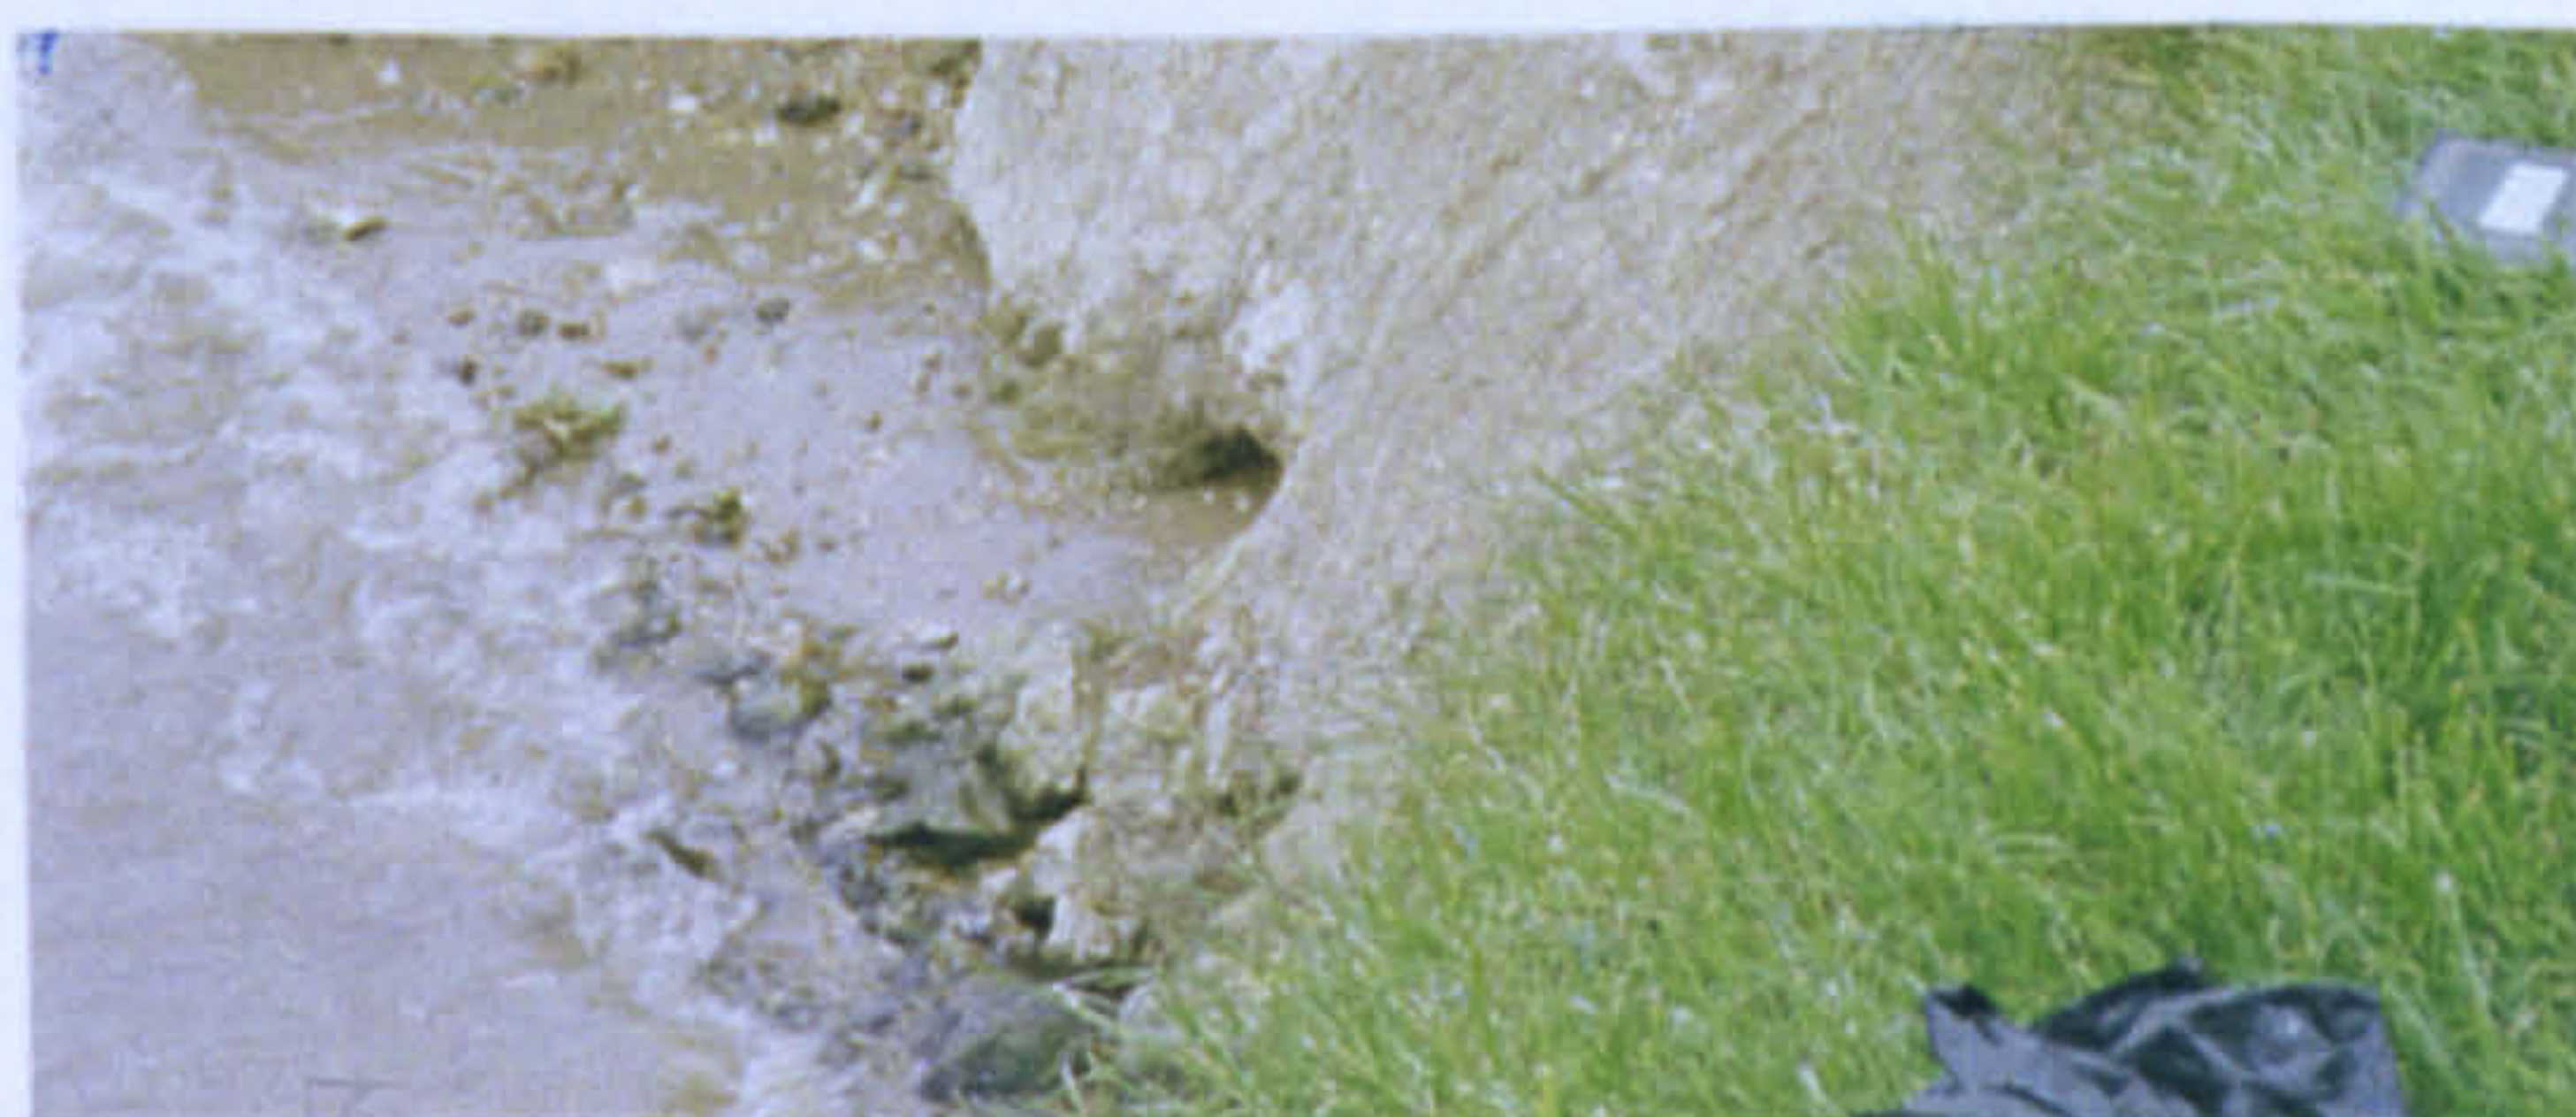
*Plate 4.14
Erosion of the clay
toe at Lower Wallingford.*

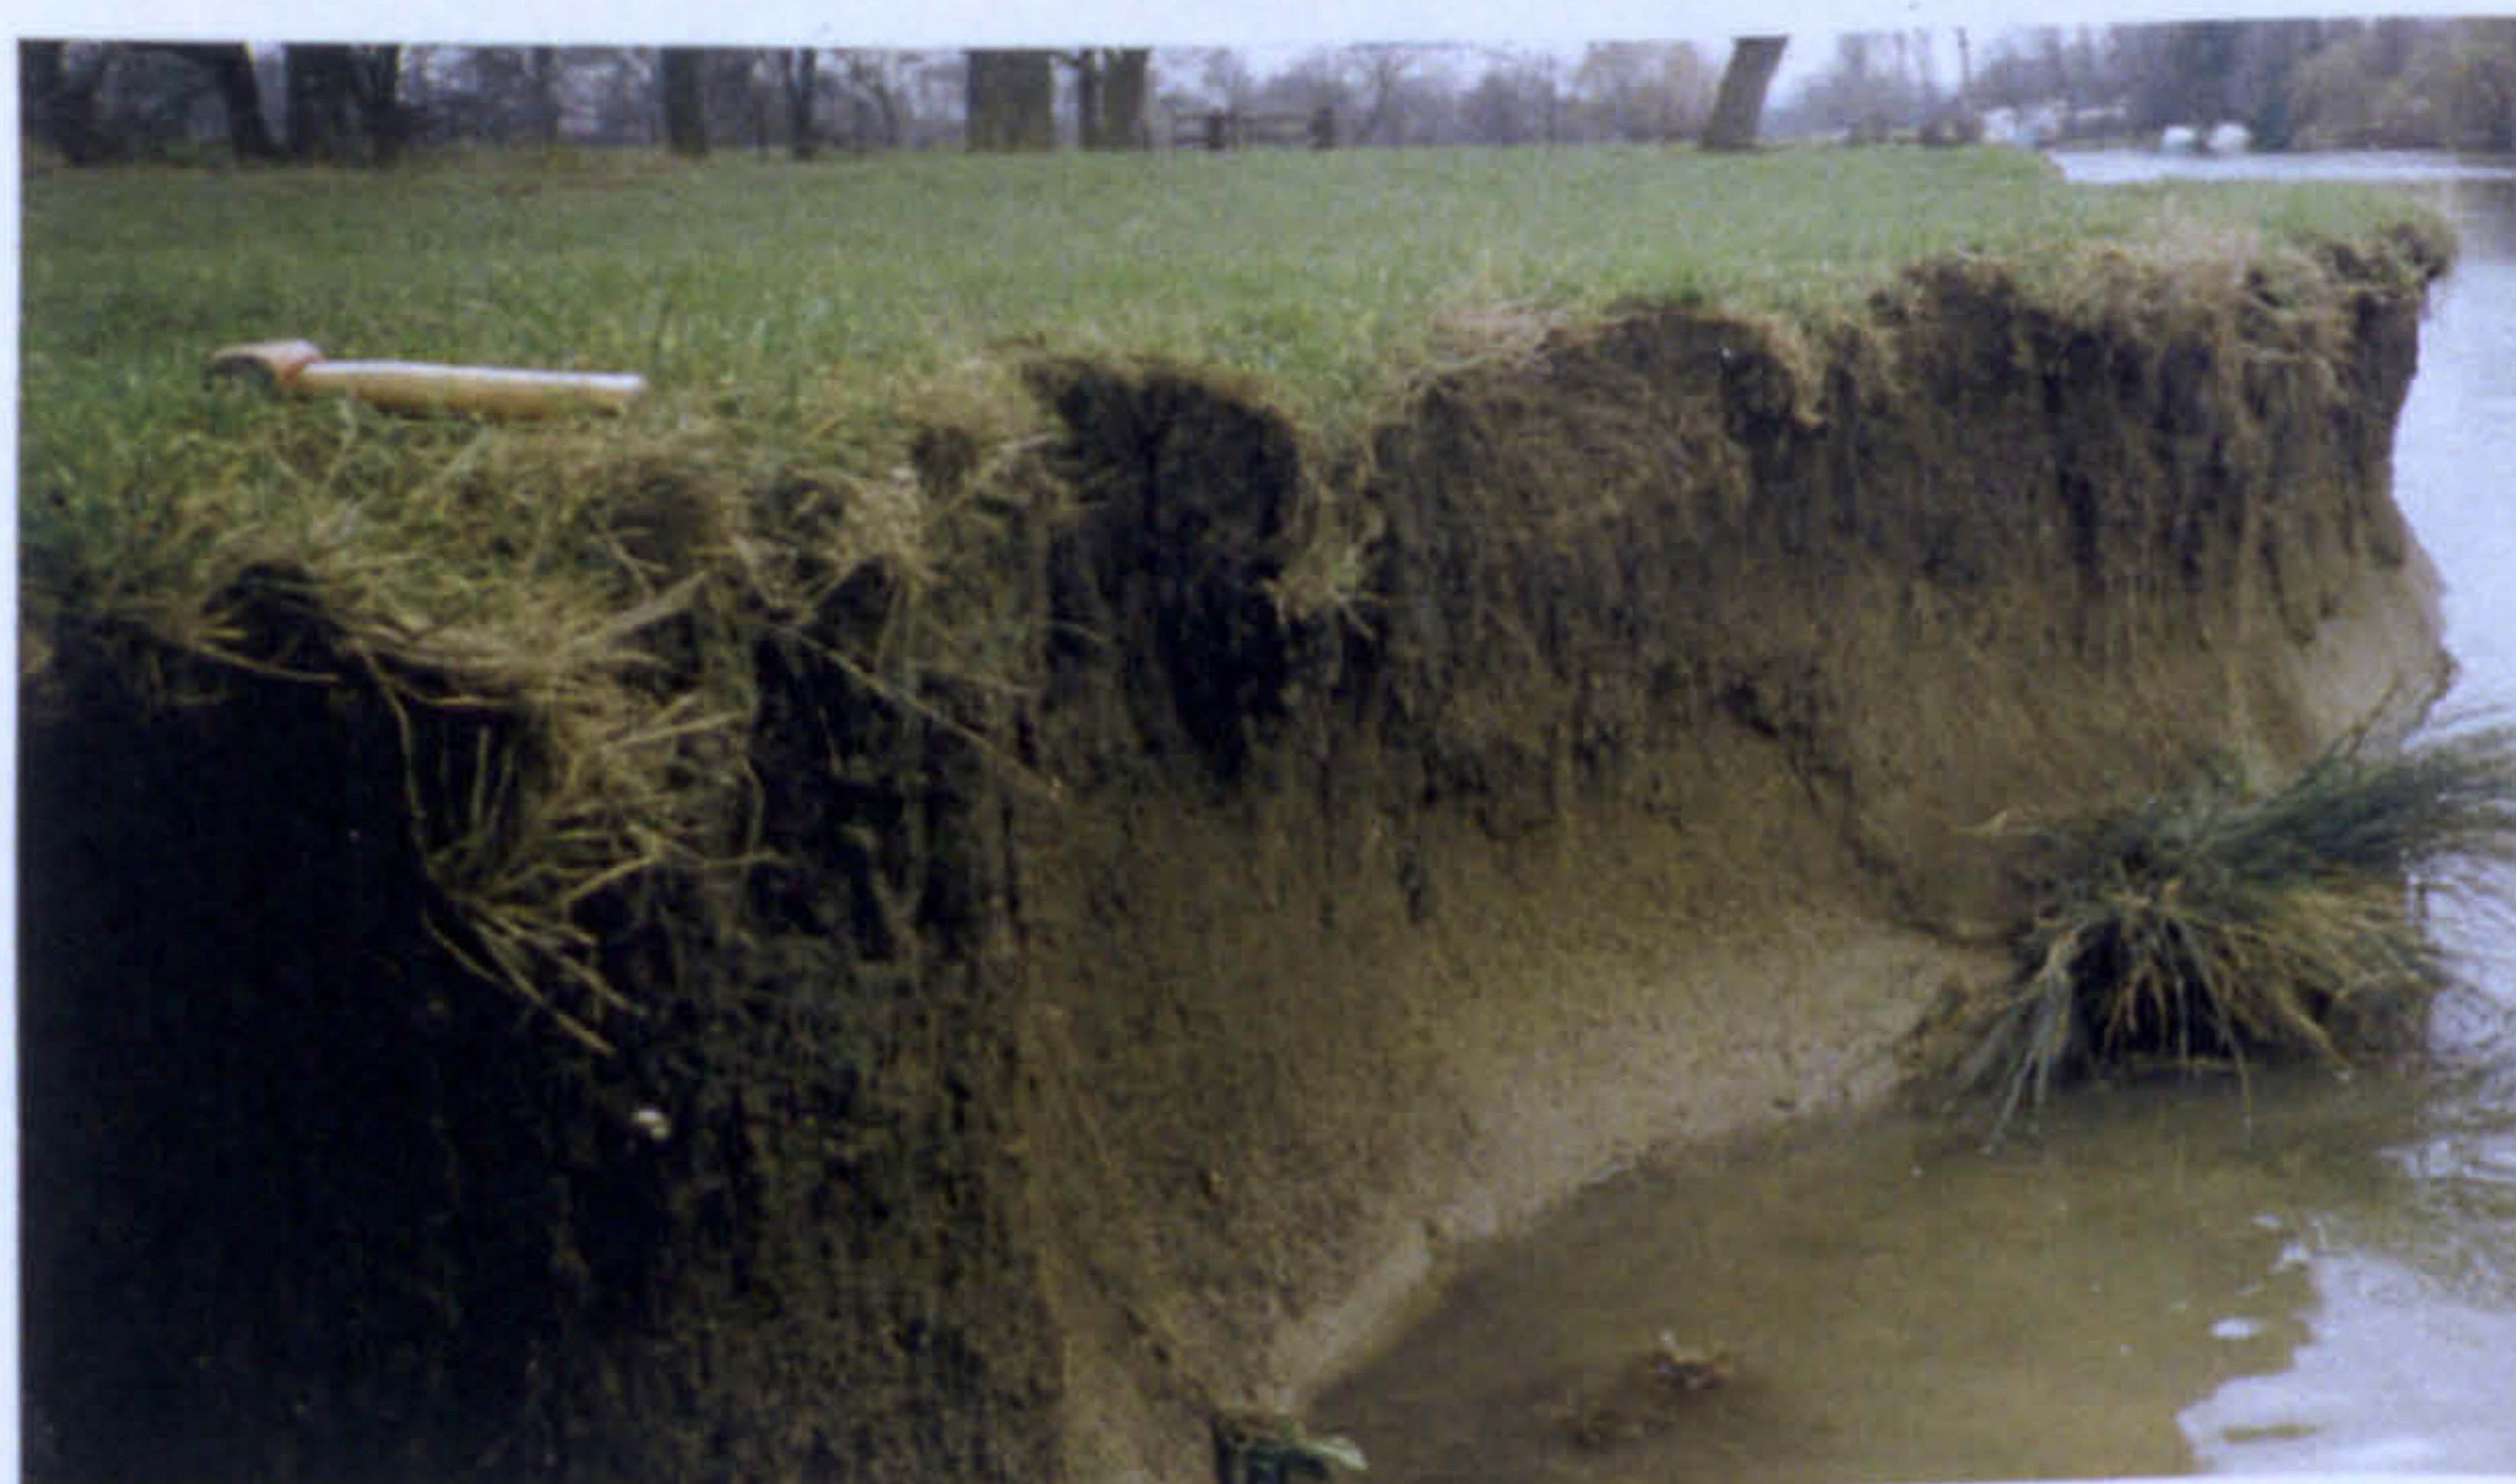
*Plate 4.15
Smoothed surface
of bank material
following peak
flood flows.*

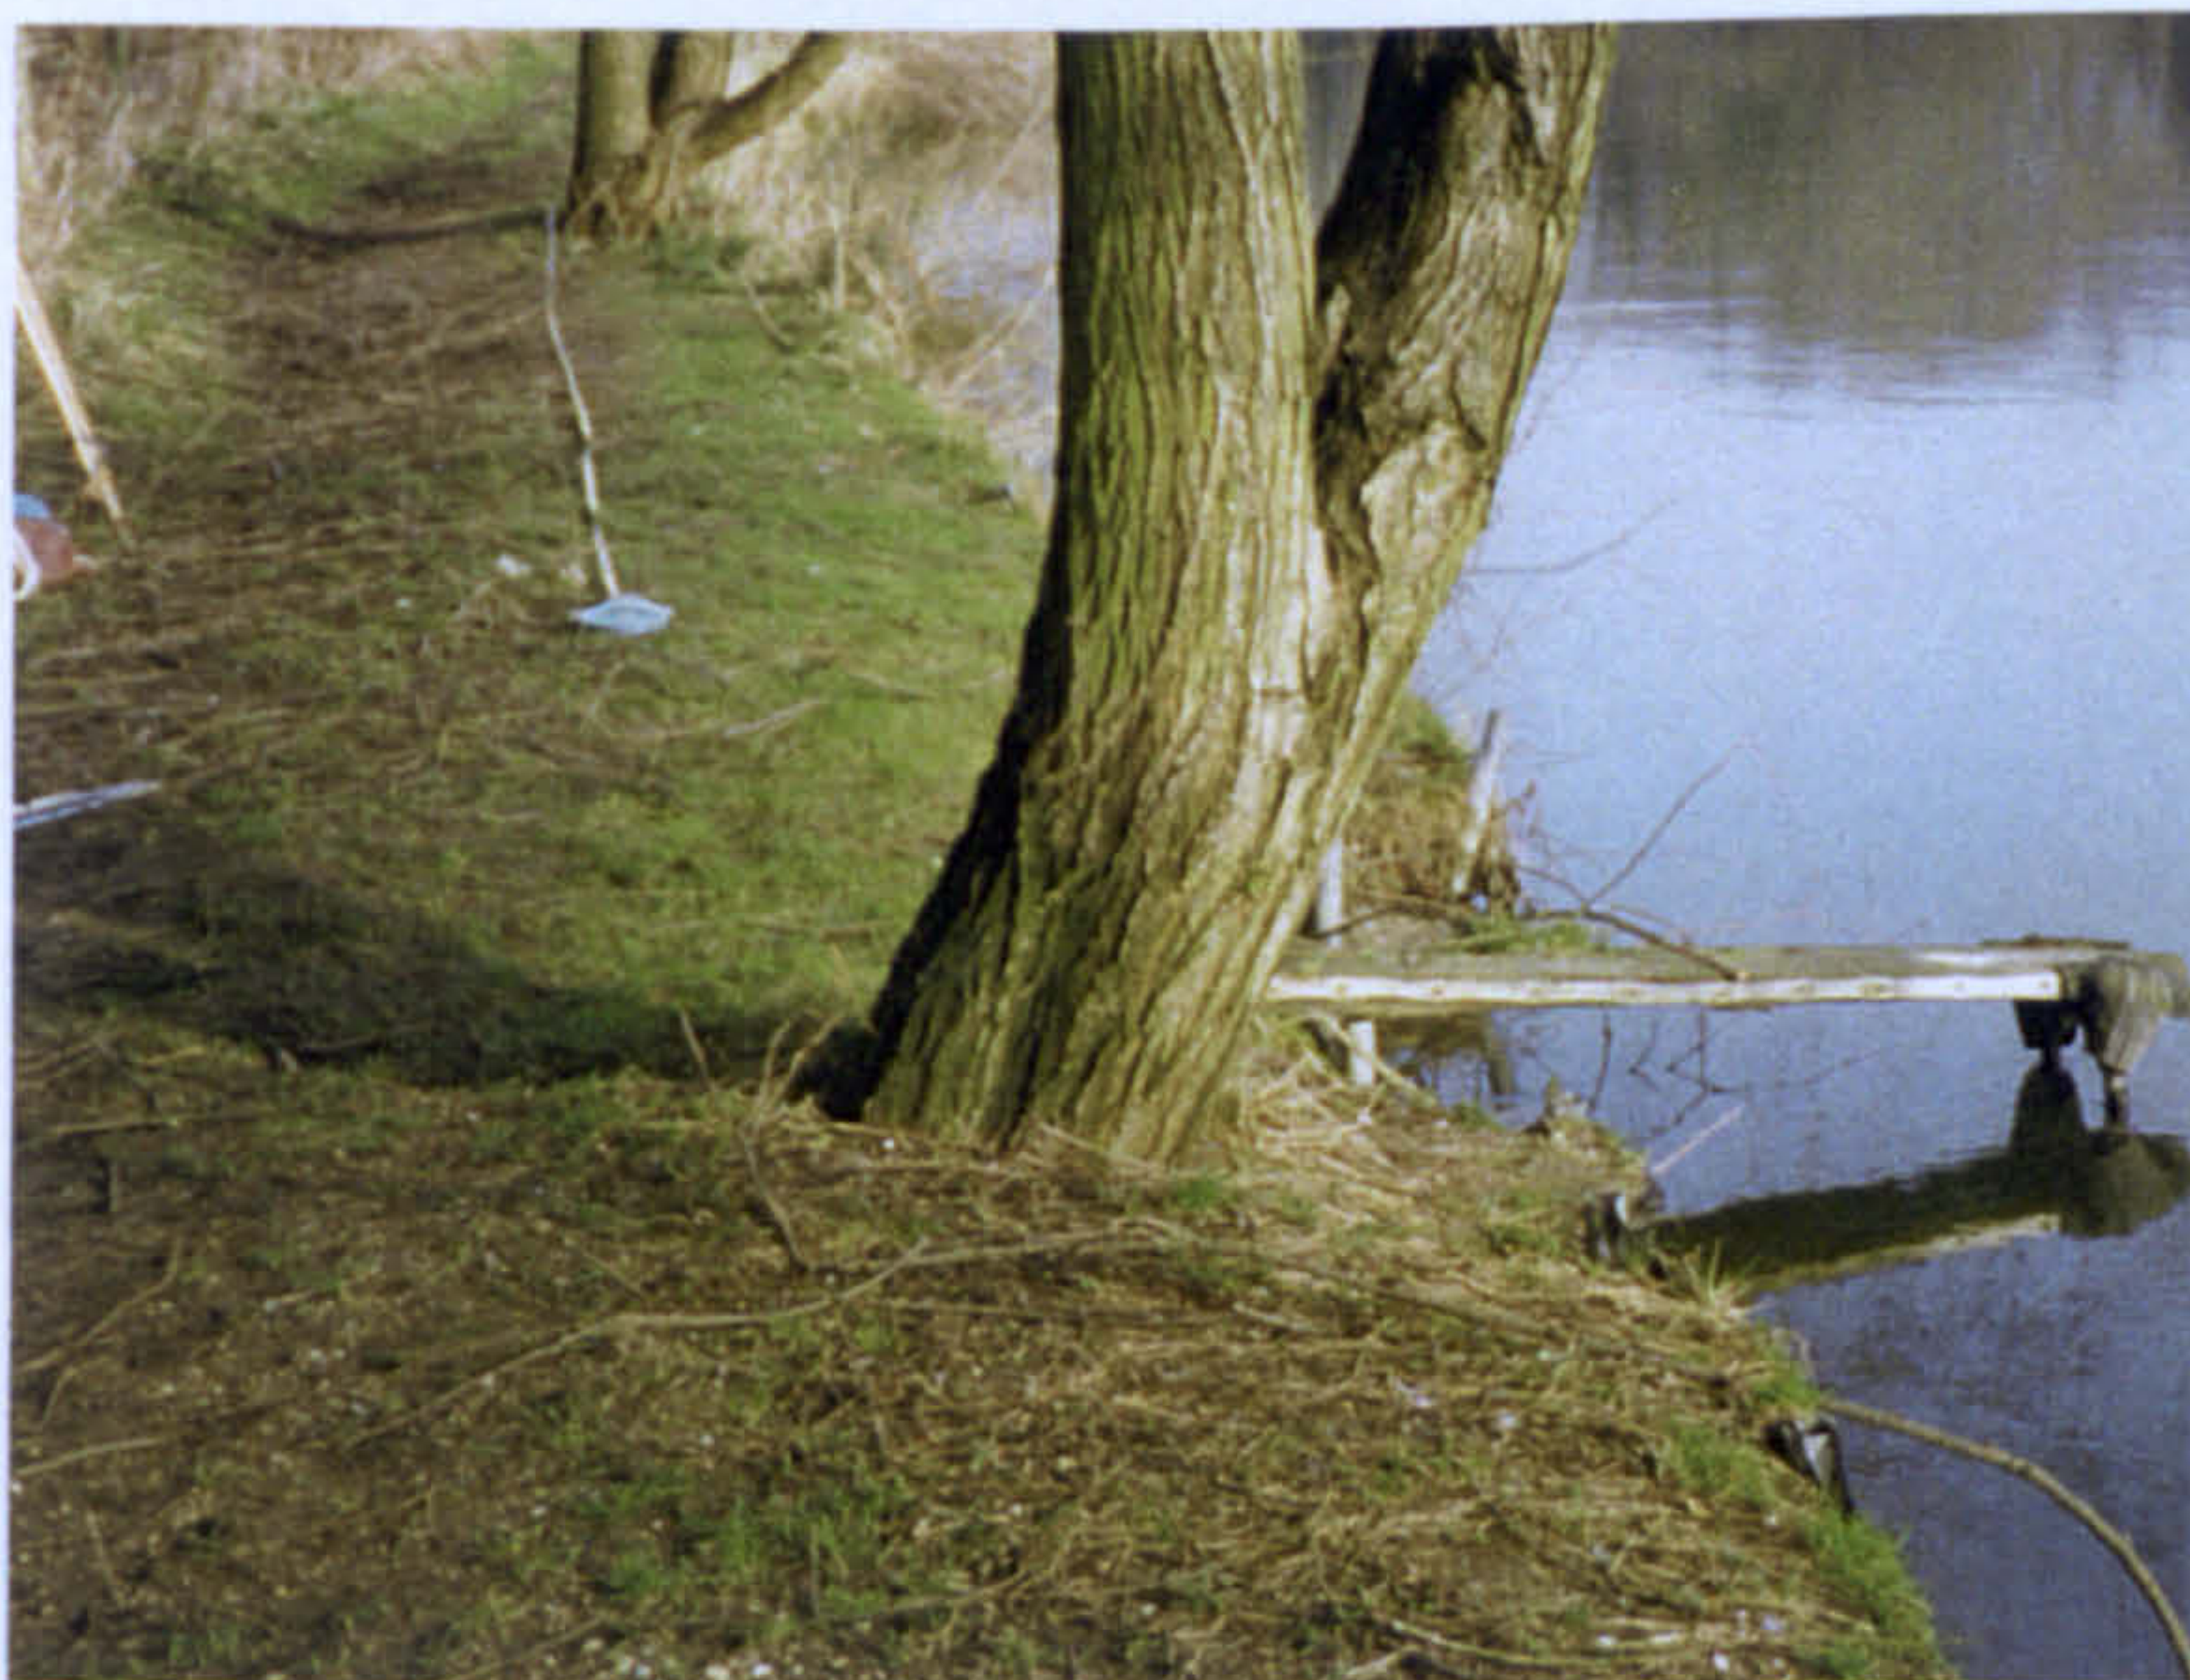
The location of the Goring monitoring site, on the right bank upstream of Goring Lock, is shown in Appendix 4.1 along with a site plan showing the positions of the bank profiles surveyed. The bank here is protected with Nicospan which is failing in some places along the length of the reach. An upstream view of the profile site on the right bank is shown in Plate 4.17.

Plate 4.17 Upstream view of the Goring monitoring site.

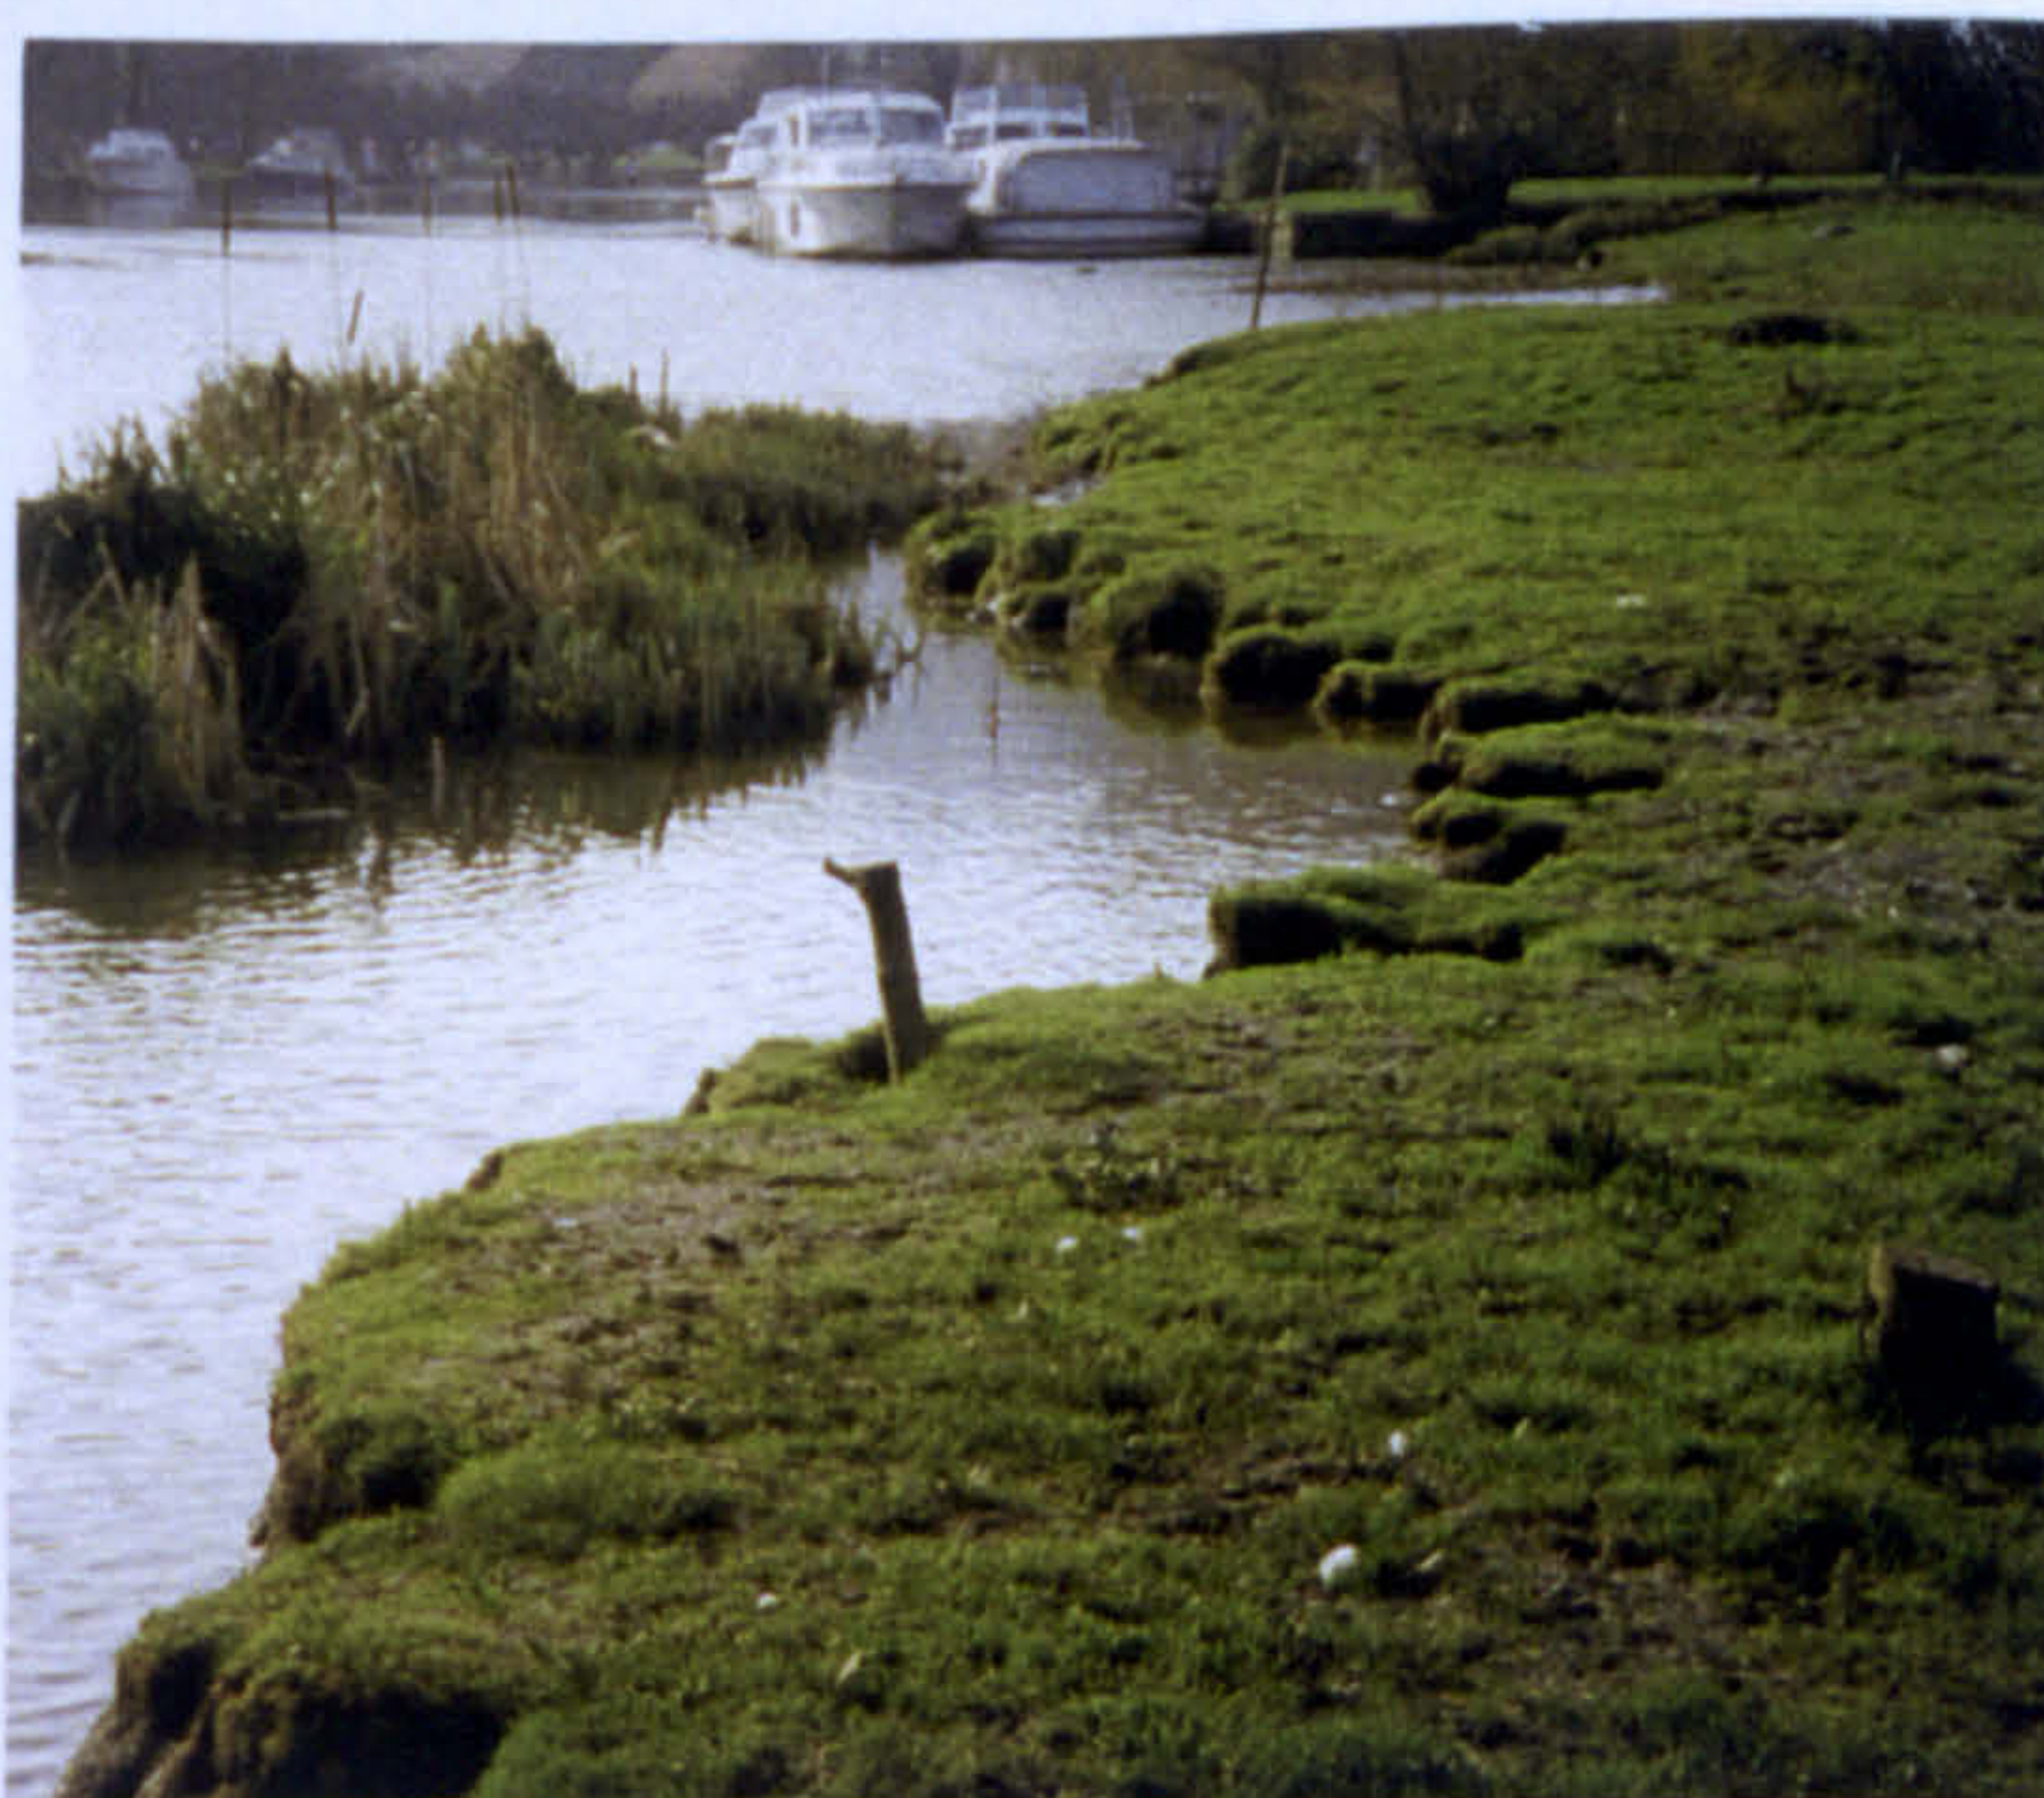
Plate 4.18 Location of erosion pins at the Goring monitoring site.

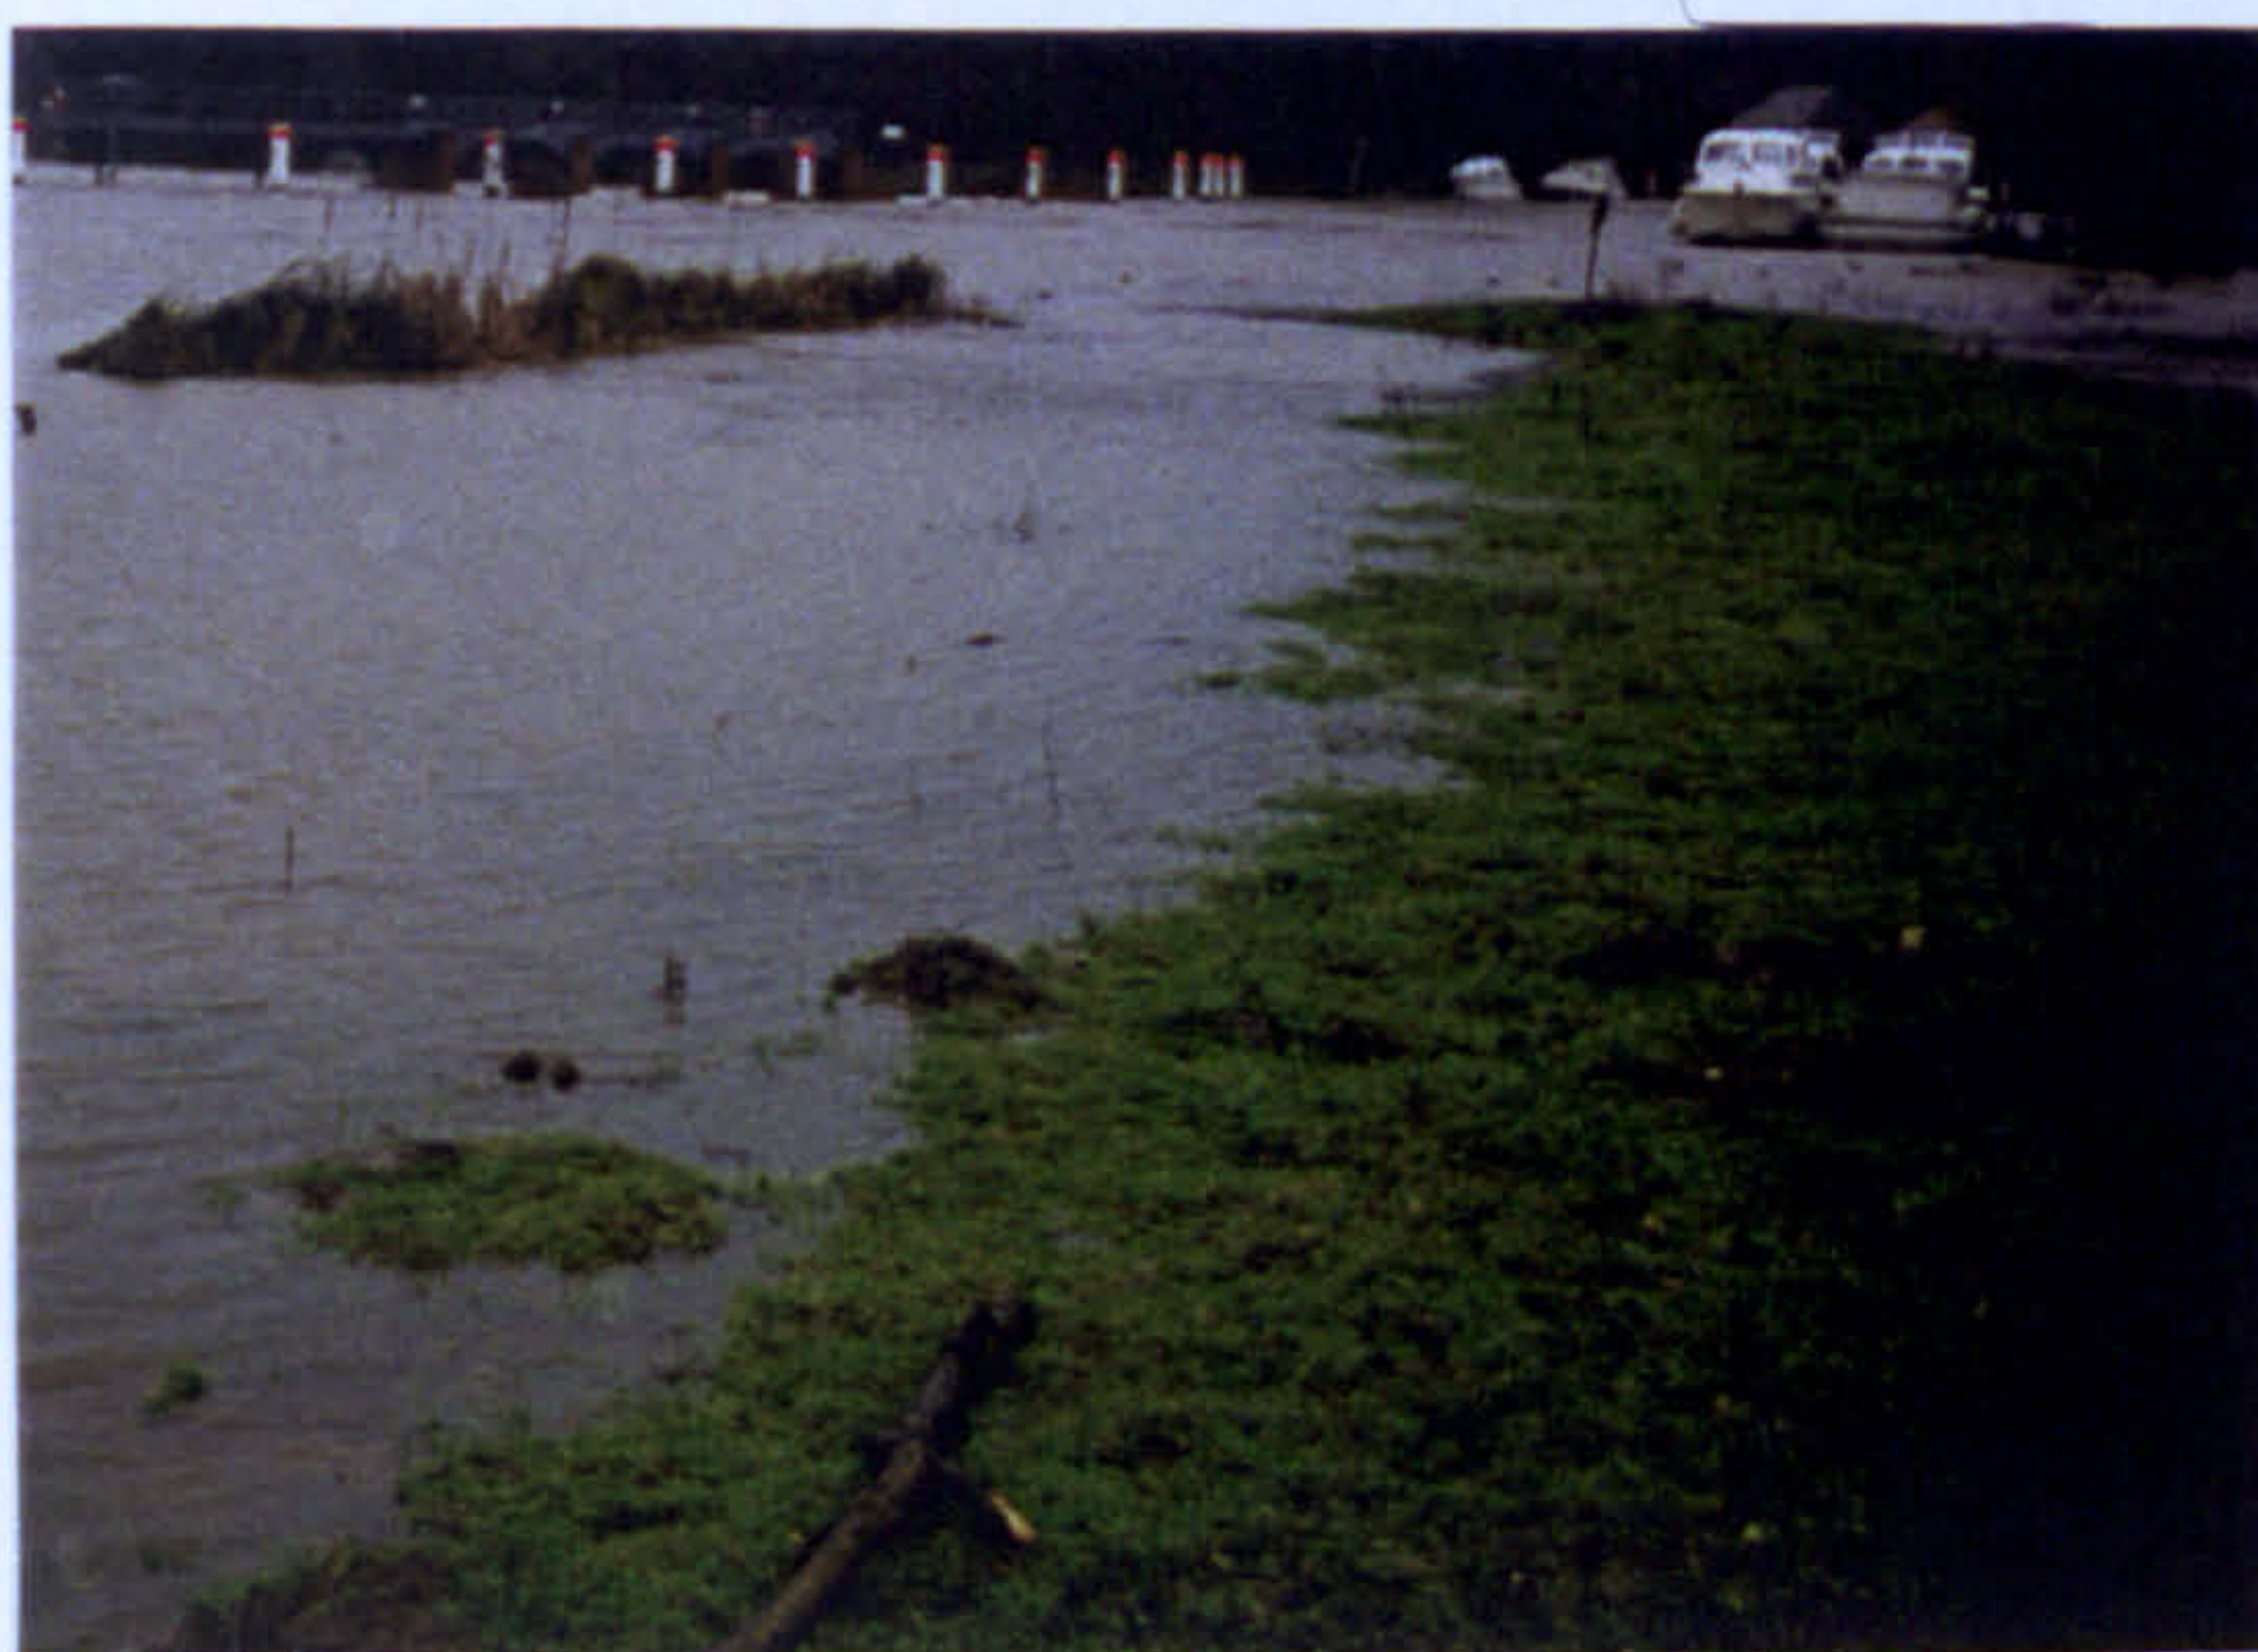
Plate 4.19 High flows at Goring in November 1992.
