**"THE NON-TIDAL, NAVIGABLE THAMES:
A BANK EROSION MANAGEMENT STRATEGY"**

by Sue Reed BSc, MSc, MCIWEM

**Thesis submitted to the University of Nottingham
for the degree of Doctor of Philosophy, October 1998**

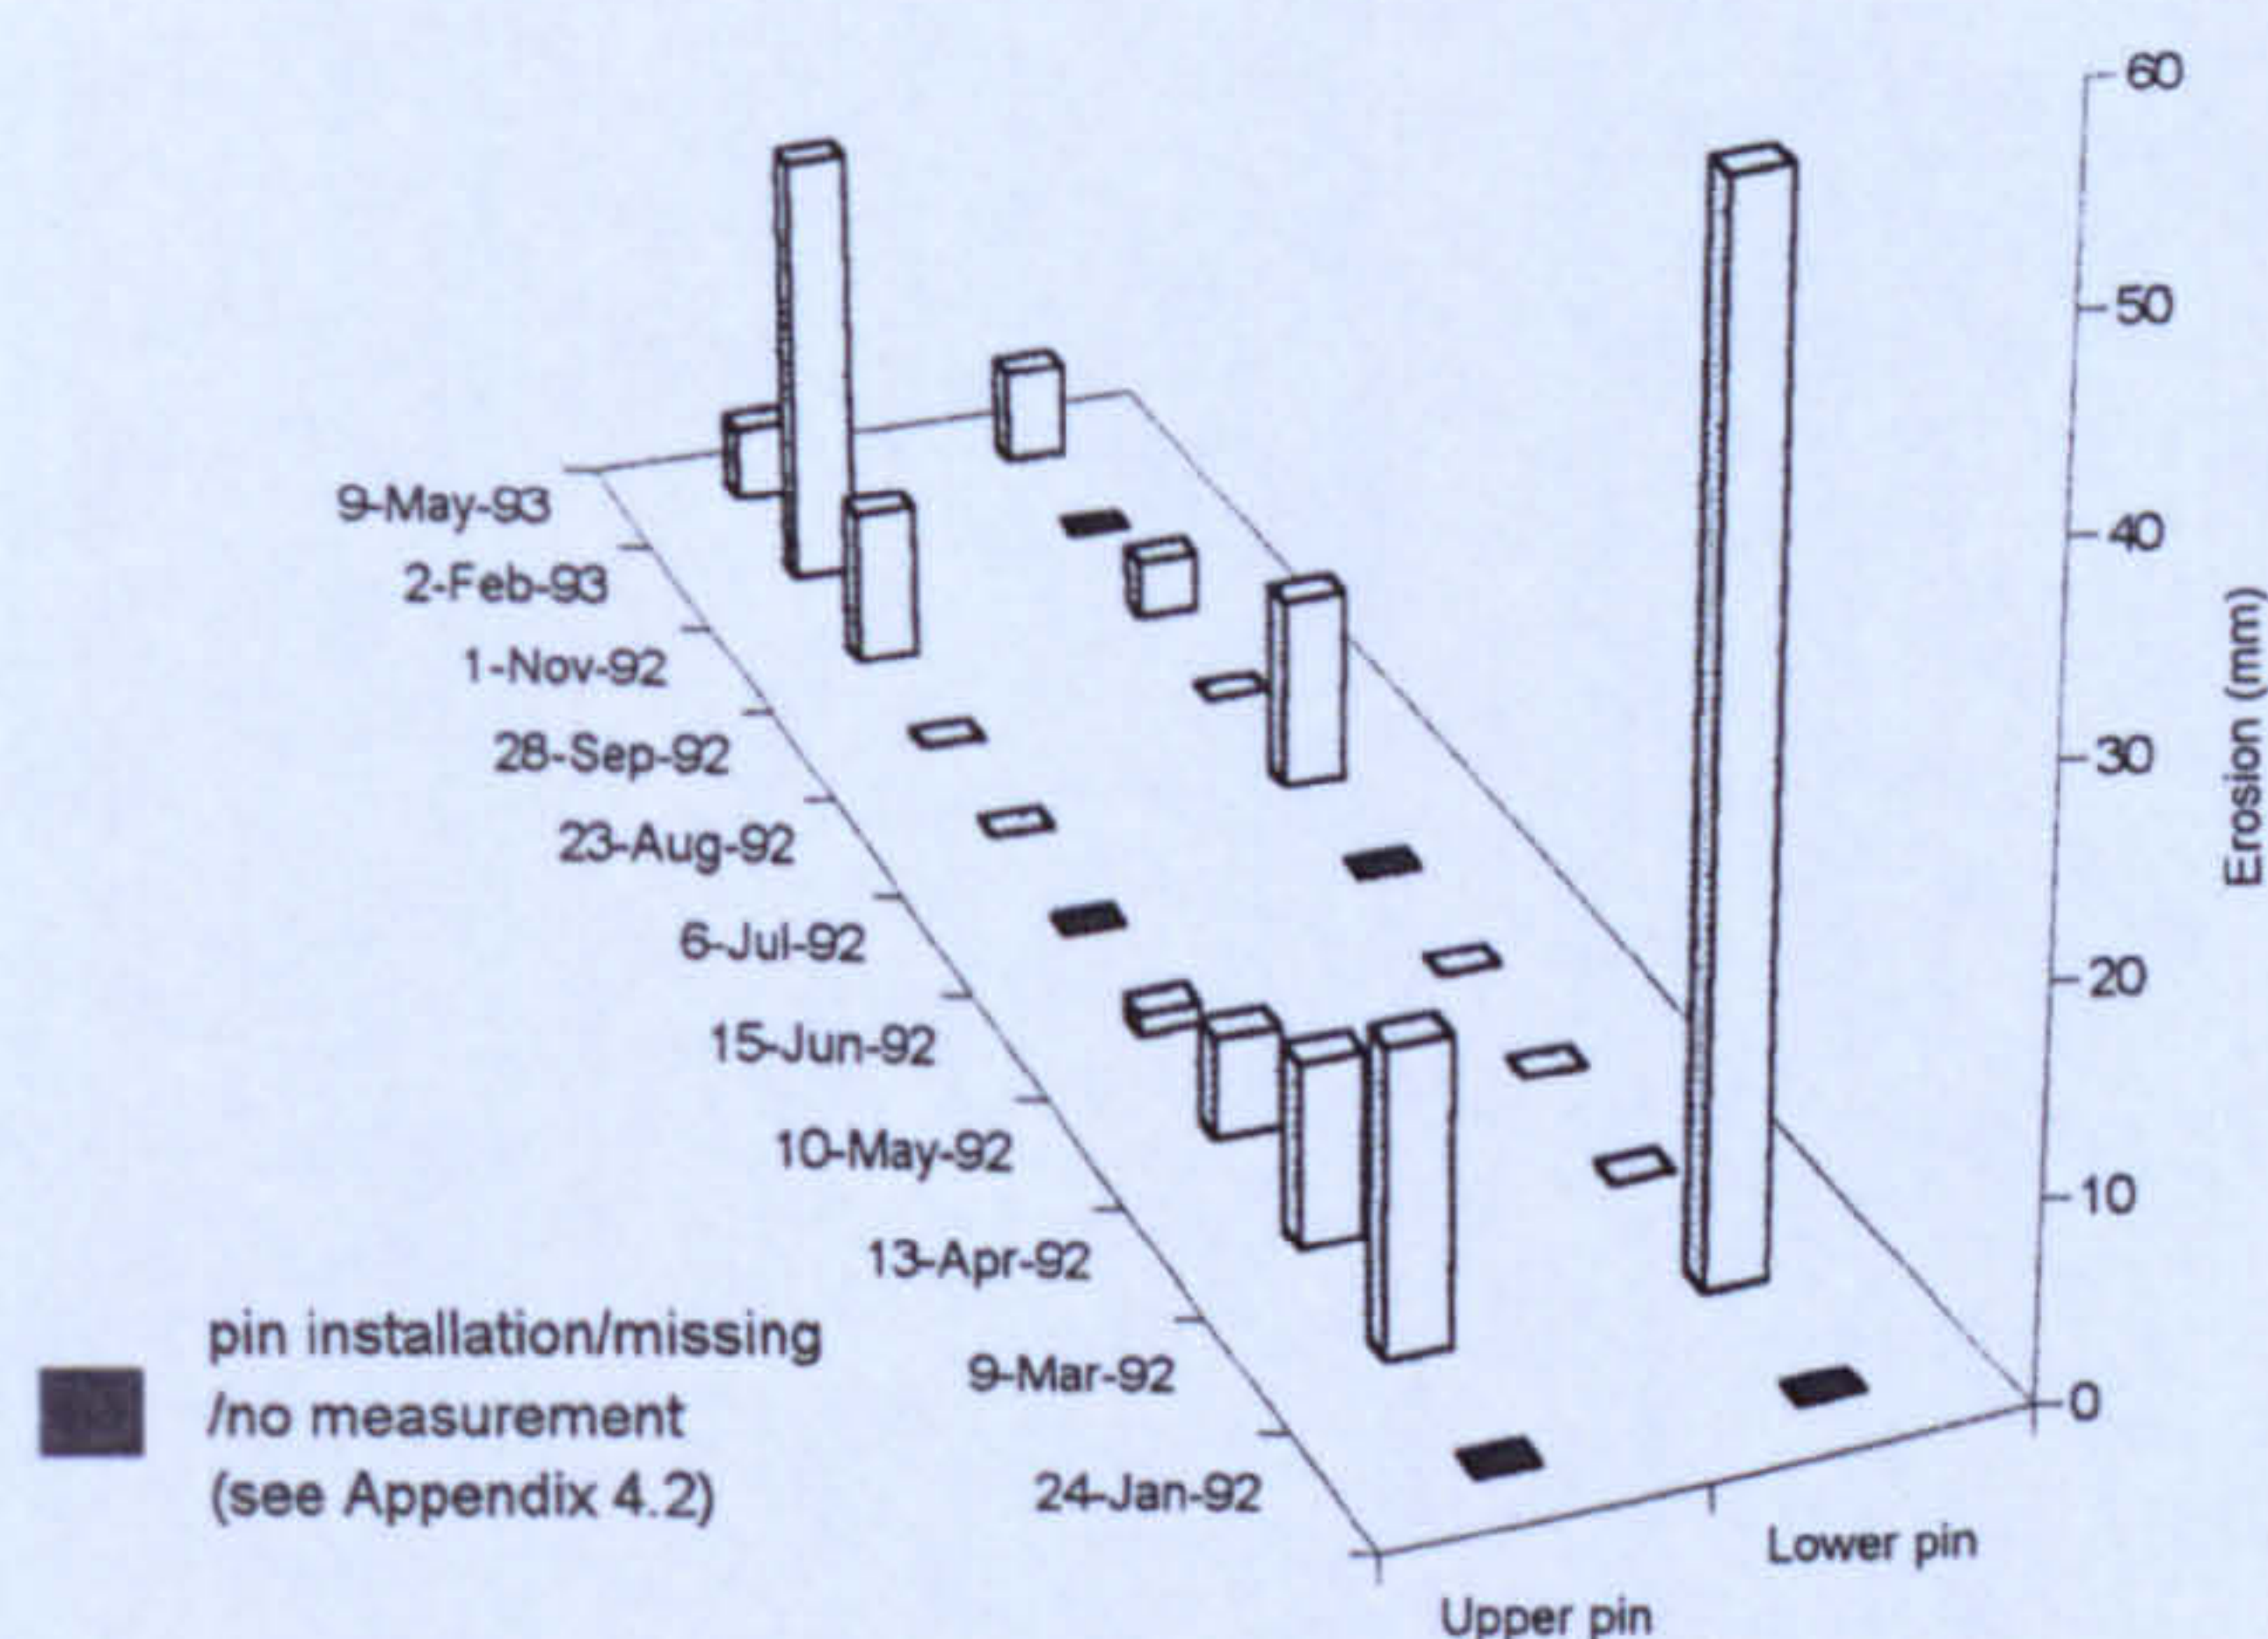
Figure 4.5
Bank erosion
measured at
Goring.

The amounts of upper and lower bank erosion measured through the monitoring period were comparable, 65mm and 70mm, respectively. The highest upper bank erosion measured during any one visit was 23mm, measured after the high winter floods, compared to maximum of 52mm measured at the lower bank for the period between 24 January and 9 March 1992. Combining the total erosion measured after both the high discharges, the

upper bank erosion amounted to 31mm, 48% of the total for the whole monitoring period. Lower bank erosion during this same period amounted to 8mm, almost 12% of the monitoring period total.

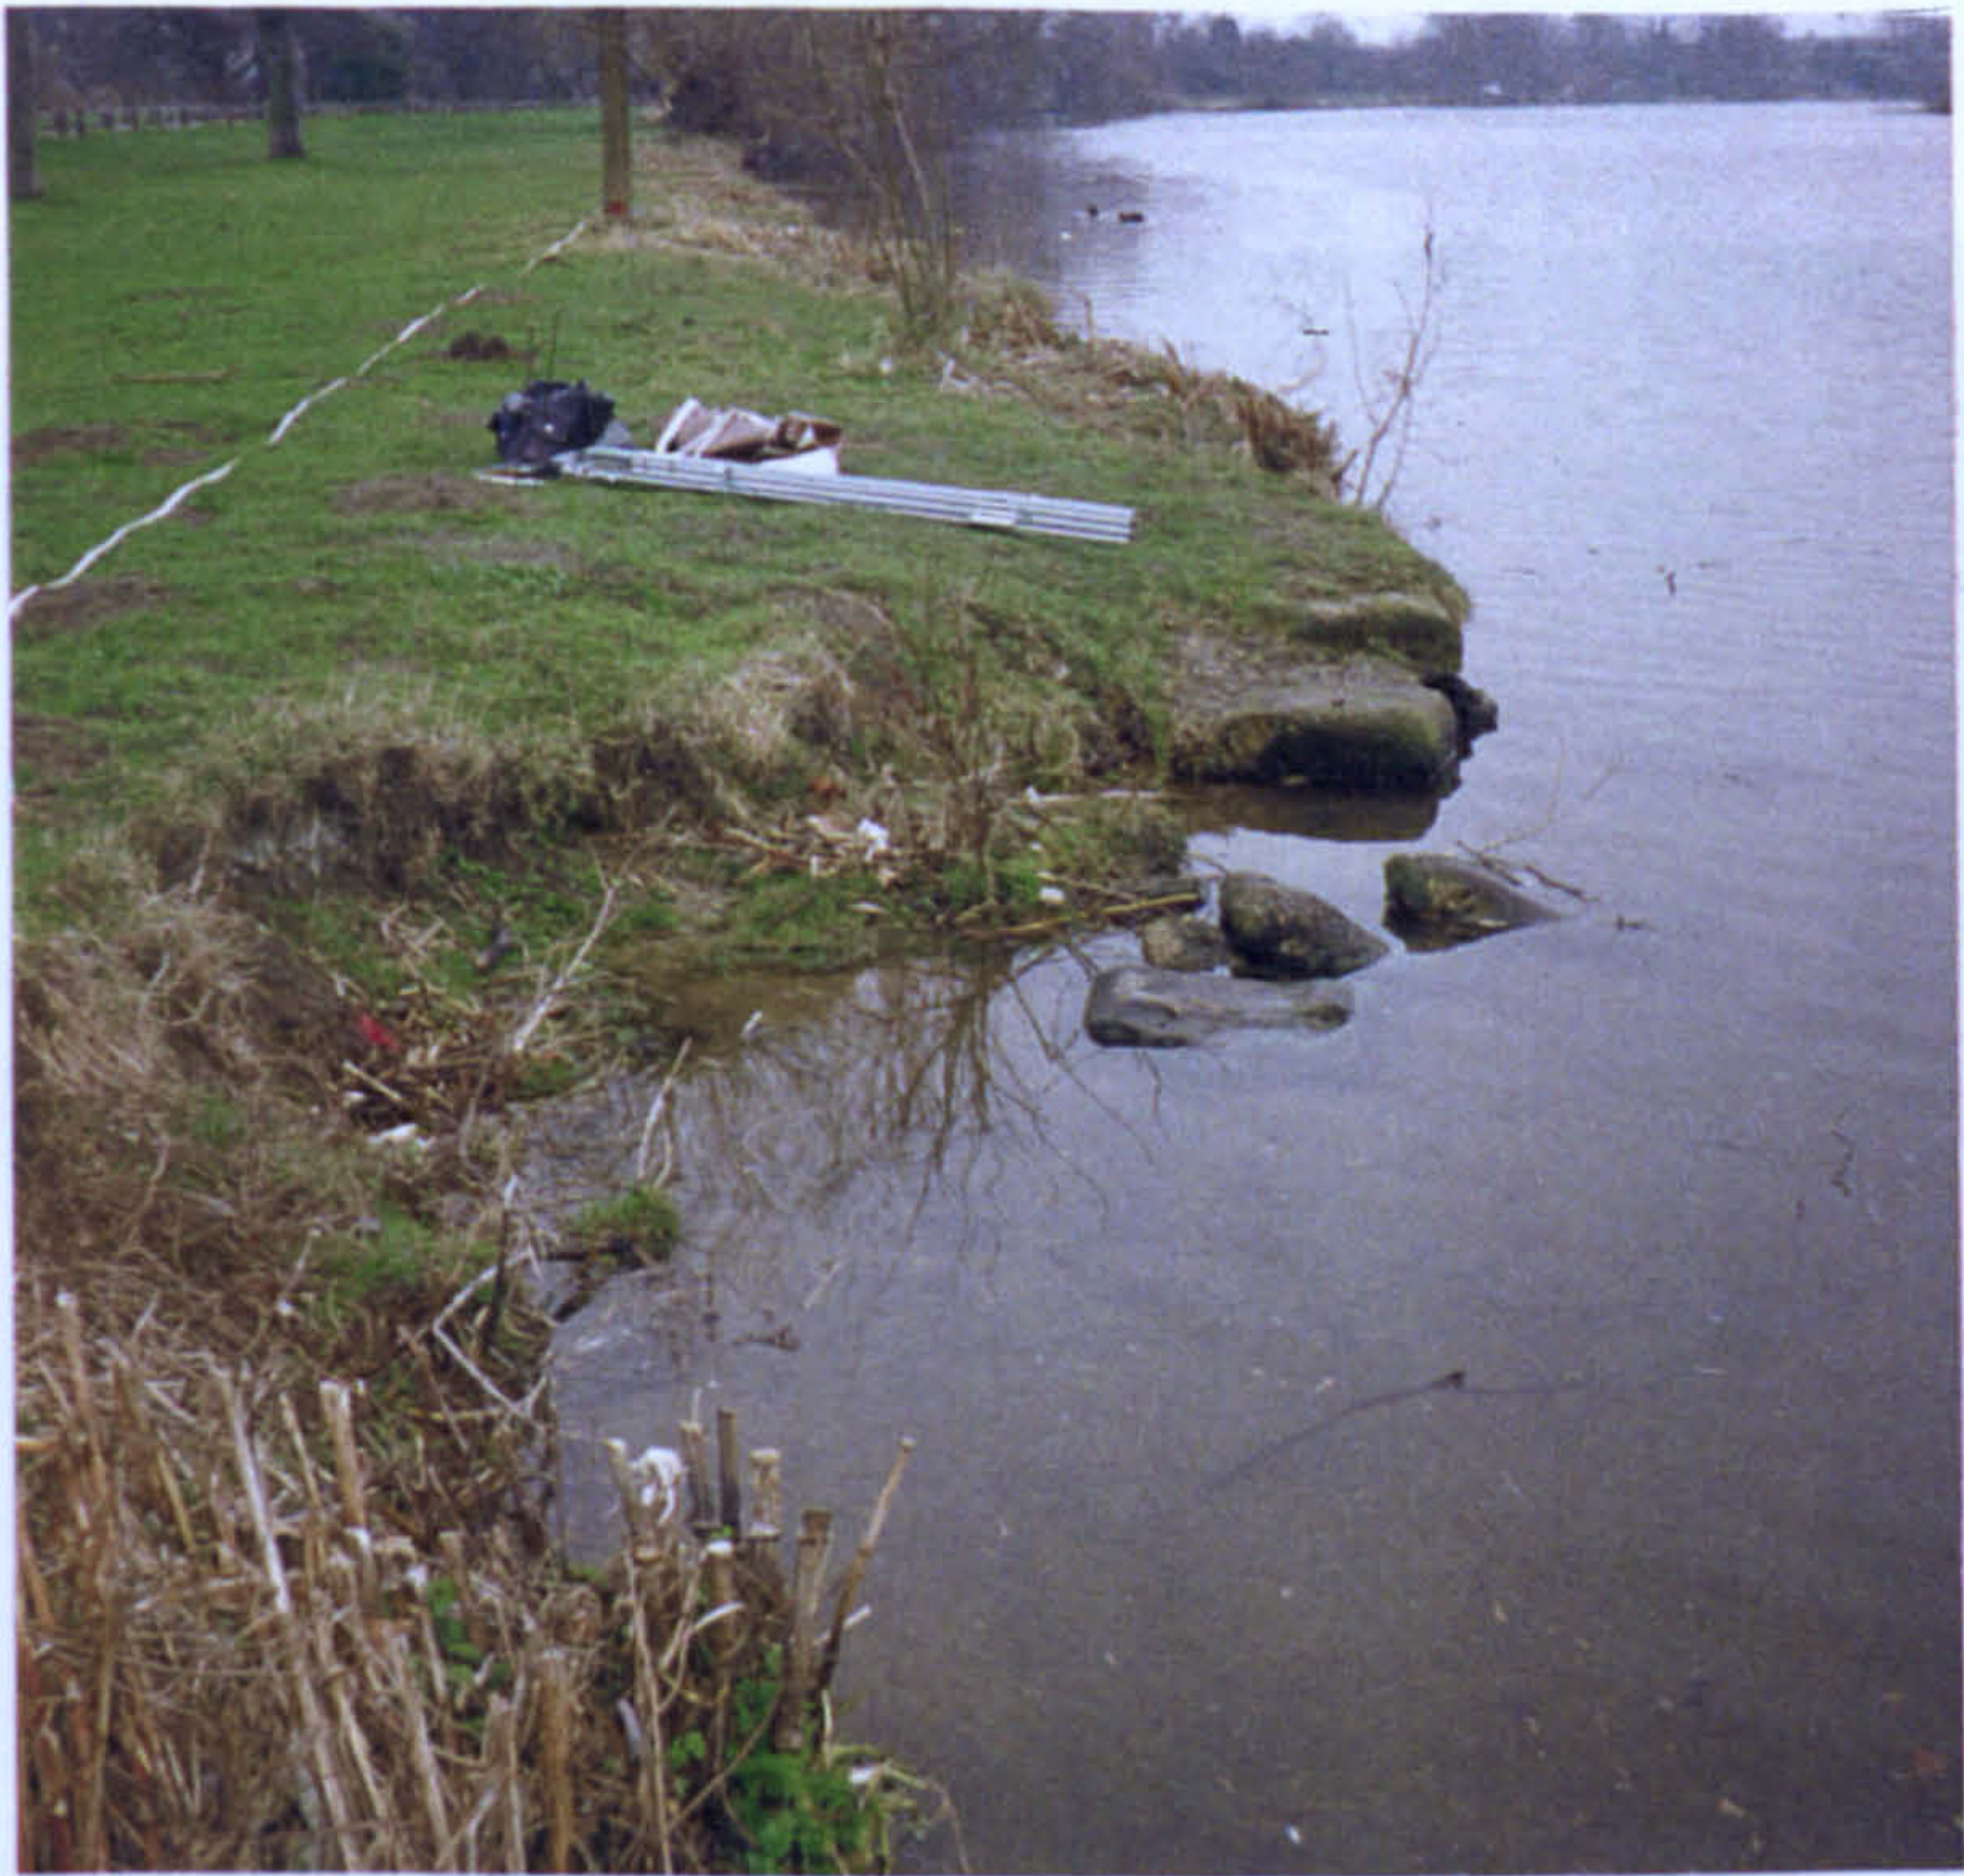
Plate 4.21 is a downstream view of the location of the erosion pins on the left bank, where the erosion pin installed in the lower bank can be seen painted red in the recess just upstream of the failed bagwork. Laleham is extremely popular for angling and recreation in general, particularly during the summer, and camping, parking and other recreational facilities are provided nearby.

Plate 4.21
 Downstream view
 of the Laleham
 monitoring site.

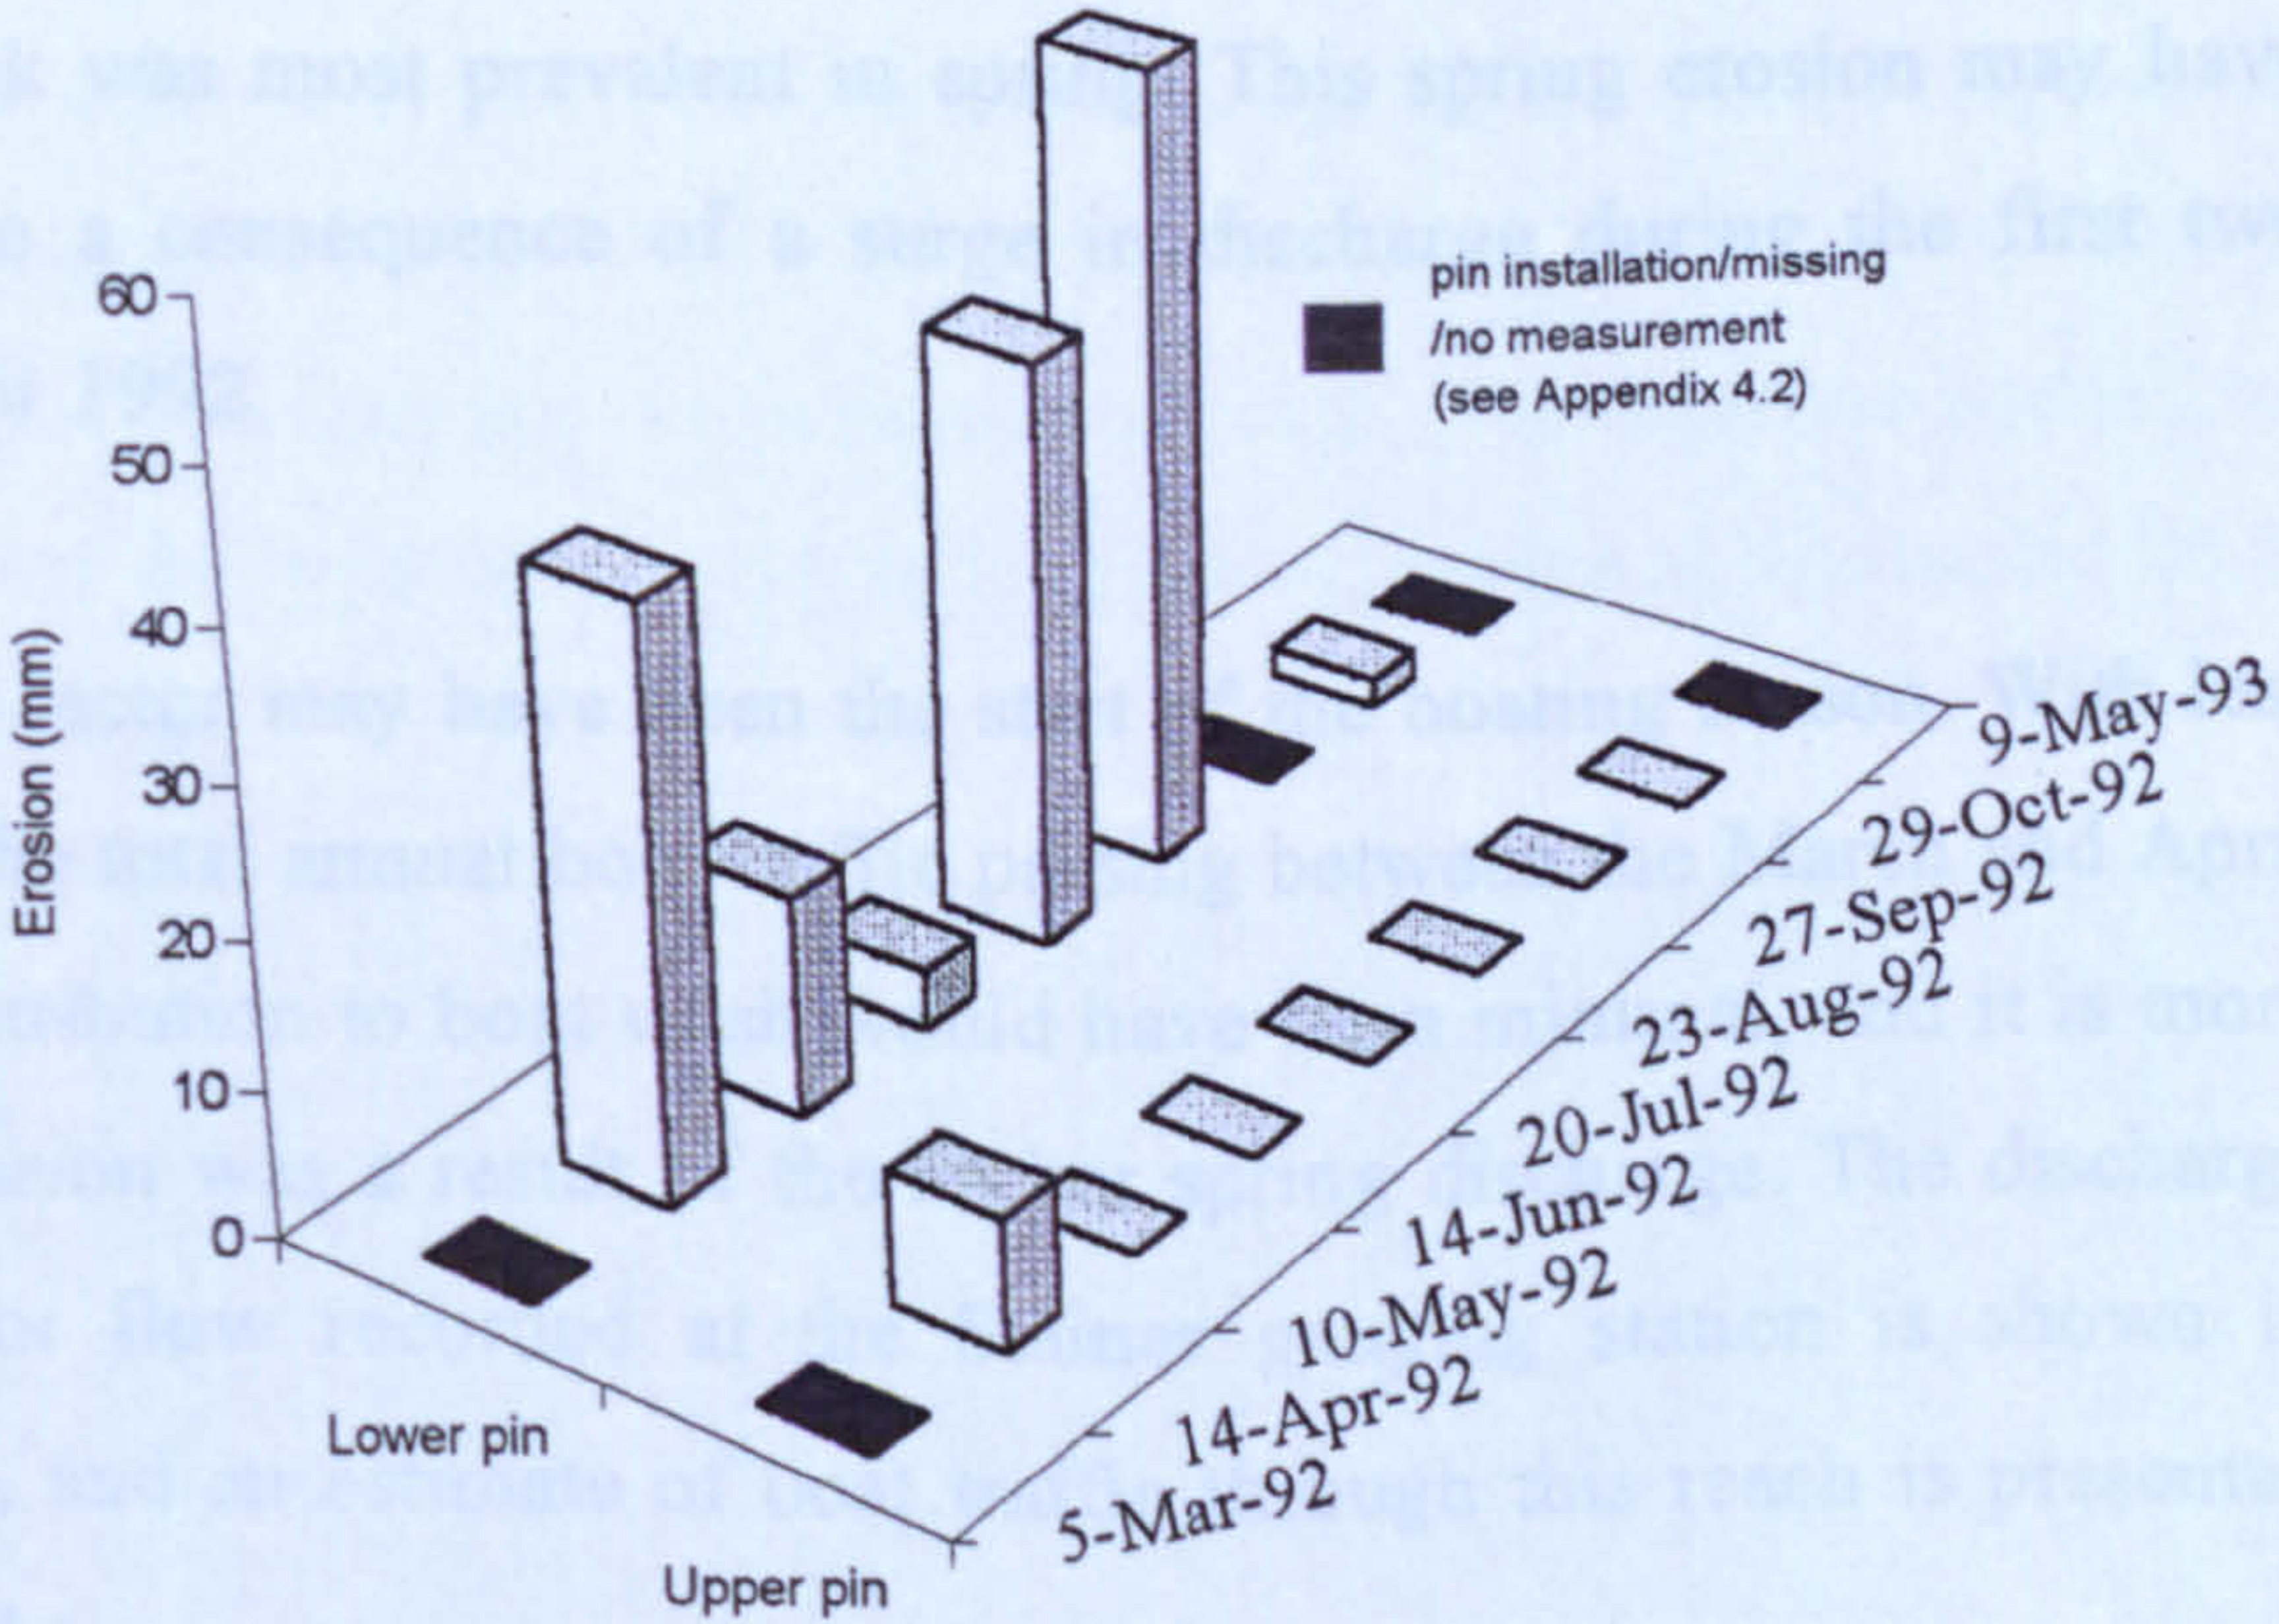
Figure 4.6
 Bank erosion
 measured at
 Laleham.

The total amount of upper and lower bank erosion measured up to 29 October 1992 was 9mm and 155mm, respectively. Besides the influence of the winter flood, the summer period dominated erosion of the lower bank and erosion of the upper bank was most prevalent in spring. This spring erosion may have primarily been a consequence of a surge in discharge during the first two weeks of April 1992.

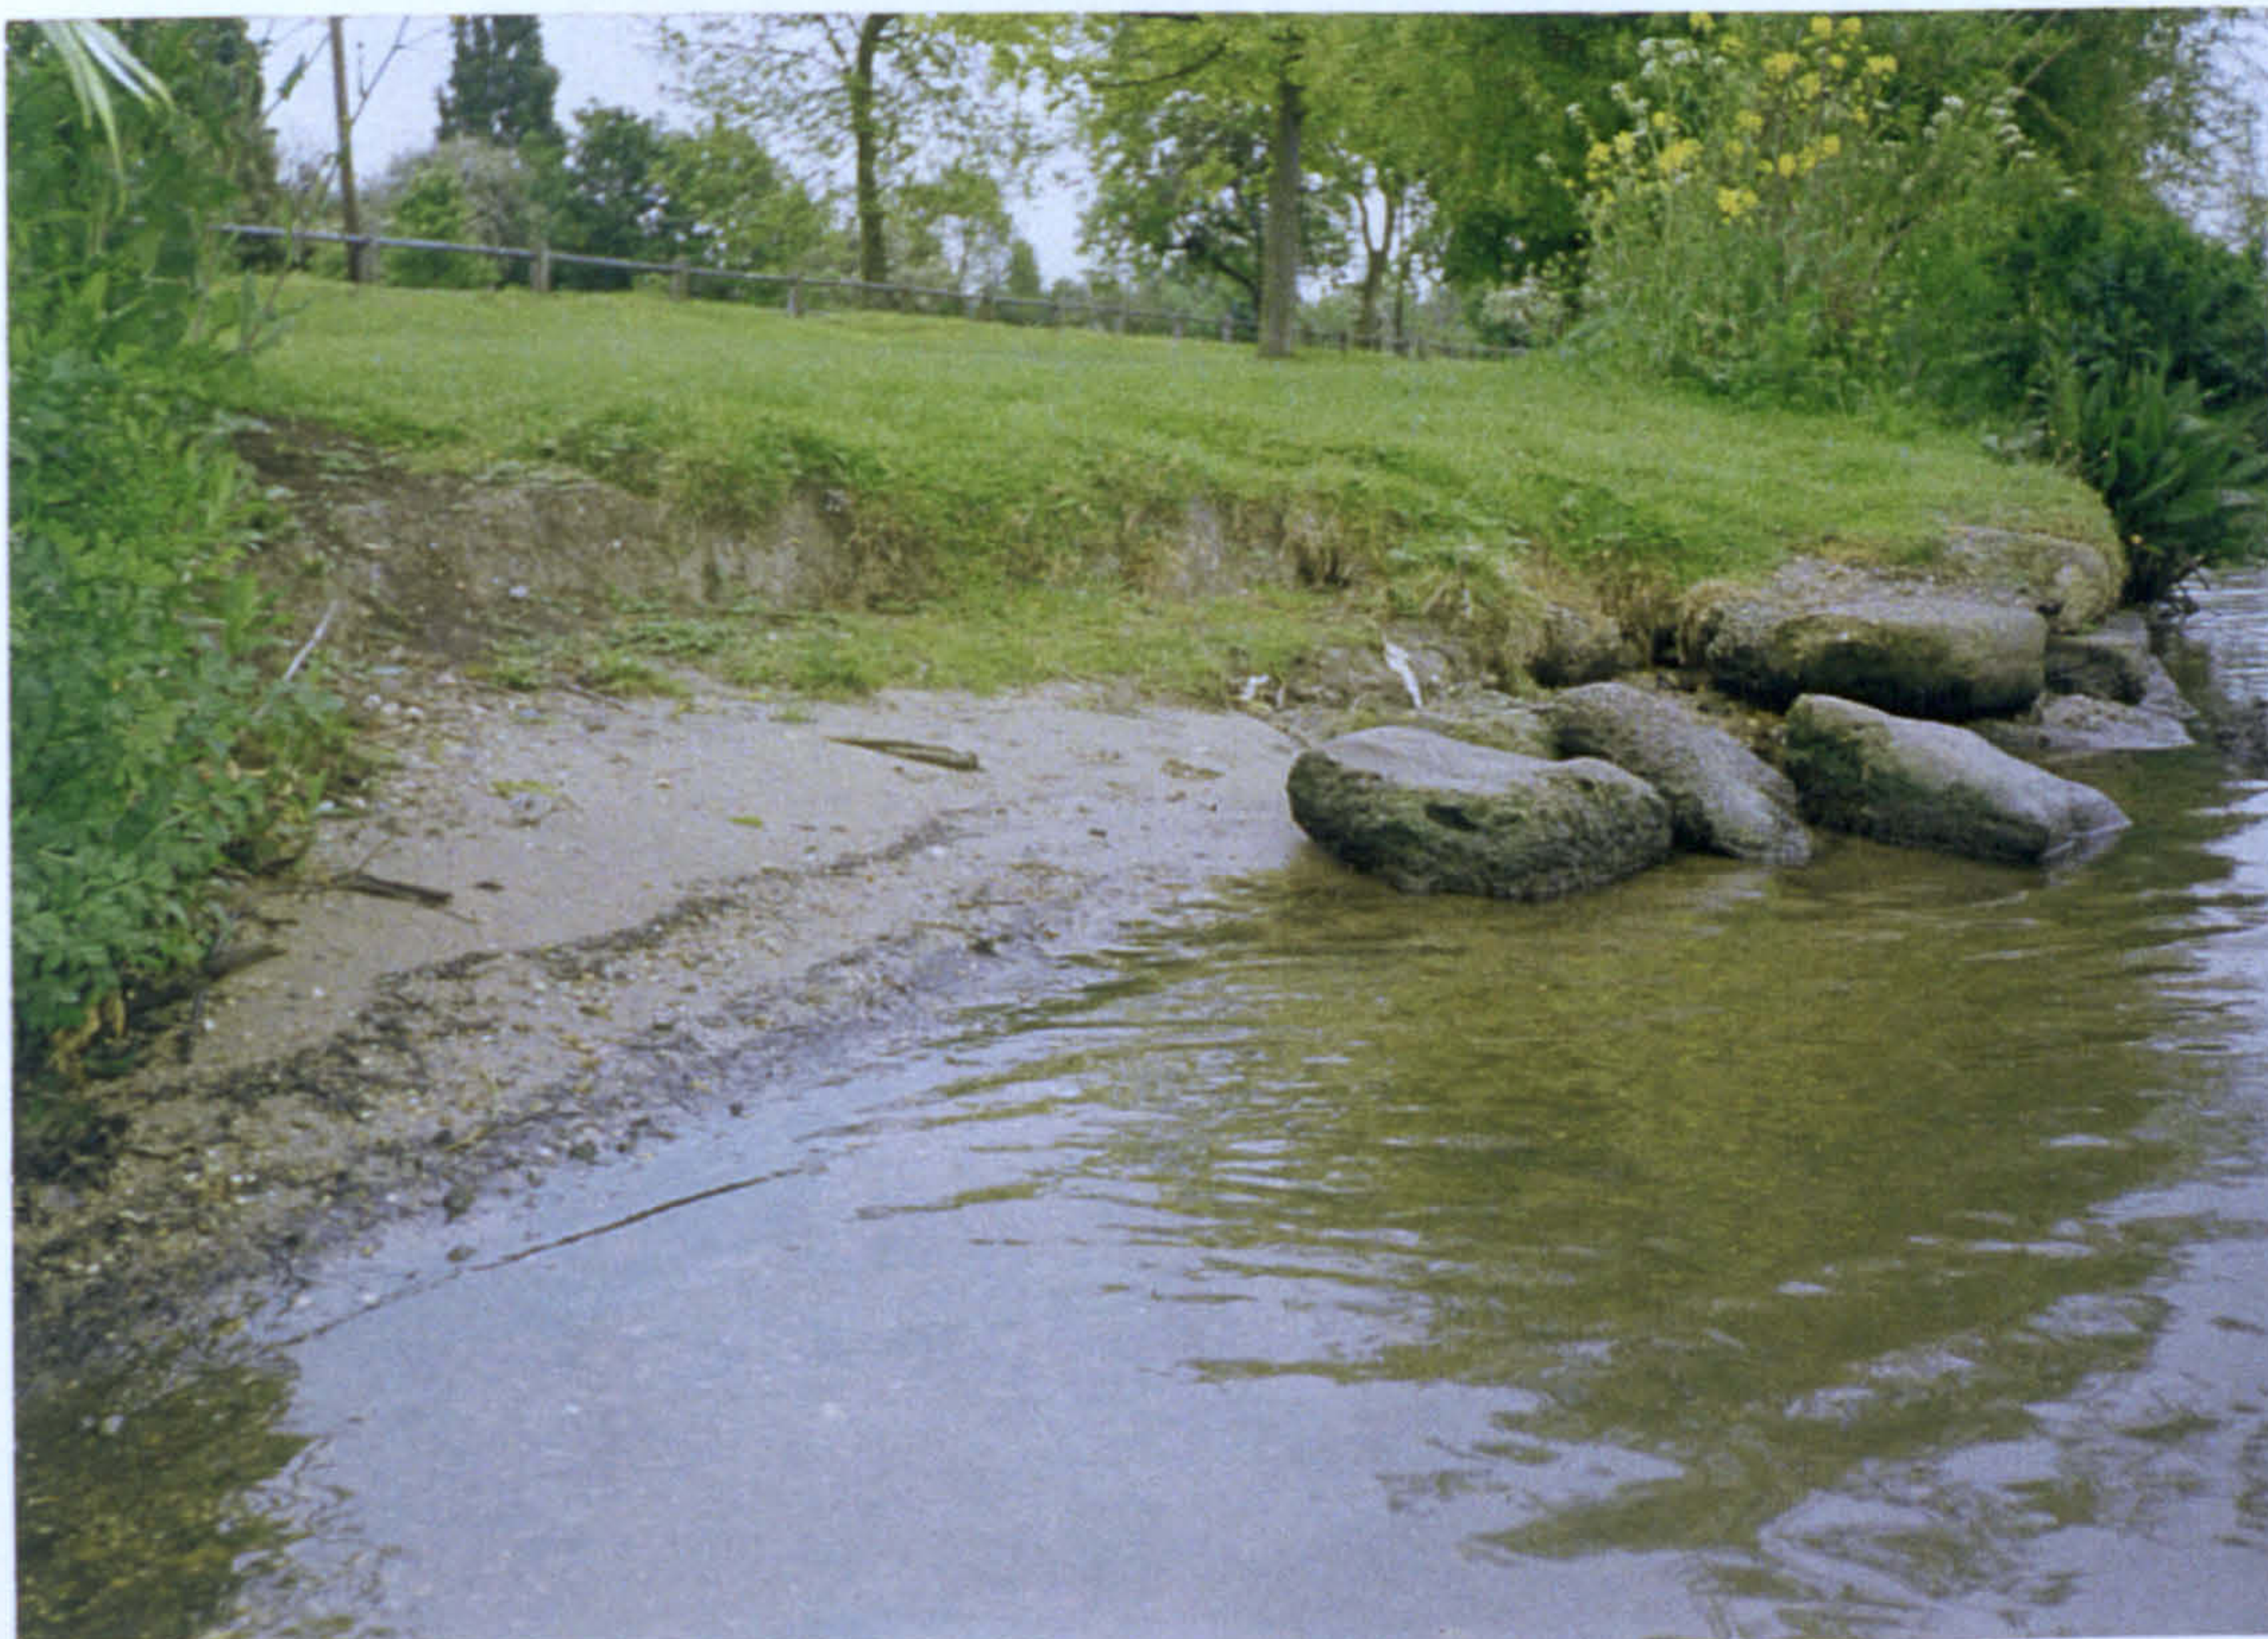
The erosion measured at the upper and lower pins at each visit to the site is given in Appendix 4.2 and shown in Figure 4.6. Neither pin could be relocated on the visit in May 1993 and the appearance of the bank suggested that approximately 0.5m of bank erosion had occurred. Plate 4.22 is a downstream view of the bank taken on 9 May 1993 which clearly shows the retreat of the bank behind the bagwork and enlargement of the spending beach.

Plate 4.22 Downstream view of the Laleham monitoring site following bank retreat.

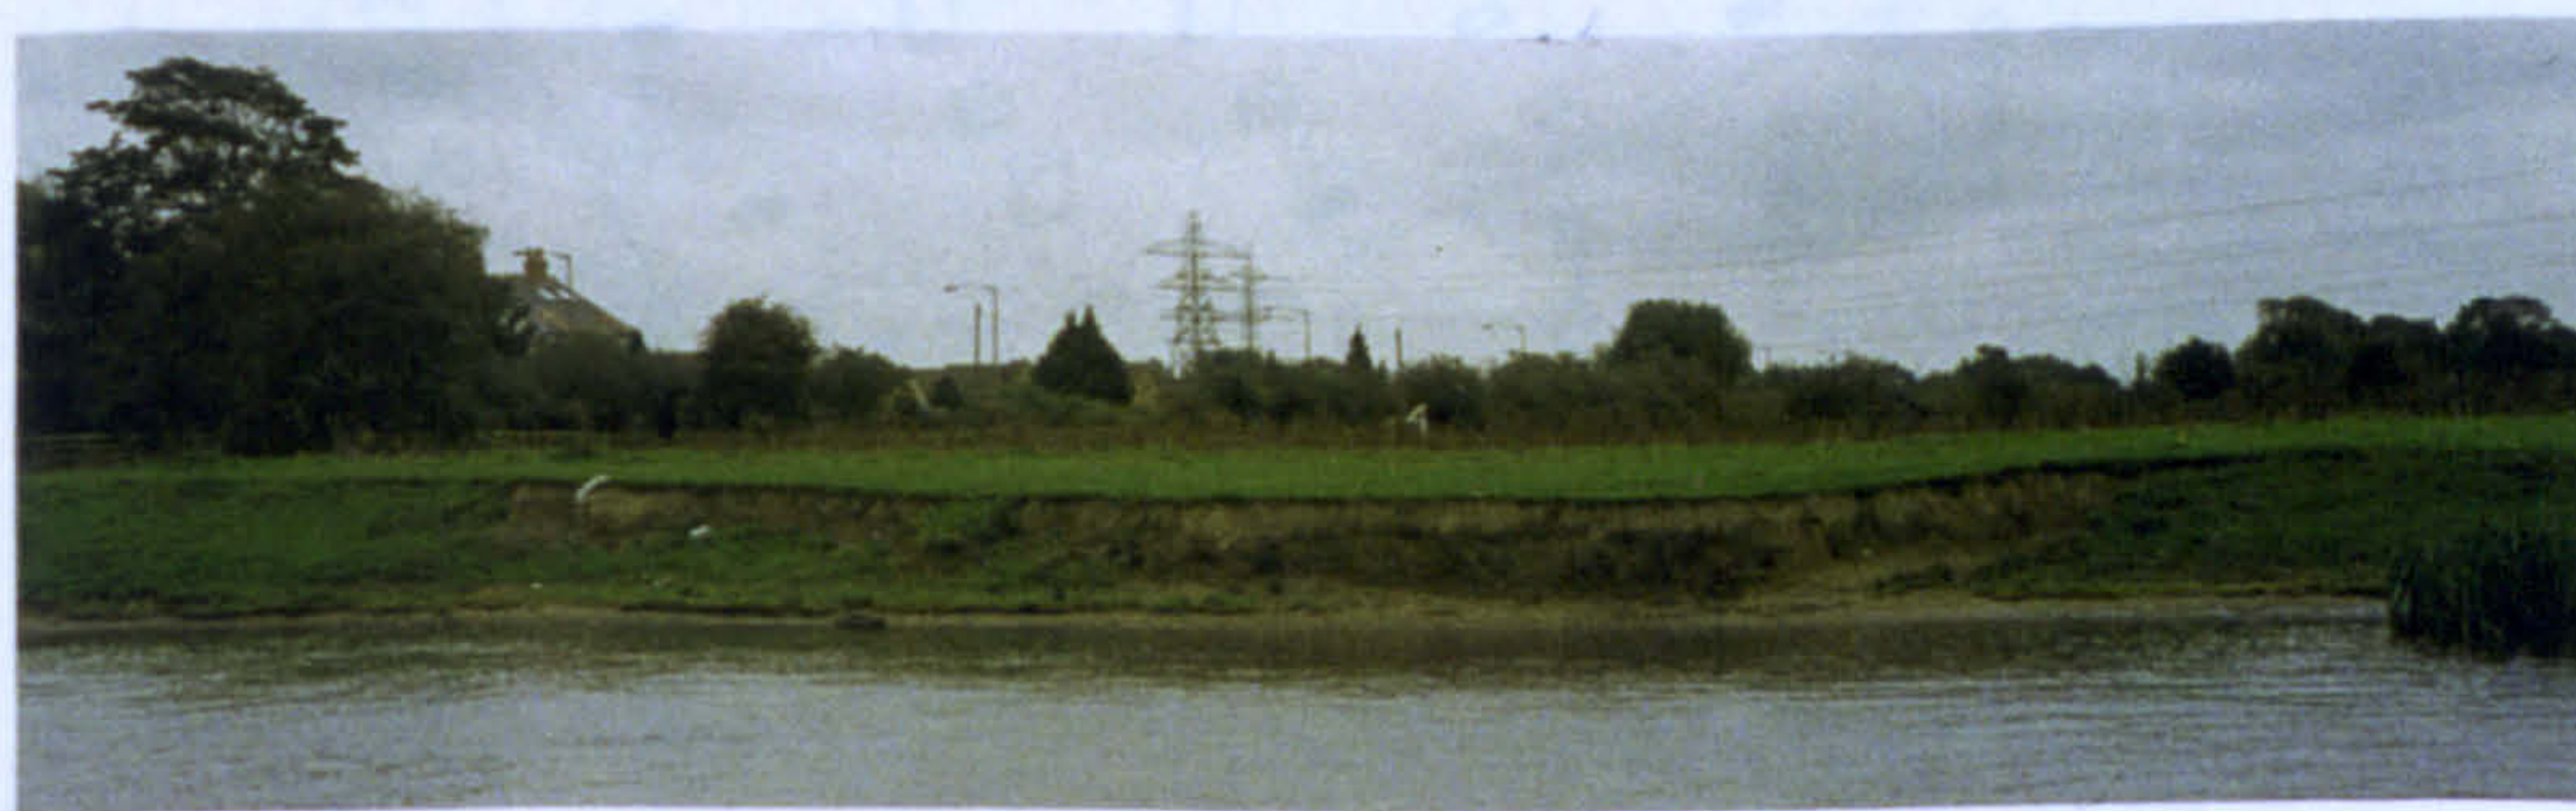
Plate 4.23 The Upper Chertsey monitoring site.

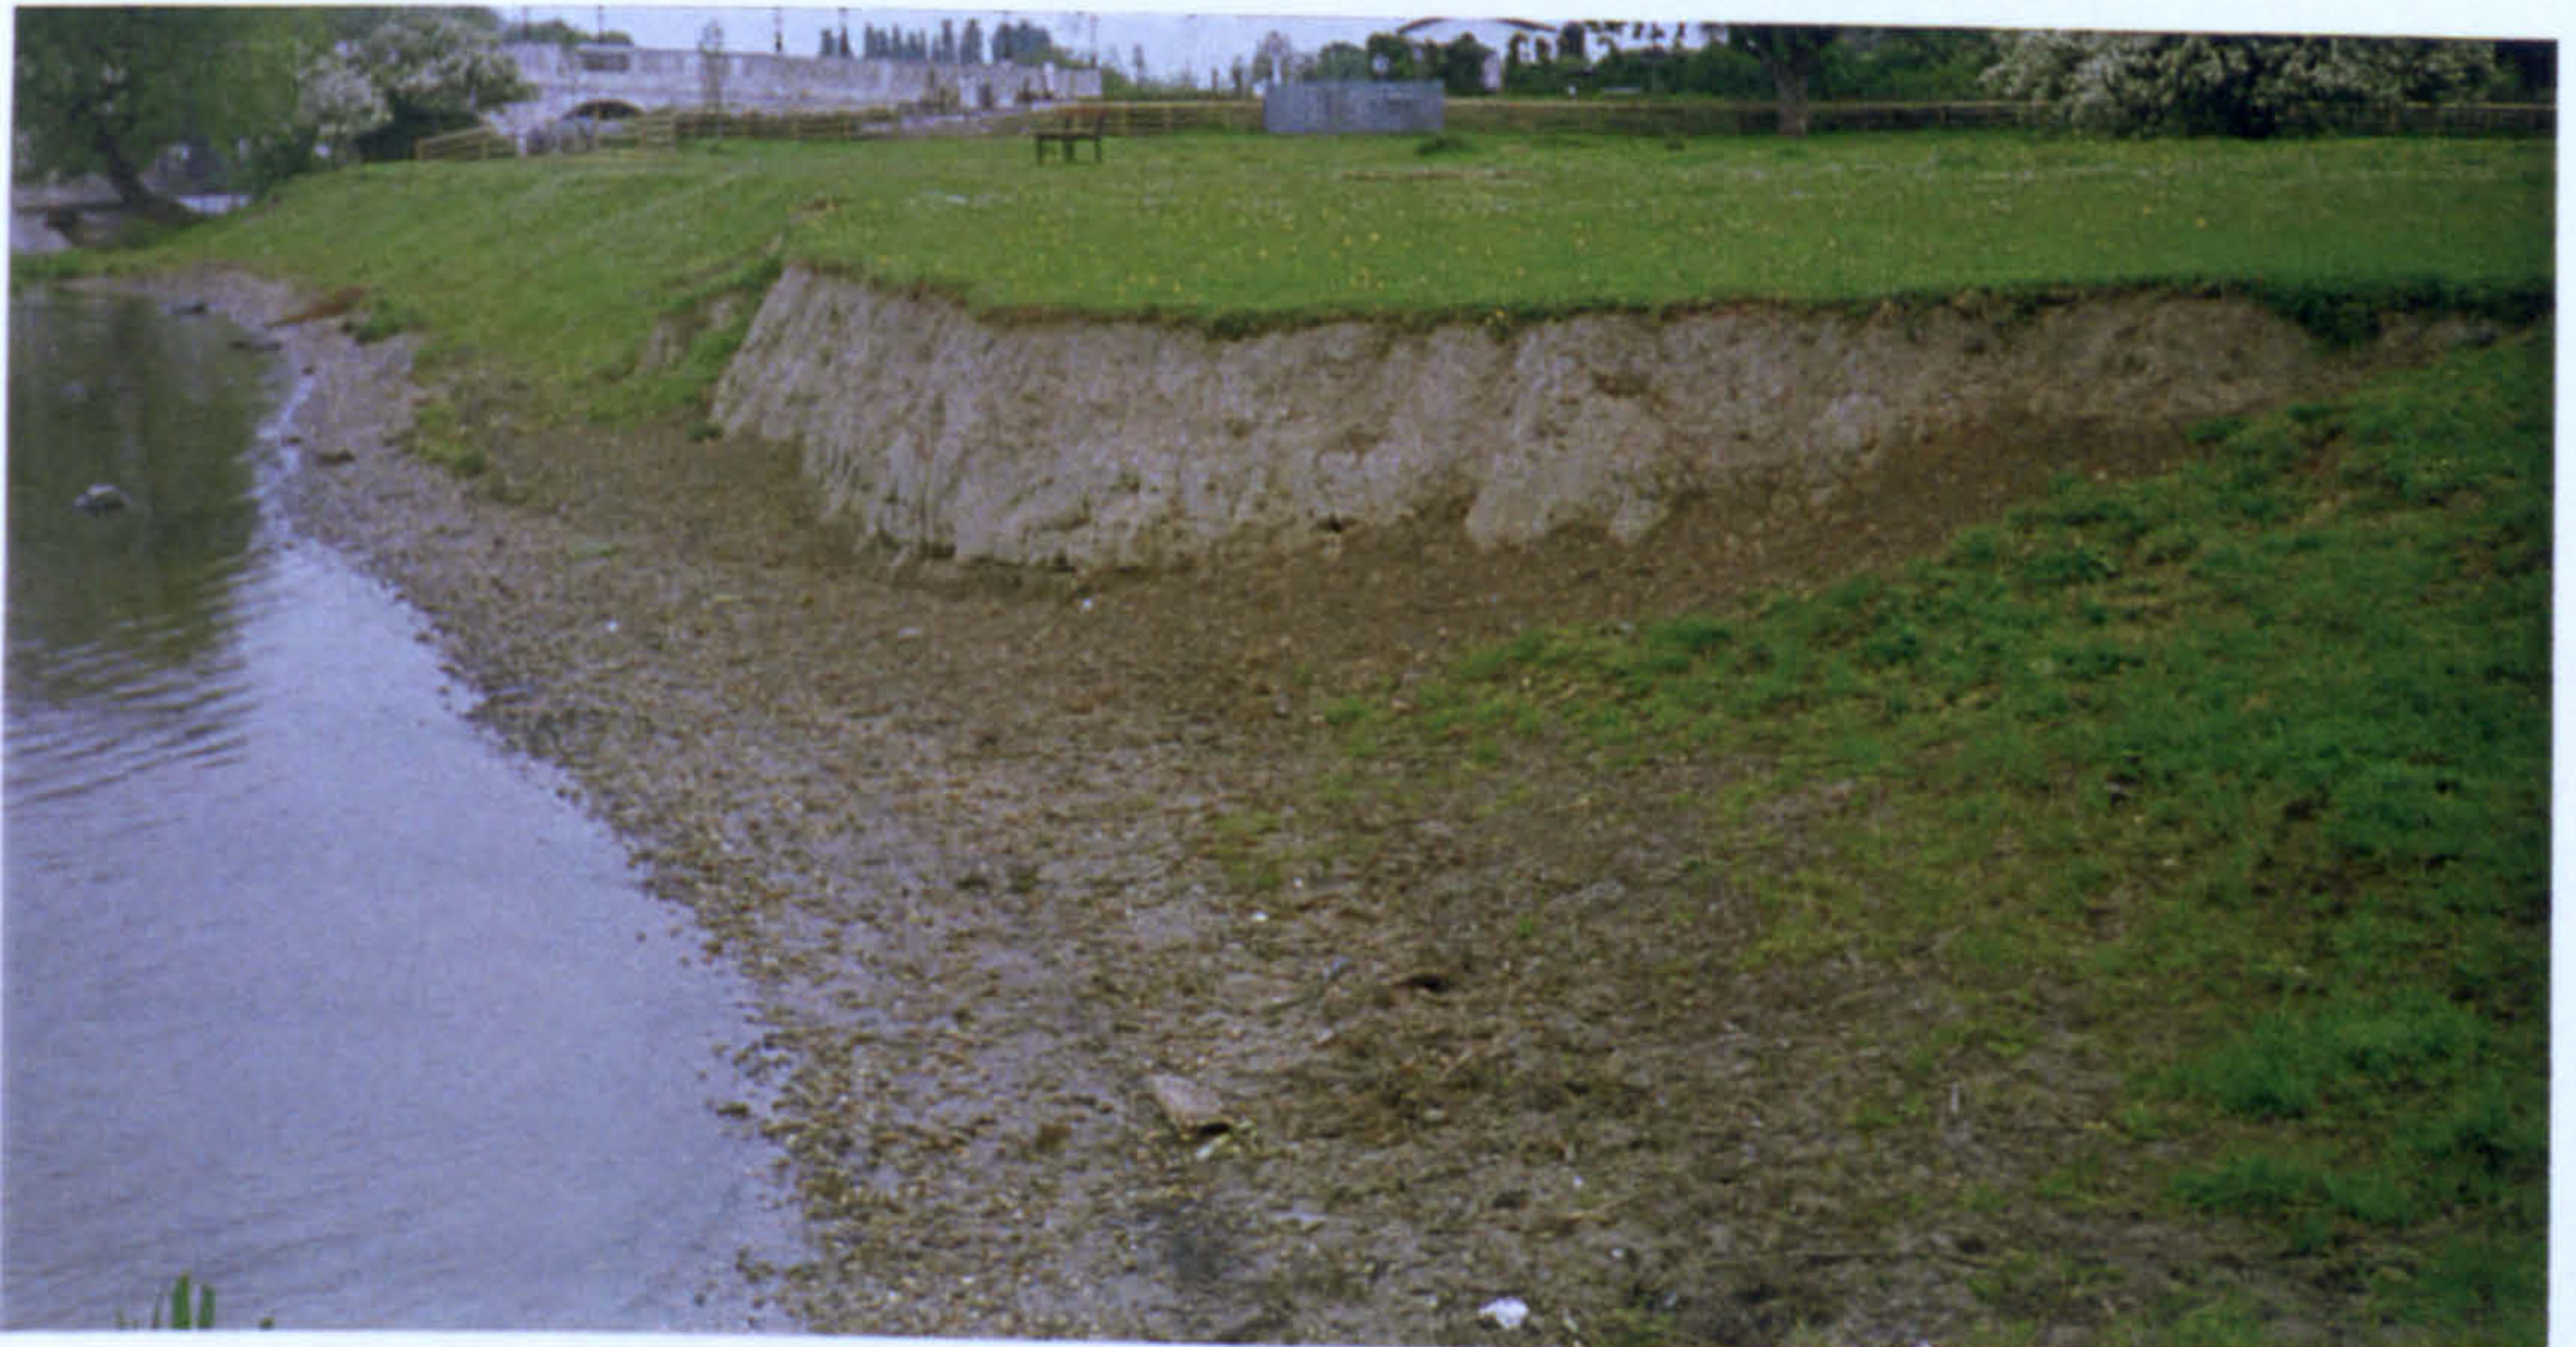
Plate 4.24 Upstream view of the Upper Chertsey monitoring site.
