**"THE NON-TIDAL, NAVIGABLE THAMES:
A BANK EROSION MANAGEMENT STRATEGY"**

by Sue Reed BSc, MSc, MCIWEM

**Thesis submitted to the University of Nottingham
for the degree of Doctor of Philosophy, October 1998**

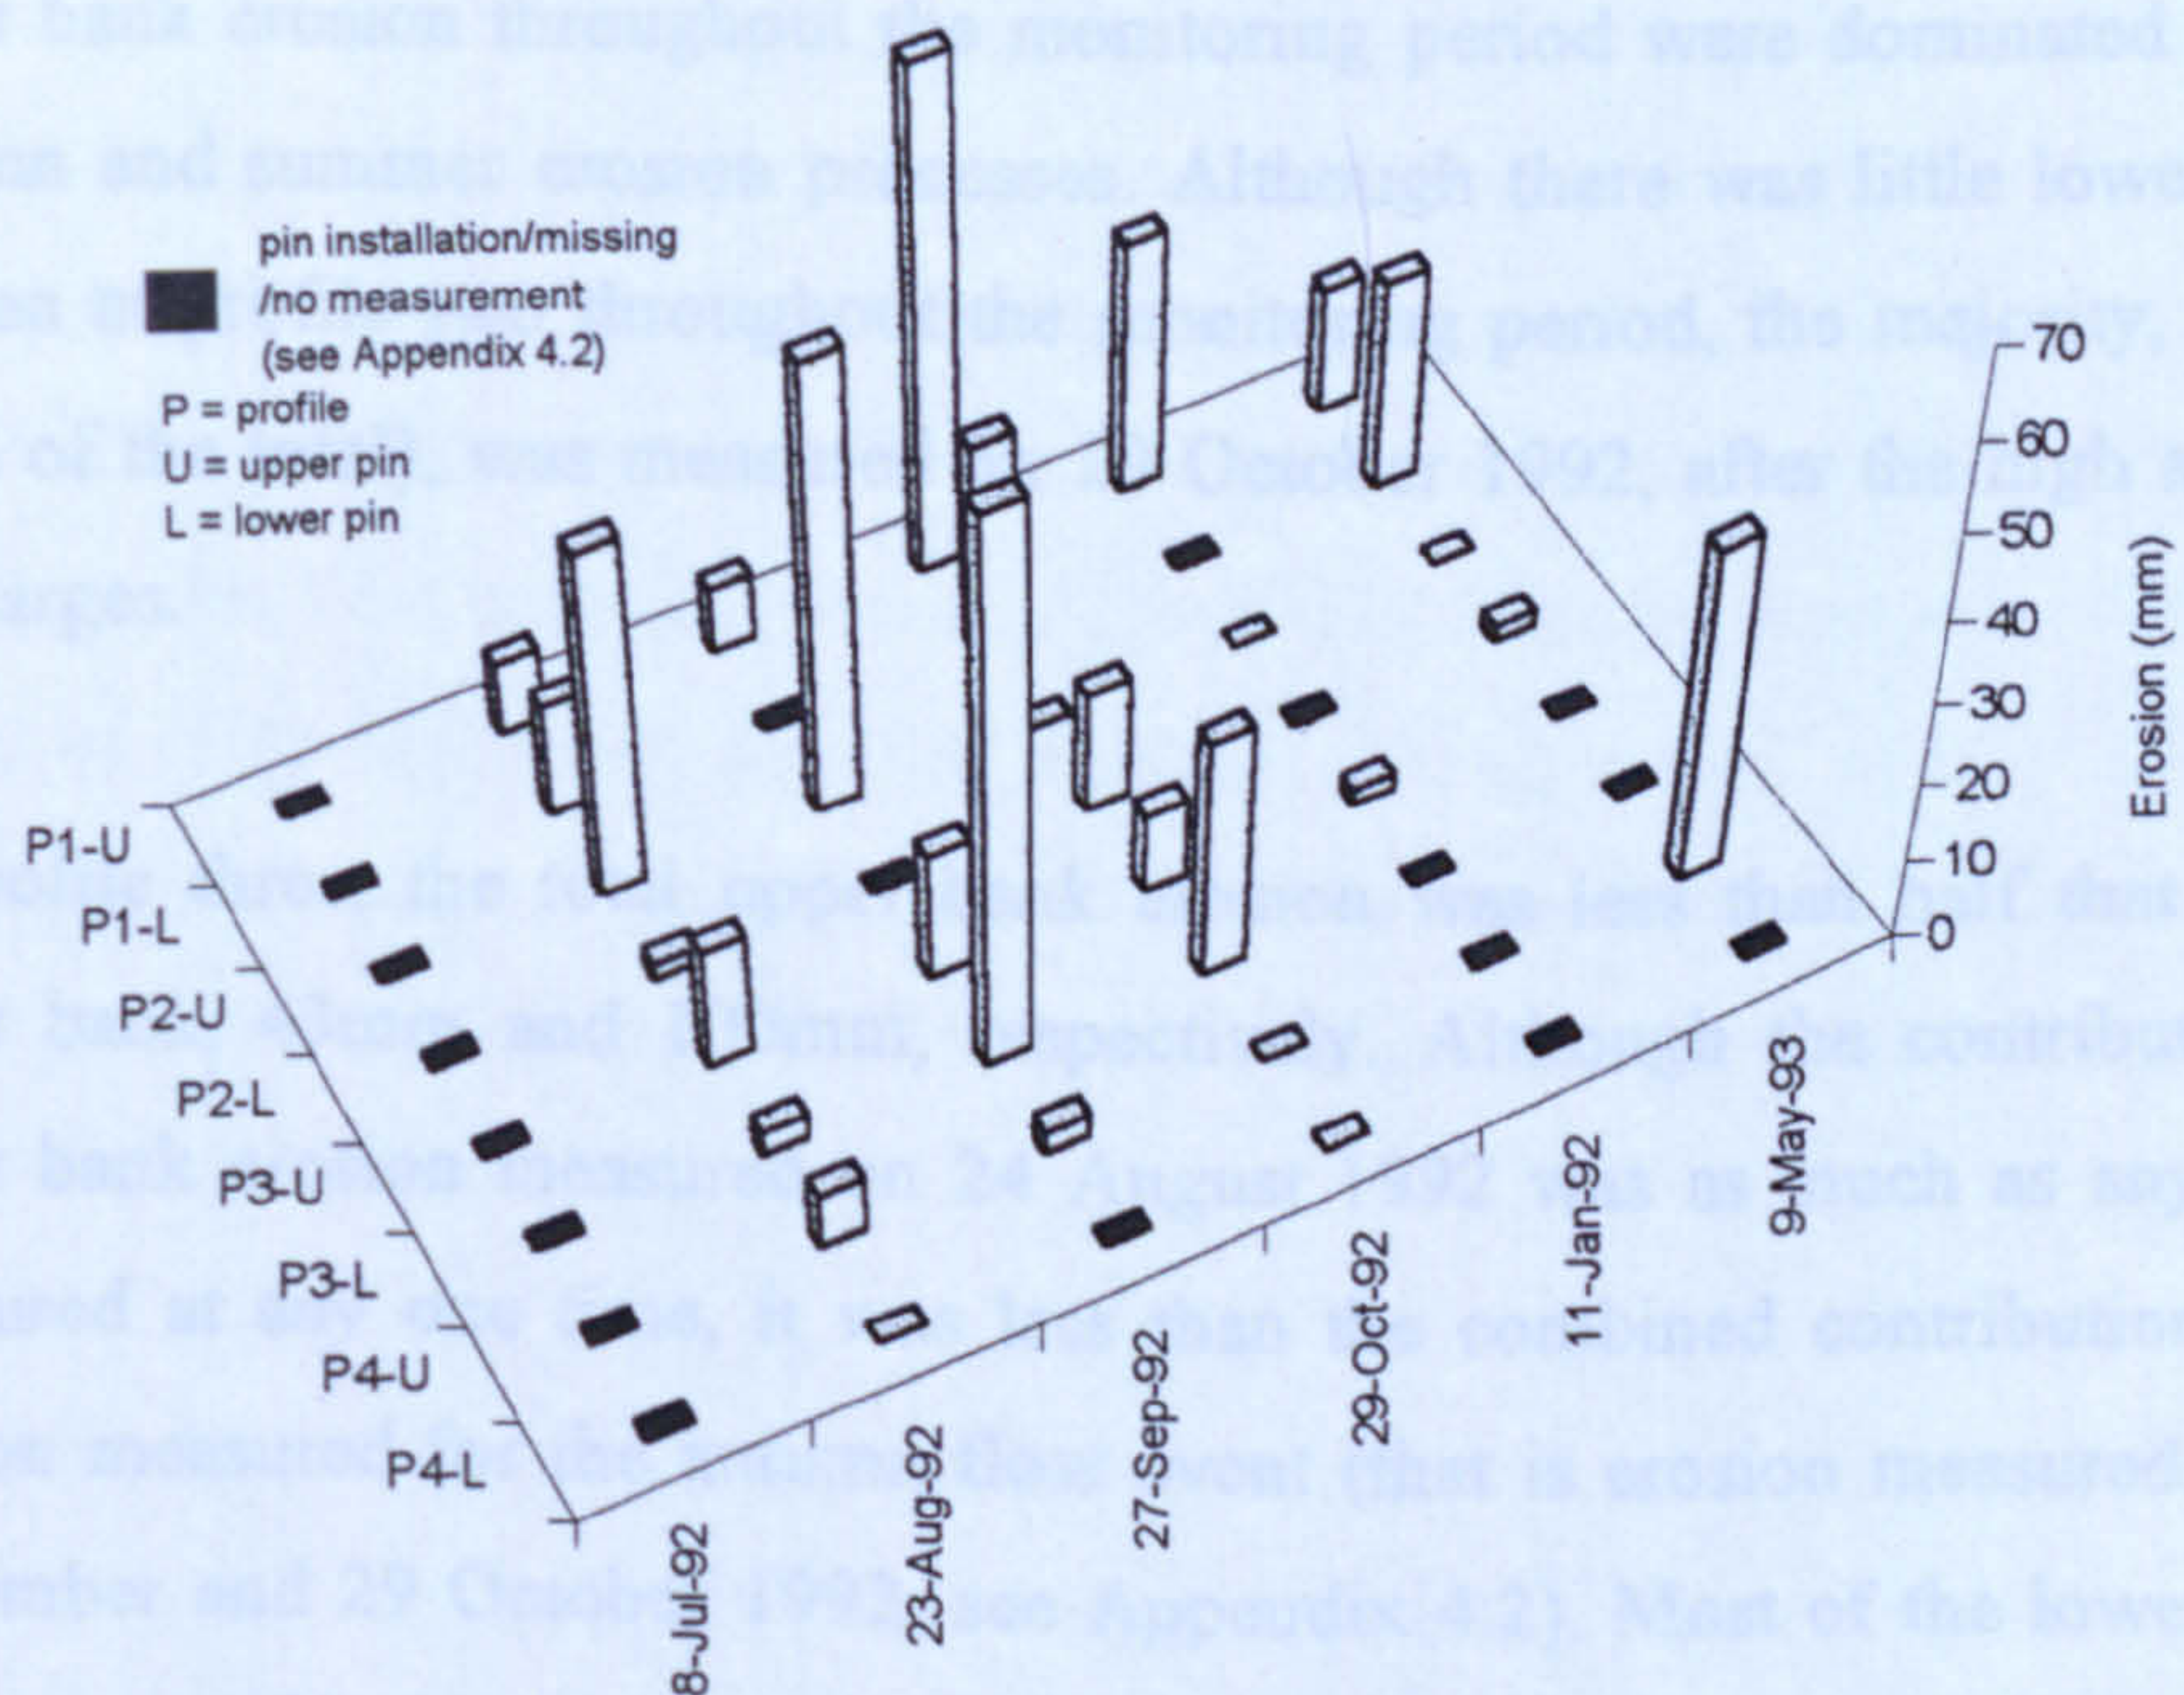
Figure 4.7 Bank erosion measured at the Upper Chertsey monitoring site.

The upper bank erosion measured through the monitoring period at profile one was almost twice that at the lower bank, 122mm compared with 64mm, respectively. Figure 4.7 shows that most upper bank erosion was measured on 29 October 1992, after the high autumn discharges. The most lower bank erosion during any one visit was 25mm, again measured on the 29 October 1992. This would imply that at profile one the high discharges towards the end of 1992 were primarily responsible for the erosion measured at the upper and lower bank.

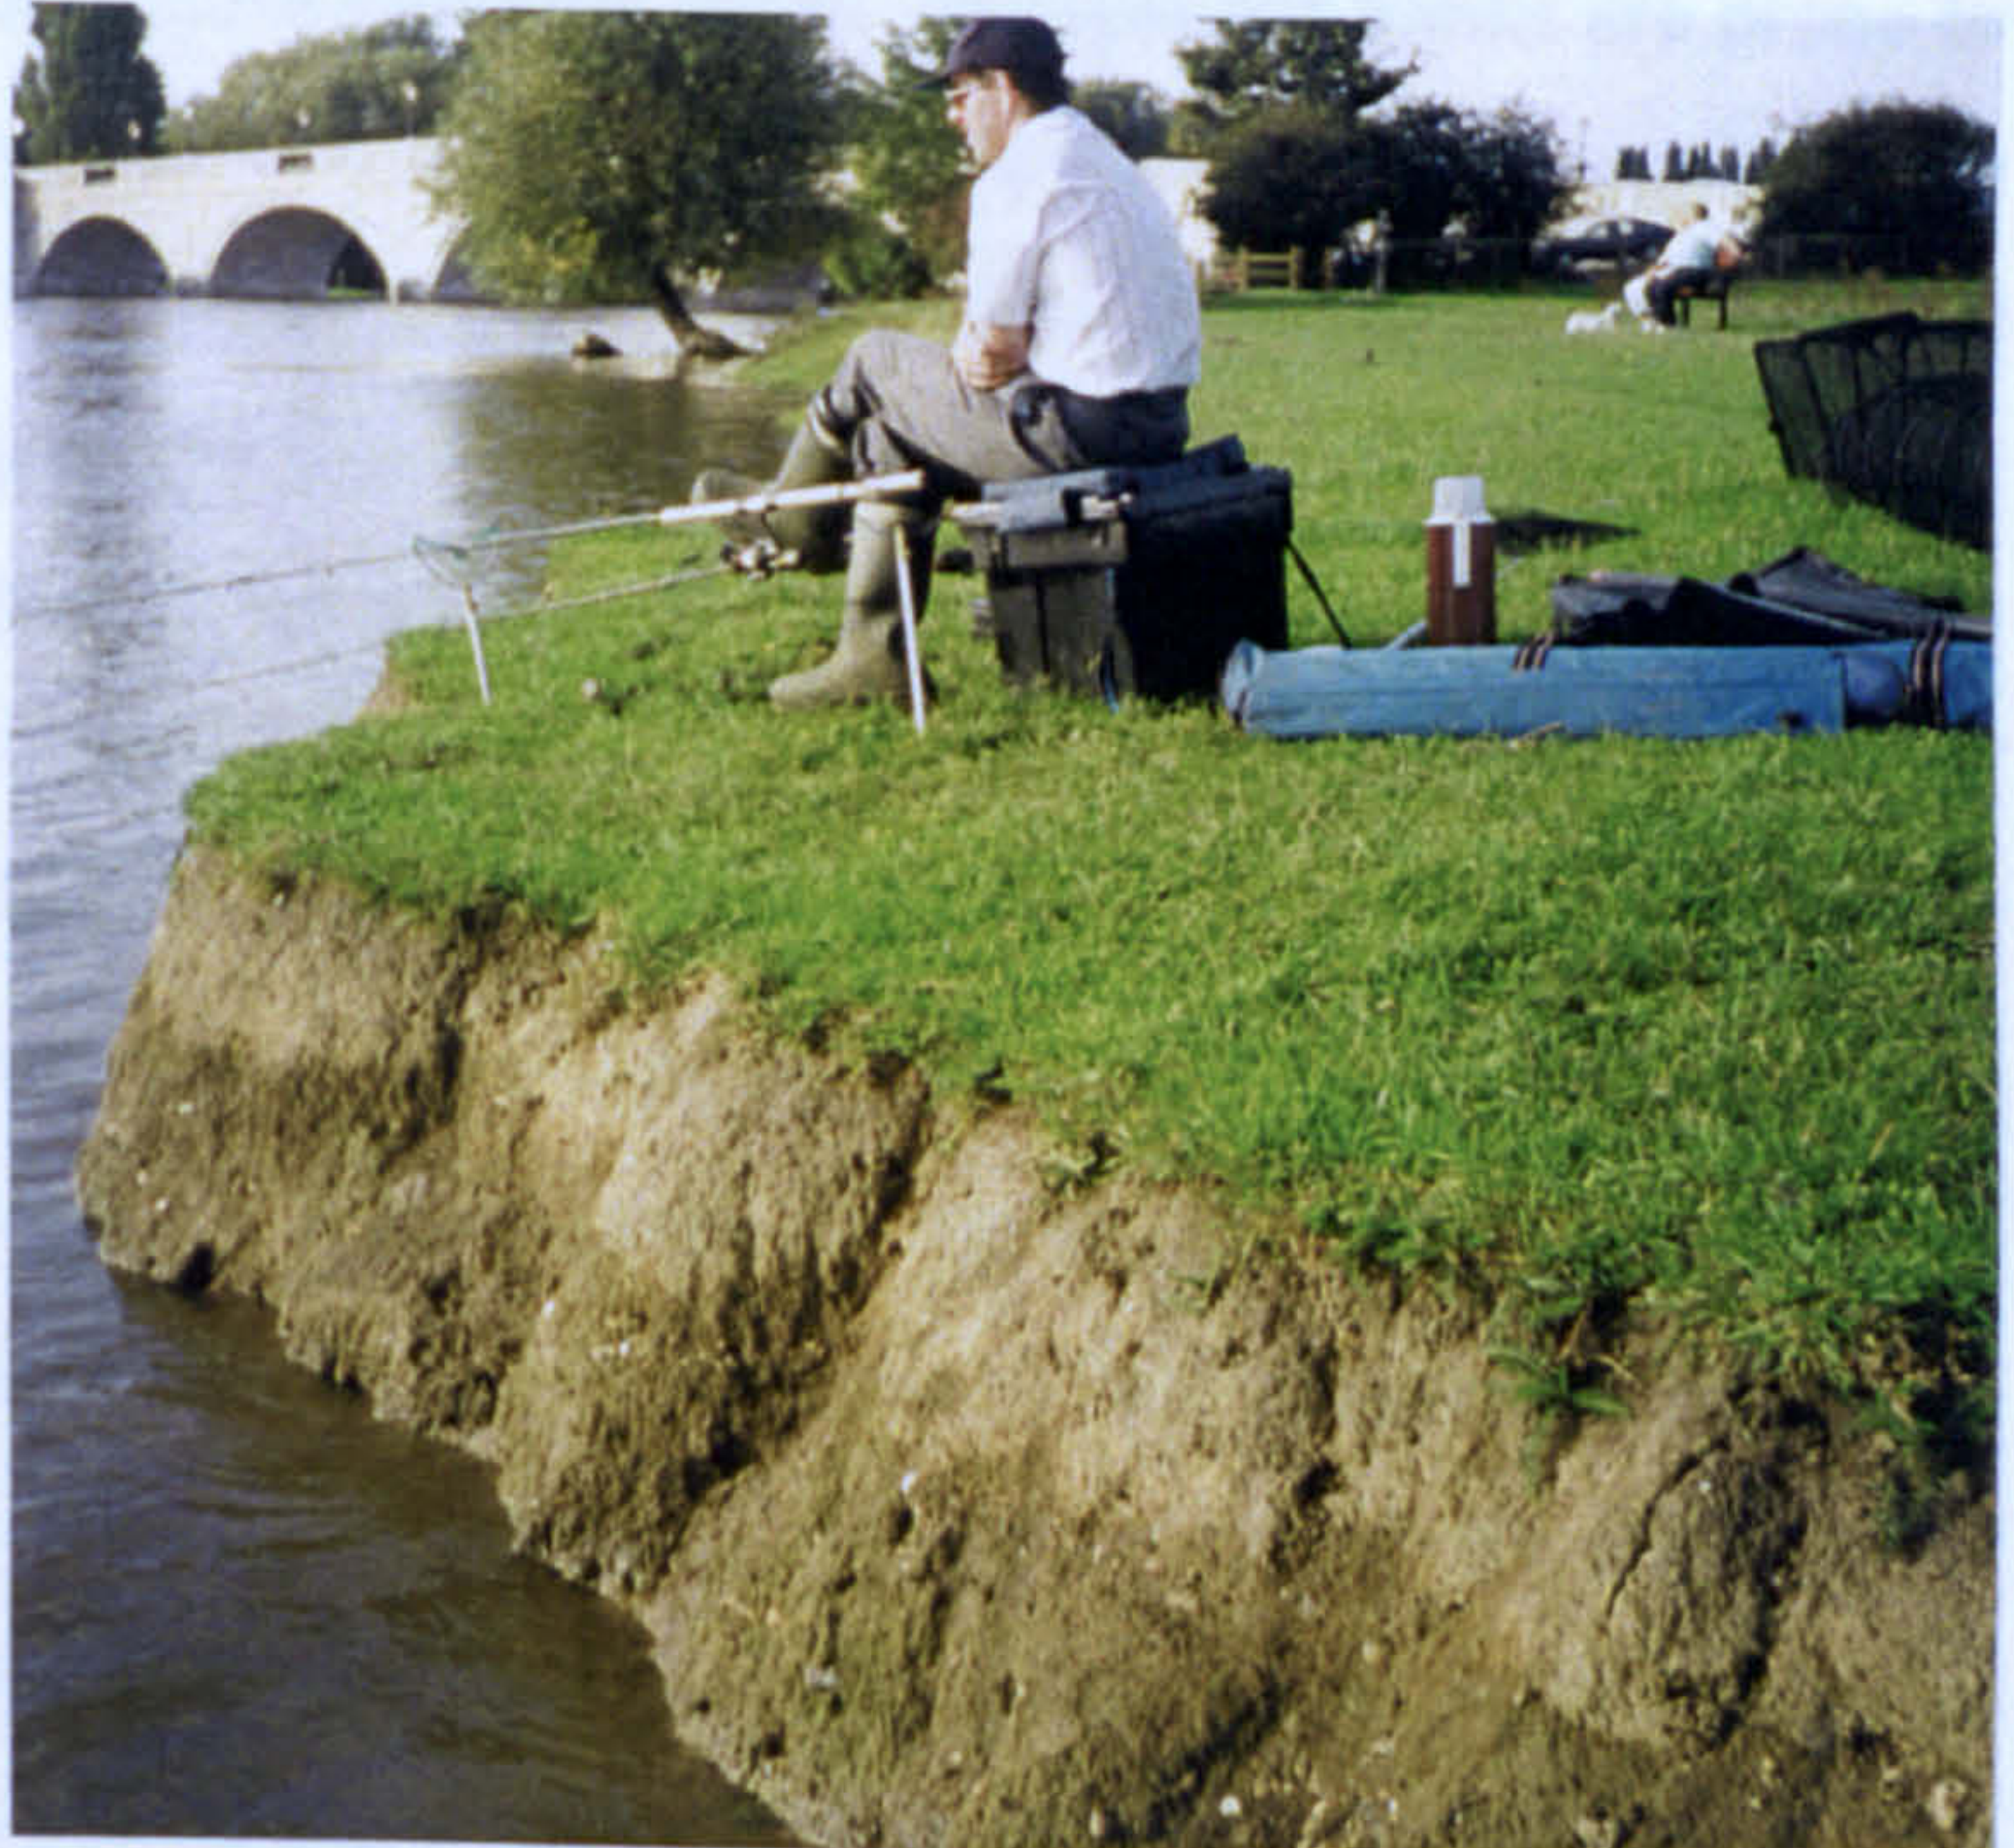
Plate 4.25 is an upstream view of the monitoring site, taken on 28 September 1992, the day after the peak autumn discharge. The tide line on the bank suggests that the autumn flow peaked at a level somewhat higher ($\sim 0.15\text{m}$) than the water level shown, which is approximately 0.1m below the top of the bank. The winter flood was at approximately bankfull discharge but resulted in no appreciable erosion compared to the autumn flows. It is, therefore, likely that preparatory factors weakened the particles at the surface of the bank material and facilitated the entrainment of material by the autumn flows, but did not act to weaken the bank material prior to the bankfull discharges experienced in the winter of 1992. Neither of the erosion pins could be located in May 1993, but the appearance of the bank suggested that no significant bank erosion had taken place since January 1992 and it is likely that the erosion pins were removed deliberately.

Plate 4.25 Upstream view of the Upper Chertsey site following subsidence of peak autumn flows (28 September 1992).

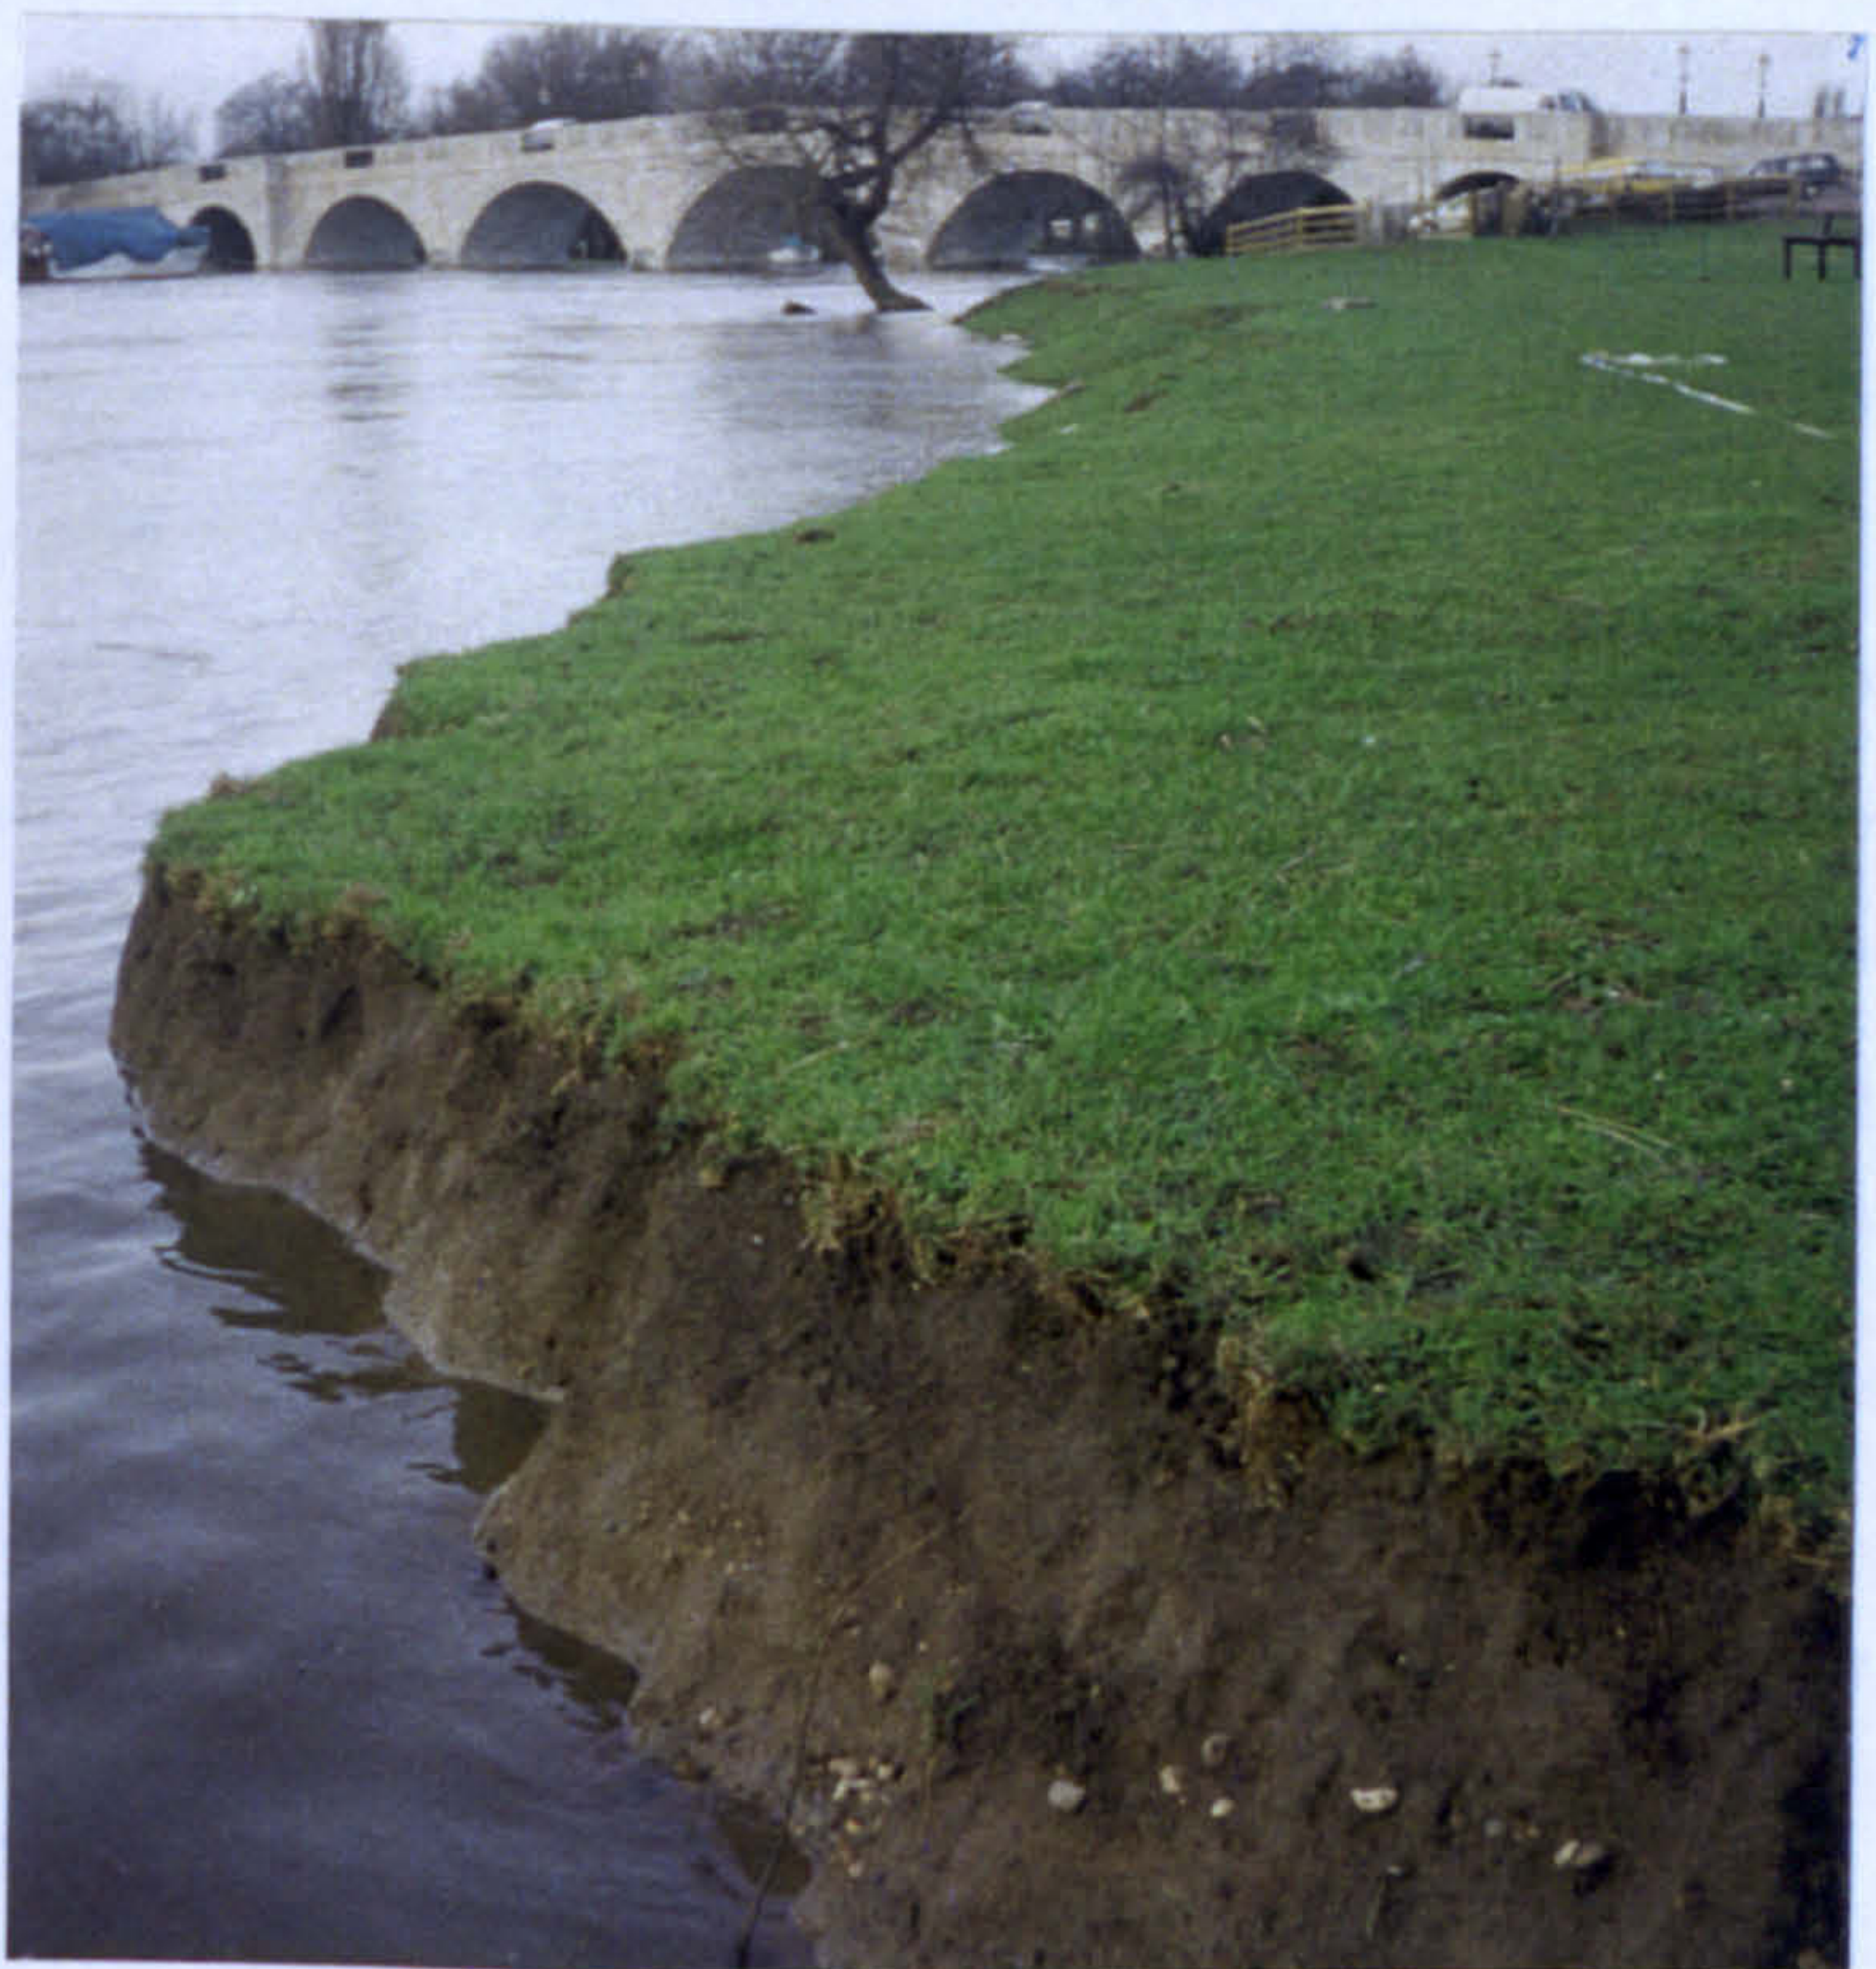
Plate 4.26 Upstream view of the Upper Chertsey site following subsidence of high winter flows (11 January 1993).

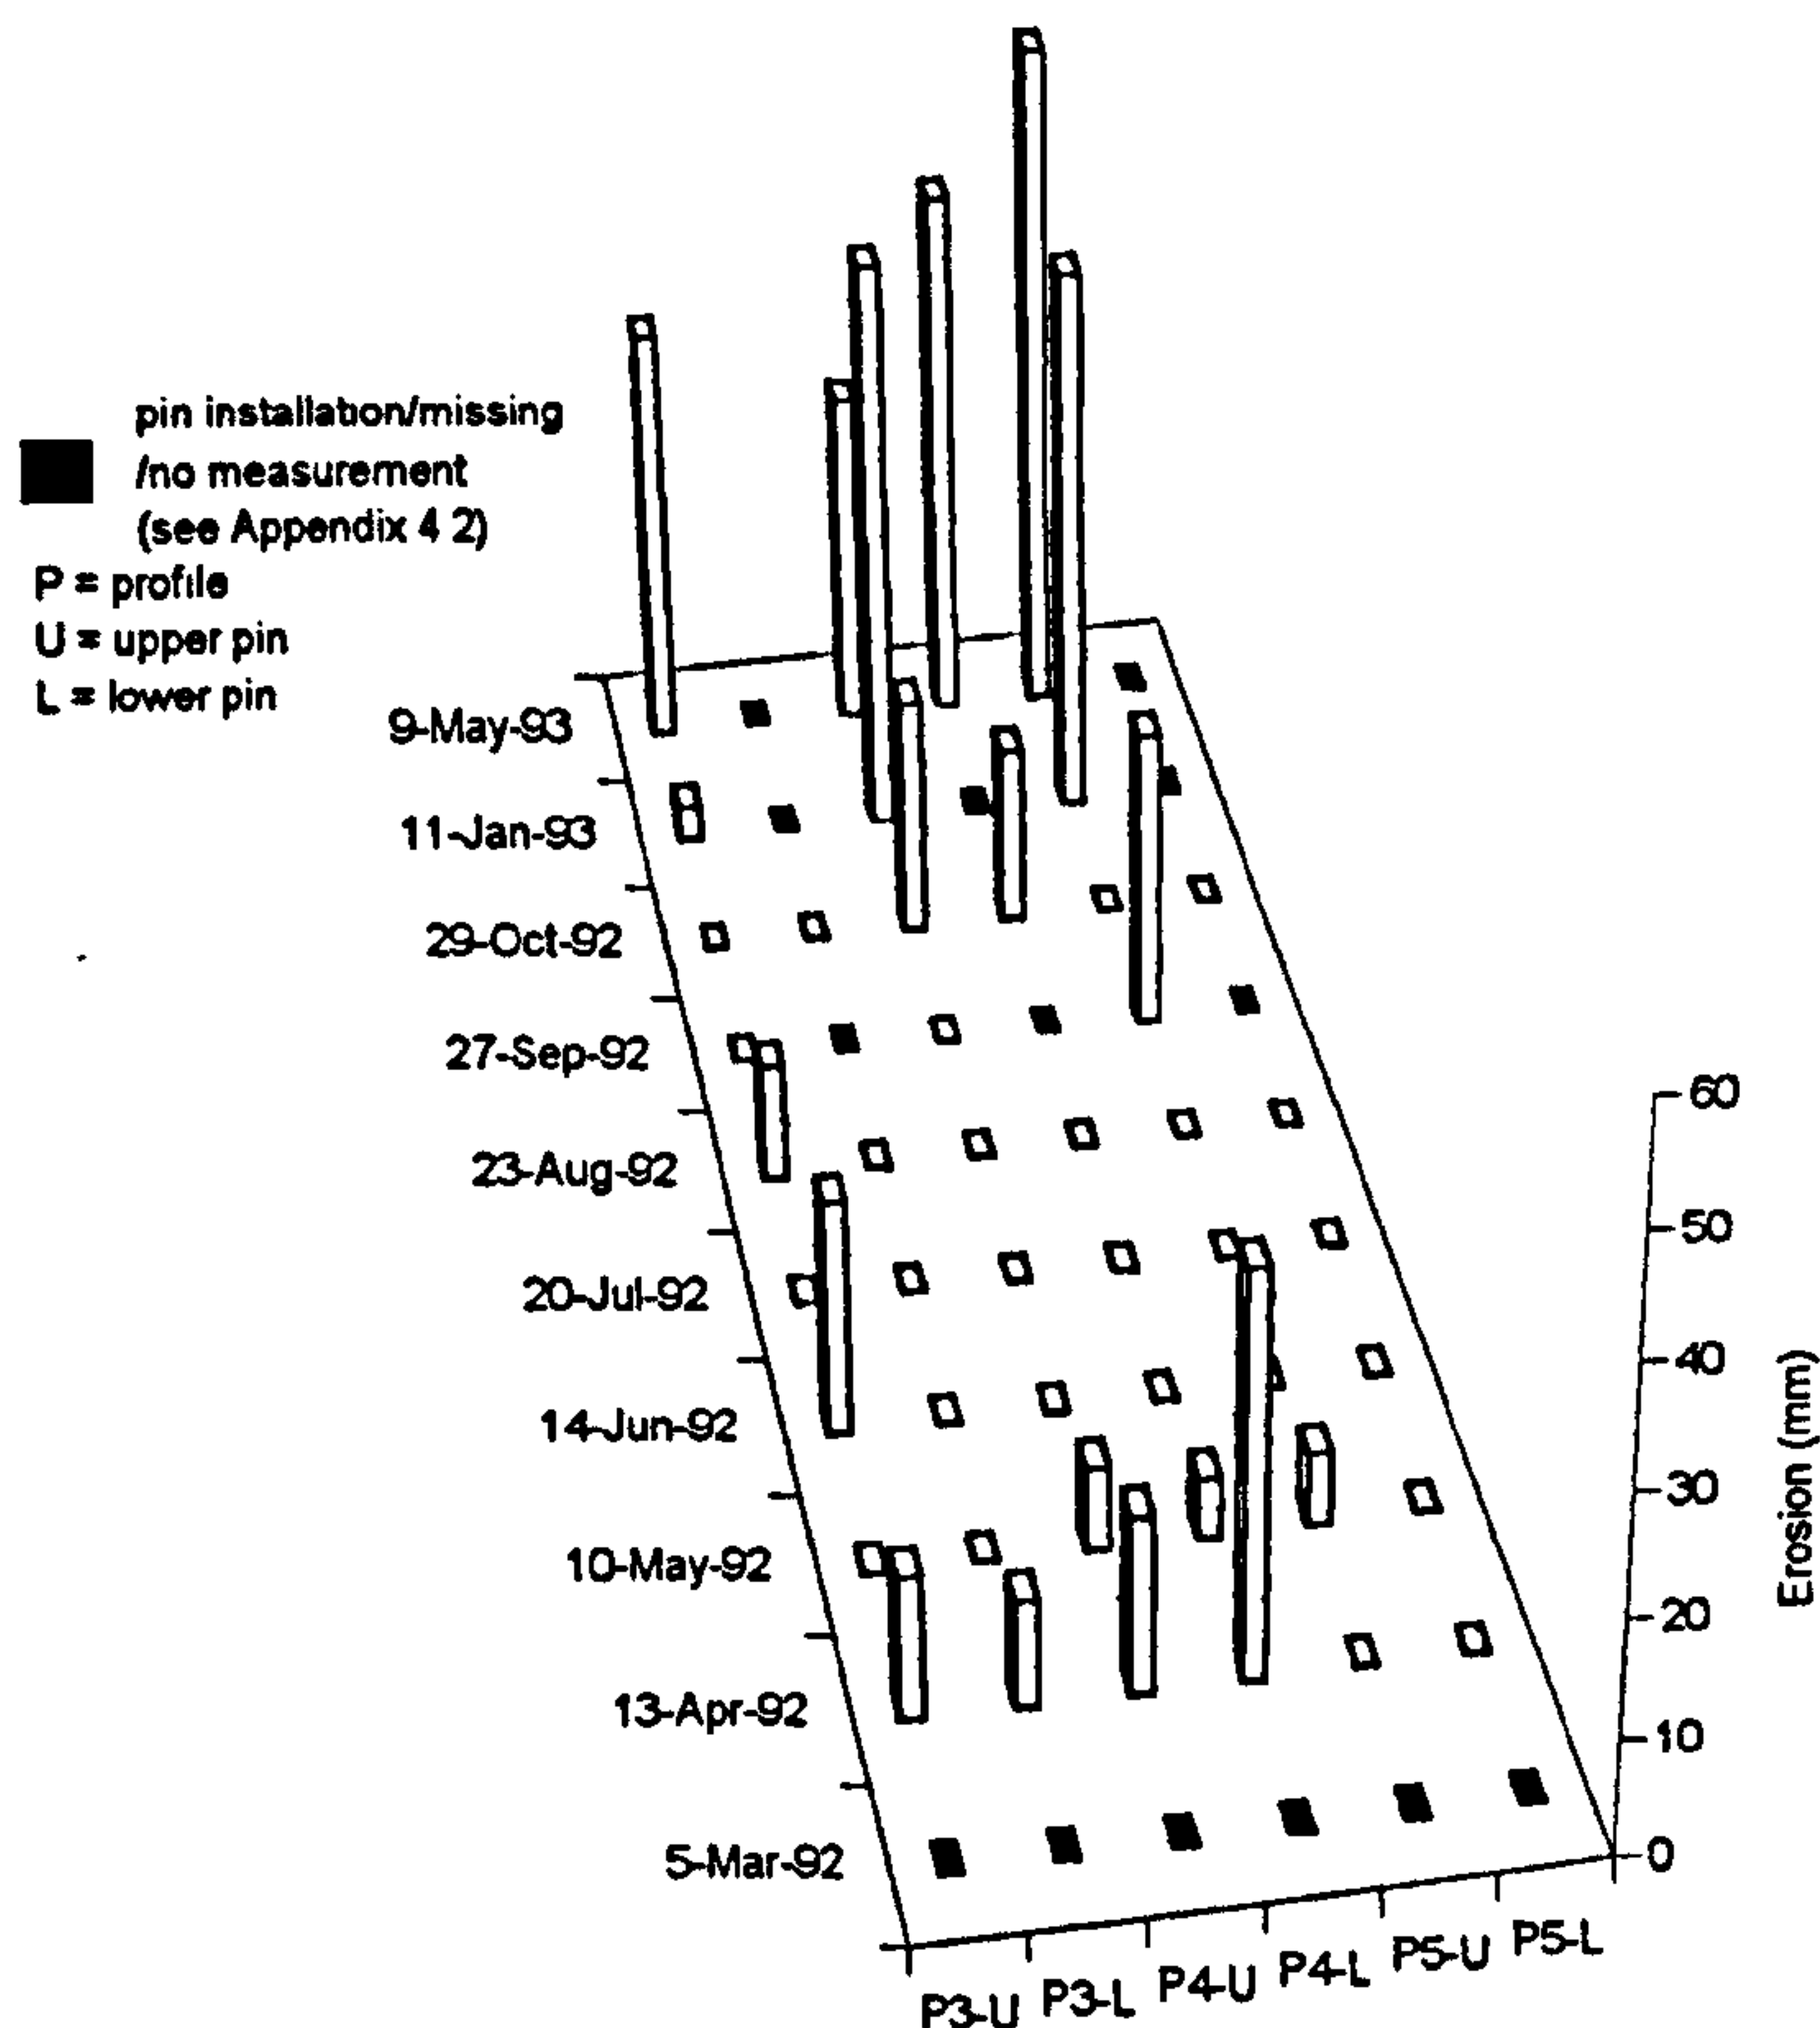
Figure 4.8 Bank erosion measured at Lower Chertsey.

The bank at profile three was higher and steeper than at profiles one and two. The erosion measured at the upper and lower pins in profile three is given in Appendix 4.2 and shown in Figure 4.8. The most upper bank erosion measured here in any one visit to the site was 35mm, 44% of the total, which eroded between 11 January and 9 May 1993. Comparable erosion, 37% of the total at the upper bank, was measured for the period between 14 June and 23 August 1992.

The erosion measured at each of the pins in profile four is also given in Appendix 4.2 and shown in Figure 4.8. In total there was slightly more erosion at the upper bank than at the lower, 118mm compared to 99mm, respectively. The most upper bank erosion measured at one time was 48mm, 41% of the total, during the period from 29 October 1992 to 11 January 1993. An

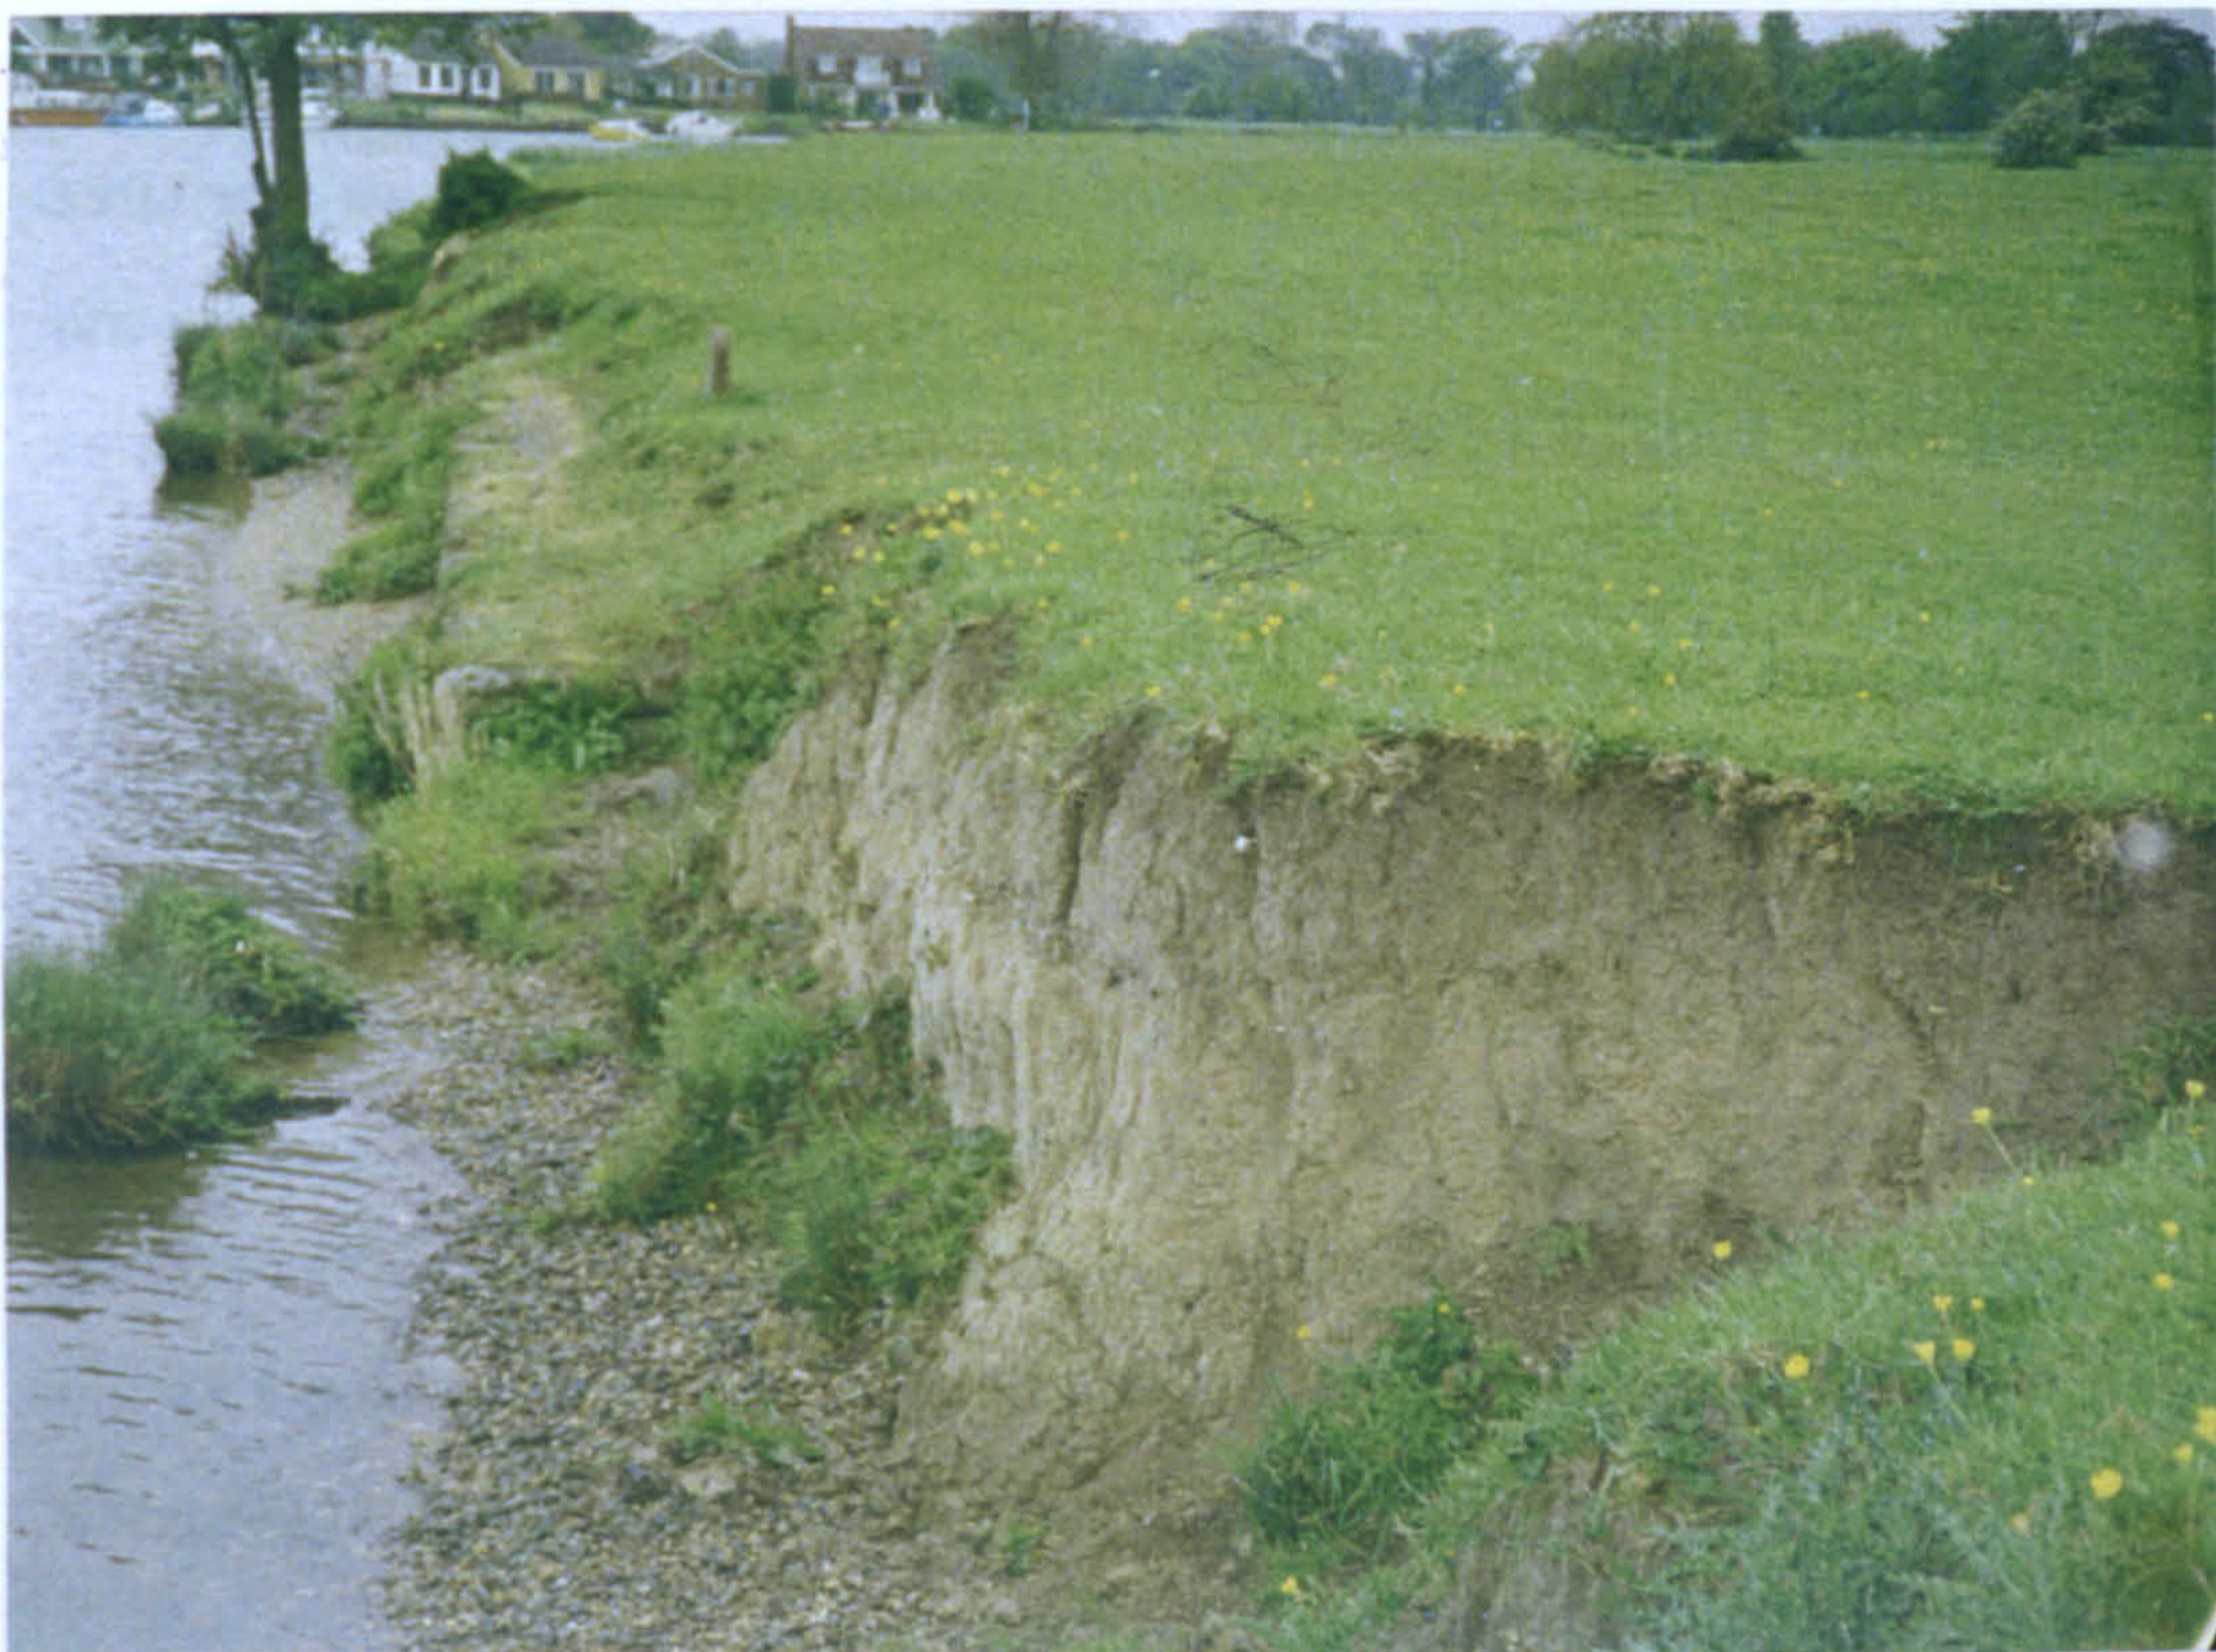
Plate 4.27 Upstream view of the Lower Chertsey monitoring site.
