**"THE NON-TIDAL, NAVIGABLE THAMES:
A BANK EROSION MANAGEMENT STRATEGY"**

by Sue Reed BSc, MSc, MCIWEM

**Thesis submitted to the University of Nottingham
for the degree of Doctor of Philosophy, October 1998**

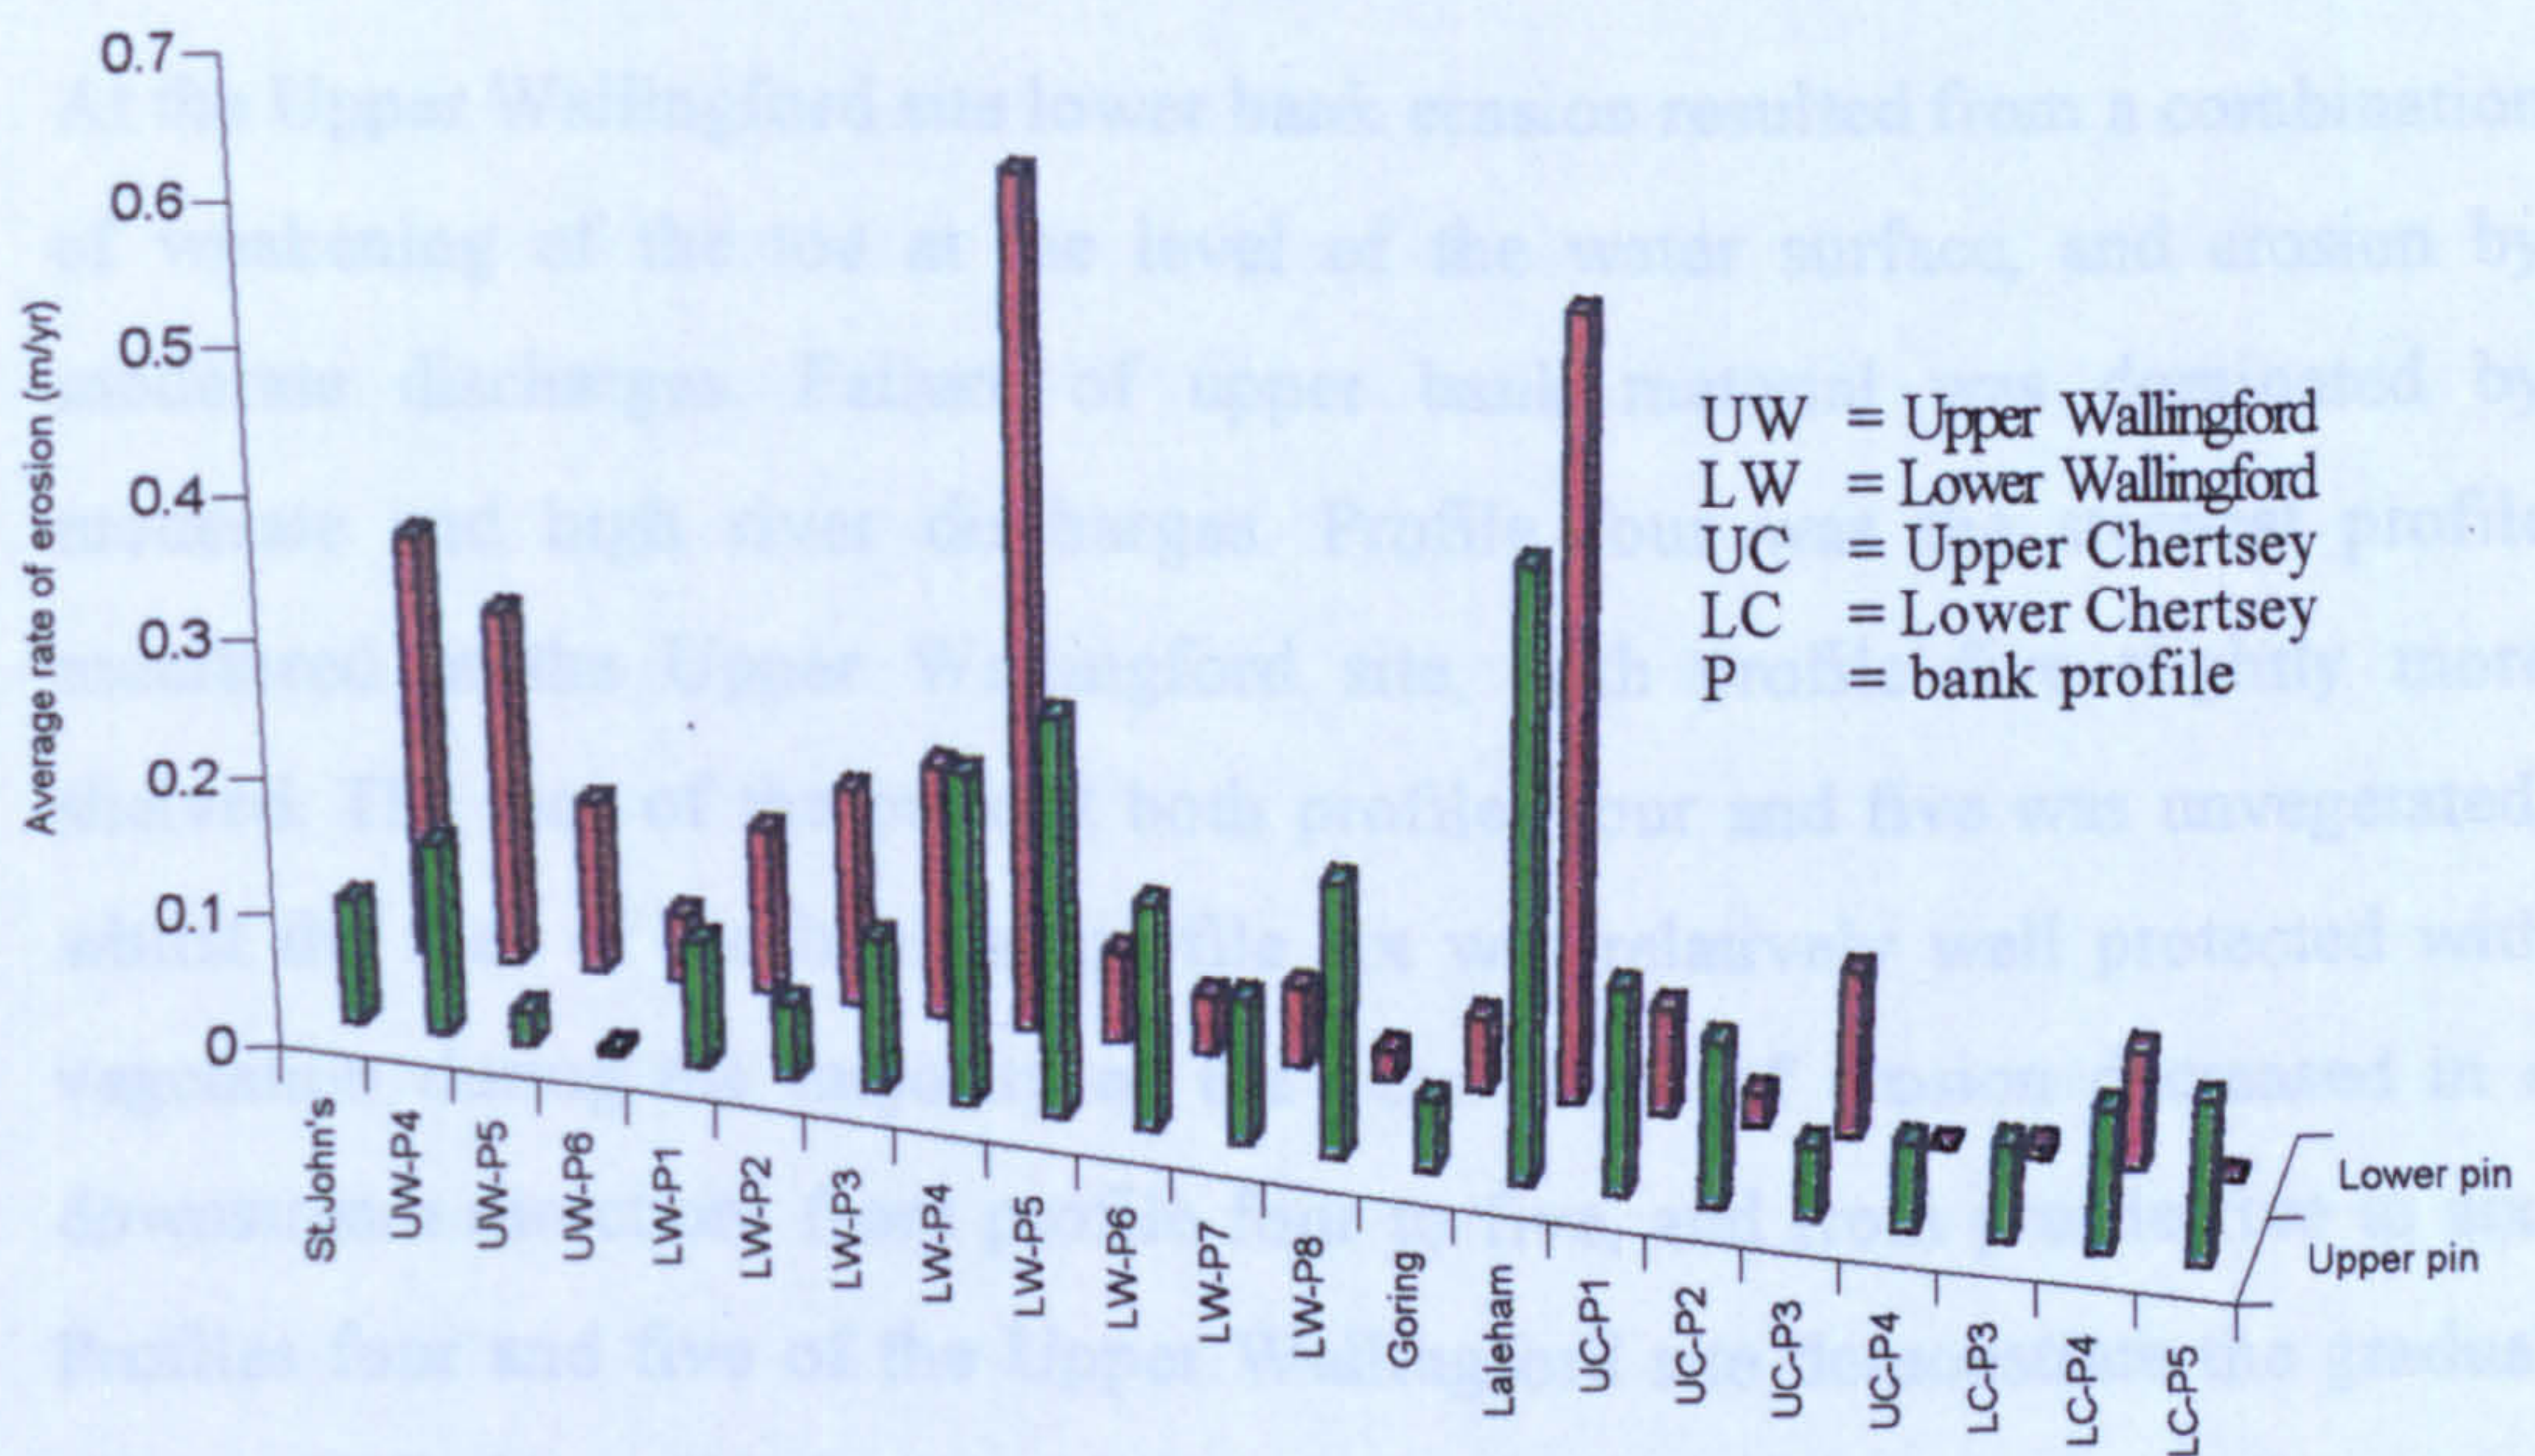
Figure 4.9 Average rate of erosion measured at each pin.

Figure 4.9 shows higher rates of erosion at the lower bank than the upper bank at St. John's, Laleham, Upper Wallingford, the first four profiles (profiles one to four) of the Lower Wallingford site and profile three of the Upper Chertsey site. Rates of upper and lower bank were roughly equal at Goring, and rates of upper bank erosion exceeded lower bank erosion at the ten remaining profiles.

The rate of lower bank erosion at St. John's was more than three times the rate of upper bank erosion. Cattle trampled both the upper and lower bank but, whereas the lower bank remained saturated throughout the monitoring period, the surface of the upper bank hardened during summer desiccation. Therefore, it may be that the upper bank remained more resistant to mechanical damage and compaction than the saturated lower bank material. Further reasons may be the curvature of the bend encouraging higher velocities at the toe of the bank, and the gently sloping bank which will reduce velocities higher up the bank.

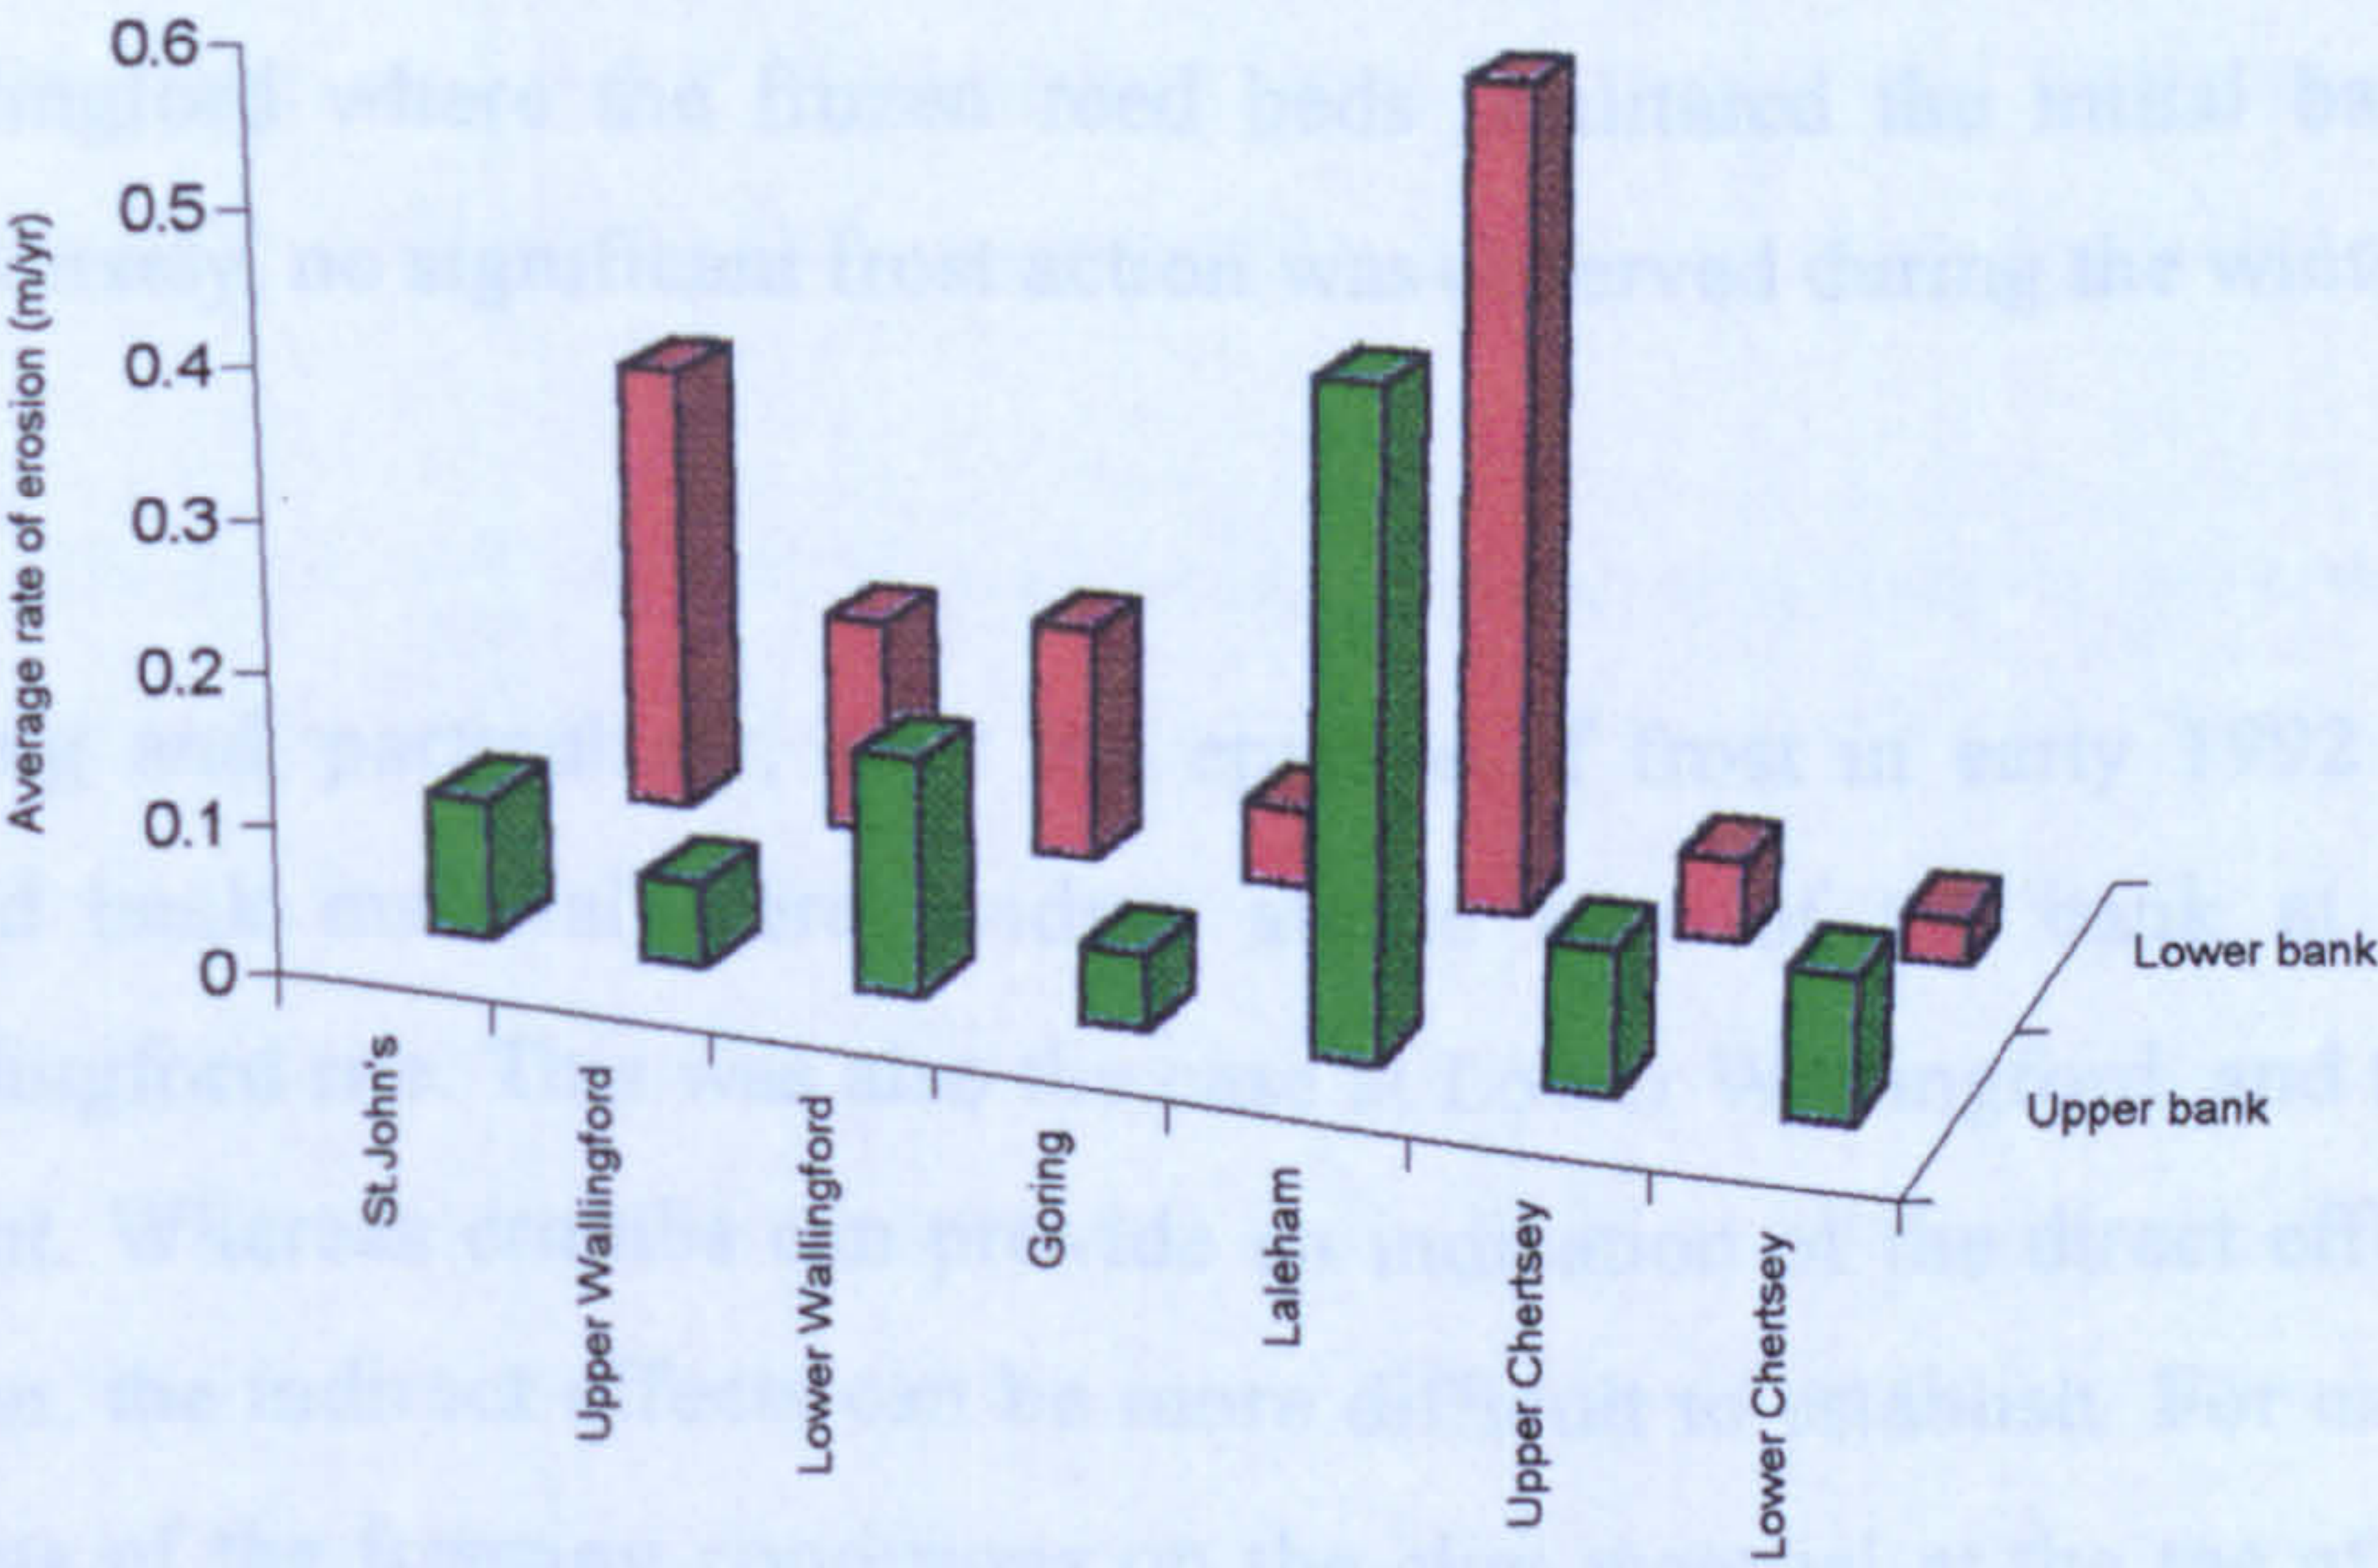
Taking an average value of the erosion at the upper and lower pins at each site, Table 4.2 compares the average rates of erosion at the upper and lower banks. The numbers in brackets indicate averages derived from incorporating estimates of erosion when pins could not be located, as described above (see Appendix 4.2). Figure 4.10 illustrates the data in Table 4.2, using the estimates shown in brackets.

Figure 4.10 Average rate of upper and lower bank erosion at each monitoring site.

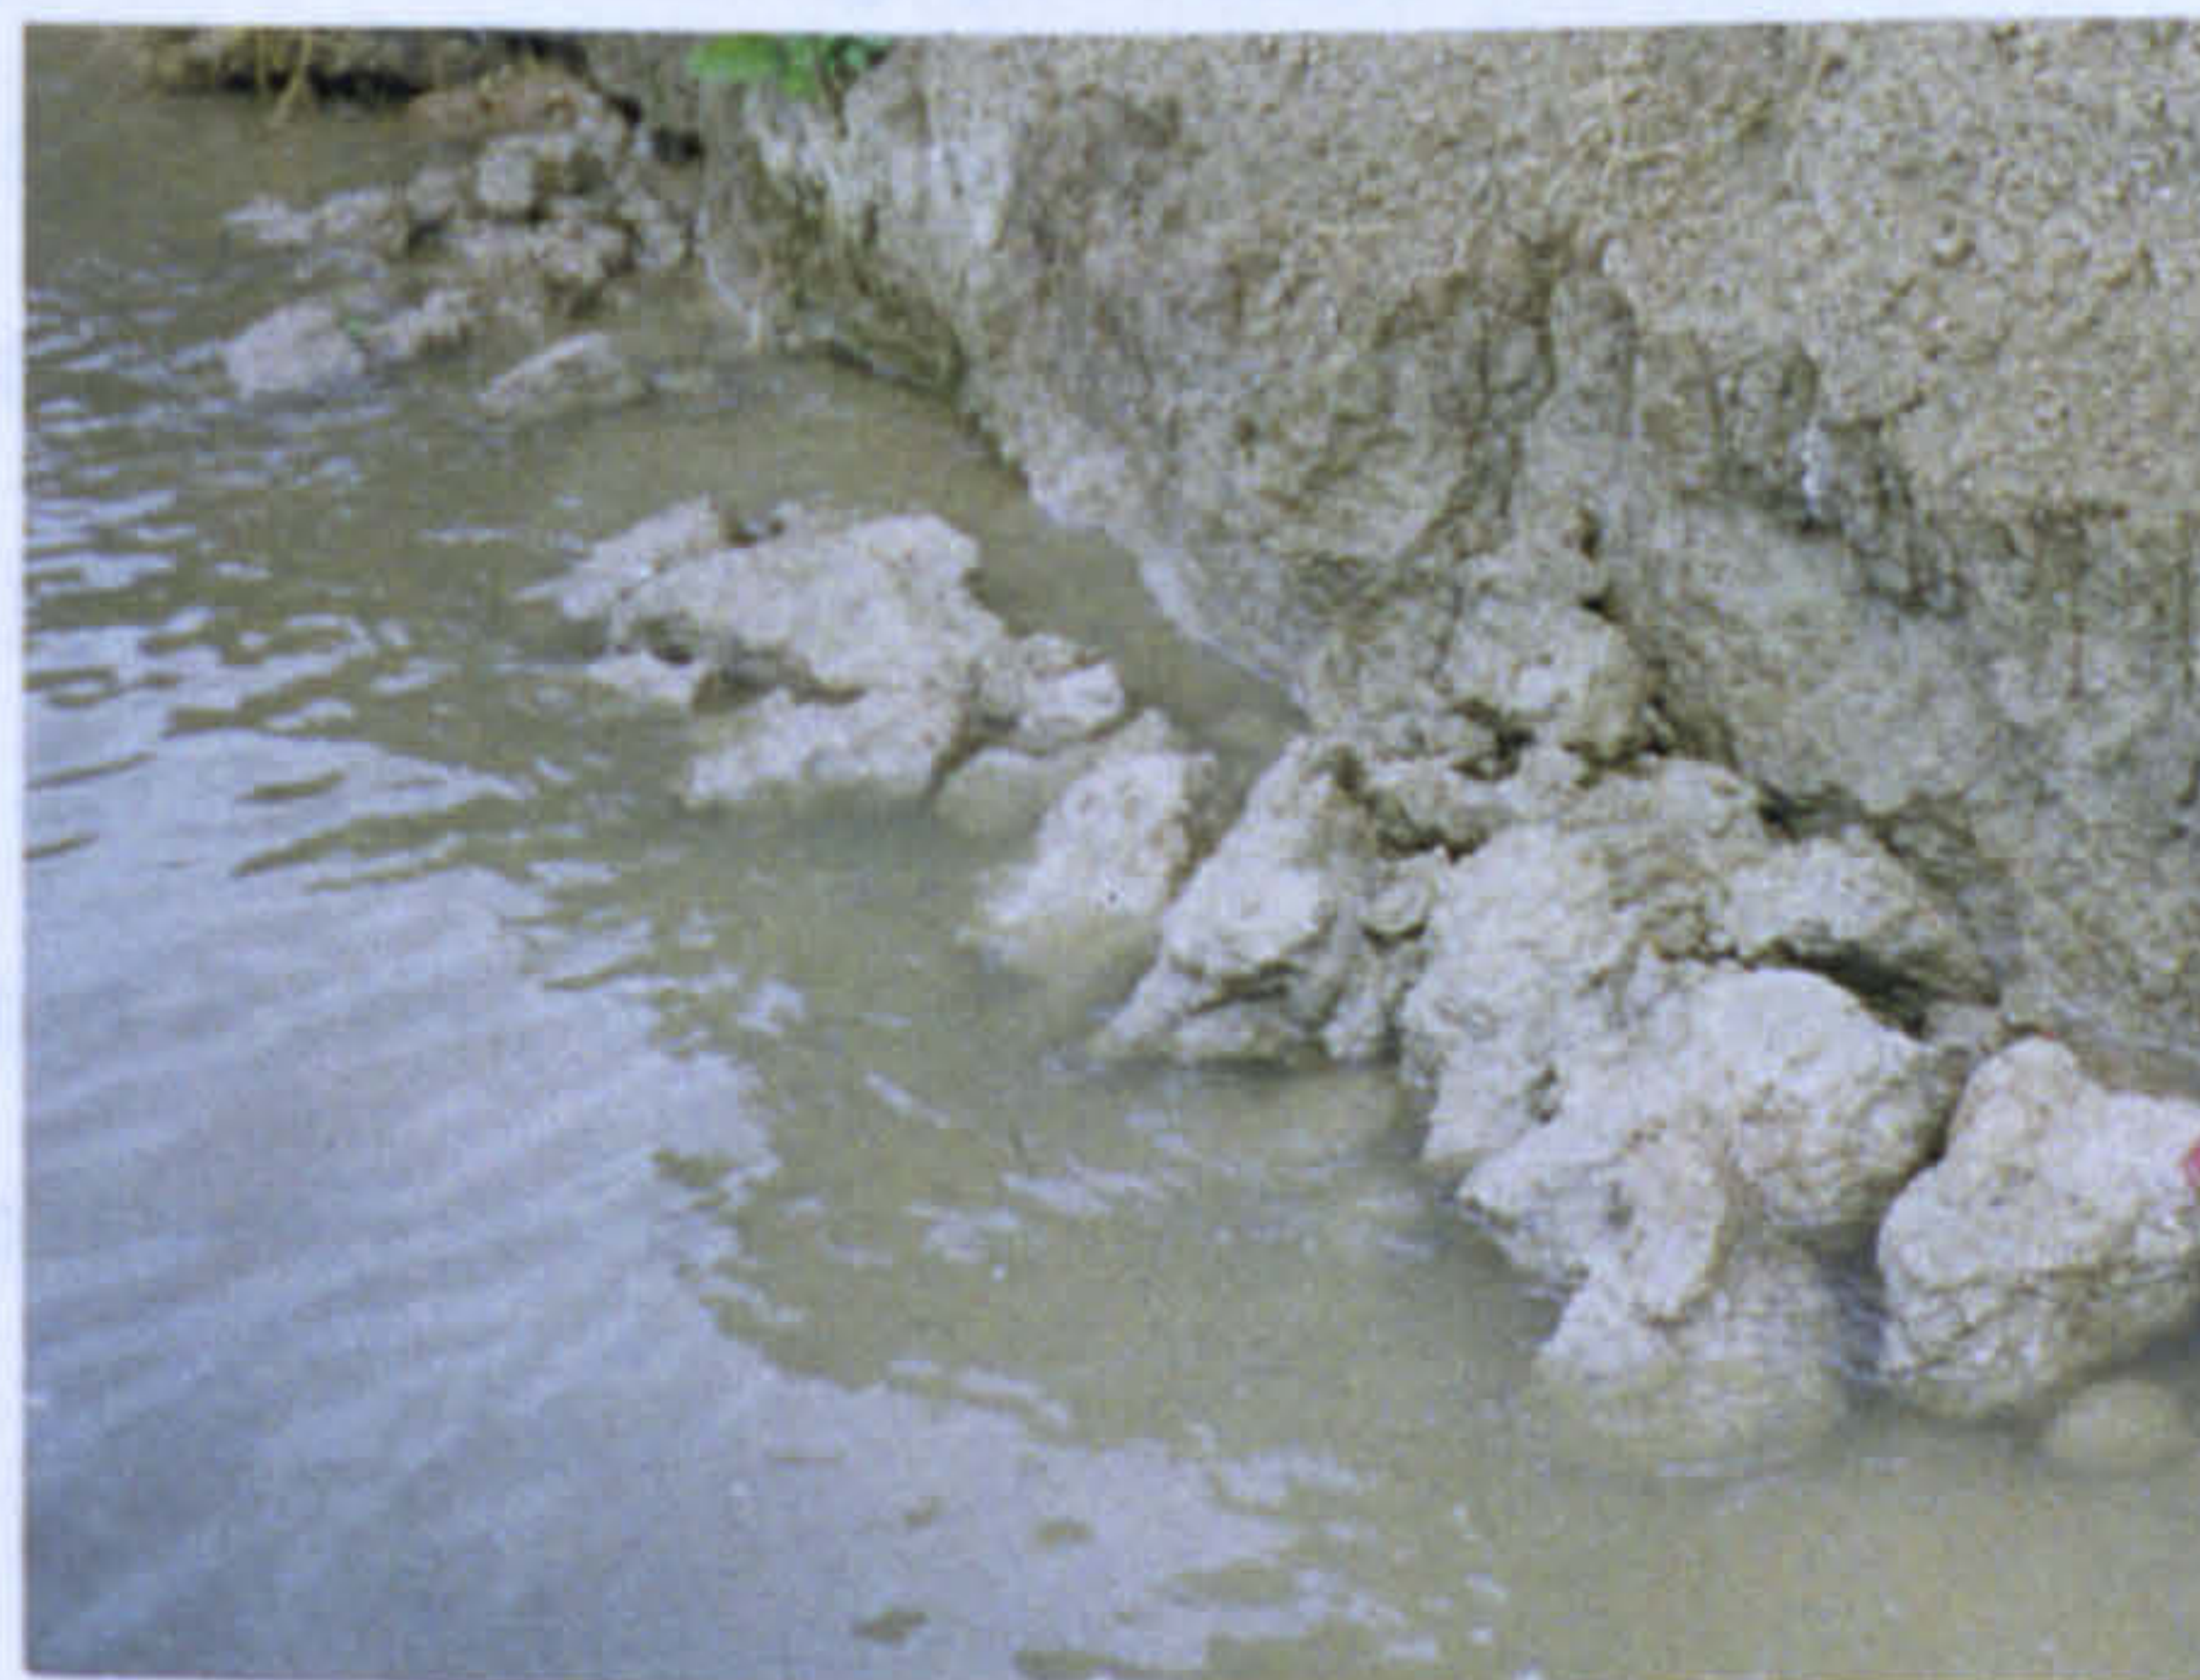
During the summer, when flows were relatively low, the toe of the bank at Lower Wallingford was at, or just above, the surface of the water in some places. The increase in tensile stress due to a combination of wetting and drying cycles and boat wash at the low summer water level resulted in tension cracks at the toe of the bank. The cracks developed in the clay parallel to the face of the bank and resulted in the vertical shearing of small wedges of clay approximately 10cm size (see Plate 4.14). Whilst shearing occurred during the low flows, the failed clay wedges tended to remain almost in their original position until a moderate flow removed them from the base of the bank. Moderate flows subsequent to these wetting and drying processes also resulted in direct erosion of the lower bank (see below). The appearance of the lower bank after the monitoring period indicated that the clay toe had also experienced this vertical shearing during the summer of 1993 (see Plate 4.28).

*Plate 4.28
Shearing of
the clay toe
at Lower
Wallingford
(September 1993).*

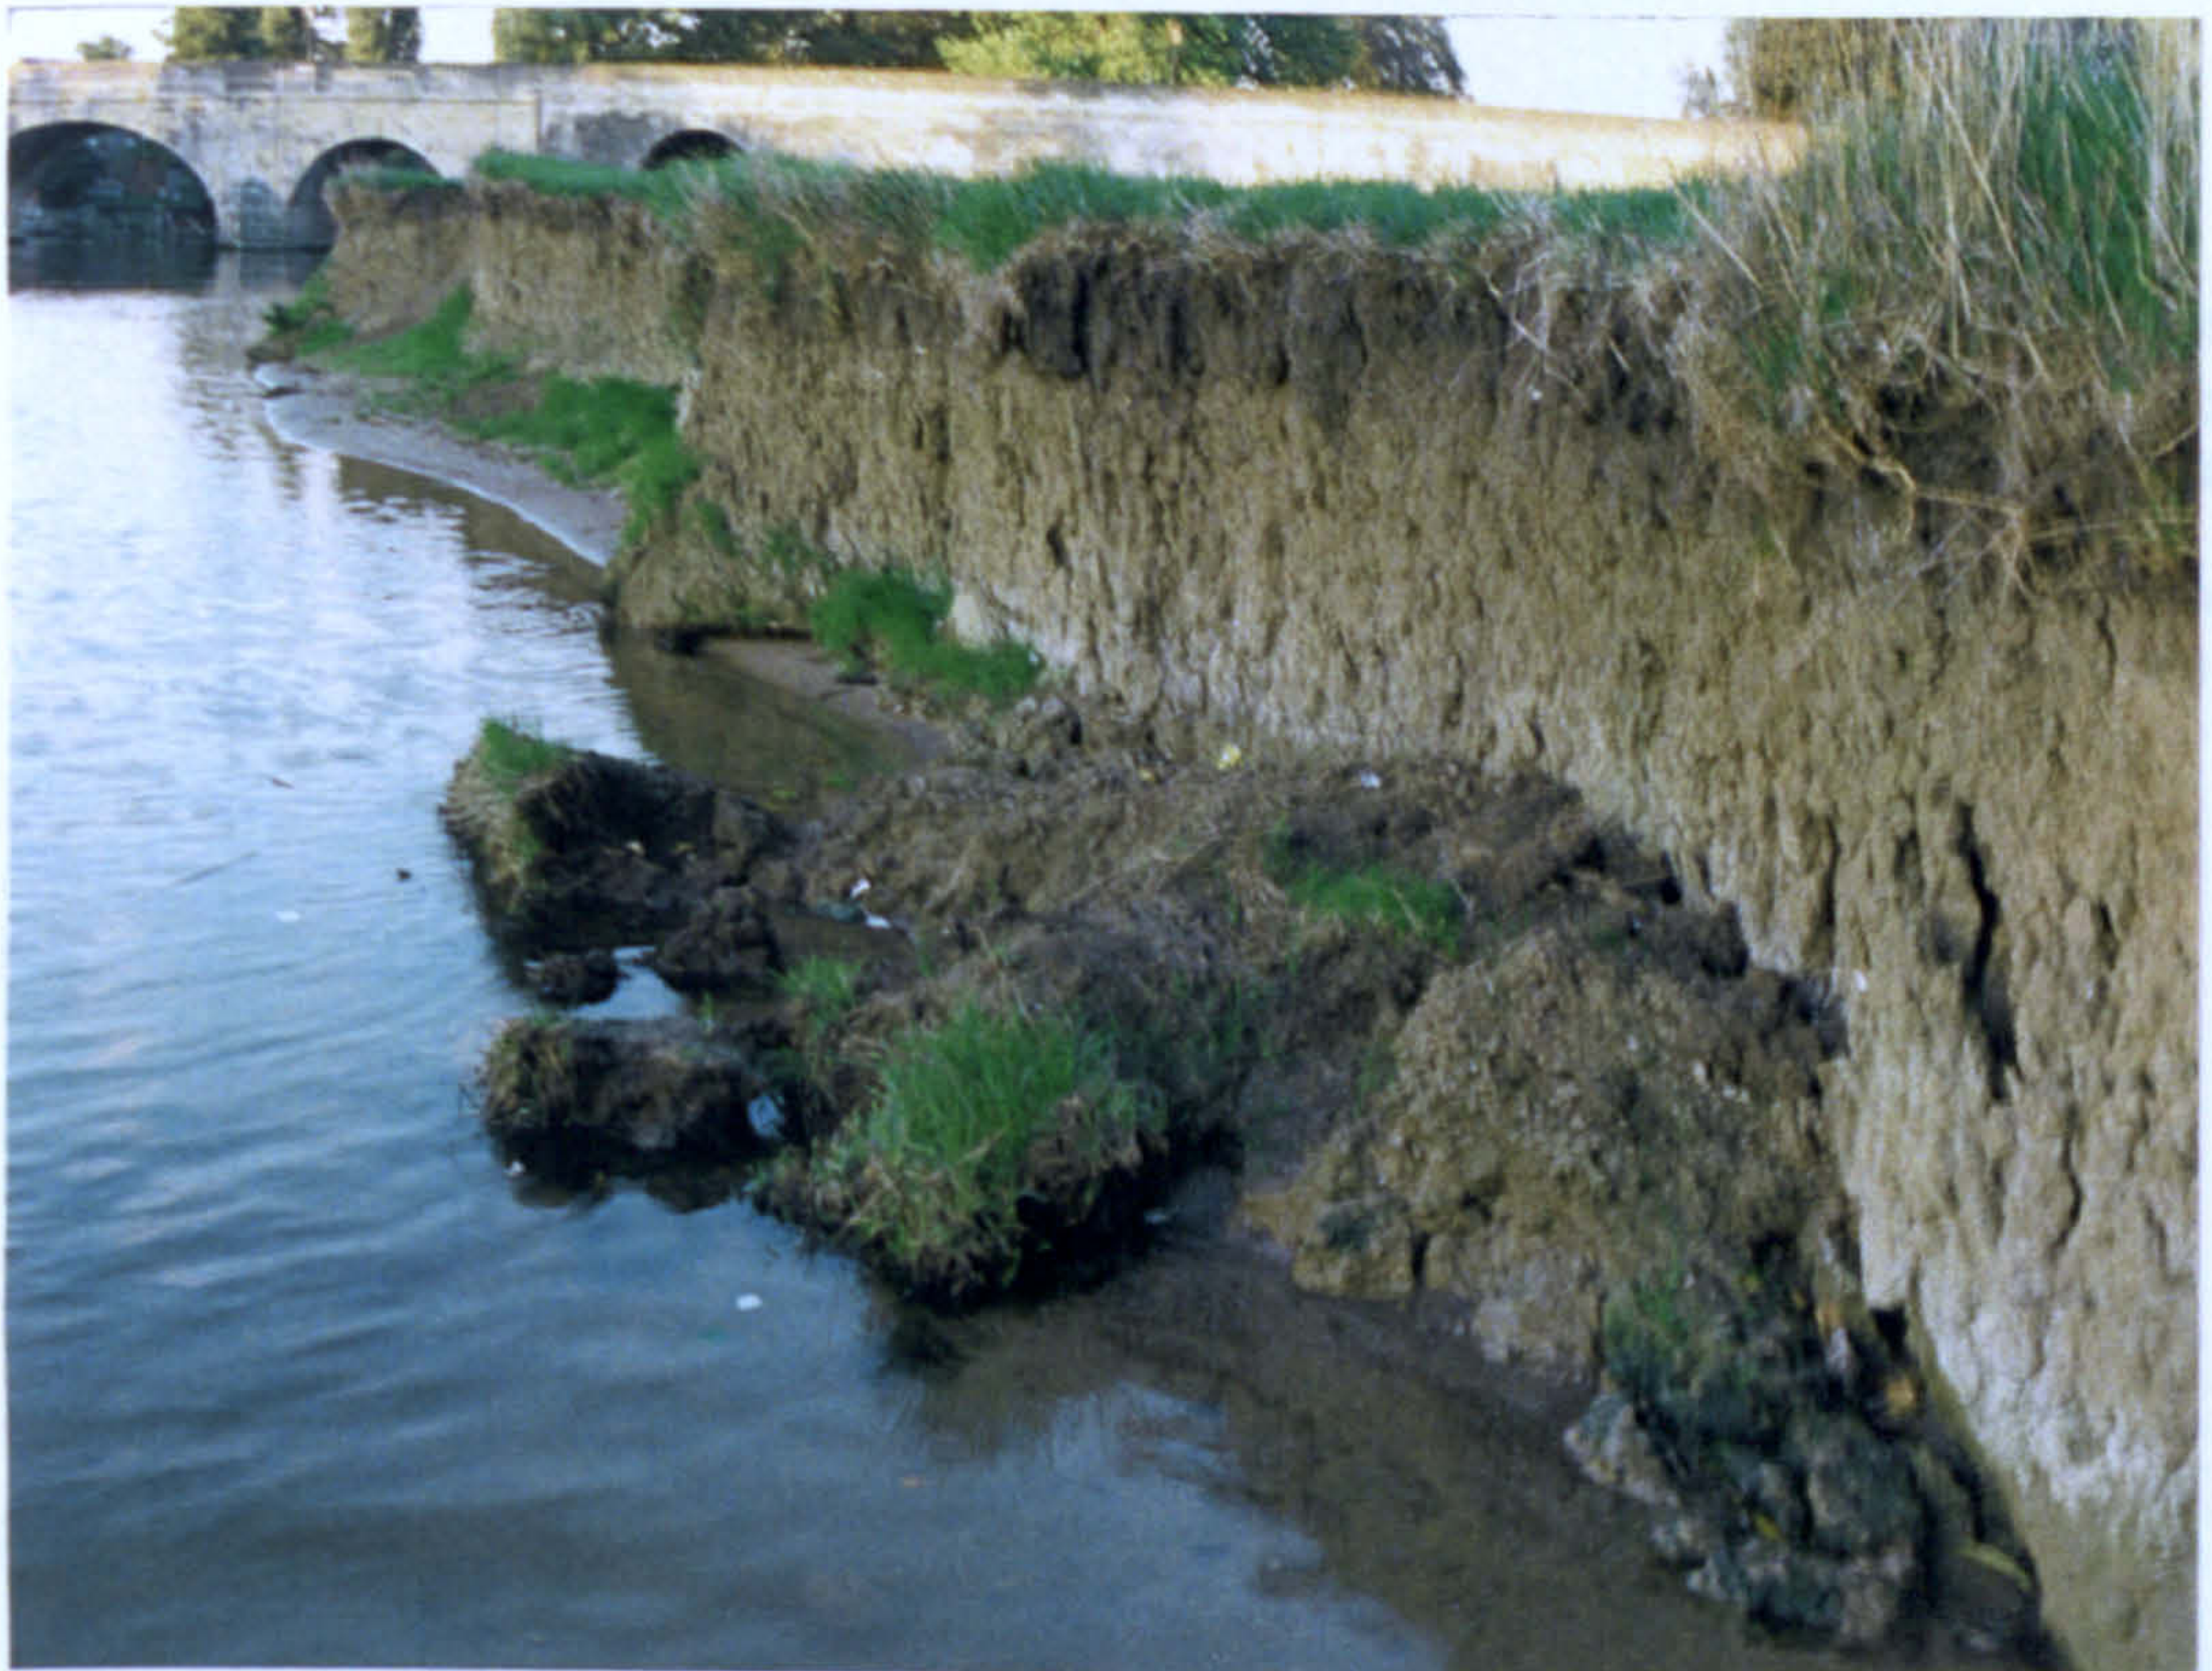
Failure of the upper bank by slumping was only observed at the Lower Wallingford site. Whereas none of the profiles monitored showed significant slumping, failed upper bank material was observed at the toe of the bank after the high September 1992 flows had subsided (see Plate 4.16). Although no significant failures were observed during the monitoring, the continued undercutting at the toe of the bank after the monitoring period (see Plate 4.28) resulted in significant upper bank failure in the end of summer 1993 (see Plate 4.29).

Plate 4.29 Bank failure at Lower Wallingford at the end of summer 1993.

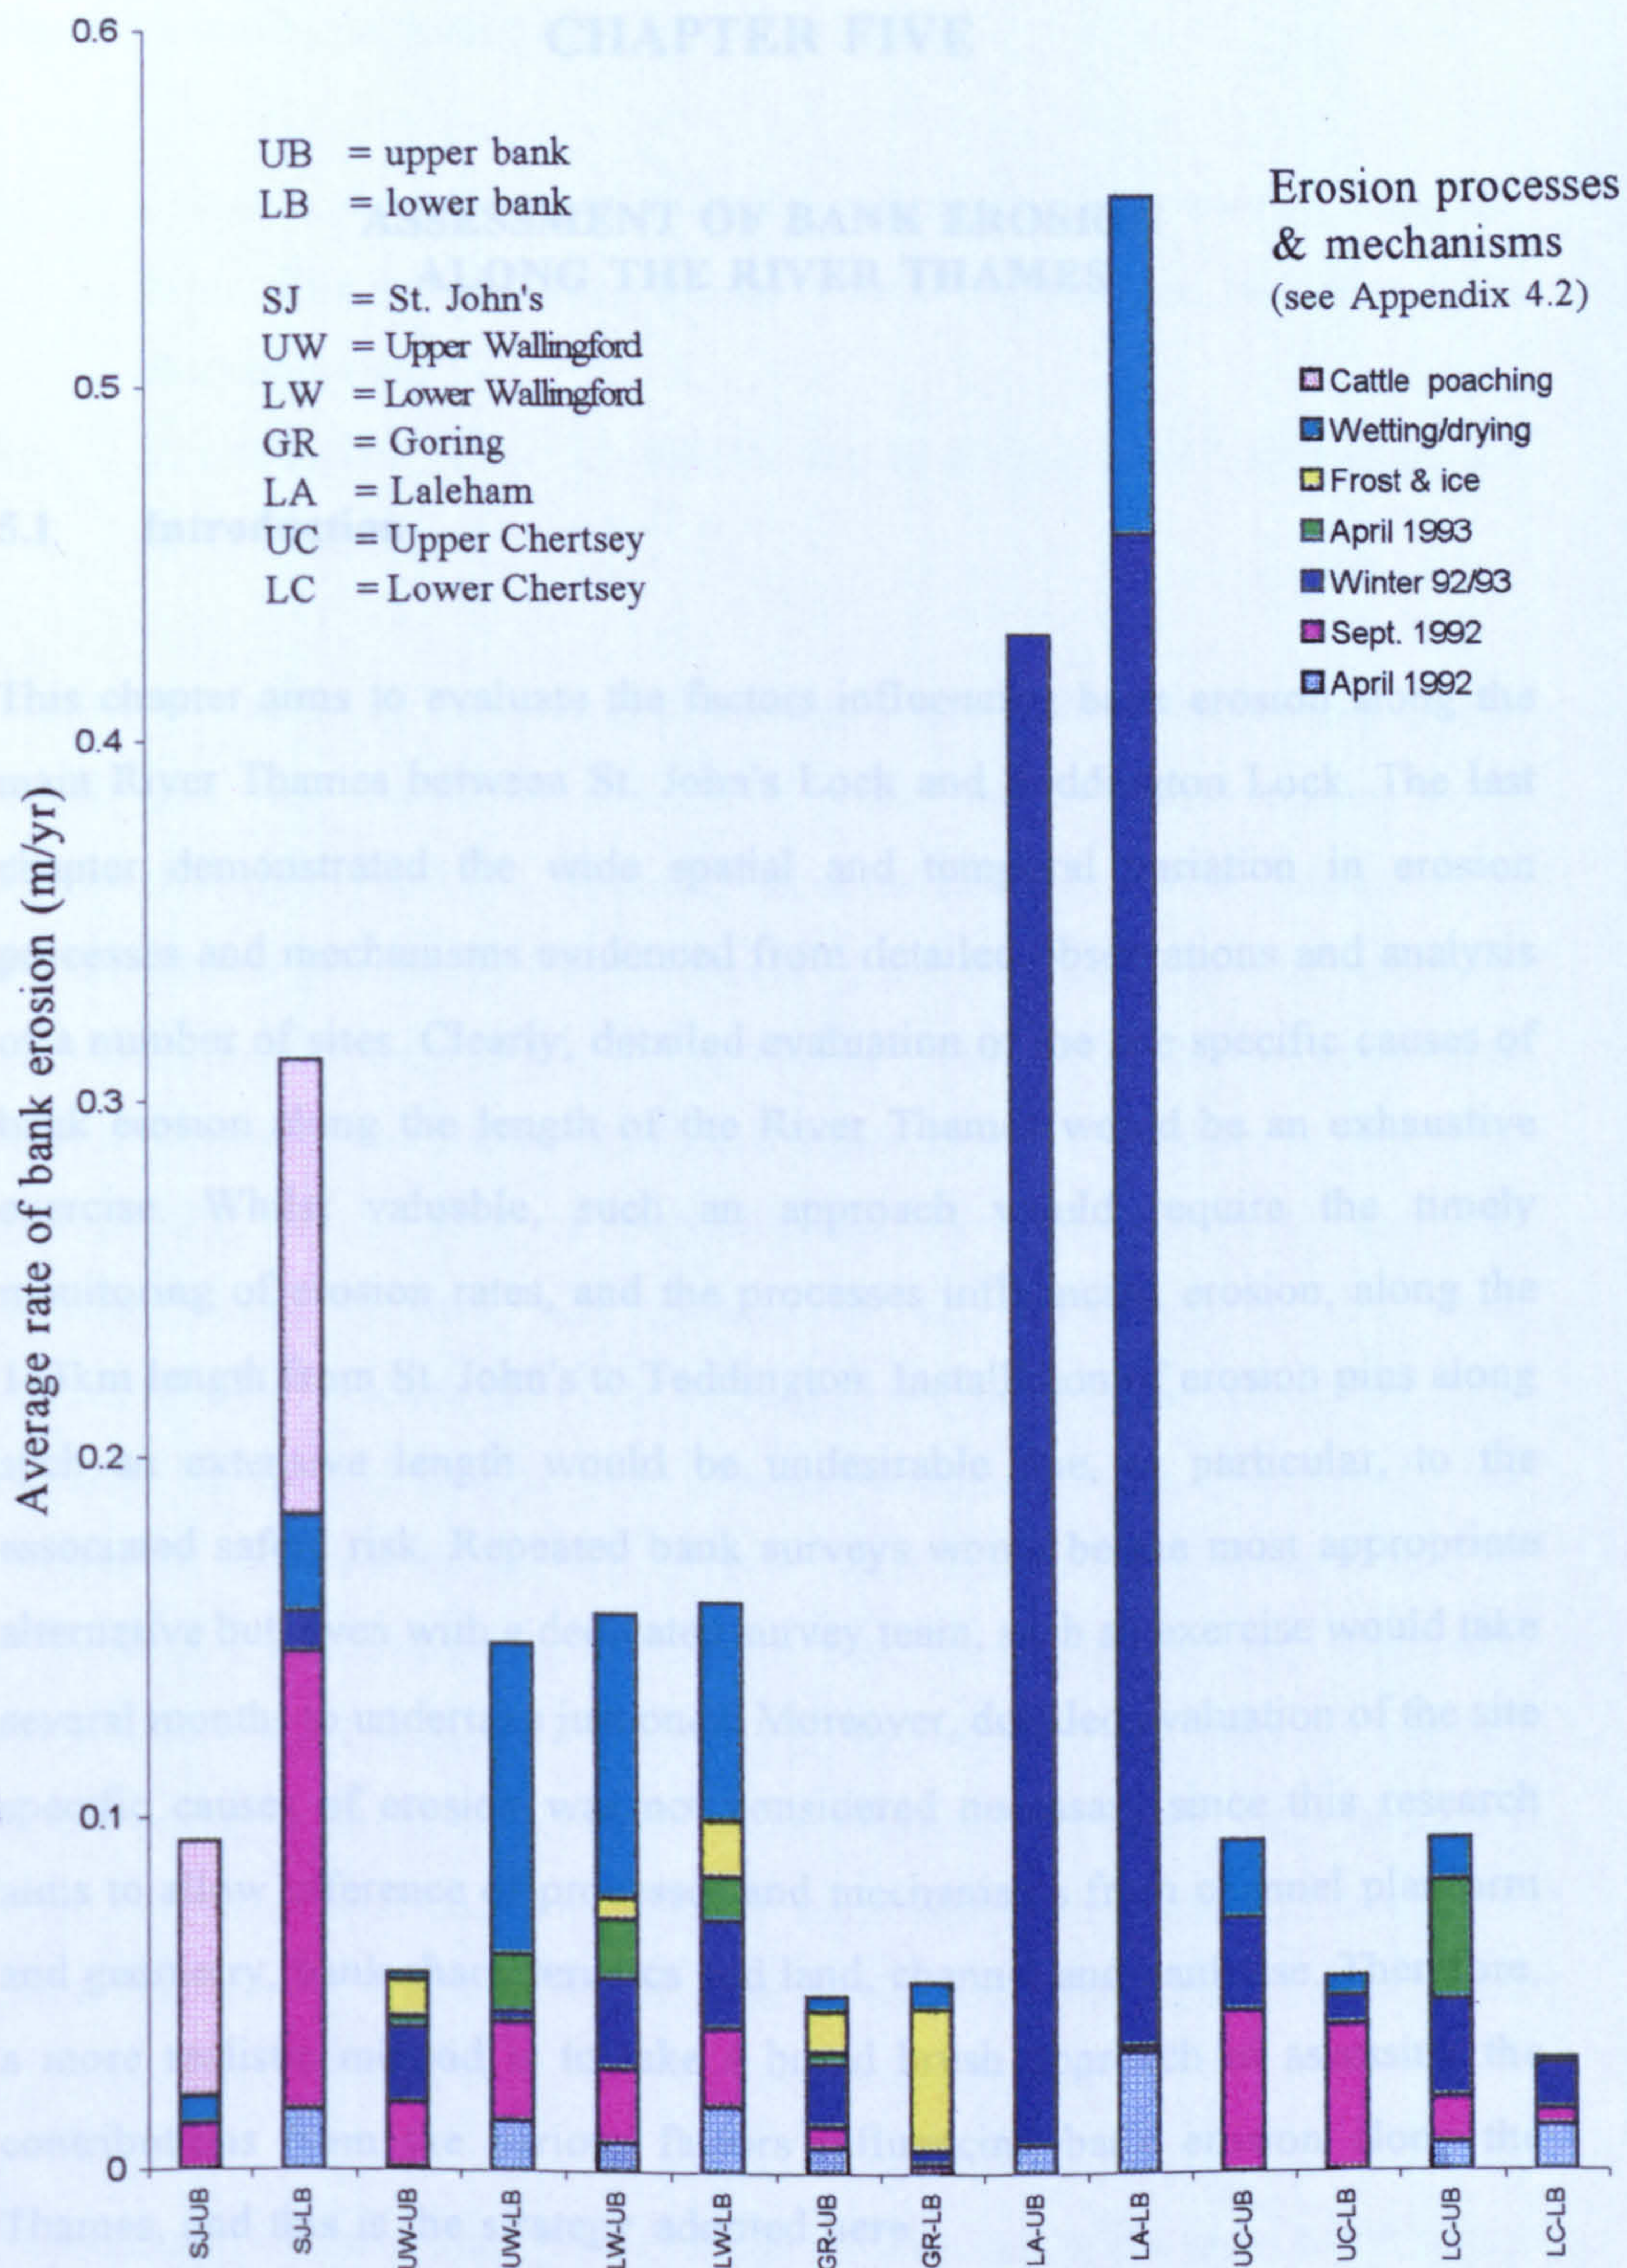
The most influential erosion processes during the monitoring period were wetting and drying, the moderate flows in September 1992 and the high flows in winter 1992-93. In addition, cattle poaching and frost action had a significant influence at St. John's and Goring, respectively. However, Figure 4.11 does not show the contribution to erosion from the significant undercutting and slumping observed at the Lower Wallingford site after the monitoring period (see Plates 4.28 and 4.29). It may be that scale of slumping observed at the end of summer 1993 occurs only every few years and only after the lower bank has eroded sufficiently to undercut the upper bank. The size of the failed blocks in Plate 4.29 suggests that such failure can result in approximately 0.5m of bank retreat. Averaged over three years, this would equate to a rate of approximately 0.16m per year due to slumping. This would double the erosion rate and make slumping the most significant erosion mechanism at the Lower Wallingford site.

Figure 4.11 Rates of upper and lower bank erosion attributed to various processes and mechanisms.
