**"THE NON-TIDAL, NAVIGABLE THAMES:
A BANK EROSION MANAGEMENT STRATEGY"**

by Sue Reed BSc, MSc, MCIWEM

**Thesis submitted to the University of Nottingham
for the degree of Doctor of Philosophy, October 1998**

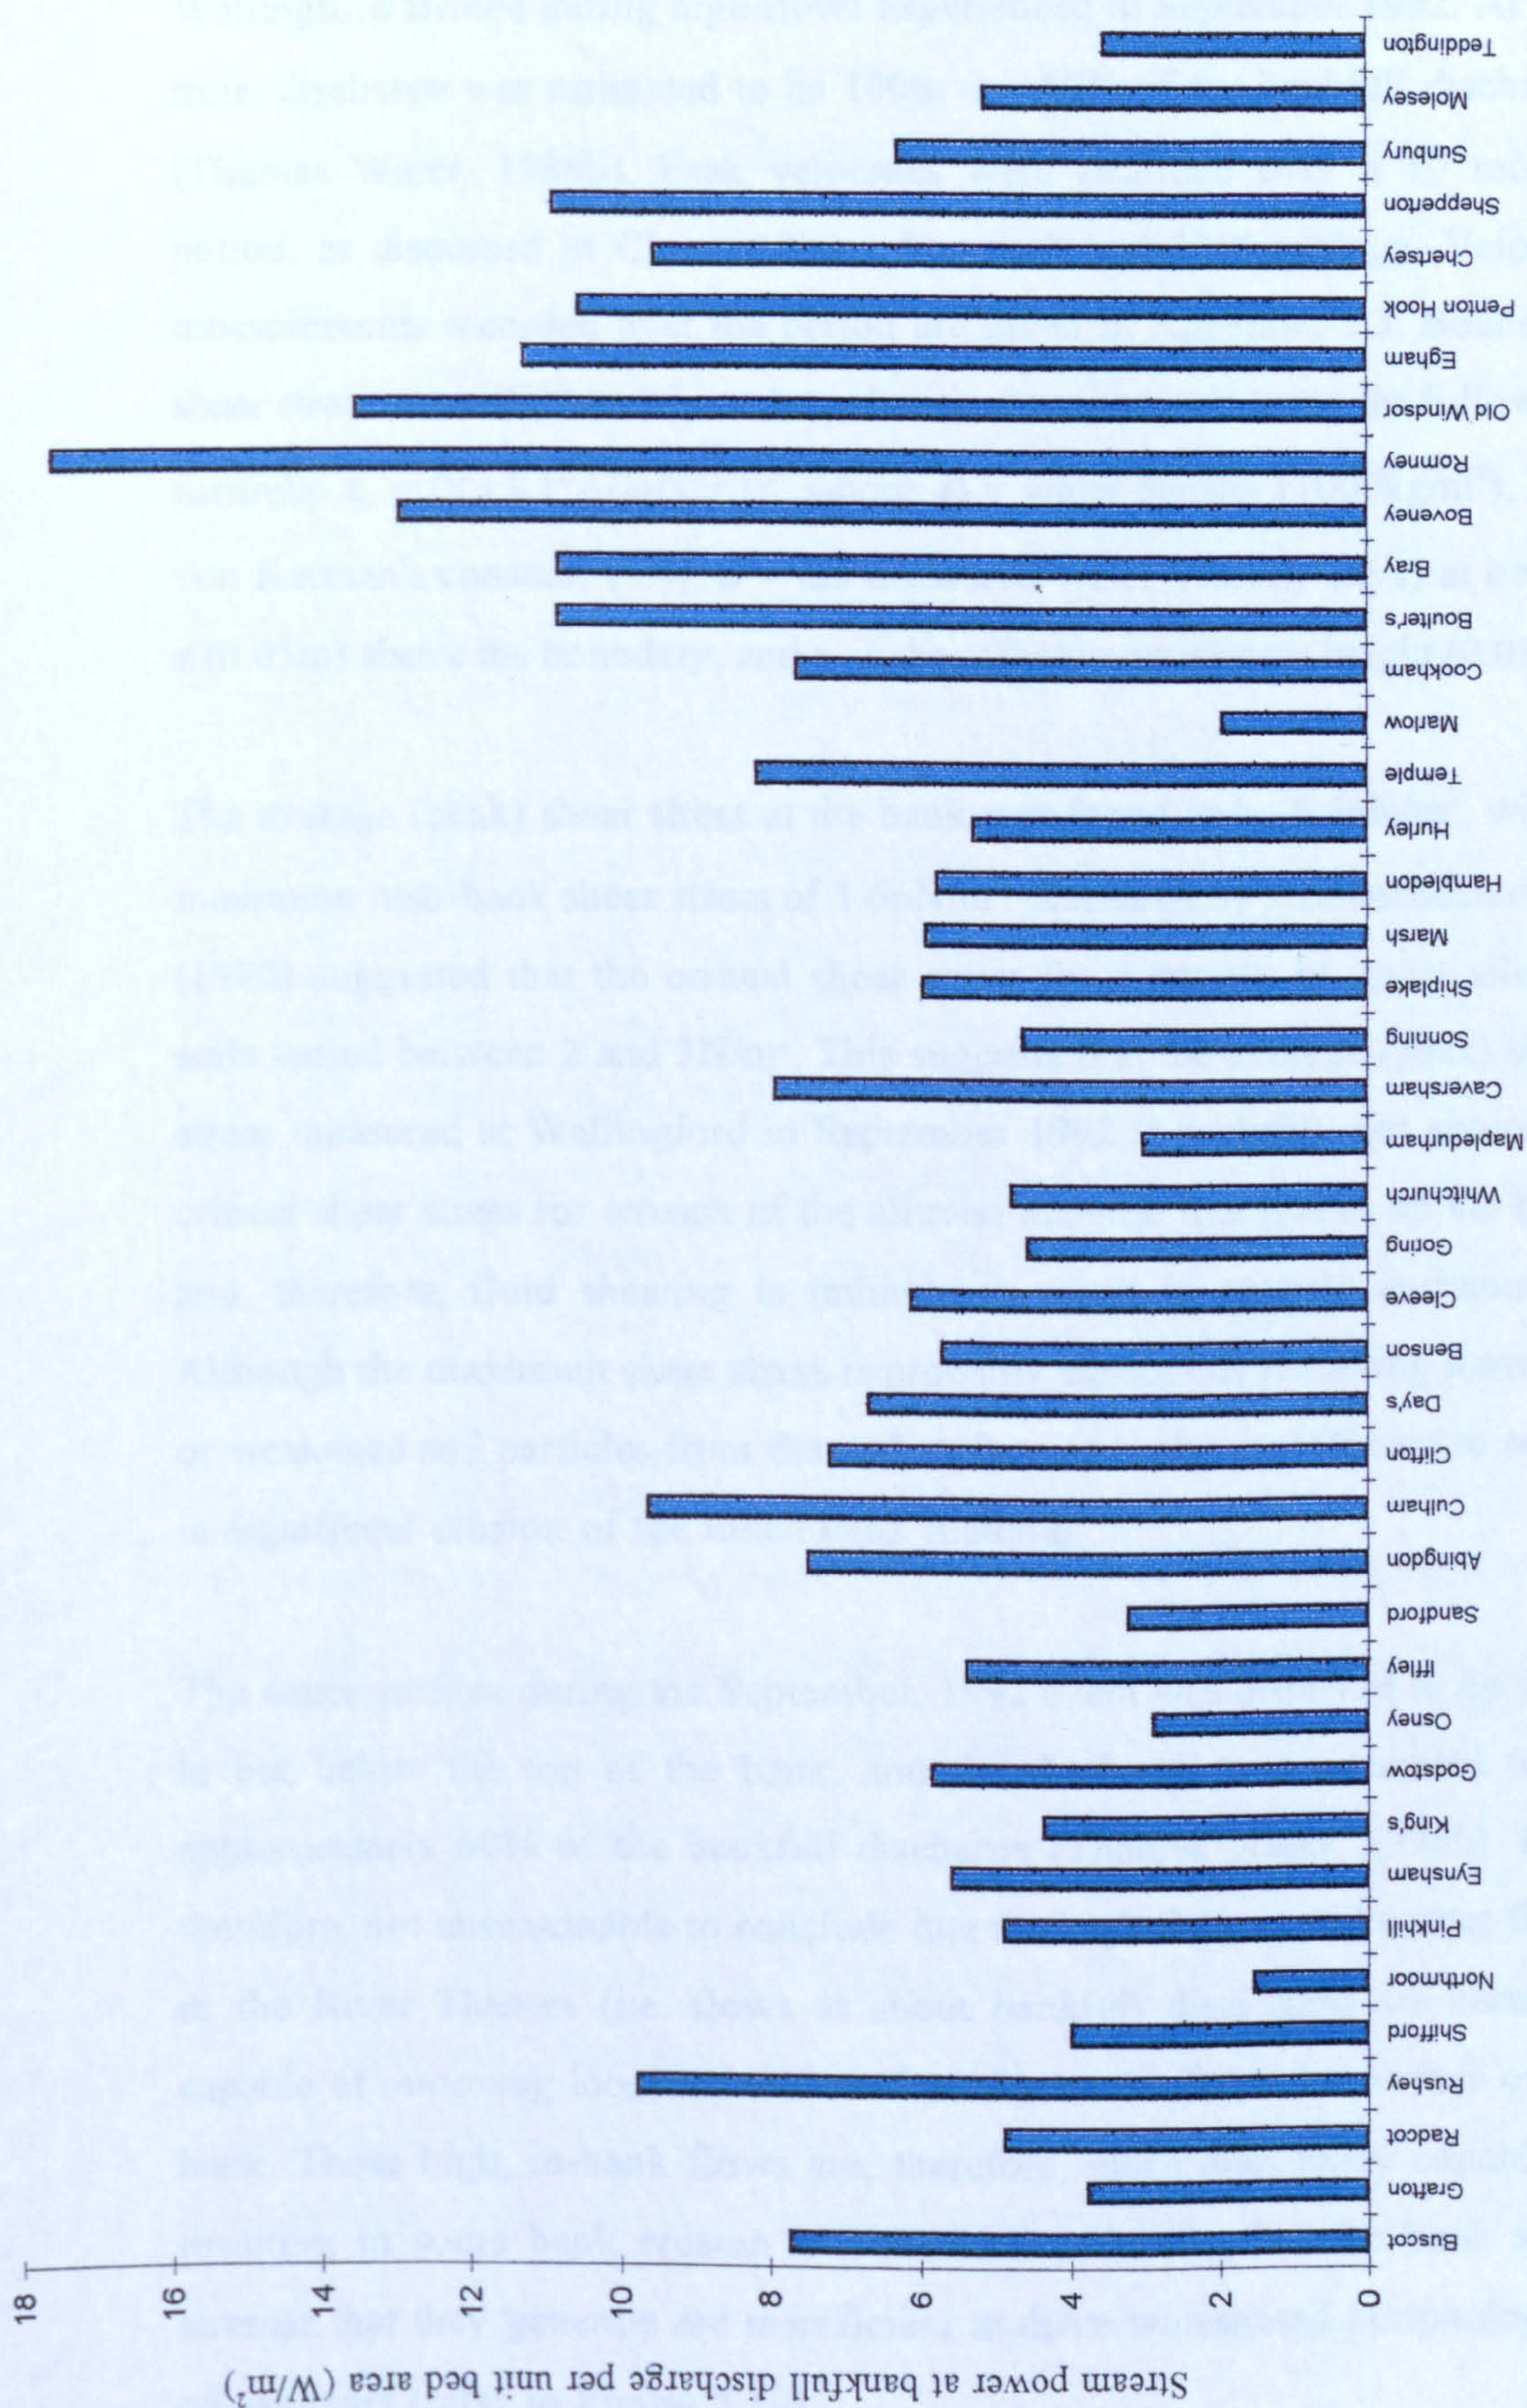
Figure 5.1 shows the stream power per unit bed area along each reach of the River Thames from St. John's Lock to Teddington Lock (data from which this was derived is given in Appendix 5.1). As expected for a lowland river, stream power along the impounded reaches is relatively low, often several orders of magnitude less than that of upland rivers (refer to Figure 3.3), and certainly less than the 35Wm^{-2} considered the threshold for morphological adjustment through erosion (Brookes, 1988). Indeed, historical evidence suggests that natural changes in planform and geometry have not been significant although, in the upper reaches, the Thames has apparently migrated across its floodplain over decades (Bass and Collett, undated).

Figure 5.1 Stream power (at bankfull discharge) per unit bed area along each reach of the River Thames.

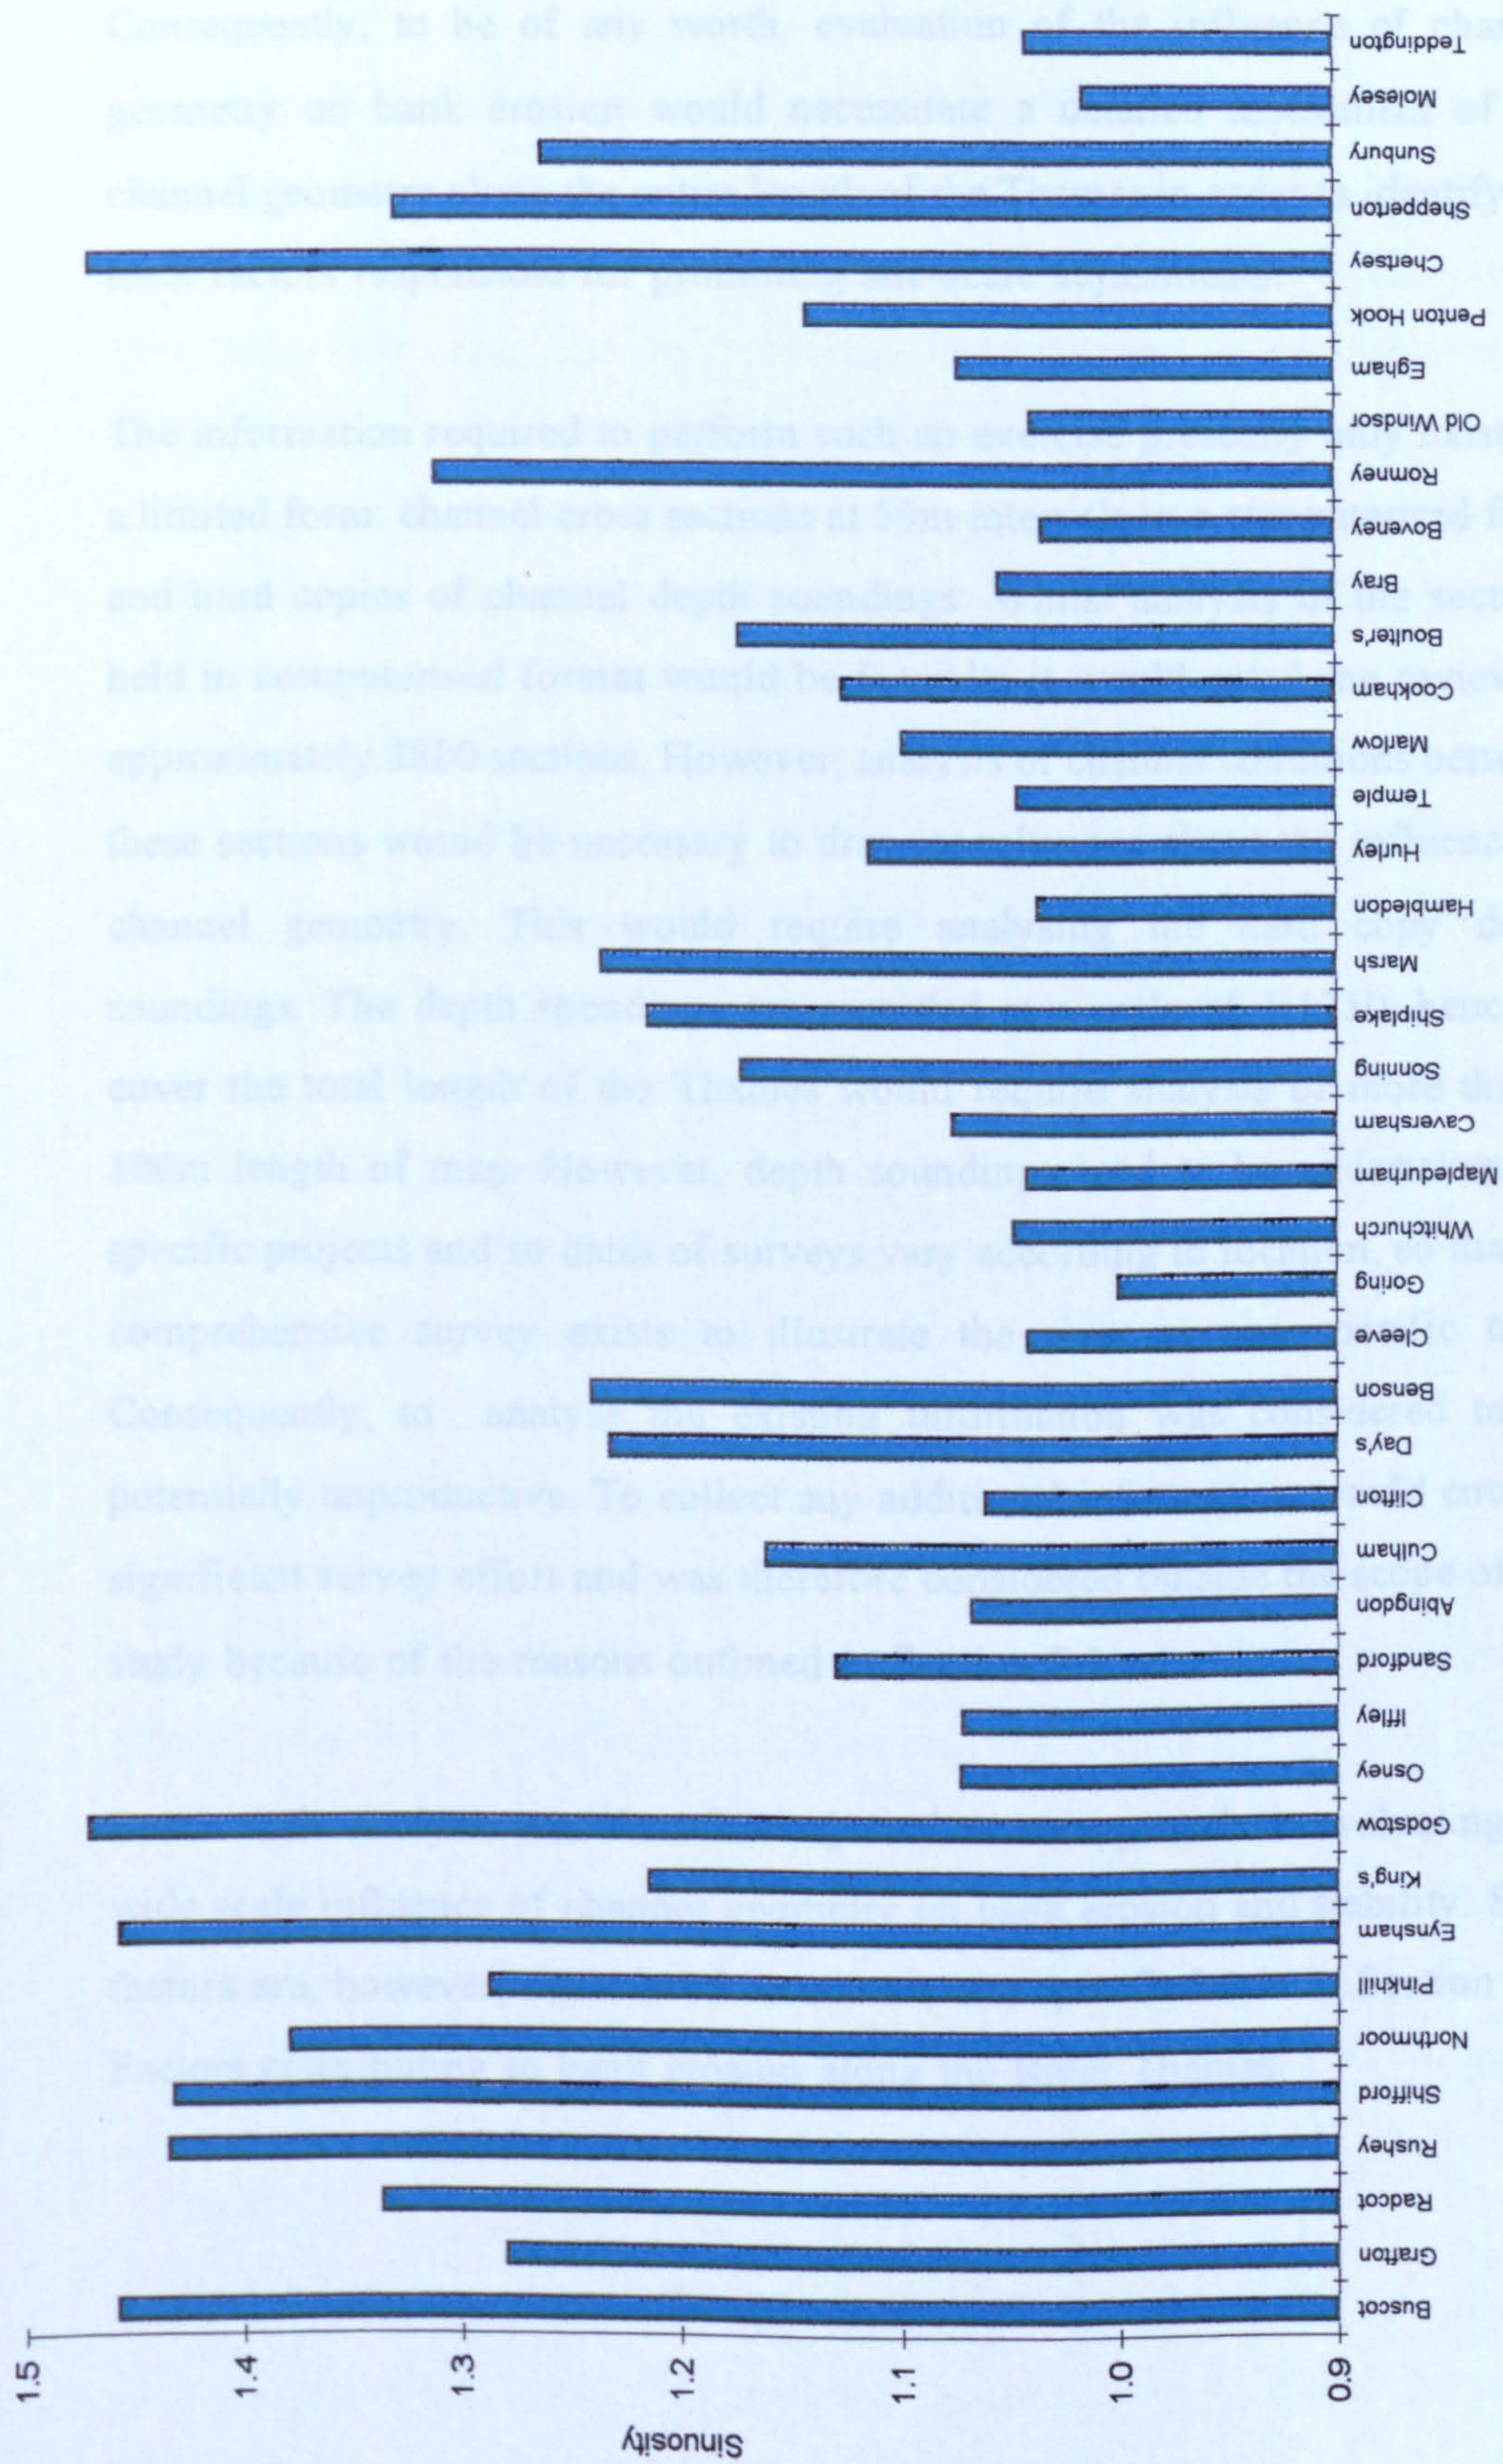
Sinuosity is a measure of the deviation of the course of the river channel from the valley axis and it can, therefore, be used to quantify the degree of stream meandering. Chapter Two discusses the measurement of this parameter, on the basis of the channel routes and valley axis. Sinuosity for each reach of the Thames is shown in Figure 5.2, and is found to range between 1.0 along the Goring and Cleeve Reaches to 1.47 along Godstow and Chertsey Reaches (see Appendix 5.1).

Figure 5.2 Channel sinuosity along each reach of the River Thames.

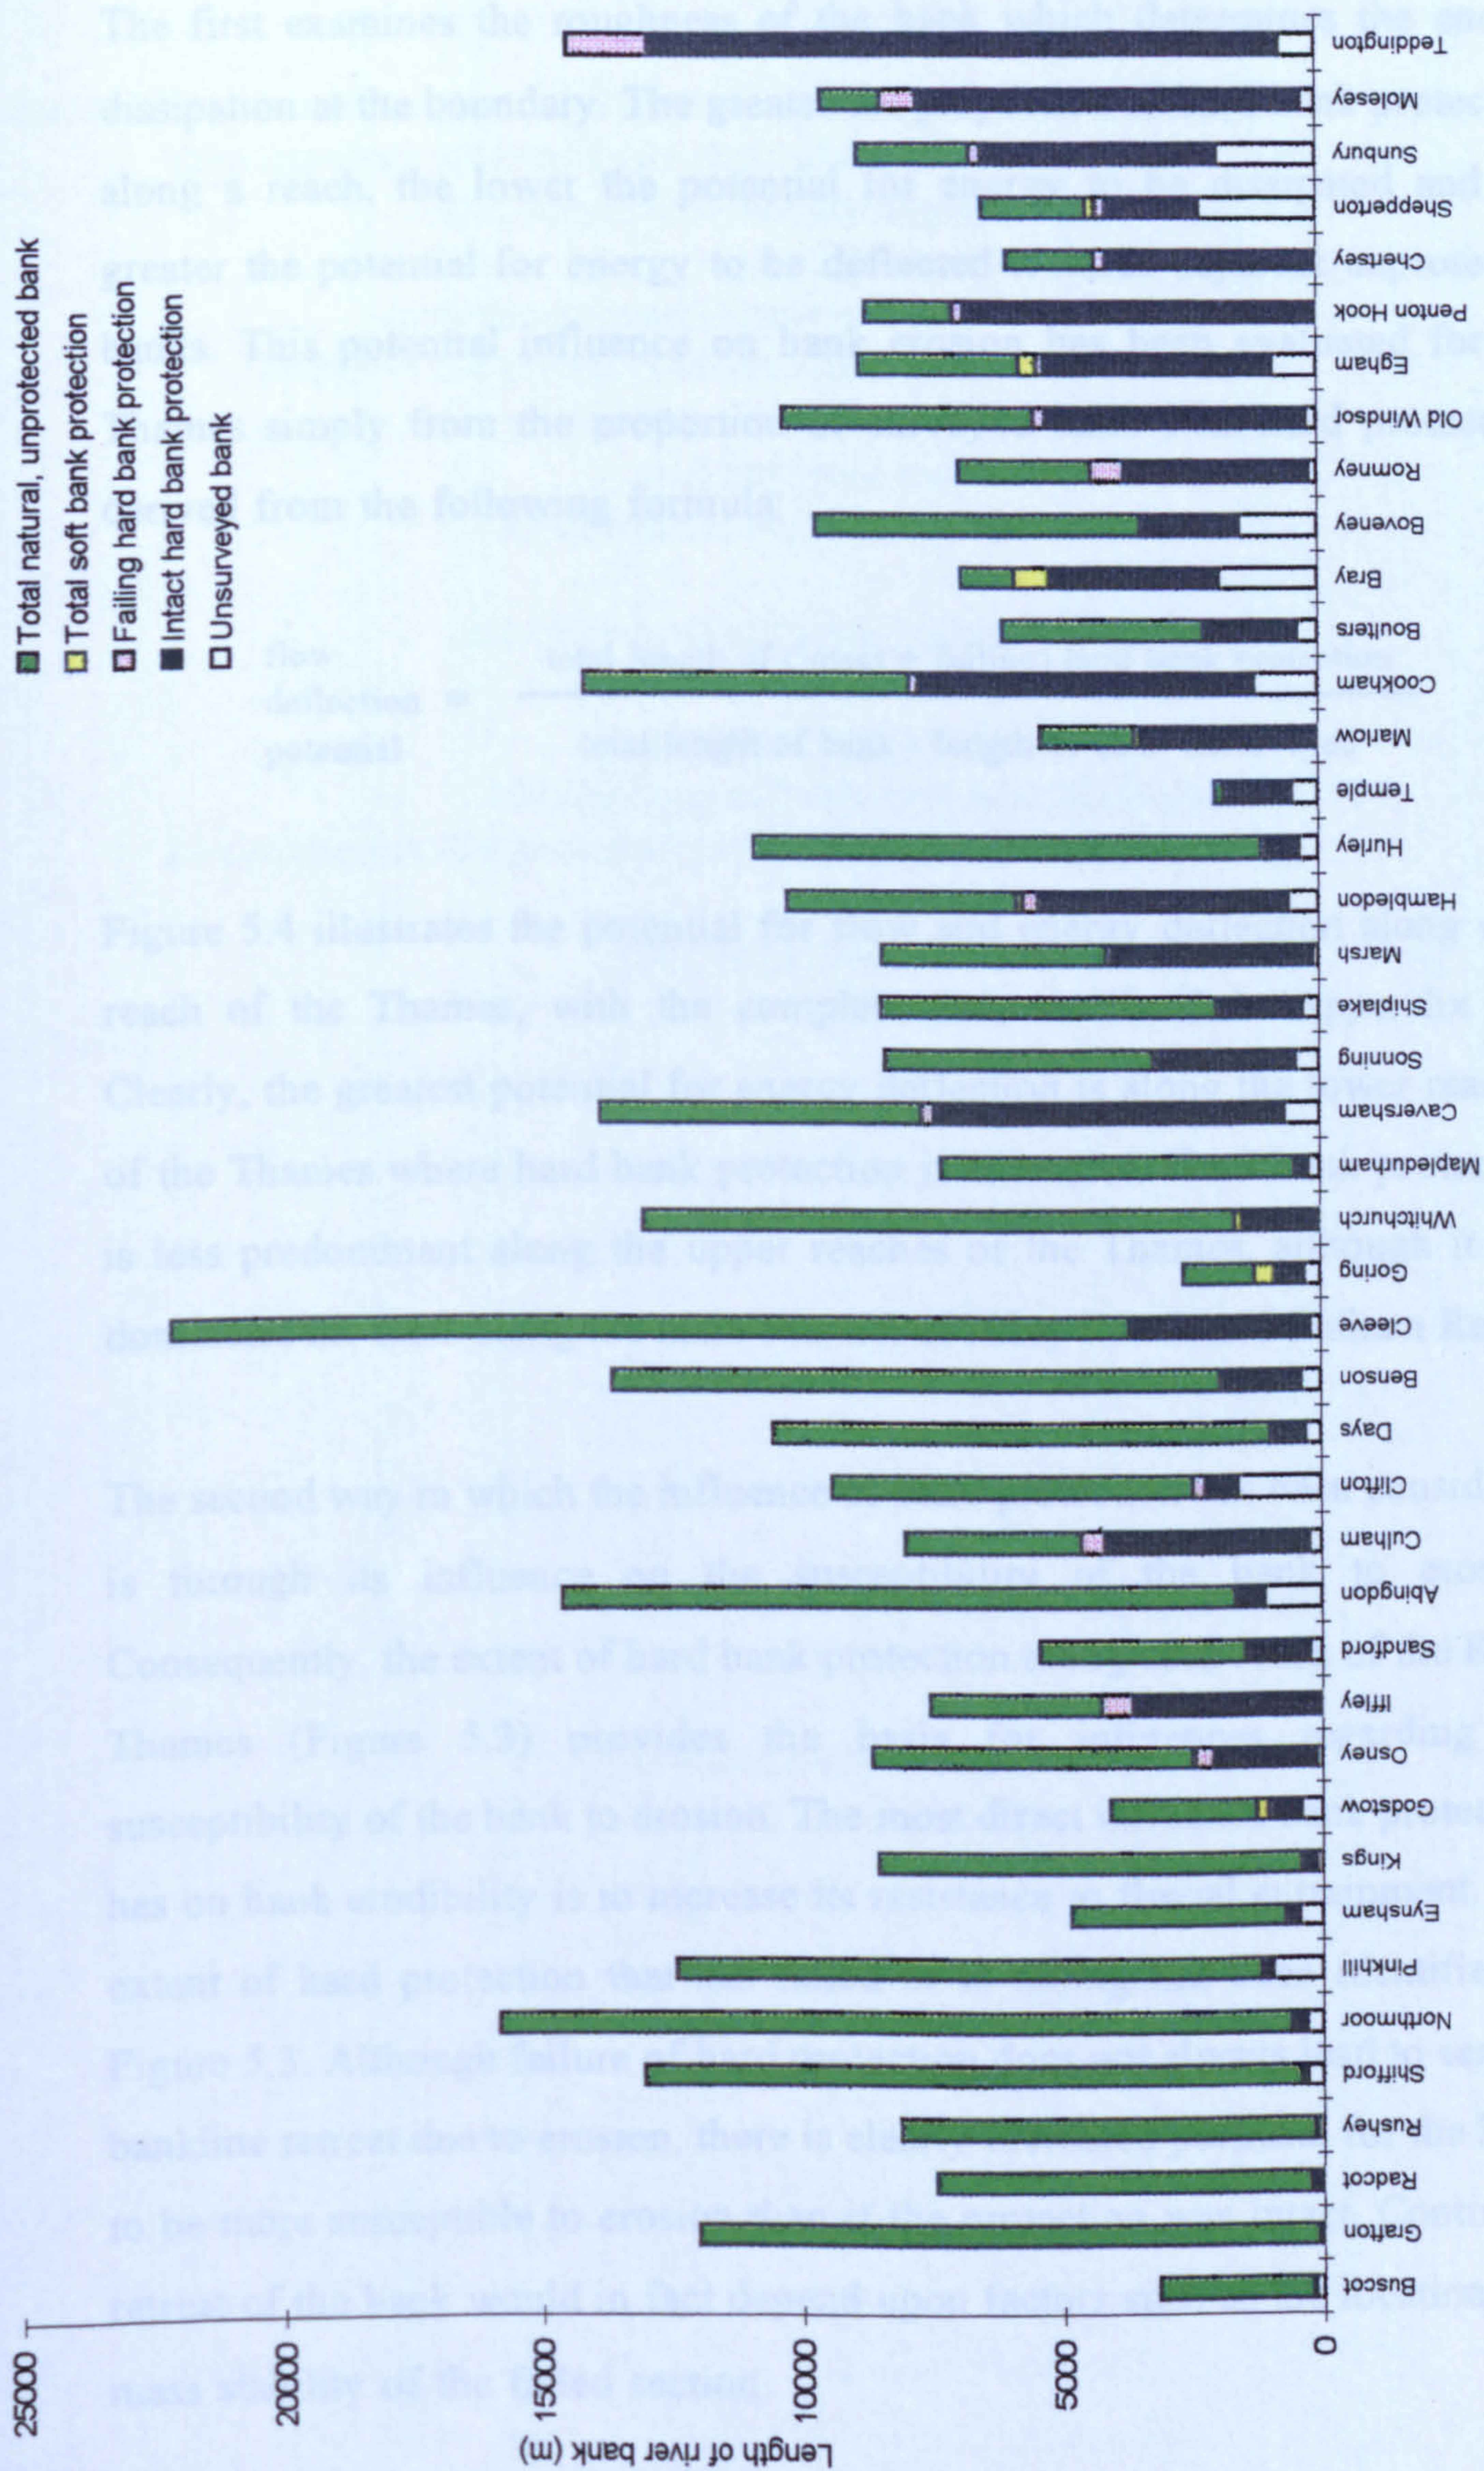
Figure 5.3 demonstrates the wide potential for bank protection to influence bank erosion along each reach, because almost a third of the banks of the Thames are protected in one form or another (see Appendix 5.2).

Figure 5.3 General character of the banks along each reach of the River Thames.

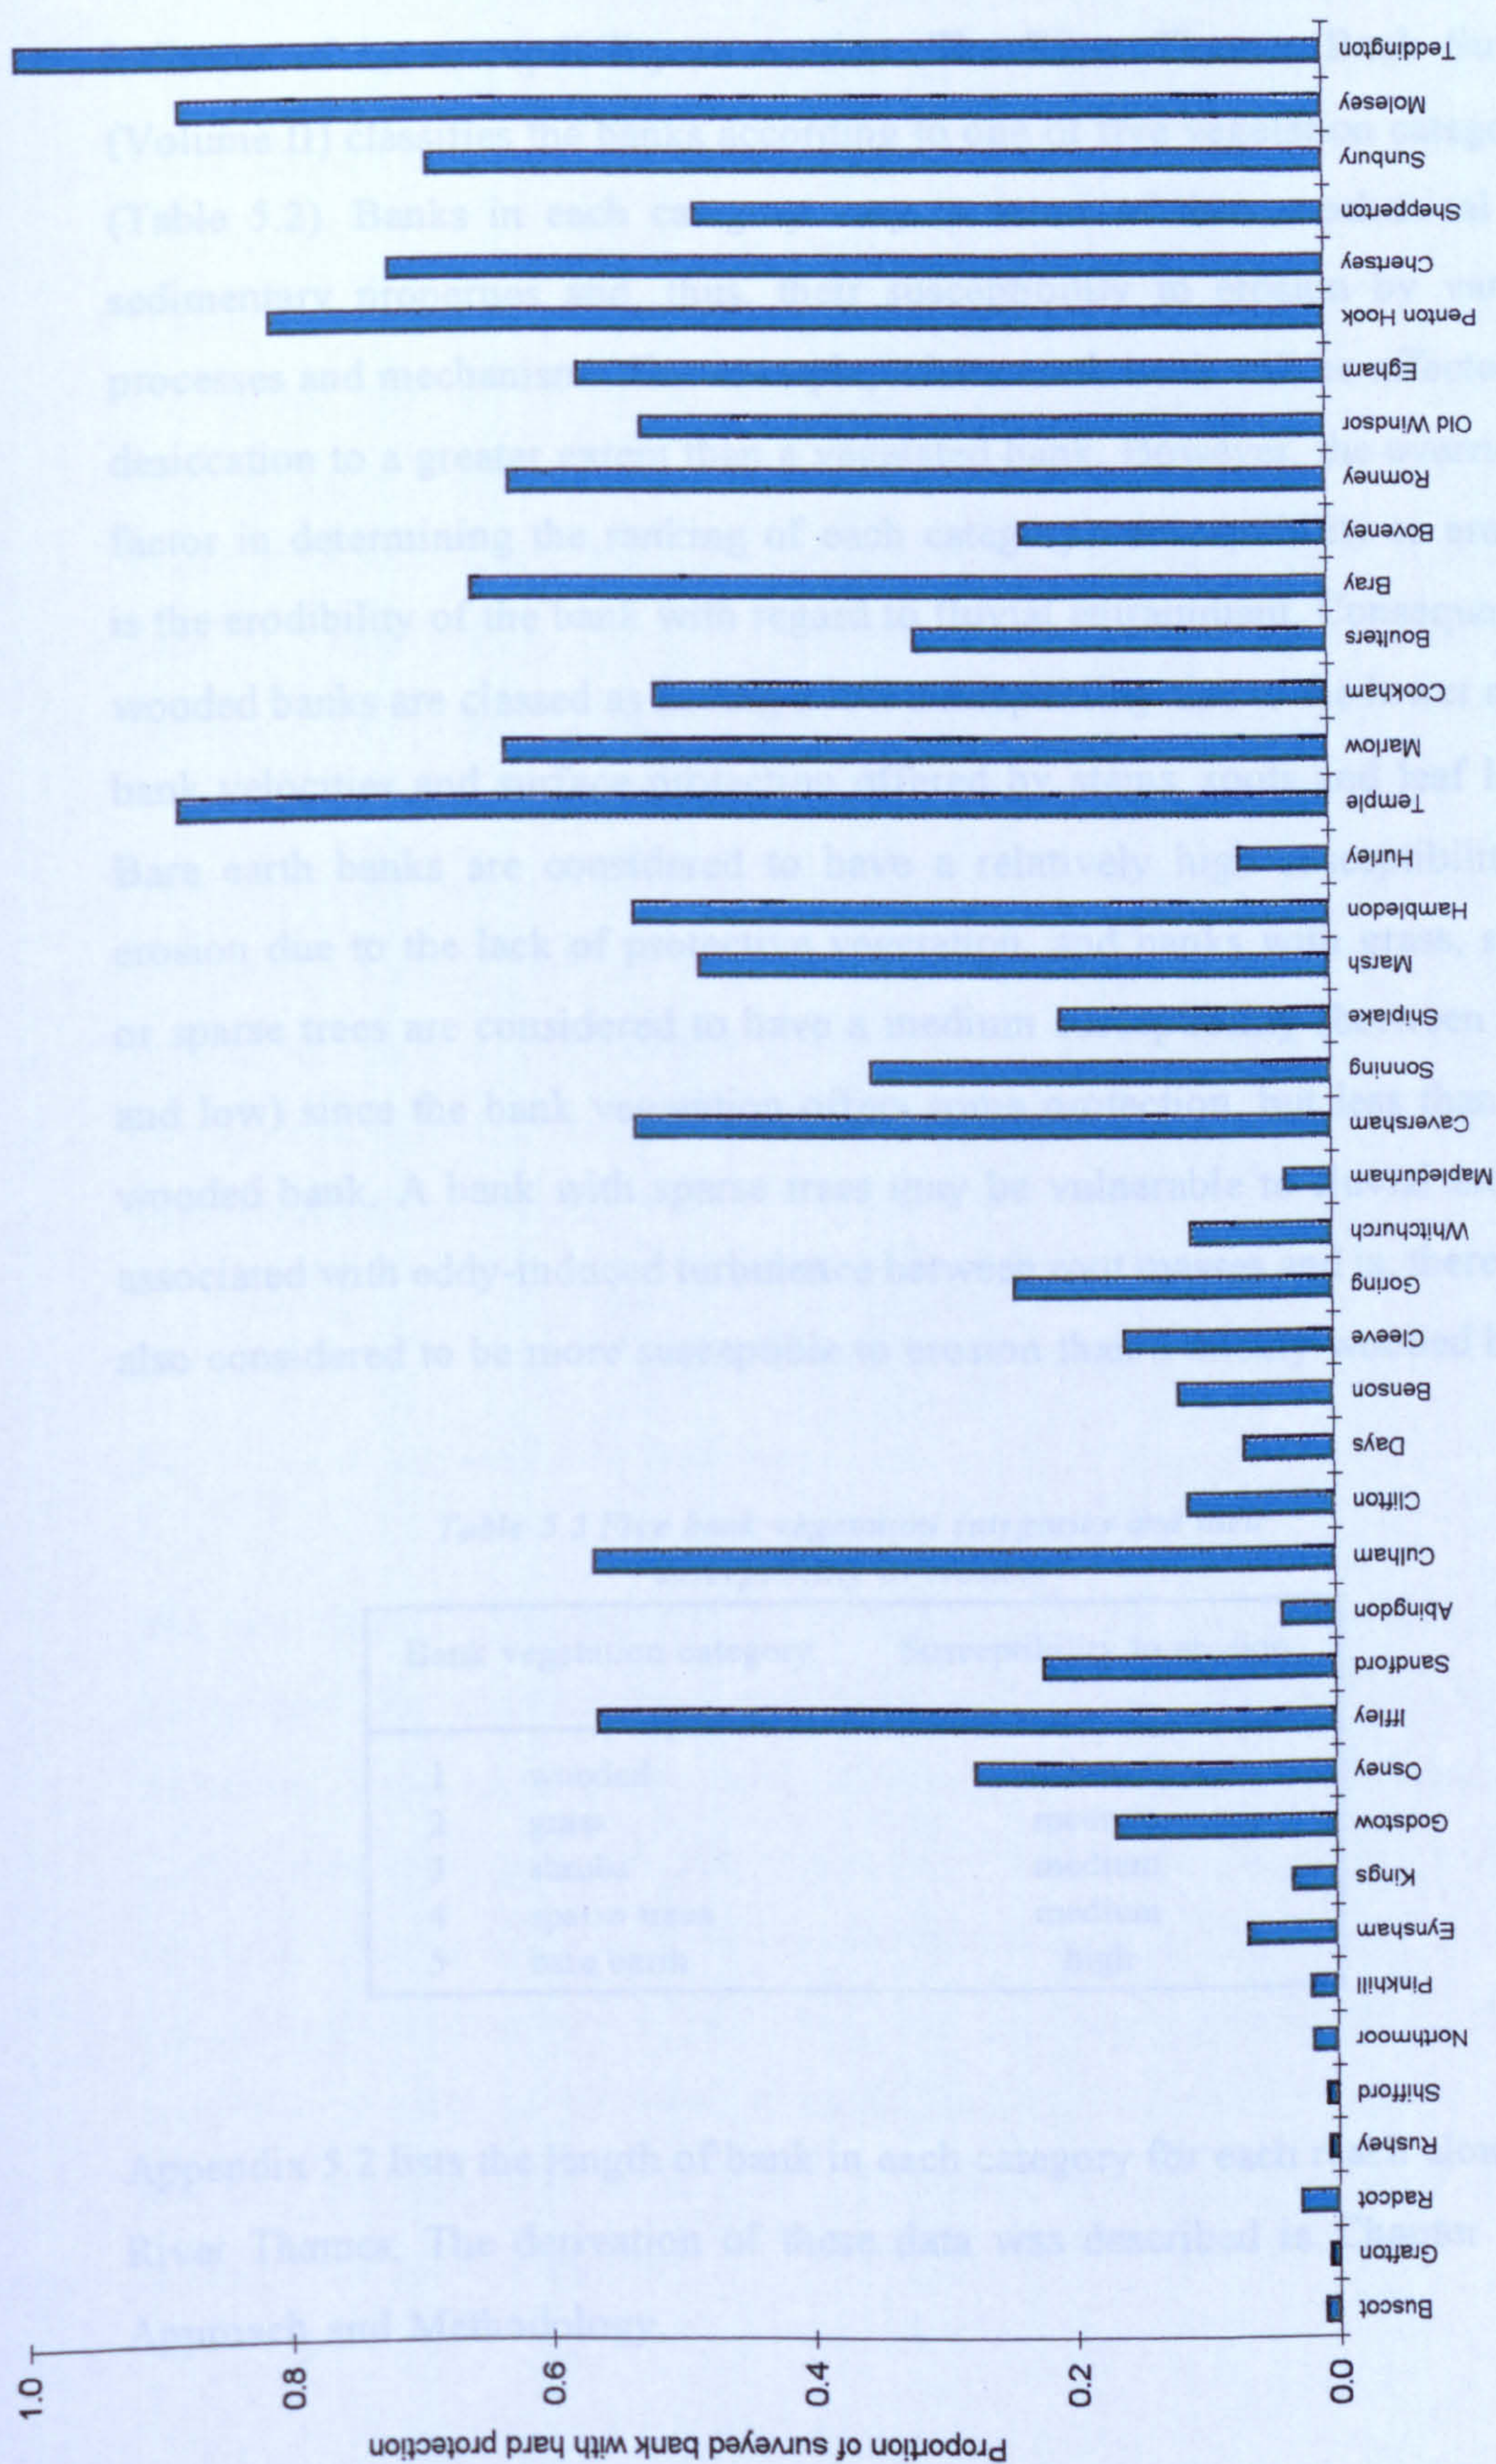
Figure 5.4 illustrates the potential for flow and energy deflection along each reach of the Thames, with the complete data set listed in Appendix 5.2. Clearly, the greatest potential for energy deflection is along the lower reaches of the Thames where hard bank protection is extensive. Hard bank protection is less predominant along the upper reaches of the Thames, although it still dominates the bank along the main channel of Iffley Reach and Culham Reach.

Figure 5.4 Flow deflection potential: proportion of surveyed bank with hard protection along each reach of the River Thames.

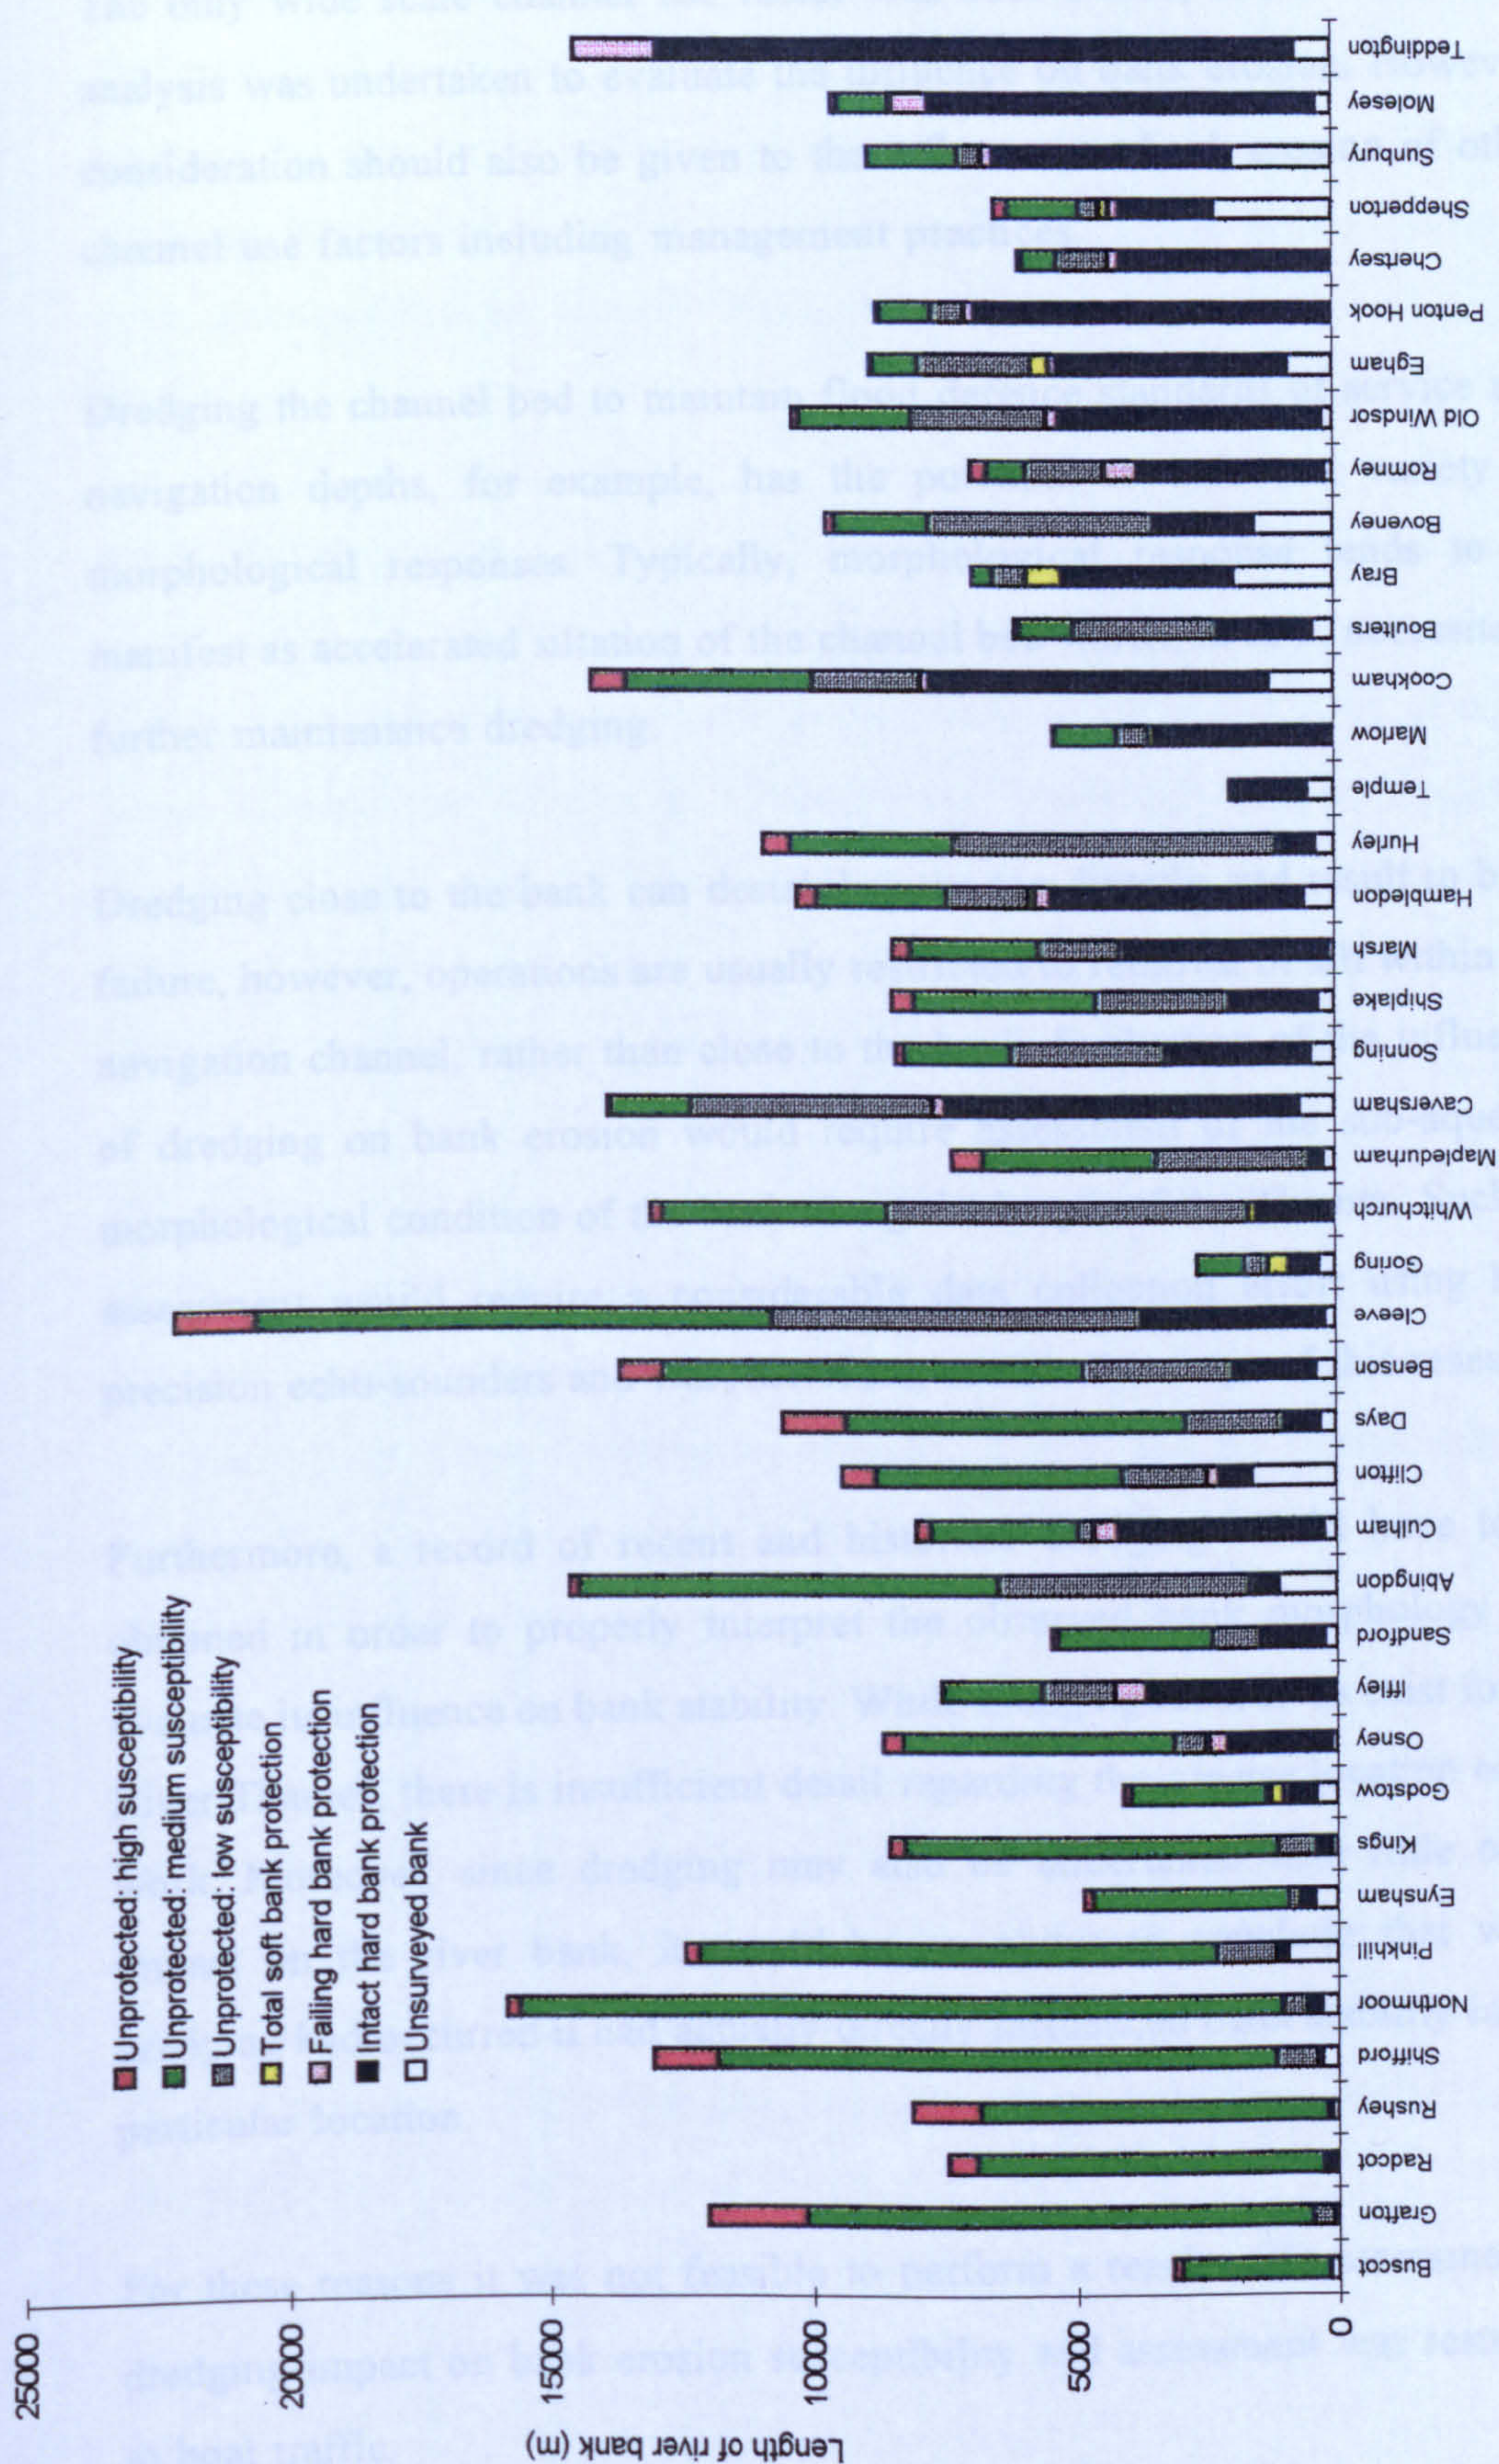
Combining the influence of hard bank protection with that of bank vegetation provides an indication of the overall erosion susceptibility of each reach of the River Thames (Figure 5.5).

Figure 5.5 Bank vegetation and hard protection as indicators of bank erosion susceptibility along each reach of the River Thames.

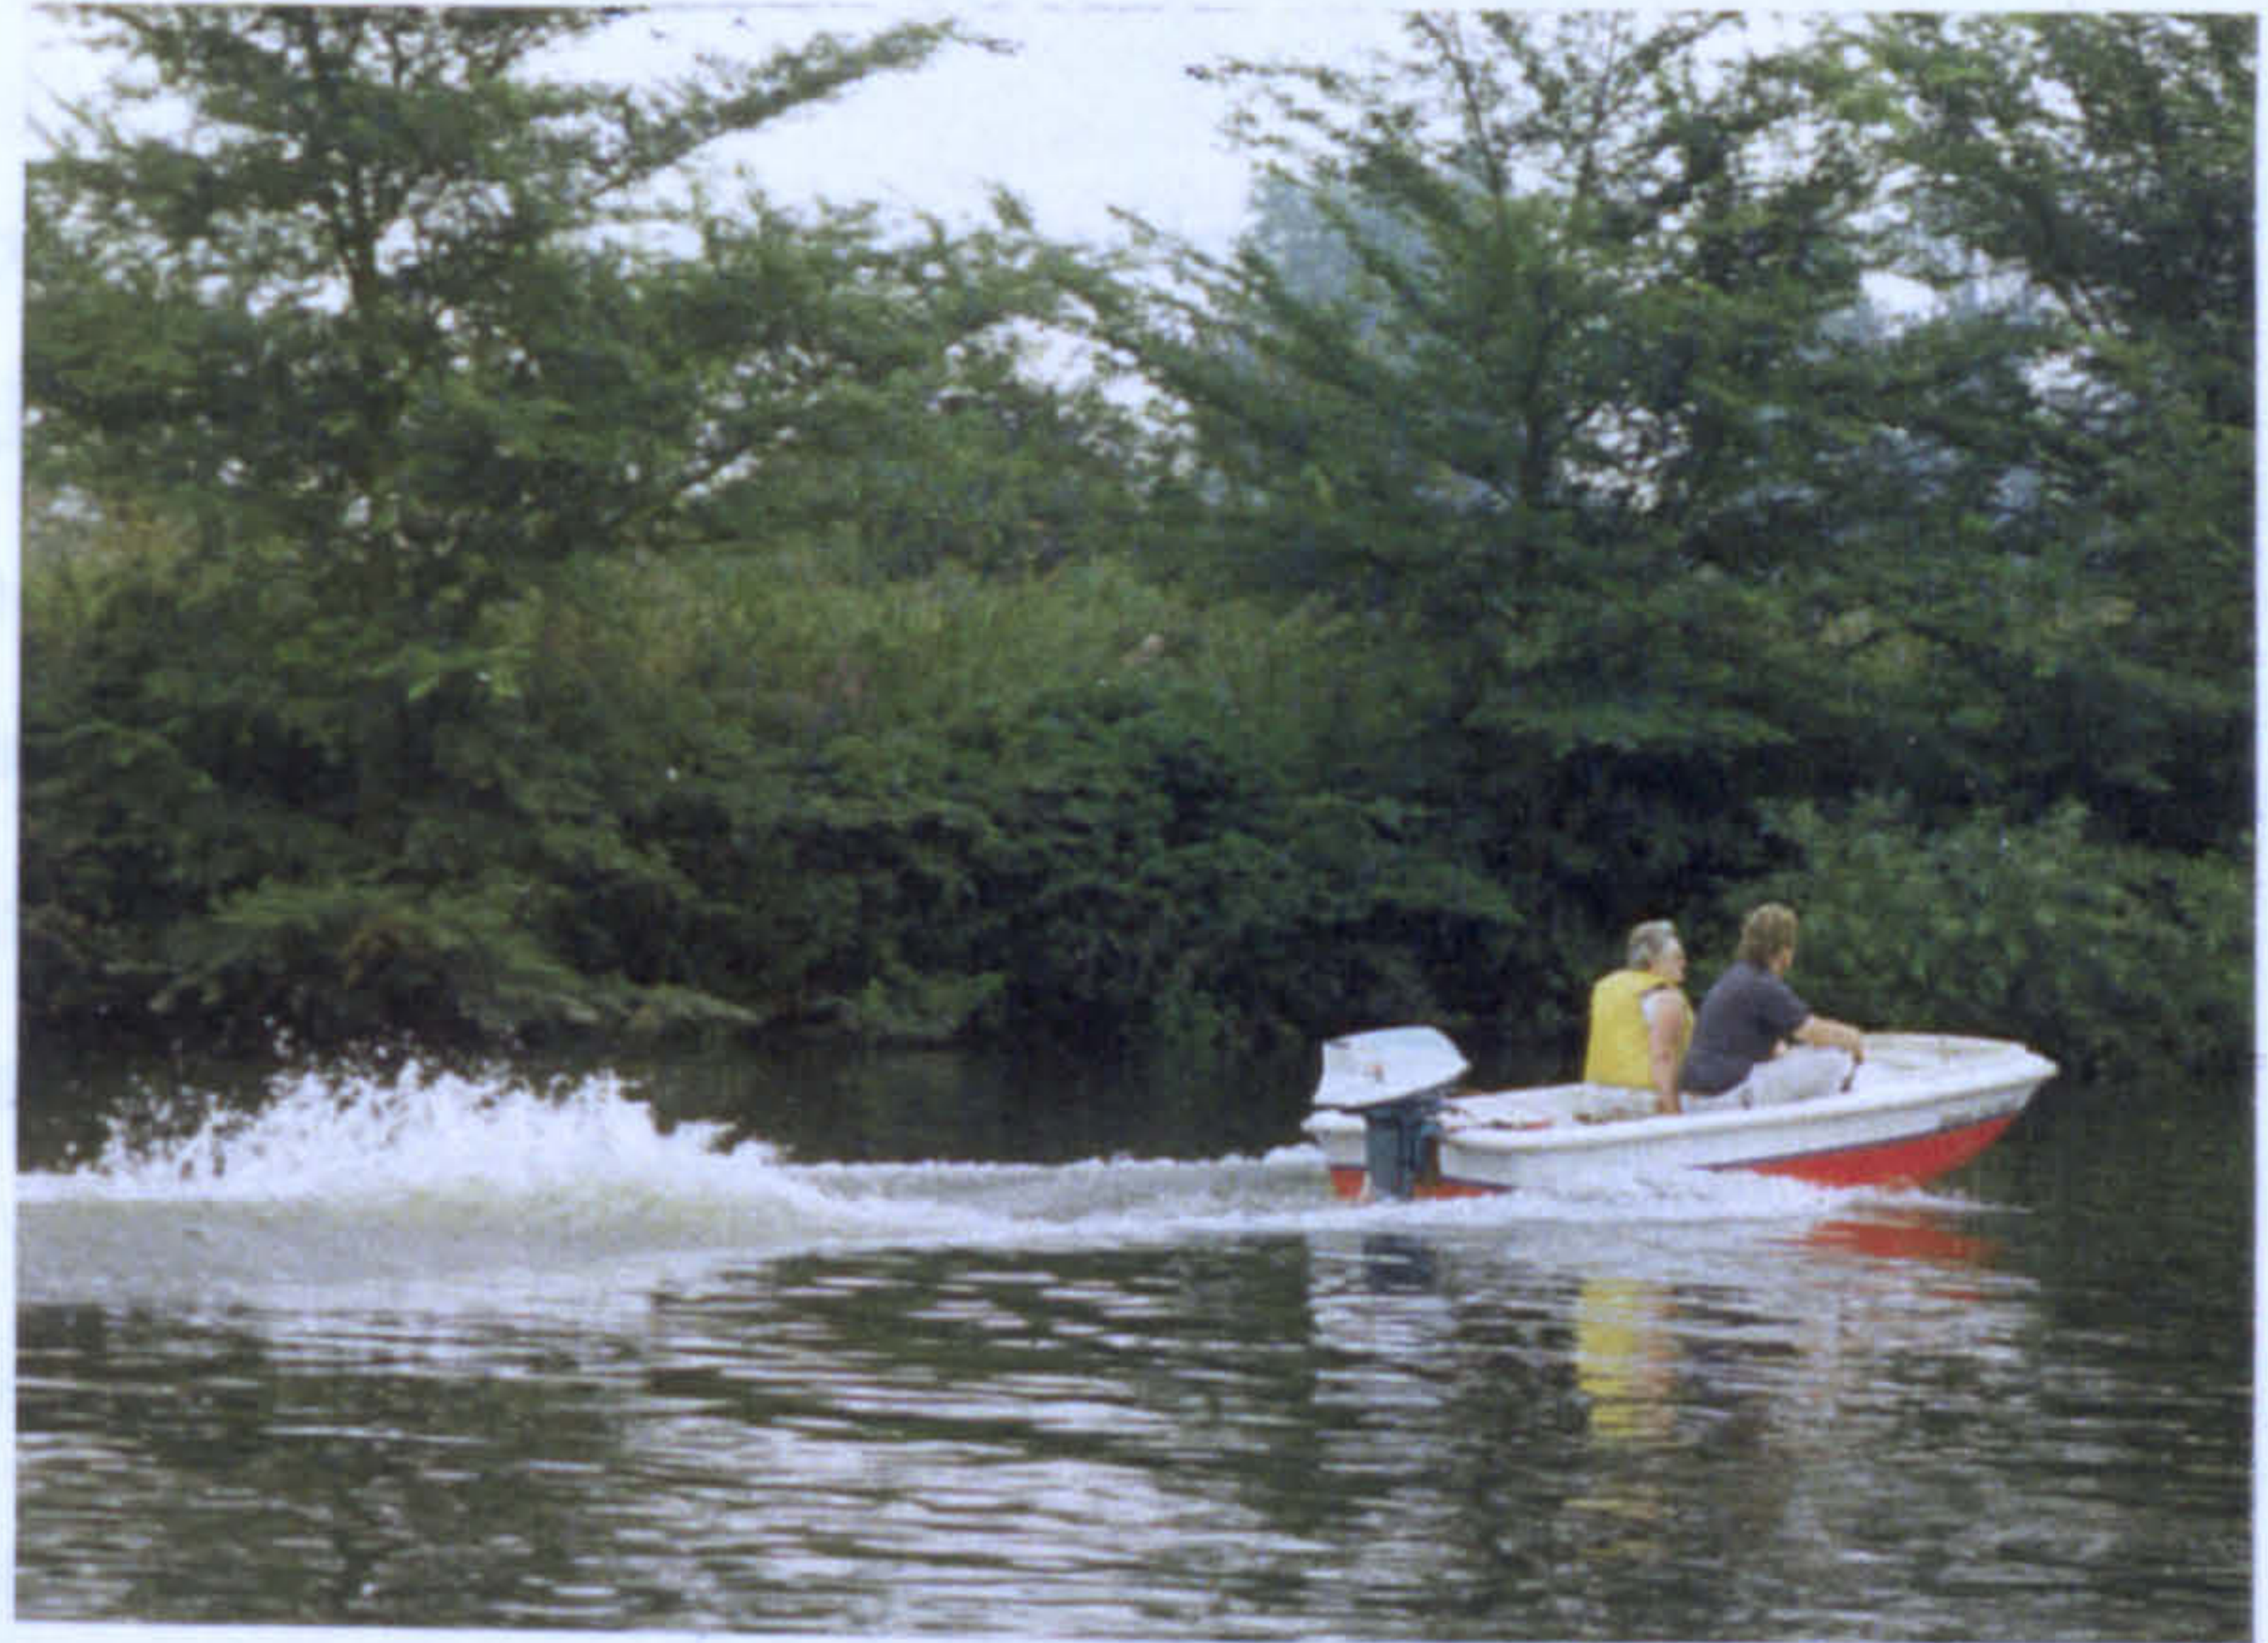
There was a greater range in the maximum boat velocities. The highest velocity, 12km/hr (7.5mph), was measured at the wood piled bank upstream of Wallingford Bridge, for the craft pictured in Plate 5.1. In comparison, the maximum boat velocities recorded at the reeded and Nicospan banks were 5.1km/hr (3.2mph) and 6km/hr (3.7mph), respectively.

Plate 5.1
Speed boat travelling
~12km/hr (7.5mph)
at the wood piled
bank at Wallingford.
