**"THE NON-TIDAL, NAVIGABLE THAMES:
A BANK EROSION MANAGEMENT STRATEGY"**

by Sue Reed BSc, MSc, MCIWEM

**Thesis submitted to the University of Nottingham
for the degree of Doctor of Philosophy, October 1998**

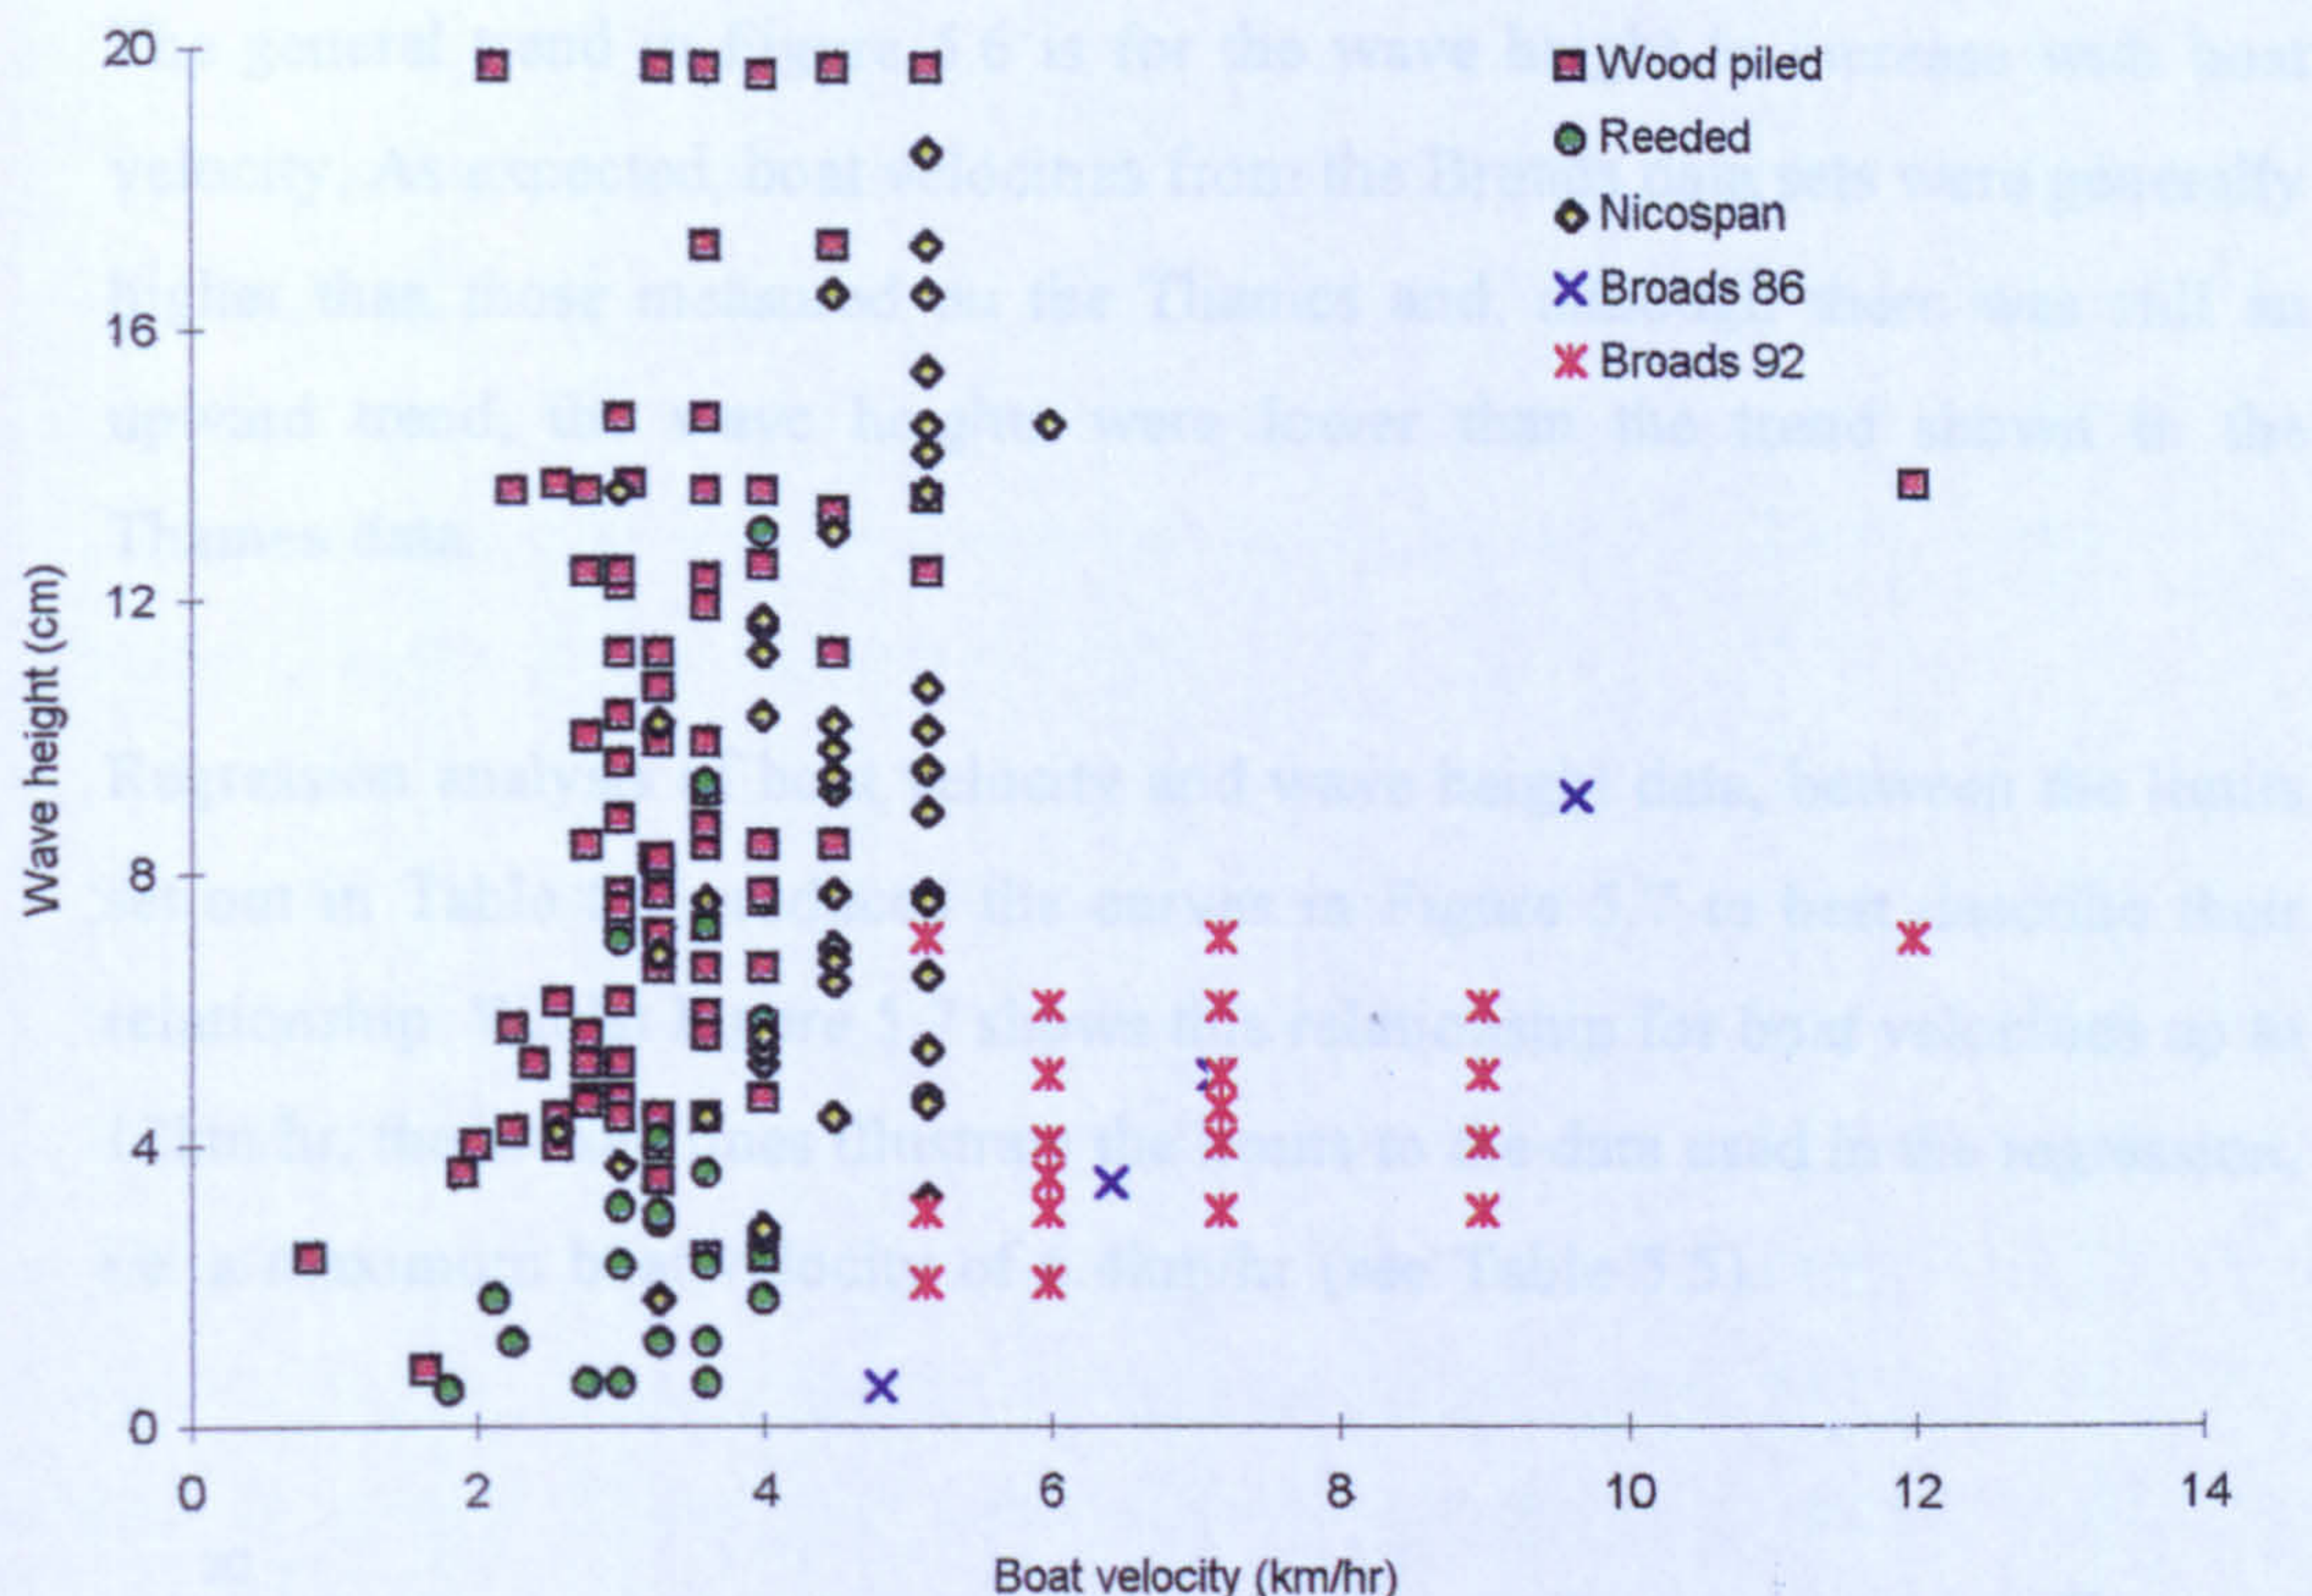
Figure 5.6 shows the relationship between the wave heights measured at the 3 bank sites and velocities of the passing boats. Two wave heights measured at the wood piled bank are not shown in Figure 5.6 since these heights, 26cm and 39cm, were generated by the only small speed boat observed during the monitoring period. This vessel passed the monitoring site twice, travelling at the highest recorded boat velocities. Plate 5.1 shows the wash generated by this craft when it was travelling at approximately 12km/hr (~7.5 mph). These wave heights were excluded from the regression analysis since the speed boat was not considered representative of boat traffic on the Thames. Alternatively, these 'uncharacteristic' wave heights are analysed independently from the remainder of the data (see Table 5.6).

Figure 5.6 Boat velocity versus wave height for Thames and Broads data.

The general trend in Figure 5.6 is for the wave height to increase with boat velocity. As expected, boat velocities from the Broads data sets were generally higher than those measured on the Thames and, although there was still an upward trend, the wave heights were lower than the trend shown in the Thames data.

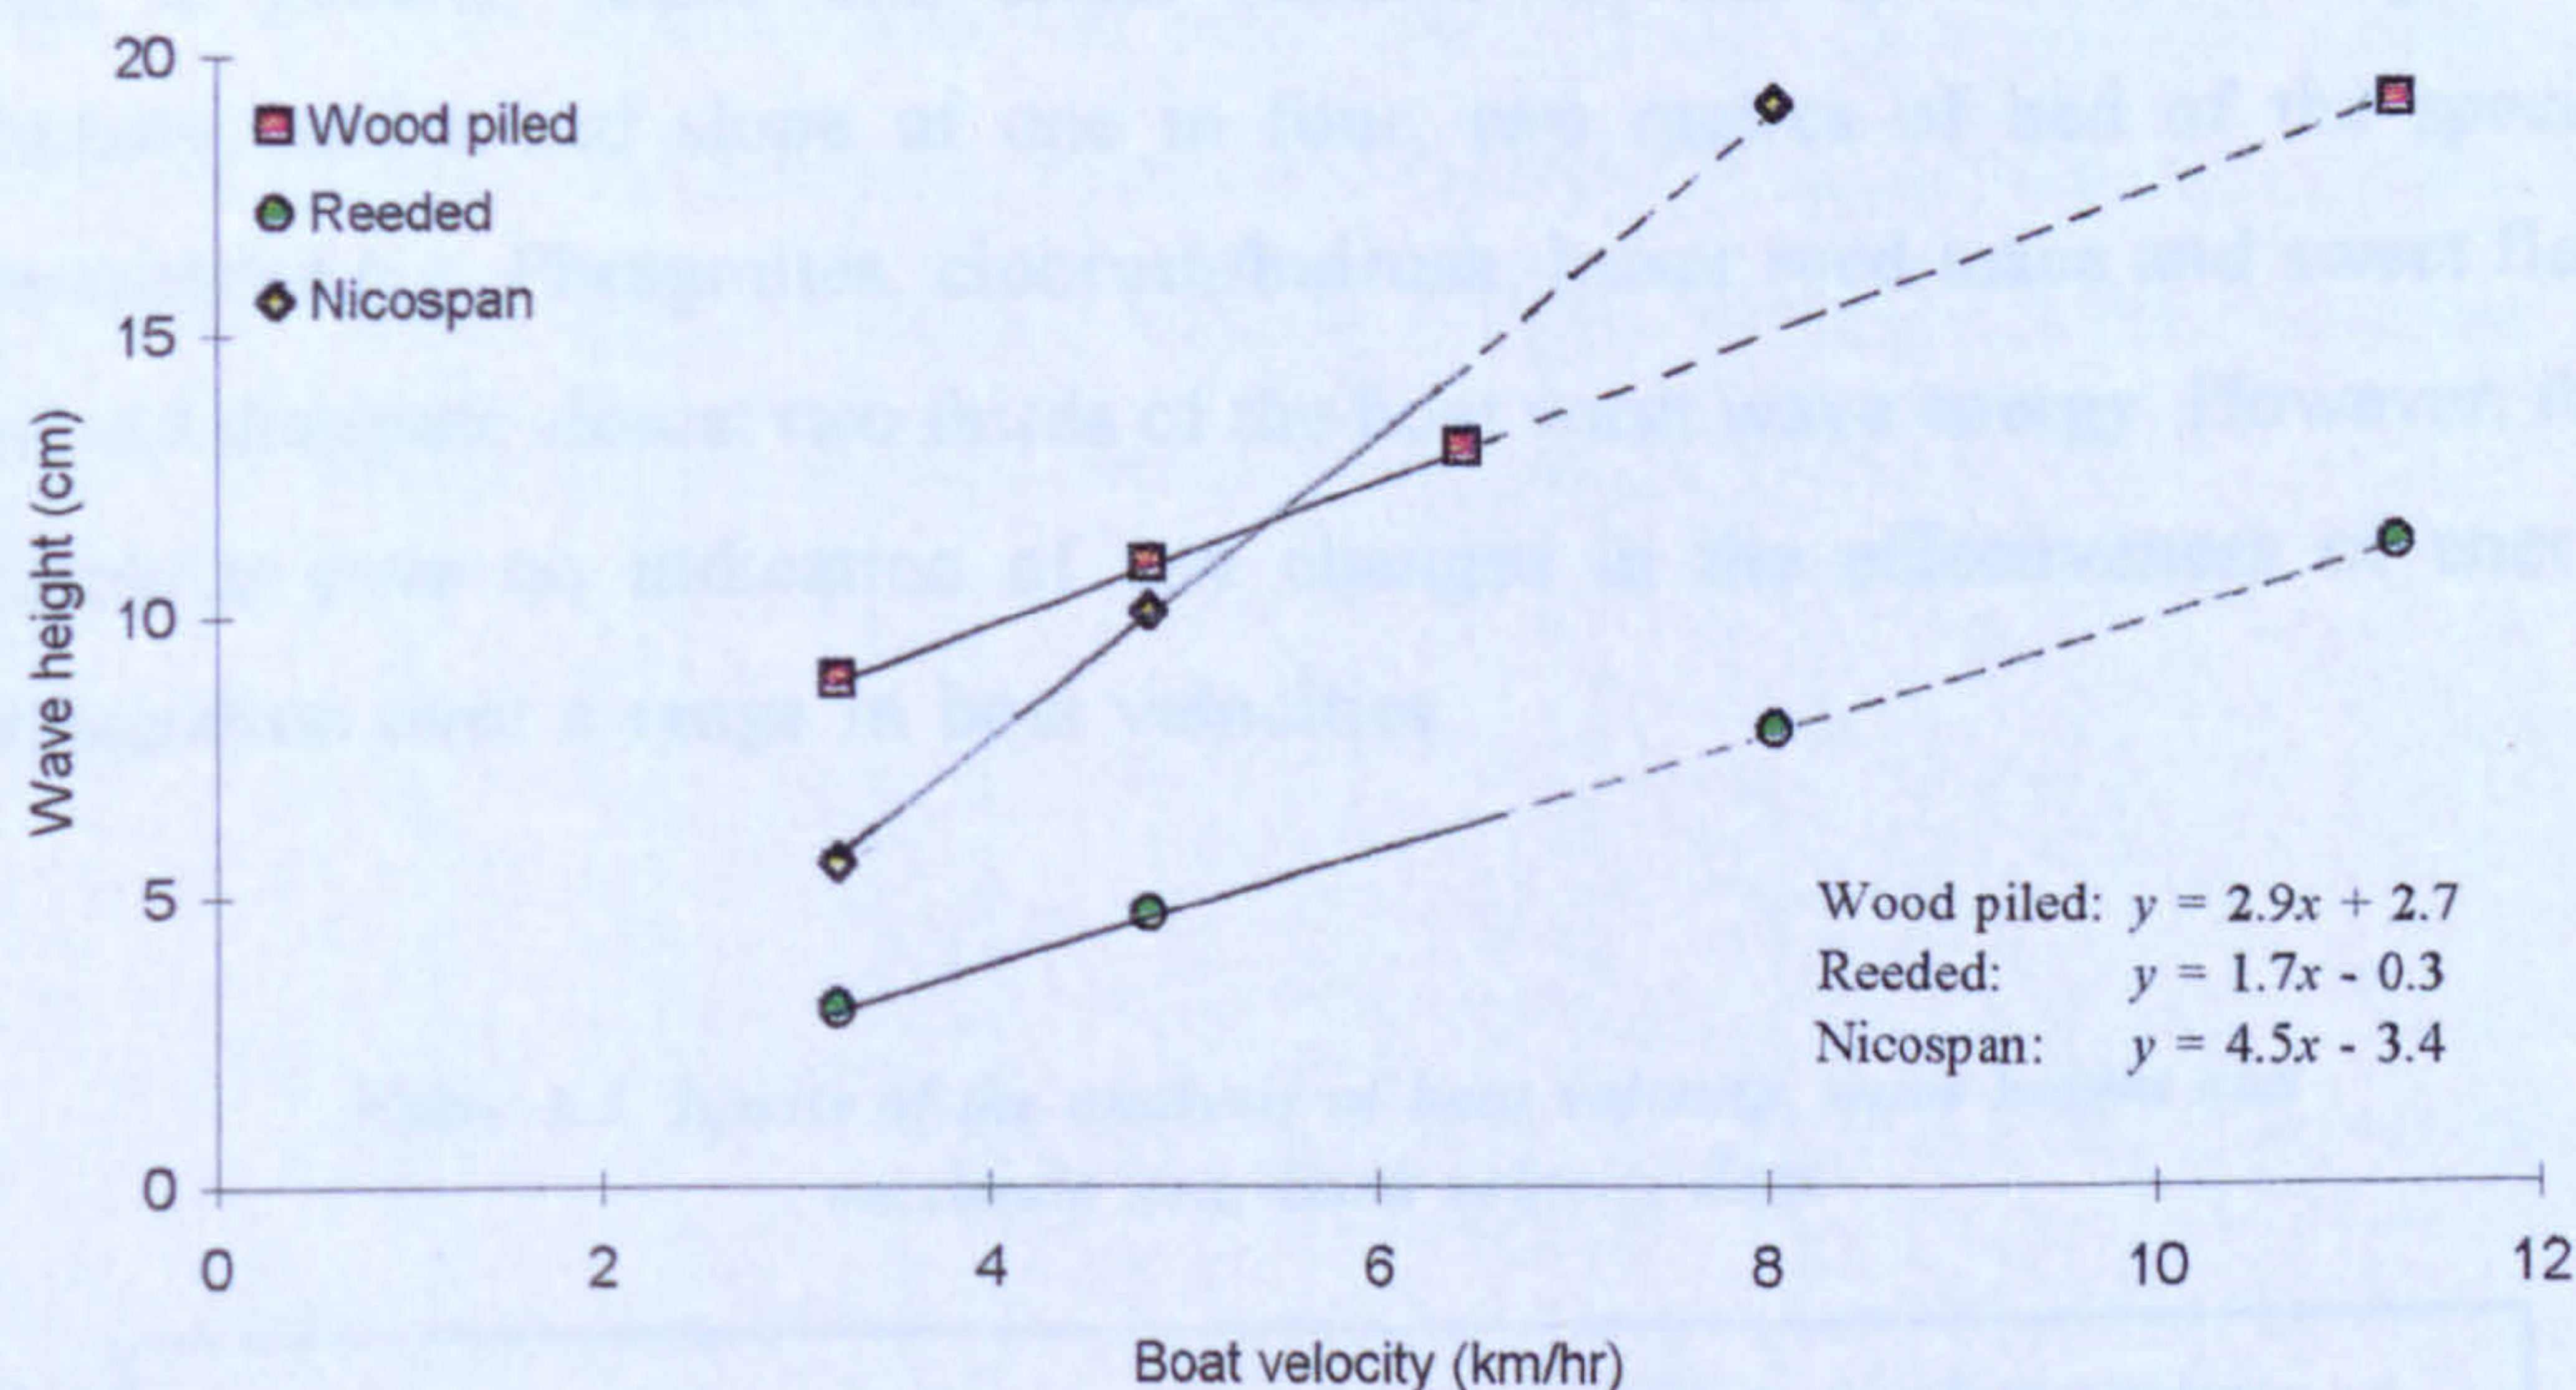
Figure 5.7 Best fit curve describing relationship between boat velocity and wave heights.

Figure 5.7 clearly shows that, for boat velocities up to ~6km/hr, the highest waves were generated at the wood piled bank, with intermediate wave heights at the Nicospan protected bank and the lowest waves at the reeded bank. At boat velocities greater than ~6km/hr, the regression analysis predicts higher wave heights at the Nicospan protected bank than at the sheet piled bank.

The regression lines shown in Figure 5.7 account for <10% of the variance in the data collected at the wood piled and reeded banks, and ~20% of that collected at the Nicospan protected banks. Consequently, output from the regression analysis only provides an indication of the likely relationship between boat velocity and wave height.

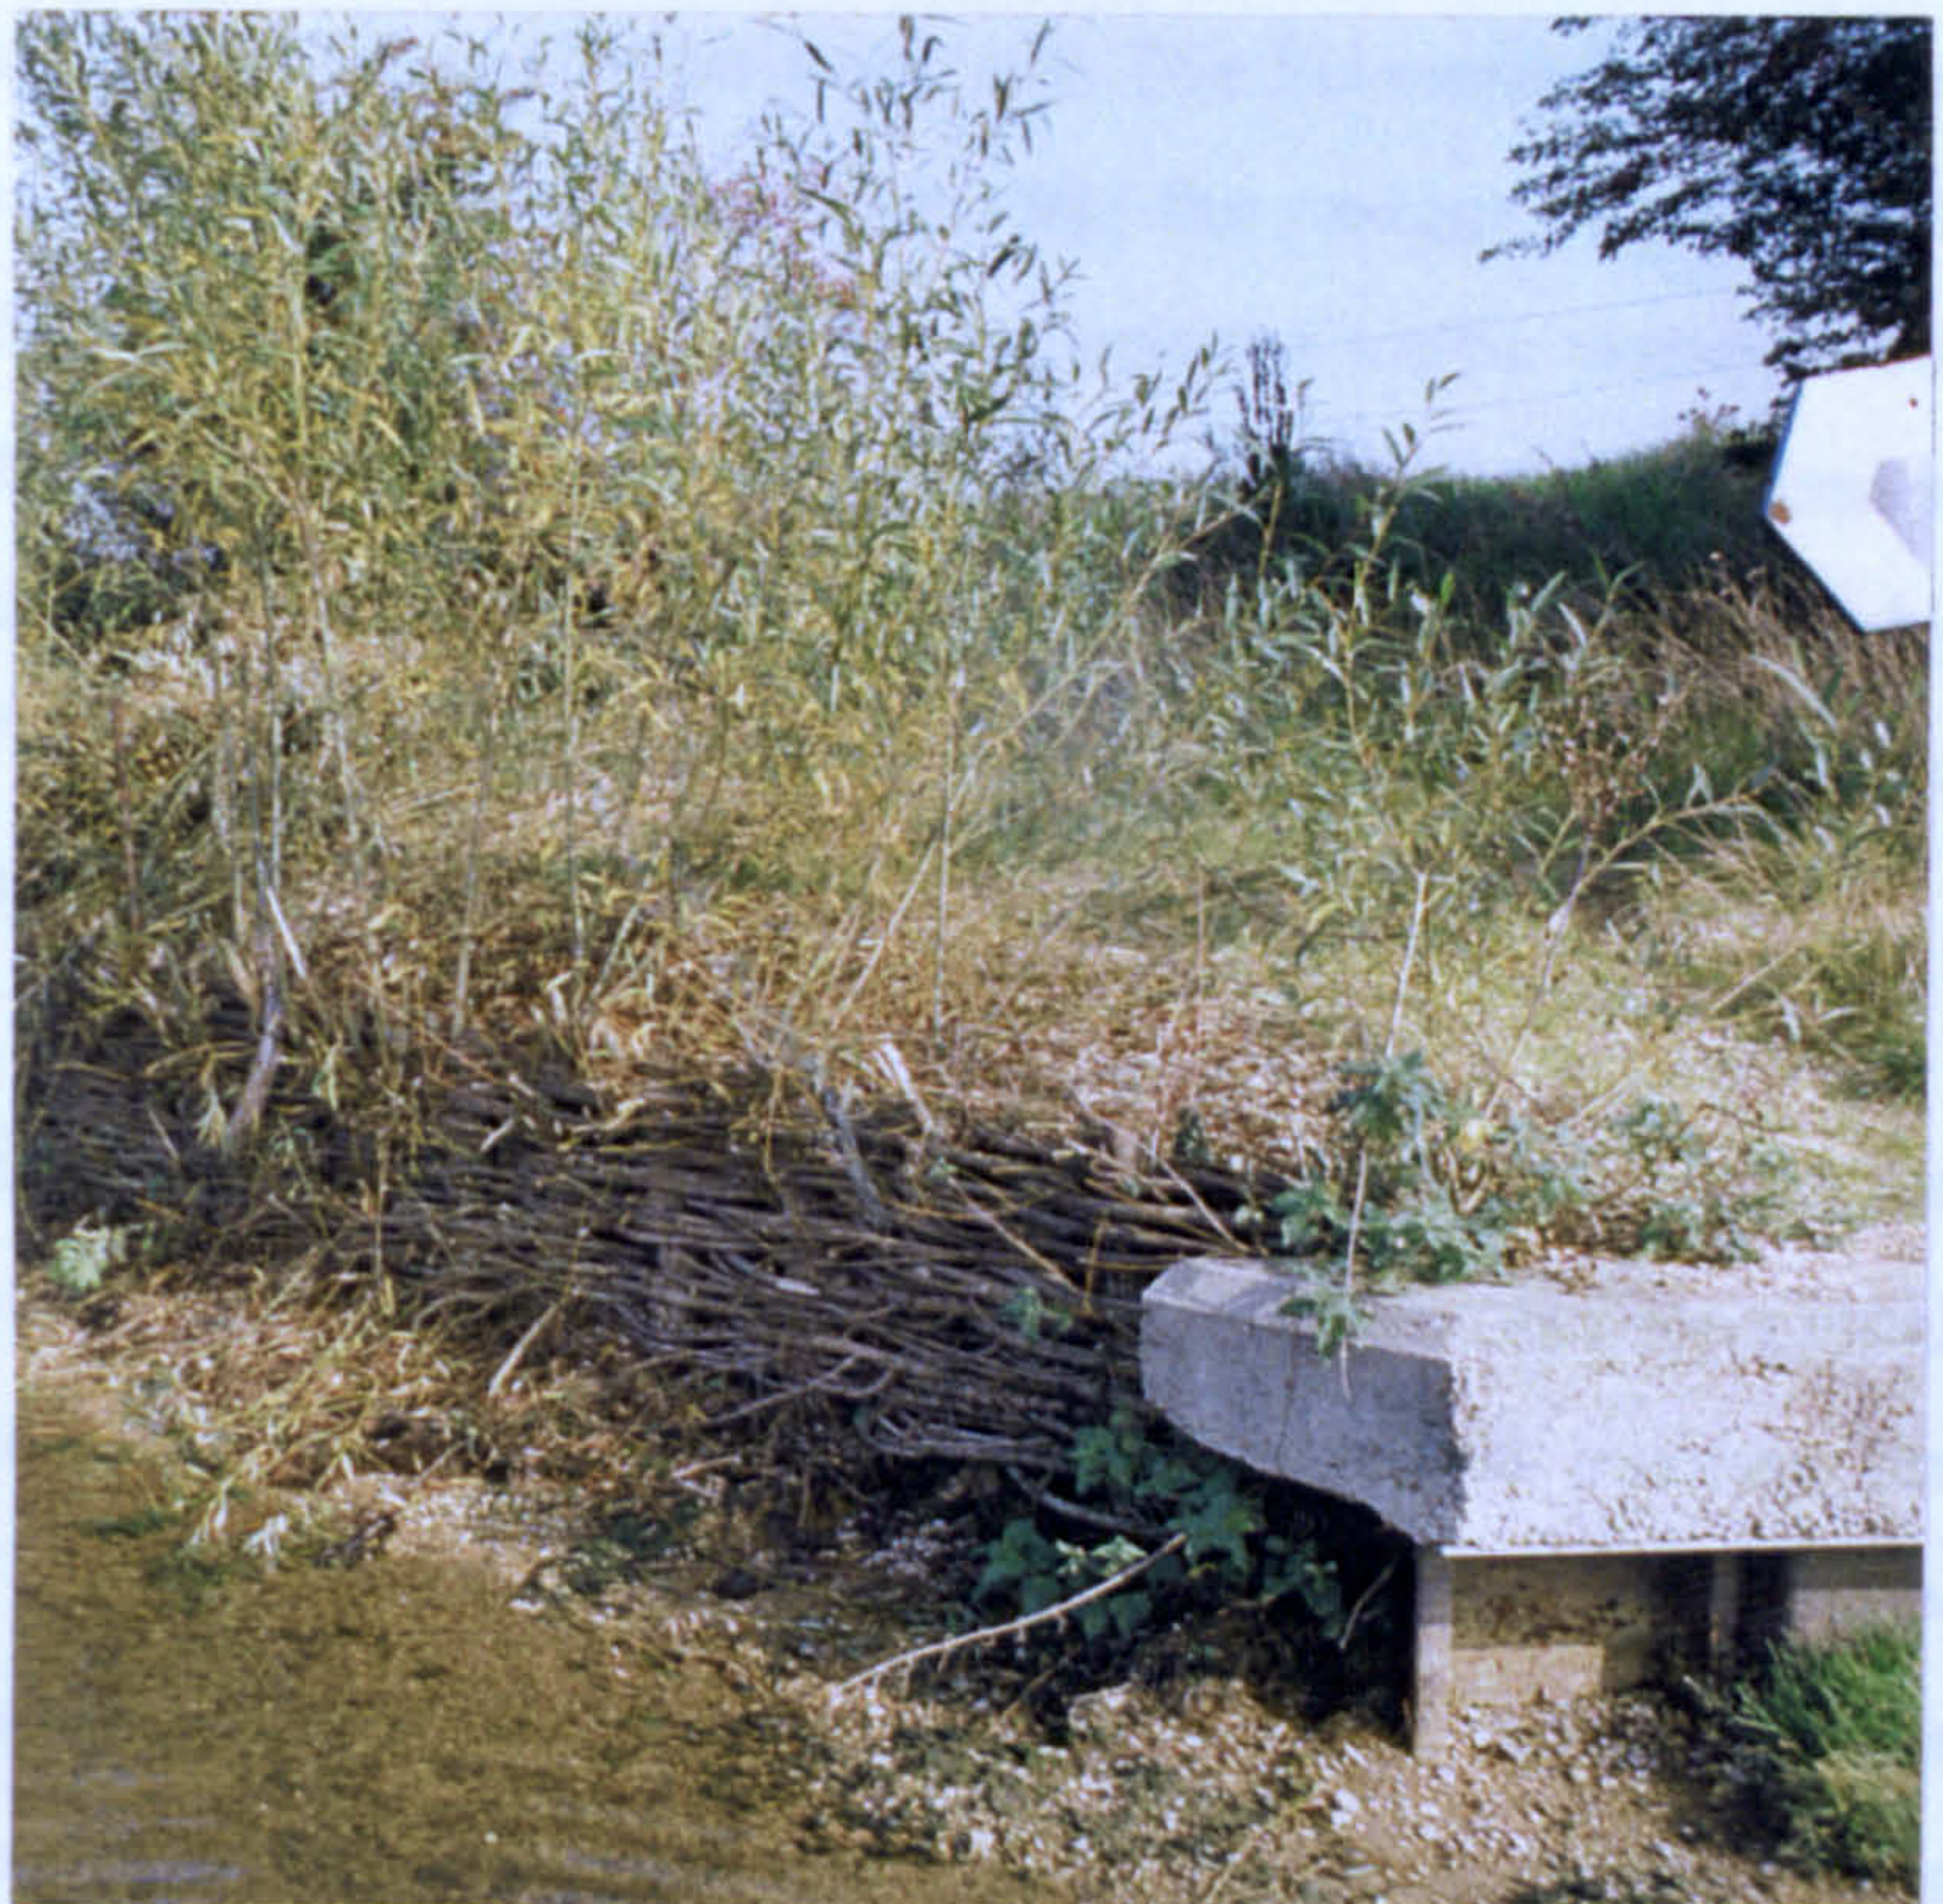
This short length of spiling was installed prior to 1994 at the entrance to Clifton Lock cut, which is downstream of the effects of flow over Clifton Weir (see Volume III - Map 16). The character of the bank prior to protection is not known although the spiling probably resulting in minimal change to geometry. The causes of erosion and failure mechanisms are also unknown but the bank is at the entrance to the lock cut and immediately downstream of concrete-capped sheet piling which protects the upstream of the lock island (see Plate 6.6). Because the site is at the entrance to the lock cut and, therefore, experiences relatively low flow velocities all year round, it is likely that the major cause of erosion was wash from boat traffic. Similarly, to the erosion monitoring sites at Lower Wallingford, Laleham and Chertsey, a spending beach was developing at the toe of the bank. Furthermore, the hard engineering

structure upstream will also tend to increase turbulence at the bank, which can lead to the erosion often observed upstream and downstream of structures.

Plate 6.6
Case study no. 6:
willow spiling at
the entrance to
Clifton Lock cut

The consequences of failure were also unknown at this site. However, the lock keeper uses the bank to moor against and it may be that the main reason for installing the spiling was to provide a mooring facility for the lock keeper. Again, the boat wash monitoring exercise (Chapter Five) suggested that boat wash generated by traffic travelling at relatively low speeds, as expected along the lock cut, would not result in sufficient near-bank velocities to erode intact bank material. However, similar wash could be expected to result in erosion of weakened material on the surface of the bank. Under these relatively low shear stresses a bioengineering solution, such as willow spiling, was an appropriate technique to use to prevent continued erosion. Indeed, under these 'moderate' consequences of erosion, the Environment Agency's (1997) framework recommends that strategies 2 or 4 are appropriate and that willows, faggots or tree and shrub planting would prove equally satisfactory solutions.

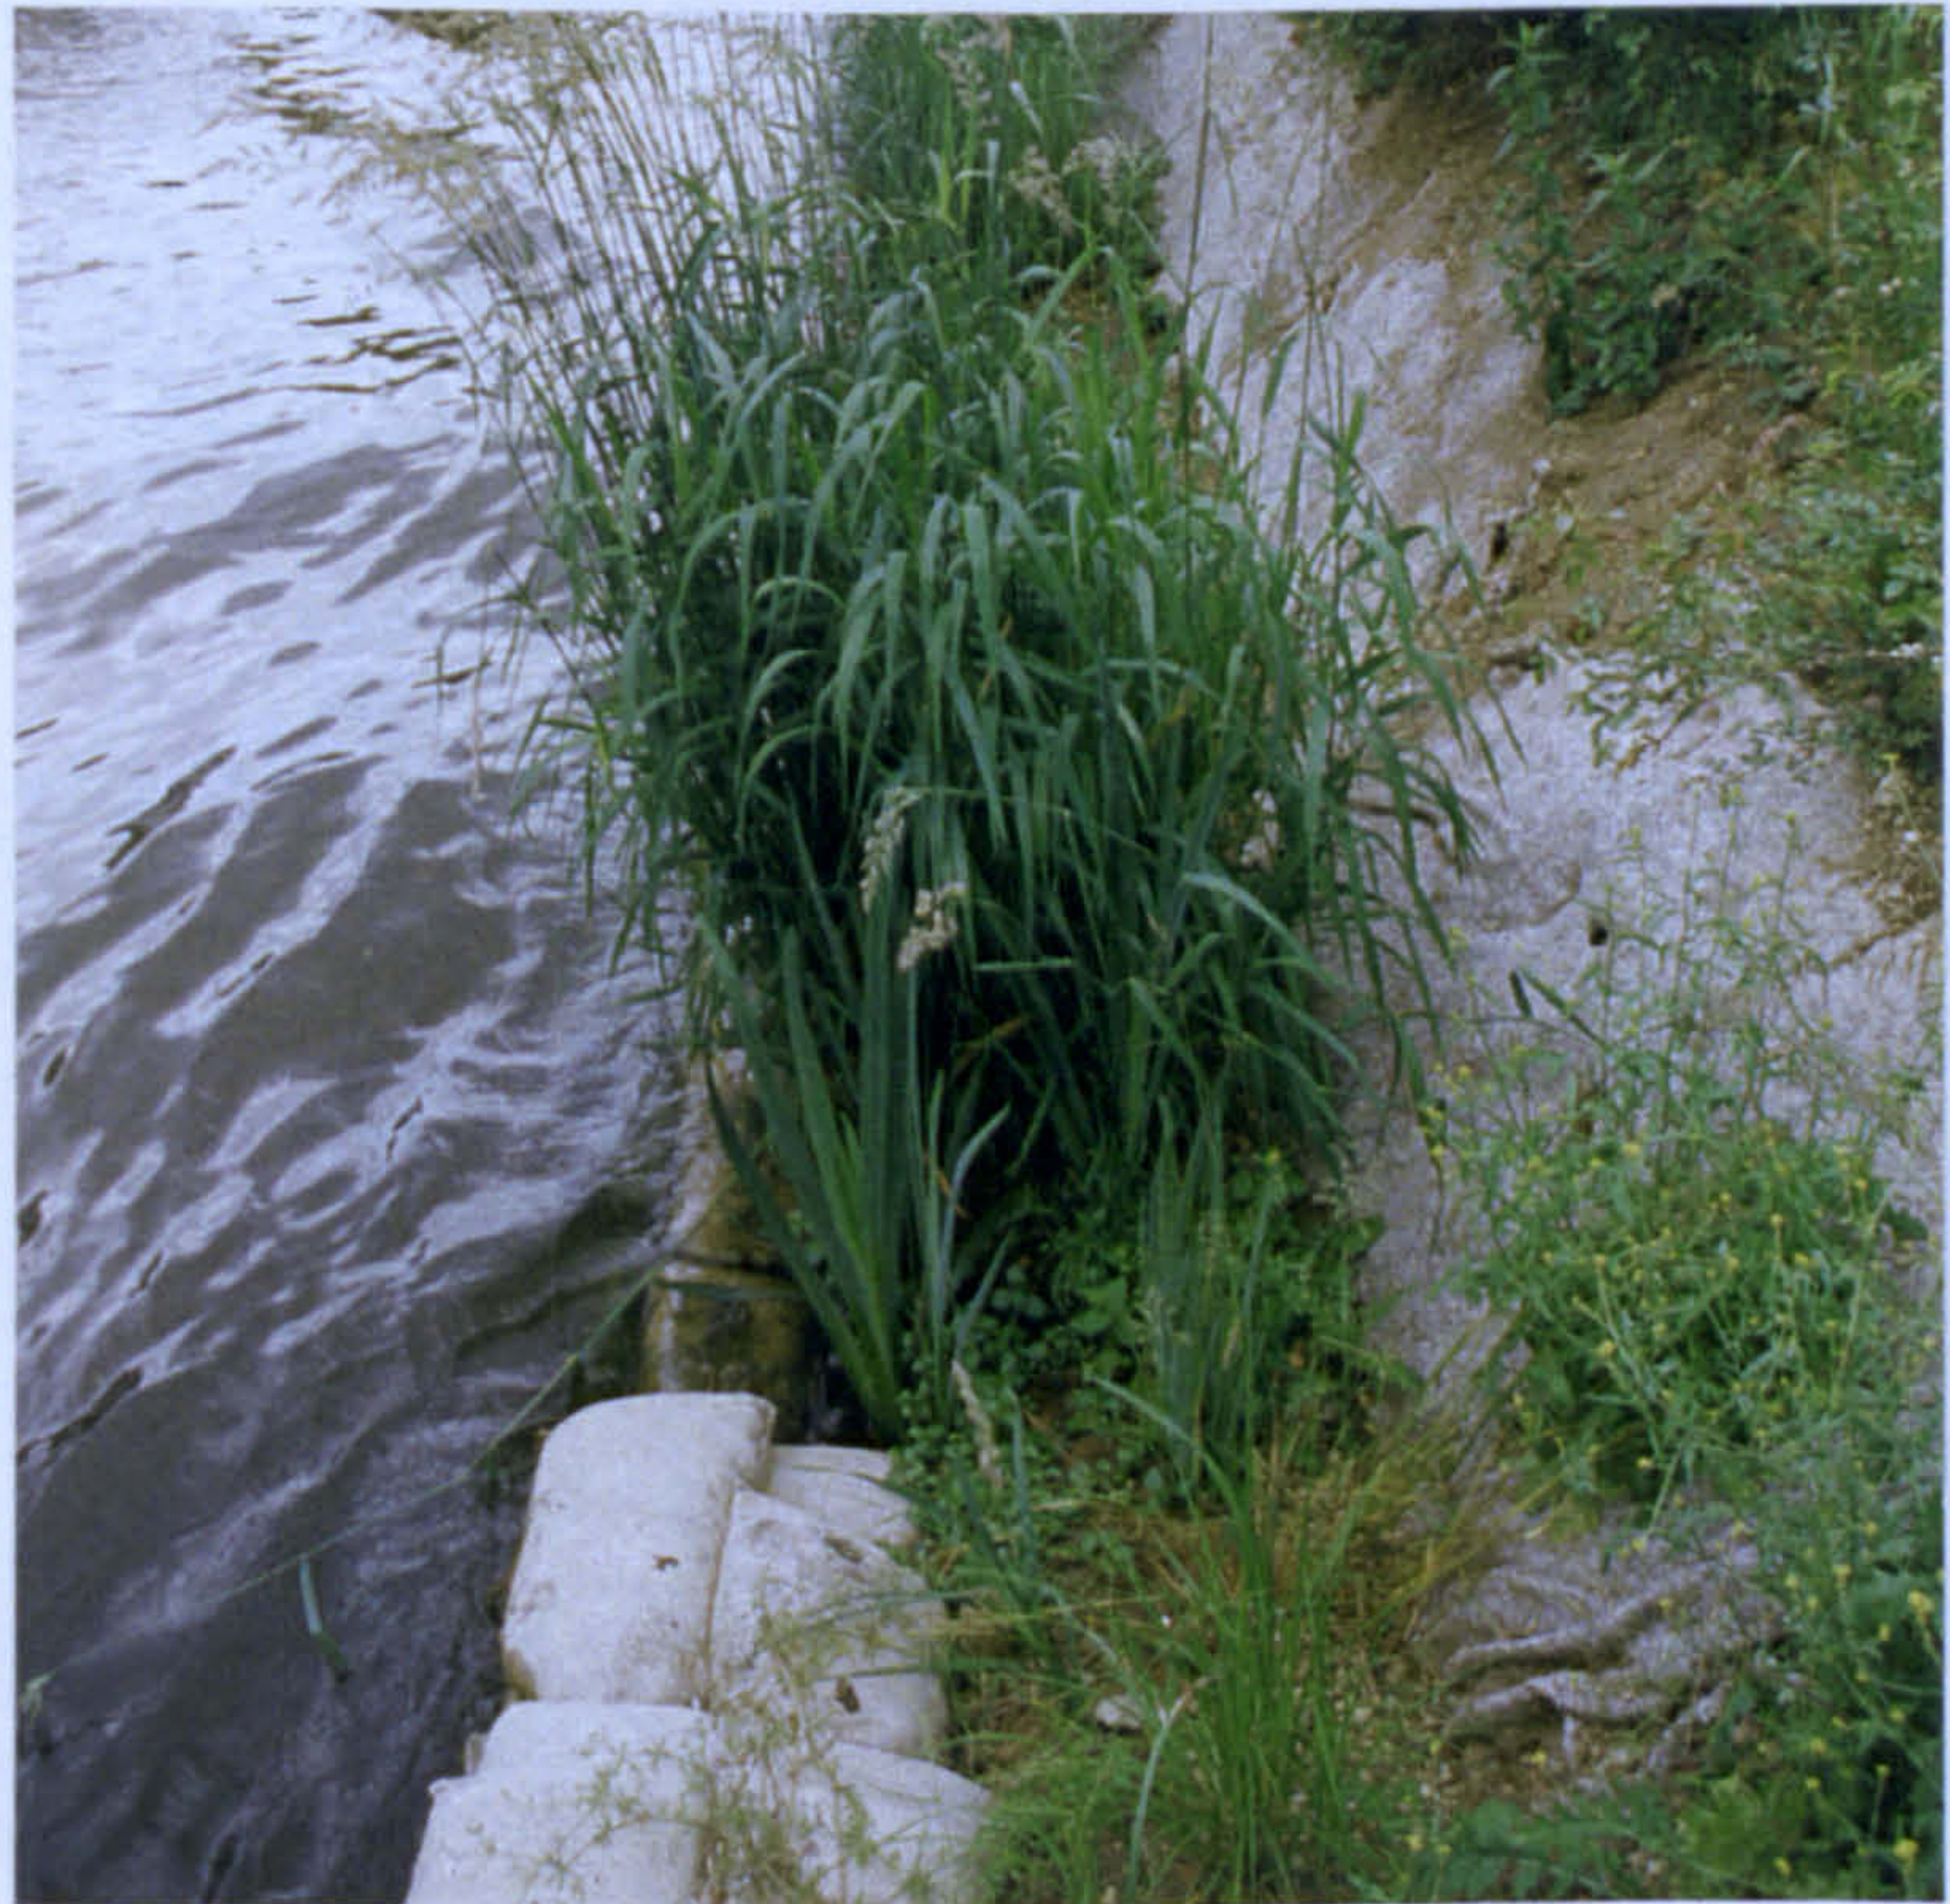
Mitigation measures were designed into the scheme, including a low-level shelf above the piling where reeds were planted in coir rolls behind concrete bagwork (see Plate 6.7). However, the boat wash monitoring exercise (Chapter Five) suggests that the use of a bioengineering solution would have been more appropriate for the low energy environment along the lock cut.

*Plate 6.7
Case study no. 7:
sheet piling and
concrete bagwork
along Clifton lock cut.
Mitigation measures
included reed planting
in coir rolls on a
low-level shelf.*

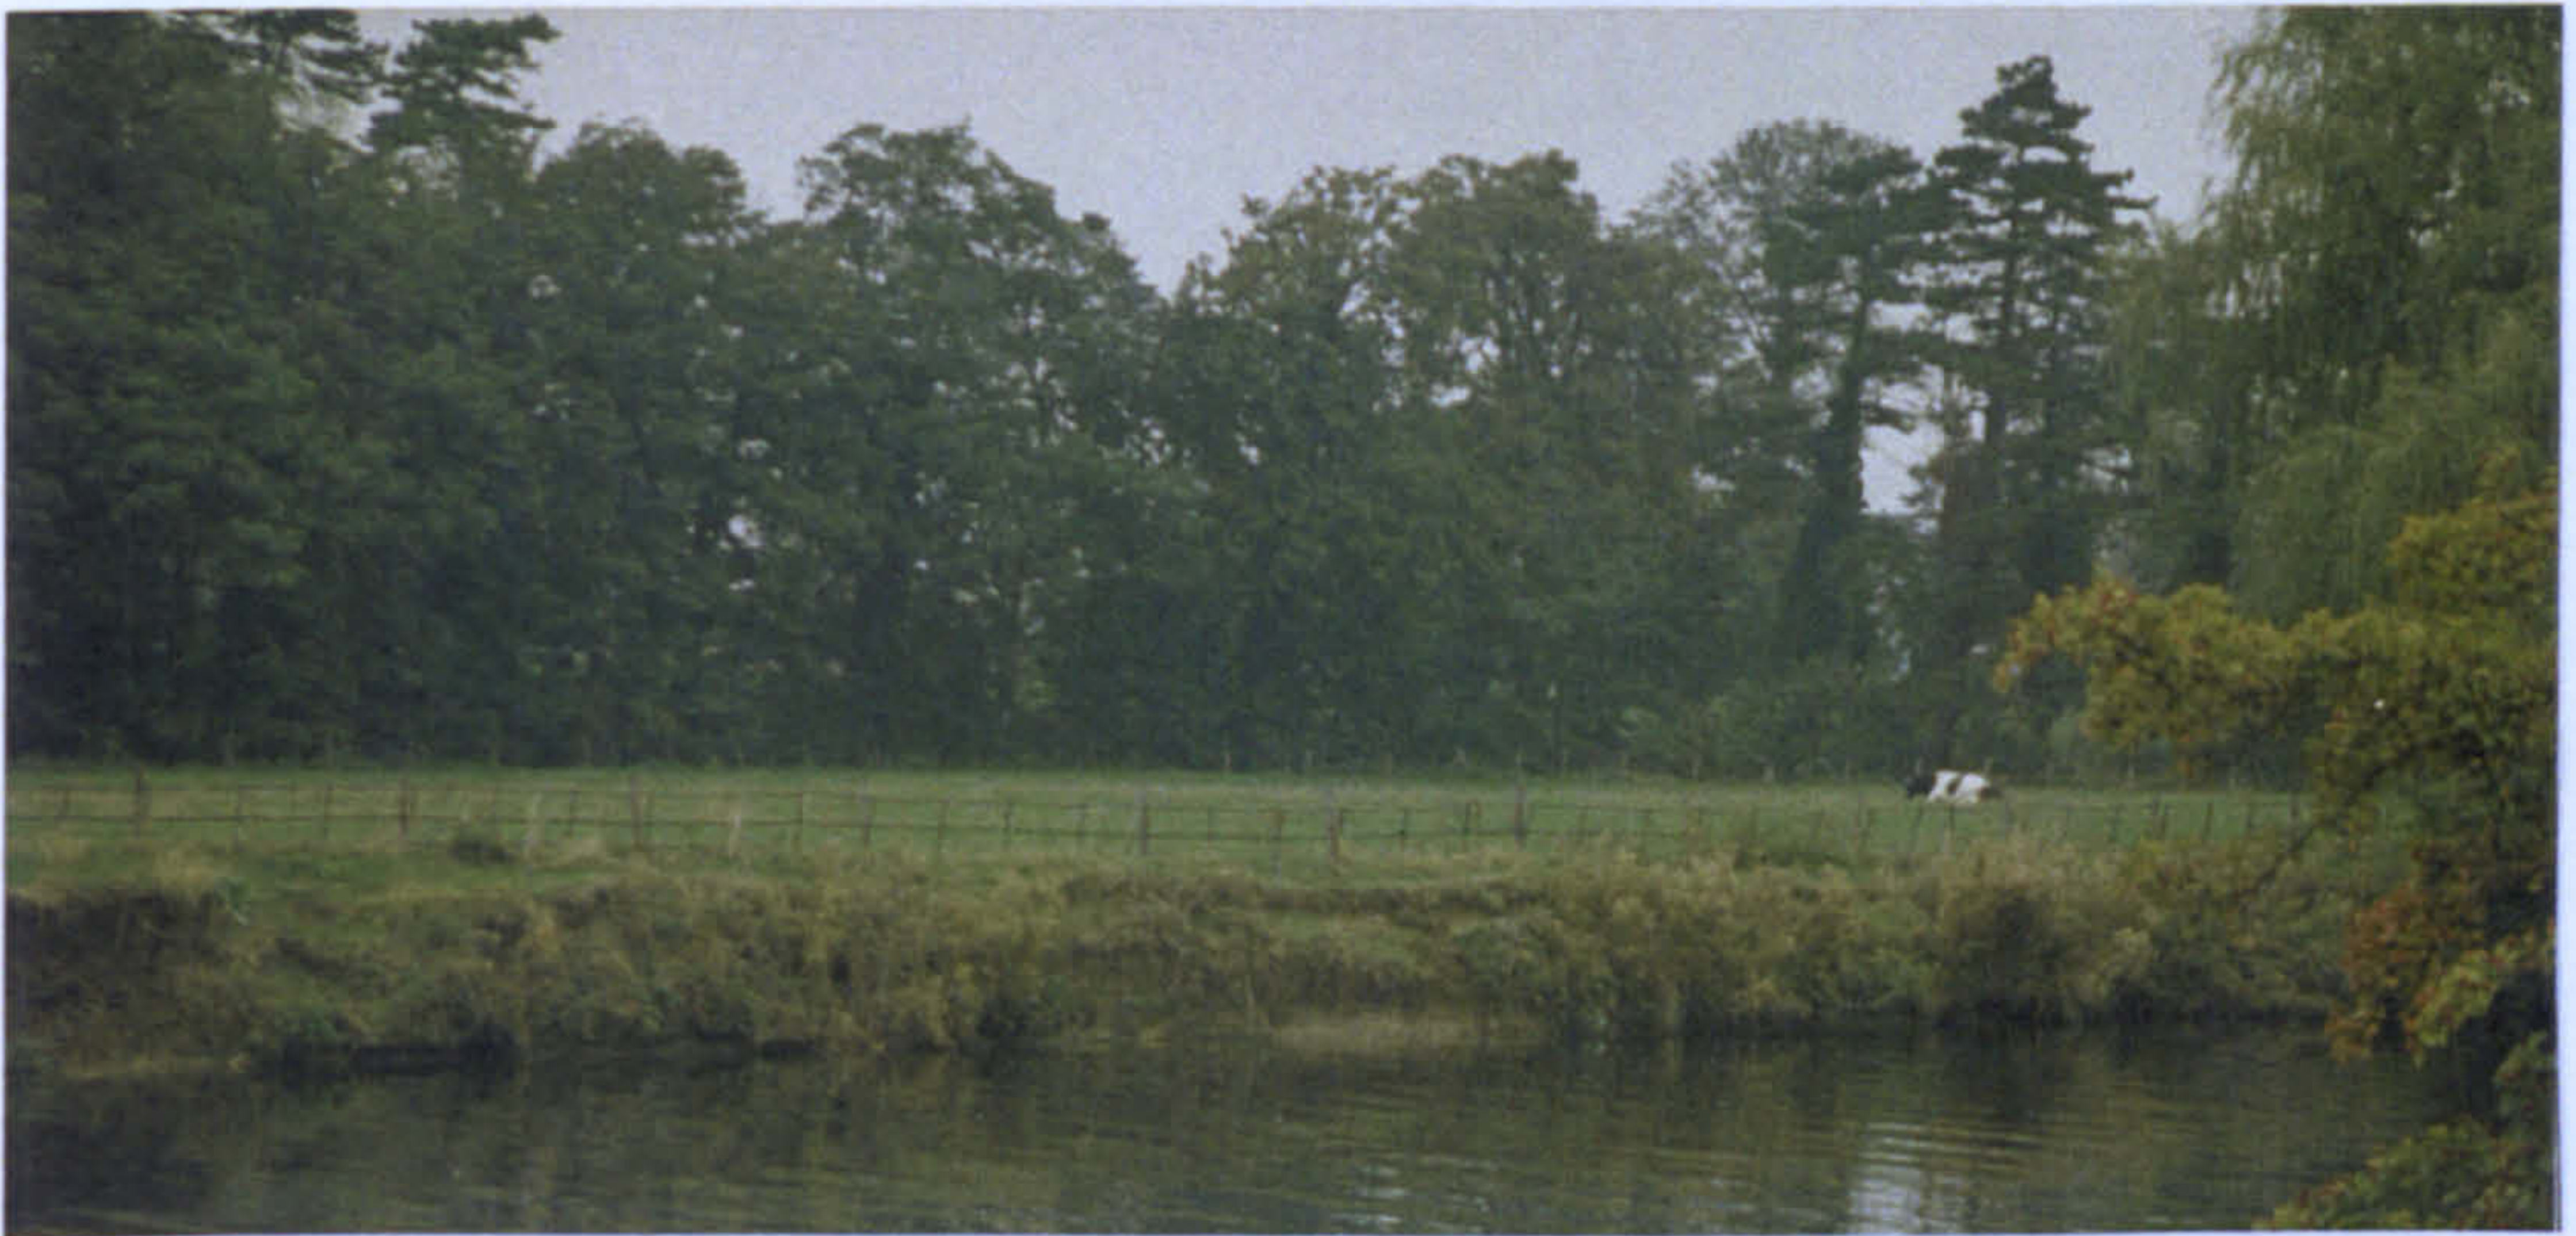
This site is along the right bank upstream of Wallingford Bridge and corresponds to the Upper Wallingford bank erosion monitoring site described in Chapter 4. Respectively, Plates 6.8 and 6.9 show slumping of the bank in

Plate 6.8 Case study no.8: bank slumping upstream of Wallingford Bridge, December 1992

The bank erosion monitoring undertaken at the Upper Wallingford site (Chapter Four) suggested that whilst the rate of erosion was not particularly excessive (approximately 0.15m per year) boat wash was a primary cause of erosion at the toe of the bank and subsequent slumping of the upper bank. Furthermore, desiccation during the summer months led to weakening of the material at the surface of the bank which contributed to its erosion by fluvial entrainment during high flow. Whilst revegetation of the bank was entirely appropriate, the relatively low near-bank velocities experienced at the toe of the bank would suggest that willows could have been installed along the entire length of the site, instead of using solely Nicospan geotextile along the downstream end of the site.

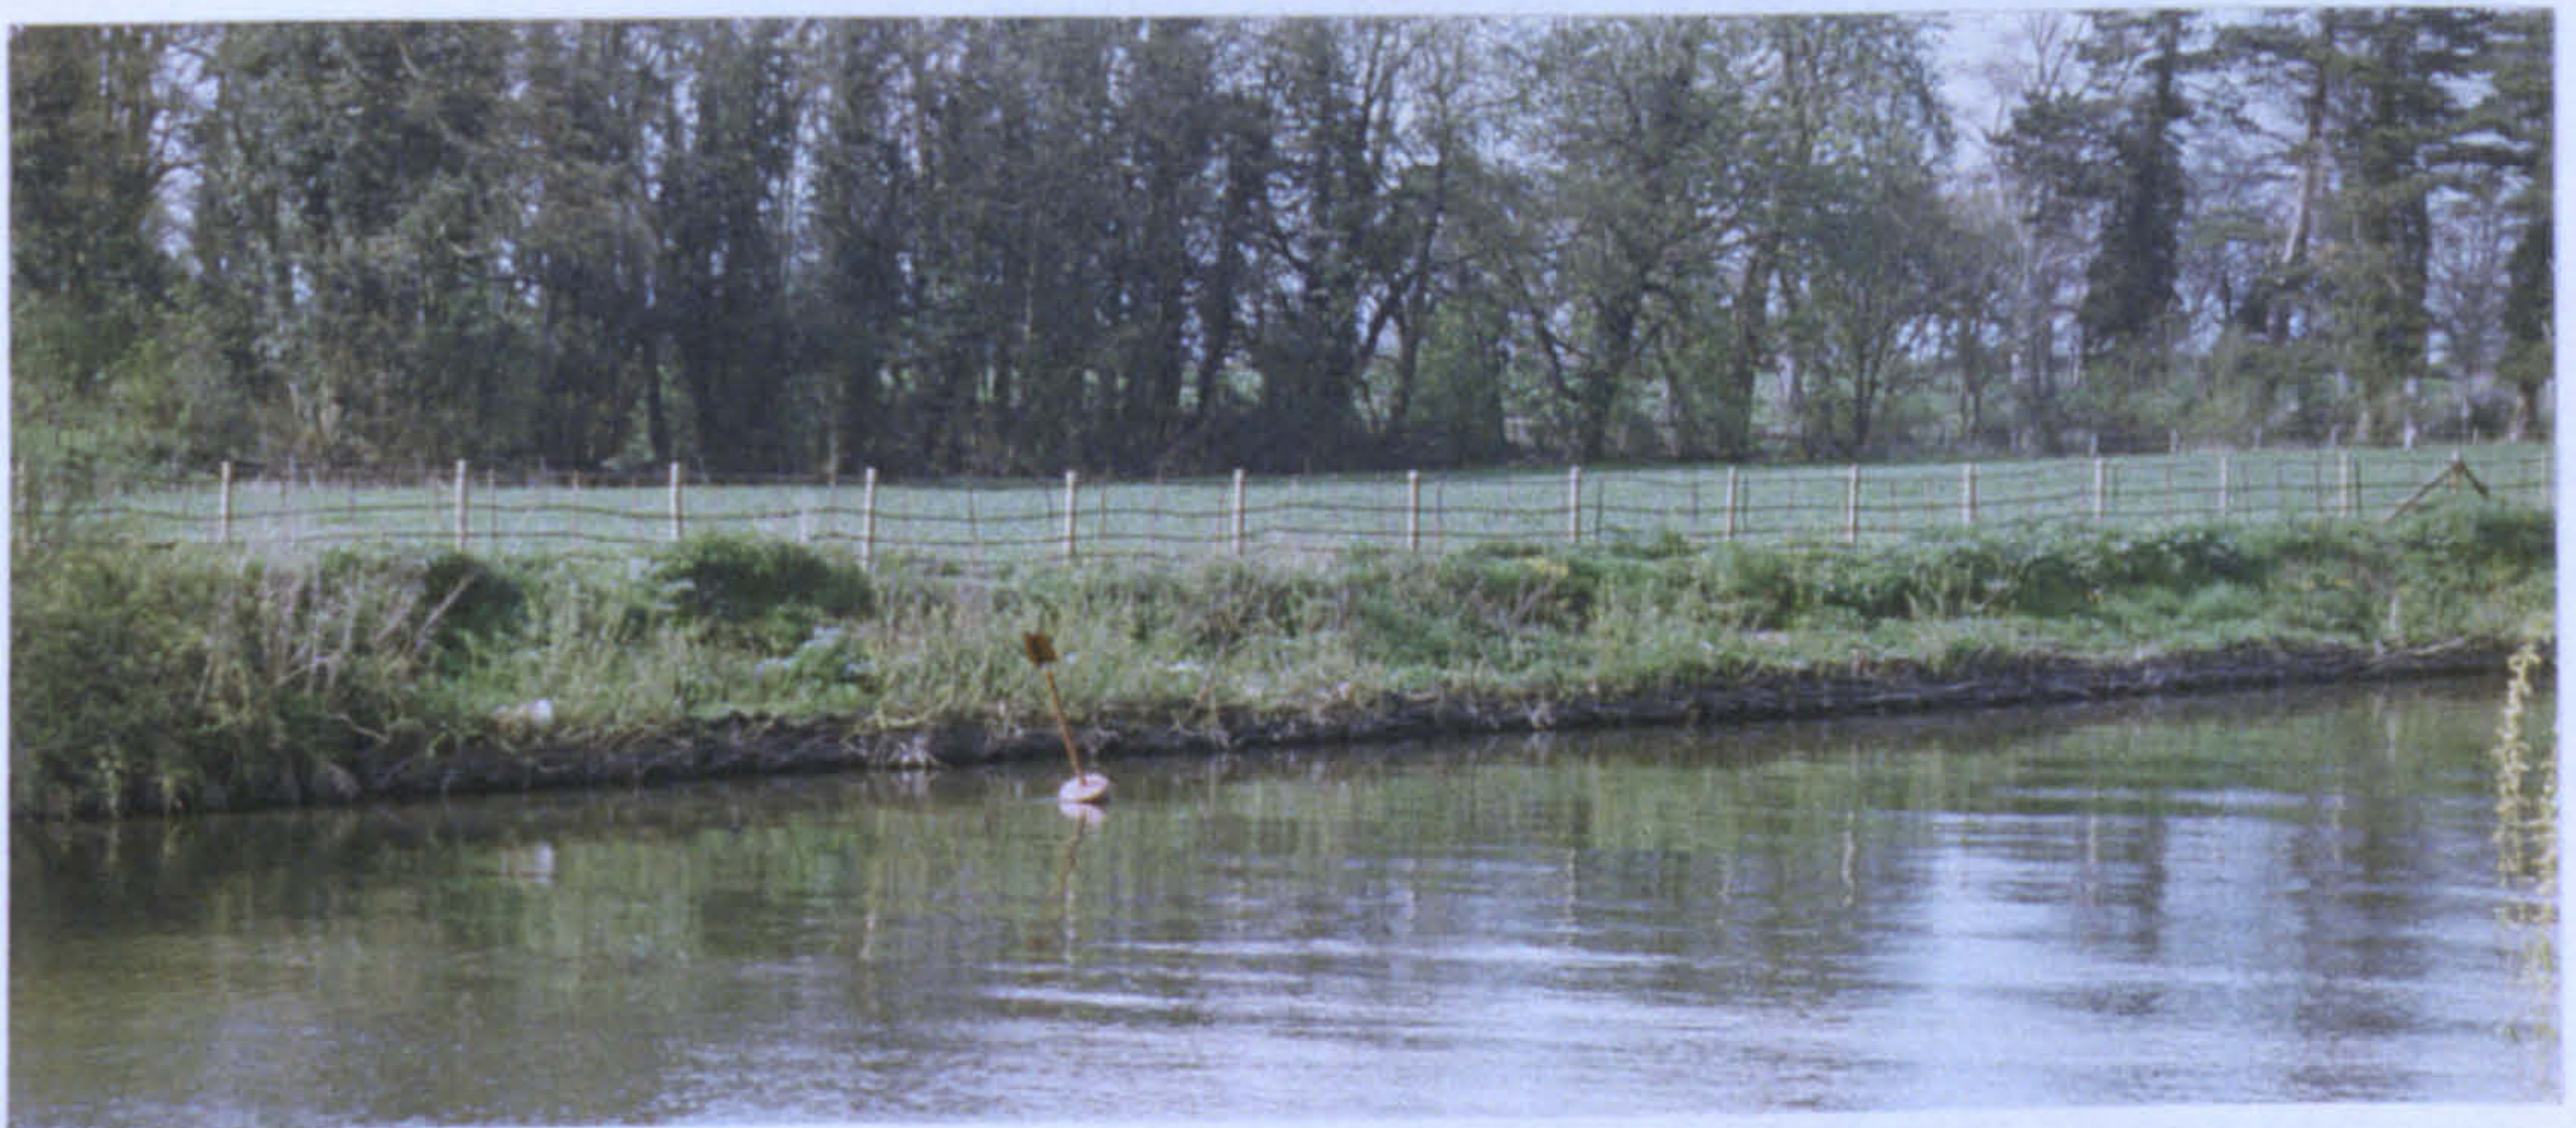
December 1992 and the willow spiling protection installed by South Oxfordshire District Council at the beginning of 1995. A combination of techniques was employed along this stretch of bank, but this case study deals with the willow and geotextiles installed along the majority of the length. Case study no. 9 deals with the structural engineering techniques installed at the upstream end of the site.

Plate 6.9 Case study no. 8: willow spiling protection along regraded bank, May 1996
