**"THE NON-TIDAL, NAVIGABLE THAMES:
A BANK EROSION MANAGEMENT STRATEGY"**

by Sue Reed BSc, MSc, MCIWEM

**Thesis submitted to the University of Nottingham
for the degree of Doctor of Philosophy, October 1998**

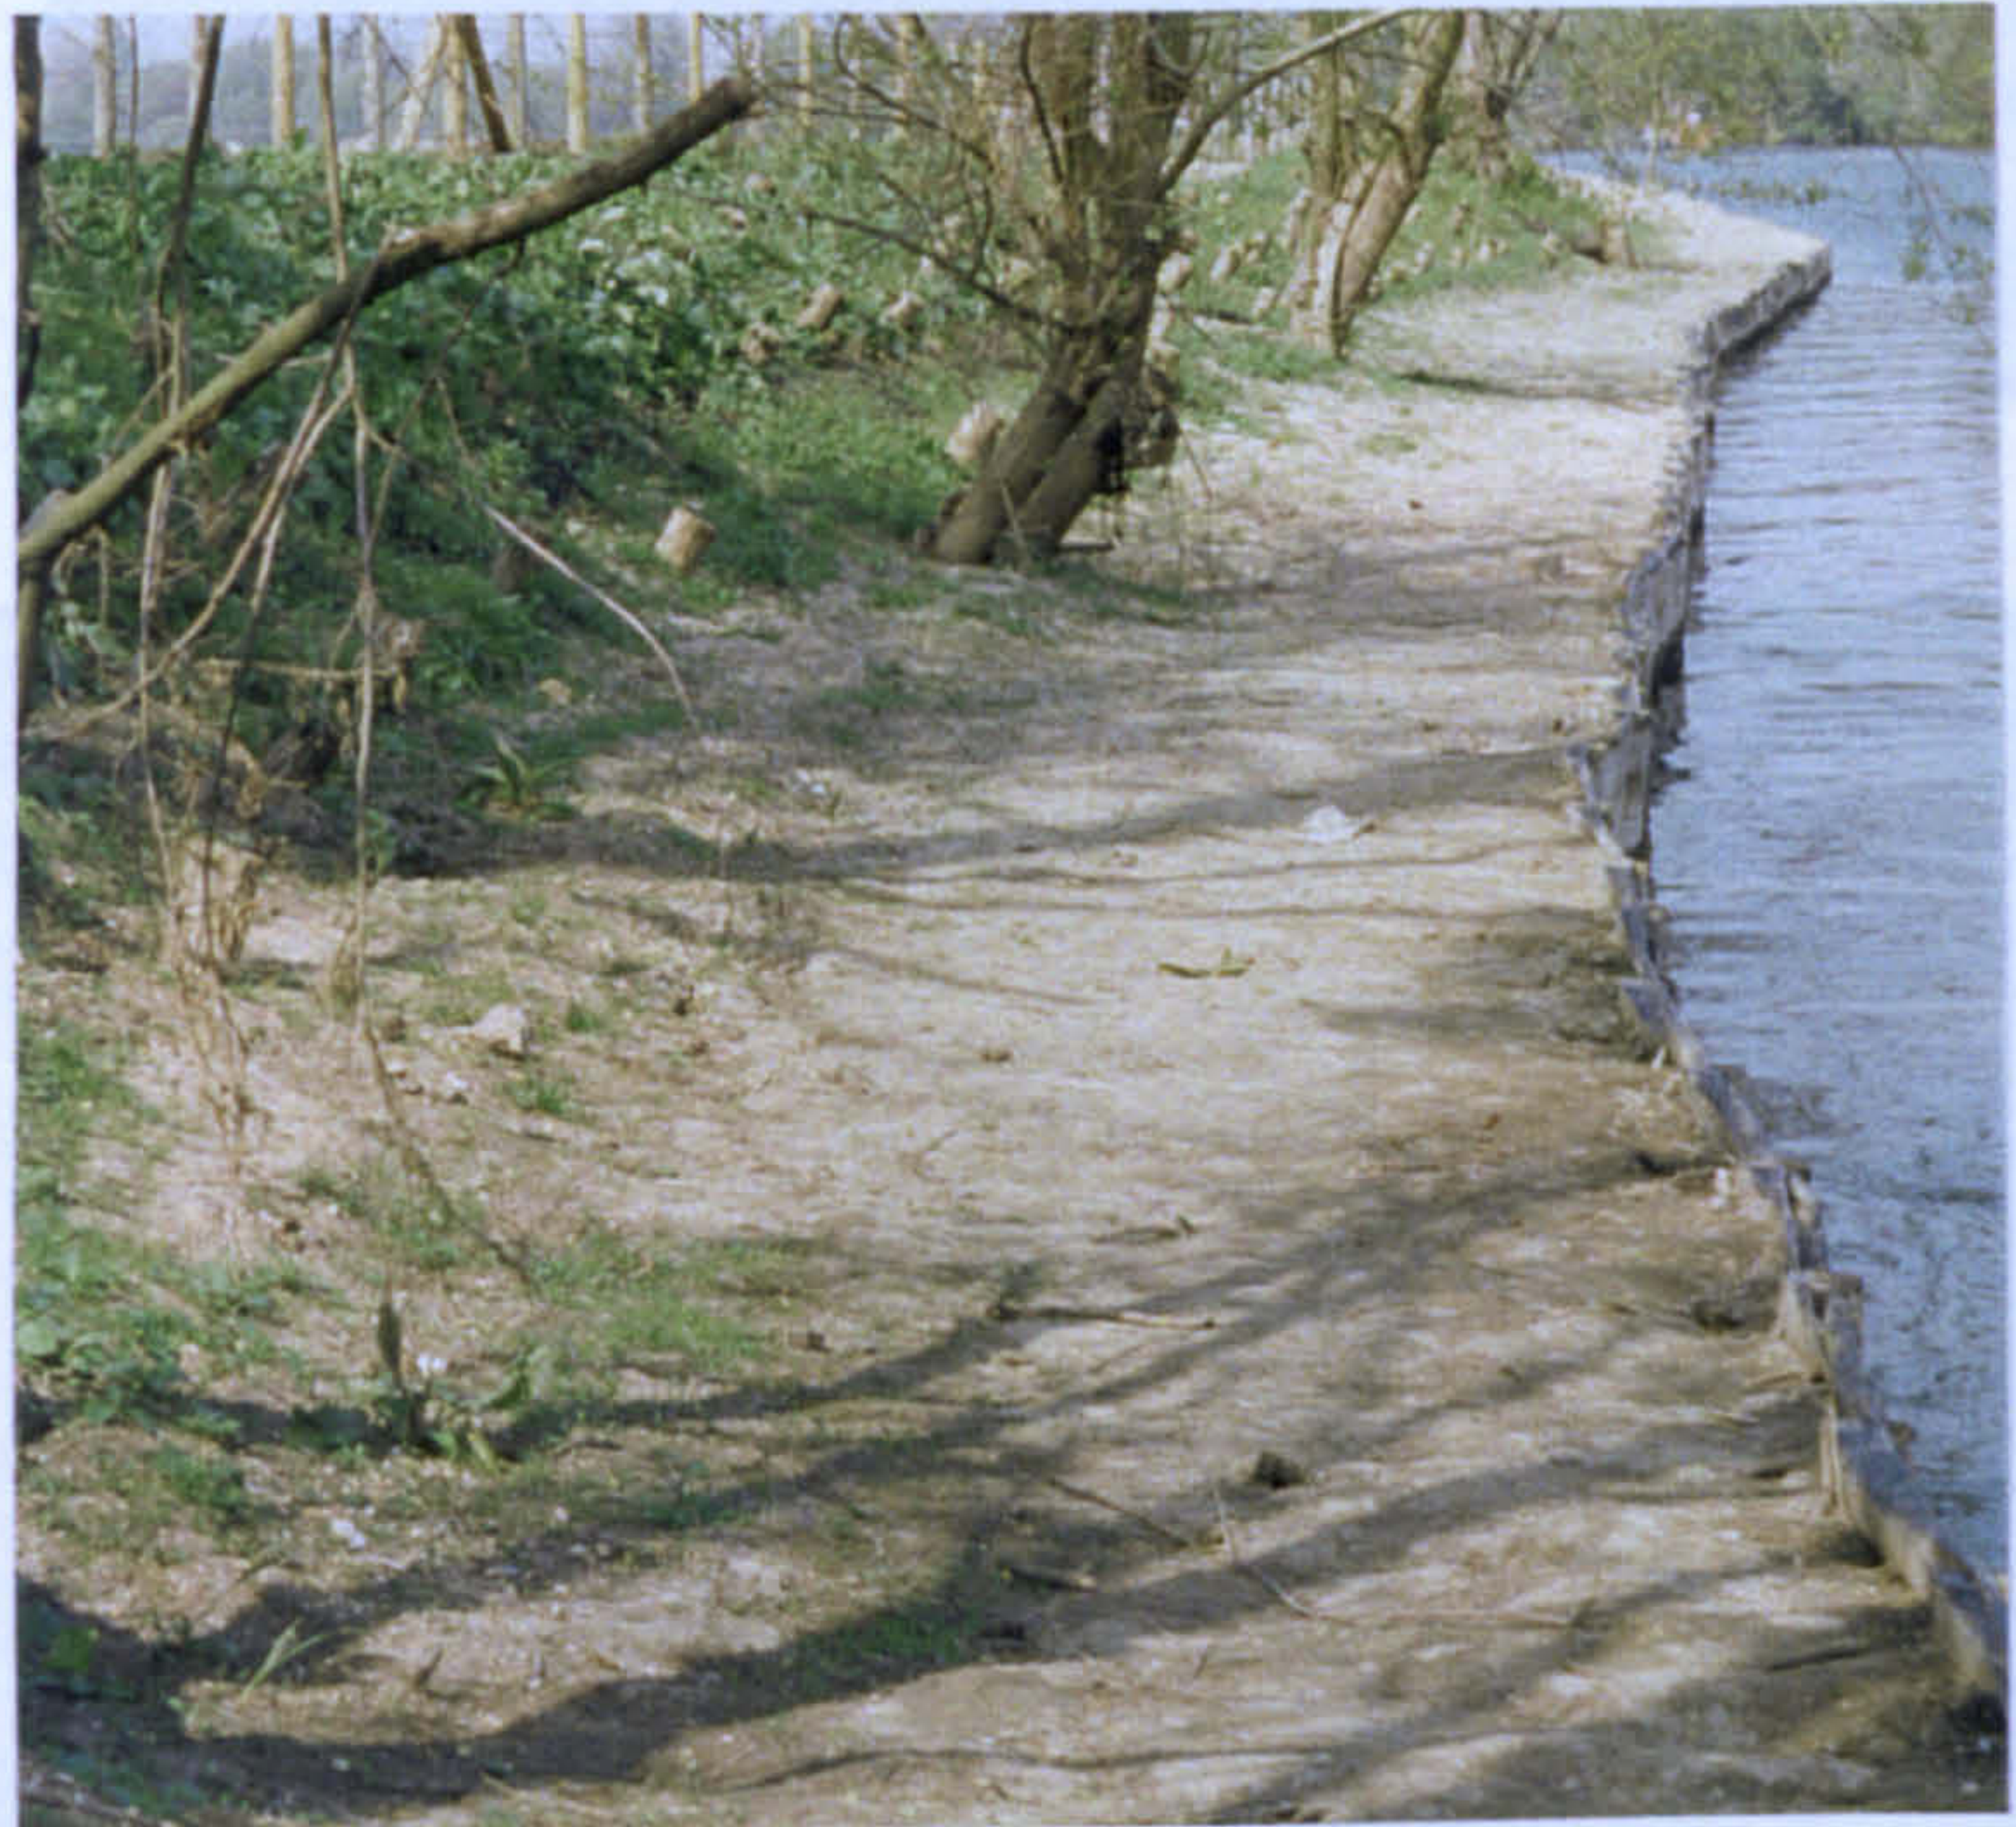
In this case, the fence could have been moved with the landowner's consent and the footpath relocated away from the edge of the bank (see Plate 6.10). Whilst such a relocation strategy would not address the causes of the erosion, it would address the threat to safety posed by erosion of the footpath. The bank was, in fact, regraded to a stepped profile and a combination of Nicospan and Enkamat geotextiles was used in conjunction with willow spiling and willow stakes.

*Plate 6.10
Case study no. 8:
regraded bank with
Nicospan geotextile
protecting the lower
shelf and willow stakes
at the sloping upper
bank (May 1995).*

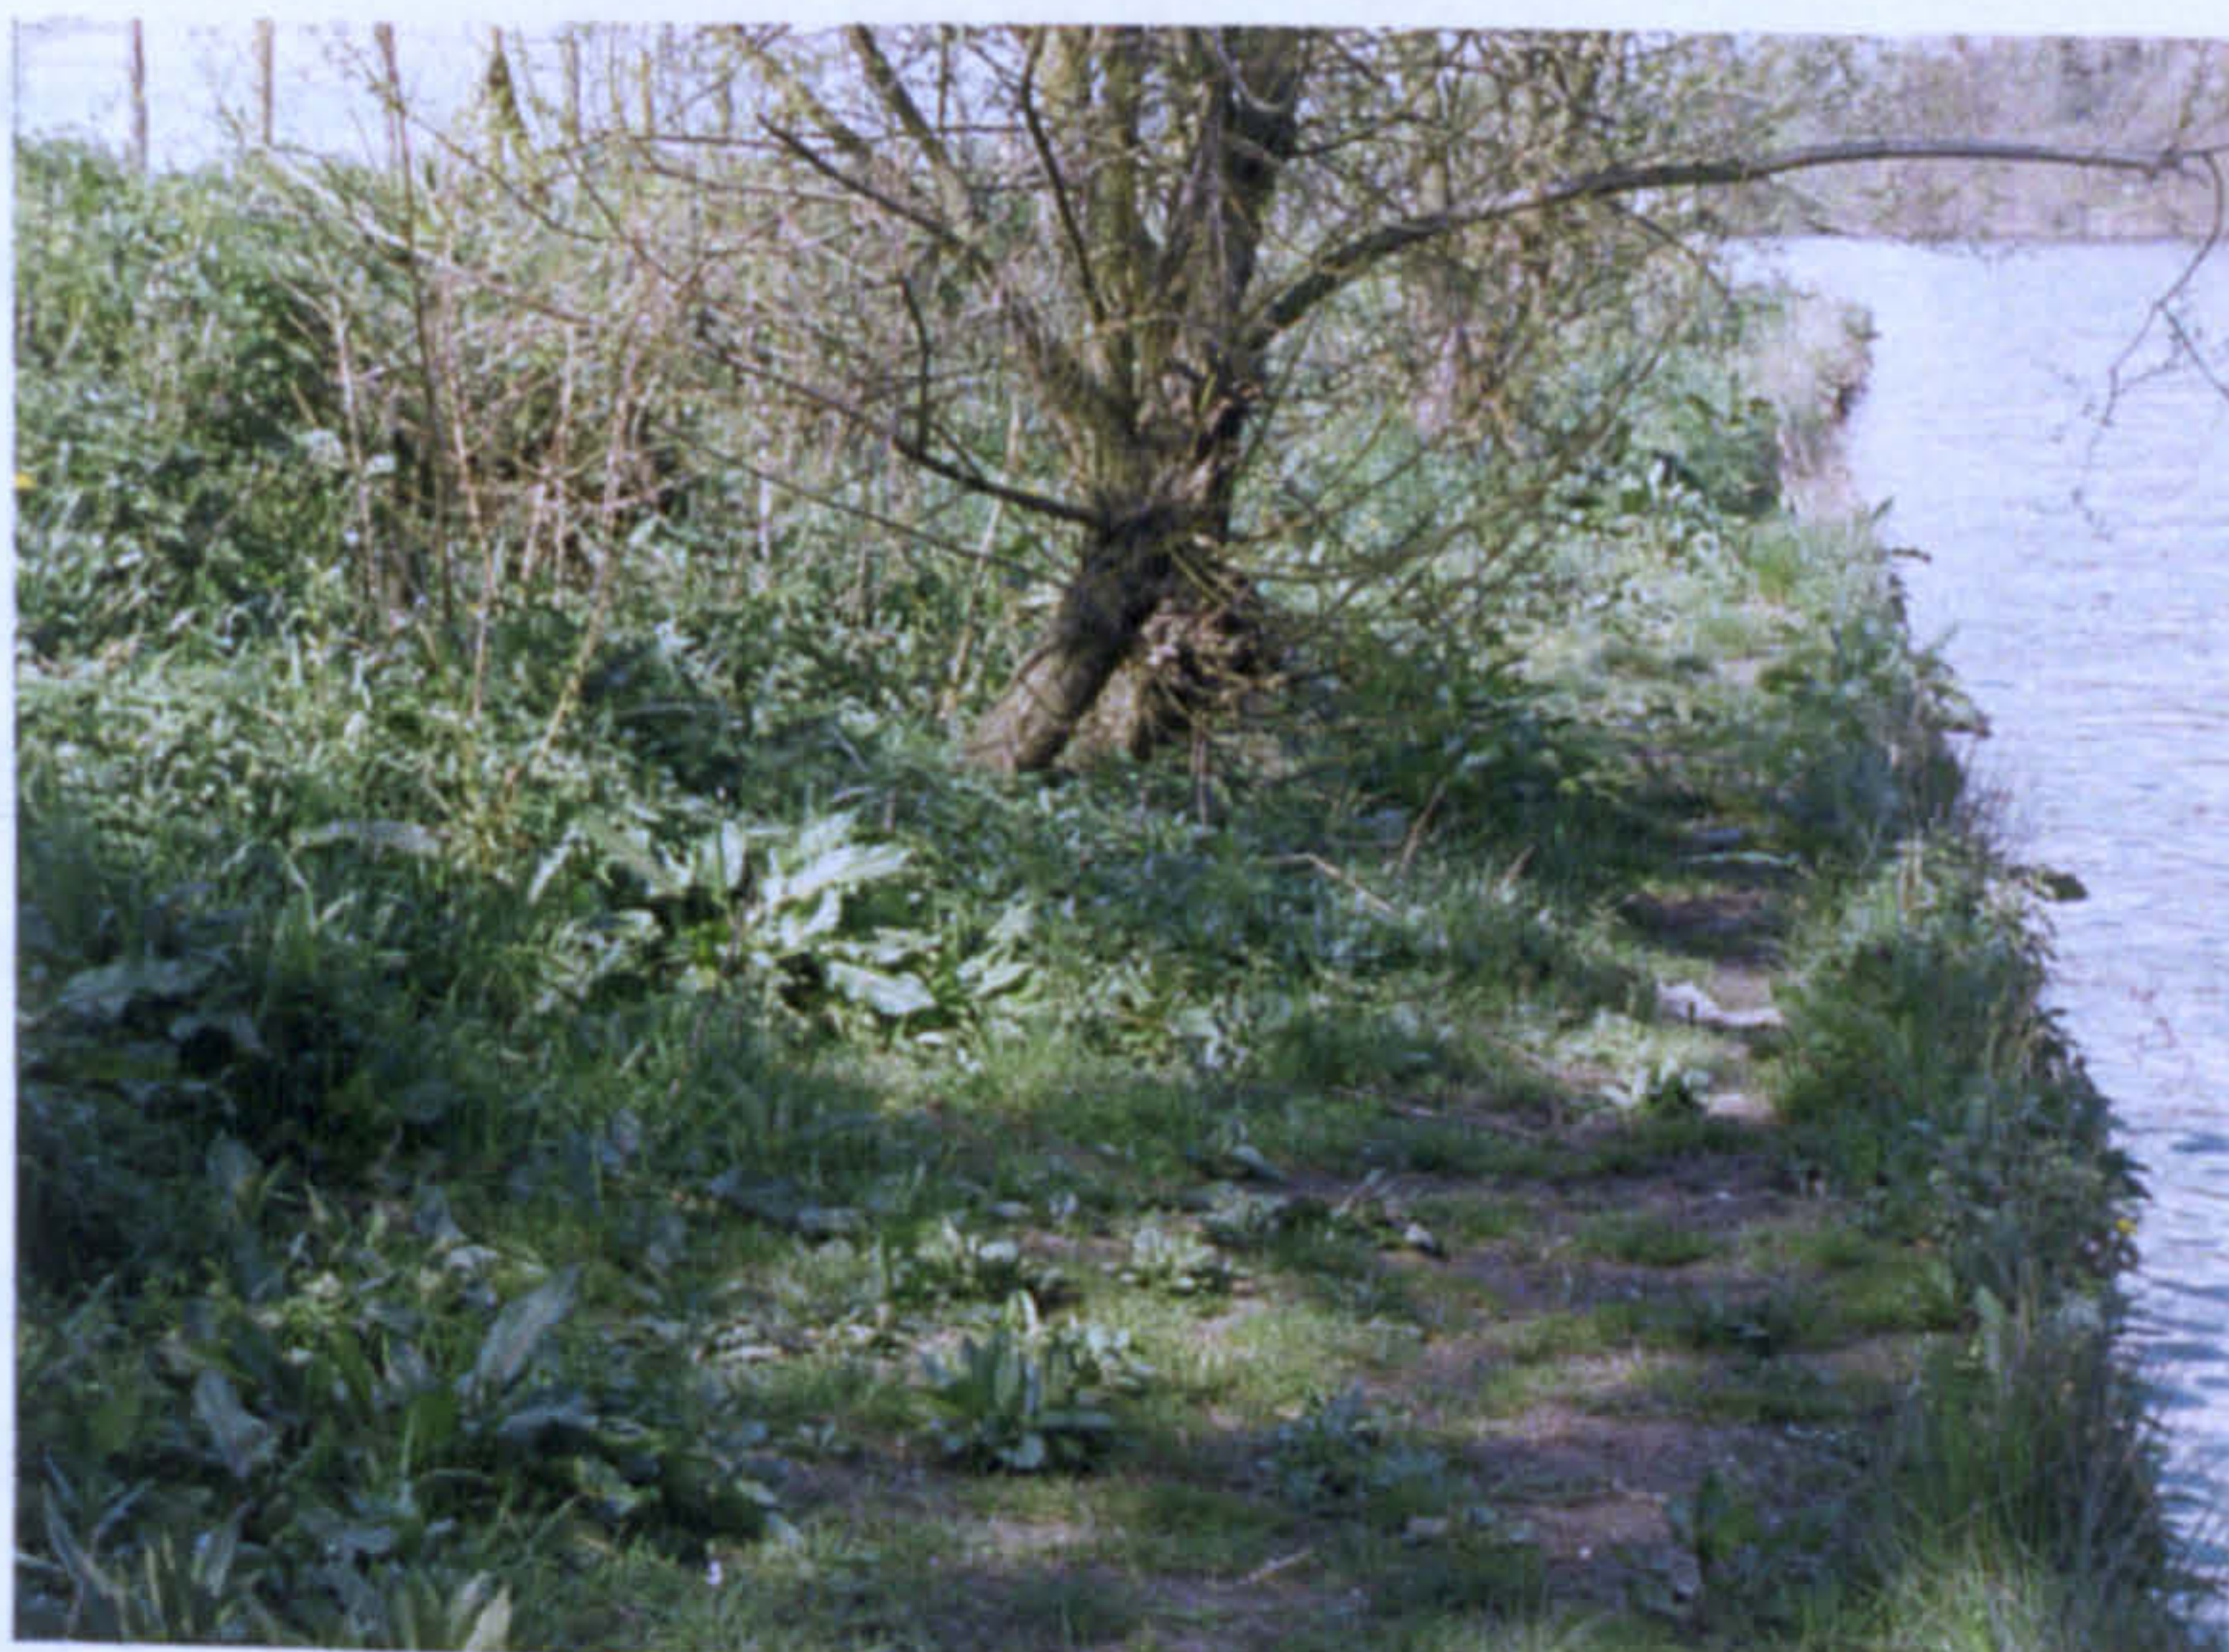
Plates 6.10 and 6.11 show the downstream end of the site, where only Nicospan geotextiles were used to protect the lower bank shelf, with Enkamat geotextiles and willow stakes along the sloping upper bank. Further upstream, willow spiling was used in addition to the Nicospan geotextile to protect the lower bank shelf and no willow stakes were planted higher up the bank (see Plates 6.9 and 6.12). The reason for this variation in design may have been the varying geometry of the banks. Along the lengths where the bank was retained at a relatively steep slope, spiling was used in addition to Nicospan, but no willow stakes were used higher up the bank. The bank angle was reduced significantly where the lower bank shelf was more extensive, thus allowing the bank to accommodate any additional loading that would result from growth of the willows.

*Plate 6.11
Case study no. 8:
regraded bank with
Nicospan geotextile
protecting the lower
shelf and willow stakes
at the sloping upper
bank (May 1996).*

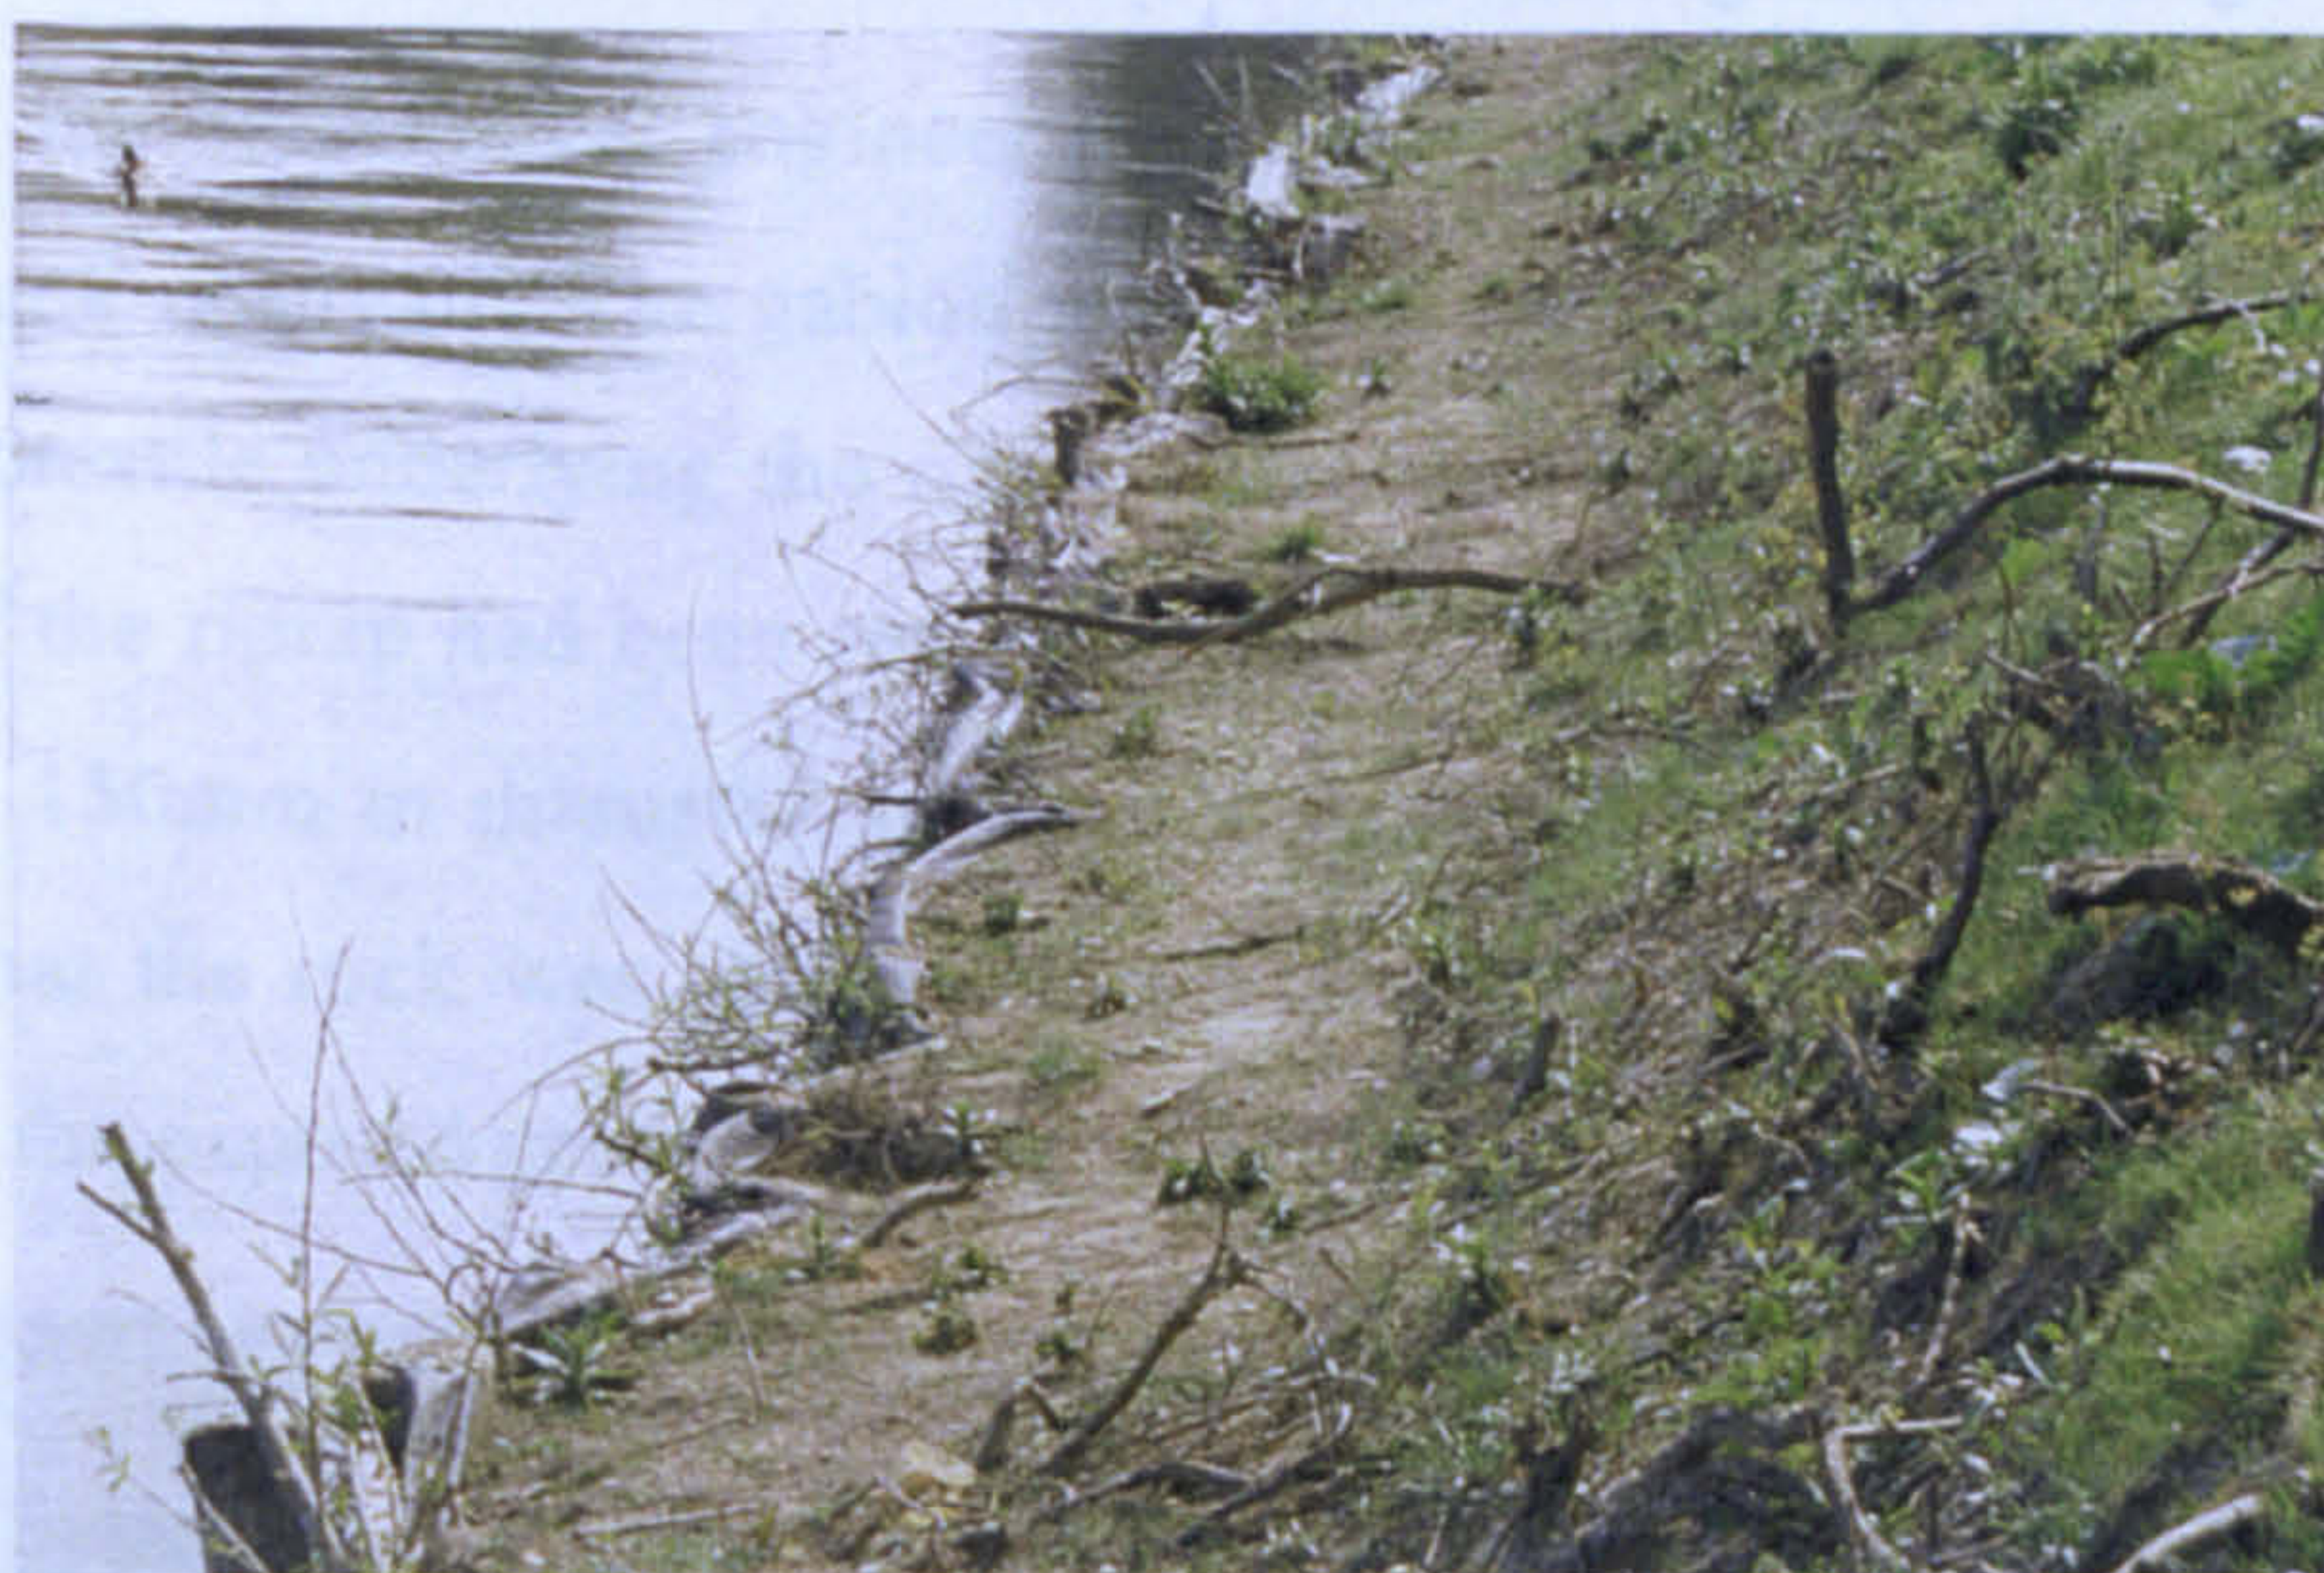
*Plate 6.12
Case study no. 8:
regraded bank
with Nicospan
and spiling
protecting the
lower shelf
(May 1995)*

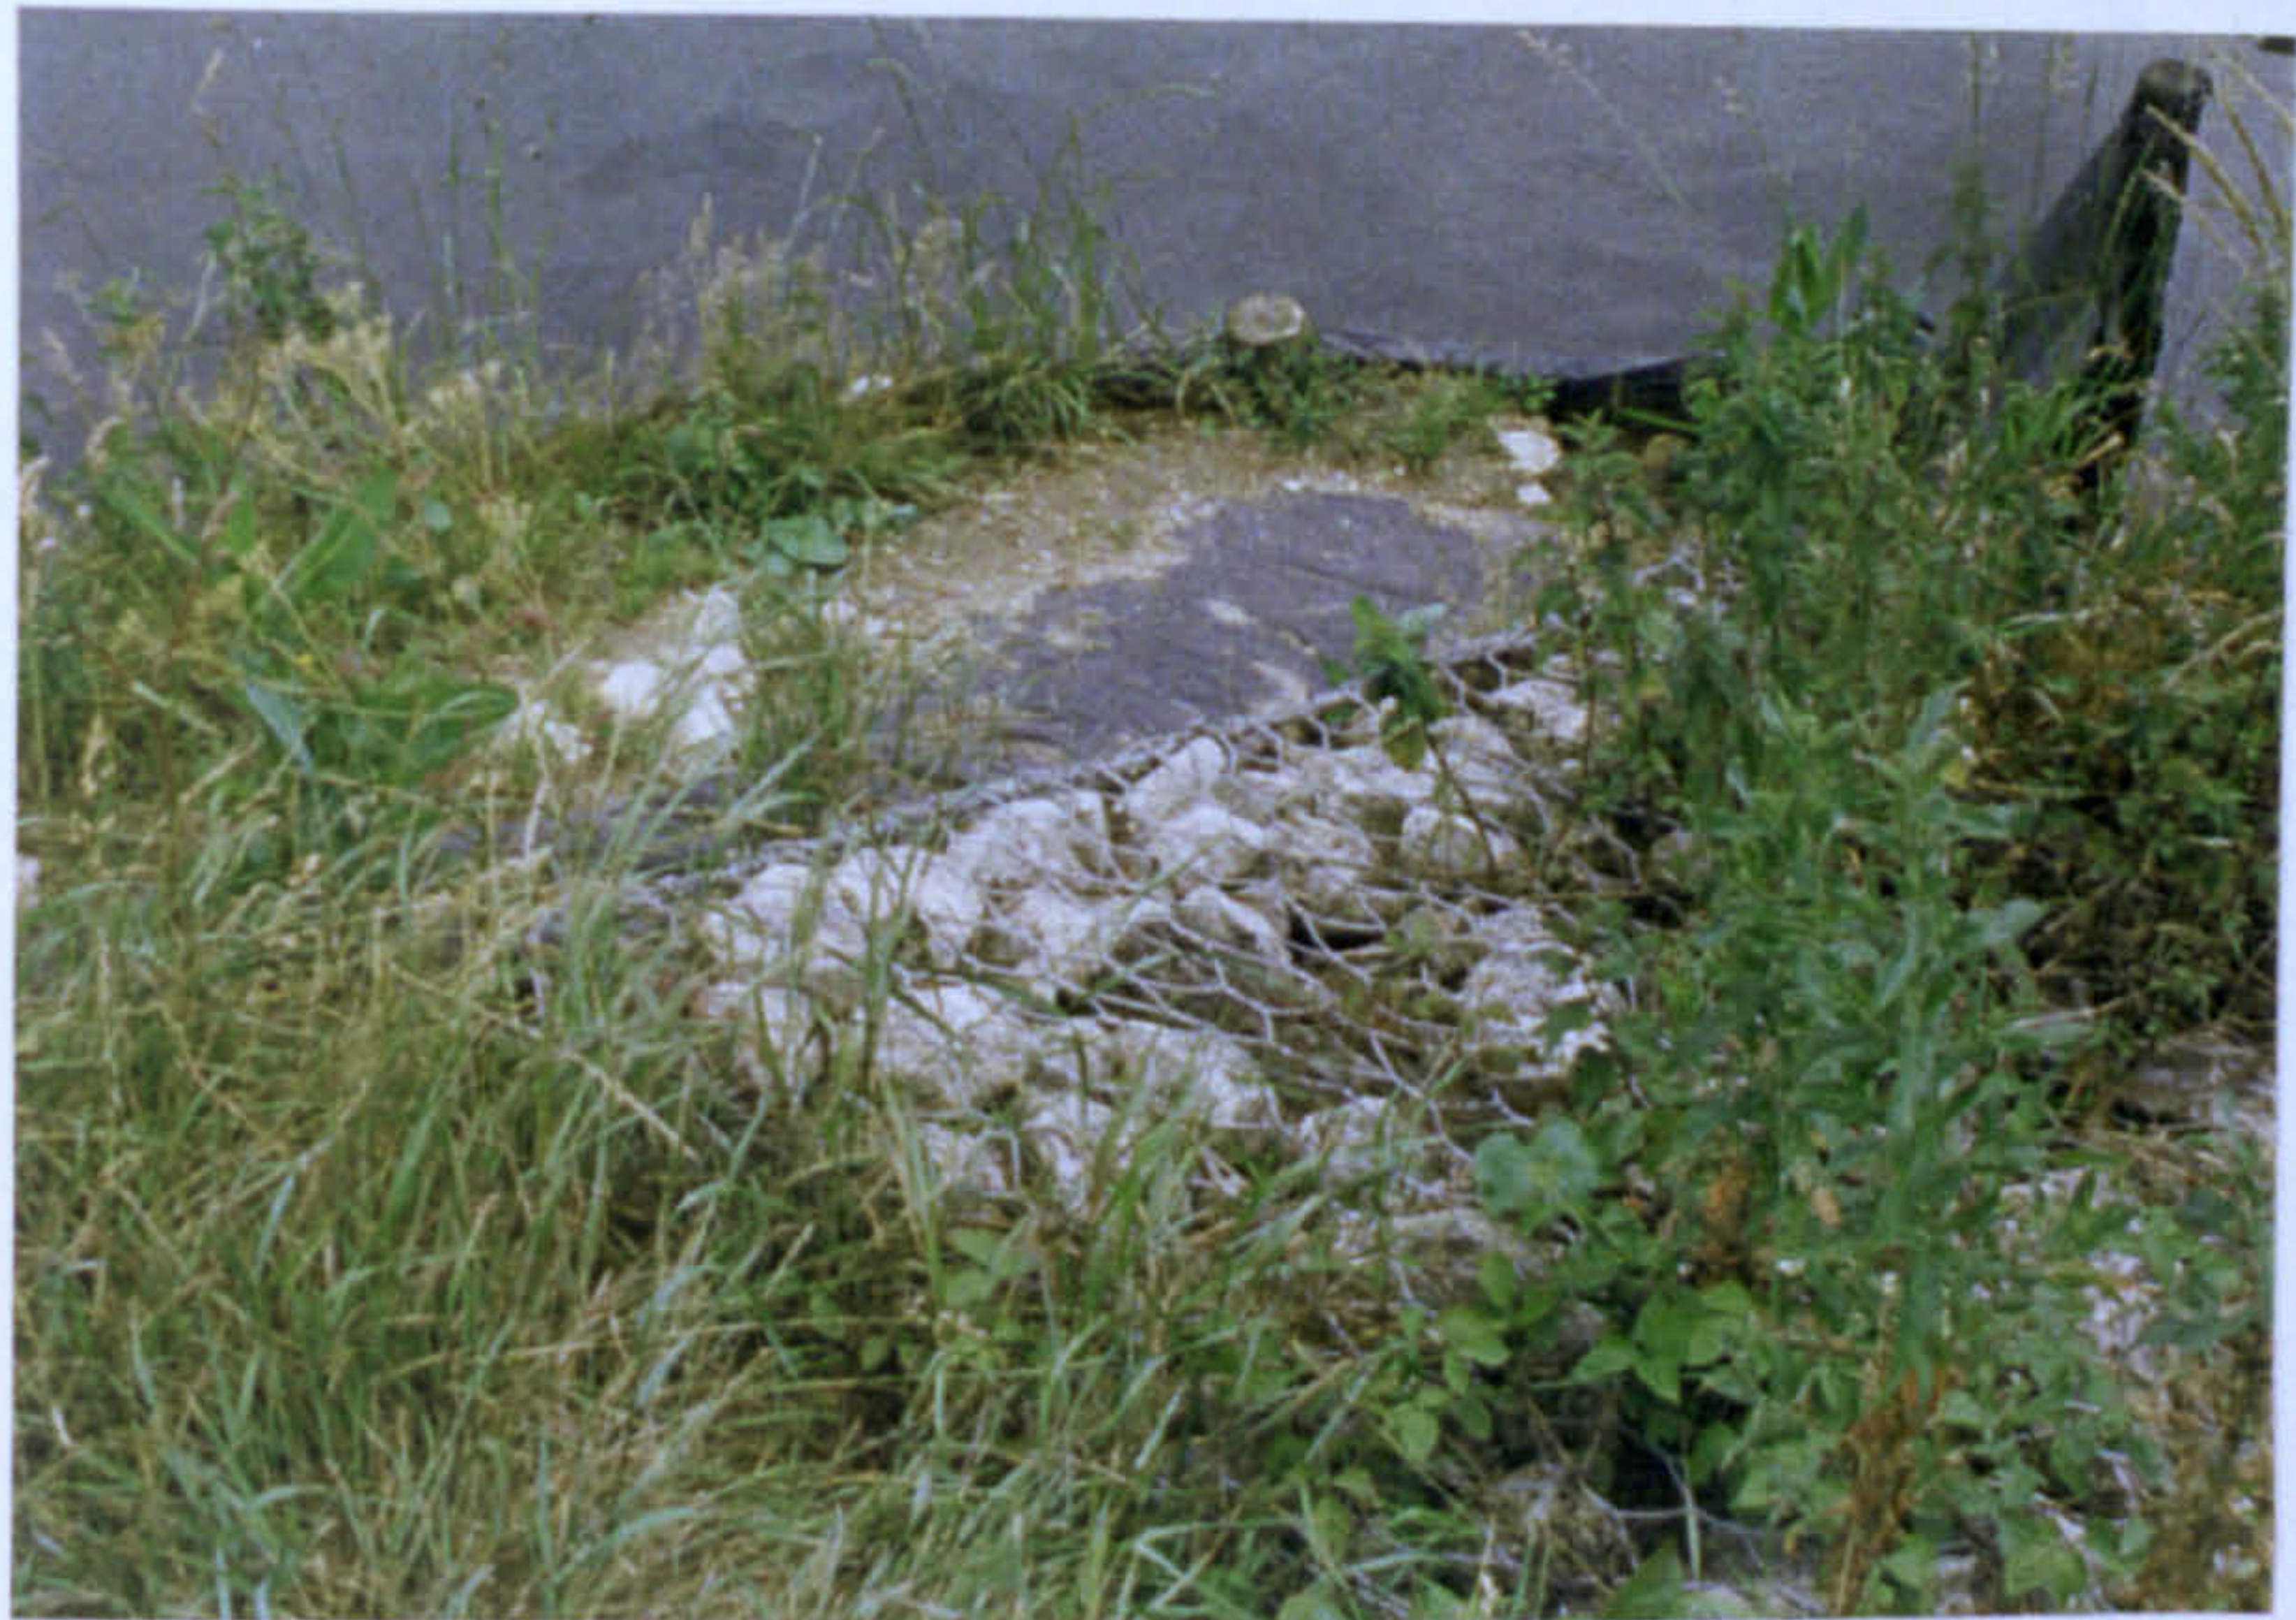
This site is immediately upstream of case study no. 8 and was also protected by the South Oxfordshire District Council at the beginning of 1995. Whereas conditions at this site were originally similar to the site downstream, here gabion mattresses and riprap were installed (see Plate 6.13). The main aim of the treatment would appear to have been to provide a robust protection which would help to ensure the integrity of the downstream biotechnical engineering solution (case study no. 8). This structural engineering strategy also allowed the slope of the bank to be increased so that there was a more gradual change in bank slope from the biotechnical engineering solution downstream to the steep unprotected bank upstream. The gabion mattresses have remained intact but, whereas the geotextile underlying the riprap protection has also remained intact, by June 1997 the riprap had been removed. The size of the riprap stone was less than about 150mm in diameter, making it vulnerable to removal by hand. It is likely that the rock was stolen. Plate 6.14 shows the revegetated gabion mattress and the exposed geotextile where the riprap has been removed.

Plate 6.14
Case study no. 9:
exposed geotextile
underlay where
riprap had been
placed (June 1997)

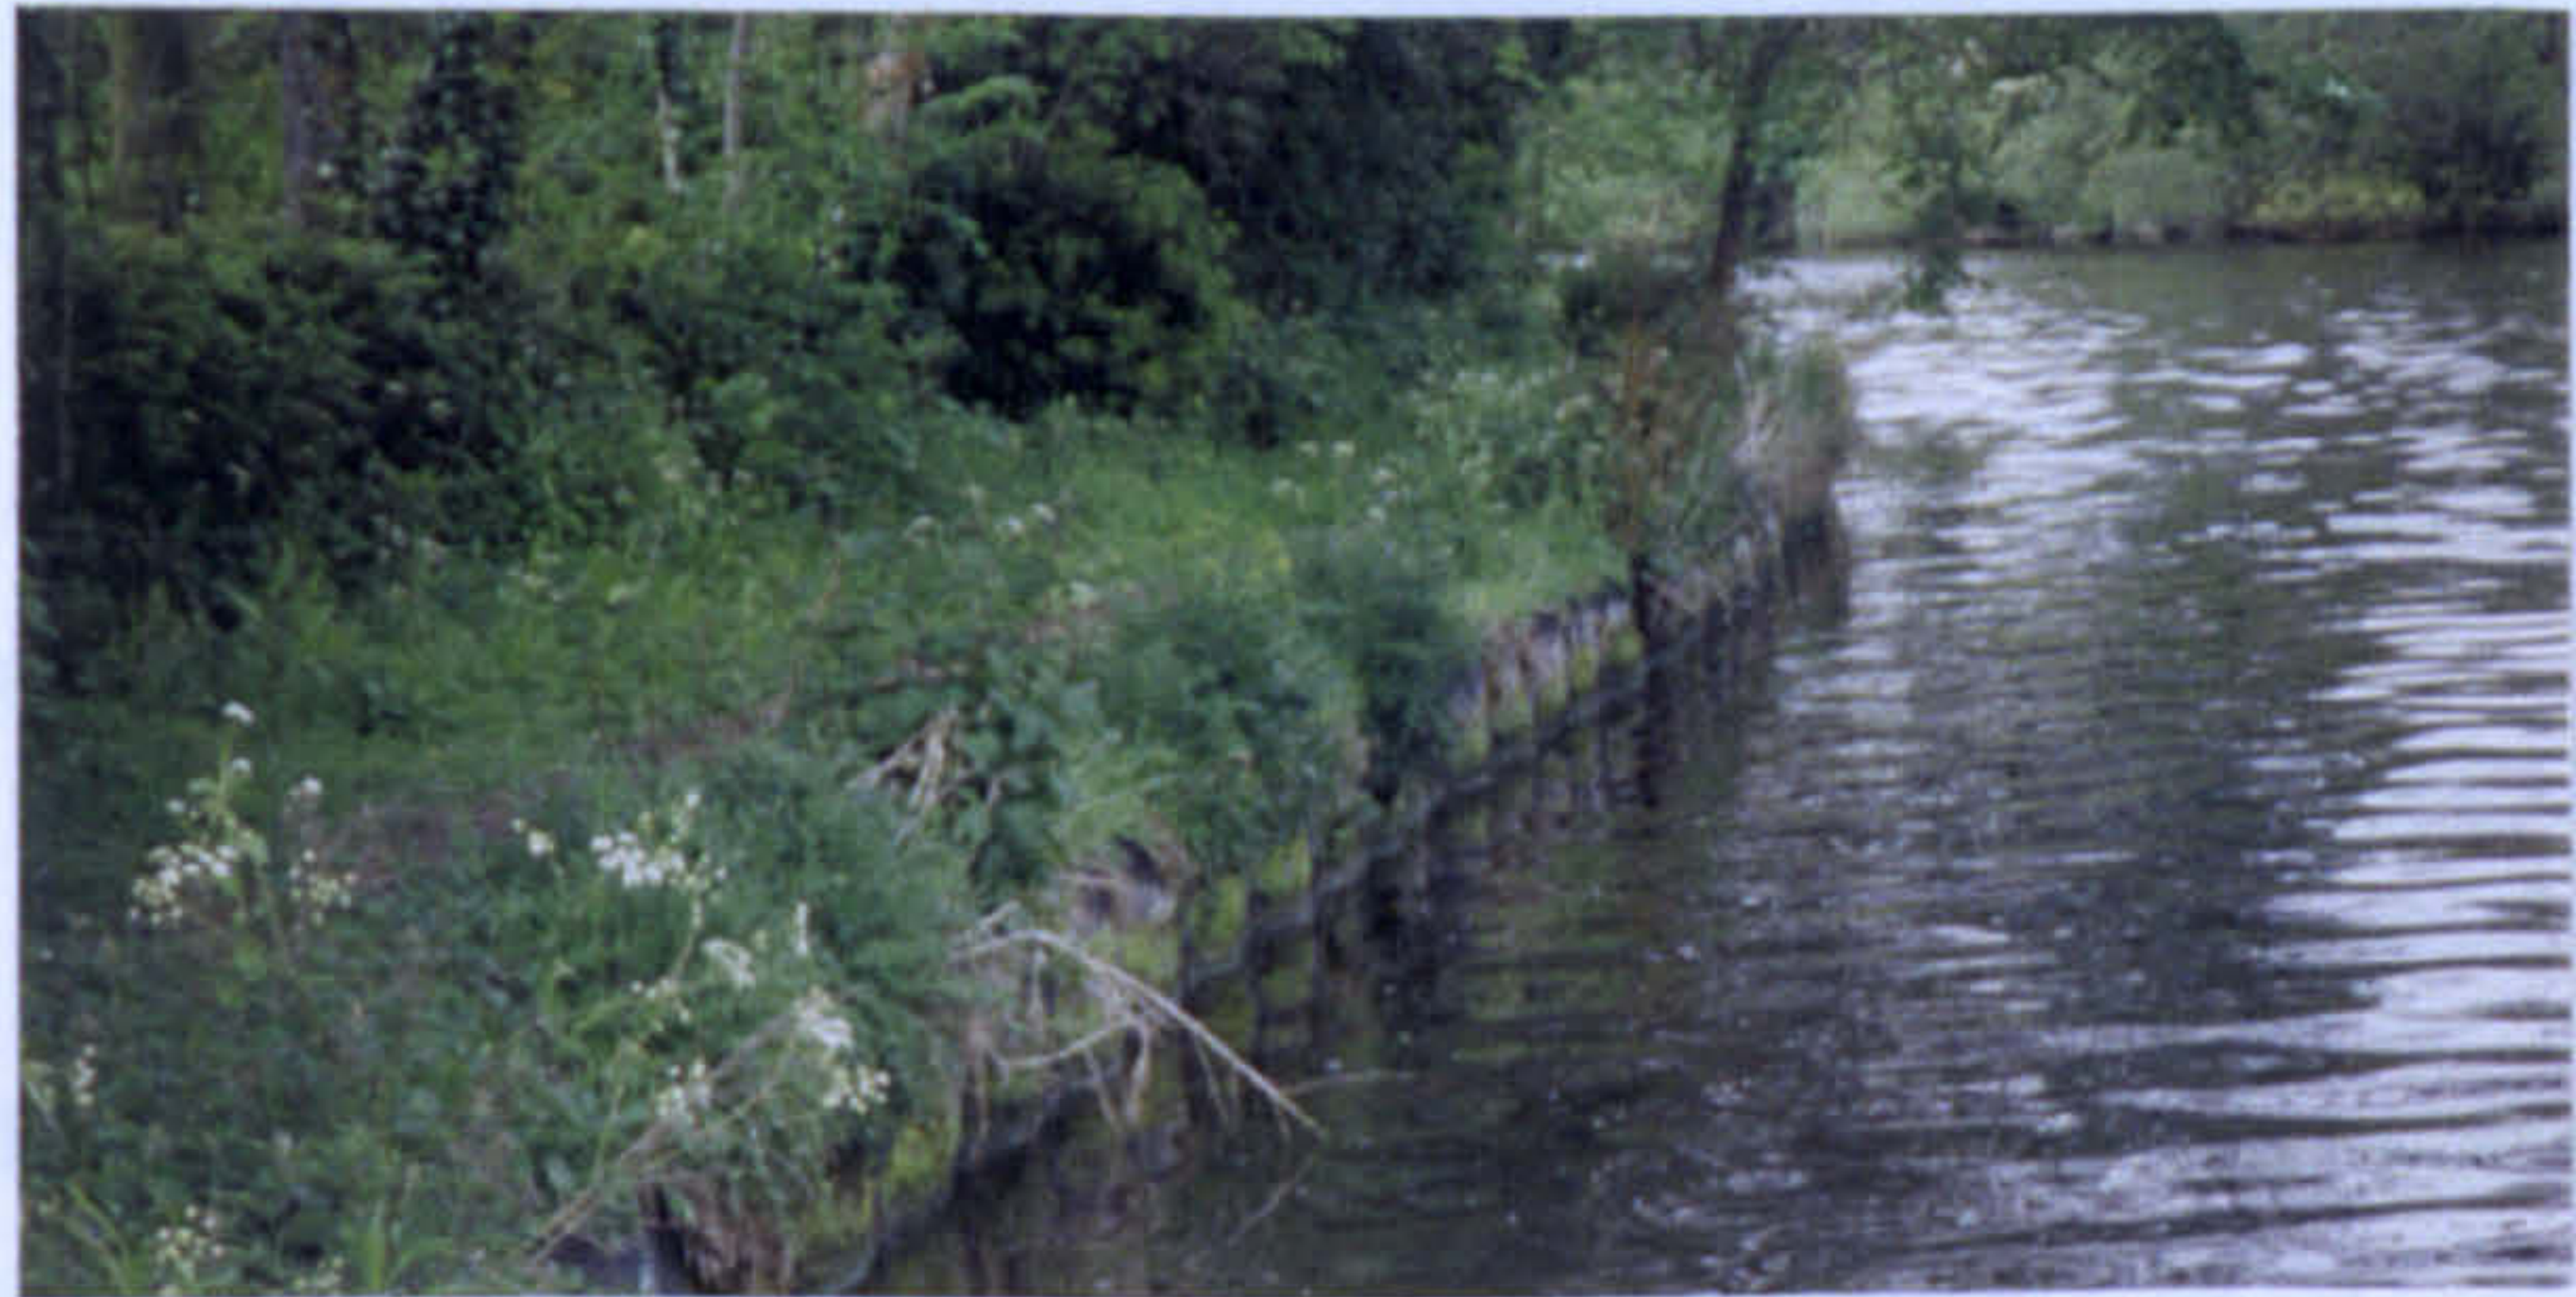
If the consequences of erosion are judged to be 'important', due to the potential risk to the public path along the bank (see Appendix 6.4), the Environment Agency's (1997) framework recommends strategies 2 or 4. Whilst a bioengineering technique such as willow spiling would have been an appropriate solution, a biotechnical engineering solution, Nicospan geotextile, was used to protect the bank (see Plate 6.15).

*Plate 6.15
Case study no. 10:
Nicospan geotextile
along Goring Reach*
