**"THE NON-TIDAL, NAVIGABLE THAMES:
A BANK EROSION MANAGEMENT STRATEGY"**

by Sue Reed BSc, MSc, MCIWEM

**Thesis submitted to the University of Nottingham
for the degree of Doctor of Philosophy, October 1998**

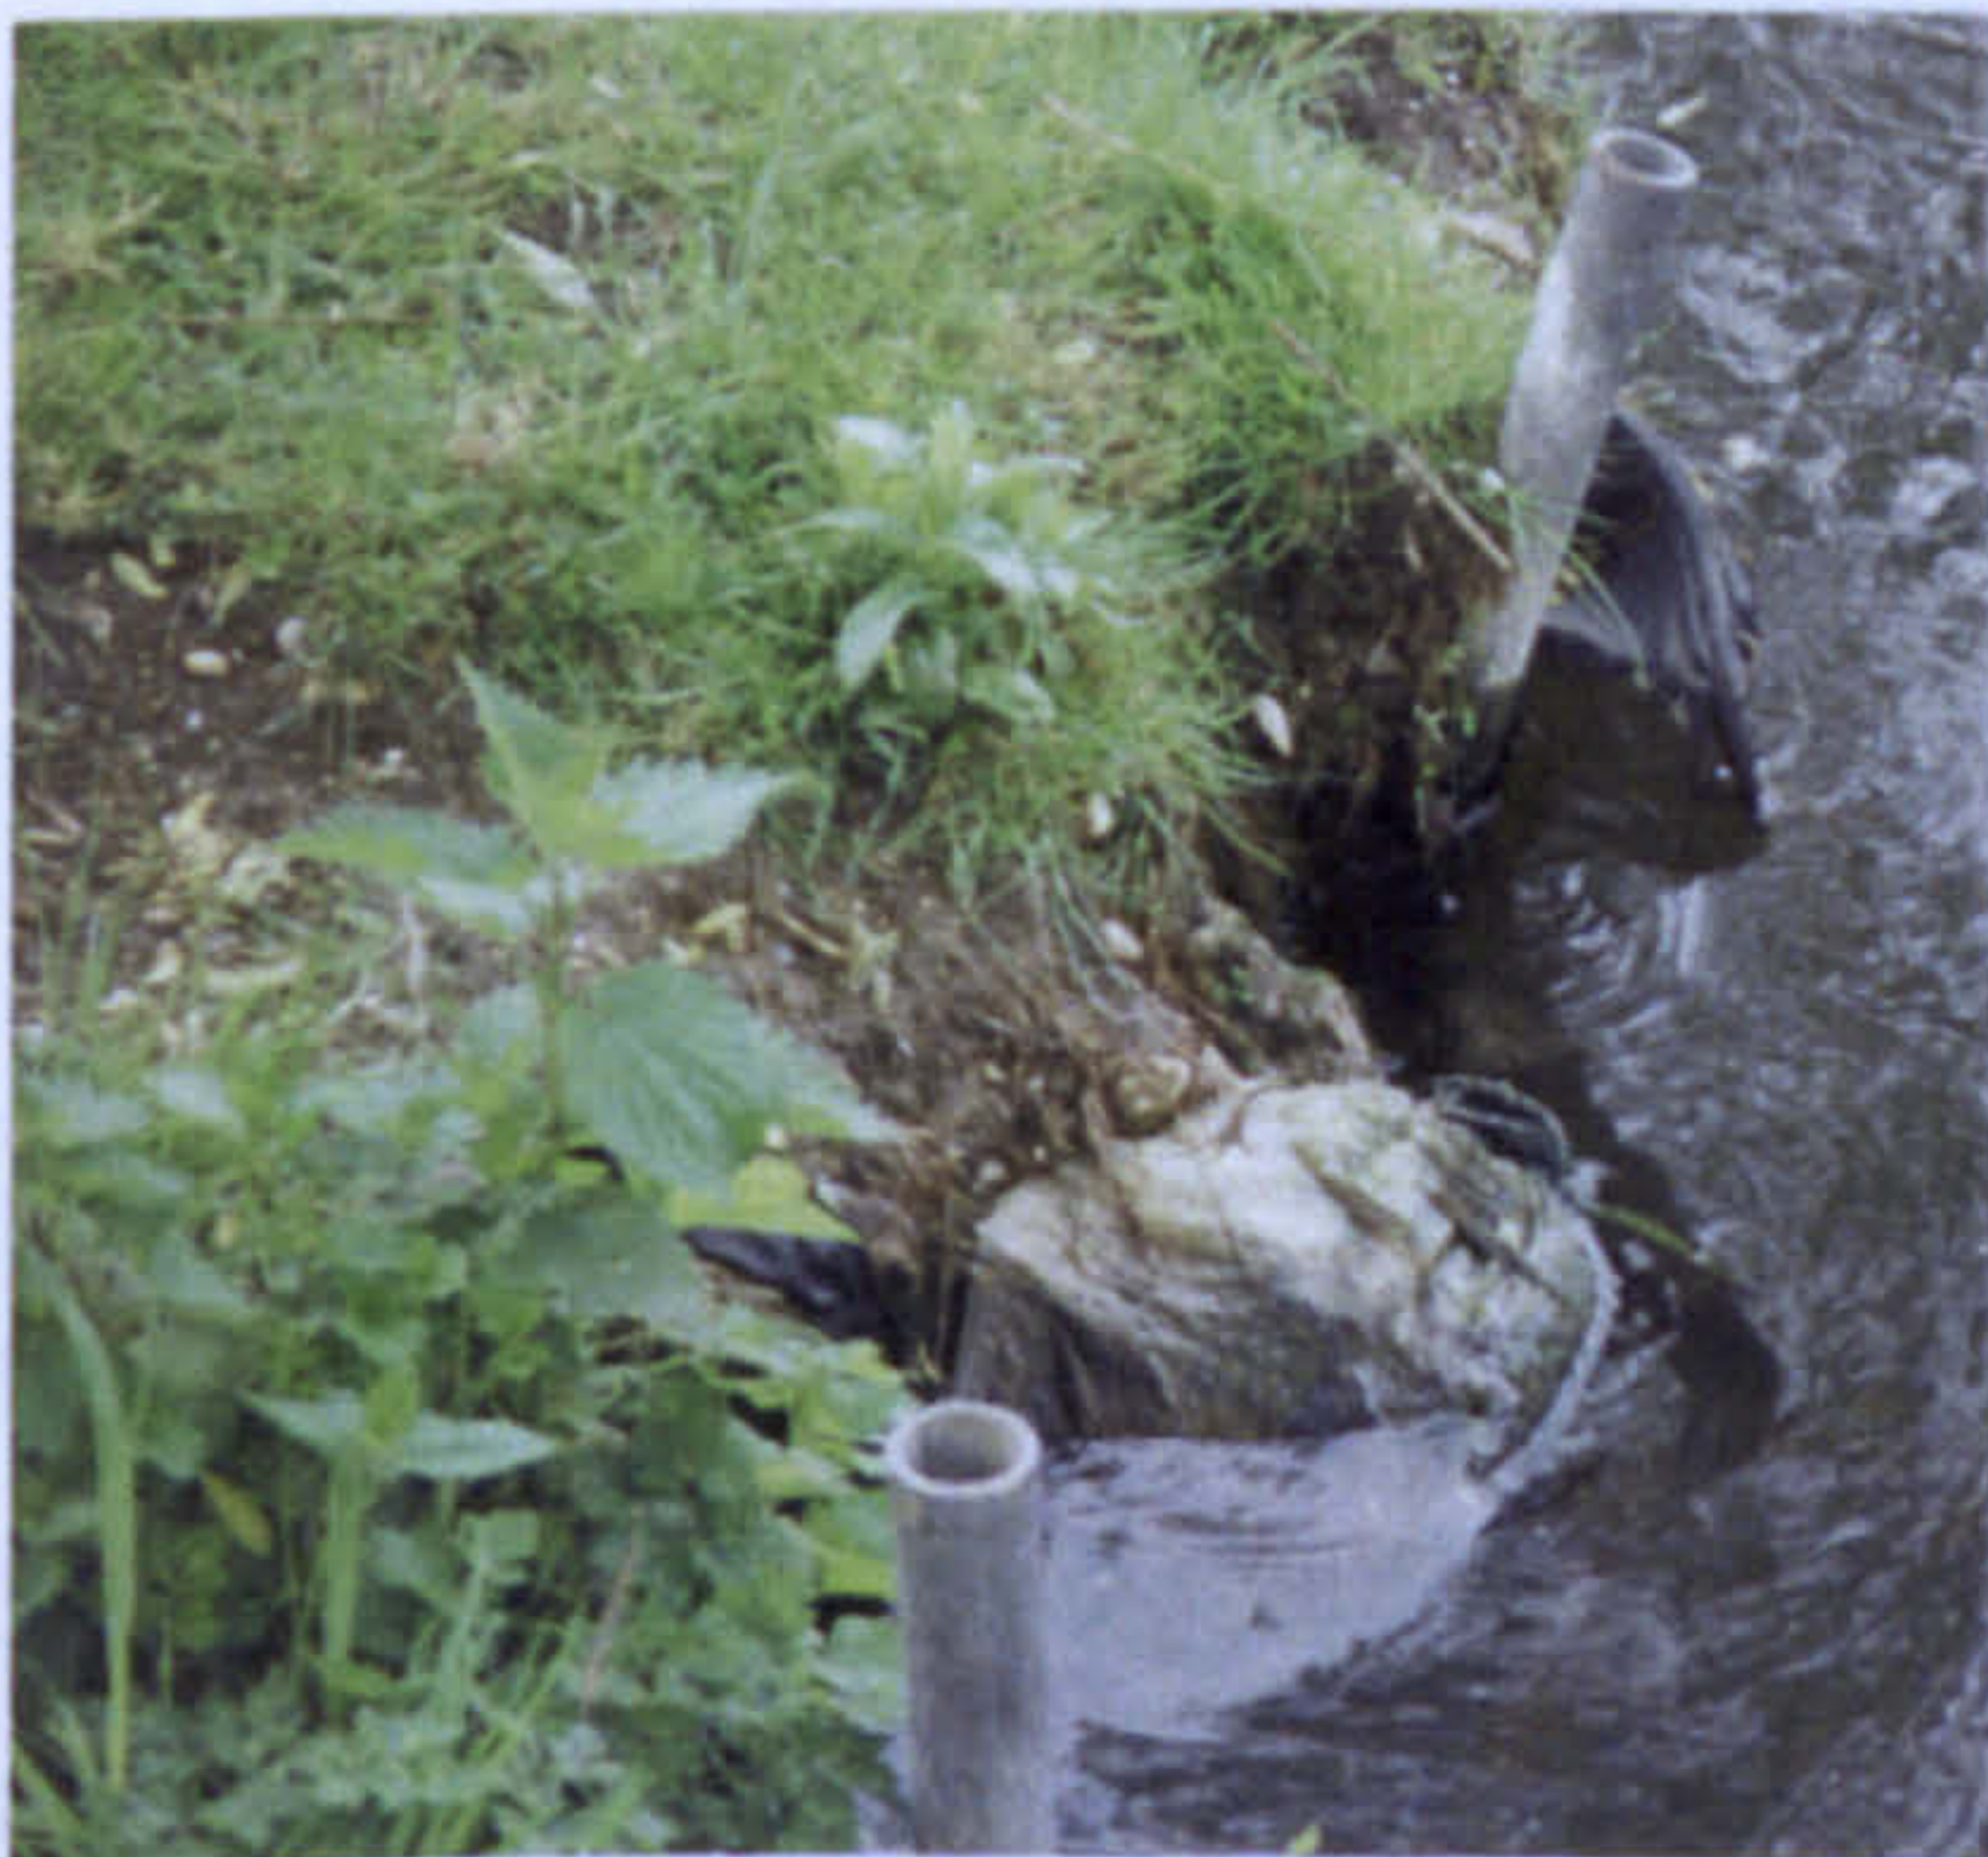
The majority of the geotextile protection has remained intact for at least 10 years. However, in one particular place, the steel rods used to support the geotextile have been displaced so that they lean towards the channel, and the geotextile has failed (see Plate 6.16). This is either because of undercutting at the toe of the protection, increased loading on the upper bank, or a combination of the two. The water level is relatively high along this reach and the public path becomes flooded during high flows. It is likely that the banks are poorly drained due to the compaction of the soil by pedestrian traffic, and it may be the case that the increased unit weight of the saturated bank has resulted in toppling failure of the steel rods. Furthermore, the length of geotextile in the worst repair is adjacent to a small wooden jetty which probably increases velocities near the bank. At other places, the backfill has been washed out, leaving voids behind the geotextile that can be further eroded (see Plate 6.17).

*Plate 6.16
Case study no. 10:
displaced support
rods and failure
of Nicospan
geotextile along
Goring Reach*

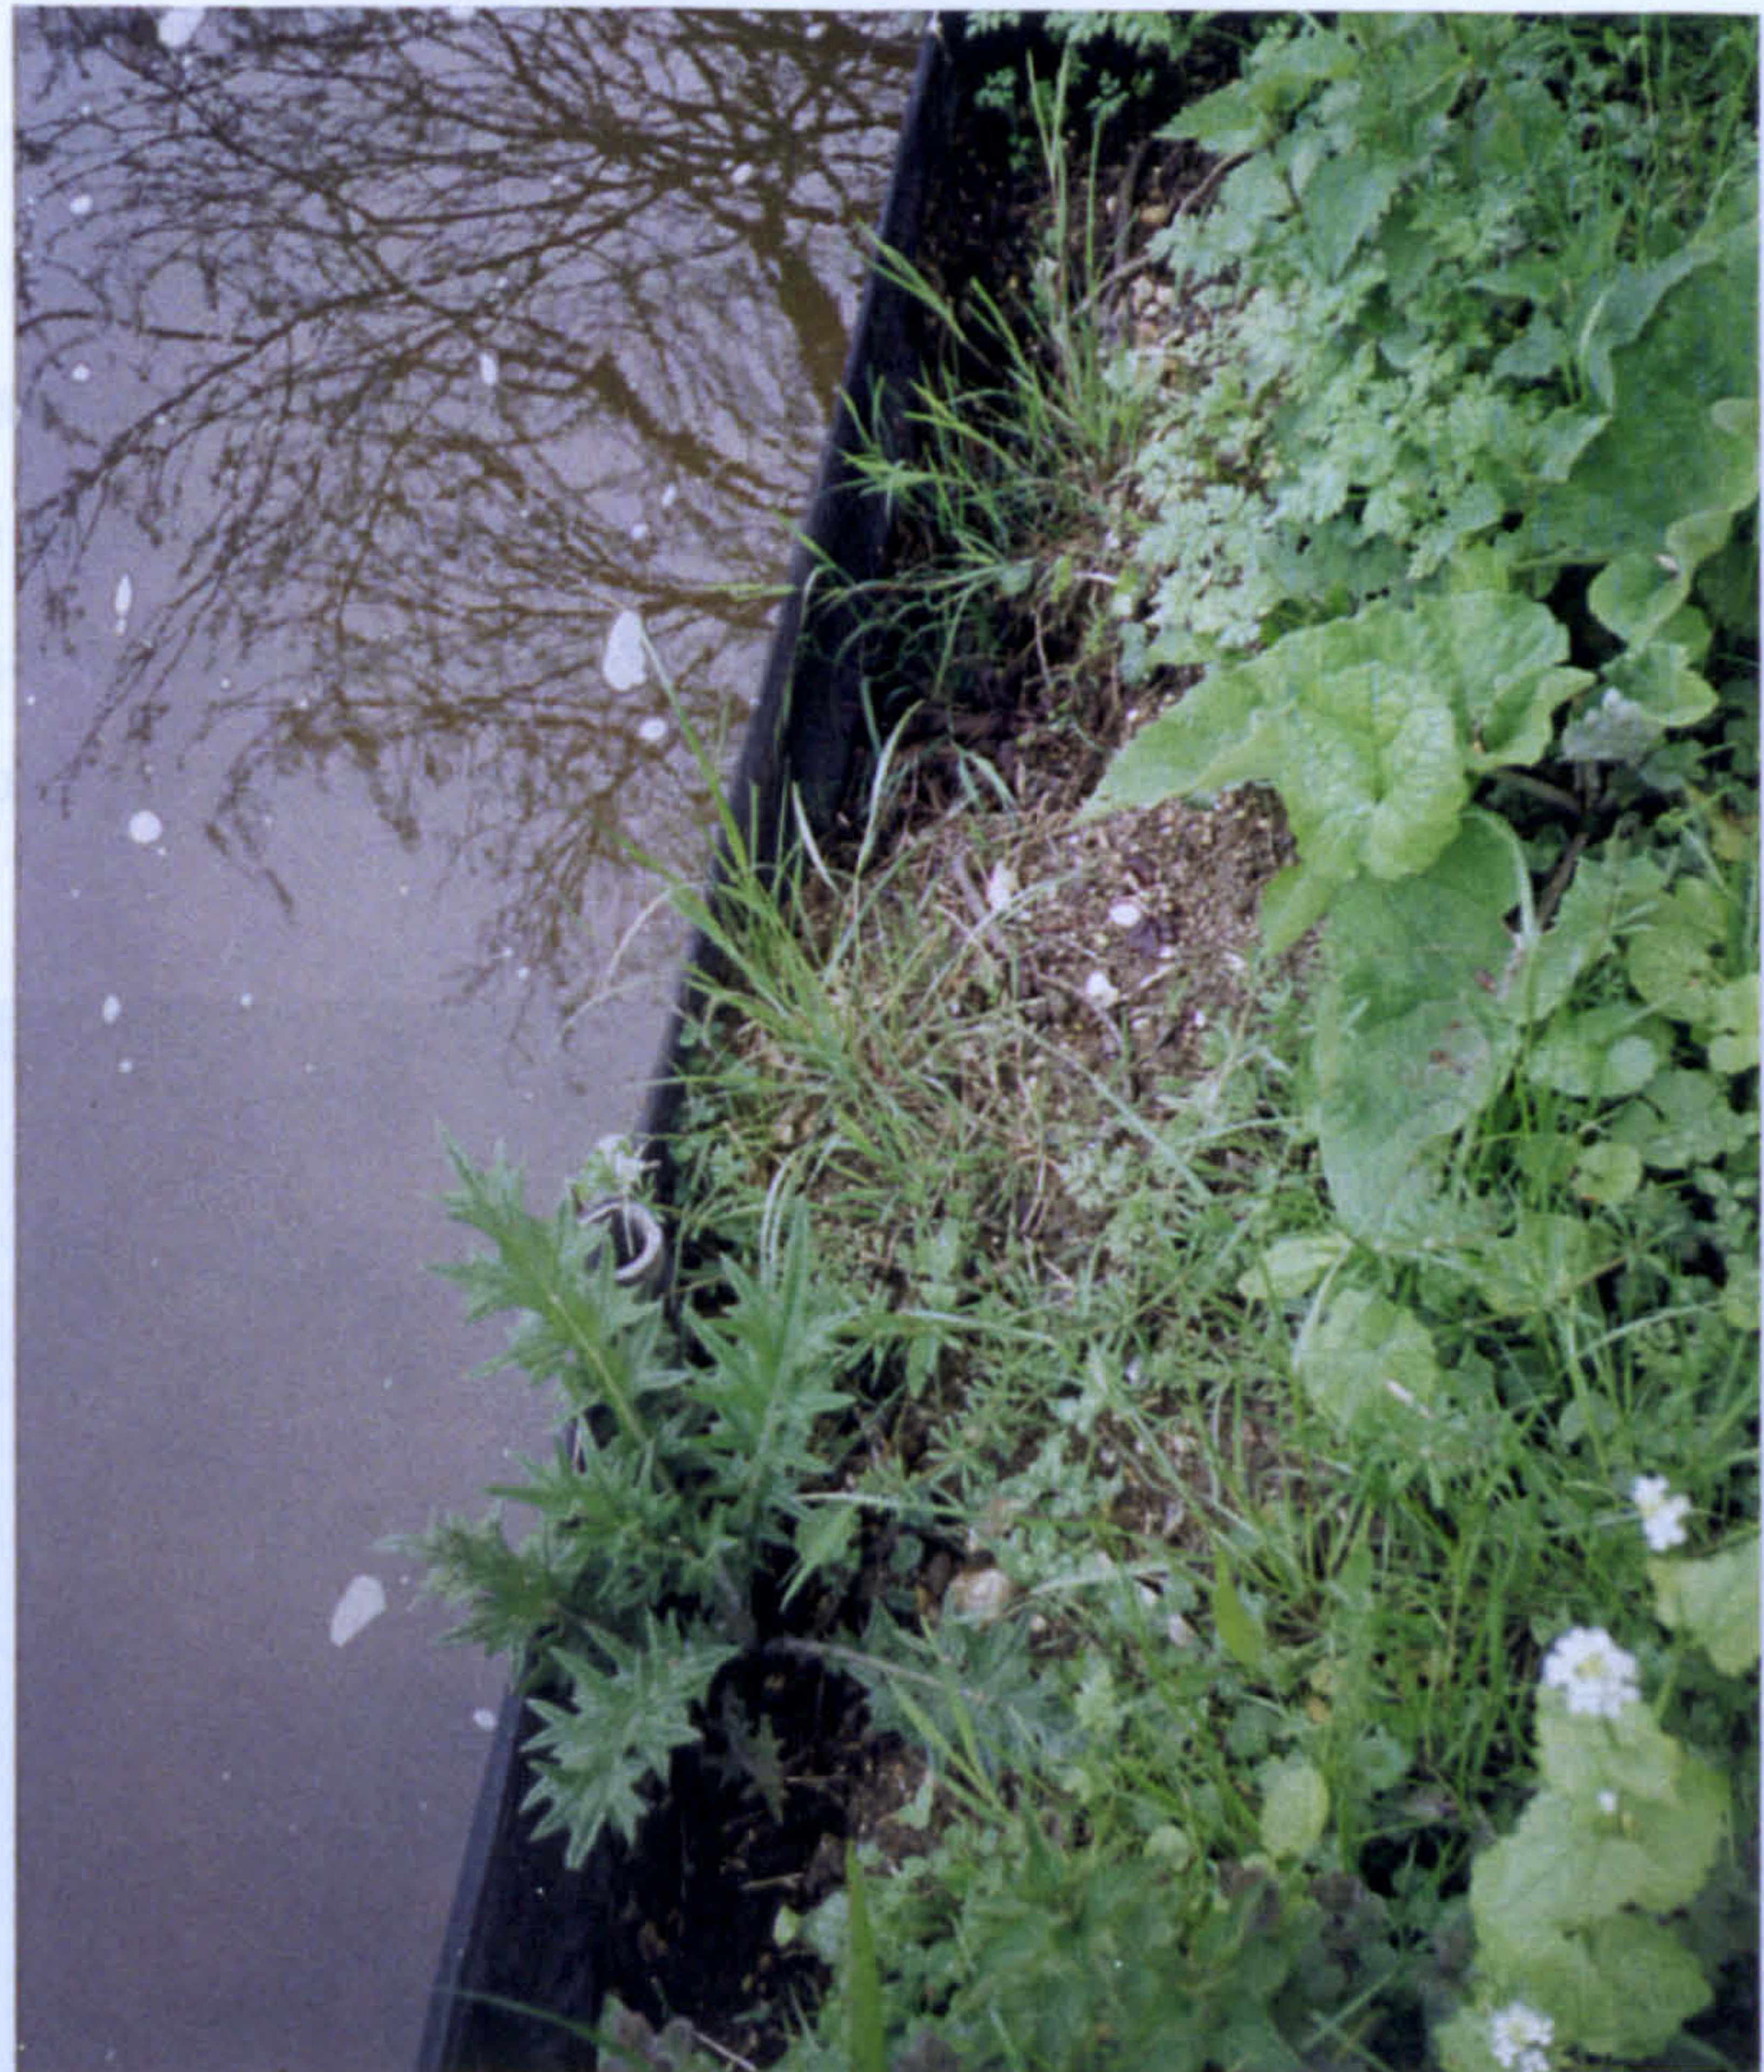
Plate 6.17
Case study no. 10:
wash out of backfill
behind Nicospan
geotextile along
Goring Reach

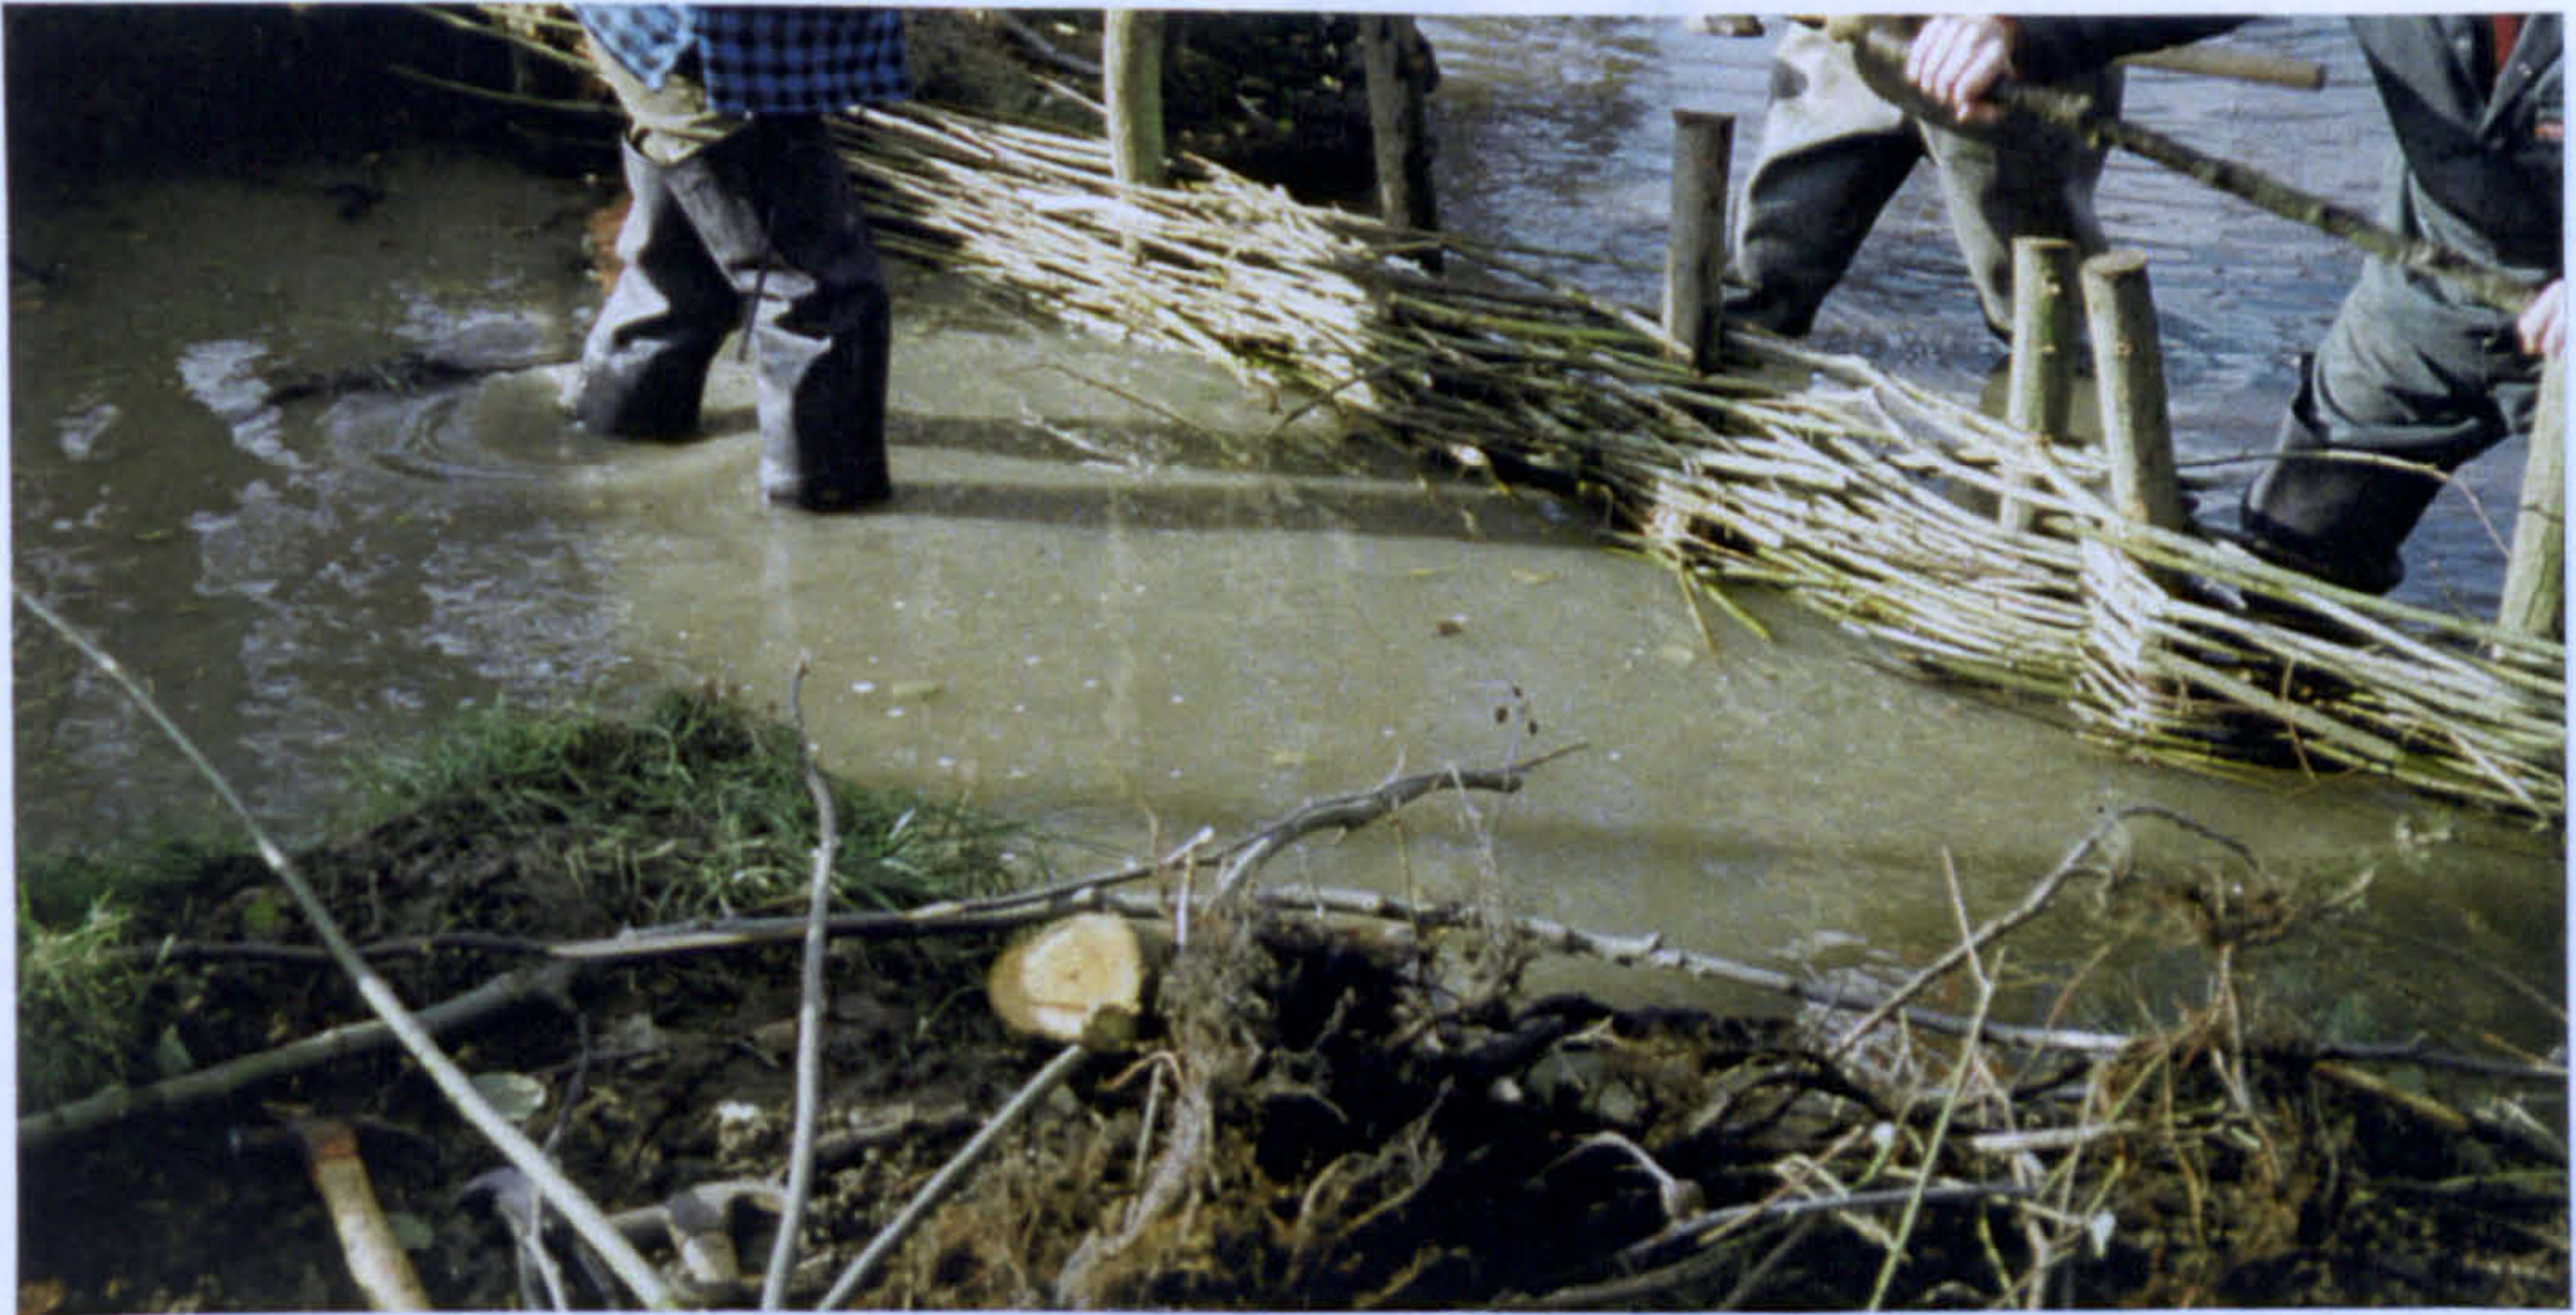
Plate 6.18 shows the short length of willow spiling installed at this site in late October 1992. The major cause of erosion here was cattle trampling the banks to access the water's edge, although this was probably exacerbated by boat wash. A geotextile was placed behind the spiling as a filter fabric and the site was enclosed within a sturdy fence to prevent access from livestock (see Plate 6.19).

Plate 6.18 Case study no. 11: willow spiling along Mapledurham Reach

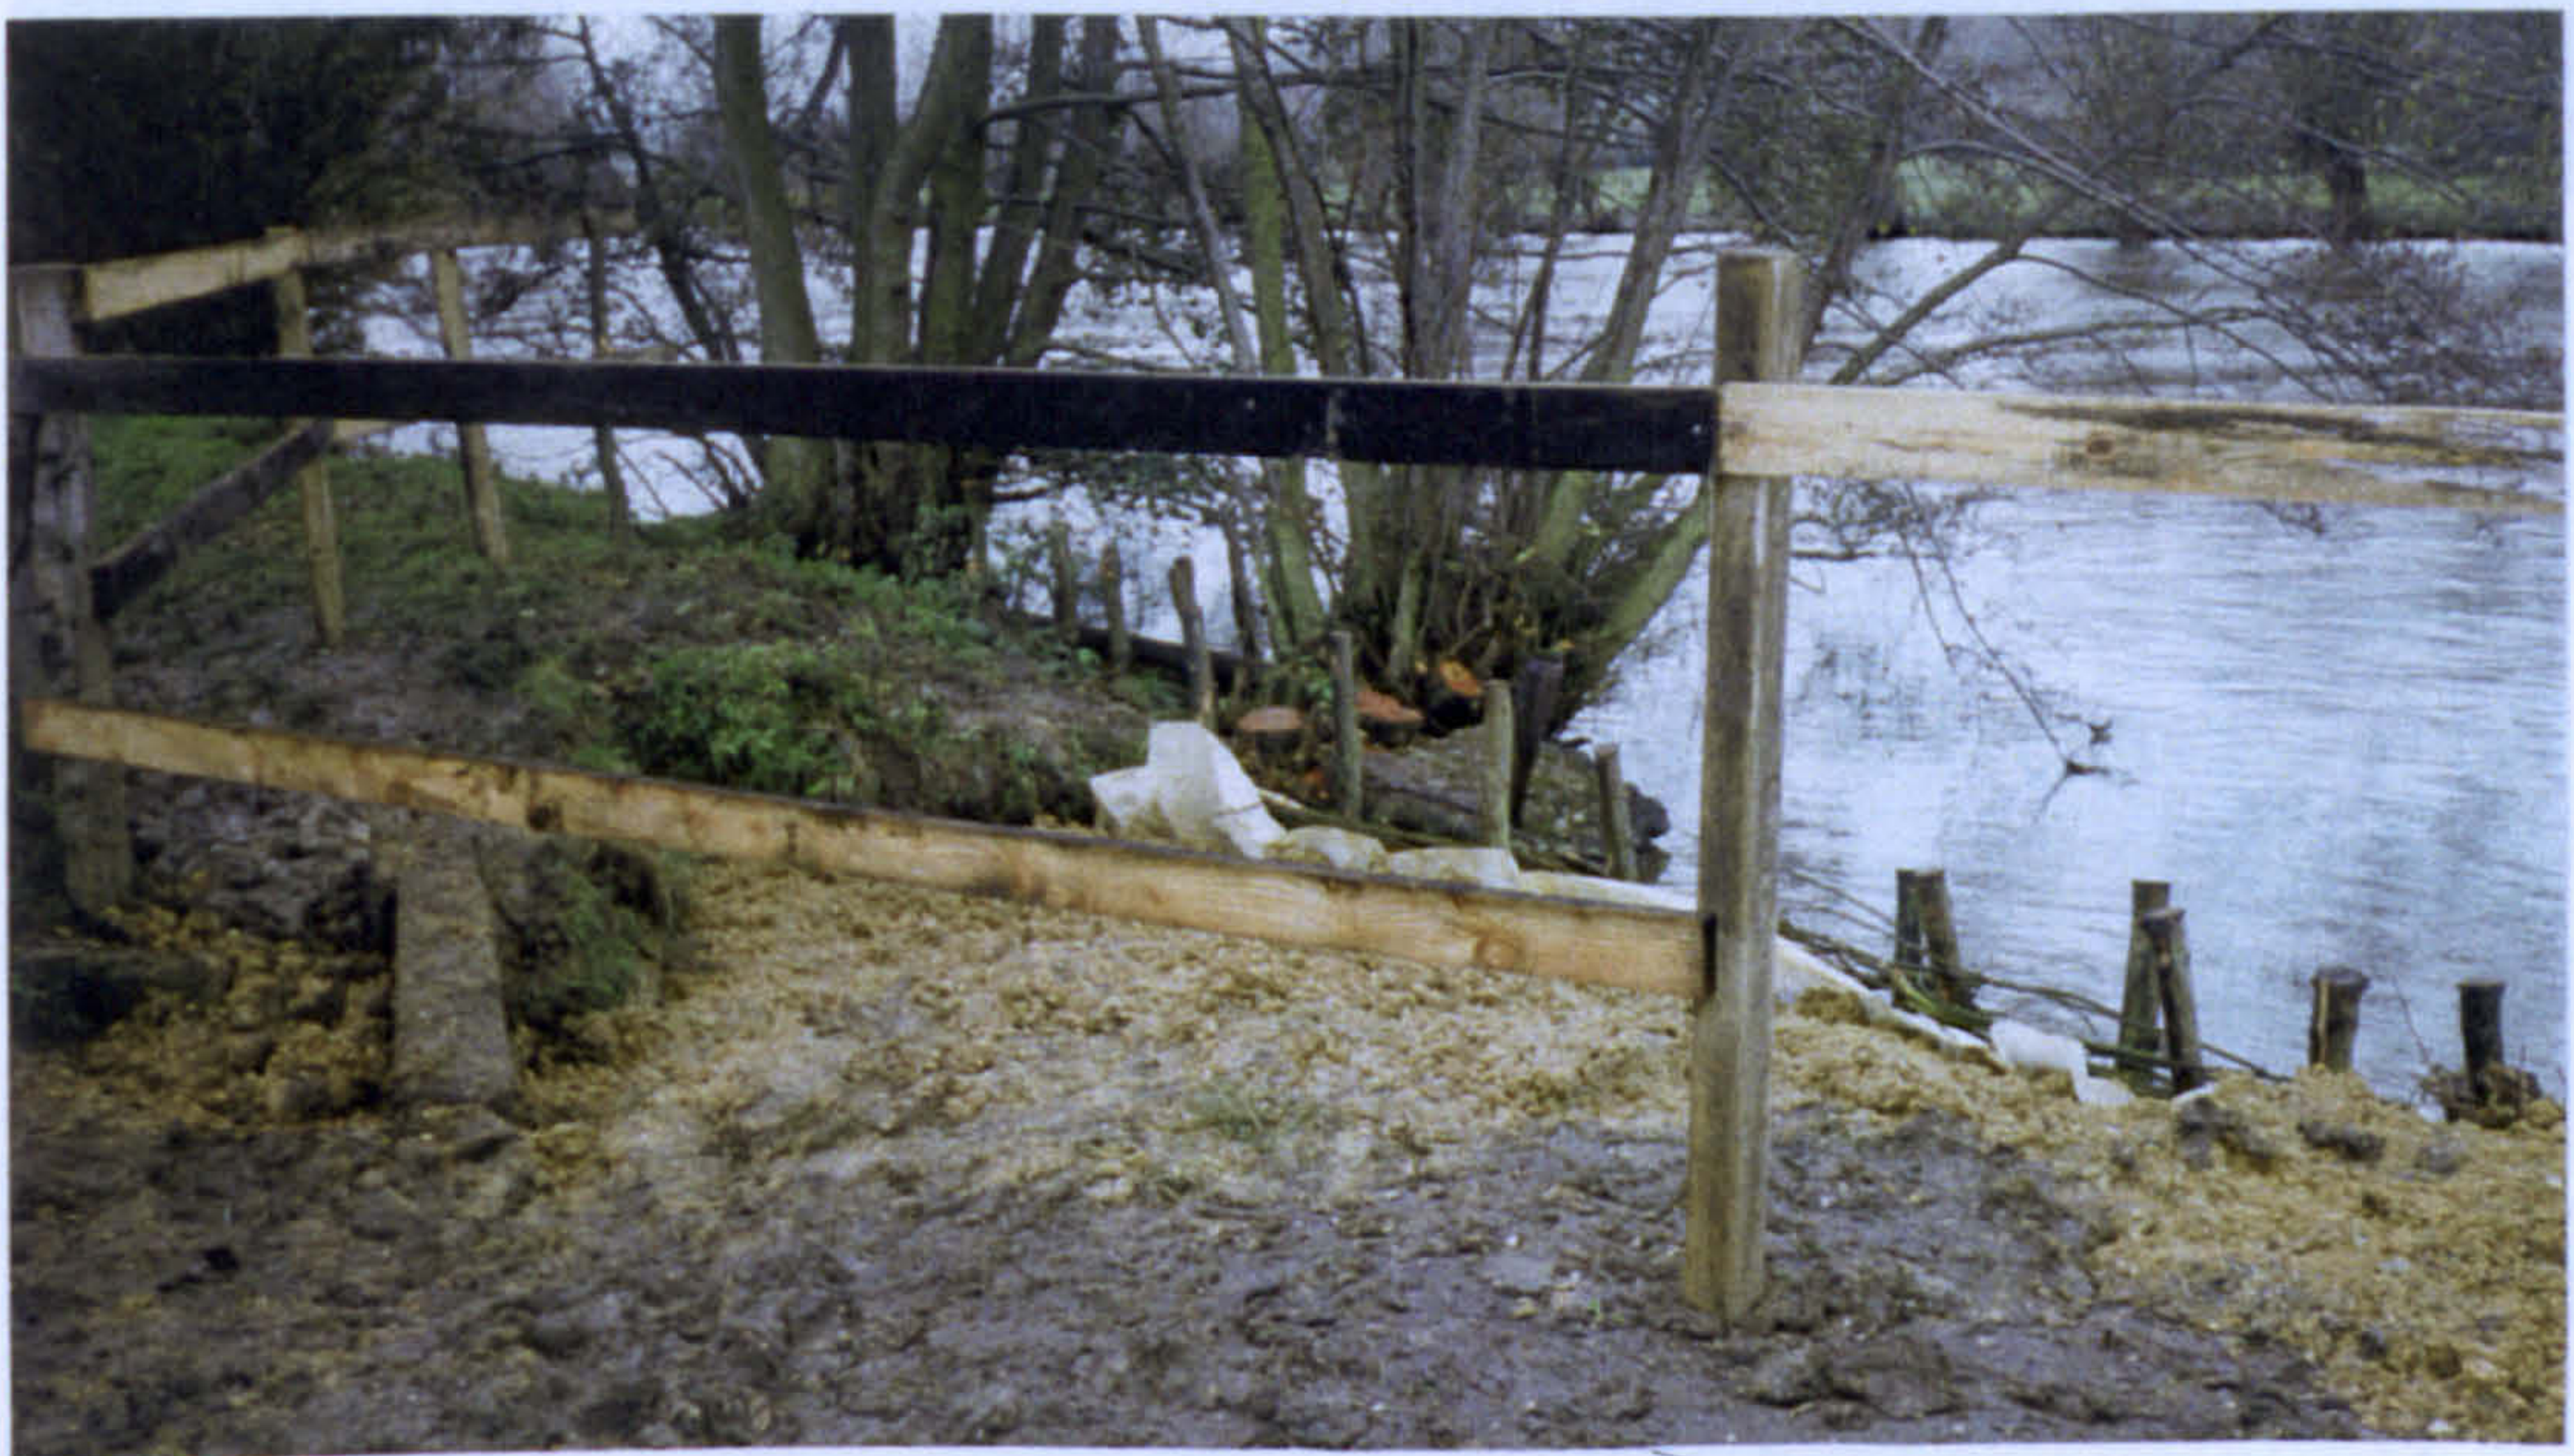
Plate 6.19 Case study no. 11: willow spiling along Mapledurham Reach, with fencing to prevent livestock access

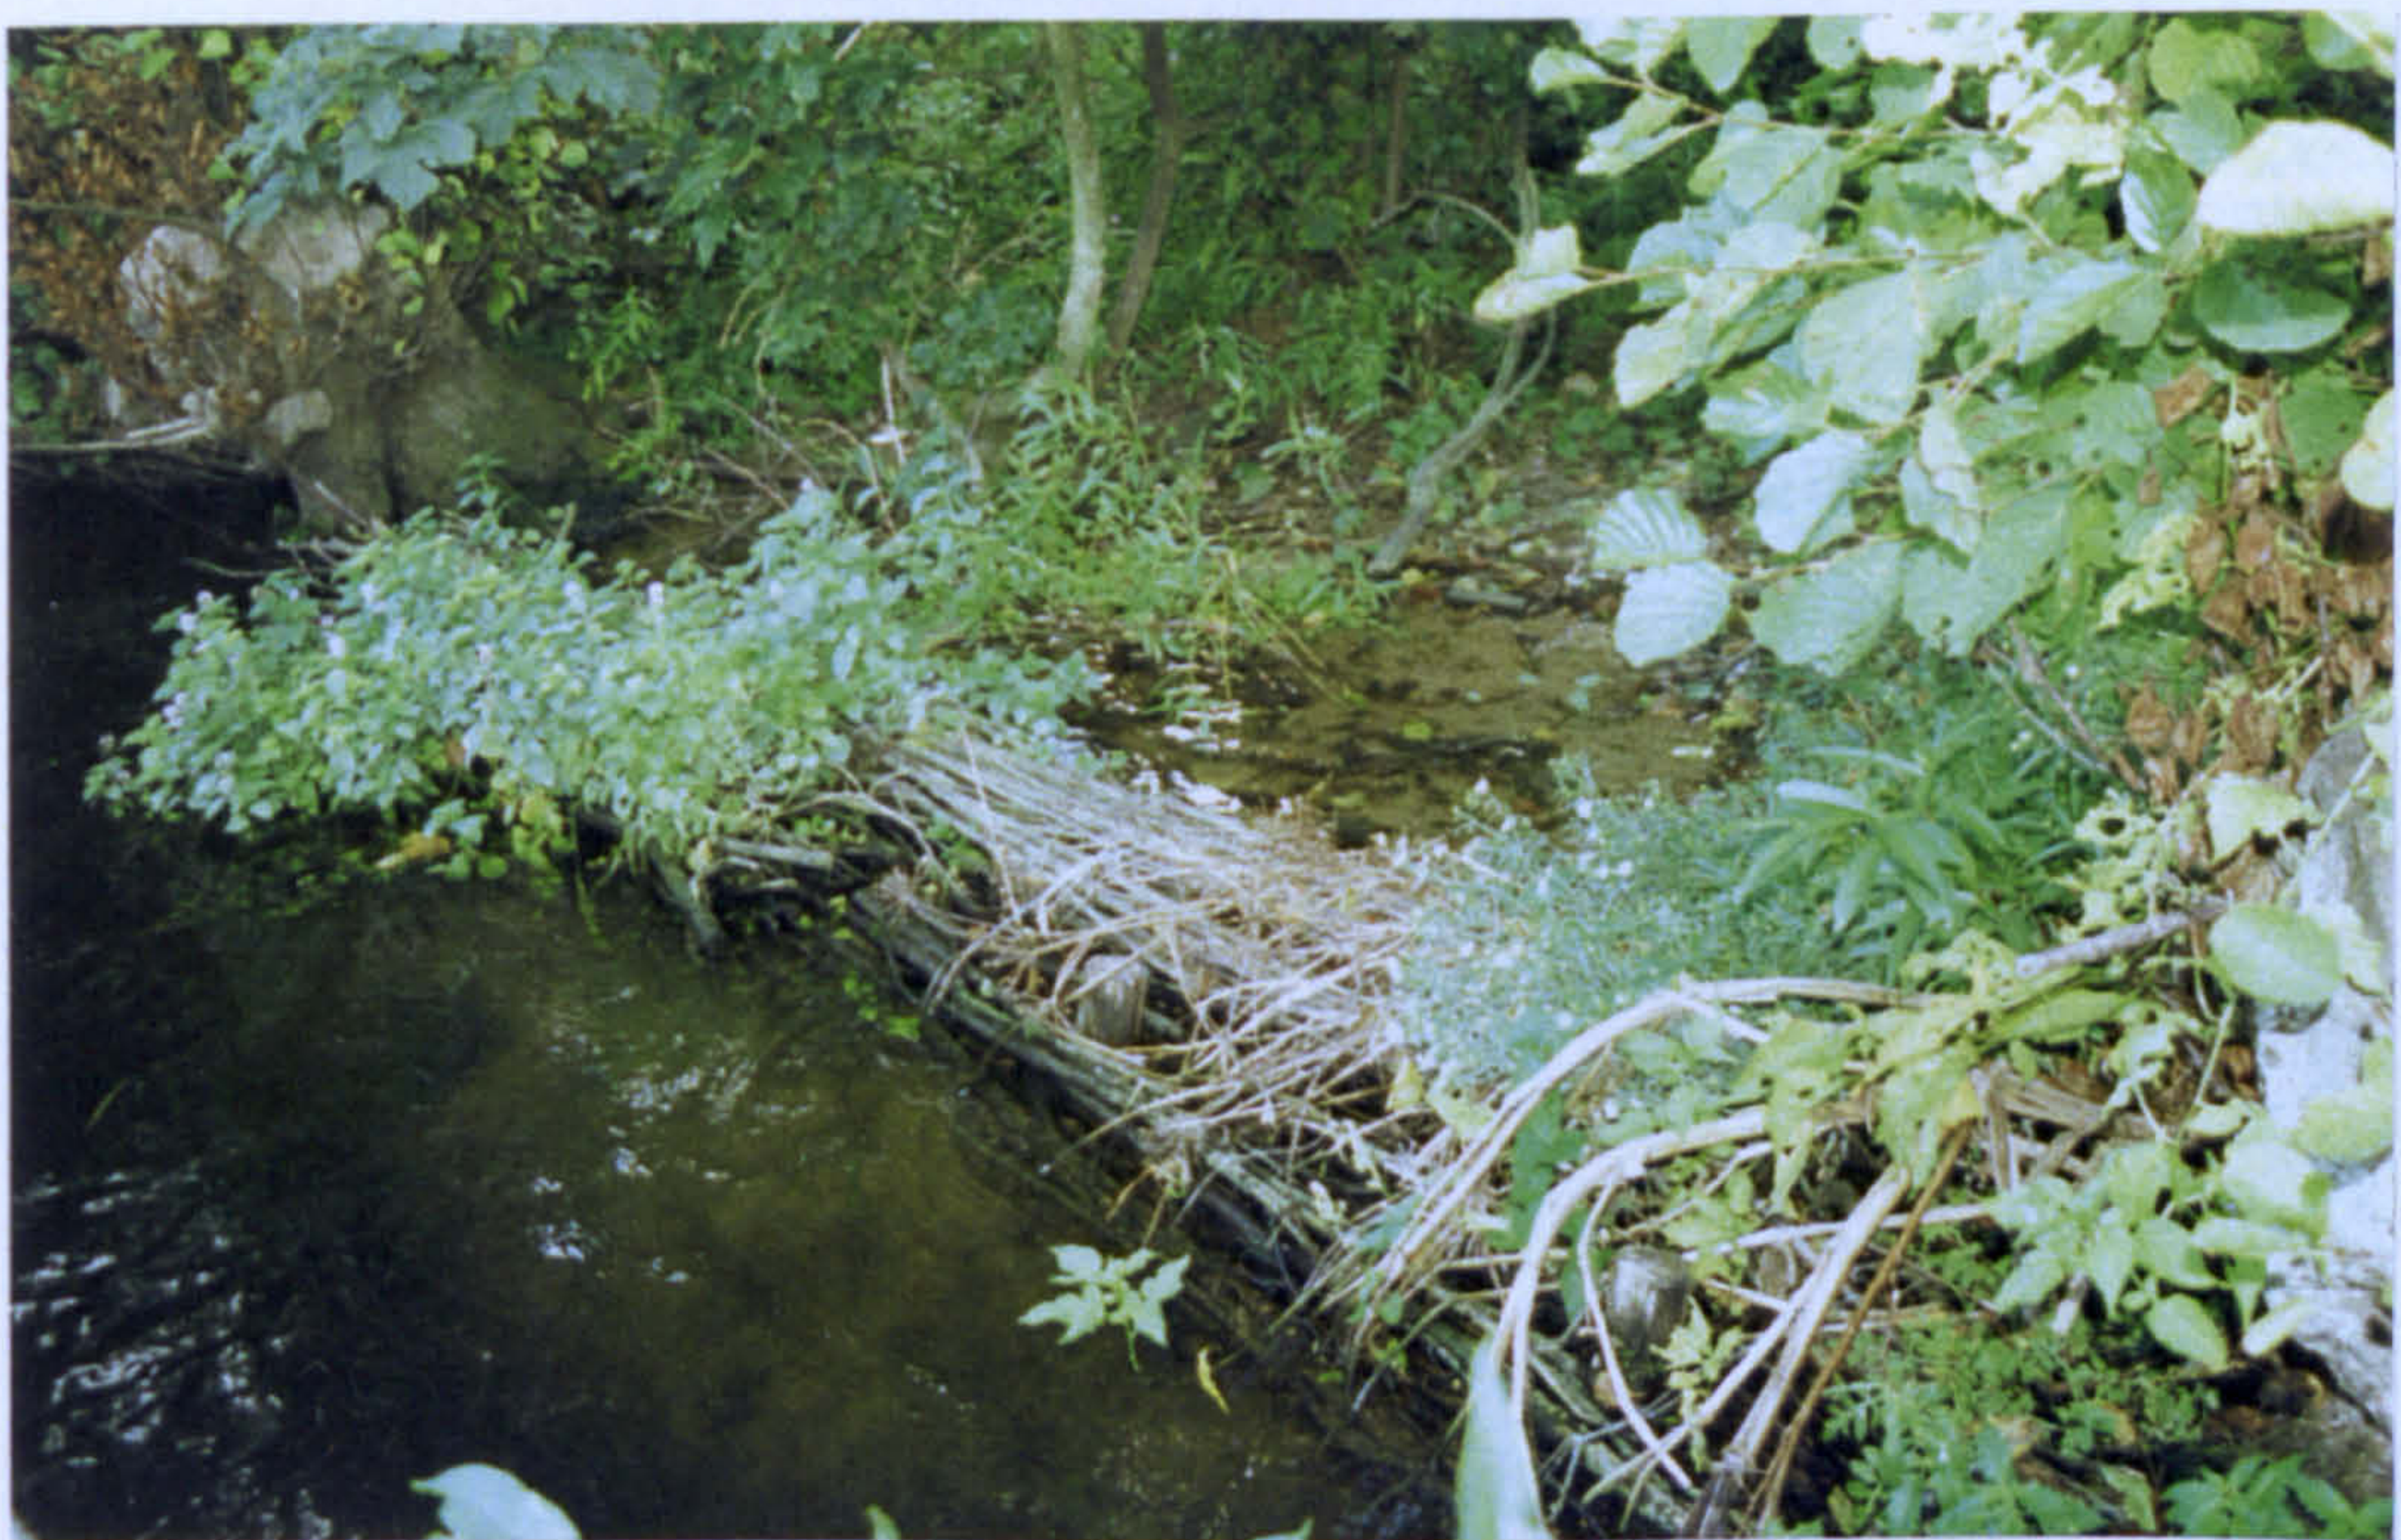
The author participated in the design team for this project in the way described by Brookes (1995), and assessed the major causes of erosion here to be high flows from the weir opposite, and boat wash. The adjacent land use is rough pasture, although there was no evidence of livestock grazing. Judging the consequences of erosion as 'moderate', the Environment Agency's (1997) framework recommends the use of strategies 1, 2, 3 or 4. Formation of a spending beach at the level of the water surface, coupled with the stability of the clayey bank material below the level of the water surface suggested that undercutting at the toe of the bank (i.e. above the clayey material) was

primarily the result of boat wash. In this respect the site is similar to the Lower Wallingford monitoring site (Chapter Four). Erosion of the upper bank cliff probably resulted from a combination of undercutting, weakening of the unvegetated face of the bank during summer months, and removal of material by high flows from the weir opposite.

Plate 6.21 Case study no. 12: faggot bank protection downstream of Mapledurham Lock

Strategy 1, allowed natural adjustment, was proposed by the author but the riparian owner would not accept further loss of land through continued bank erosion. The option to regrade the slope of the upper bank to a stepped profile and replant the bank for longer-term stability was also proposed by the author but, again, agreement could not be secured from the landowner. Consequently, faggots were installed to protect the toe of the bank from continued erosion by boat wash and also, to some extent, from high flows from the weir (see Plate 6.21). In developing this design, it was recognised that, without protecting the steep upper bank, the high flows from the weir may continue to erode the upper bank. However, with adequate toe protection, rate of upper bank retreat would be expected to decline with time, and the bank would eventually stabilise and revegetate.
