**"THE NON-TIDAL, NAVIGABLE THAMES:
A BANK EROSION MANAGEMENT STRATEGY"**

by Sue Reed BSc, MSc, MCIWEM

**Thesis submitted to the University of Nottingham
for the degree of Doctor of Philosophy, October 1998**

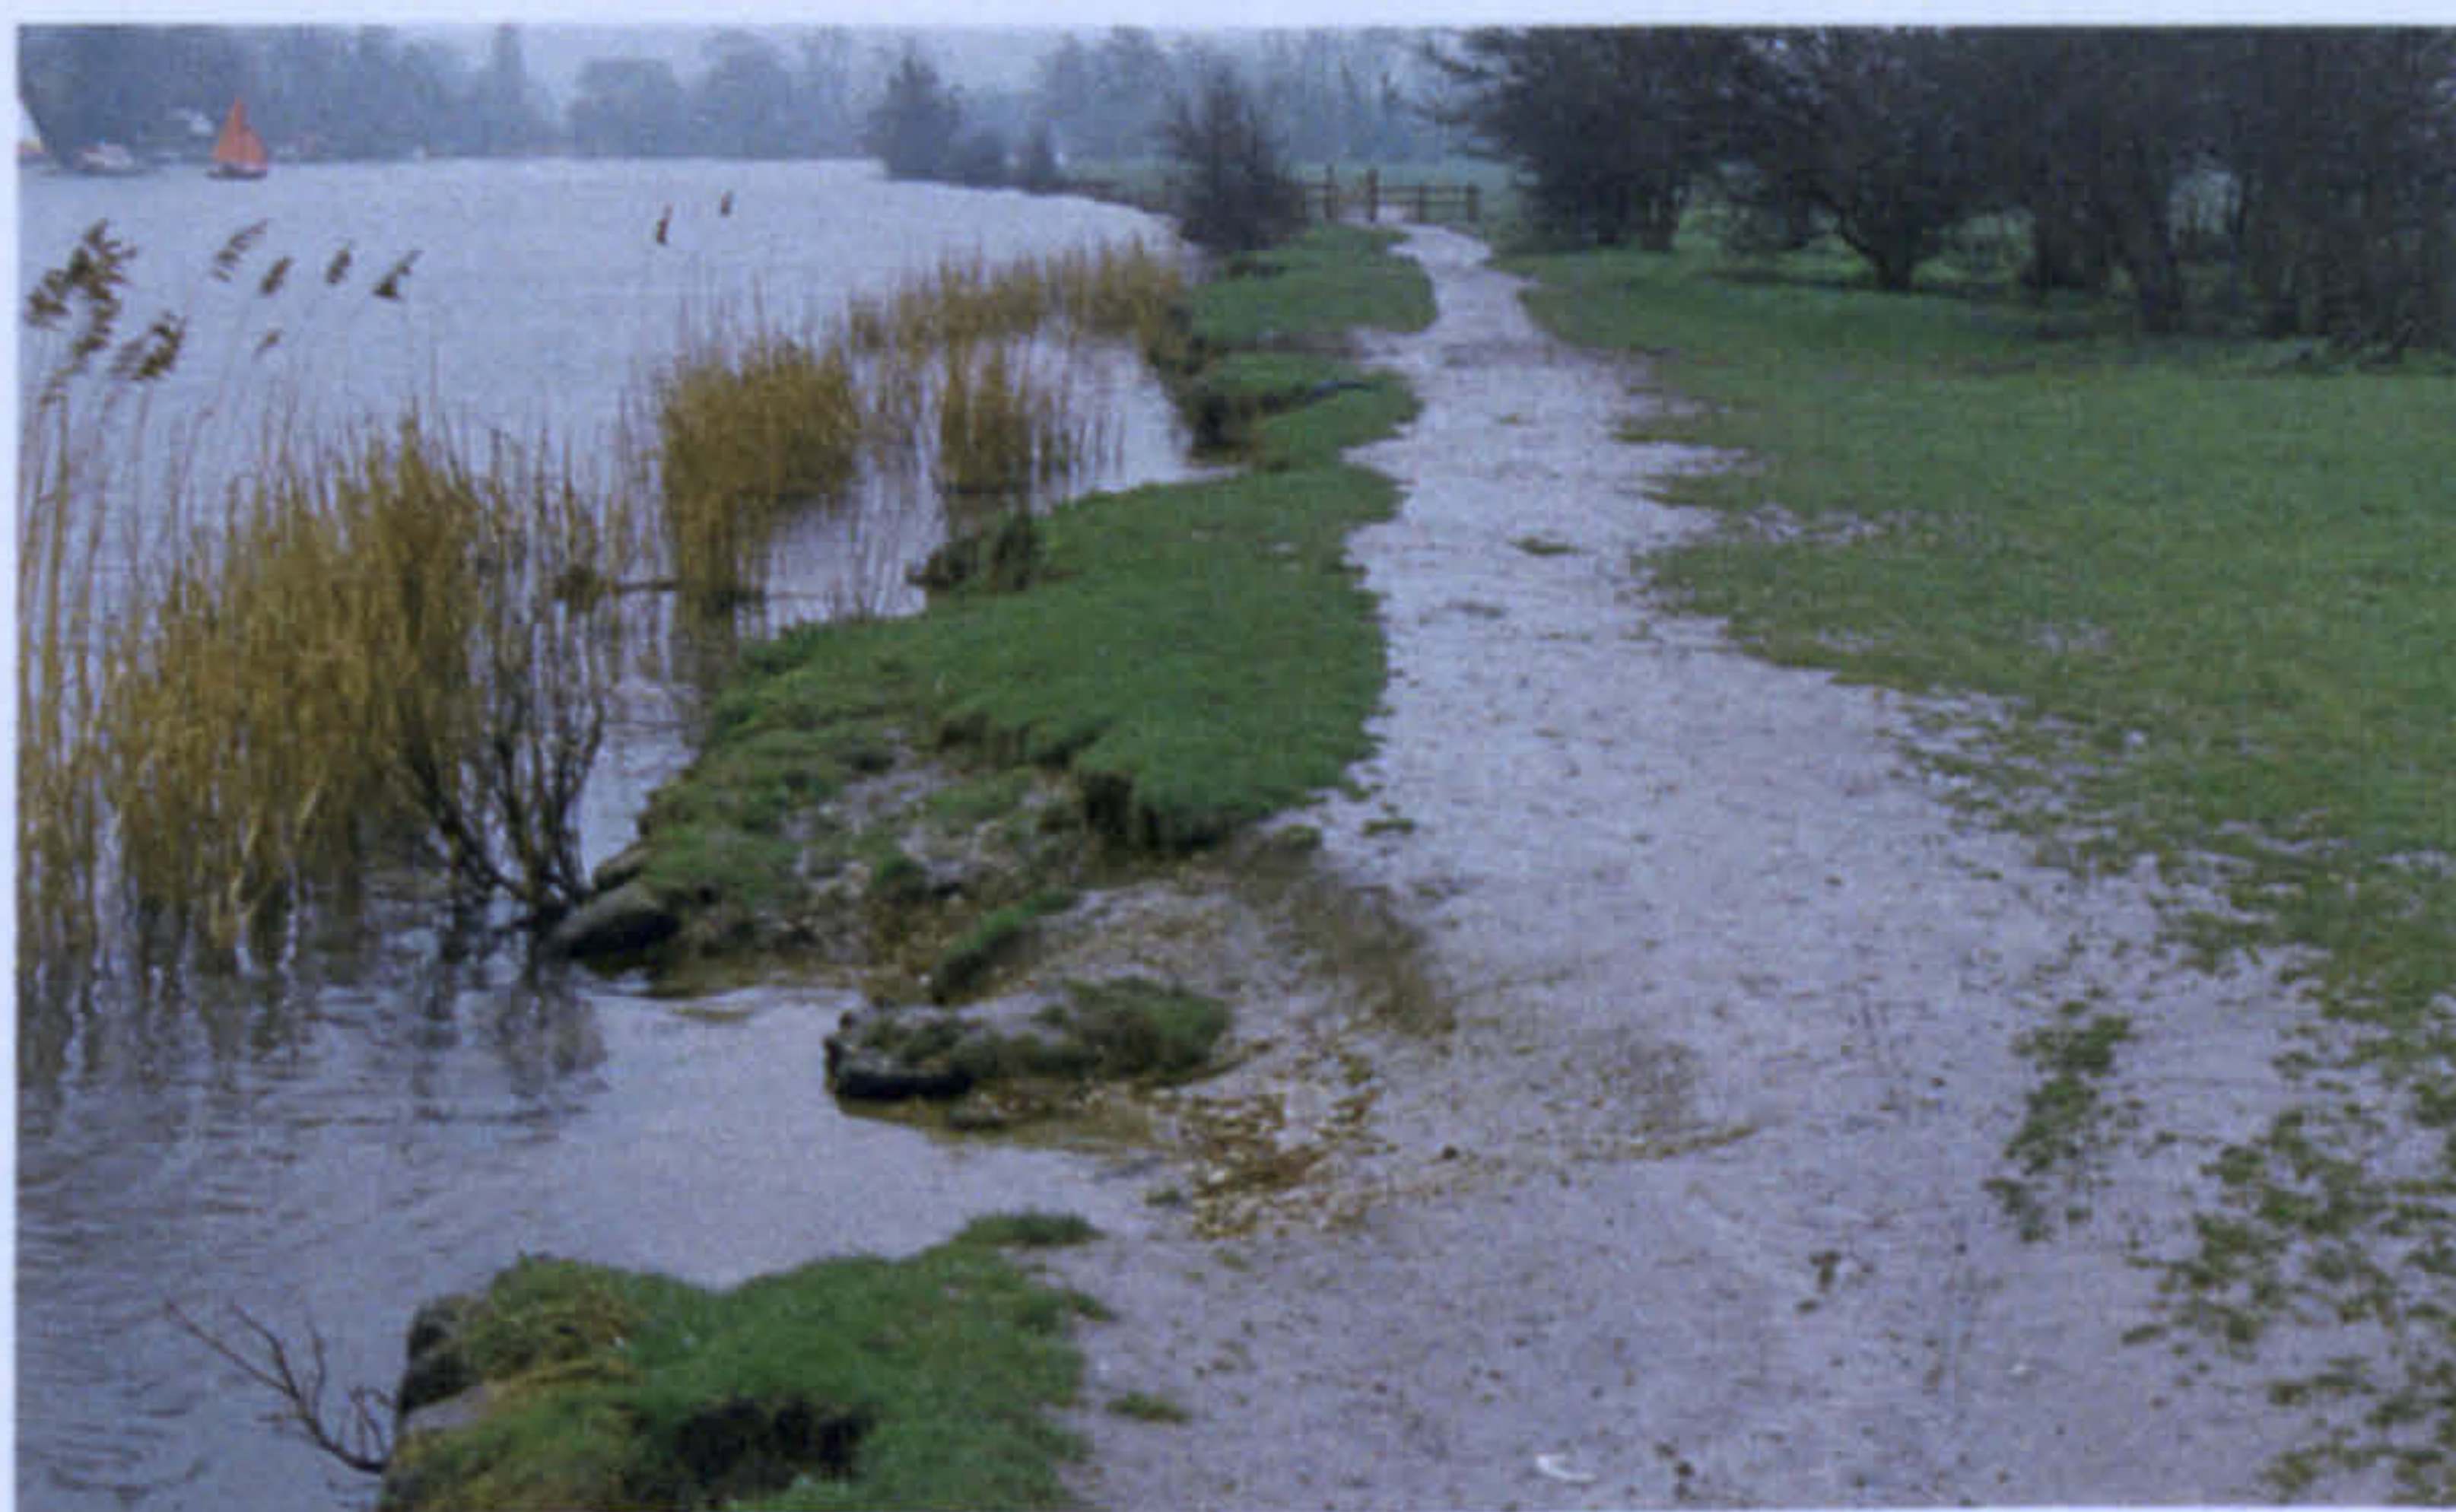
Plate 6.23 shows erosion of the bank along Marlow Reach, adjacent to an unvegetated public path which runs parallel to the river. The major causes of erosion were identified as boat wash and pedestrian access (Browne, 1993). The consequences of erosion here could be judged as 'moderate' because there is sufficient space along the river corridor to accommodate realignment of the footpath if erosion continued. In this case, the Environment Agency's (1997) framework recommends the use of strategies 1, 2 or 3. Whereas strategies 1, 2 and 3 could have been adopted, the willow spiling that was used provided adequate protection from boat wash, allowed the bankline to be reinstated and provided a more diverse habitat along the bank (see Plate 6.24).

*Plate 6.23
Case study no. 14:
bank erosion at
Marlow Reach.*

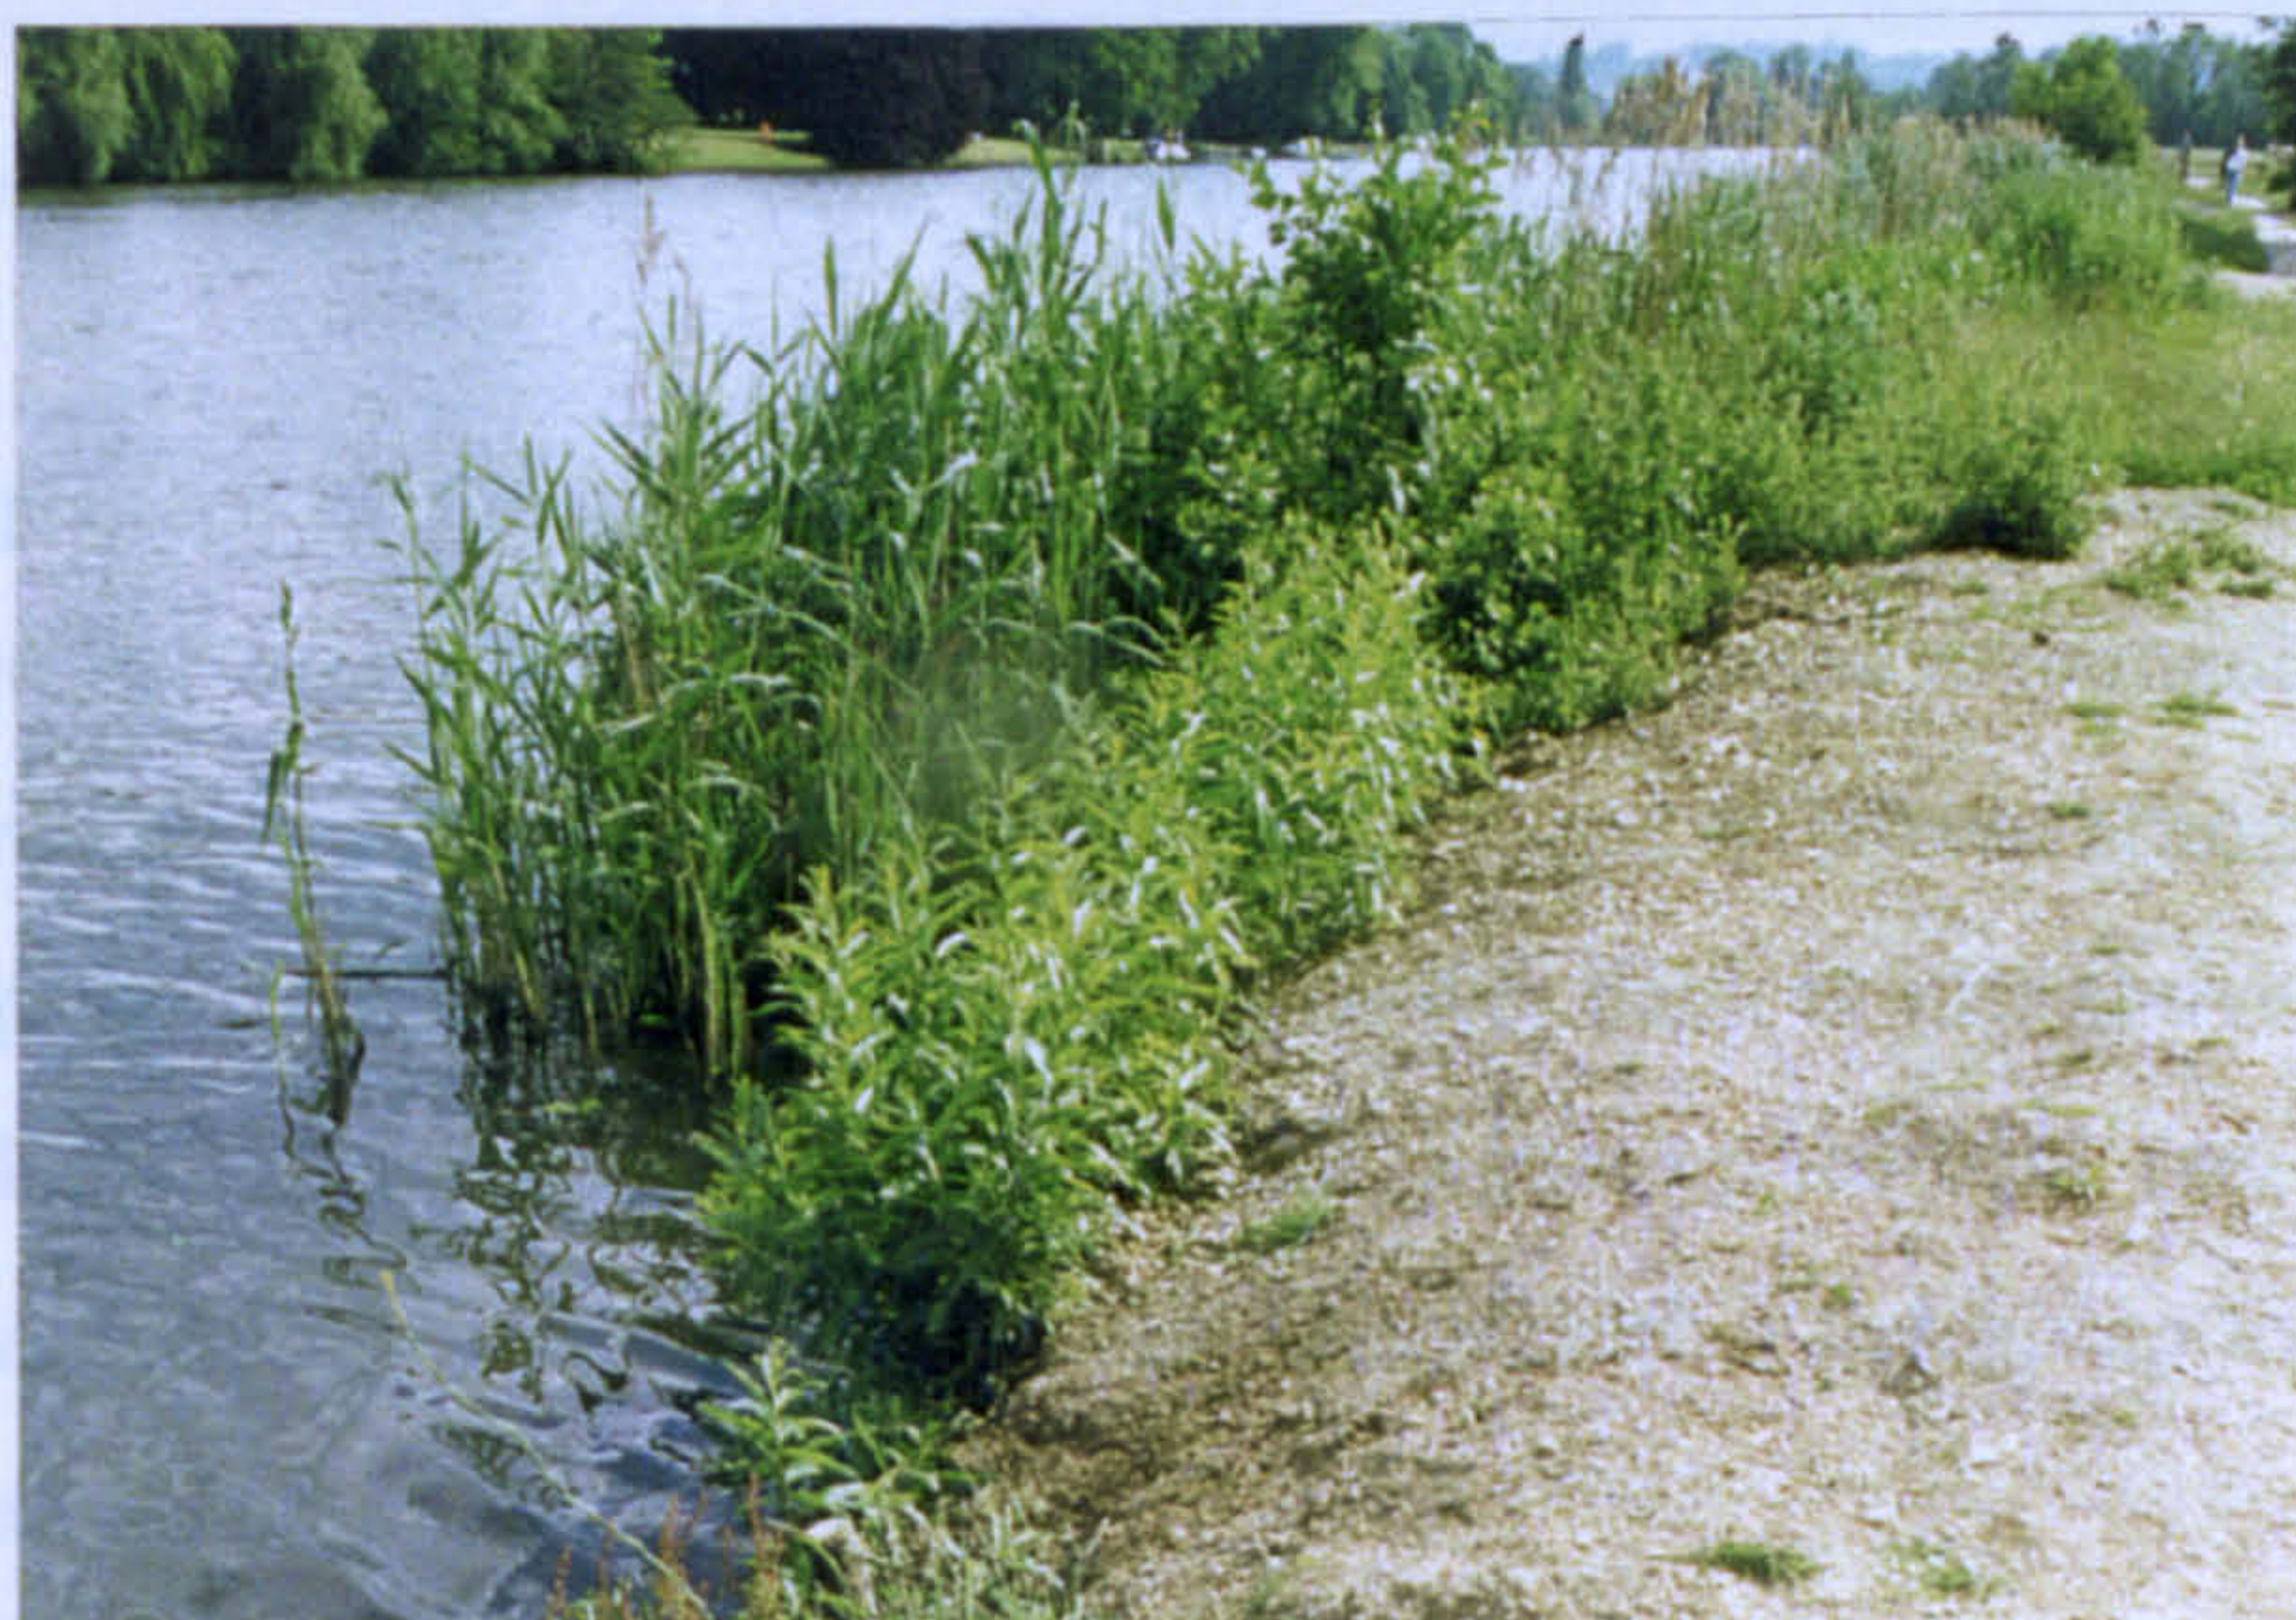
*Plate 6.24
Case study no. 14:
willow spiling bank
protection along
Marlow Reach.*

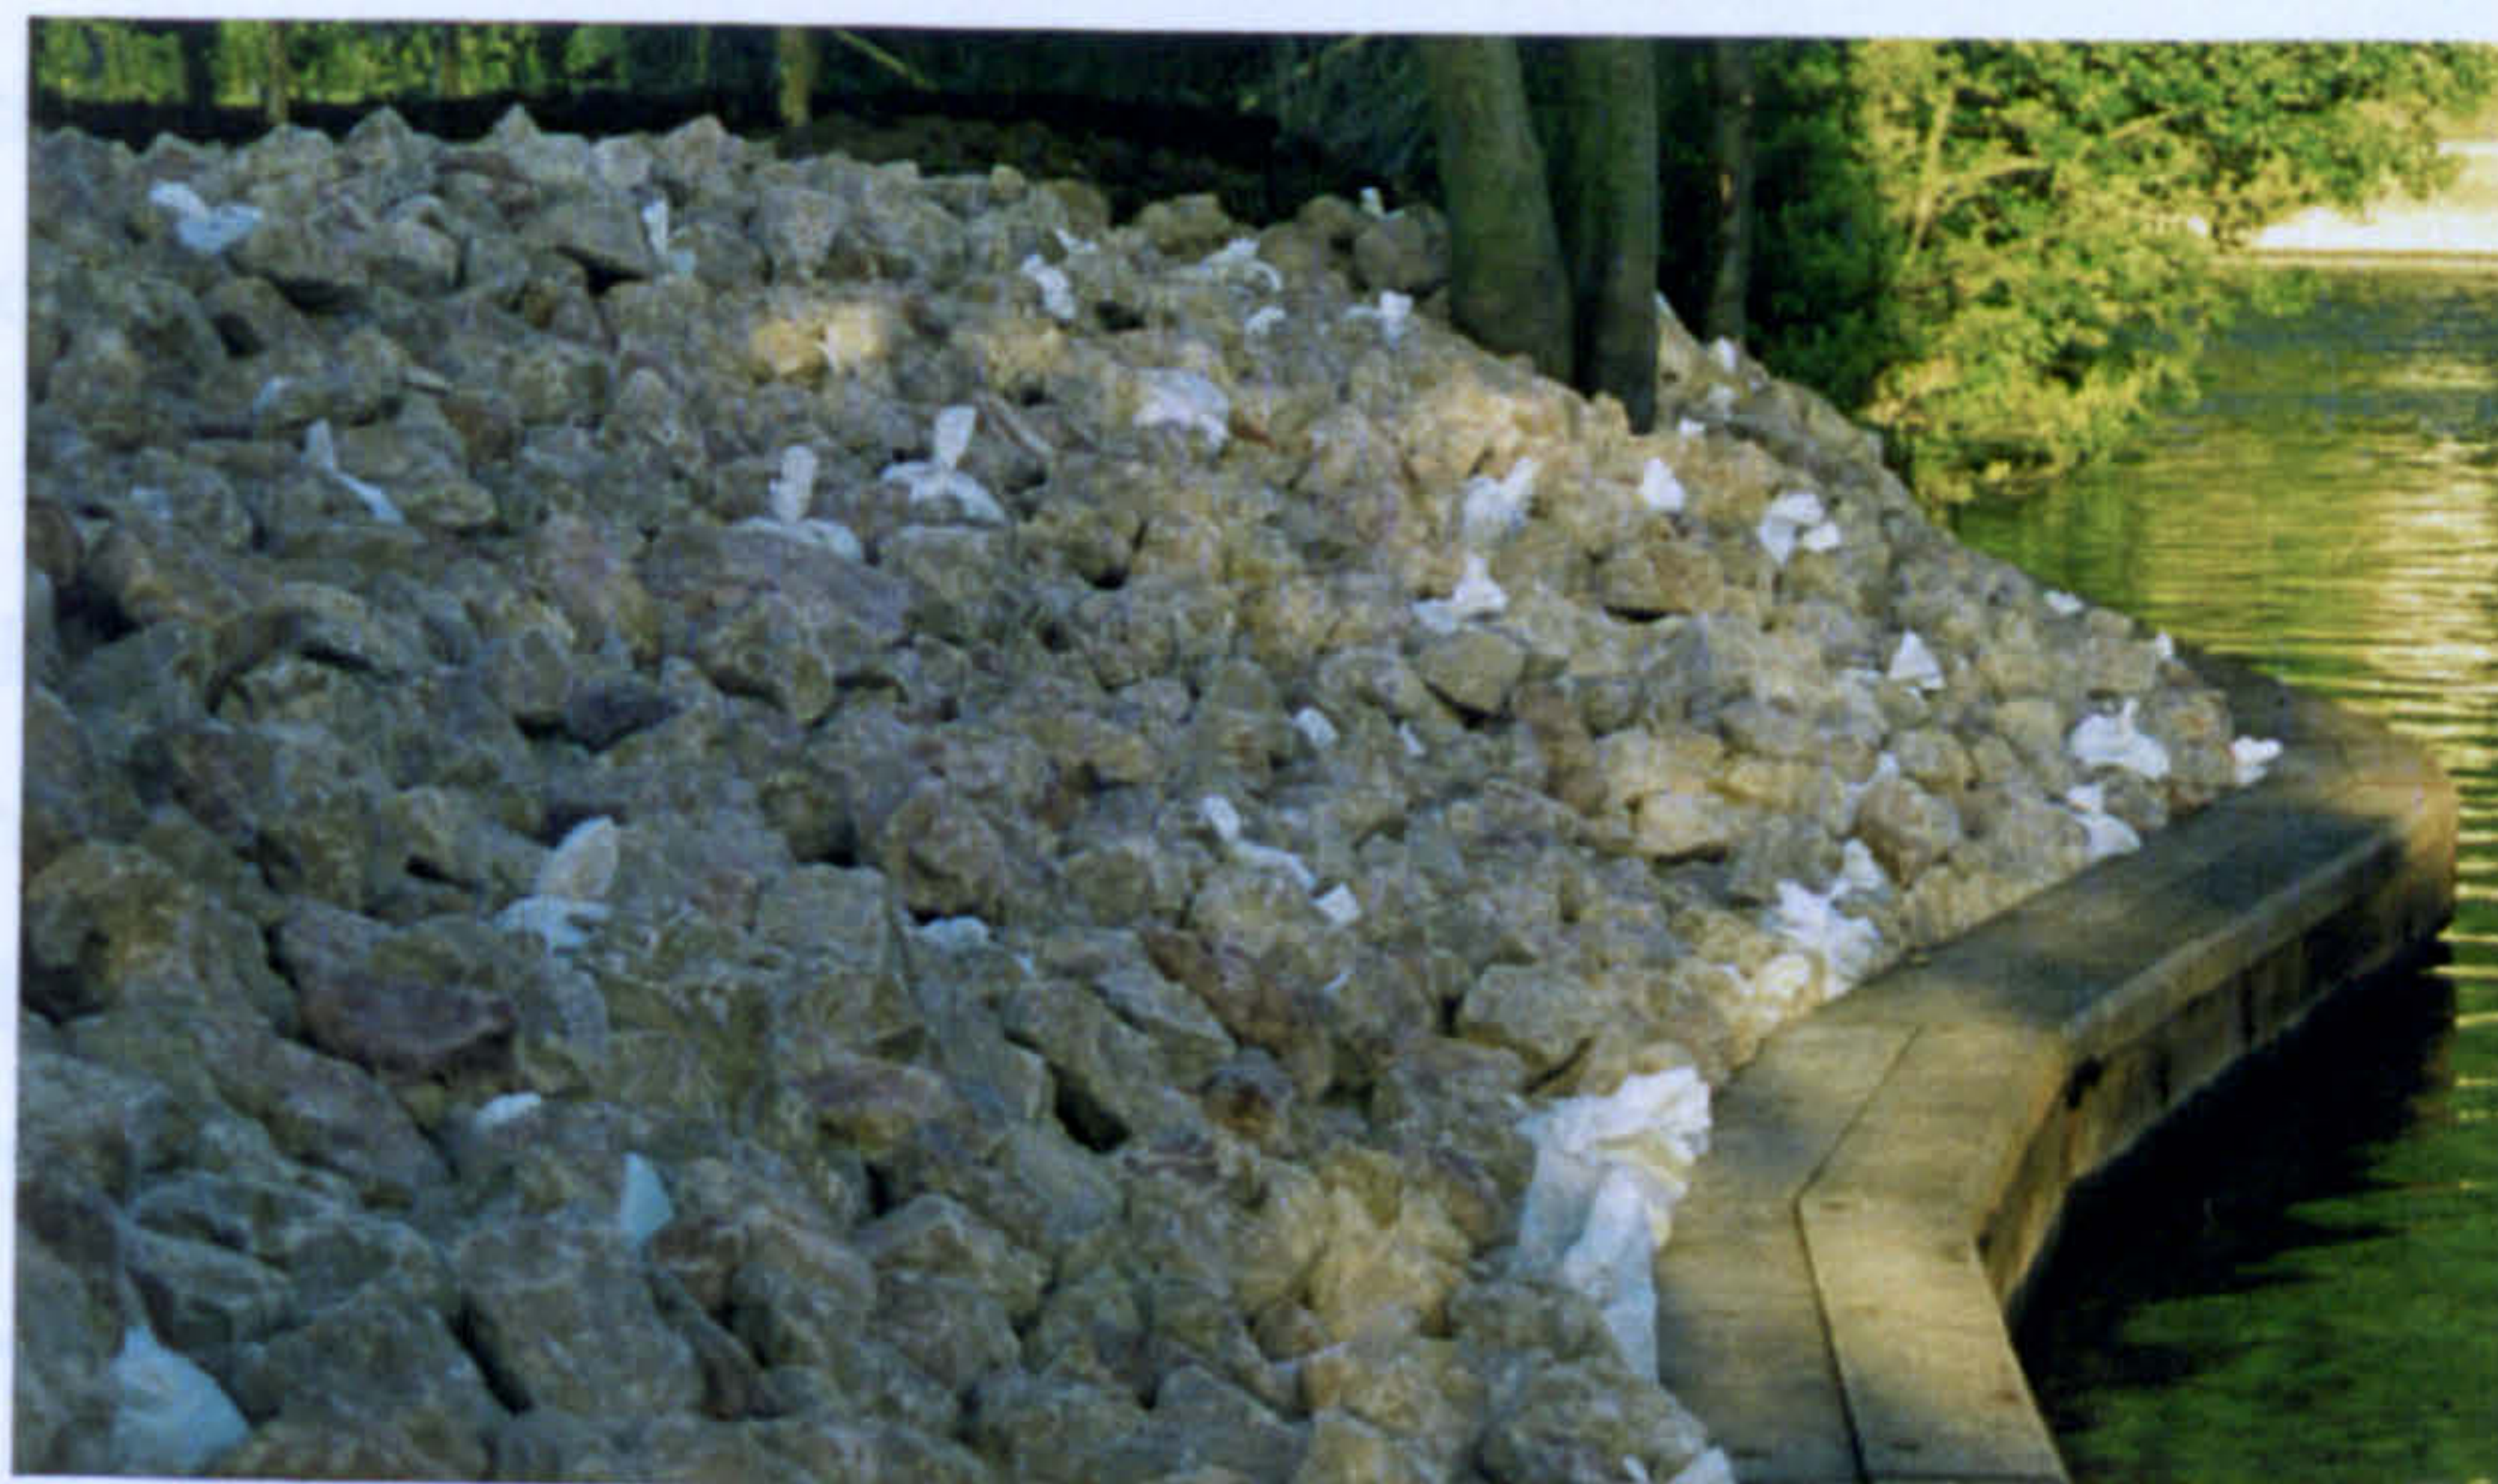
Judging the consequences of the slab failure to be 'important' and the major causes of erosion to be river processes (see Appendix 6.4), the Environment Agency's (1997) framework recommends strategies 4, 5 and 6. Sheet piling with a wooden capping beam was used to protect the lower bank to just above the standard water level and riprap was used to protect higher up the bank (see Plate 6.26). Willow plantings in hessian bags were placed within the riprap to accelerate revegetation (see Plate 6.27).

*Plate 6.26
Case study no. 15:
wood-capped sheet
piling and riprap
protection along
Cookham Reach,
after installation
in spring 1995*

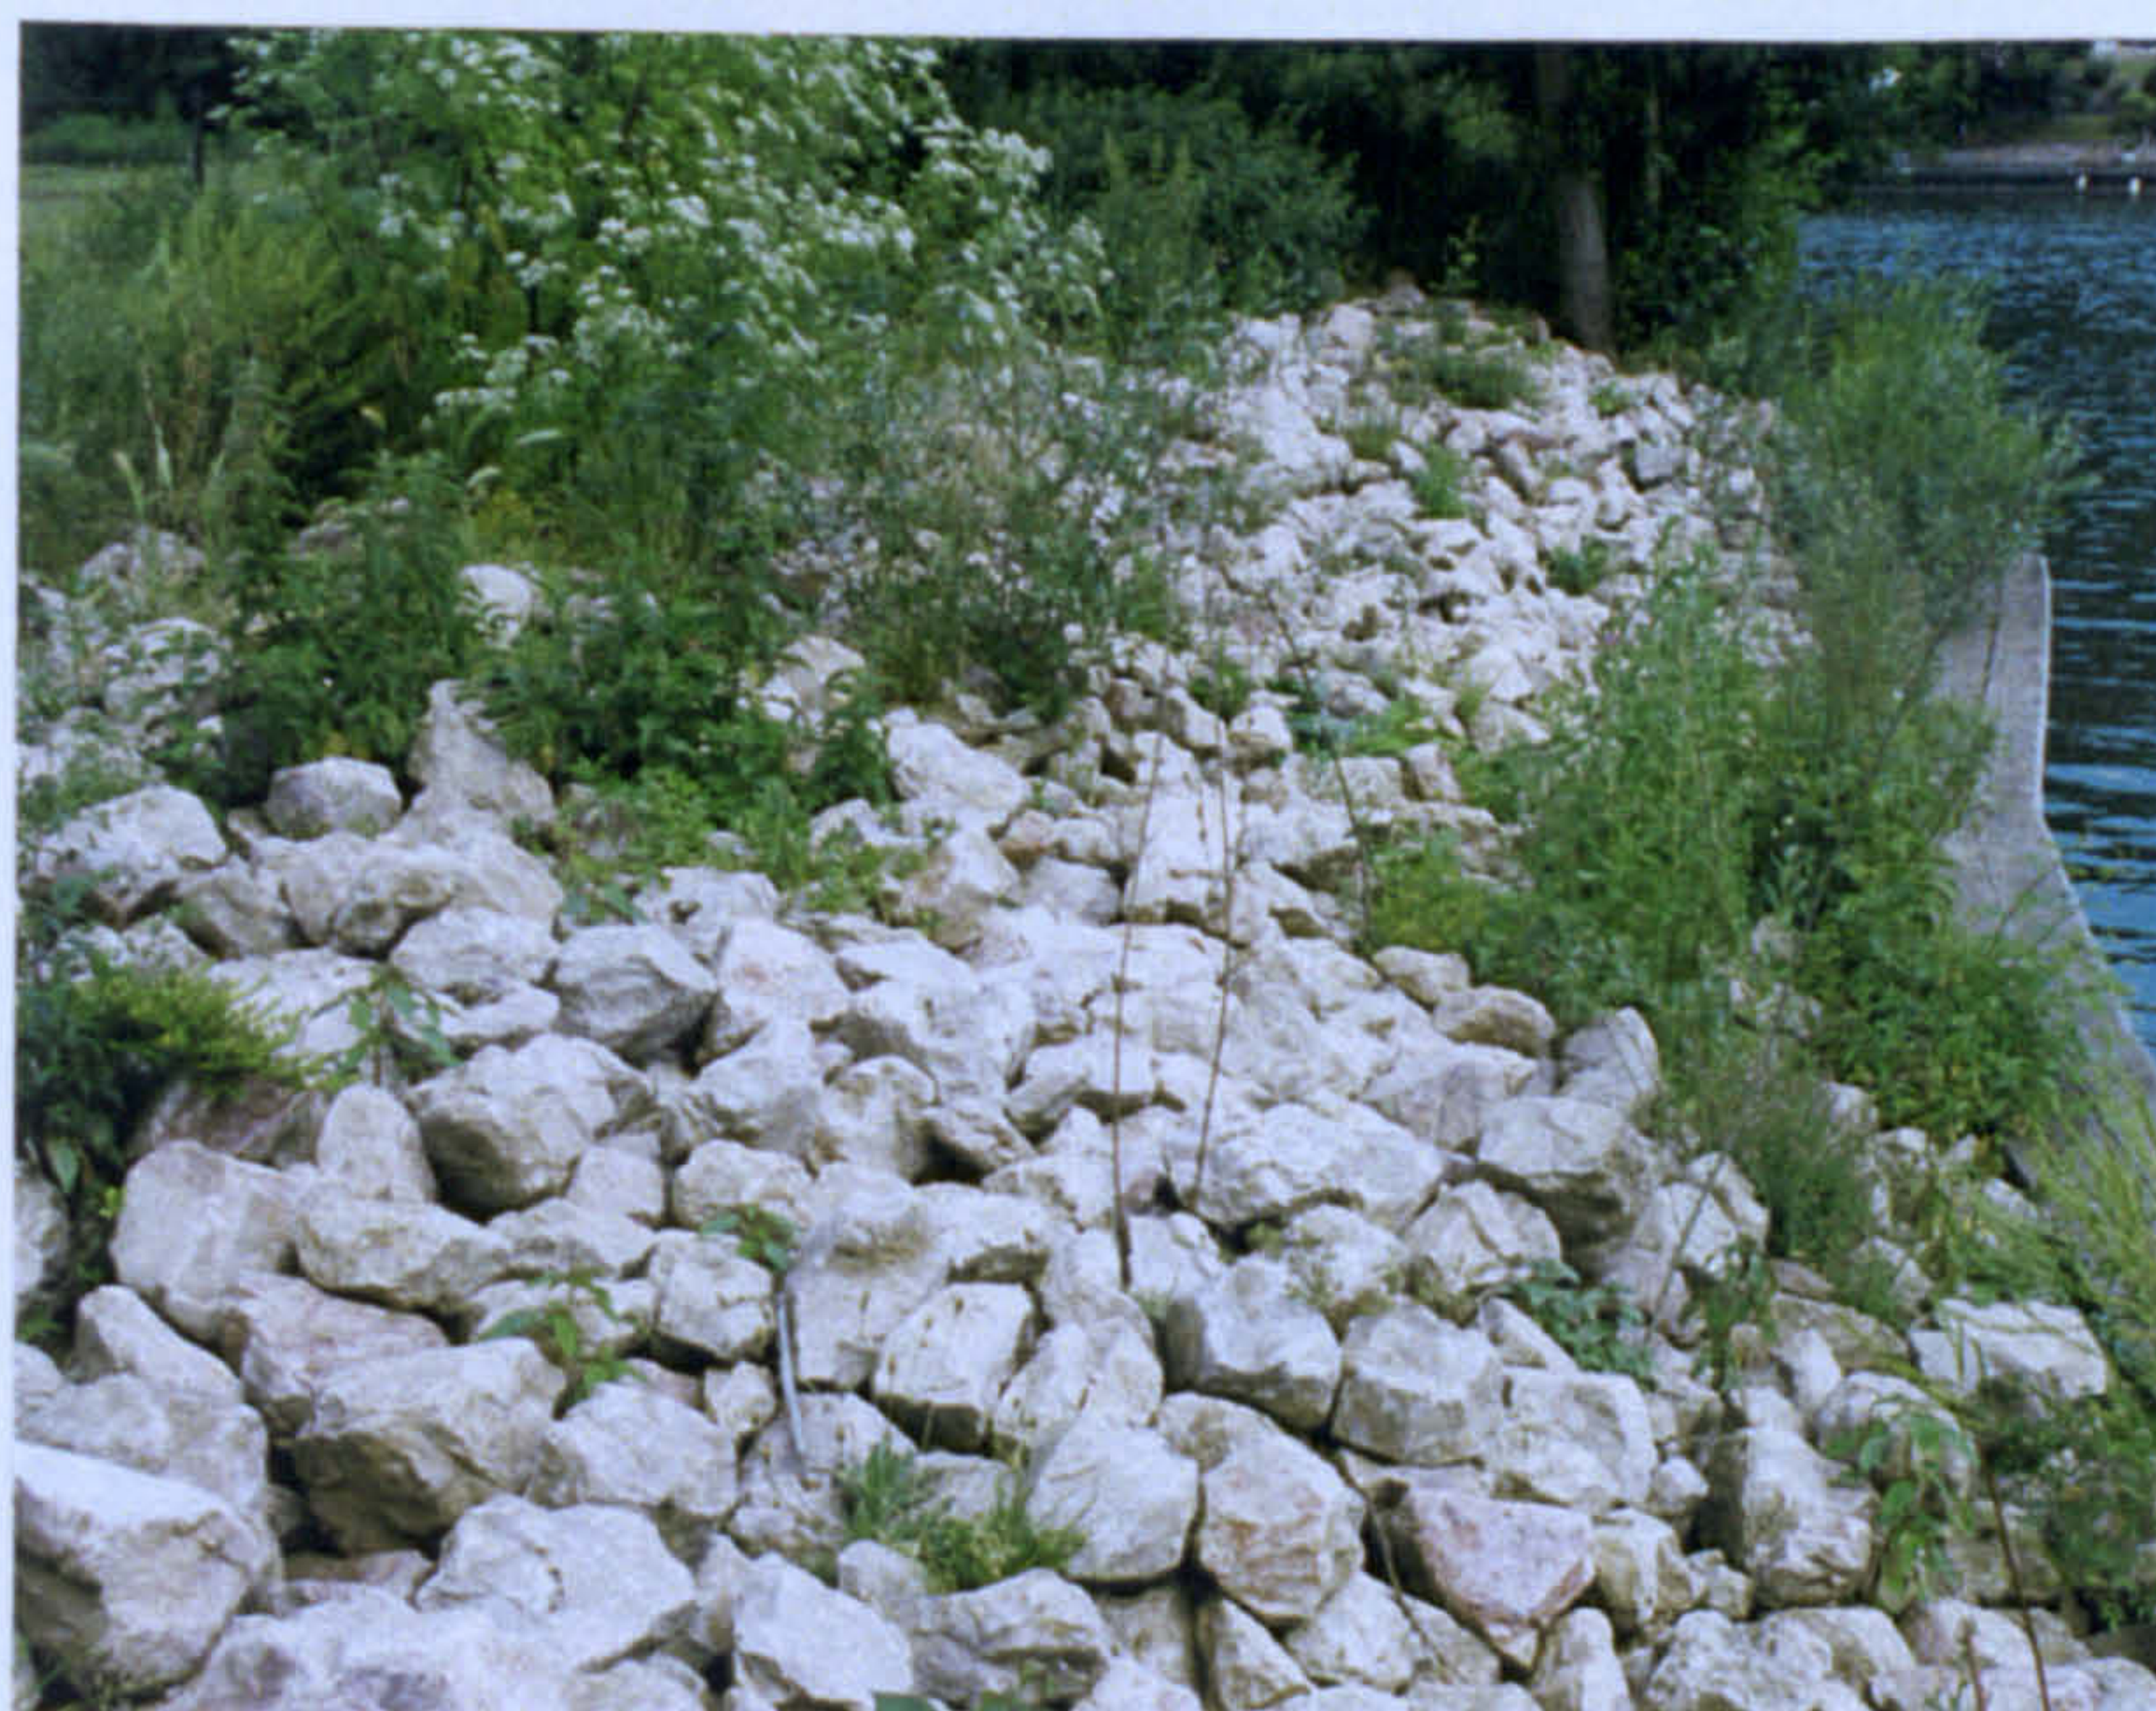
*Plate 6.27
Case study no. 15:
revegetation of
riprap protection
along Cookham
Reach (June 1997)*

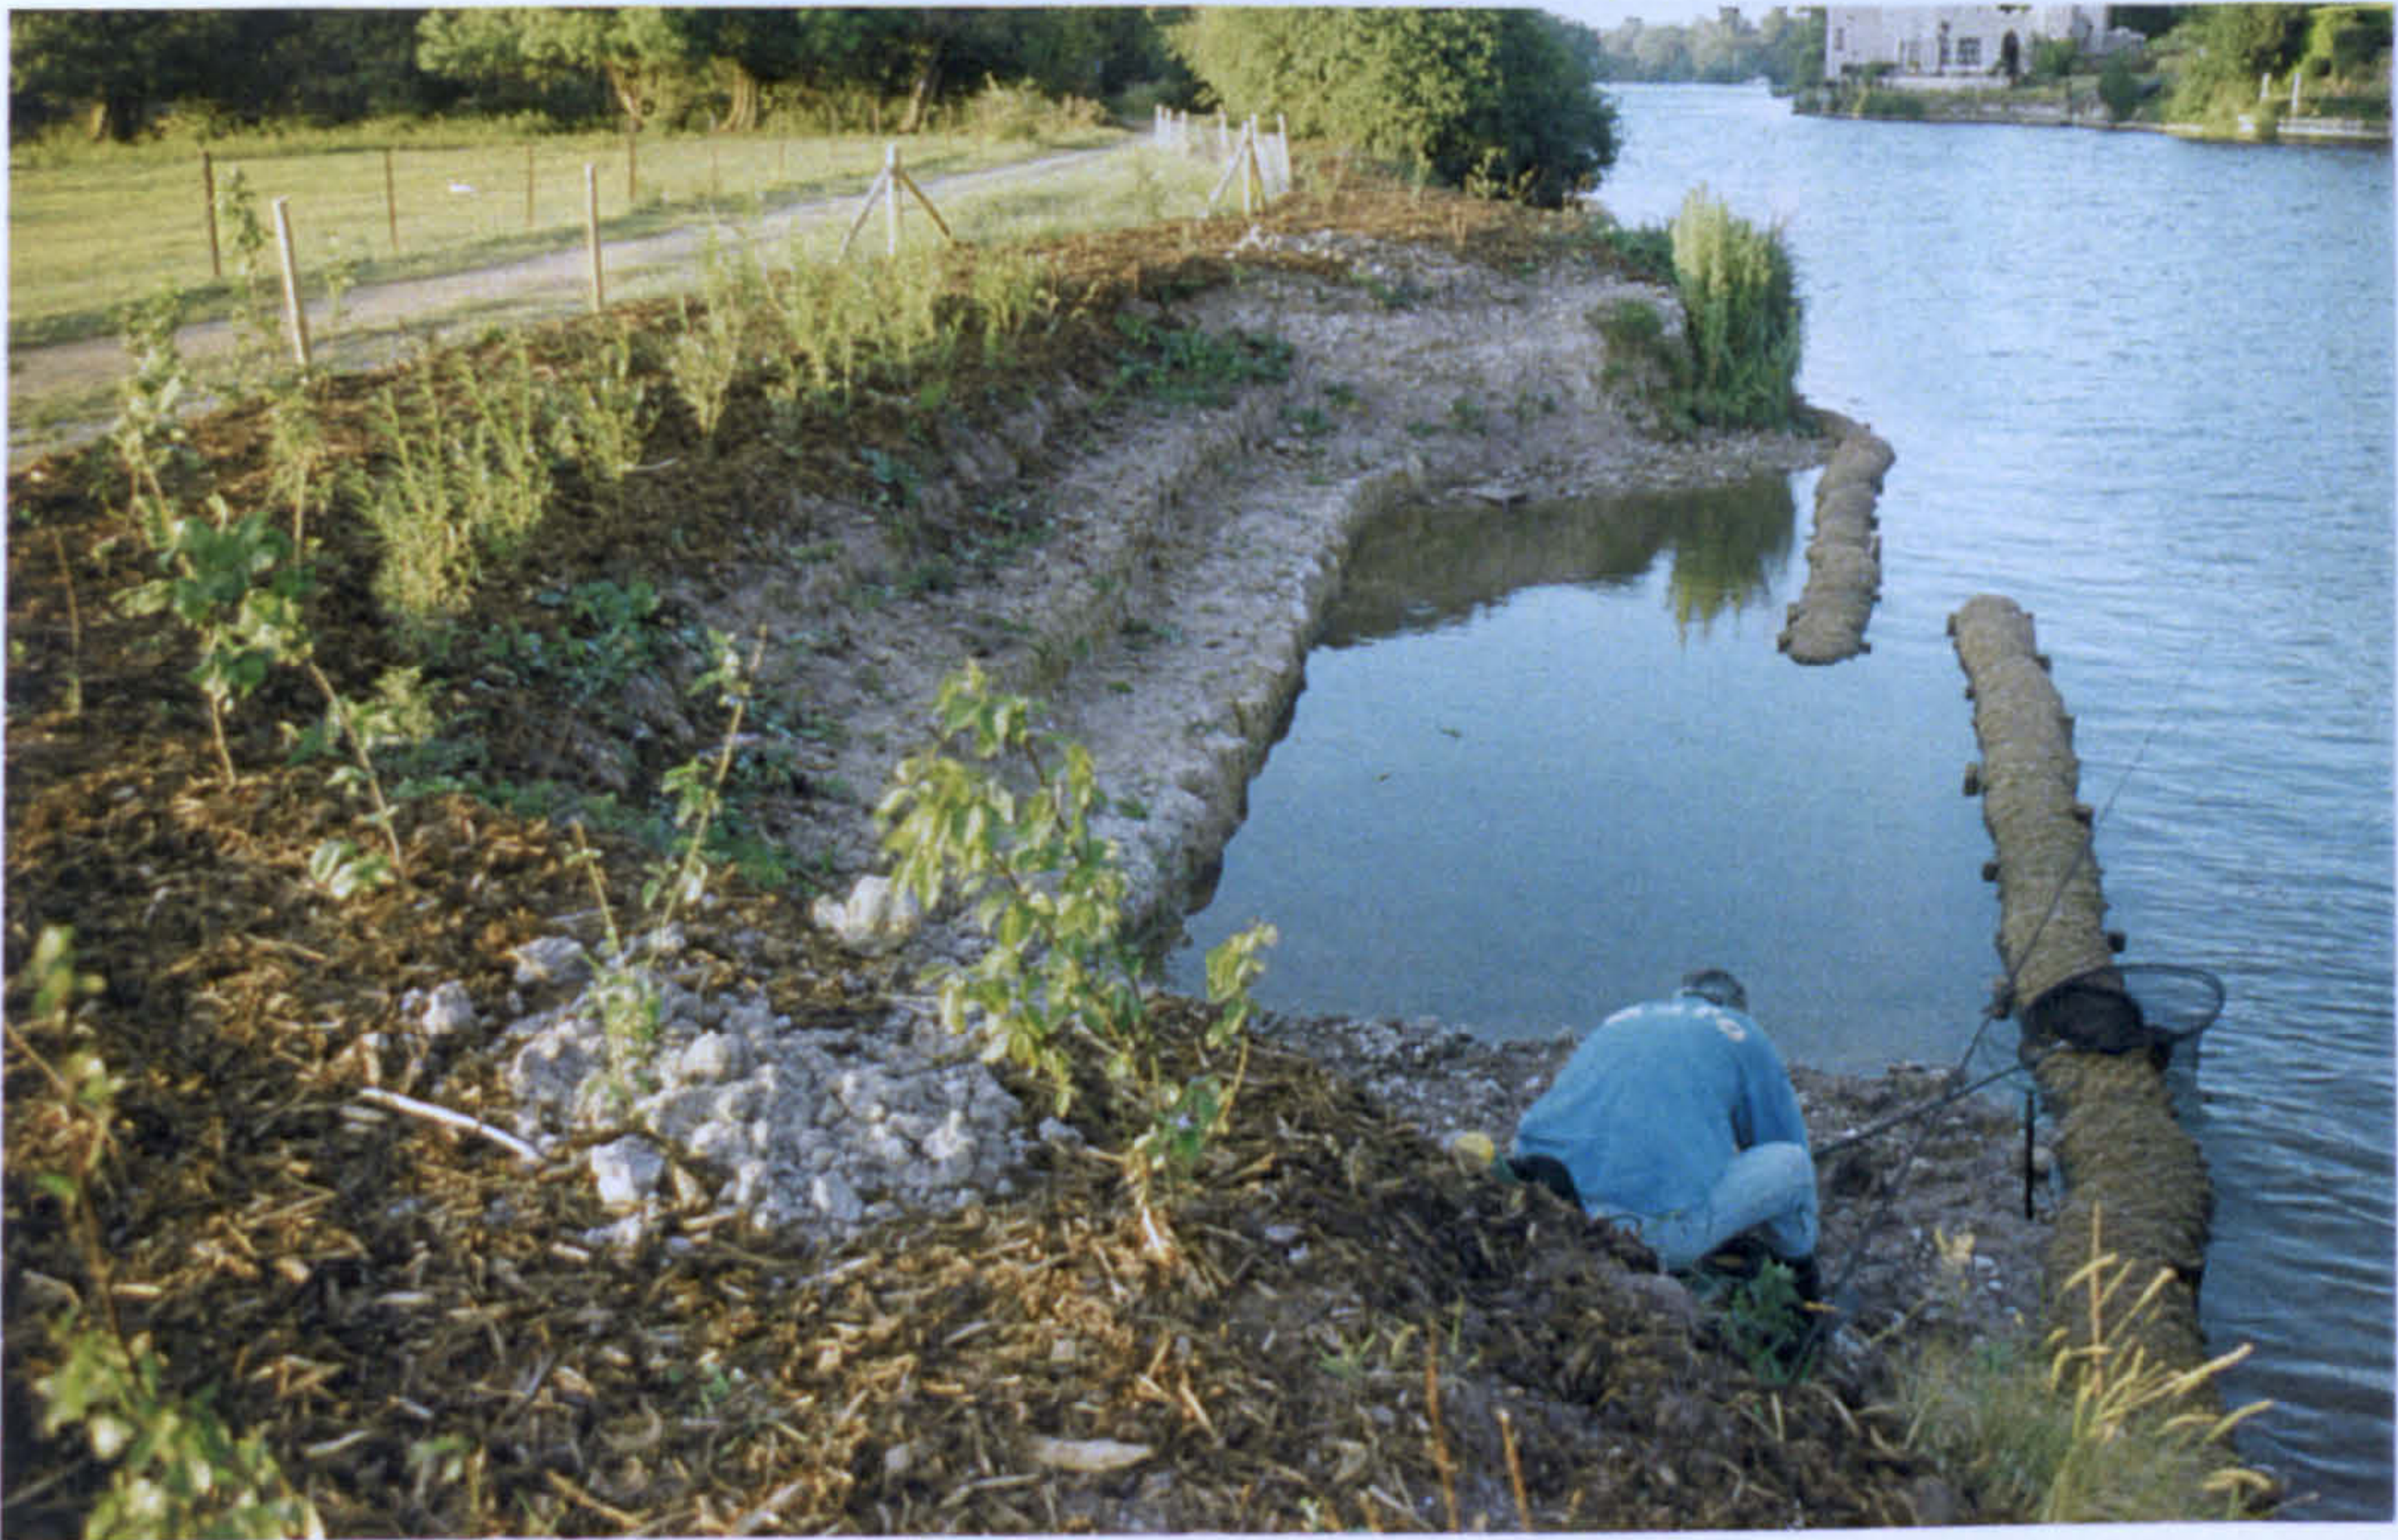
This bank protection project was undertaken as part of a larger project to construct new mooring facilities downstream of Marlow Lock. This reach of the River Thames is popular for angling and, in recognition of the impacts on angling that would result from the new mooring facilities, a number of mitigation measures were incorporated into the project. These included the removal of several lengths of old, redundant sheet piling and the construction of a fishing bay. The fishing bay was excavated along the inside of a bend and enclosed with coir fibre rolls planted with reeds (see Plate 6.28).

Plate 6.28 Case study no. 15: fishing bay excavated along Cookham Reach as an environmental enhancement

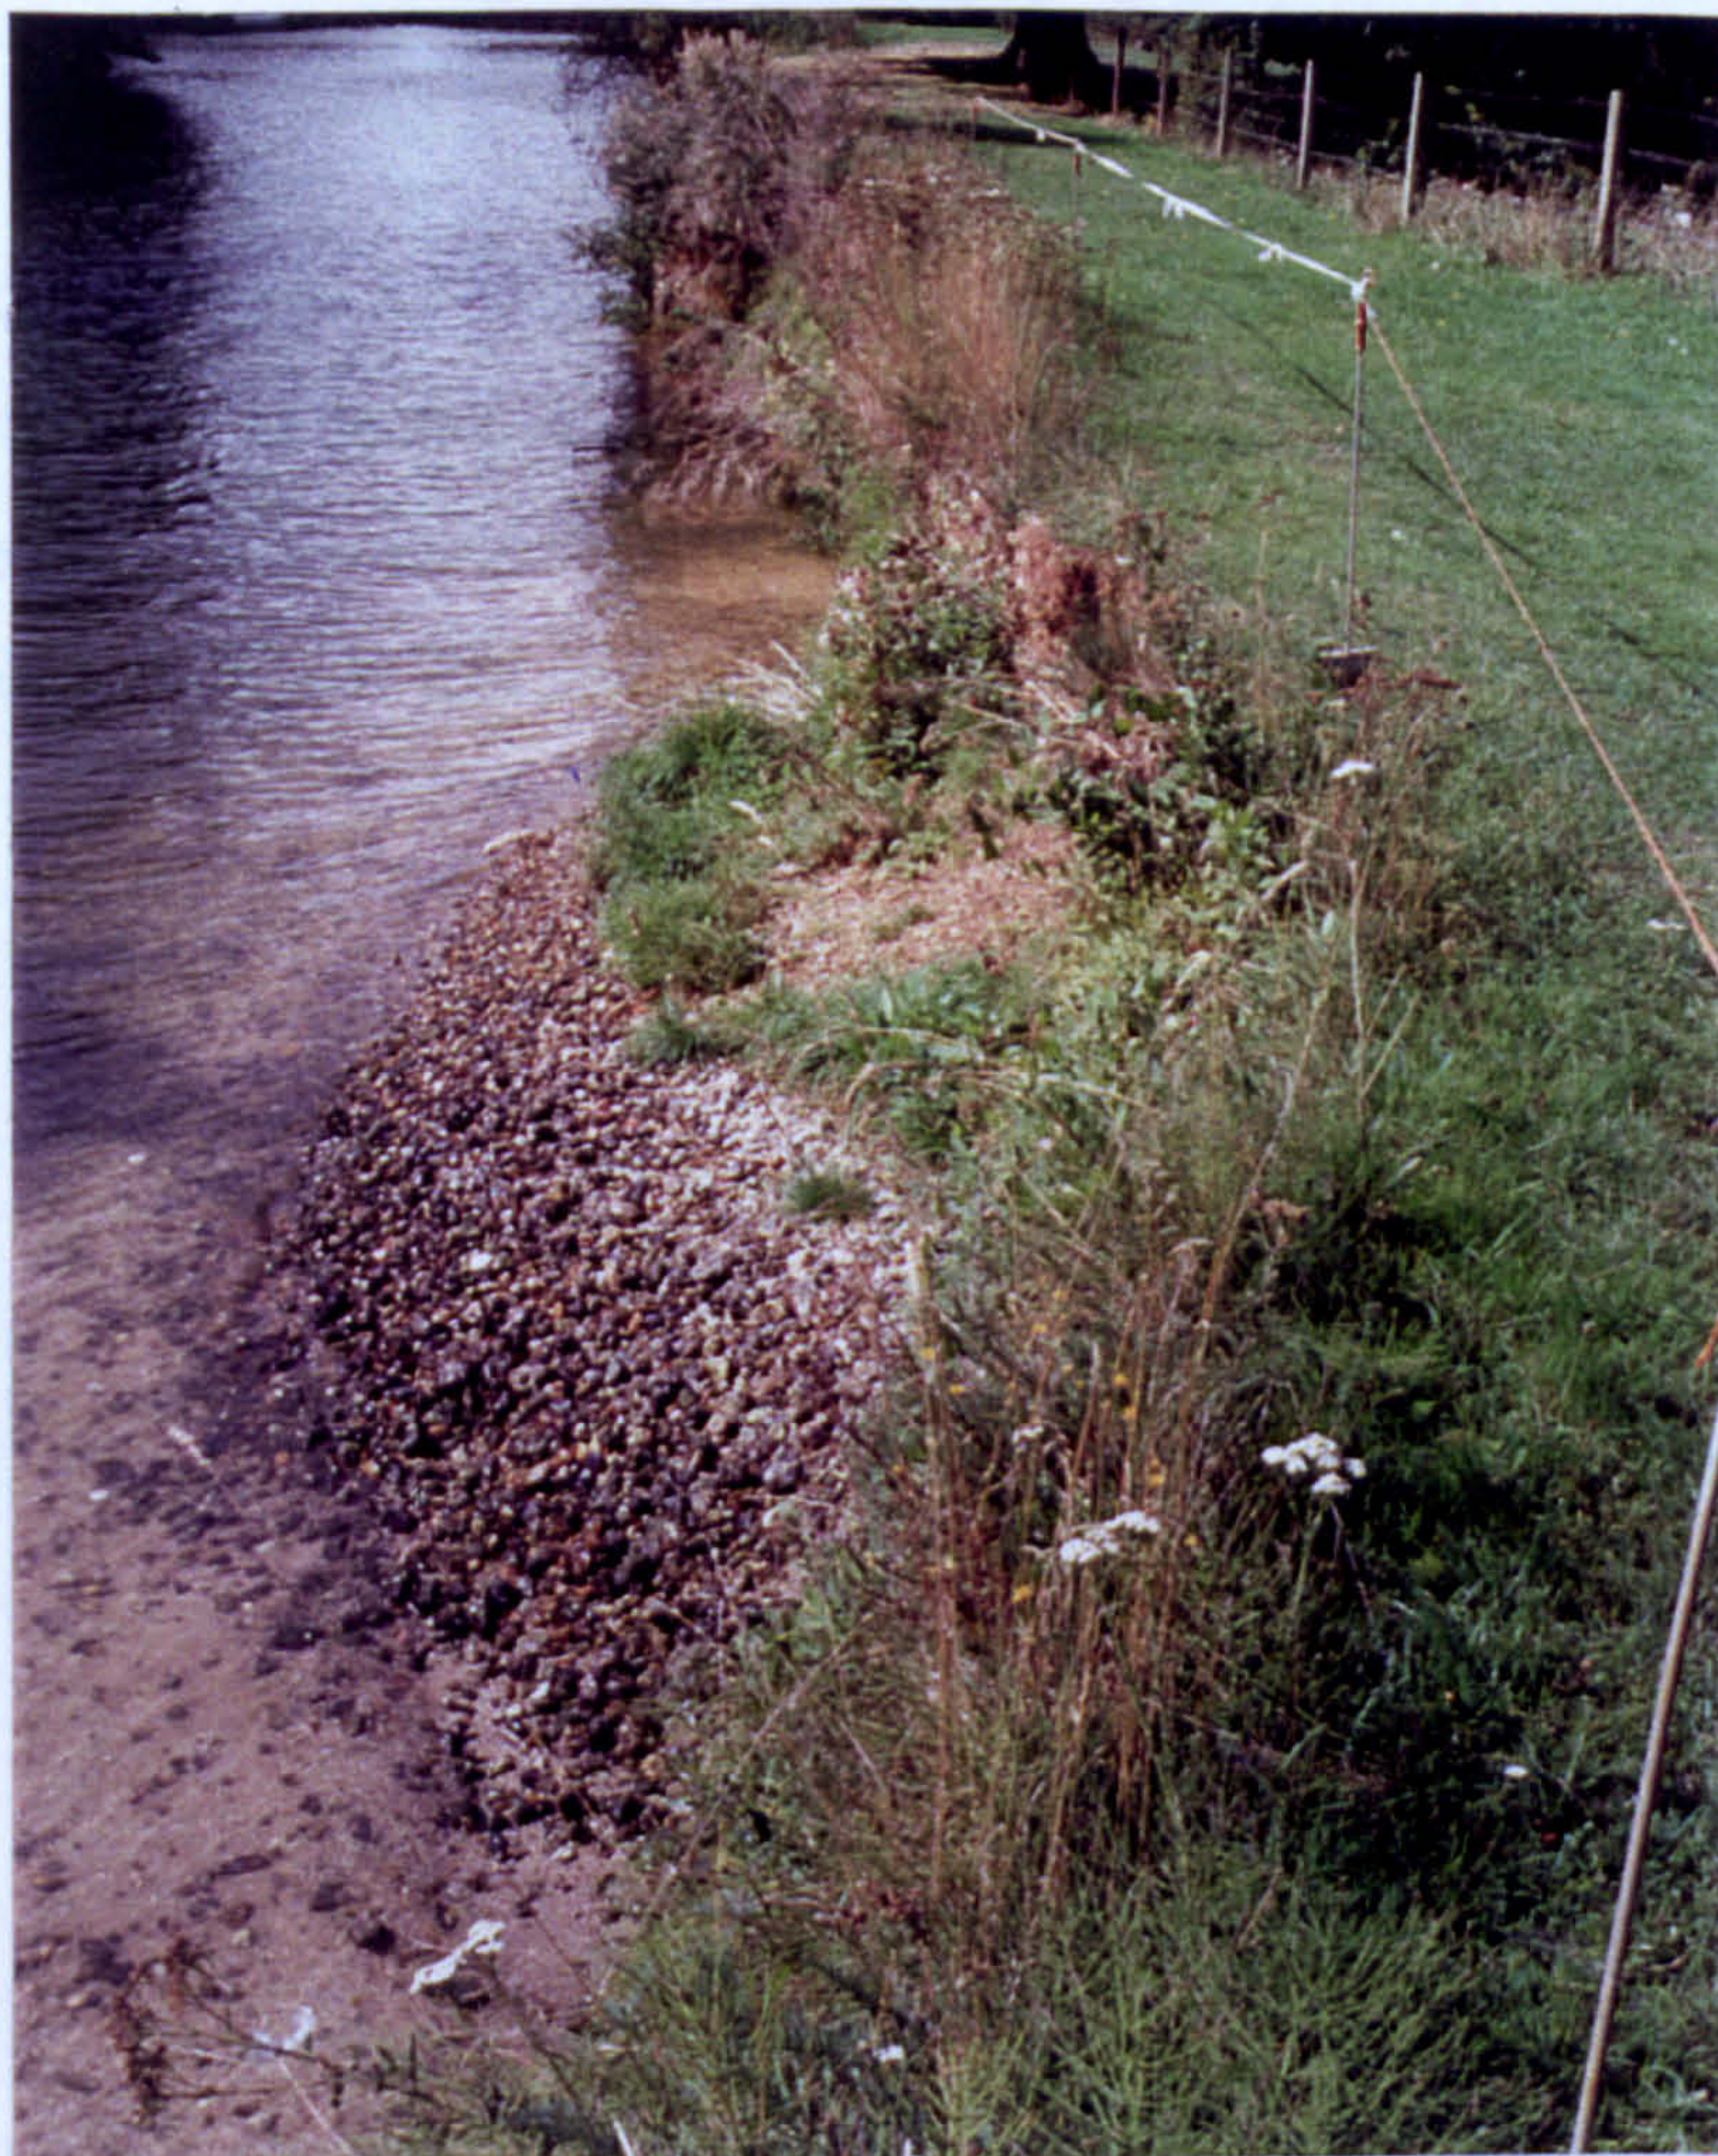
This site is at the upstream end of Cookham Lock Cut, along the right bank of Sashes Island. Originally, the bank was vertical and approximately 1.2m high (see Plate 6.29). The major factors contributing to erosion here were identified as access for fishing and boat wash along the lock cut. In addition, the bank upstream is protected with a length of sheet piling that will tend to concentrate high velocity flow near the unprotected bank downstream.

Plate 6.29
Case study no. 16:
bank erosion along
Cookham Lock Cut
