**"THE NON-TIDAL, NAVIGABLE THAMES:
A BANK EROSION MANAGEMENT STRATEGY"**

by Sue Reed BSc, MSc, MCIWEM

**Thesis submitted to the University of Nottingham
for the degree of Doctor of Philosophy, October 1998**

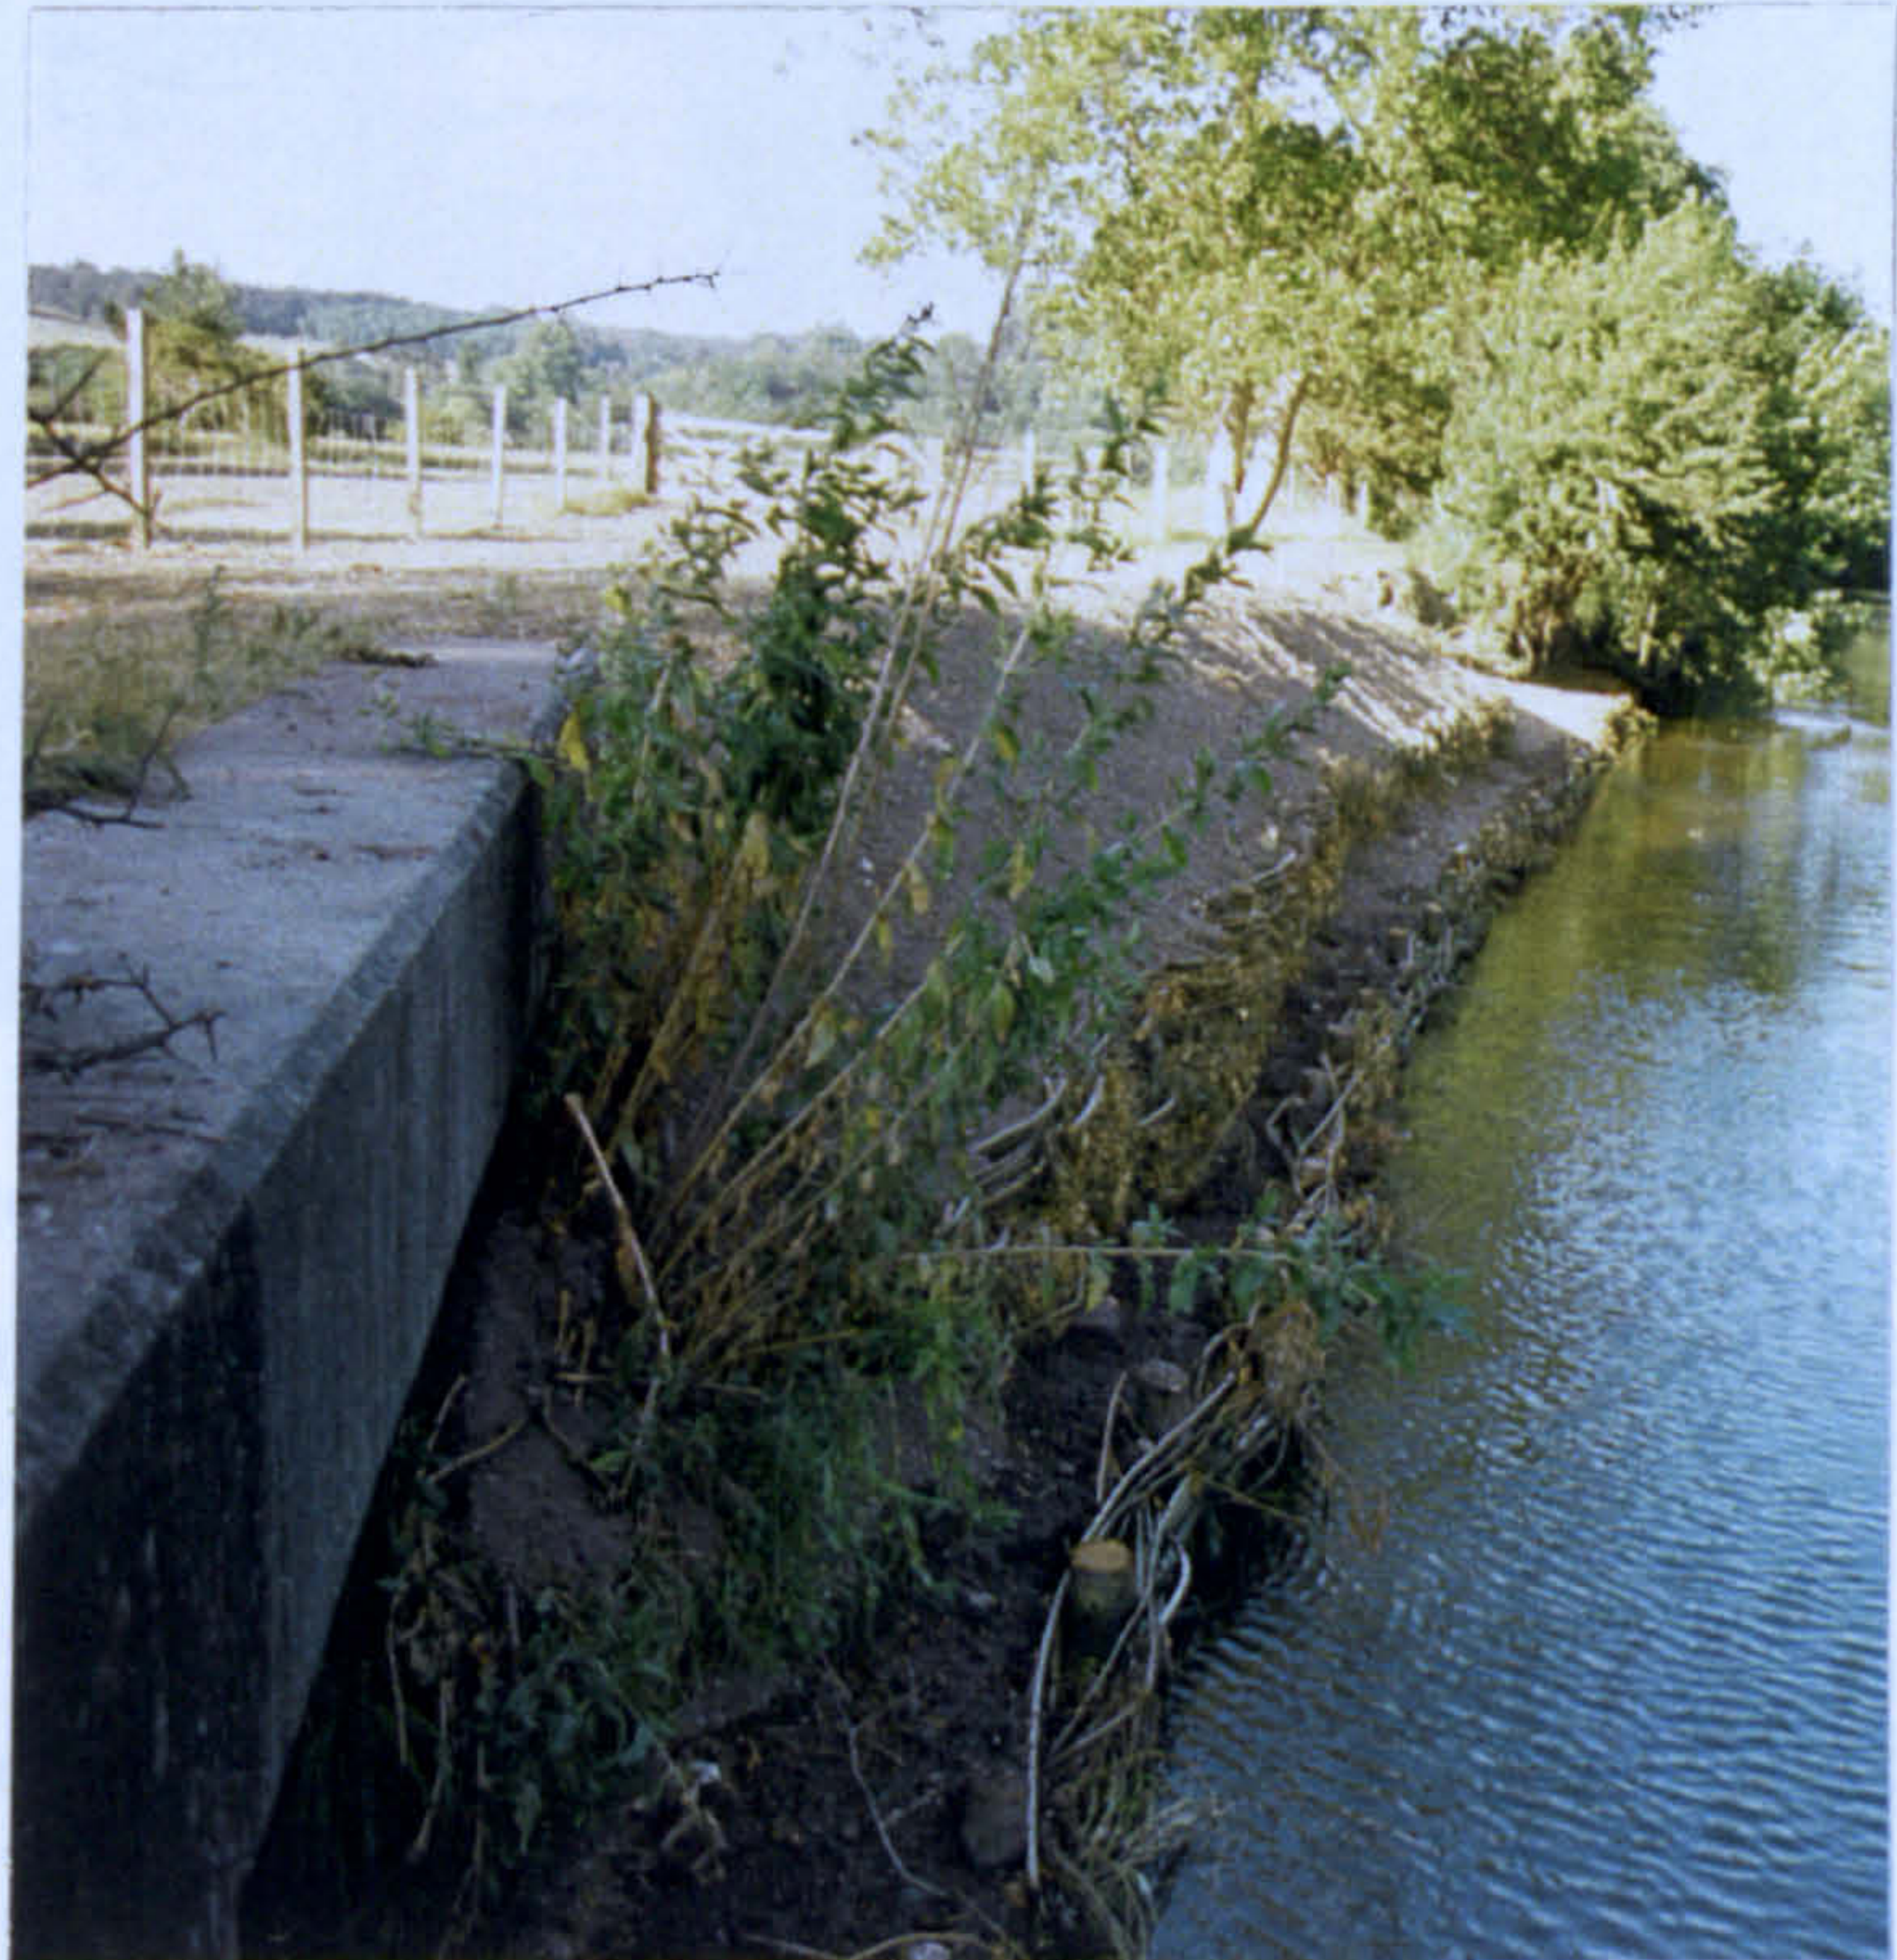
In order to accommodate access for anglers, the bank was regraded to stepped profile and willow spiling was installed to protect the toe and shelf (see Plate 6.30). As a further enhancement measure, flint gravels were placed at the toe of the bank to provide additional fish spawning habitat.

*Plate 6.30
Case study no. 16:
willow spiling along
Cookham Lock Cut*

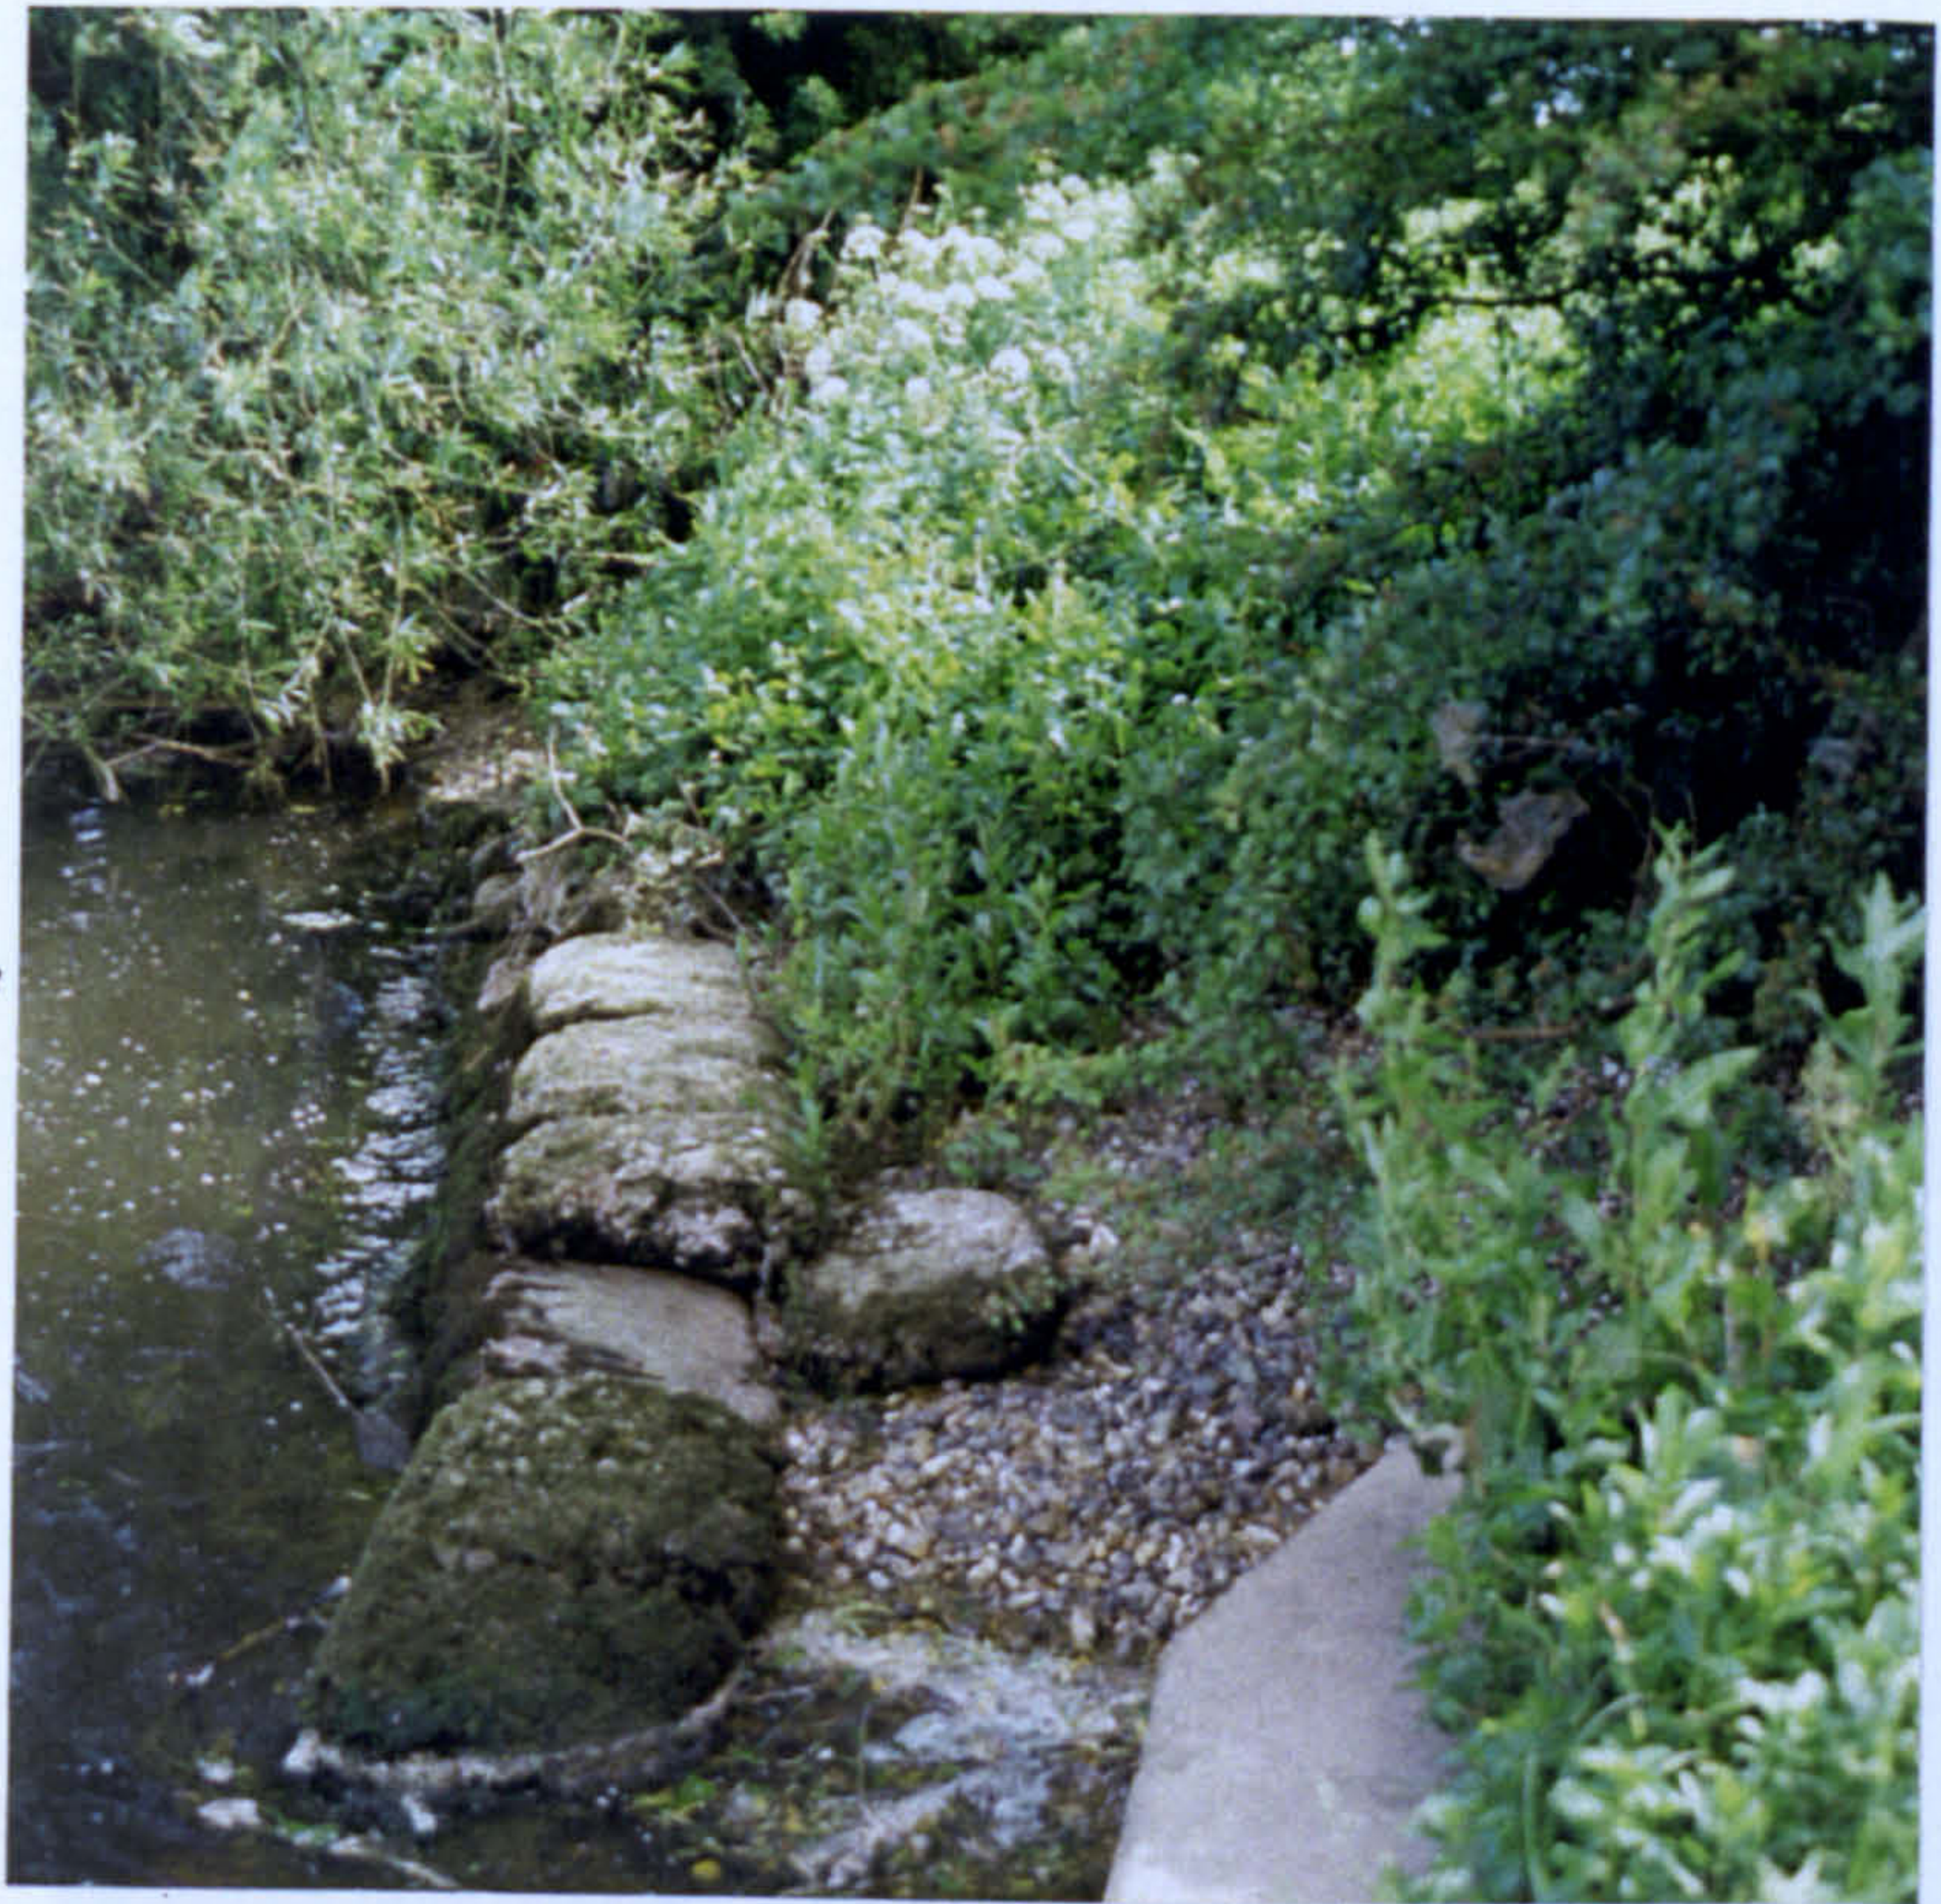
This site is directly opposite Cookham Weir and on the other side of Sashes Island to Case study no. 16, described above. The eroding bank was downstream of a length of intact sheet piling where the displaced concrete bagwork is shown in Plate 6.31. Continued erosion of the bank and a resulting breach across the Island would lead to a similar flood risk to that described for Case study no. 16. However, flow opposite the weir would reach significantly higher velocities than along the lock cut and, therefore, the consequences of continued erosion were considered 'severe'.

Plate 6.31
Case study no. 17:
Bank erosion opposite
Cookham Weir

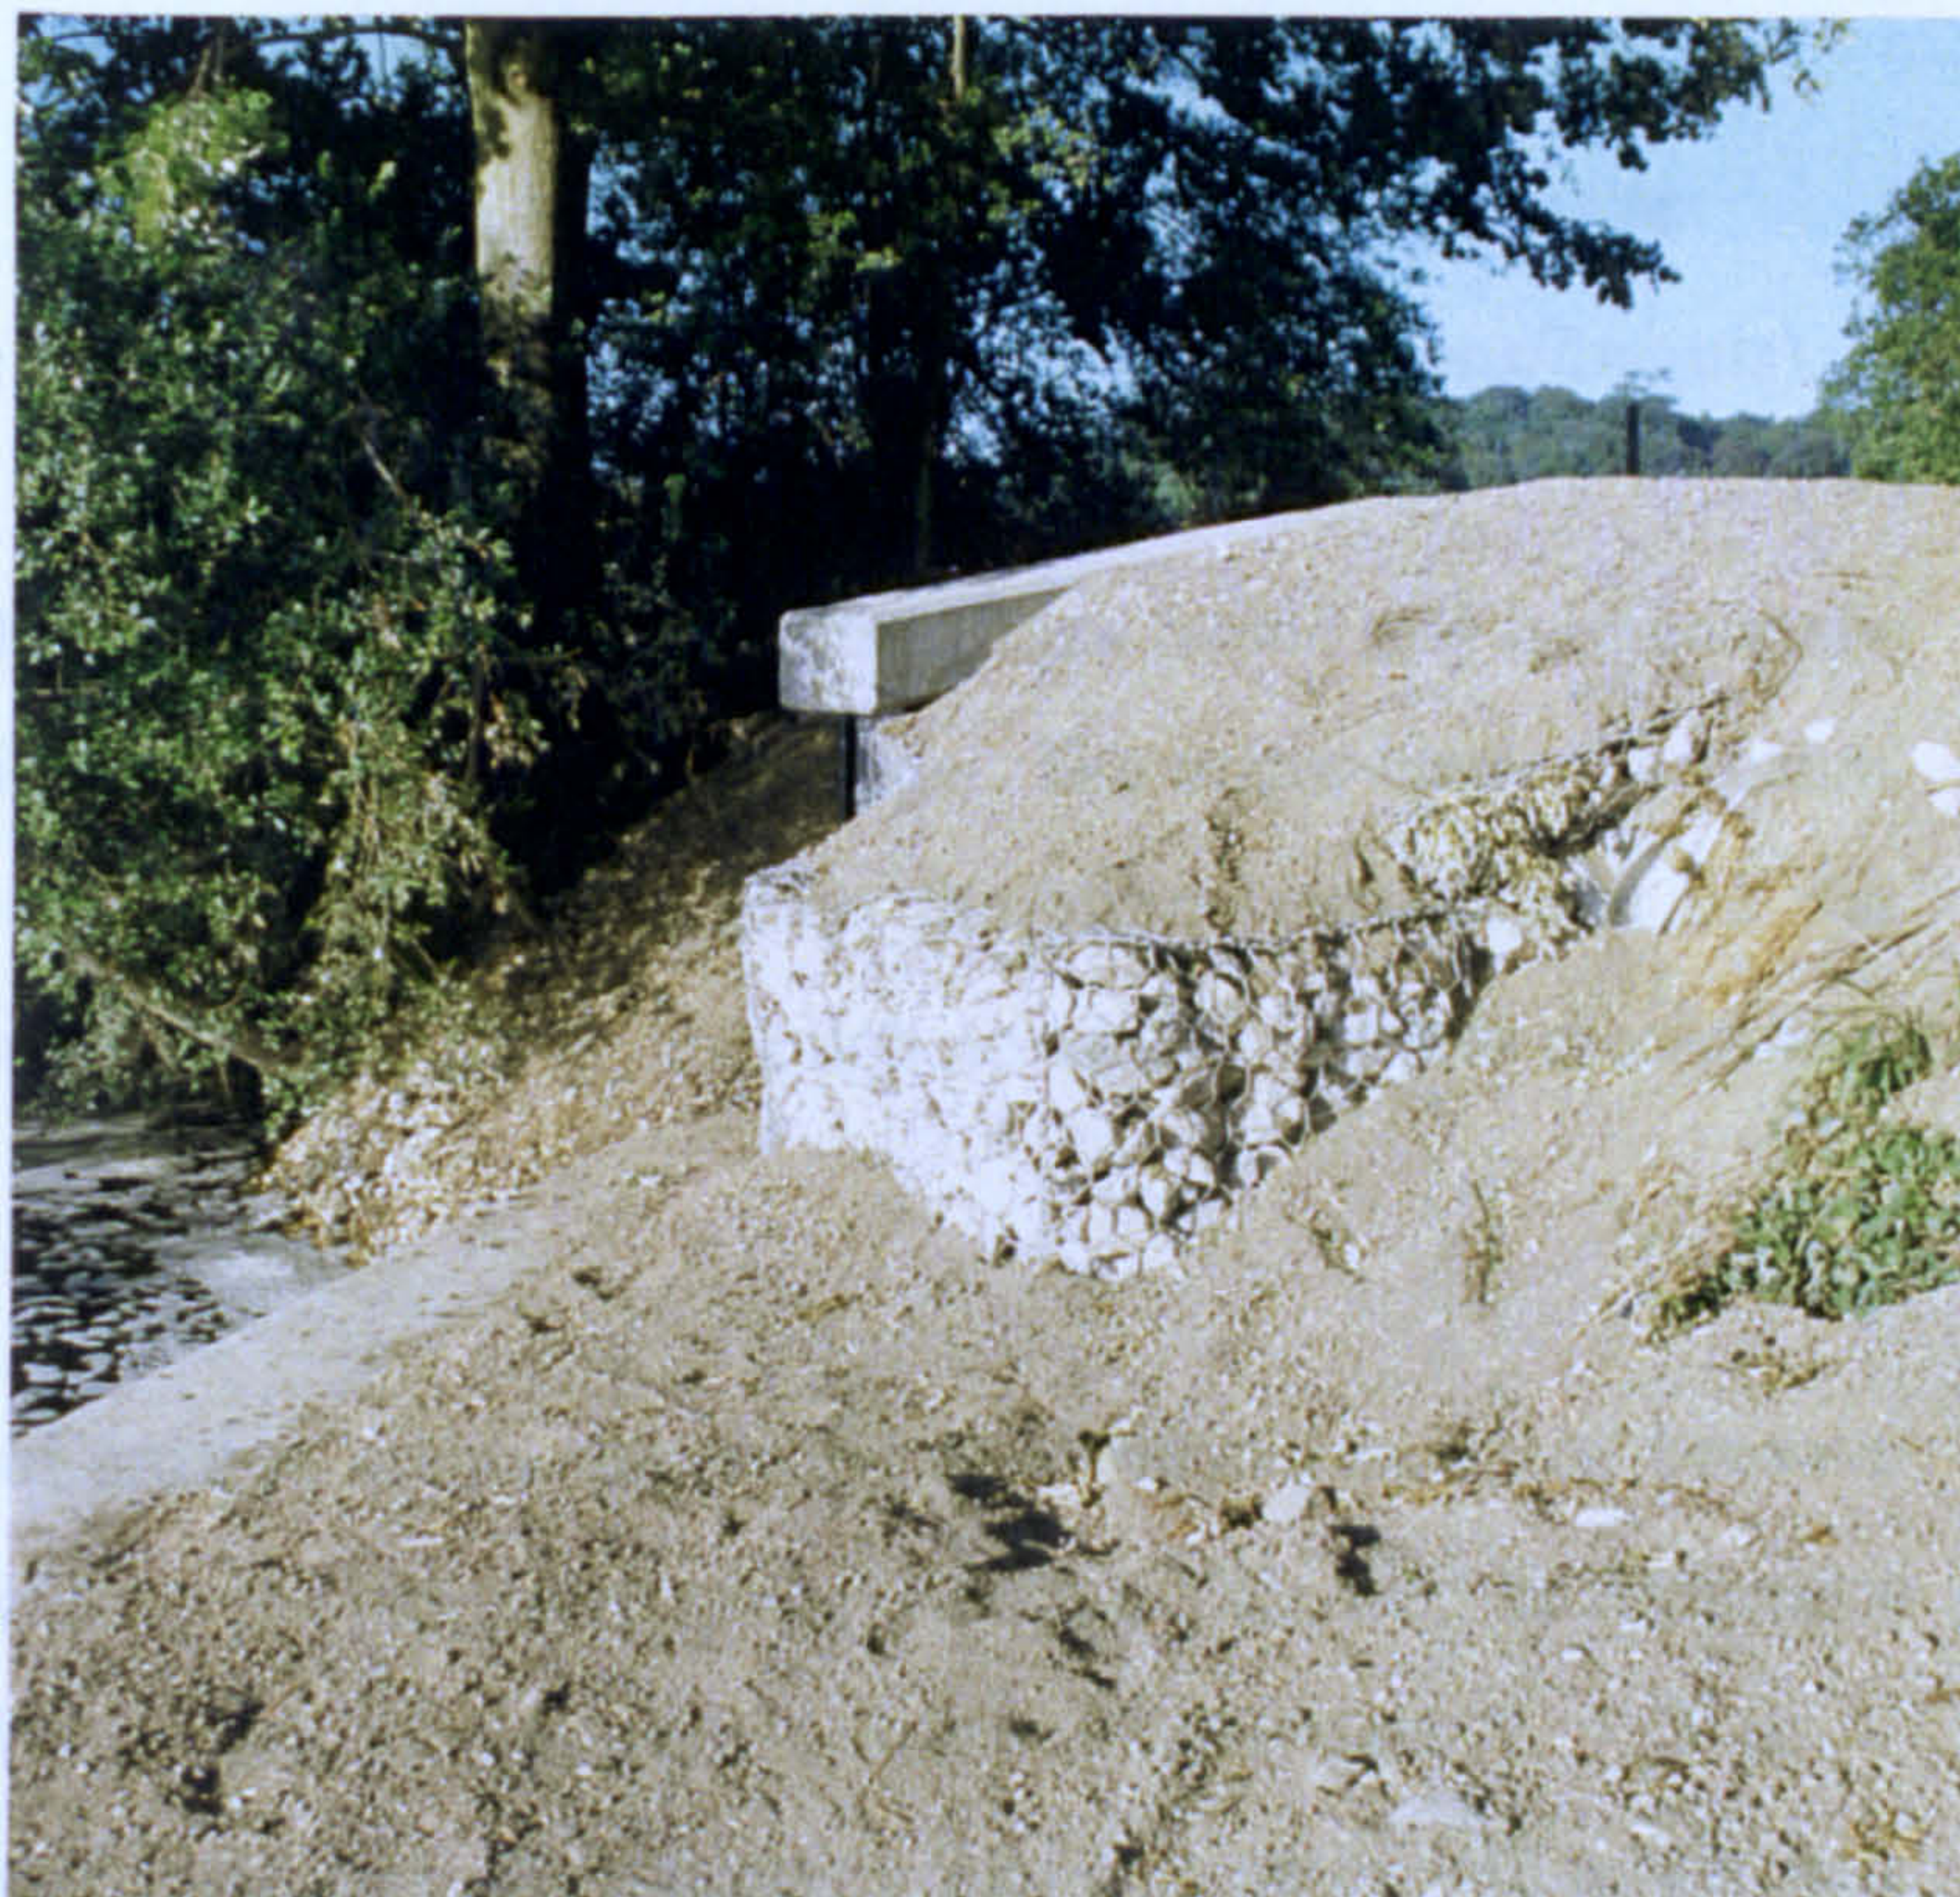
The author participated as the geomorphology specialist in the design team for this project in the way described by Brookes (1995). Consideration of the relatively high turbulence expected downstream of the weir led the author to propose an option to regrade and the bank to a stepped profile using gabion baskets as protection. However, the limited space available and the detrimental impact on the mature vegetation at the top of the bank meant that this option was not pursued. Alternatively, sheet piling was installed to protect the toe of the bank, with gabion baskets above the piling to protect higher up the bank and prevent high flows from the weir causing erosion behind the piles (see Plate 6.32). The site was also seeded with a wild-flower mix and has since revegetated sufficiently to mask the visual appearance of the hard engineering structure (see Plate 6.33).

Plate 6.32
Case study no. 17:
sheet piling and
gabion baskets
opposite Cookham
Weir (June 1995,
after construction)

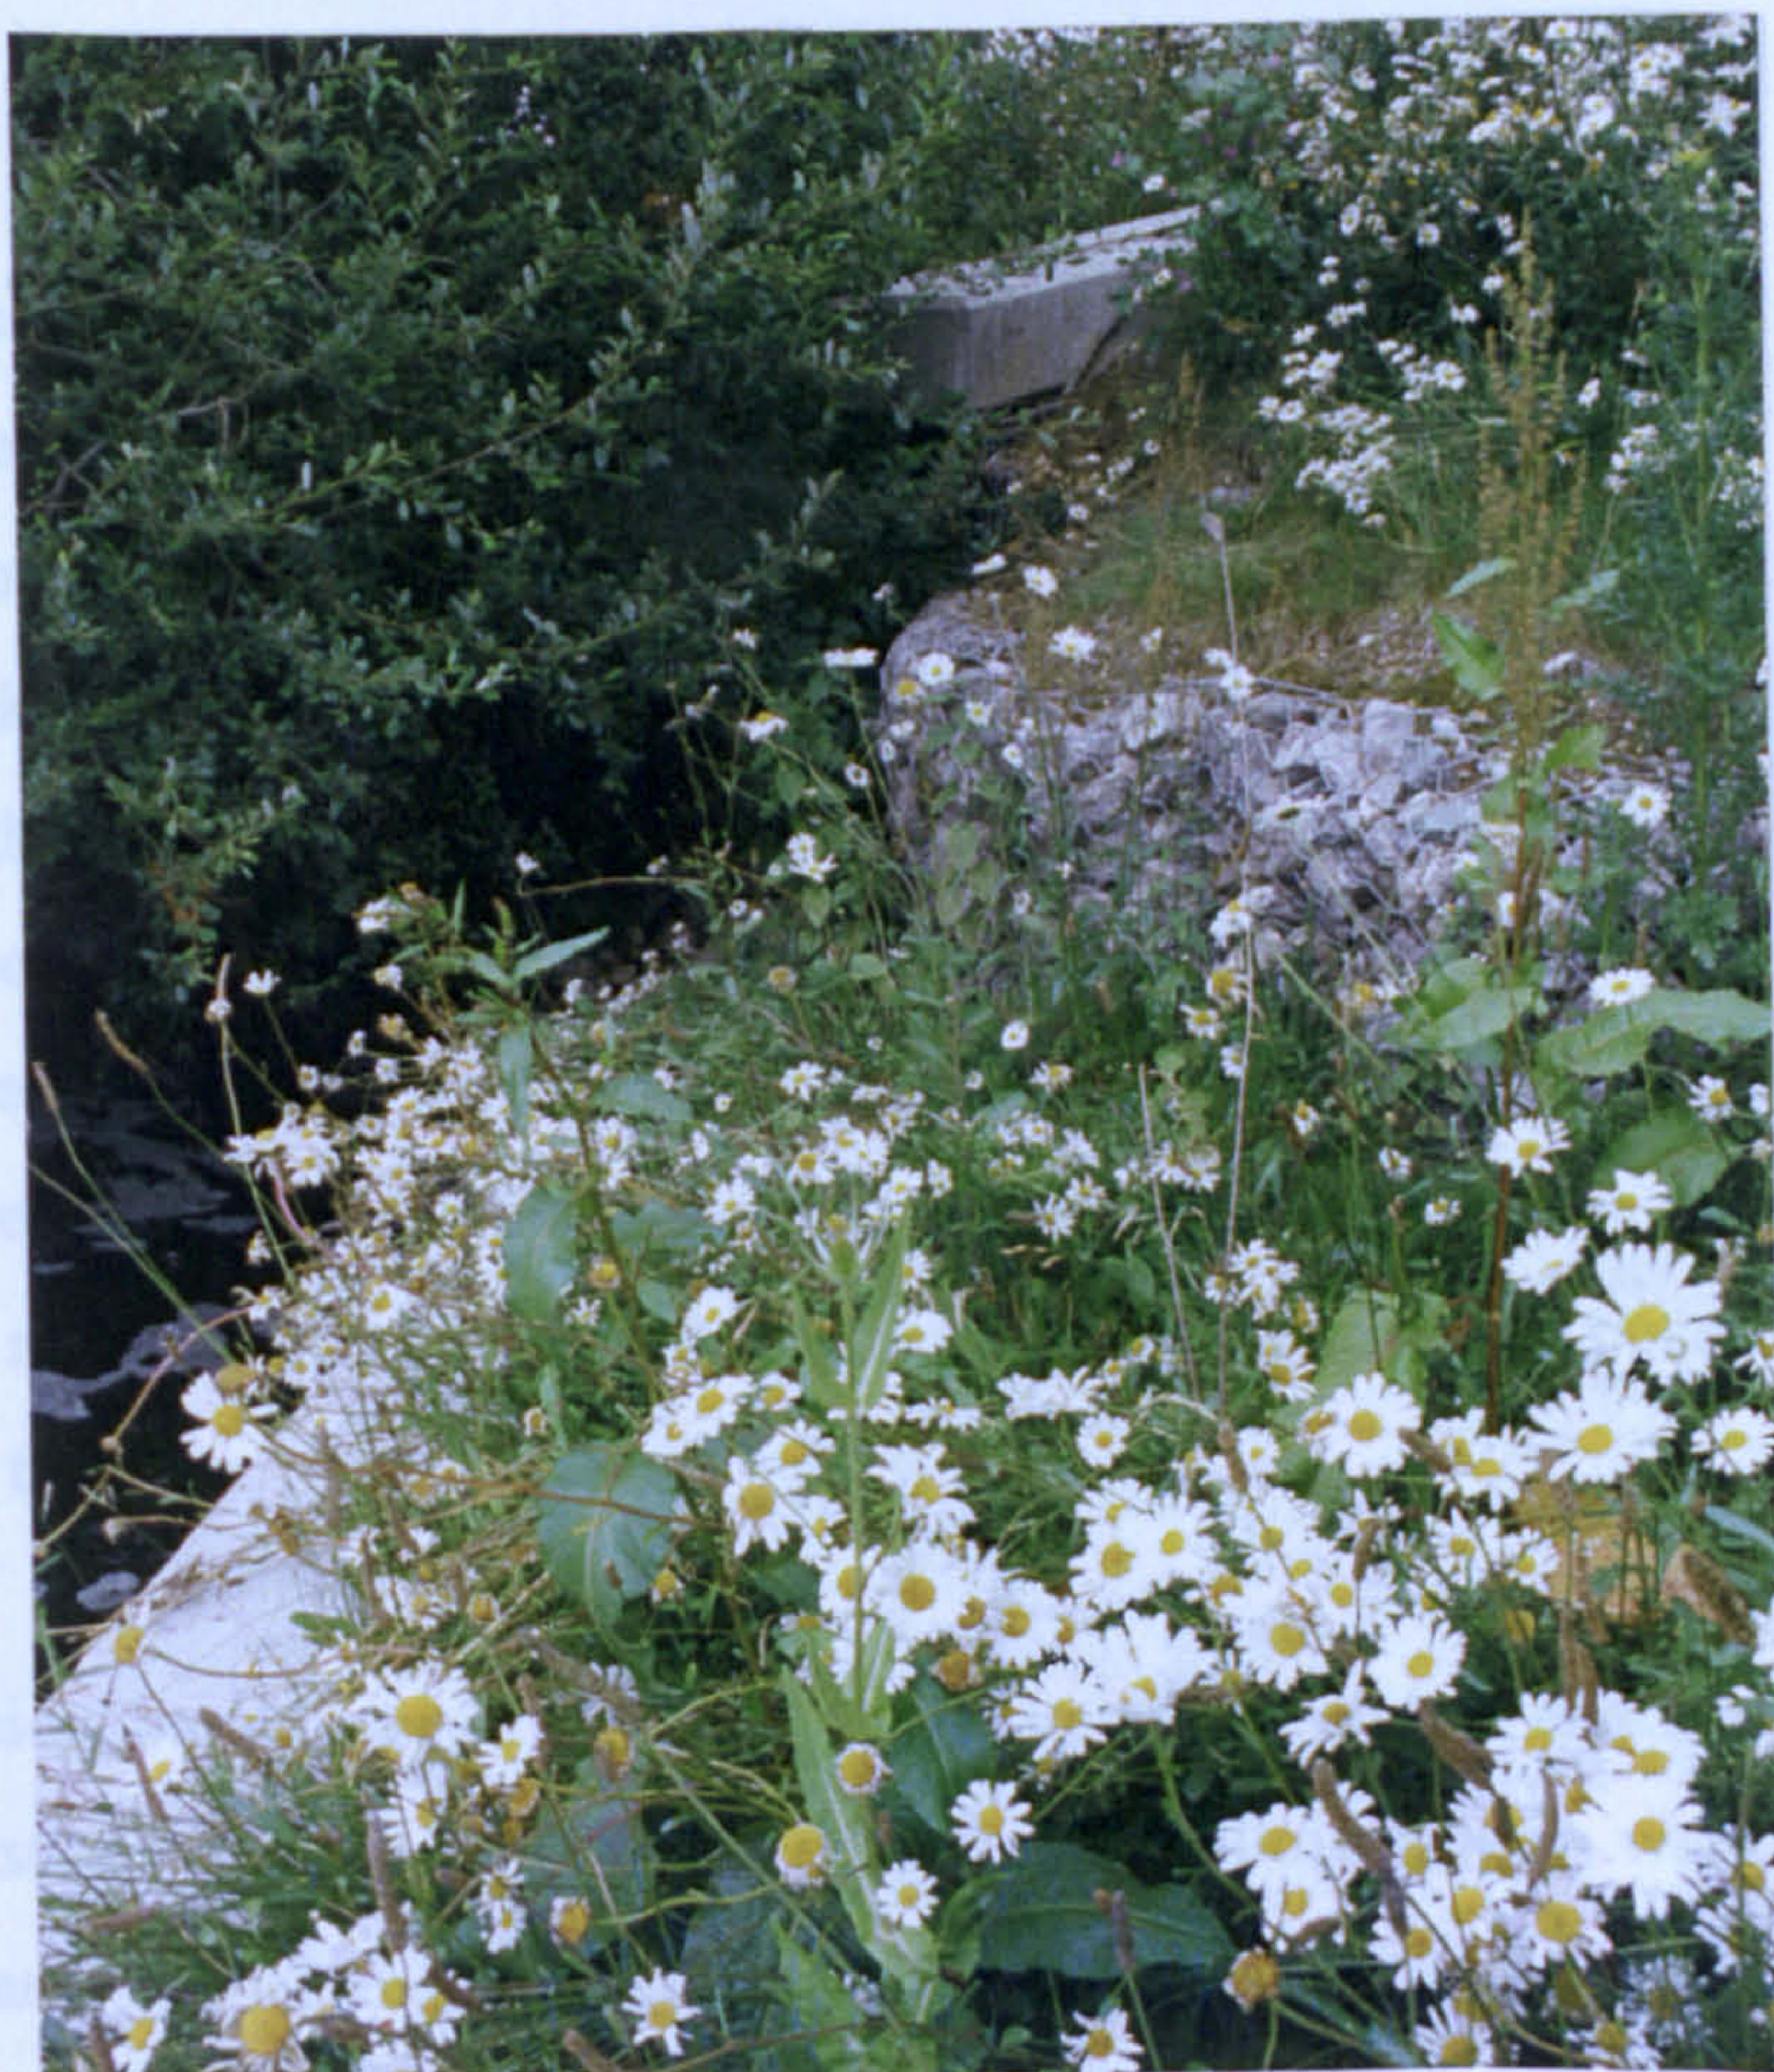
Plate 6.33
Case study no. 17:
revegetation of
gabion baskets
2 years after
installation

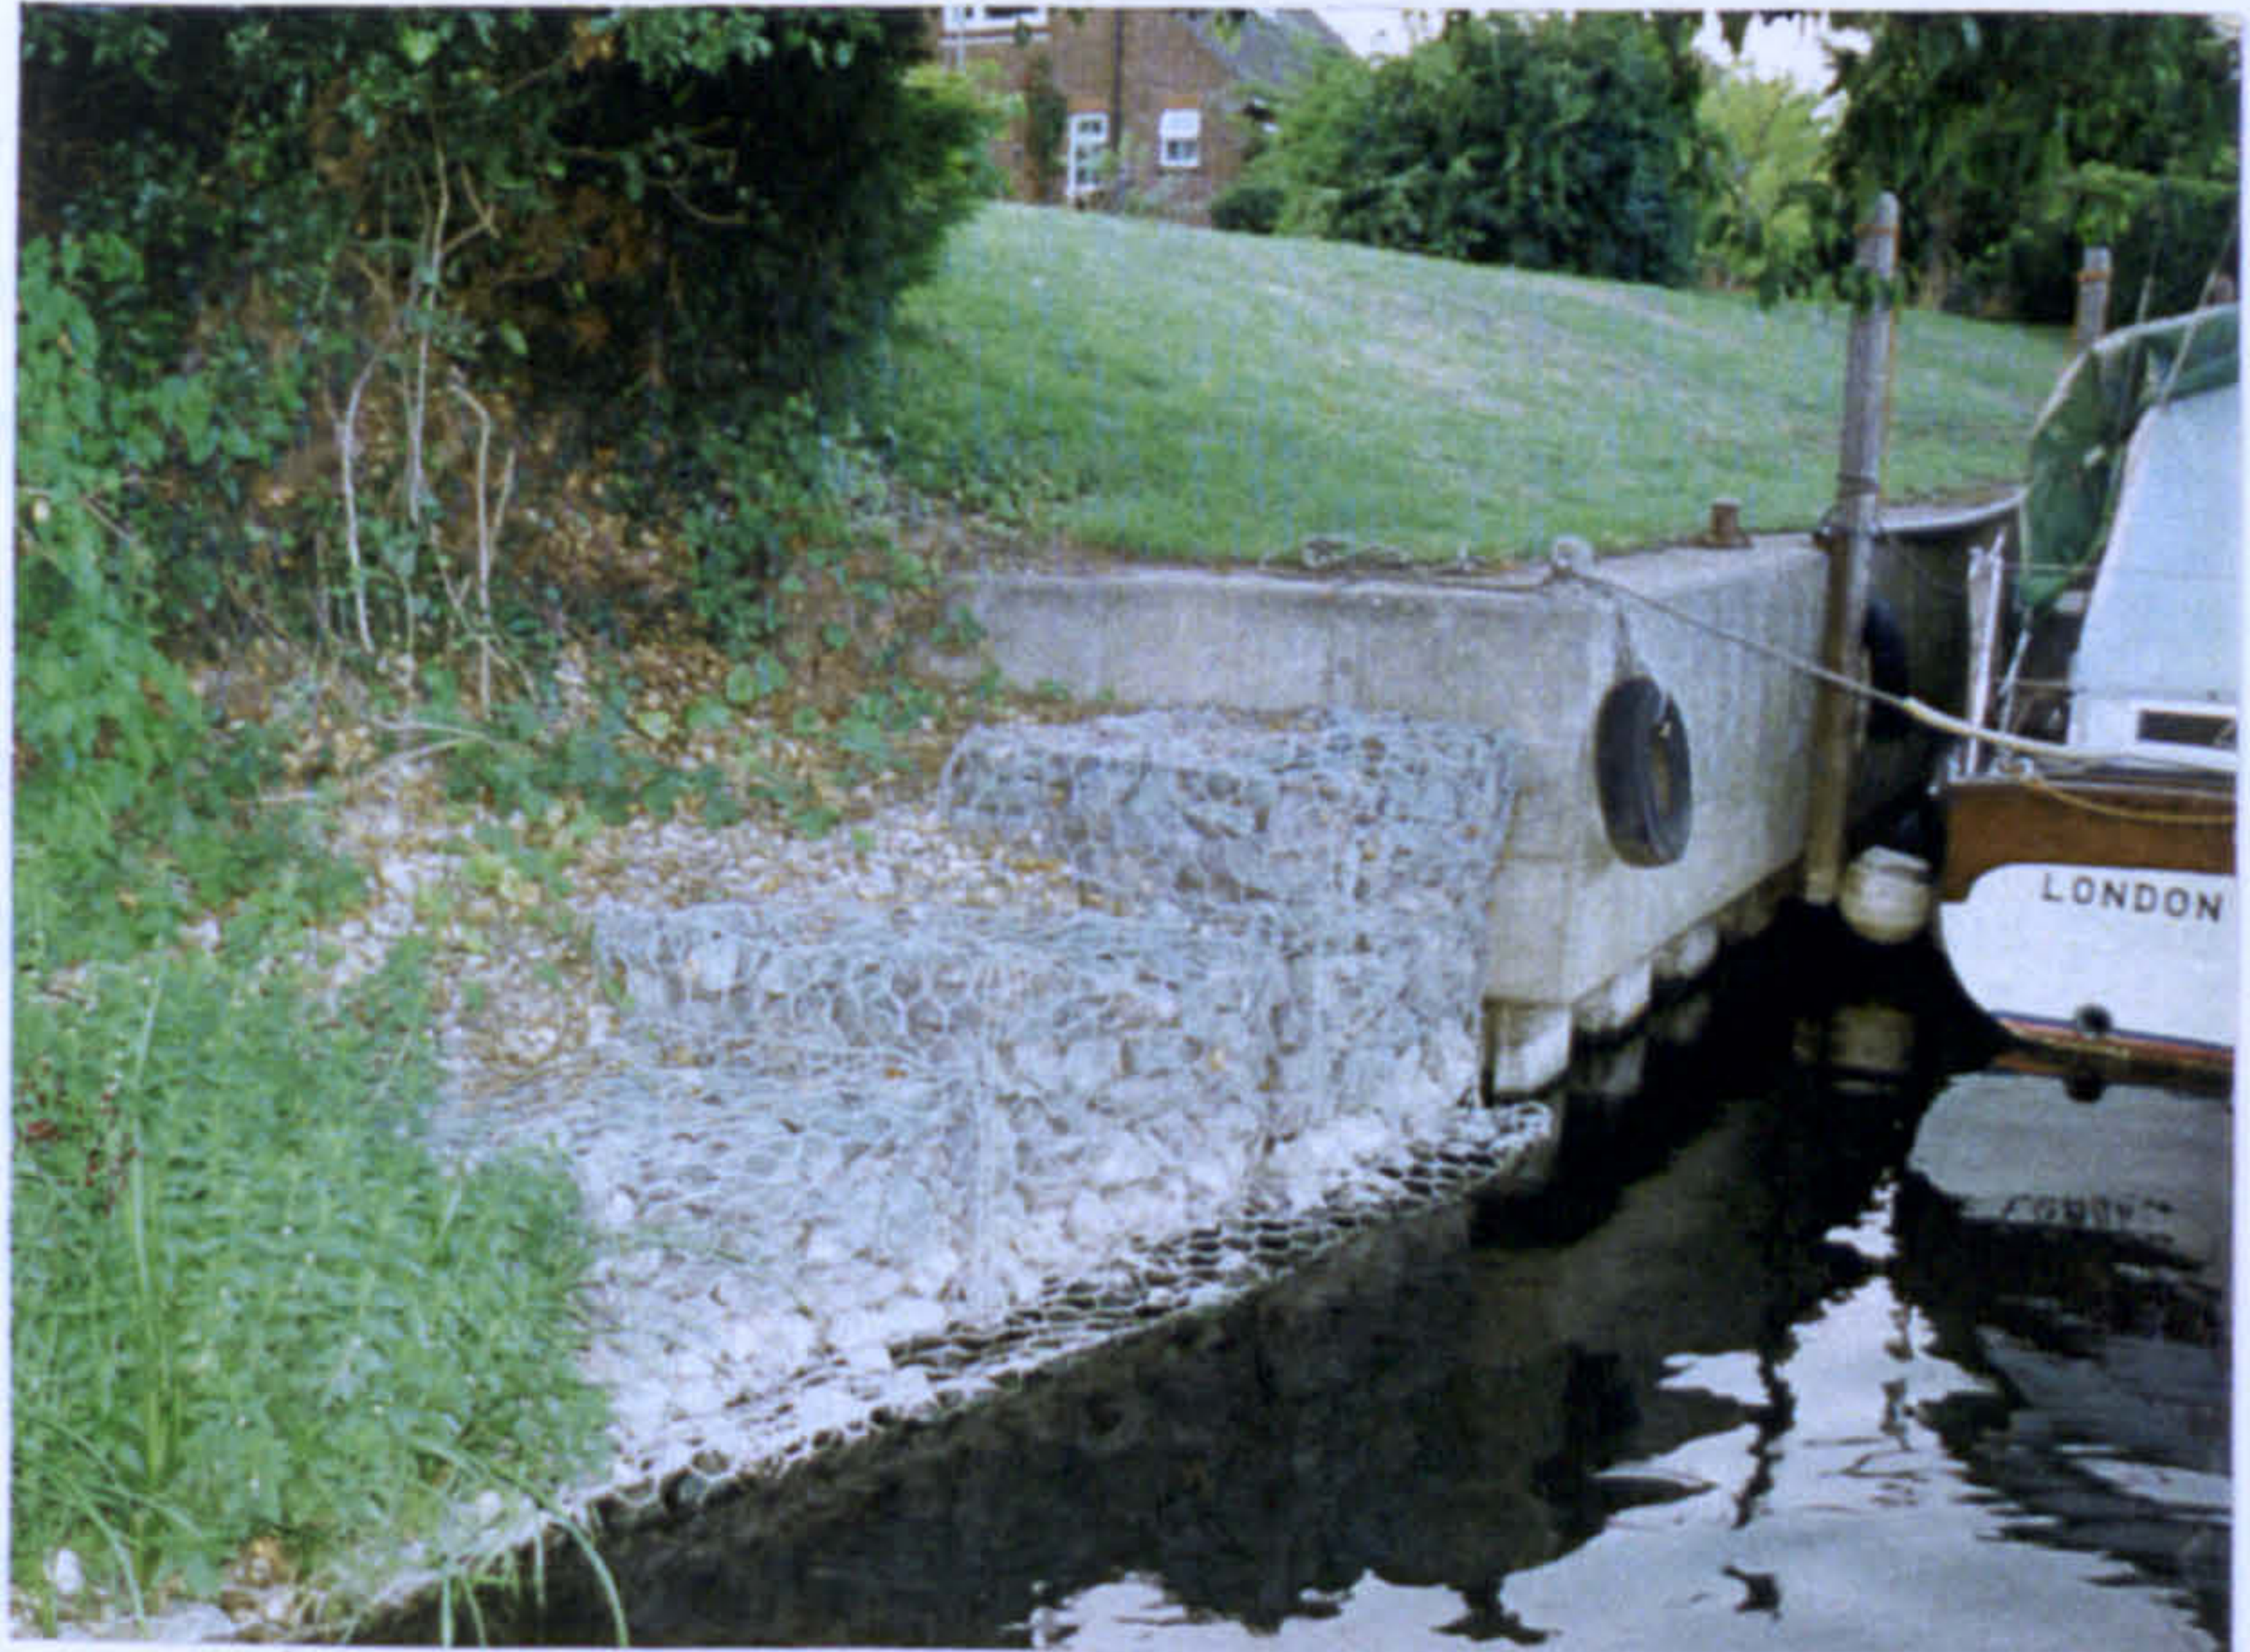
This site is along the right bank of Old Windsor Lock Island and immediately downstream of a side-sluice off the main channel. The major cause of erosion was identified as high flow velocities from the sluice exacerbated by the upstream sheet piling (see Plate 6.34), although no specific failure mechanism was identified.

Plate 6.34
Case study no. 18:
gabion baskets
installed along
Egham Reach

Consequently, gabion baskets were installed at the upstream end of the site adjacent to the existing sheet piling (see Plate 6.34), and willow faggots were installed downstream where erosion posed less of a risk to the sluice (see Plate 6.35).
