**"THE NON-TIDAL, NAVIGABLE THAMES:
A BANK EROSION MANAGEMENT STRATEGY"**

by Sue Reed BSc, MSc, MCIWEM

**Thesis submitted to the University of Nottingham
for the degree of Doctor of Philosophy, October 1998**

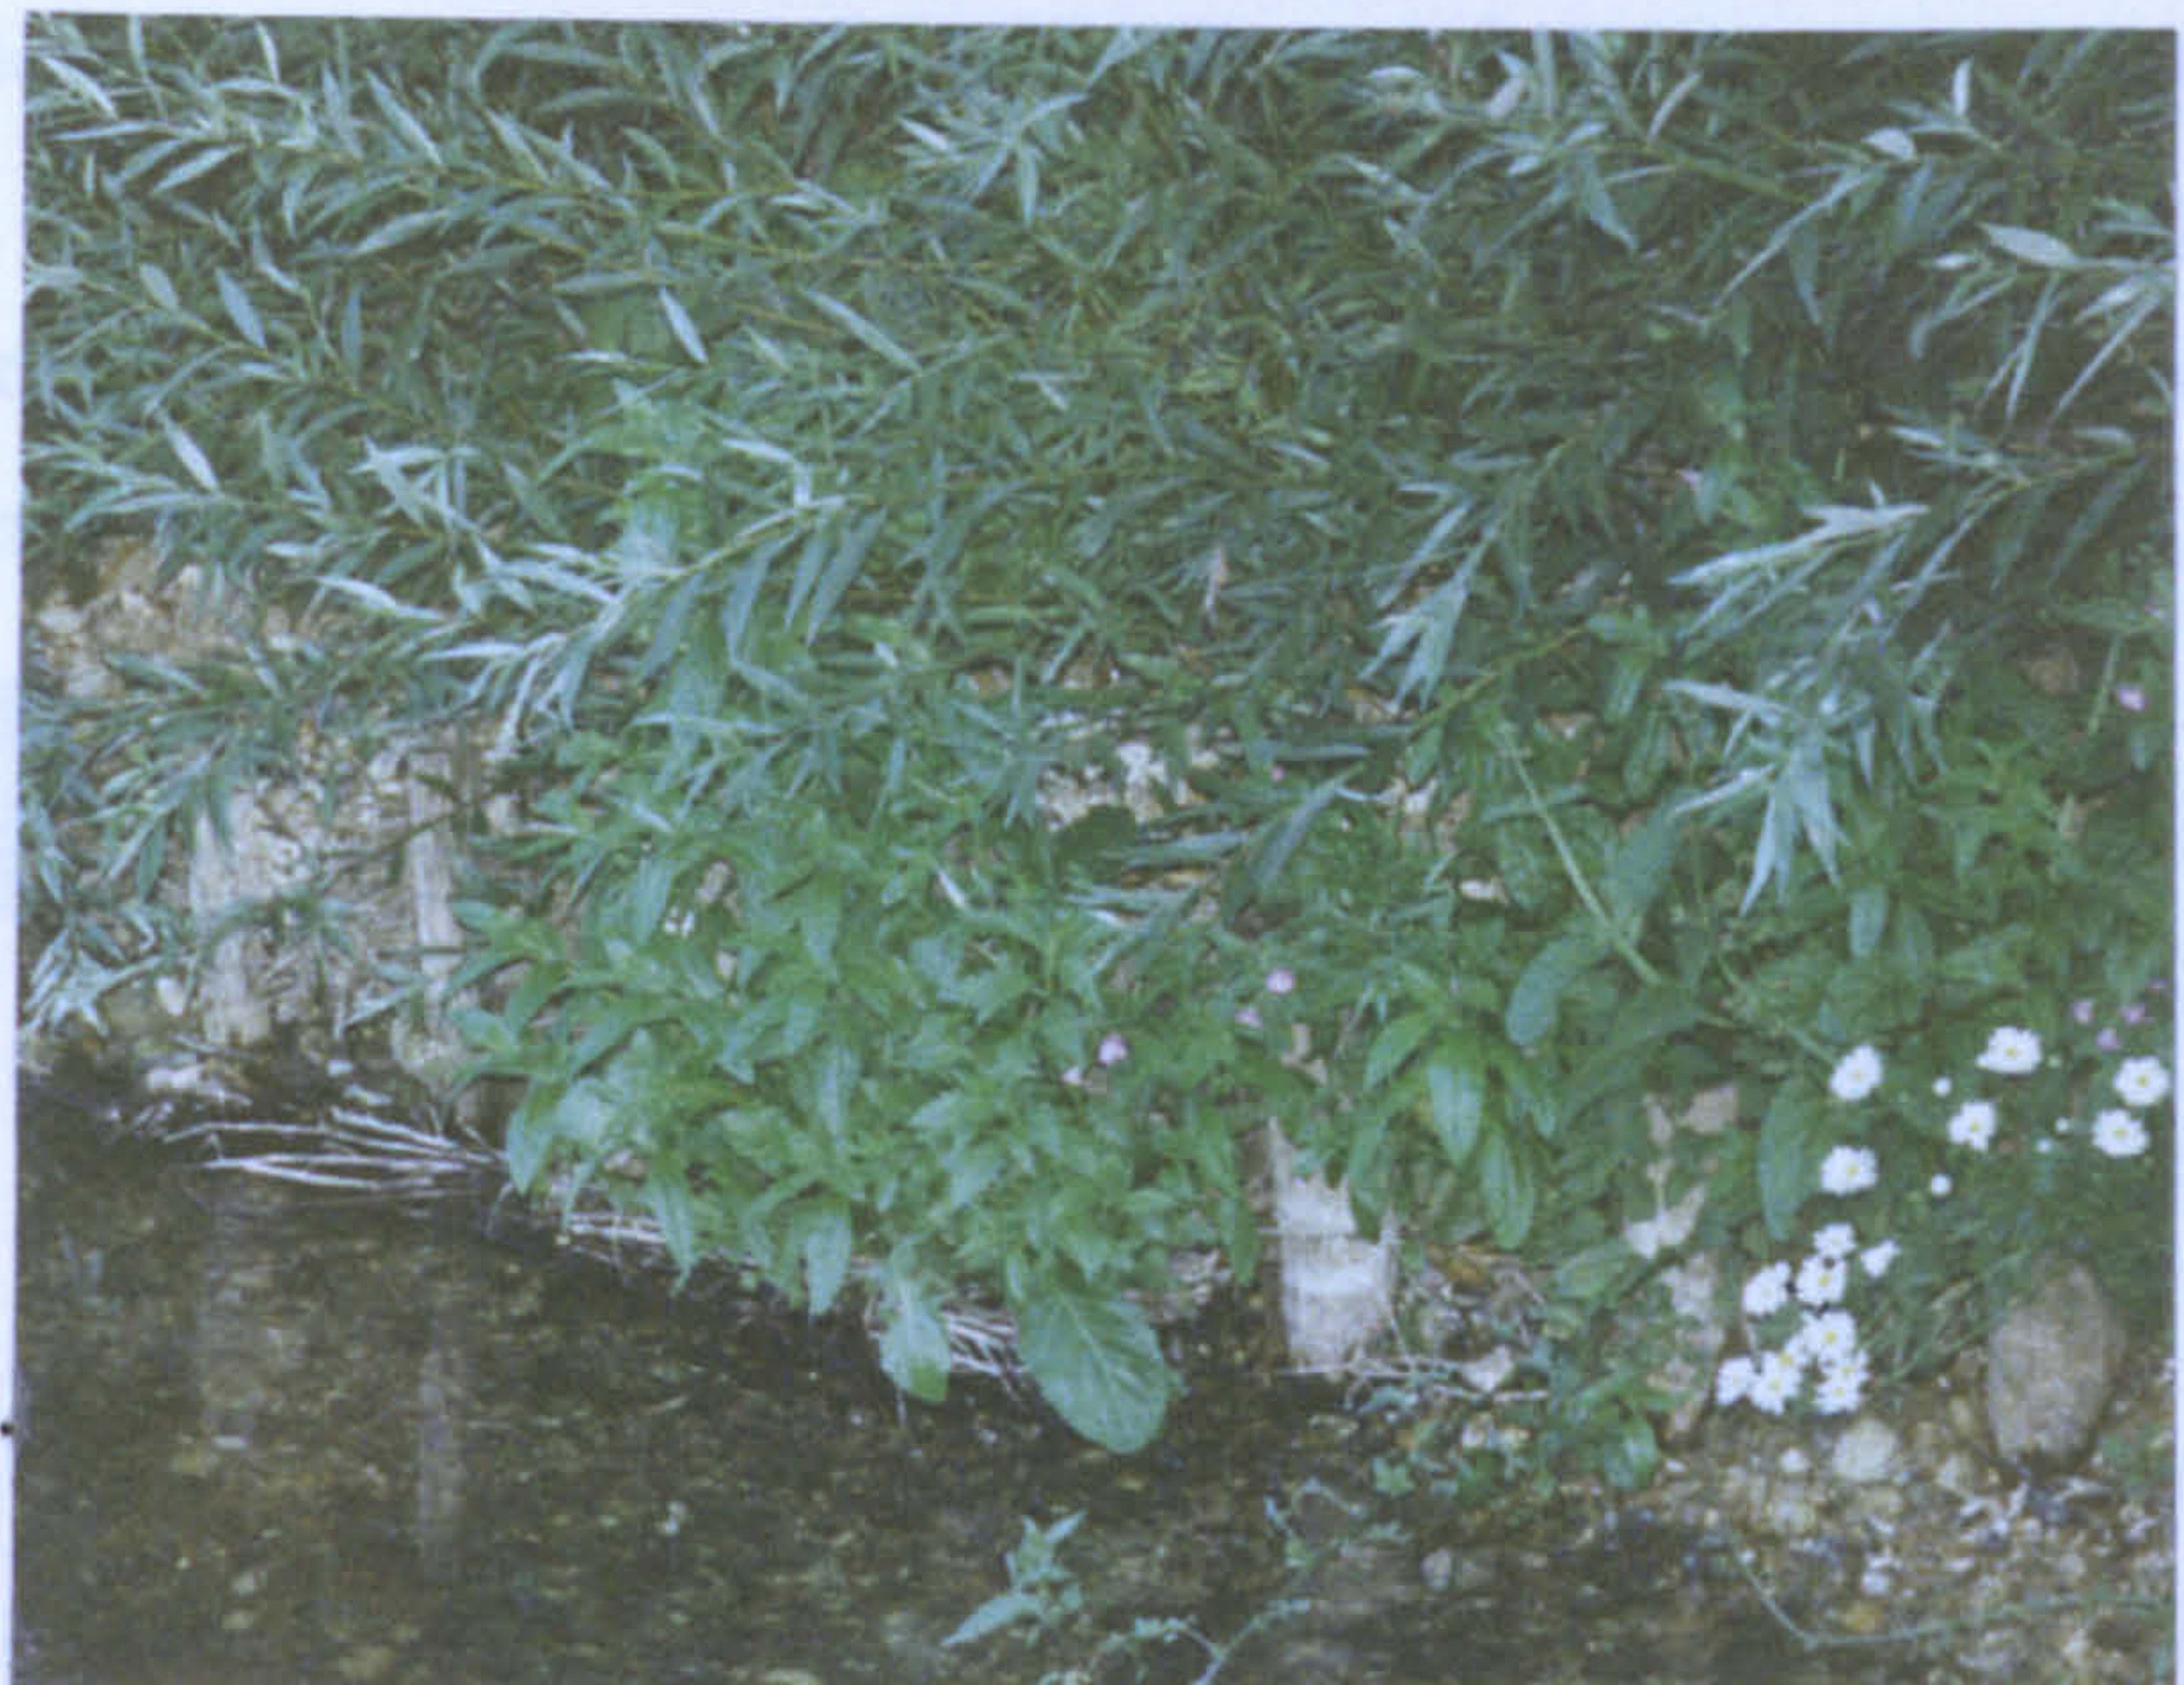
This site is along the inside of a bend upstream of Egham Lock and was protected with gabion baskets some time prior to 1992 (see Plate 6.36). The characteristics of the bank prior to installation of the protection are unknown. Likewise, the specific failure mechanisms are also unknown but the location is particularly popular for navigation and general amenity hence, the major causes of erosion were likely to be boat wash and other recreational activities.

This site is along the inside of a bend, and is, therefore, not subject to significant fluvial attack during high flows. It is, therefore, likely that a biotechnical solution such as willows could have been used to protect the bank from boat wash if prevention of continued erosion was the overriding objective. Alternatively, a more appropriate strategy might have been to allow the natural adjustment of the bank.

*Plate 6.36
Case study no. 19:
gabion baskets
installed along
Egham Reach*

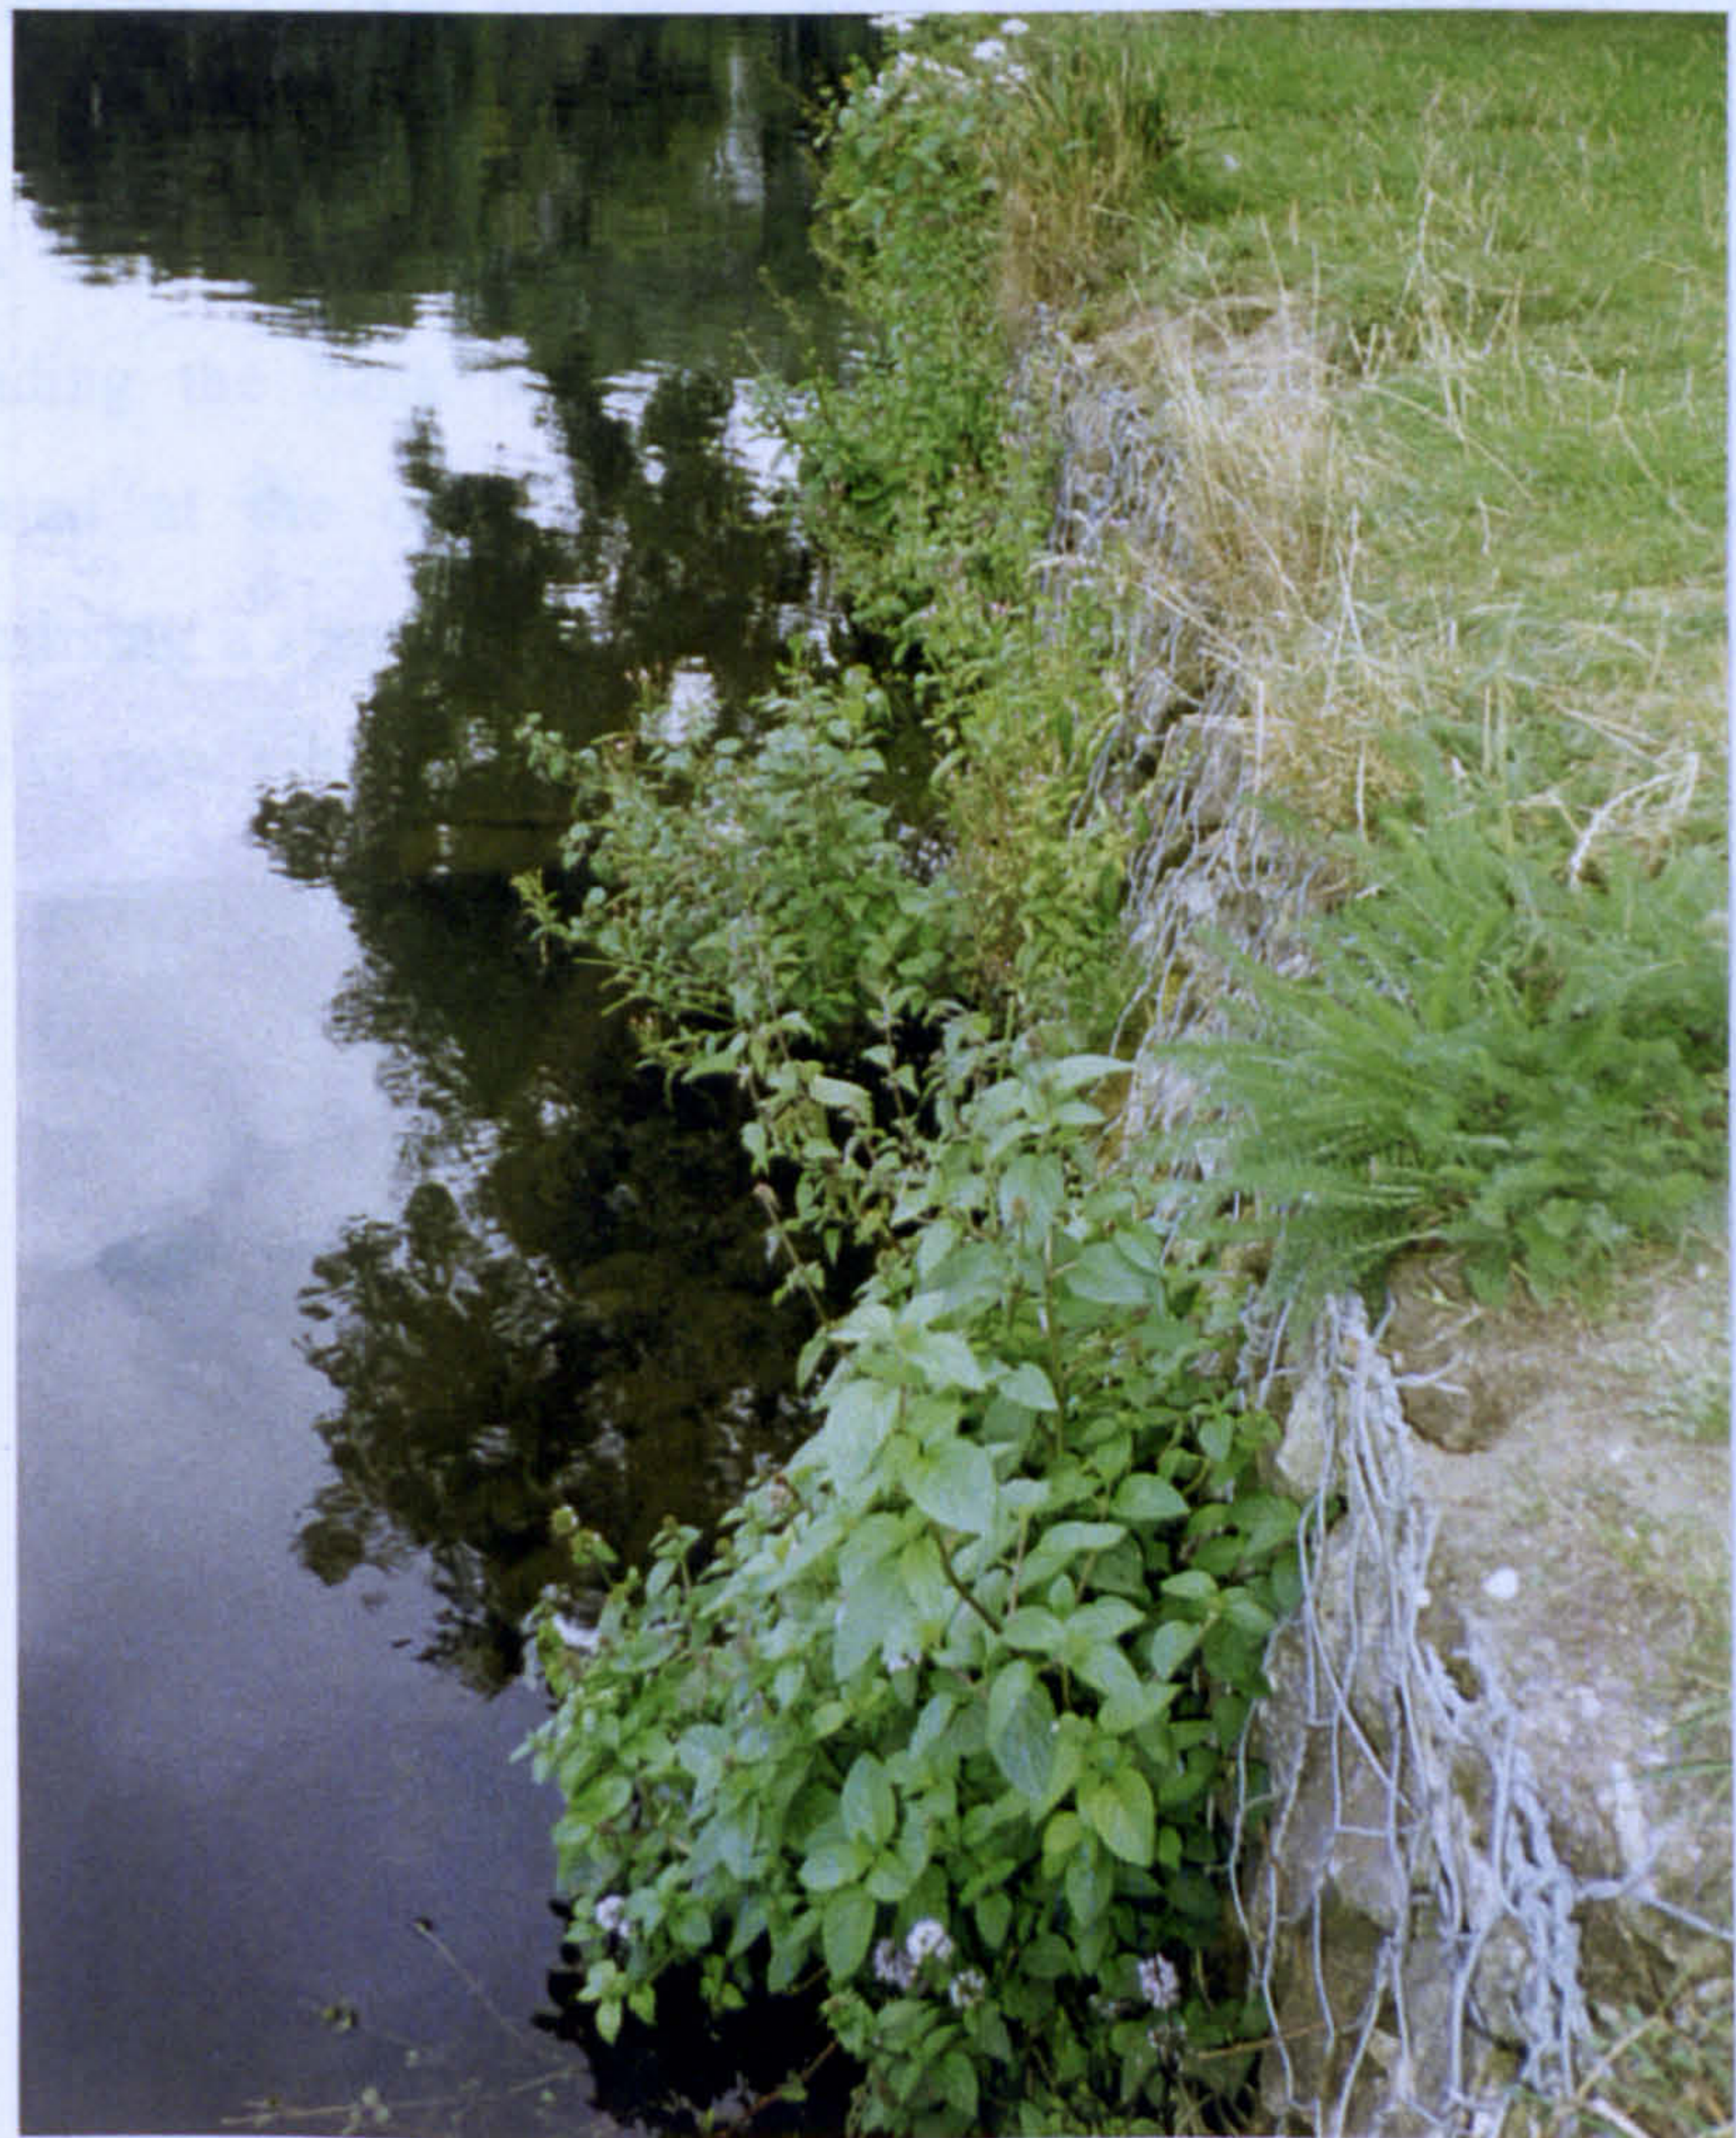
This site is along the outer bank of a meander bend downstream of Chertsey Lock. The condition of the site and the specific erosion mechanisms prior to works are unknown. However, the channel geometry would suggest that erosion was primarily due to high velocities along the outside of the bend, probably exacerbated by hard bank protection upstream. The adjacent land has as an informal picnic area and a public path approximately 75m from the edge of the river. Hence, the consequences of erosion can be considered 'moderate'. Assuming that either cantilever or slab failures were the main failure mechanism, the Environment Agency's (1997) framework recommends the use of strategies 1 or 4.

Gabion baskets were installed to protect the bank in the late 1980s (see Plate 6.37). It is not known if other strategies were considered, but alternative approaches could have been to allow the natural adjustment of the bank, or to regrade the bank to a stepped profile and use a bioengineering protection technique. Regrading the bank angle would have reduced the near-bank velocities generated at the outside of the bend by secondary currents. Furthermore, stabilising a stepped profile would have facilitated access to the river where there is now a high, vertical bank.

*Plate 6.37
Case study no. 20:
gabion baskets
installed along
Shepperton Reach*

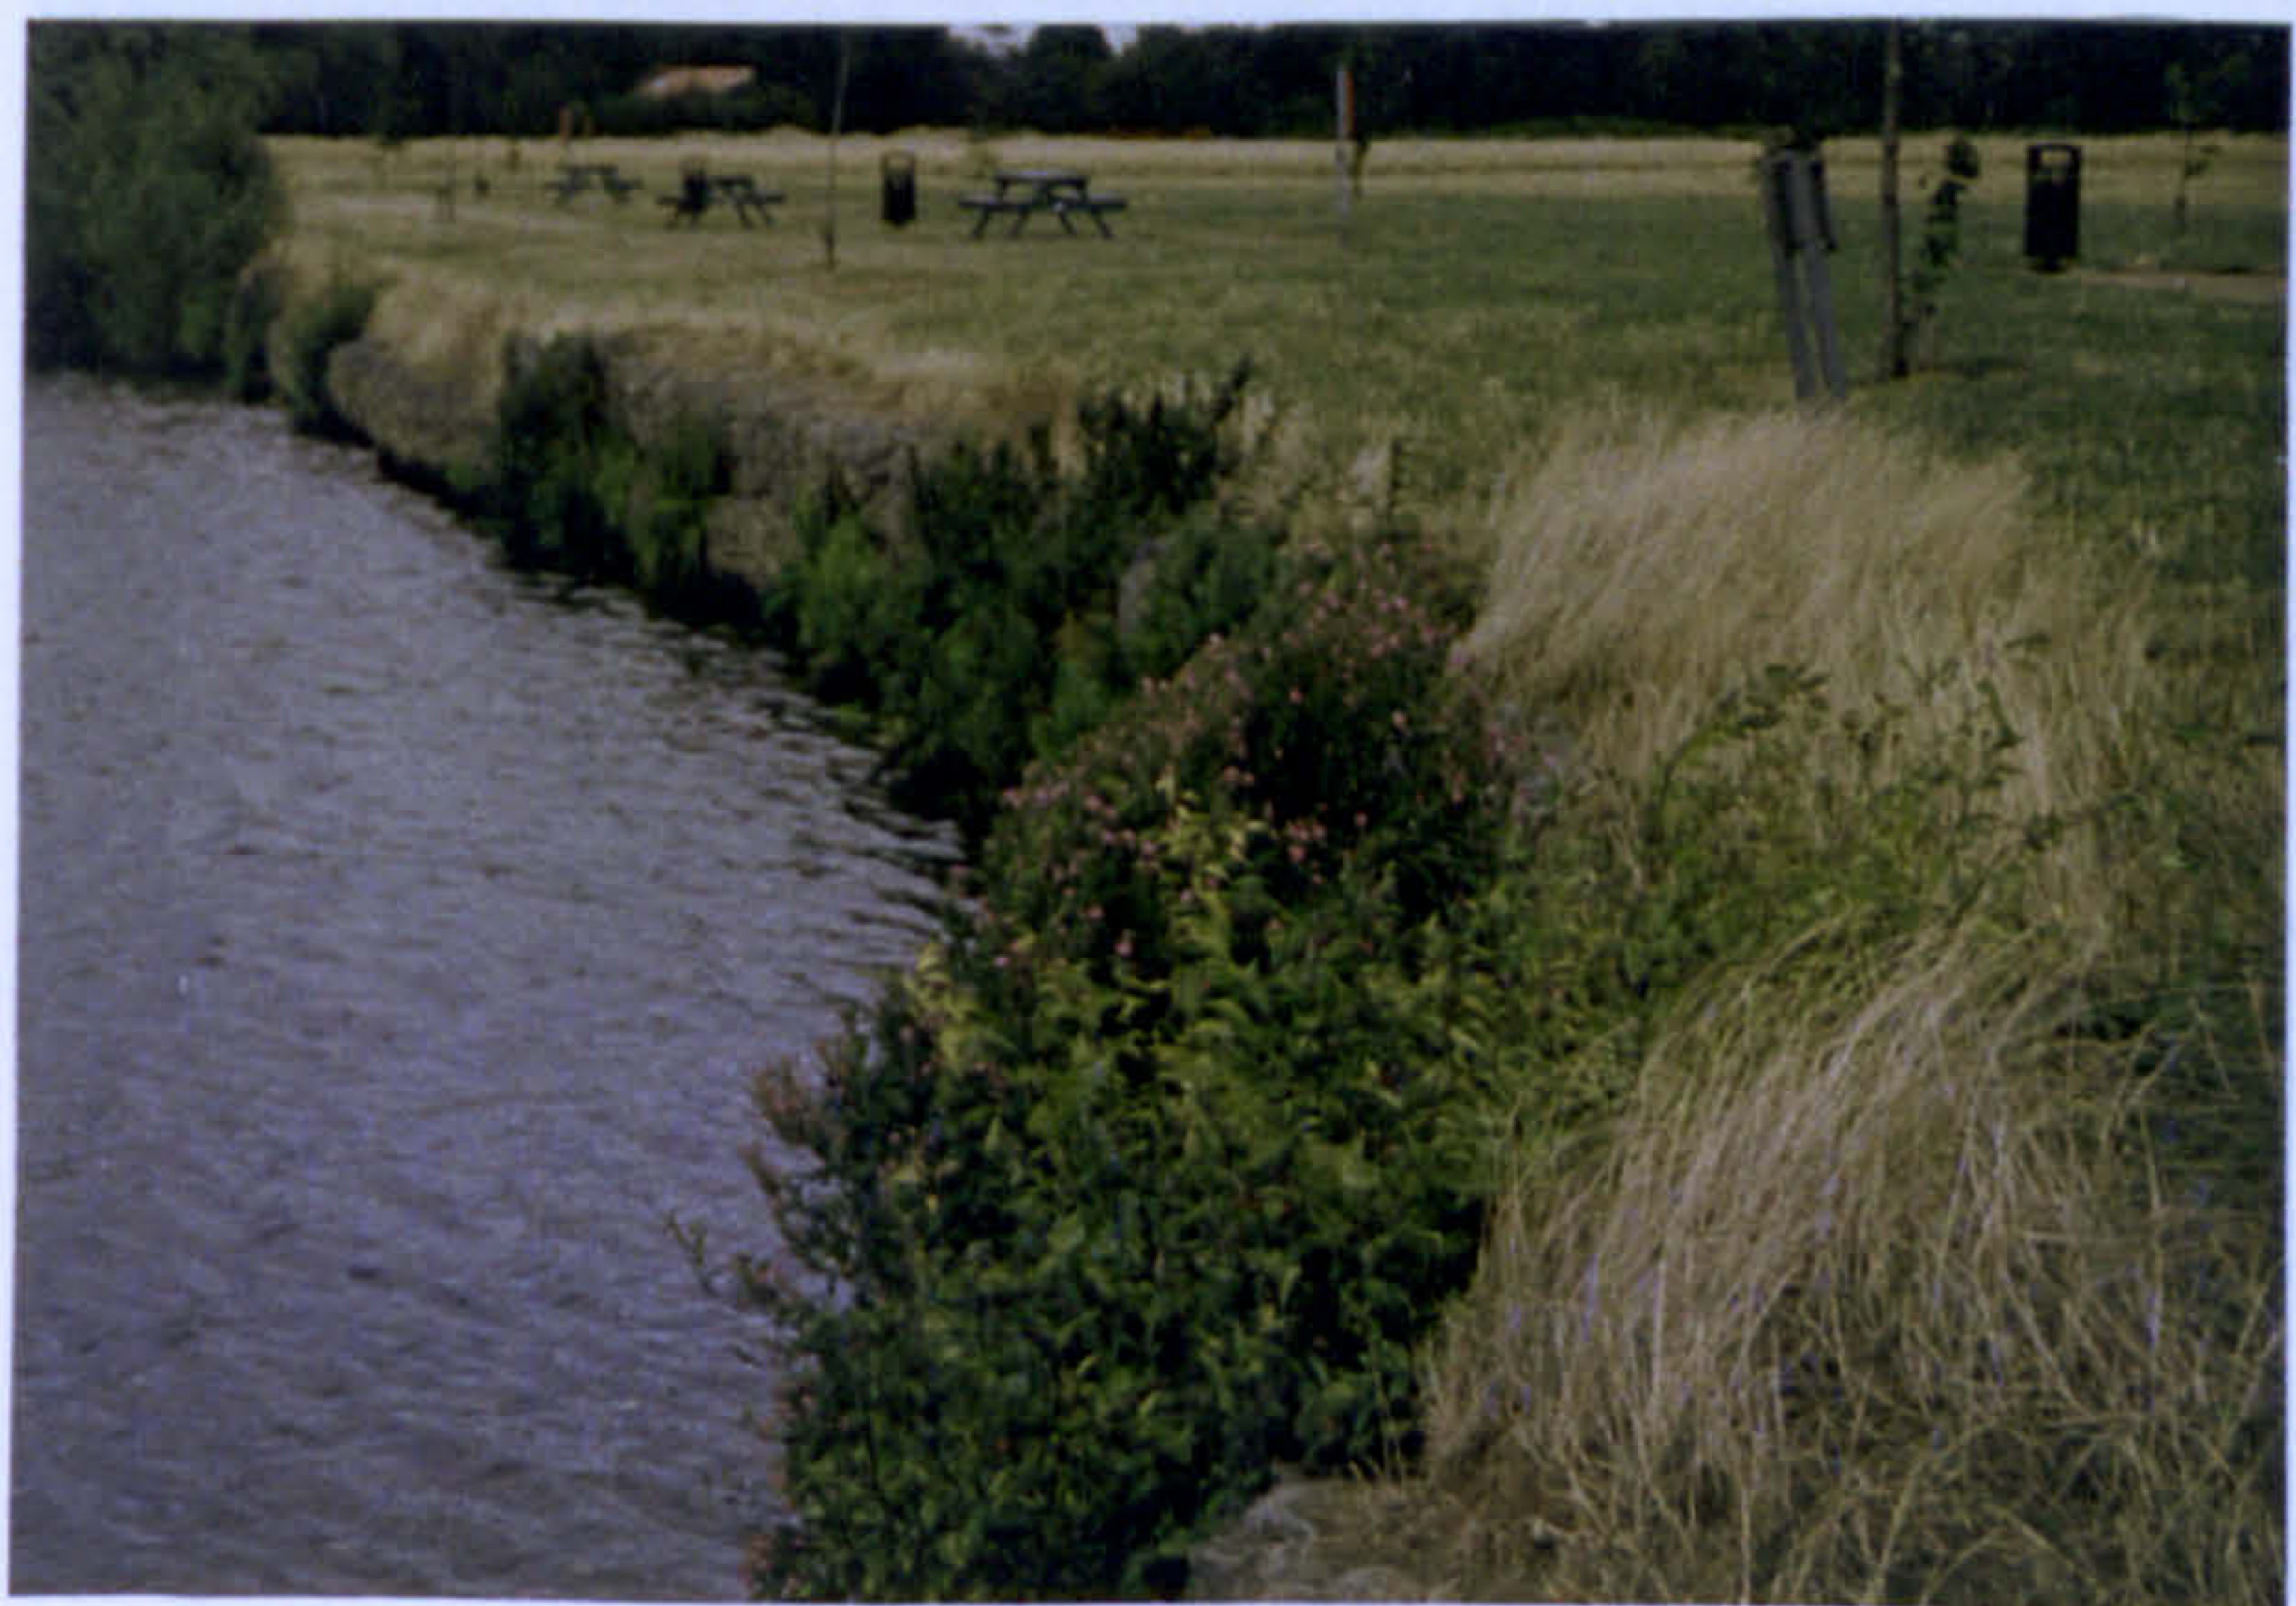
Plate 6.40 Case study no. 21: riprap installed to prevent scour downstream of sheet piling, with Teddington Weir in the background

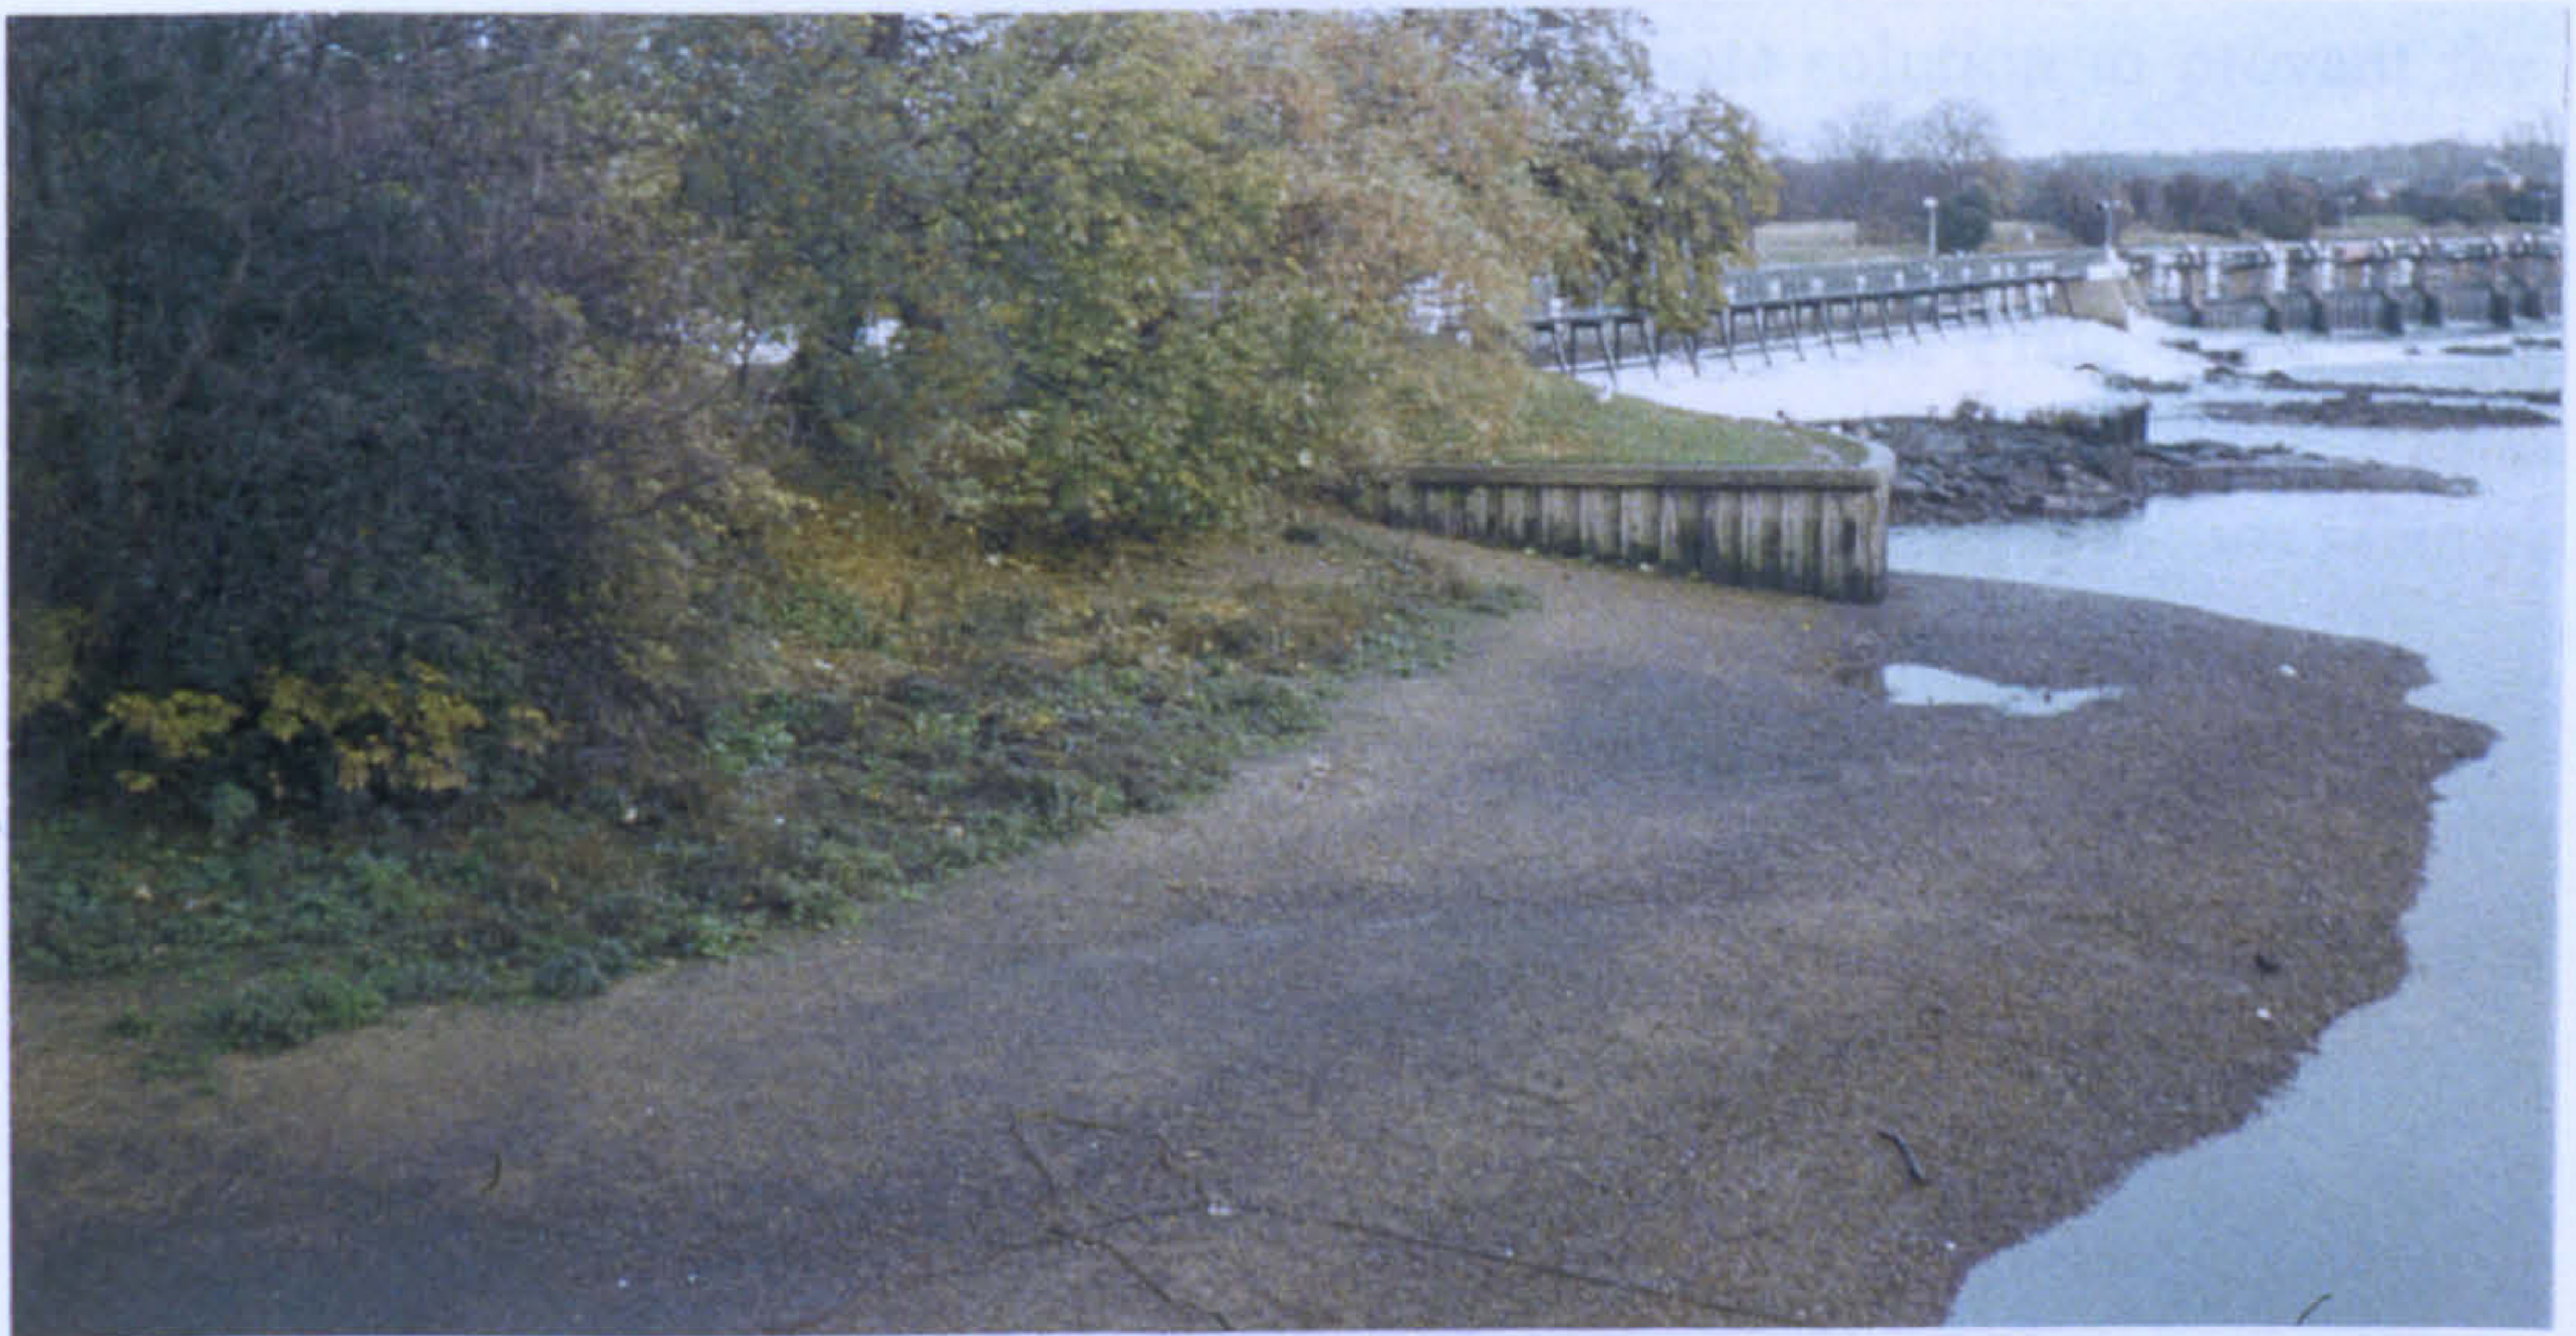
This site is along the right bank of Teddington Lock Island, immediately downstream of Teddington Weir. The site is, therefore, not strictly within the Teddington Reach, but is just within the tidal limits of the River Thames. Plate 6.38 shows the bank along which the erosion problem was identified, and Plate 6.39 shows the scour behind the sheet piling which supports the upstream weir.

Plate 6.38 Case study no. 21: downstream of Teddington Weir prior to bank protection

The author participated as the geomorphology specialist in the design team for this project and identified the major cause of erosion as the high velocity flow from the weir scouring the reach where the bank was unprotected and most vulnerable, immediately downstream of the sheet piling. The consequences of erosion could be judged as 'important' due to the potential risk to the weir structure and, as such, the Environment Agency's (1997) framework recommends the use of strategies 2, 4, 5 or 6.

High flow velocities downstream of the weir would suggest that a structural engineering technique would be the most appropriate solution to prevent the localised erosion immediately downstream of the piling. Riprap was, in fact, used to protect the bank at the end of the sheet piling (see Plate 6.40).

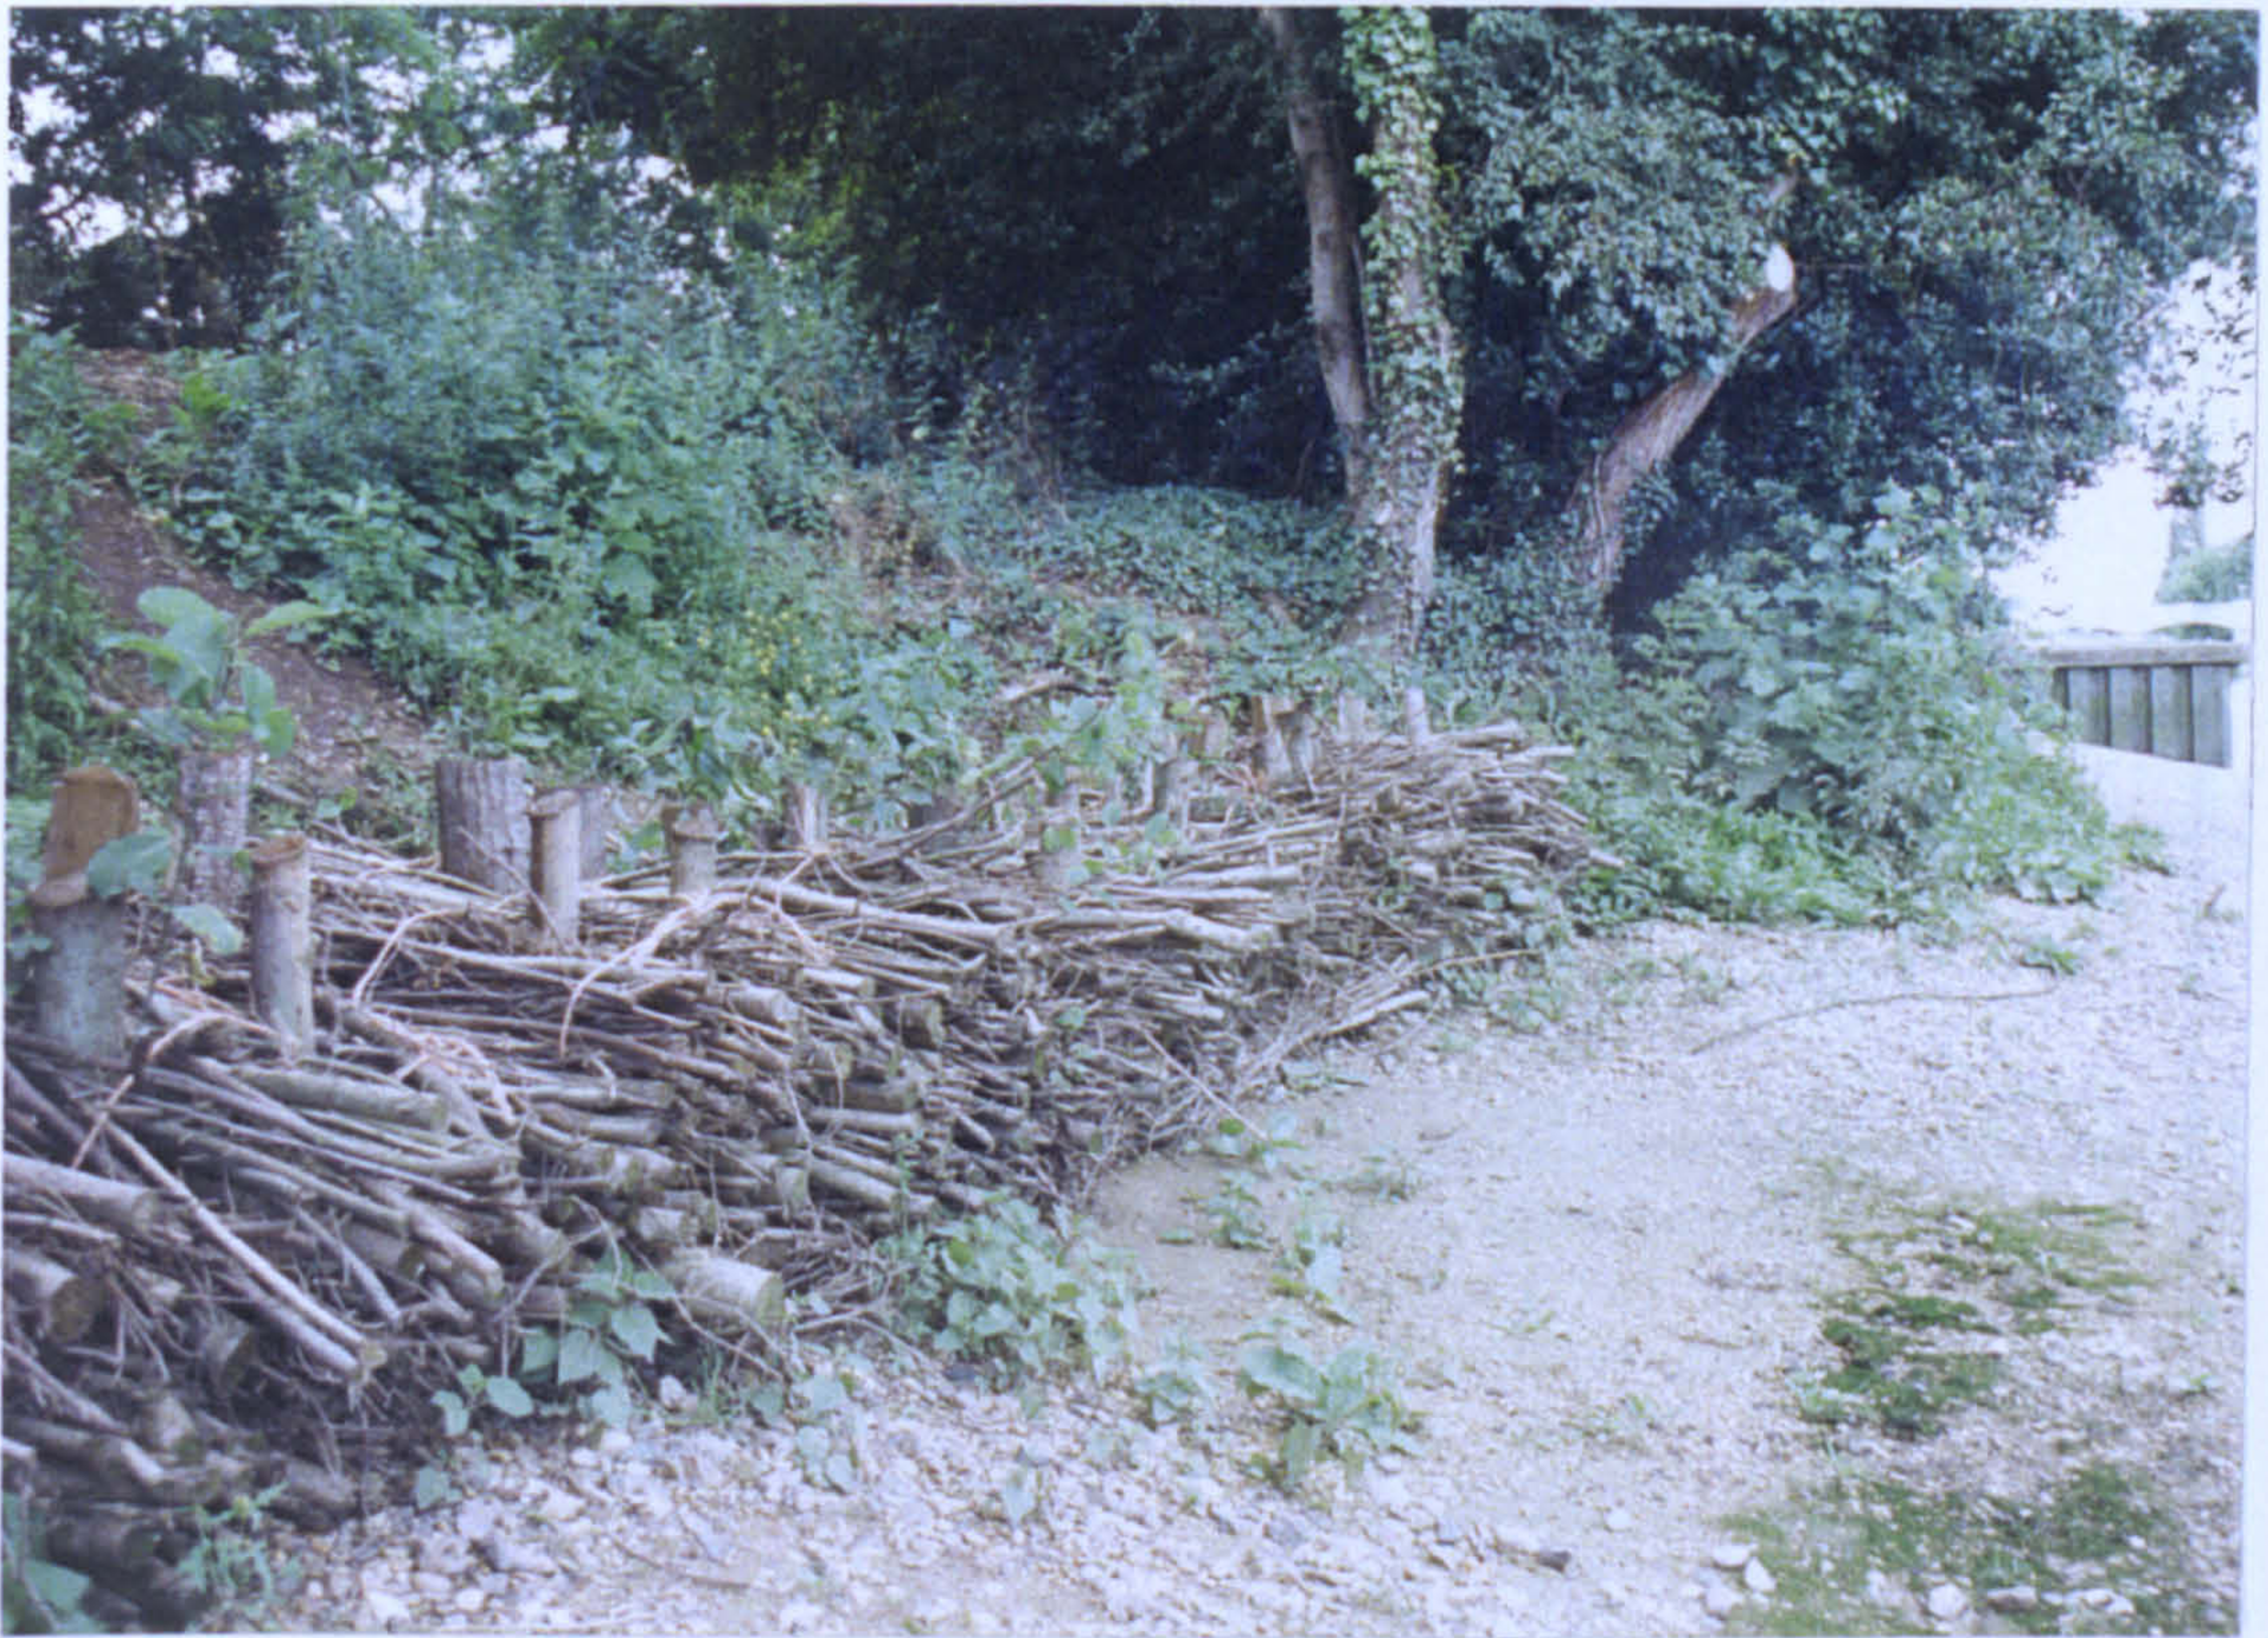
Plate 6.41 Case study no. 21: faggots installed downstream of Teddington Weir

Faggots were installed above the level of the riprap to provide protection to the upper bank and help dissipate the energy from high flows. Further along the site and downstream from the influence of the weir, erosion was considered to pose less risk to the adjacent structure and faggots were again used to protect the bank and dissipate energy (see Plate 6.41). As an additional enhancement measure, a footpath was formalised along the top of the bank.
