ASSESSMENT OF BOND BETWEEN ASPHALT LAYERS

Thesis submitted to the University of Nottingham
for the degree of Doctor of Philosophy

November 2009

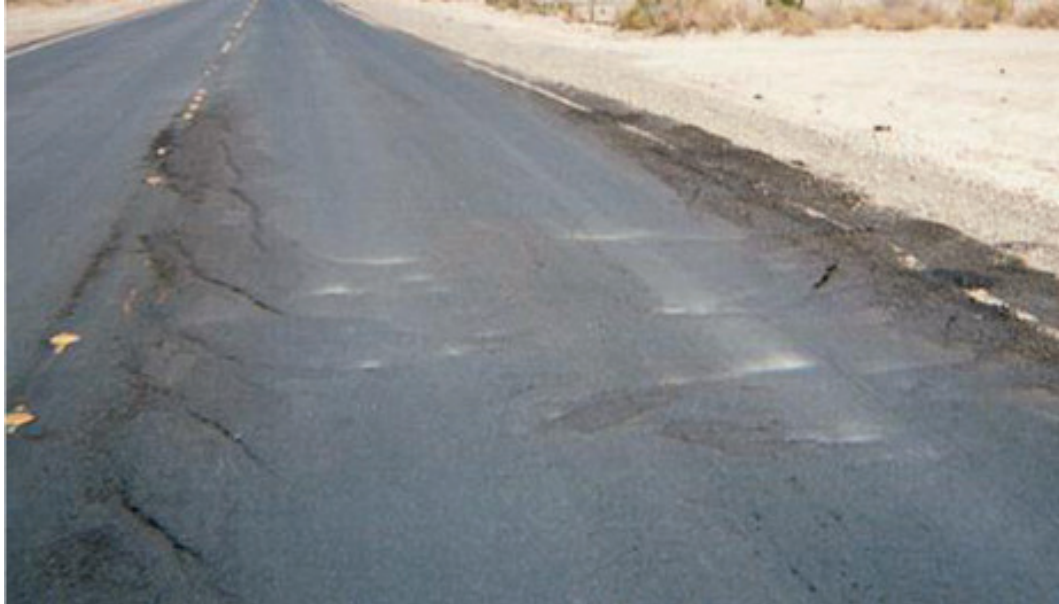
Figure 2.4 – Premature slippage failure on an overlay project in Nevada, USA (Charmot *et al.*, 2005)

occurred on 44% of an overlay project in Nevada, USA in June 2002, soon after completion of the project.

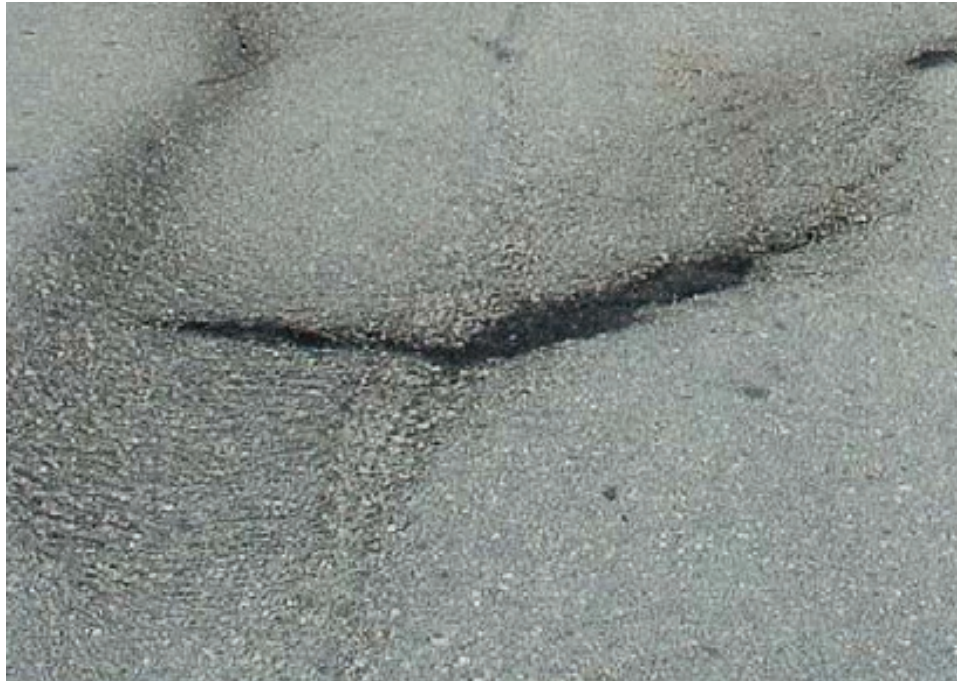
Figure 2.19 – Crescent shaped slippage crack (From West *et al.*,1987)

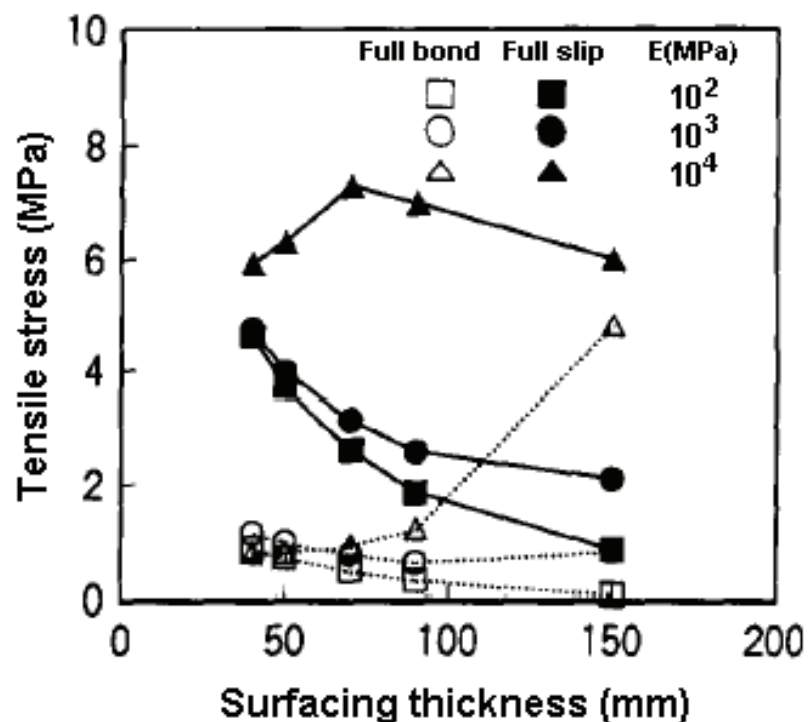
Figure 2.21 - Effect of bond condition and the thickness of the surfacing (i.e. wearing course) on horizontal tensile stress at the bottom of the surfacing (From Hachiya and Sato, 1997)

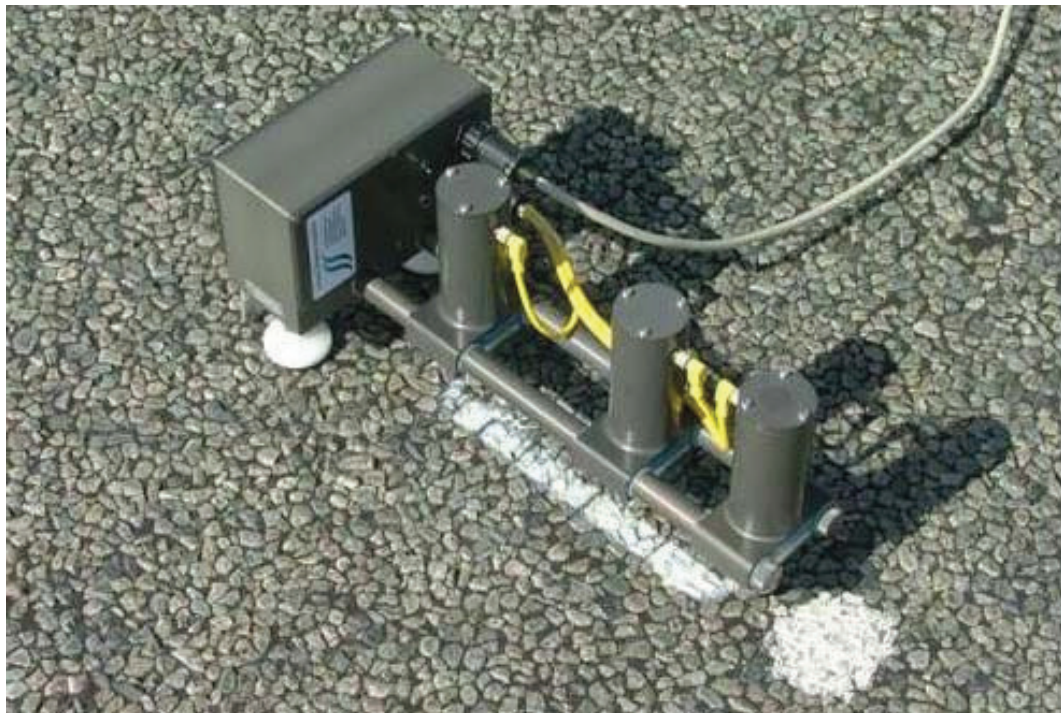
Figure 2.53 – Photograph of the PSPA device (From Steyn and Sadzik 2007)

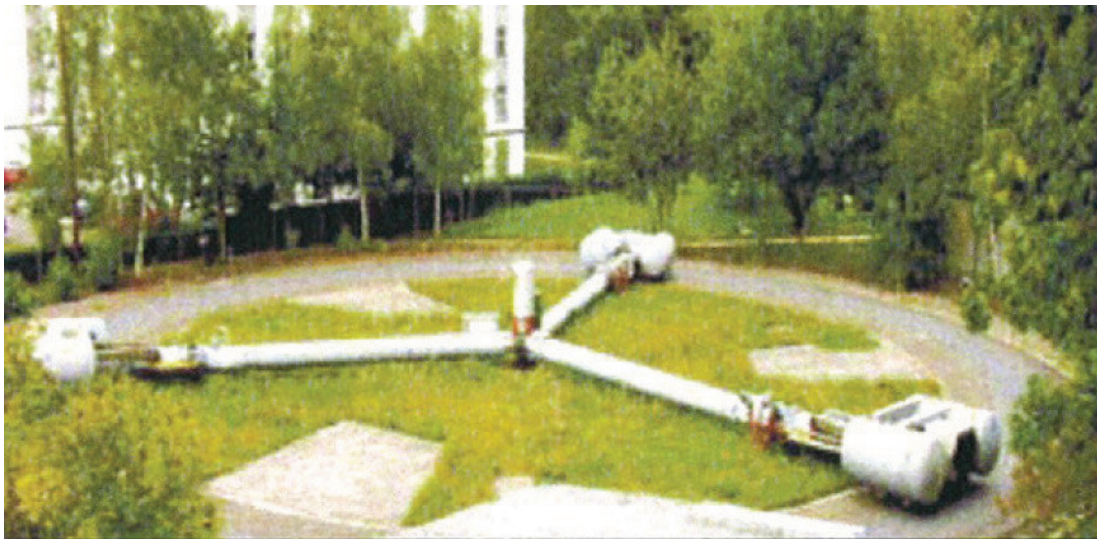
Figure 2.56 – Circular Track used by Raab and Partl [2007a and 2008].

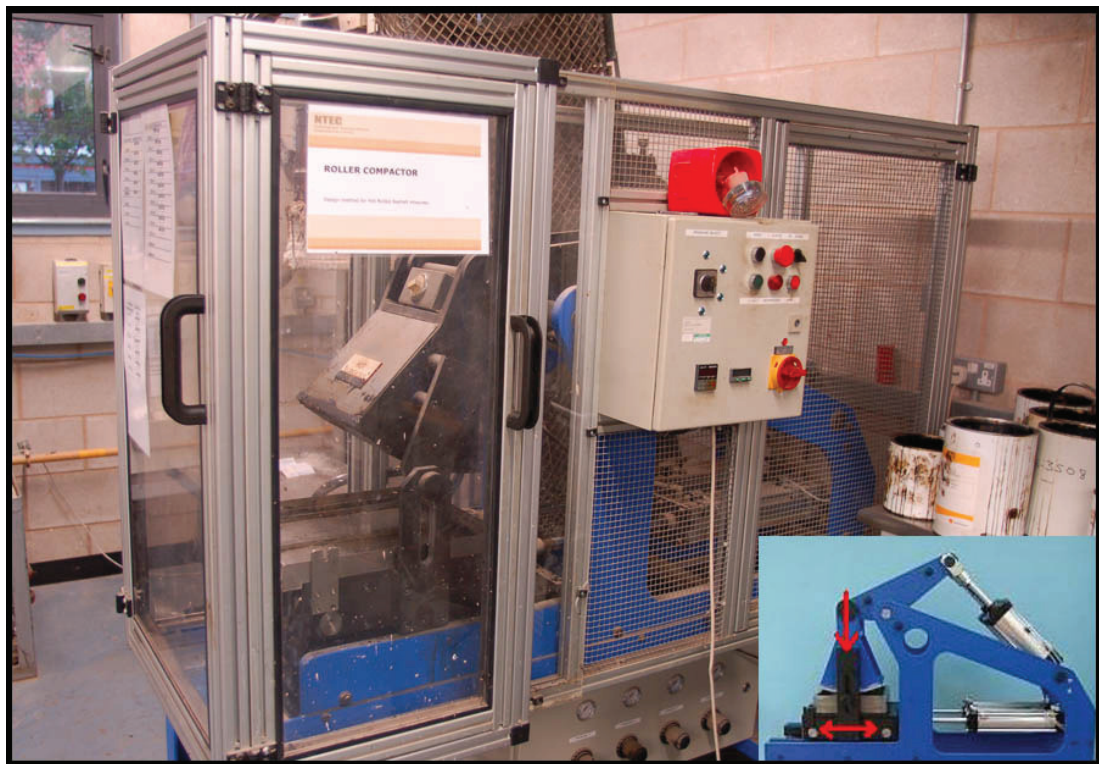
Figure 3.2 - Photograph of the slab roller compactor

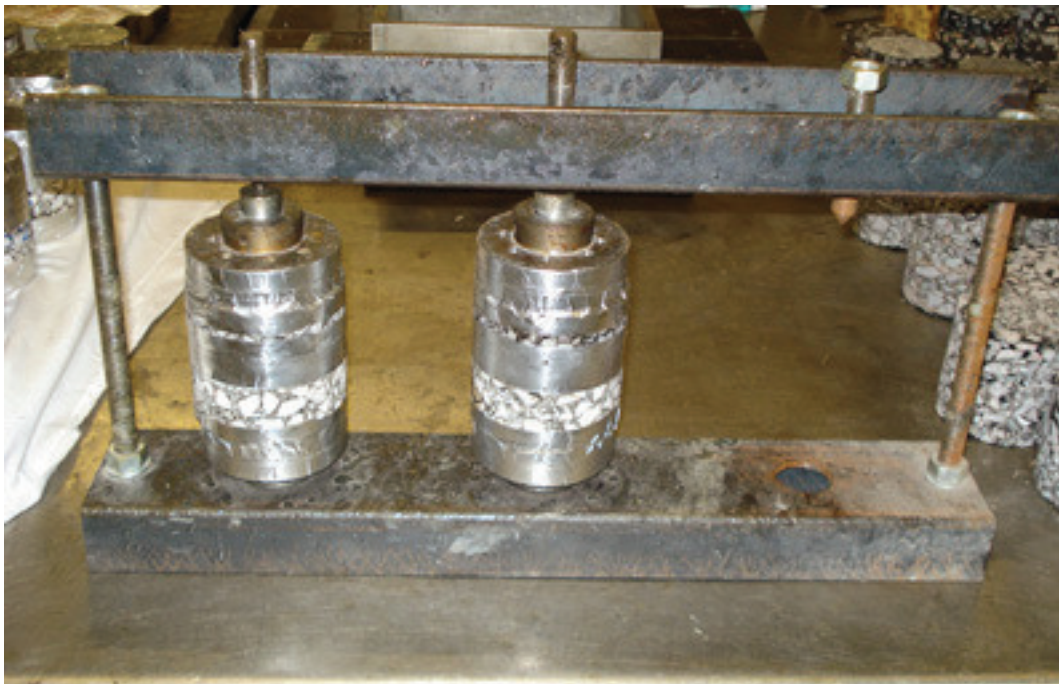
Figure 4.5 – Jig for gluing the loading platens to the torque specimens

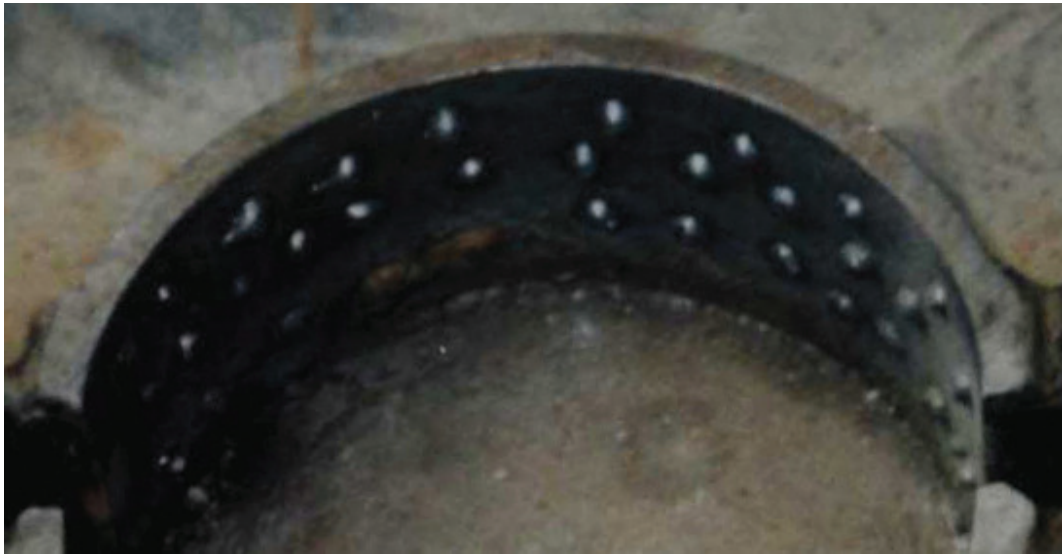
Figure 4.8 – Small welding patches applied into the inner surface of the clamping unit
